INVISTA – Wilmington, NC

Investigation Report

Date of Incident: Sunday, May 30, 2010

Investigation Report Date: July 23, 2010

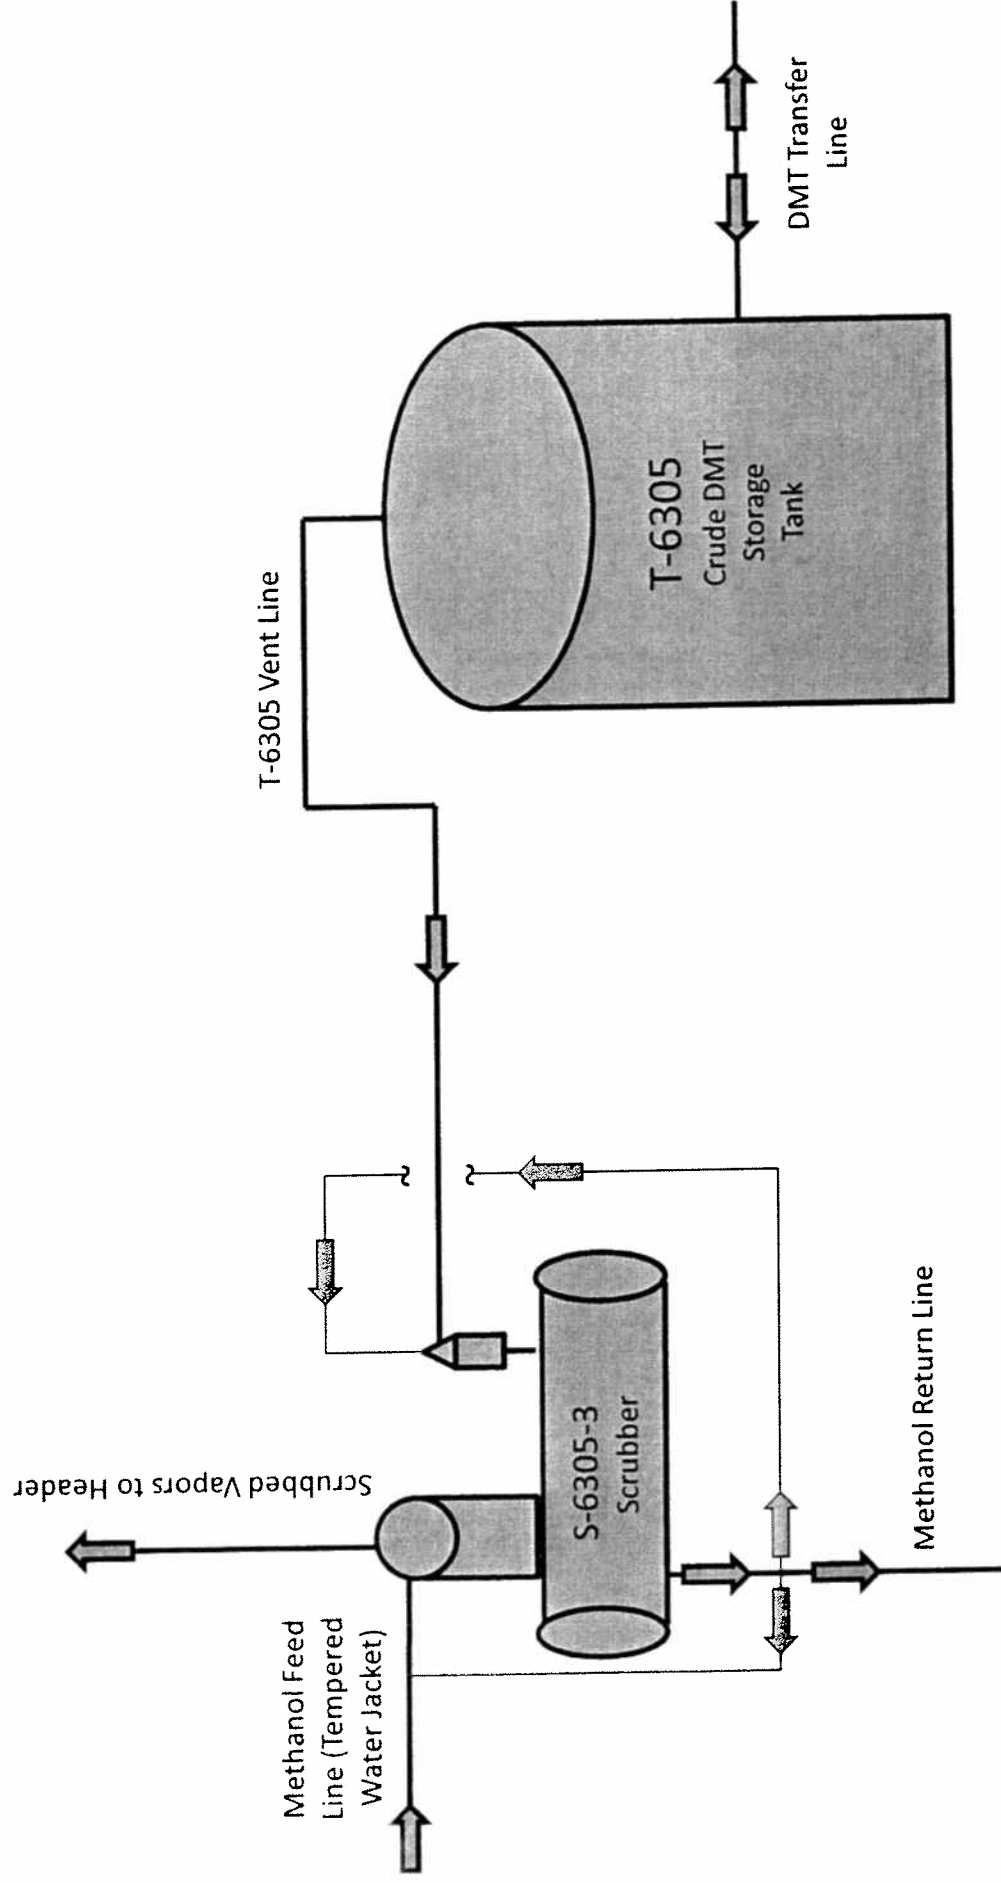
Diagram of Scrubber S-6305-3 and Tank T-6305

The INVISTA – Wilmington, NC site investigation team has determined that Methanol being fed to Scrubber S-6305-3 from Tank T-6309 overflowed into Tank T-6305 via the tank's vent line due to the Scrubber level indicator not providing an accurate reading. The inaccurate reading was a result of the float on the level indicator becoming embedded in solids in the Scrubber, thus resulting in an inaccurate low level indication in the Scrubber tank. As discussed below, the excessive solids in the Scrubber resulted from a lower than normal temperature of the tempered water system.

The investigation team evaluated the evidence and concluded that S-6305-3 plugged with solids thus causing the float on the level indicator to become stuck. The team concluded that the scrubber plugged because the tempered water temperature in D-line drifted down to approximately 50 degrees Celsius during shutdown activities.

This high level of solids in the Methanol feed liquid resulted in the plugging of the scrubber tank. Because of the plugging in the Scrubber tank, the float on the level indicator became imbedded in solids resulting in an inaccurate low level reading to the Control Room Operator ("CRO").

- Methanol overflowed from S-6305-3 via the Scrubber vent line and entered T-6305. At this point in the shutdown process, the DMT in T-6305 had cooled resulting in a crust forming over the molten DMT. The Methanol accumulated on the solidified surface of the DMT. When molten DMT was transferred to T-6305 from C-Line, as part of a routine procedure, the integrity of the crust on the DMT was compromised. This allowed the accumulated Methanol to come into contact with the molten DMT, rapidly vaporizing the Methanol creating a rapid rise in pressure inside T-6305, and resulting in the release and ignition of vapors from the tank.
