#### Trip Report:

David Kappelman, Health Physicist, US EPA Environmental Response Team

#### USEPA ERT site visit at R4 Smoky Mountain Smelter site

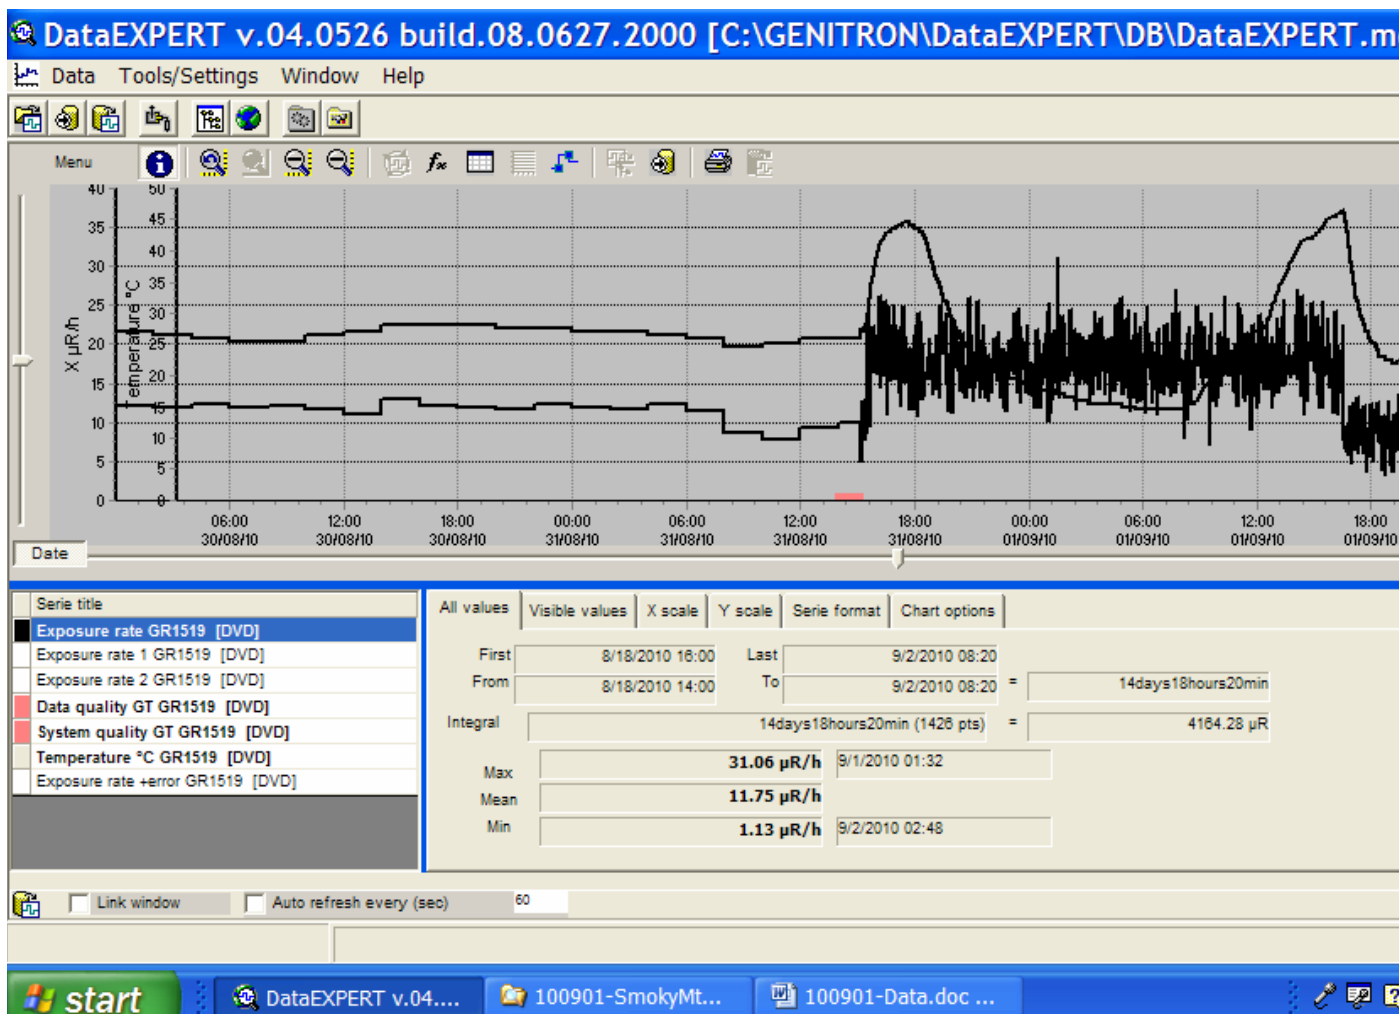
GF1519 Green Fence Post

boundary close to residences and in close proximity to where the TLDs were stored. Measurements indicate that the exposure rate at the property boundary is at normal background levels.
