RE: Category N Baseline Environmental Assessment  
Former Power Station and Copper Ore Processing Facility  
Lake Linden (Torch Lake Township), Michigan

On behalf of Meninc, Incorporated, Coleman Engineering Company is pleased to submit this Baseline Environmental Assessment for the Former Power Station in Lake Linden, Michigan.

**PHASE I ENVIRONMENTAL SITE ASSESSMENT**

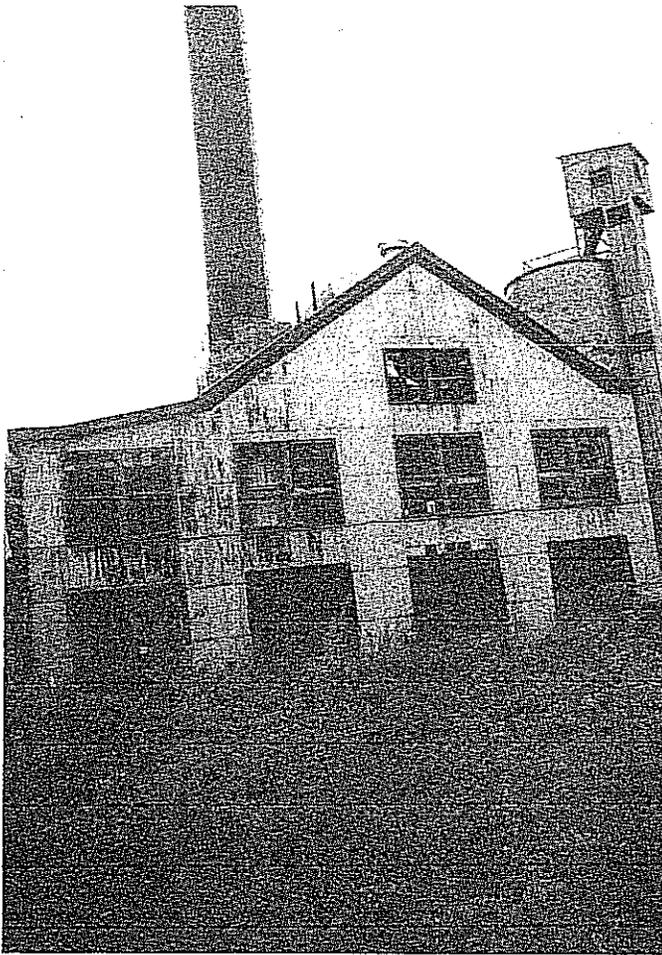
Condemned Building- The building which remains on the site bears a notice on one its doors identifying the structure as Condemned as Dangerous and Unsafe. The building should be properly razed and the material disposed if in an acceptable manner.

**SOUTH SIDE OF POWER PLANT BUILDING**

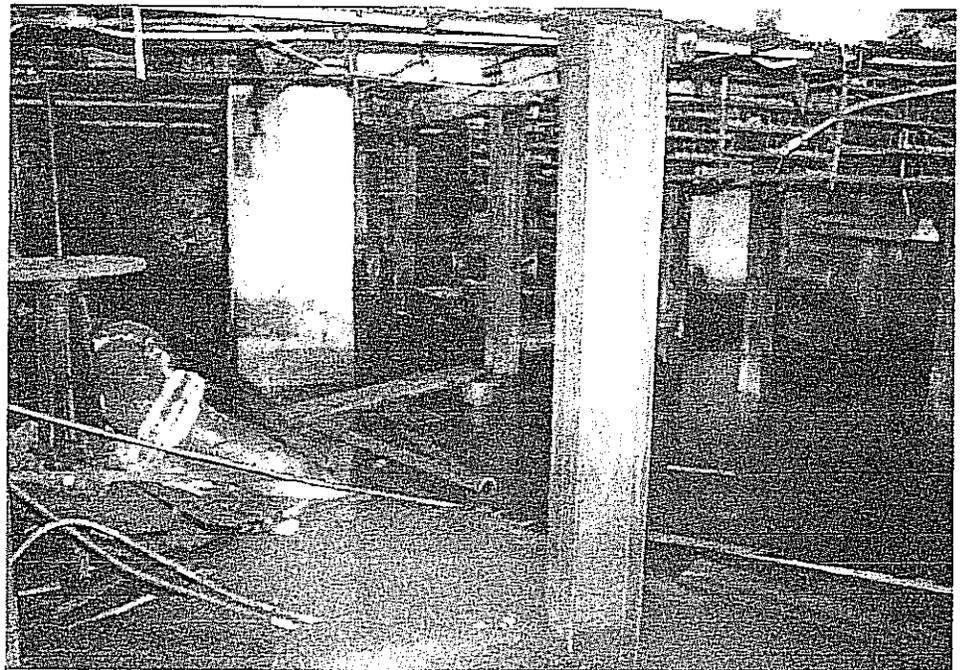
- Water in basement of the building - There is a large volume of water in the lower level of the power plant building. This water may contain elevated concentrations of metals or other compounds used in the building. The presence of the water may obscure, by submergence, evidence of the presence of hazardous materials.

**FLOODED LOWER LEVEL OF POWER PLANT BUILDING**

- Water in basement of the building - There is a large volume of water in the lower level of the building. This water may contain high concentrations of metals or other compounds used in the building. This material may pose a threat of a release of a hazardous substance. The water, which has accumulated within the basement, should be sampled for appropriate parameters. (This should be considered a REC until investigative efforts indicate there is no threat to the environment.)  
At a minimum, this water should be characterized and disposed of properly.

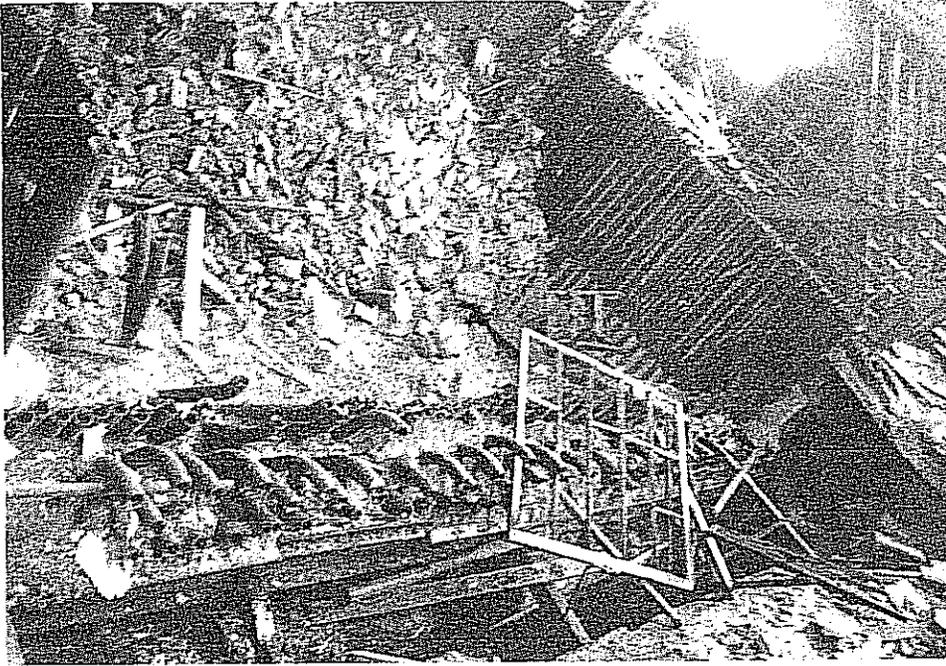
**DISMANTLED BOILER IN POWER PLANT BUILDING**

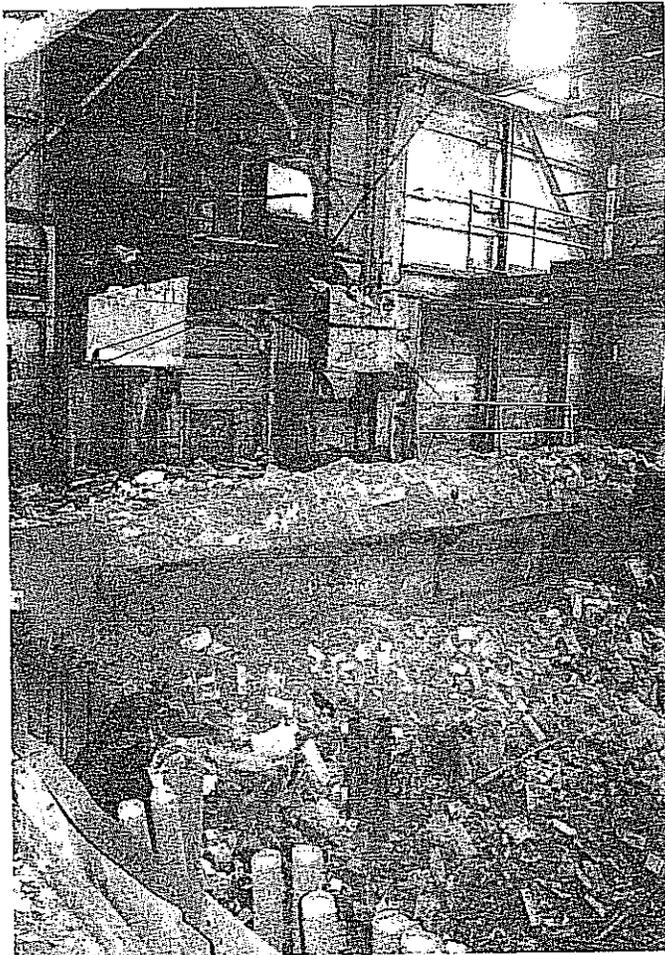
**DISMANTLED BOILER AND  
COAL SHOOTS IN POWER PLANT**

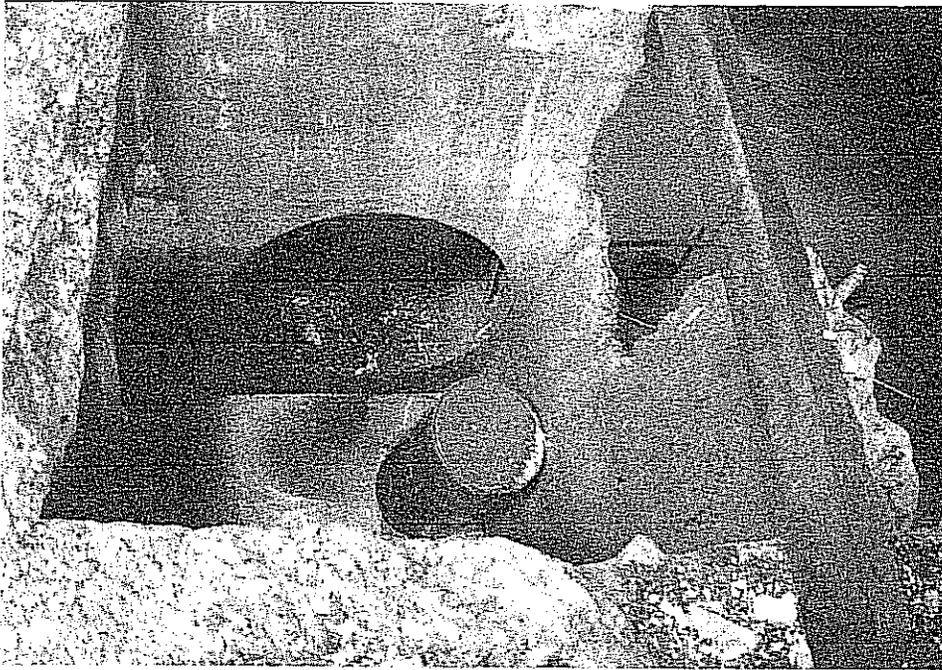
- Drums inside of building - The contents of the drum observed inside the power plant building at the site are unknown. The drum is presumed to represent a material threat of a release of a hazardous substance.

**DRUMS IN FLOODED LOWER LEVEL  
OF POWER PLANT BUILDING**

- Drums in and outside of building - The contents of the drums observed at the site are unknown, the drums are presumed to represent a material threat of a release of a hazardous substance. The contents of the drums should be identified and then disposed of properly.

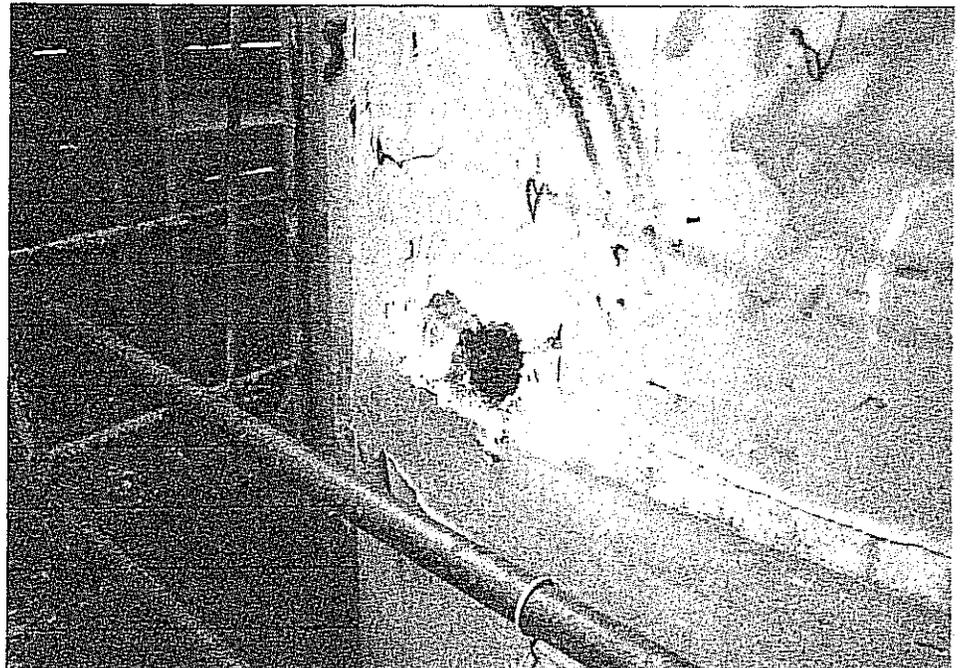
**POSSIBLE ASBESTOS CONTAINING INSULATION AROUND  
SMOKE STACK SOUTH END OF POWER PLANT BUILDING**

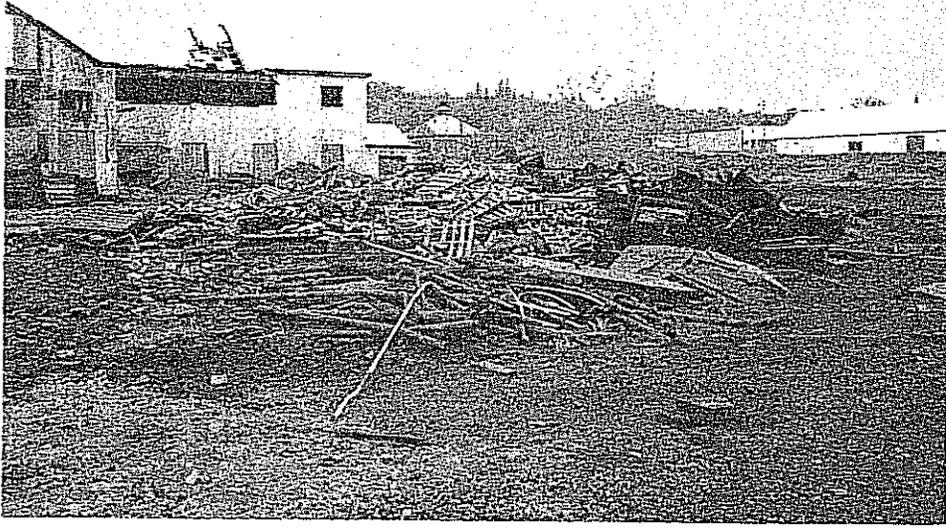
- Improper disposal of general wastes over the years - The disposal practices of waste at the facility is not completely known. There are several areas on the property, which are covered with debris (including coal ash and stamp sands) exceeding 10 feet in depth. It is not known what materials may have been included with the debris.

**DEBRIS PILE ON BOILER PLANT RUINS BOILER  
PLANT BUILDING IN BACKGROUND - LEFT**

- Improper disposal of general wastes - The disposal practices of waste at the facility is not completely known. There are several areas on the property which have several feet of debris (including coal ash and stamp sands) exceeding 10 feet in depth, piled in haphazard manner. It is not known what materials may have been included with the debris. This should be considered a REC until investigative efforts indicate there is no threat to the environment. Further research on waste disposal practices and a subsurface investigation of these areas may be appropriate.

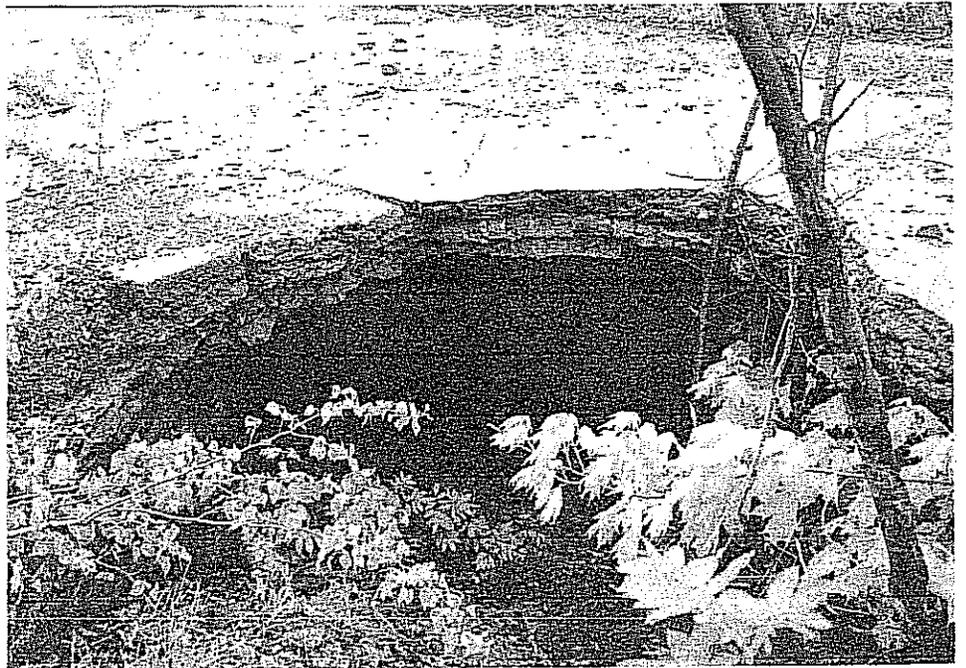
- Tunnel-Portions of a brick lined tunnel were found adjacent to the foundation of the former boiler house. Because of concerns regarding personnel safety, the interior of the tunnel could not be inspected. There may be hazardous materials in the inaccessible portions of the tunnel.

**TUNNEL ENTRANCE UNDER BOILER PLANT RUINS**
