**AFTER-ACTION REPORT  
for the  
Lawrence Aviation Industries**

**LANDSCAPE RESTORATION PLAN  
Village of Port Jefferson, NY**

Date Generated : June 7, 2010

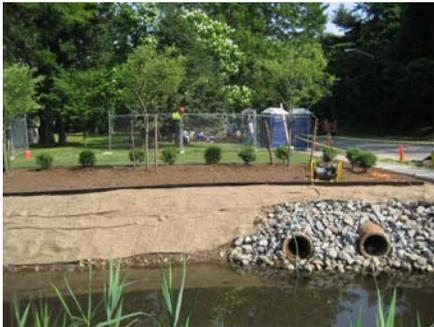
View of the restored area with jute mat used as erosion control.

Although EPA worked closely with Village representatives and others during the planning phase, deviations from the Landscape Restoration Plan were necessary for better project efficiency. Originally thought that erosion along the Creek bank would be an issue, grasses were going to be planted to provide structural integrity of the land. It was found that phragmites, known as common reeds, started reclaiming the bank less than 2 weeks following sediment removal activities. These plants

are capable of providing erosion control along the Creek bank, as well as providing the natural vegetative theme the Village suggested. A seed blend of rye grasses was spread along the Creek bank as an interim measure until the phragmites completely return.

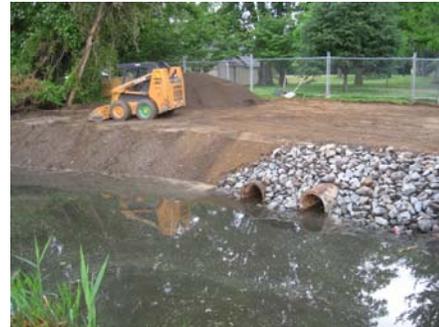
Outfall pipes, found in the center of Old Mill Creek, were reattached during the Landscape Restoration activities.

During the sediment removal activities, two outfall pipes were found in the center of Old Mill Creek. It was decided that EPA should reinstall the pipes since work was being conducted along the Creek bank. Personnel added additional support under the pipes prior to reinstallation. This activity was not outlined in the Landscape Restoration Plan.

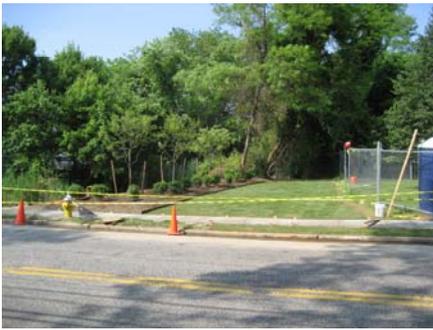
View of newly restored area.
