**Expanded Site Inspection Update
Cone Mills (Old Union Bleachery) Site
Greenville County
EPA ID. SCD 003 358 744**

Site Assessment Section

South Carolina Department of Health & Environmental Control

November 15, 2006

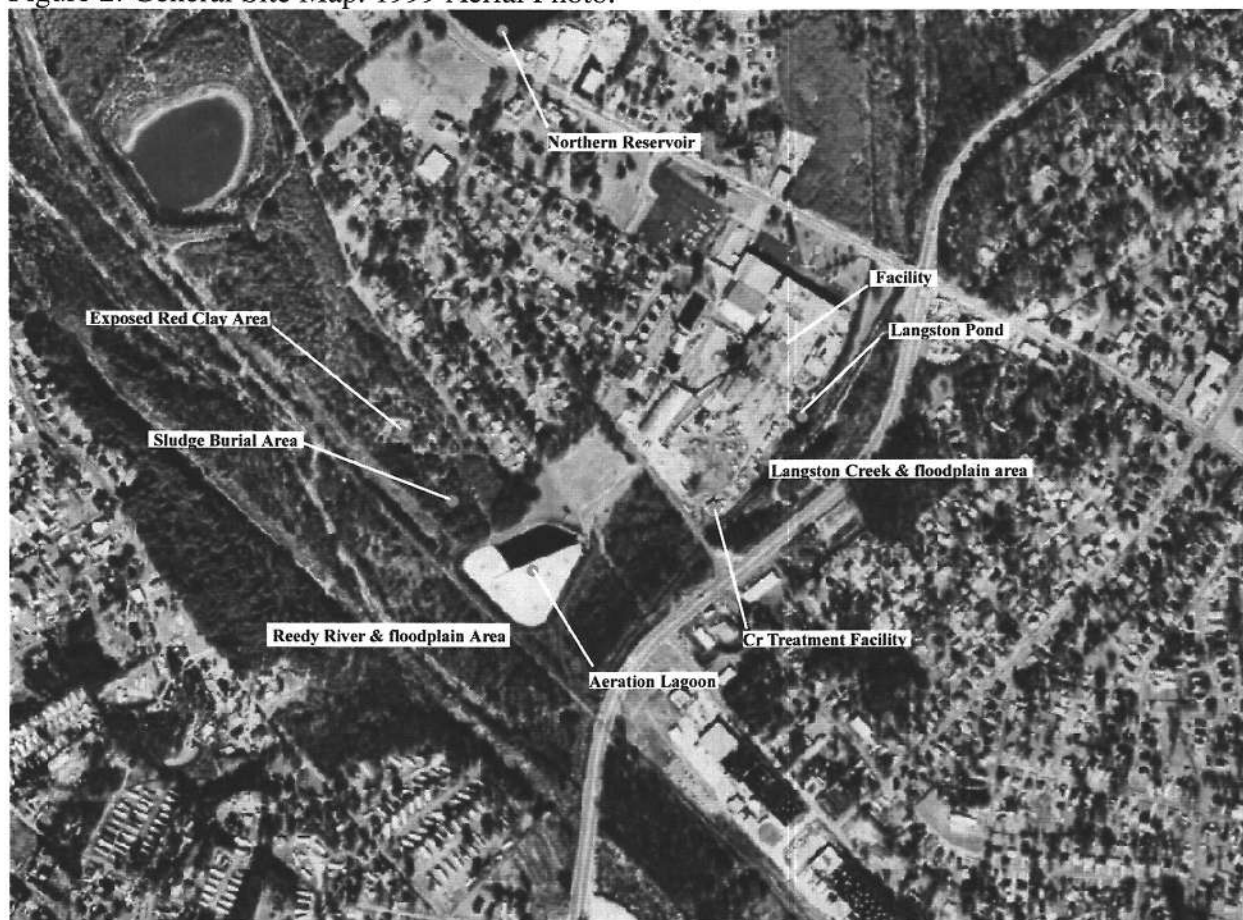
Figure 2: General Site Map. 1999 Aerial Photo.

The Cone Mills/Union Bleachery site is located along the Reedy River approximately 3 miles north of downtown Greenville in Greenville County, South Carolina (34° 53' 2.91" North Latitude, 82° 25' 31.31" West Longitude) (Ref. 4, 22). The old textile facility is bordered to the east by Langston Creek and Hwy 253, and to the south by the Reedy River. Old Buncombe Road forms the northern boundary of the facility, and a residential neighborhood is located immediately to the west. The entire facility is fenced and a guard is stationed at the gate. However, the fence is not maintained in several areas and evidence of unrestricted access was observed (Ref. 7). The general topography of the site is a northwest to east/southeast slope toward Langston Creek and the Reedy River. Groundwater flow in the area follows the same trend (Ref. 21). Several ponds are located in the area. One small pond (<0.25 ac.), an impoundment of Langston Creek, is immediately east of the facility. Two other large ponds (both >1 ac.) are north and northwest of the facility. These two ponds historically received water pumped from the Langston Creek impoundment. Access is not adequately restricted to either impoundment, and fishing occurs in both (Ref. 7). Langston Creek and the Reedy River are also fisheries (Ref. 7, 13). In addition, a school is located north of the site directly across Old Buncombe Road from the large easternmost reservoir. A large aeration lagoon (>3 ac.) occupies a portion of the southern extent of the site as well. Other notable site features include: a former sludge burial area west of the aeration lagoon; Cone Mills' groundwater remediation system (chemical precipitation of chromium), housed in a fenced area on the eastern side of the site; and the Reedy River floodplain dump area, south of the aeration lagoon. A general site map showing areas of concern is included in Figure 2.

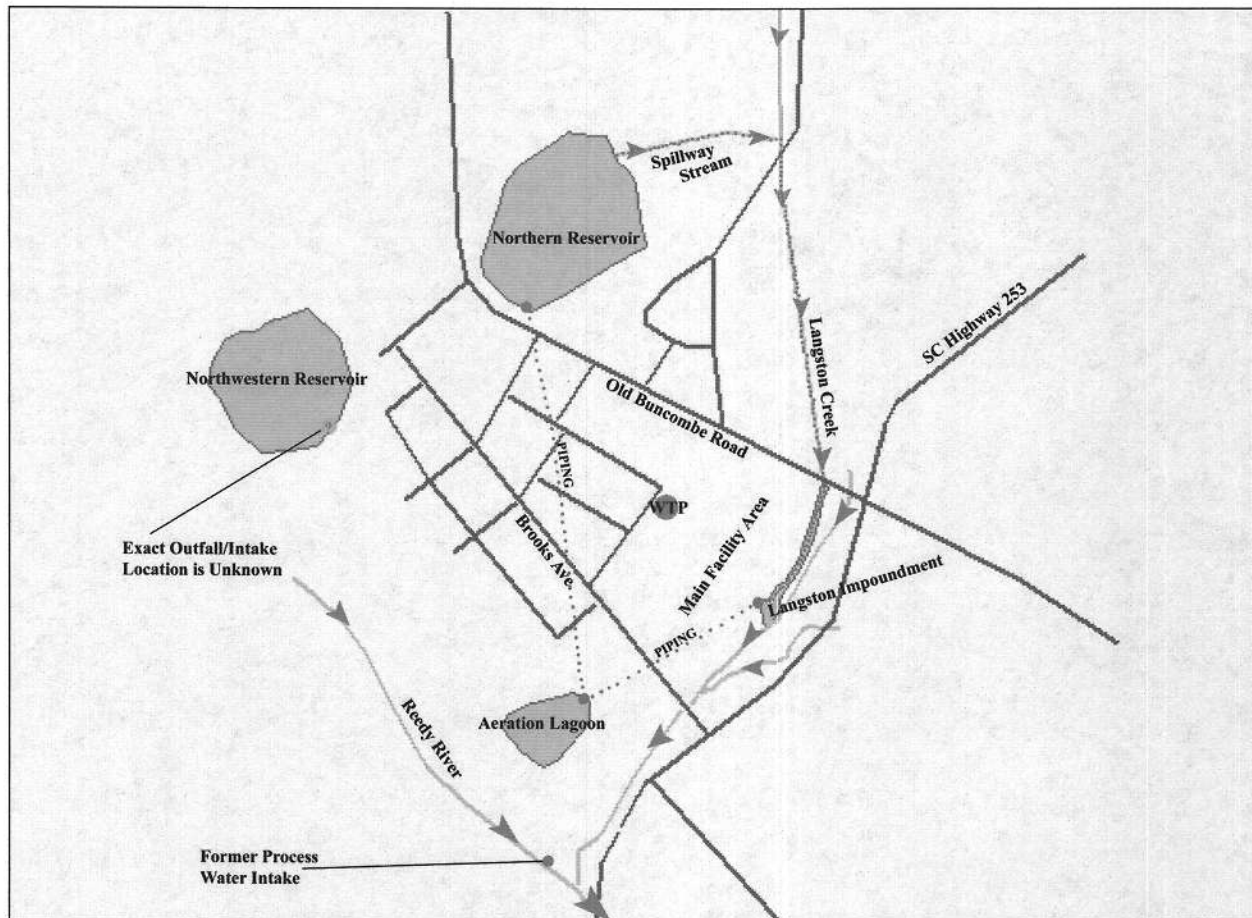
The surface water characteristics of this site are complex. Langston Creek flows along the eastern boundary of the site from north to south and joins the Reedy River on the southeastern corner of the site near the Reedy River Floodplain source area. Four tributaries join Langston Creek as it flows past the site. The floodplains of both Langston Creek and the Reedy River include wetlands. In addition, Langston Creek has been impounded onsite, although today the dam of this impoundment is damaged and not currently in service. The original, now unused, outfall from the mill is located in this impoundment (Ref. 7). There is a water intake in this impoundment that was used to pull water up to a large reservoir (<16 acres) to the north of the site for process water storage. This reservoir, when filled to capacity, discharged overland to wetlands and subsequently Langston Creek - upstream of the site. A general diagram of surface water features is included in Figure 3. In addition, a second reservoir is located to the northwest of the site. Cone Mills formerly used this reservoir for process water storage as well. Prior to the construction of the aeration lagoon, intakes on the Reedy River brought water to these reservoirs. Neither reservoir receives water from a perennial or an intermittent stream.

Figure 3: General Site Surface Water Attributes Map. The dotted red line indicates the cycle of water between Langston Creek, the plant process water piping system, and the Northern Reservoir. All known current and former intakes/outfalls are shown as large red markers. The exact location of the former intake/outfall in the Northwestern Reservoir (yellow marker) is unknown. Blue arrows indicate flow direction. The large blue marker depicts the location of the process water treatment facility. Note: piping from the Langston Impoundment and the Northern Reservoir intersects at the aeration lagoon; however, water from the lagoon is not exchanged at this intersection.

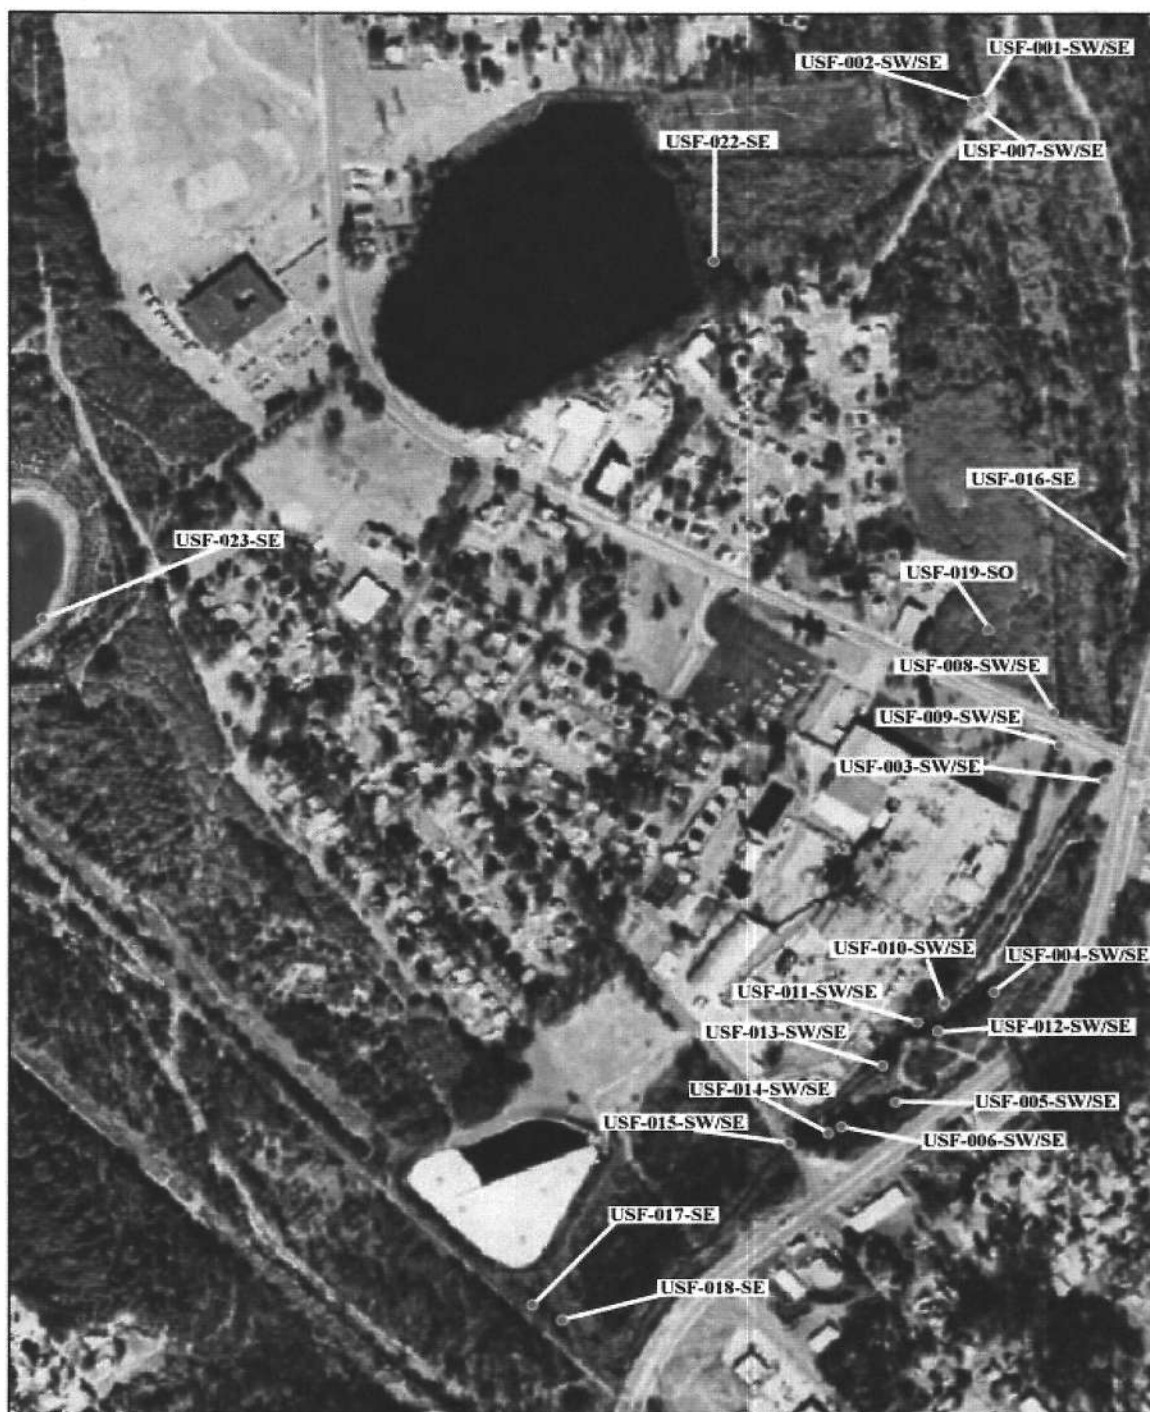
Figure 4: ESI Update Cone Mills (Old Union Bleachery) Site Surface Water and Sediment Sample Location Map. 1999 Aerial Photo.

Additional sampling of the Langston Creek surface water pathway was also conducted as part of the ESI Update during June 2005. The primary purpose of this sampling was to re-evaluate the surface water conditions at the site with background values collected from upstream of all known site influences. Fifteen (15) surface water and fifteen (15) sediment samples were collected from Langston Creek and its tributaries as part of the ESI Update investigation. These samples show elevated metals in both surface water and sediment as the creek flows past the site. Most notably, chromium levels in surface water were as high as 140 ppb in surface water (*USF-013-SW*). The highest chromium level identified in sediments was 11,000 ppm (*USF-005-SE*). Selected analytical results are shown for the surface water and sediments collected from Langston Creek in Tables 2 and Table 3 respectively. A sample map is included in Figure 4. A complete list of analytical results is attached in Appendix 2.

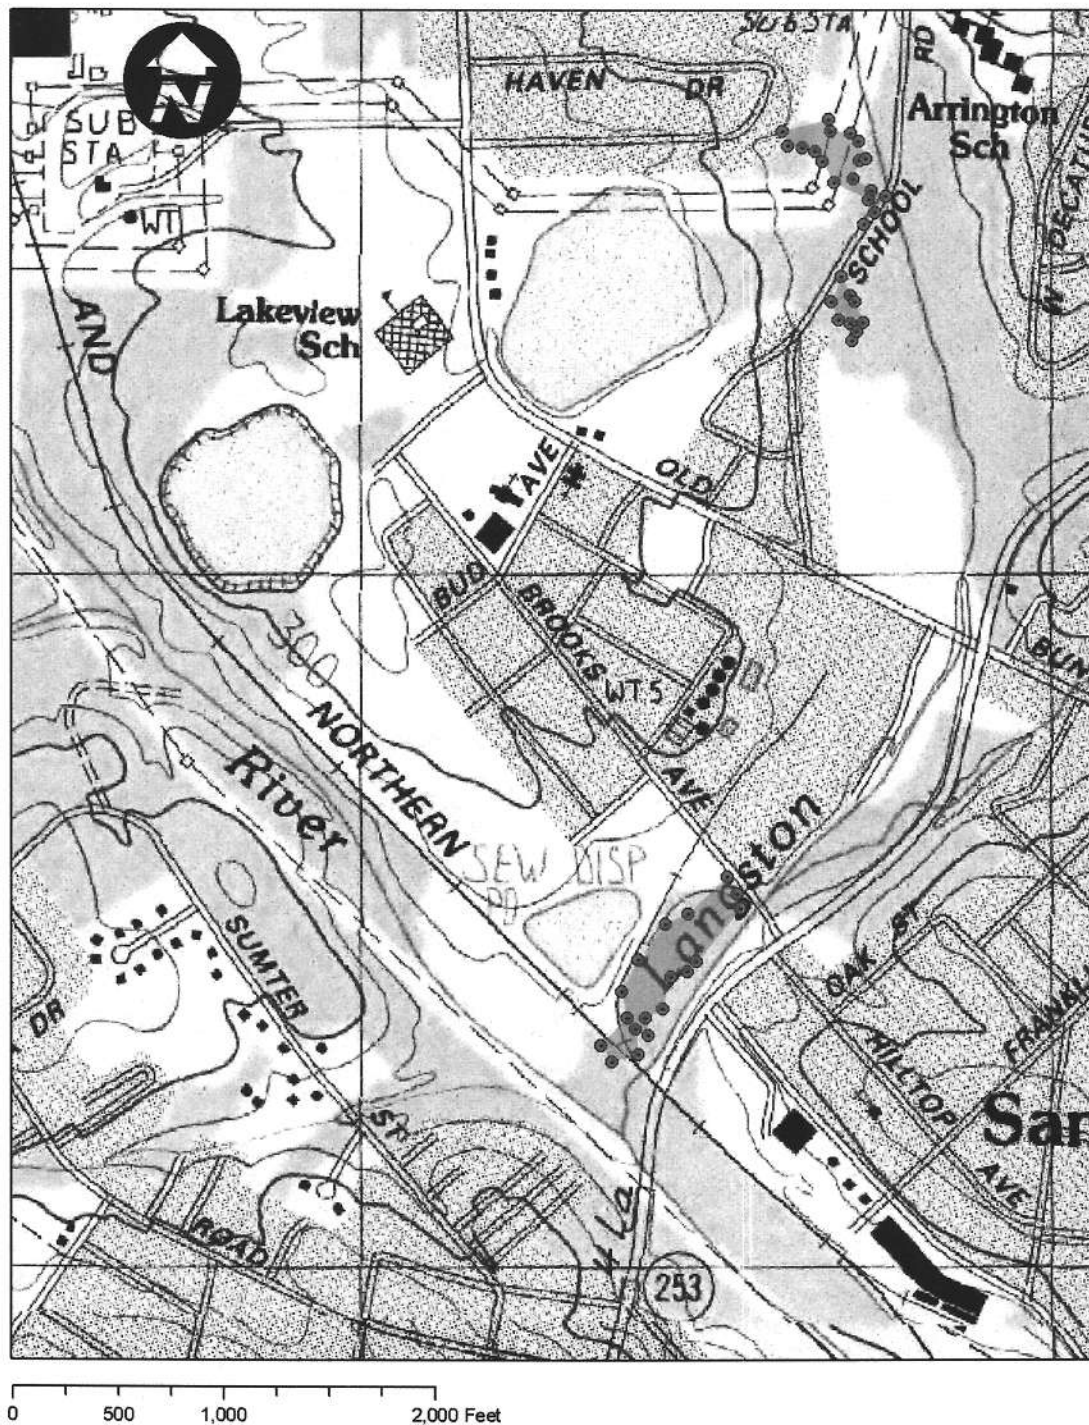
According to the USFWS, "The Service's objective of mapping wetlands and deepwater habitats is to produce reconnaissance level information on the location, type and size of these resources. The maps are prepared from the analysis of high altitude imagery. Wetlands are identified based on vegetation, visible hydrology and geography. A margin of error is inherent in the use of imagery; thus, detailed on-the-ground inspection of any particular site may result in revision of the wetland boundaries or classification established through image analysis" (Ref. 4). Since a release has been identified in this wetland, onsite delineation of the wetland was necessary. The boundaries of the wetland were identified and delineated with GPS (see Figure 5) (Ref. 4, 7).

Figure 5: ESI Update Cone Mills (Old Union Bleachery) Site Wetlands Delineation. USGS 1980 Topo. Wetlands Areas are highlighted in red.
