Asbestos Inspection Report

Cone Mills / Old Union Bleachery Site
3335 Old Buncombe Road
Greenville, SC 29617

AECOM Project 60133878.03
Date of Inspection: June 14-16, 2010
Date of Report: July 19, 2010

RE: Asbestos Investigation Report
Cone Mills/Old Union Bleachery Site
Greenville, South Carolina
AECOM Project No. 60133878

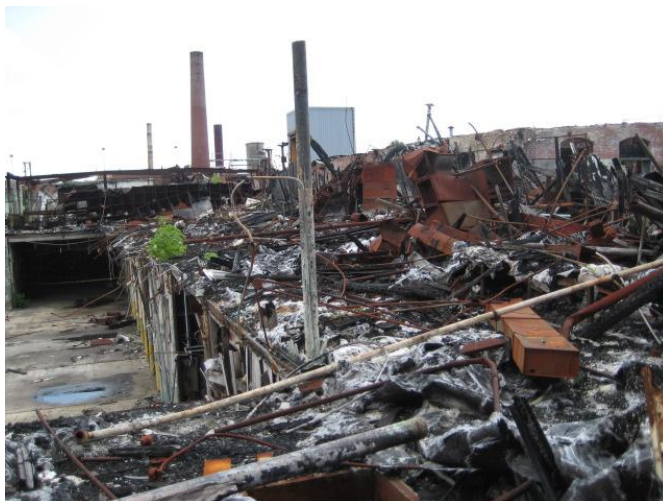
The building was largely damaged in a fire. The fire caused most of the roof and second floor to collapse. The portion of the second floor that did not collapse is covered with various debris and the structural stability is unknown and therefore was inaccessible for sampling for this survey. The below photo (Photo 1) is taken from an access ladder to the second floor.

Debris on the second floor include roofing material, piping, insulation, metal, wood, and ash. The second floor is assessable by this ladder and a stair case.

Photo 1. Second Floor View

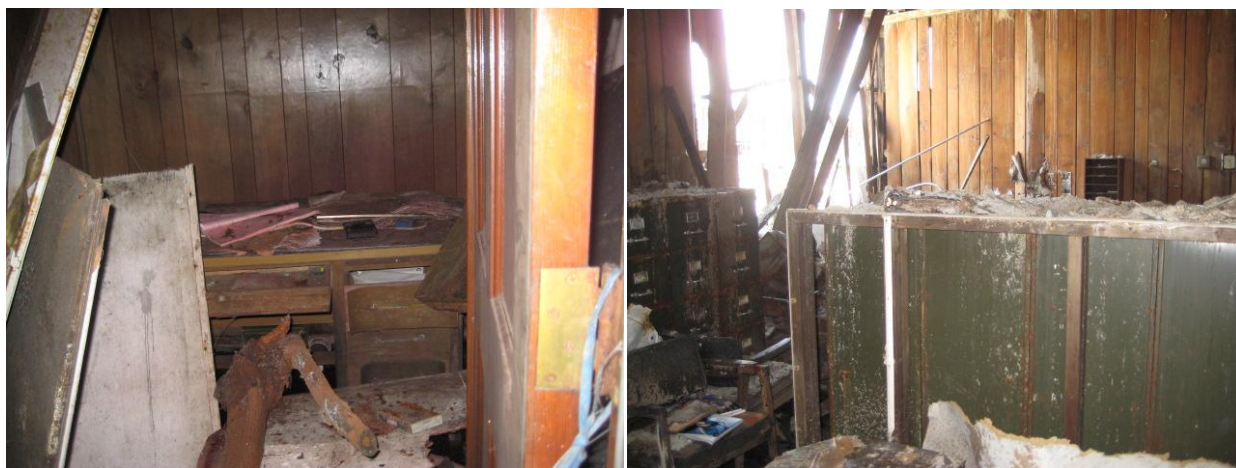
Photos 2 and 3. Front Offices (Figure 1, Area 8)

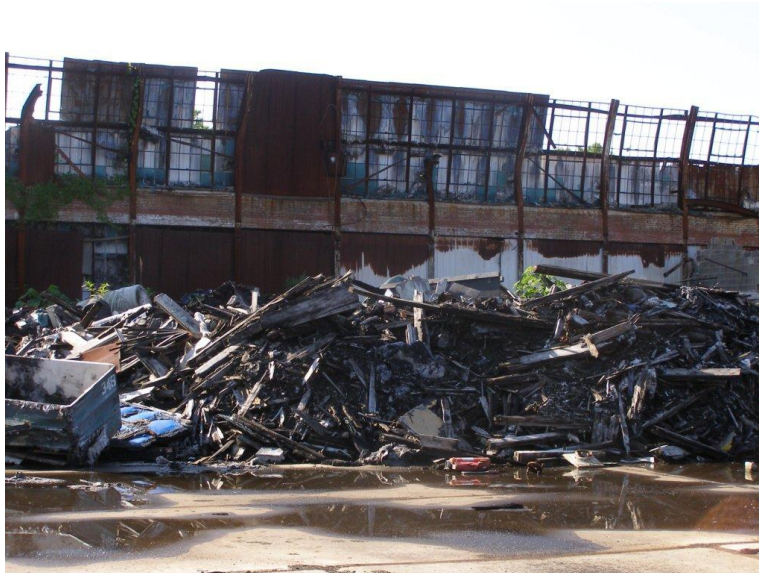
Photo 8. An example of debris piles.

Debris piles are observed to contain wood, ash, metal, roofing materials, plastic, fabric, piping, and insulation. In order to properly sample these piles, the entire pile would need to be sorted. The potential for creating a fiber release was deemed high and would require heavy machinery to move the debris.

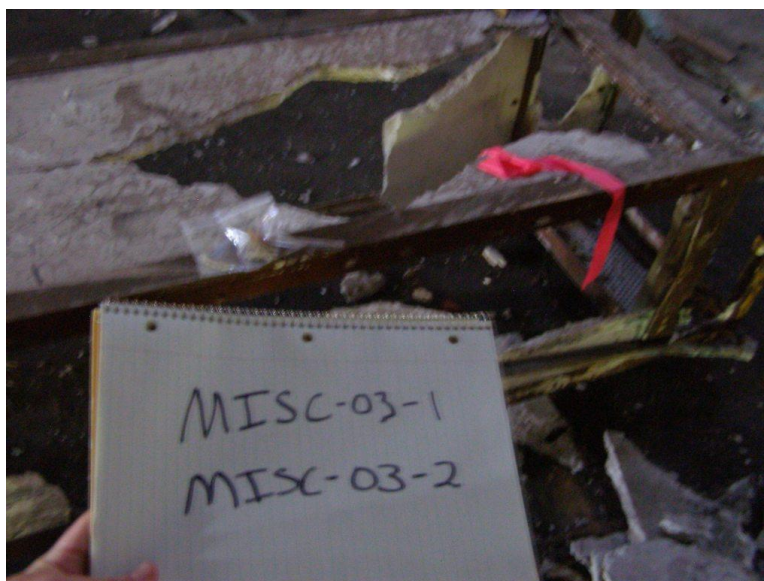
Misc-03-1_Particle Board Appearance

Misc-03-2_Particle Board Appearance

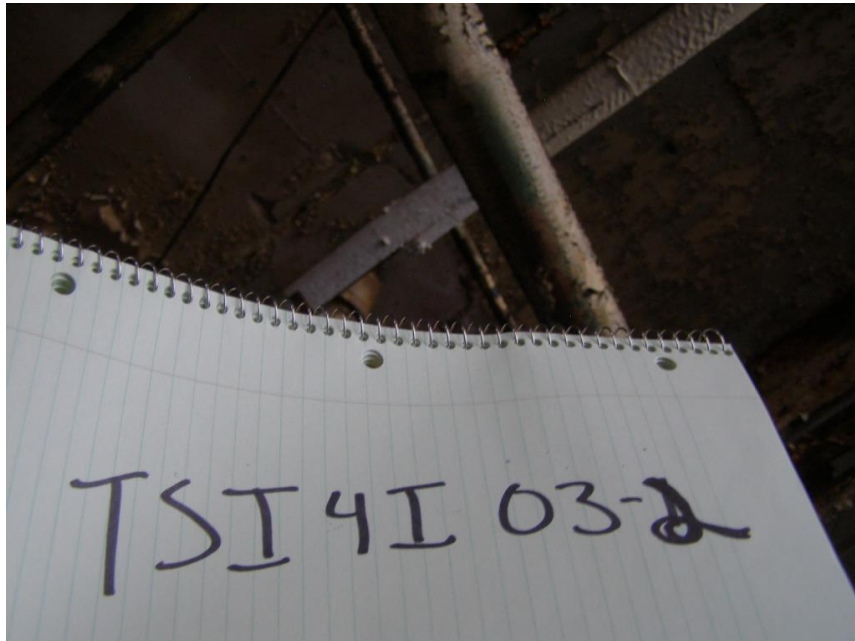
Tsi4i-03-2_4 inch White Wrapped Piping-Orange Band

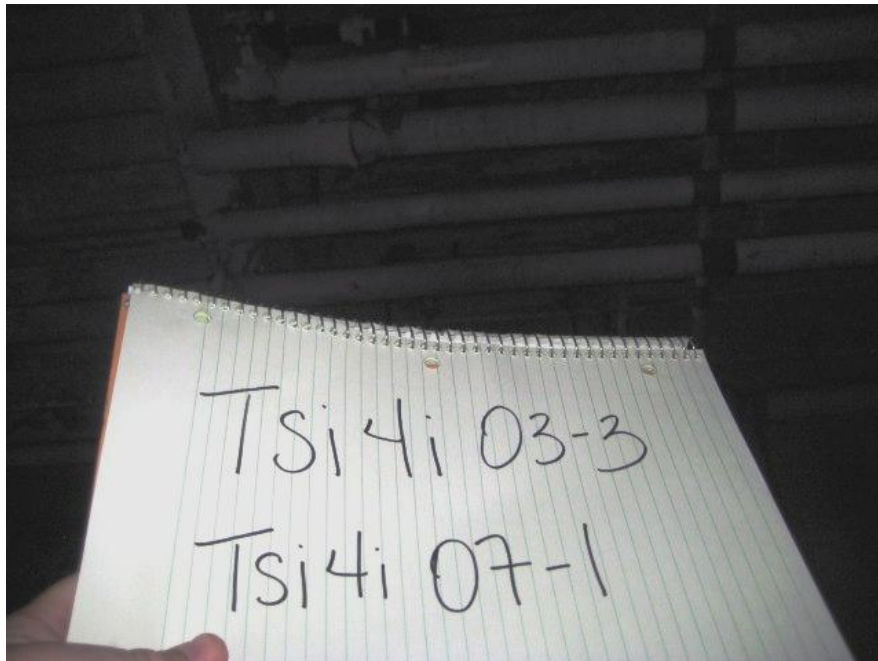
Tsi4i-03-3_4 inch White Wrapped Piping-Orange Band

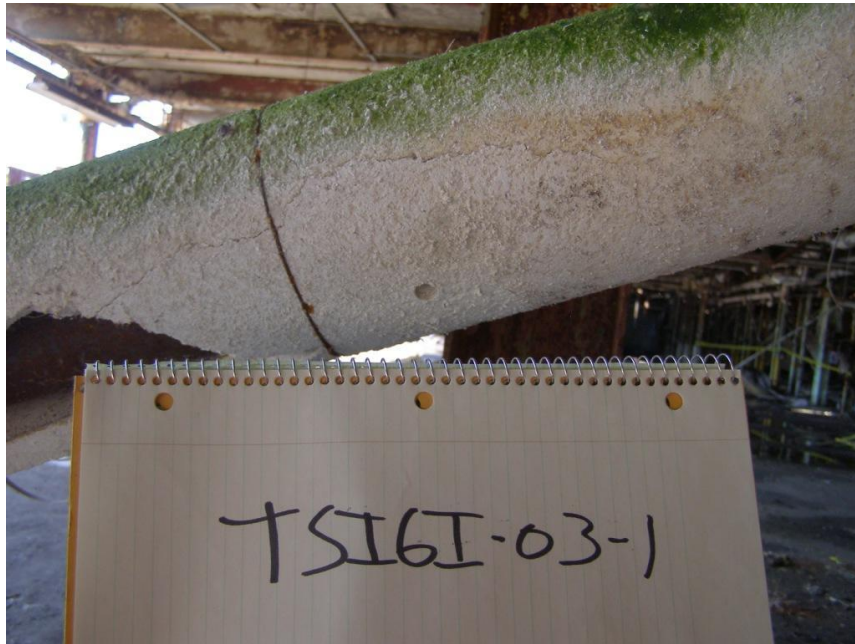
Tsi6i-03-1_6 inch Wrapped with Red Arrows

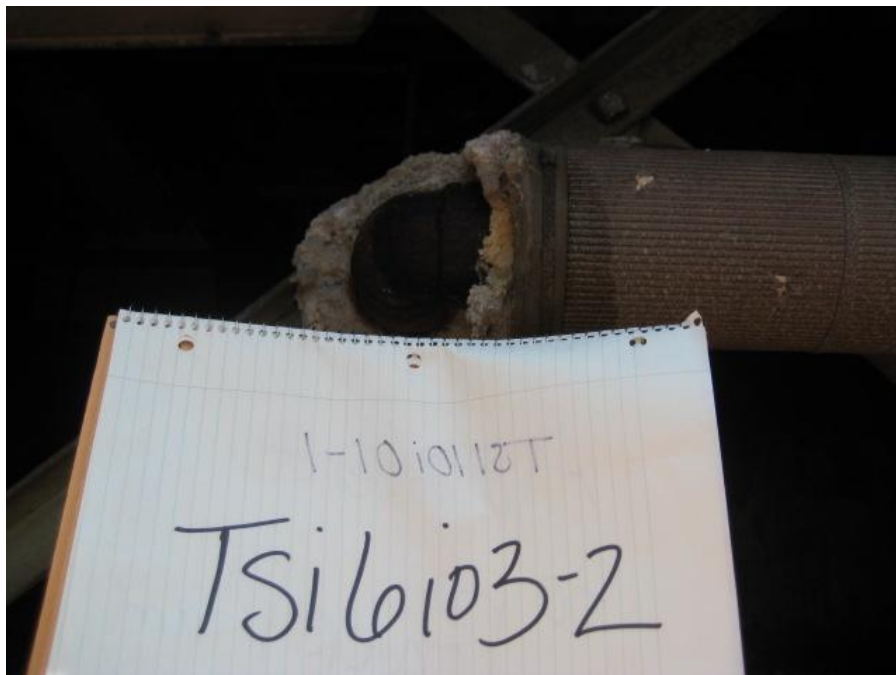
Tsi6i-03-2_6 inch Metal Wrapped Piping

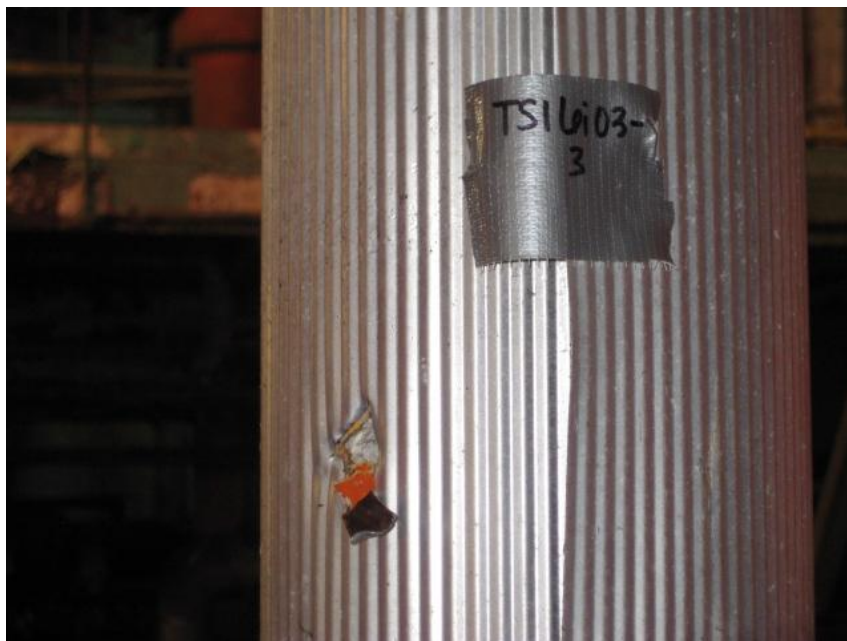
Tsi6i-03-3_6 inch Metal Wrapped Piping
