Photographic Documentation

Client: U.S.E.P.A

Location: Barker Chemical, Inglis, FL

Prepared by: Tetra Tech EMI

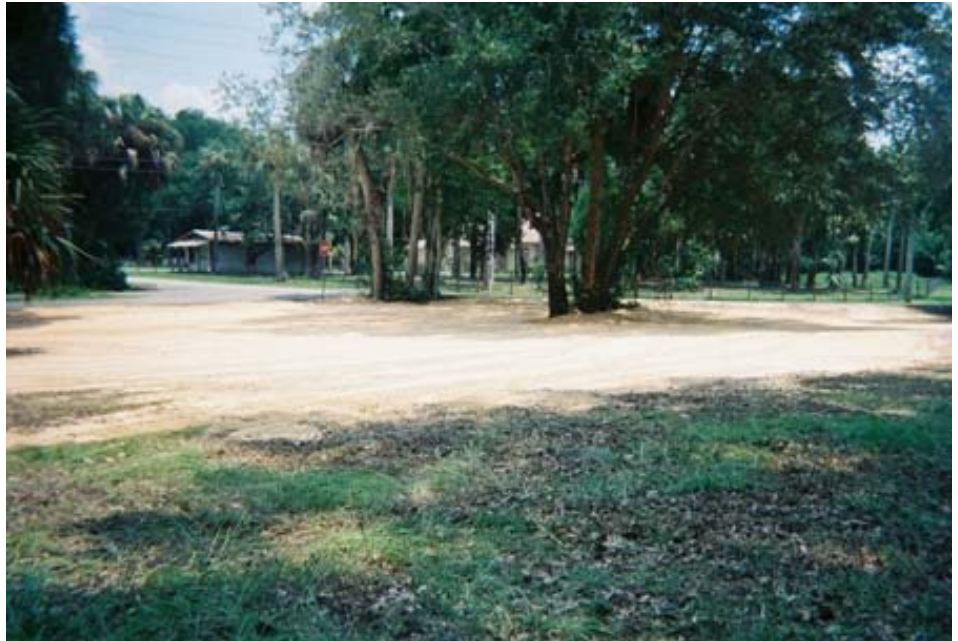
Photograph No. 1

Description: Final grade in parcel BCC-102

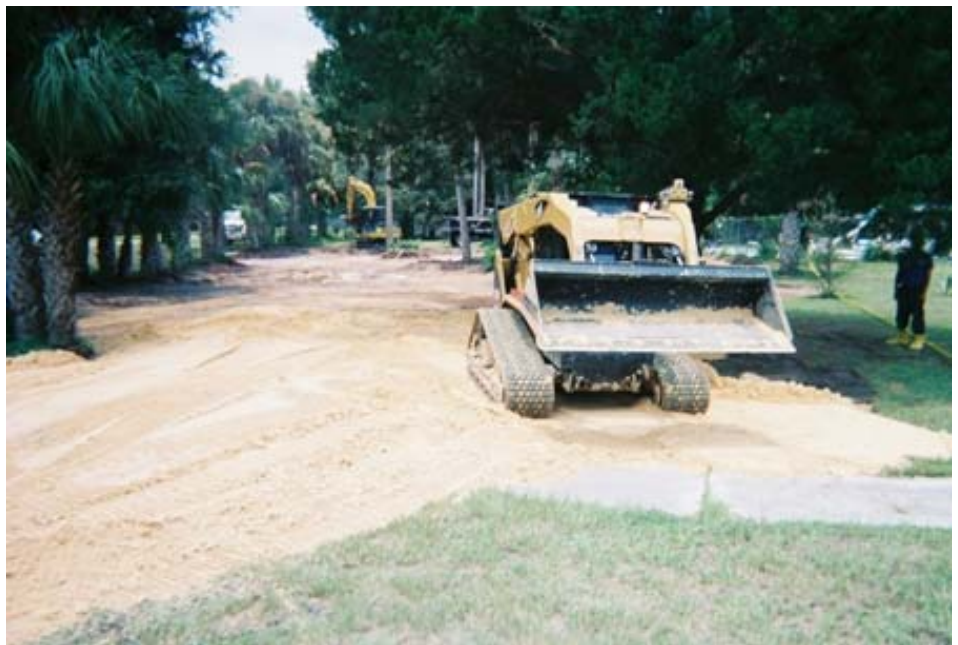
Photograph No. 2

Description: Backfilling and excavating activities in BCC-103.

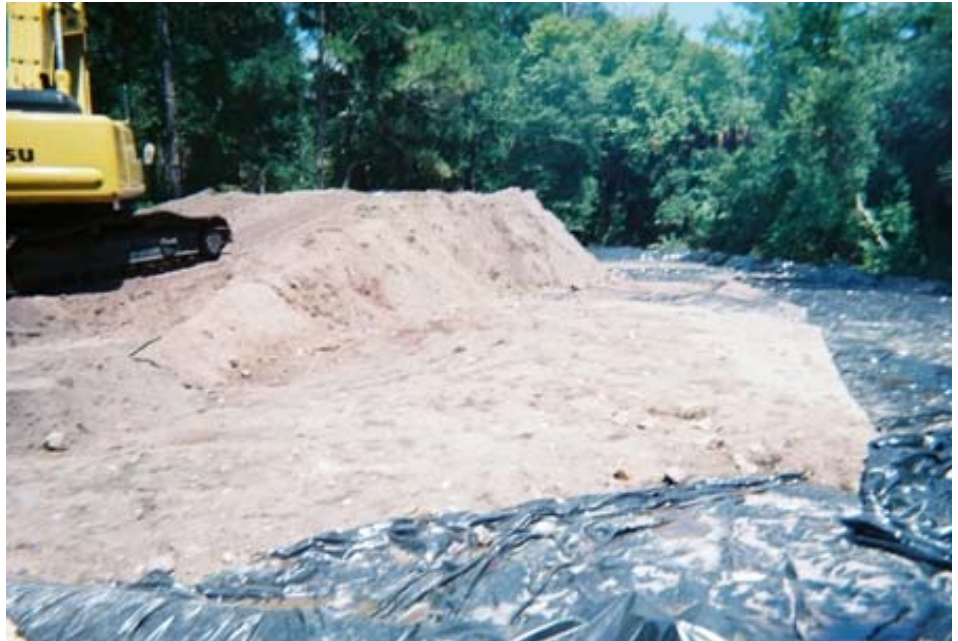
Photograph No. 3

Description: Stockpile of excavated soil to be treated.

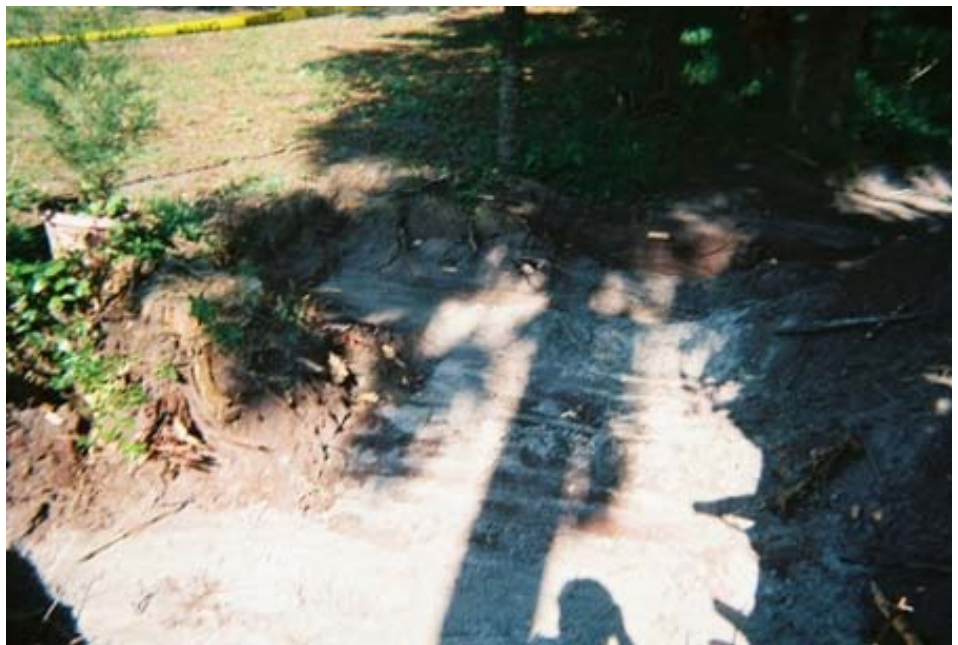
Photograph No. 4

Description: Excavation with stained soil in BCC-103.

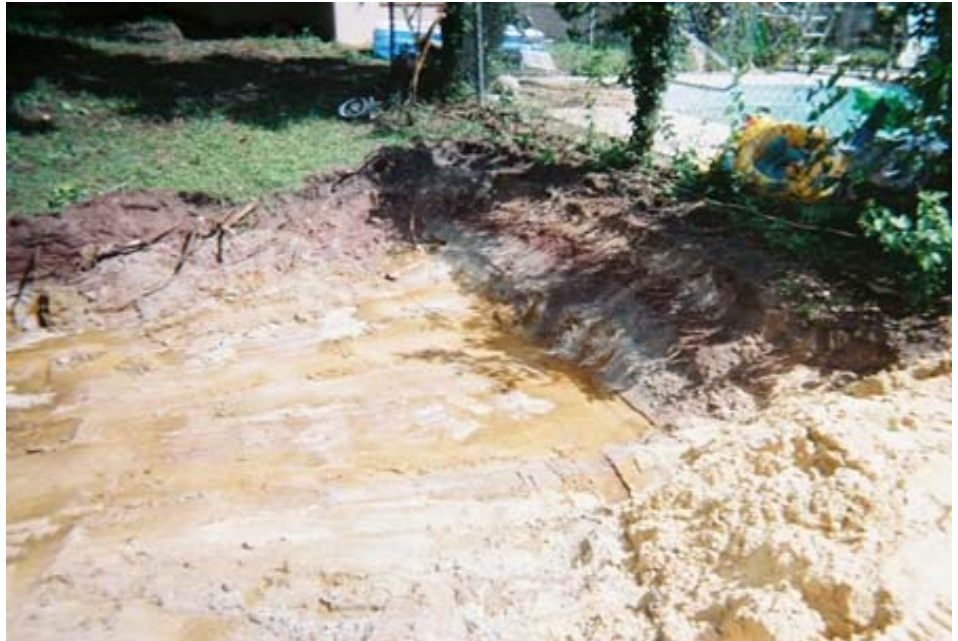
Photograph No. 5

Description: Excavation and shoring with stained soil near pool in BCC-103.

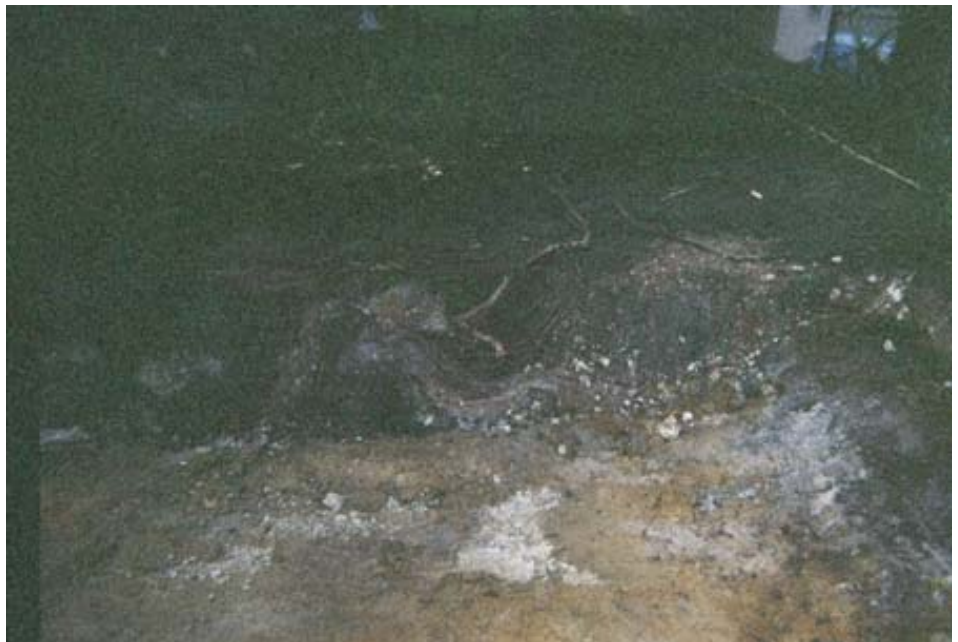
Photograph No. 6

Description: Stained soil in BCC-103.

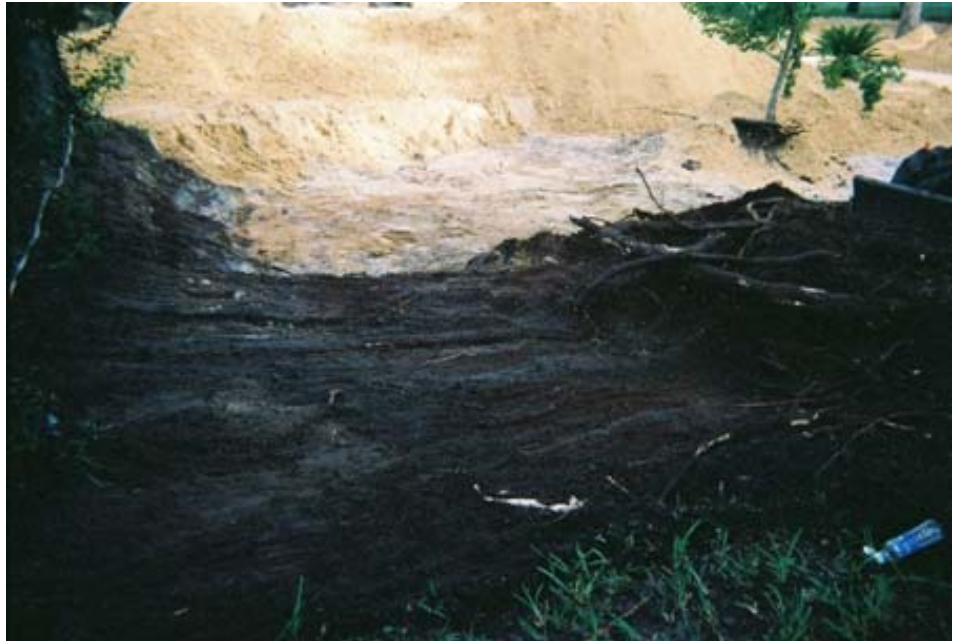
Photograph No. 7

Description: Excavation and stained soil in BCC-103.

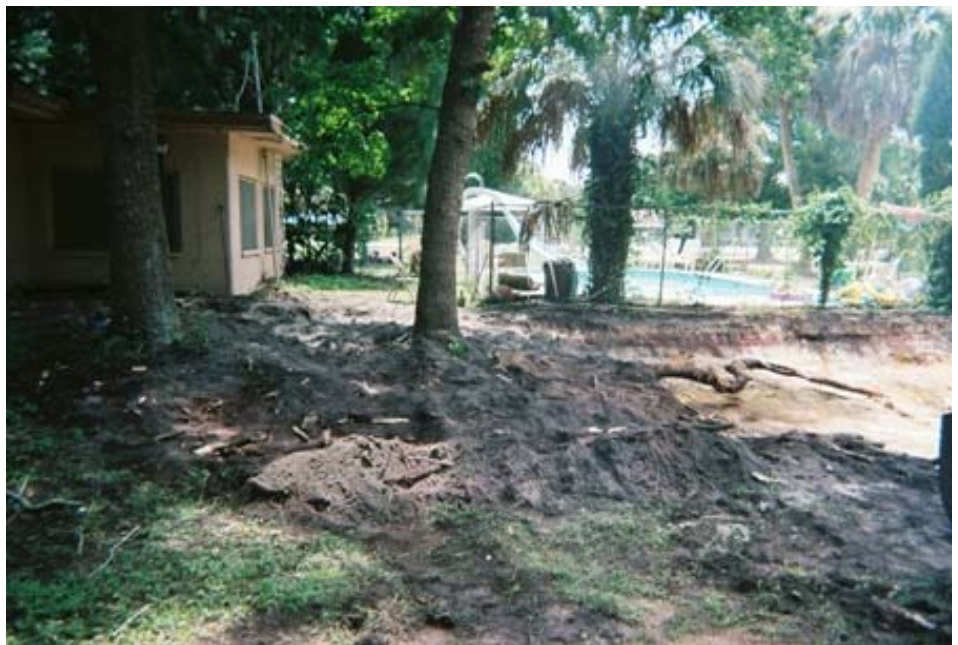
Photograph No. 8

Description: Scrape excavation of root mass with stained soil in BCC-103.

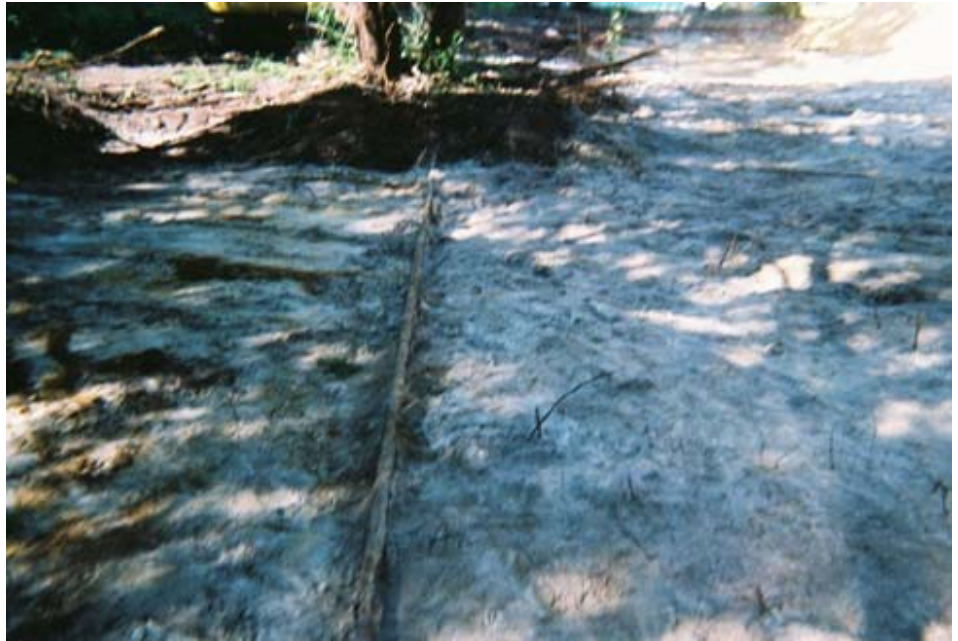
Photograph No. 9

Description: Unknown pipe uncovered in BCC-103.

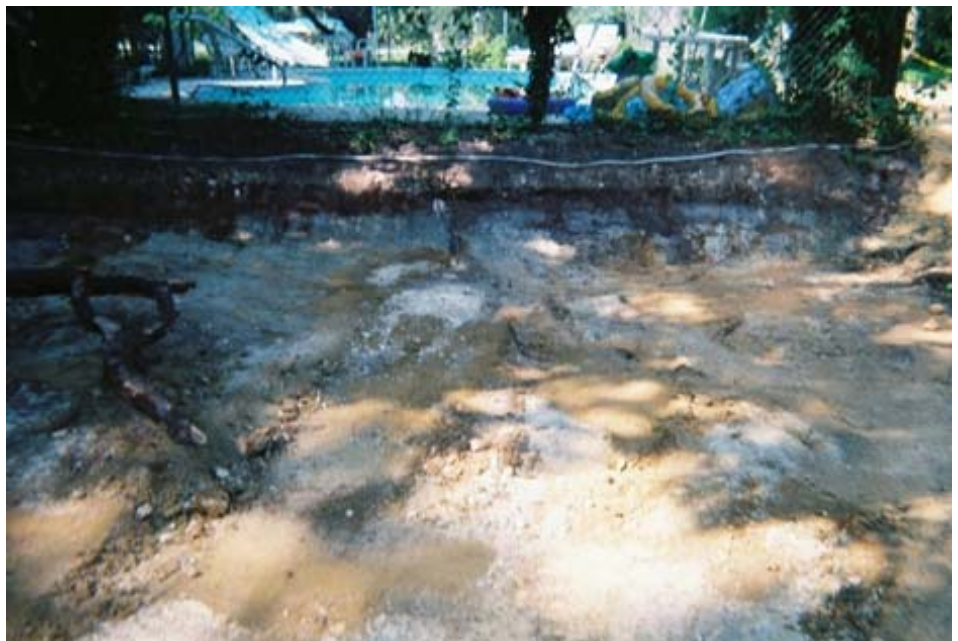
Photograph No. 10

Description: Contaminated soil lens in BCC-103.

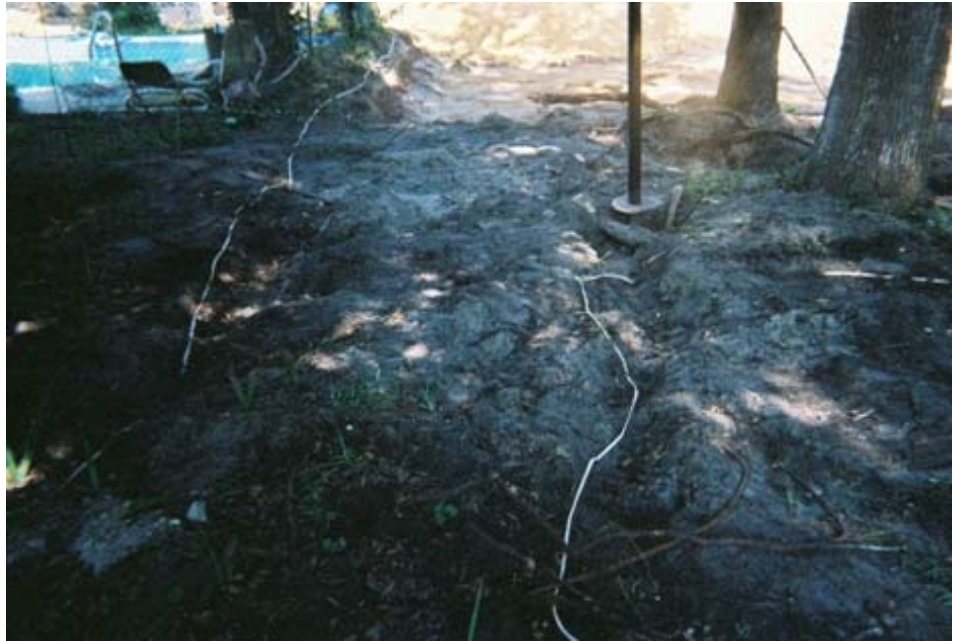
Photograph No. 11

Description: Utility lines uncovered near house in BCC-103.

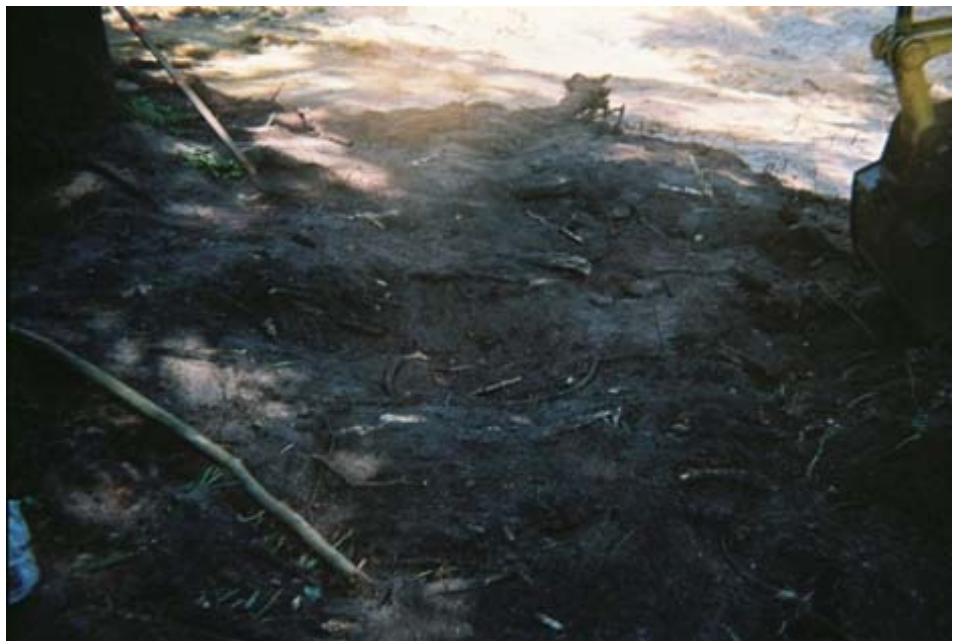
Photograph No. 12

Description: Stained soil in root mass in BCC-103.

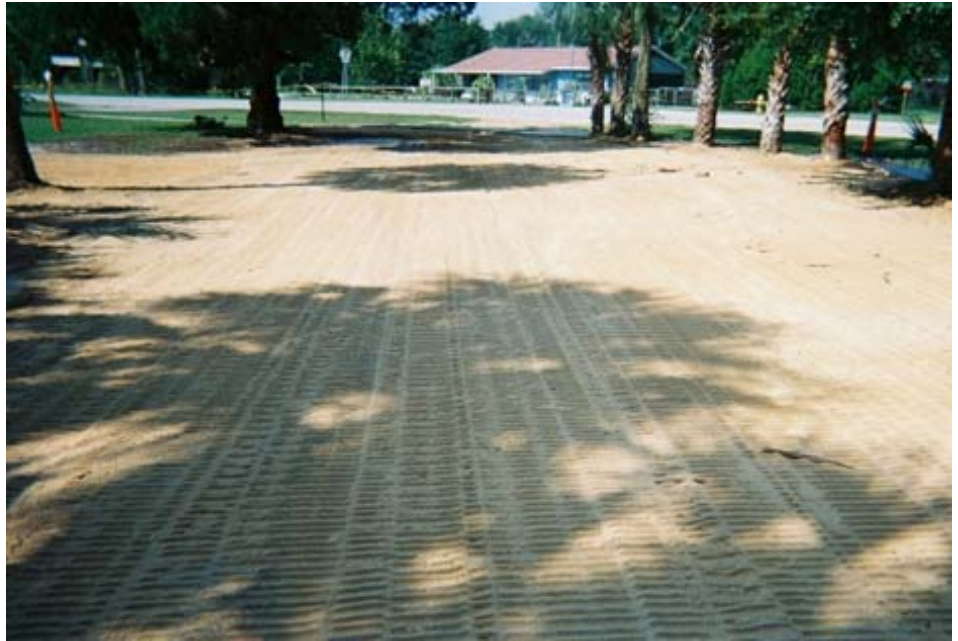
Photograph No. 13

Description: Final grade in southwest portion of BCC-103.

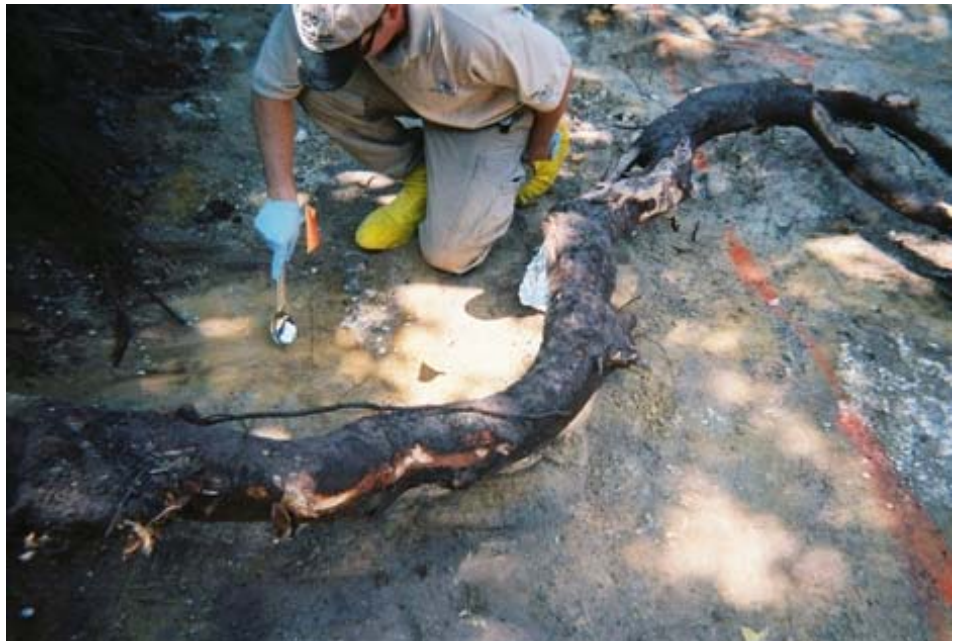
Photograph No. 14

Description: START collecting laboratory confirmation sample from BCC-103.

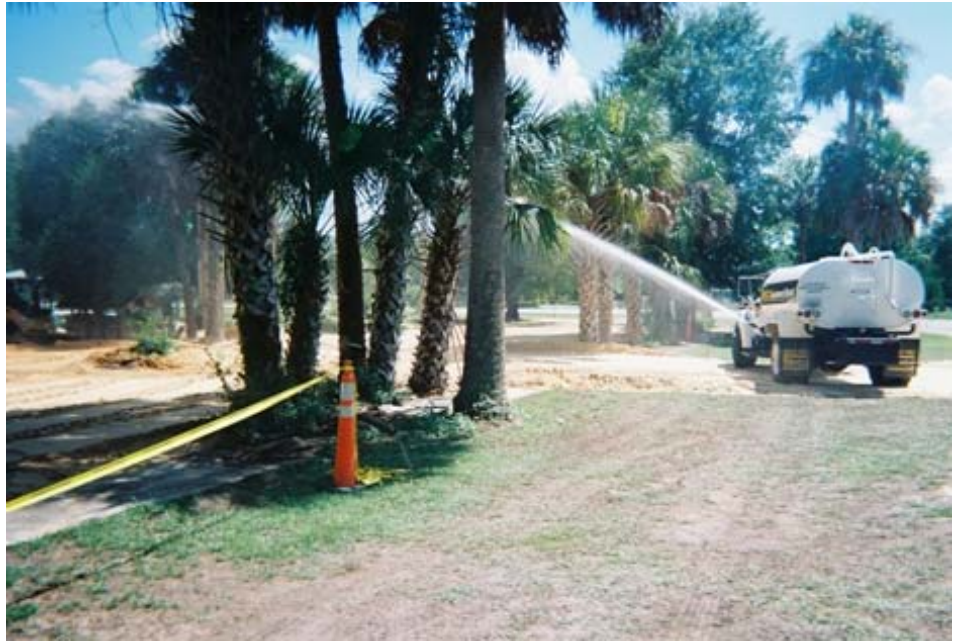
Photograph No. 15

Description: ERRS
conducting dust suppression in
BCC-103.

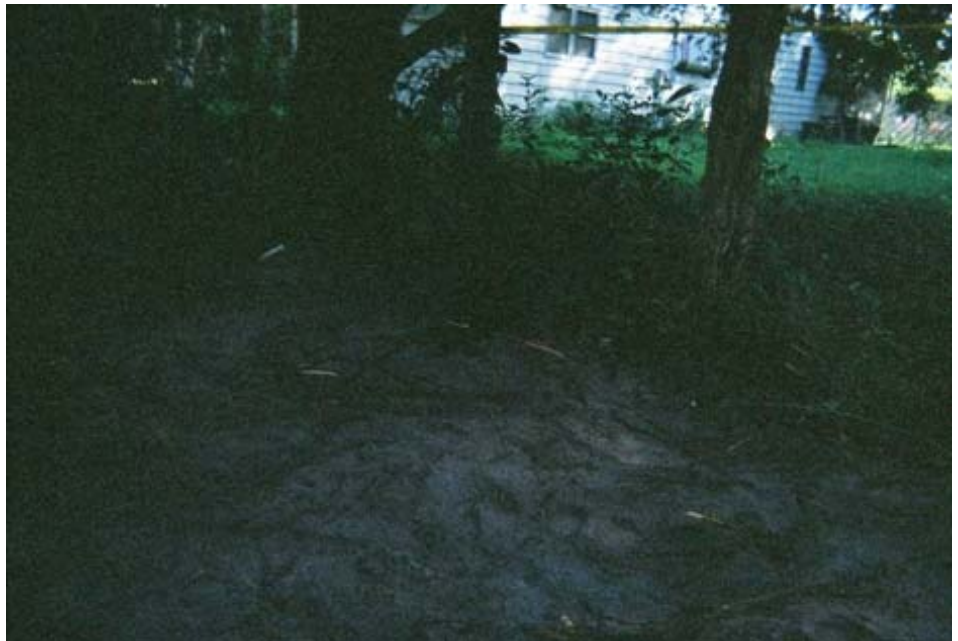
Photograph No. 16

Description: Abandoned
telephone line in BCC-103.

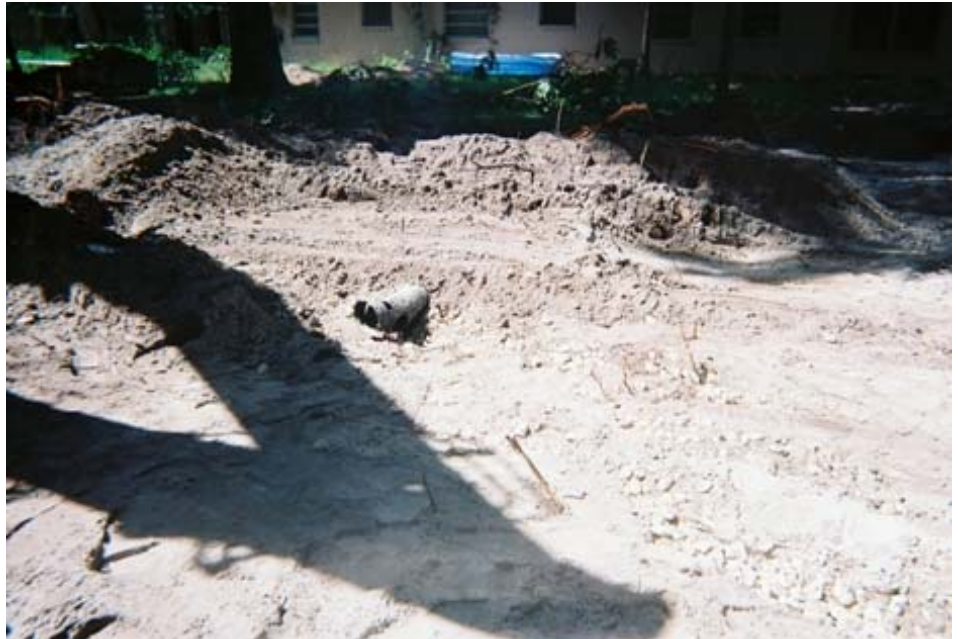
Photograph No. 17

Description: Septic system
leach field in BCC-103.

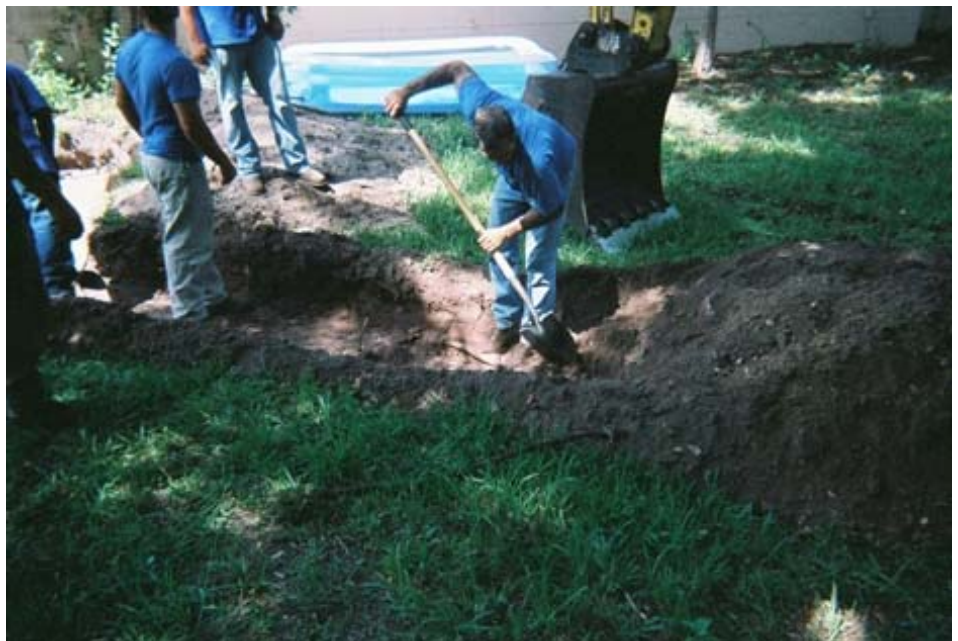
Photograph No. 18

Description: ERRS
investigating septic system
prior to excavating near t.

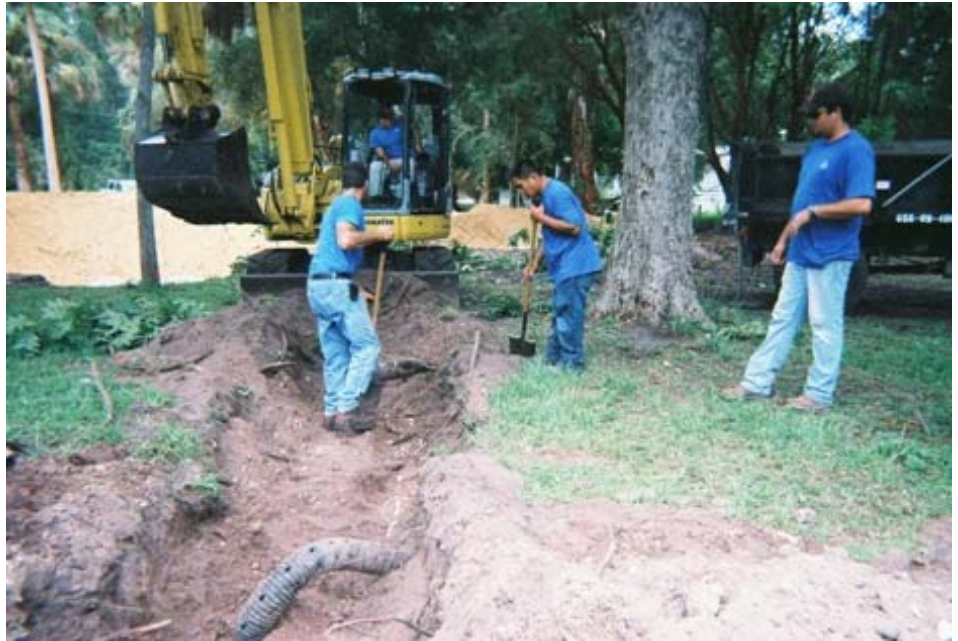
Photograph No. 19

Description: ERRS
uncovering septic line.

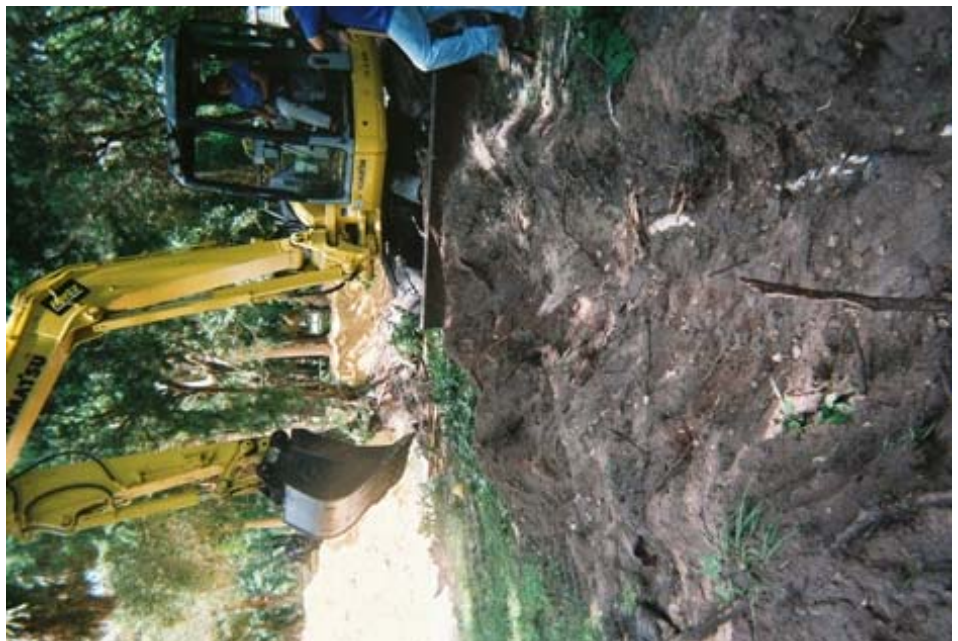
Photograph No. 20

Description: Septic line
towards leachfield.

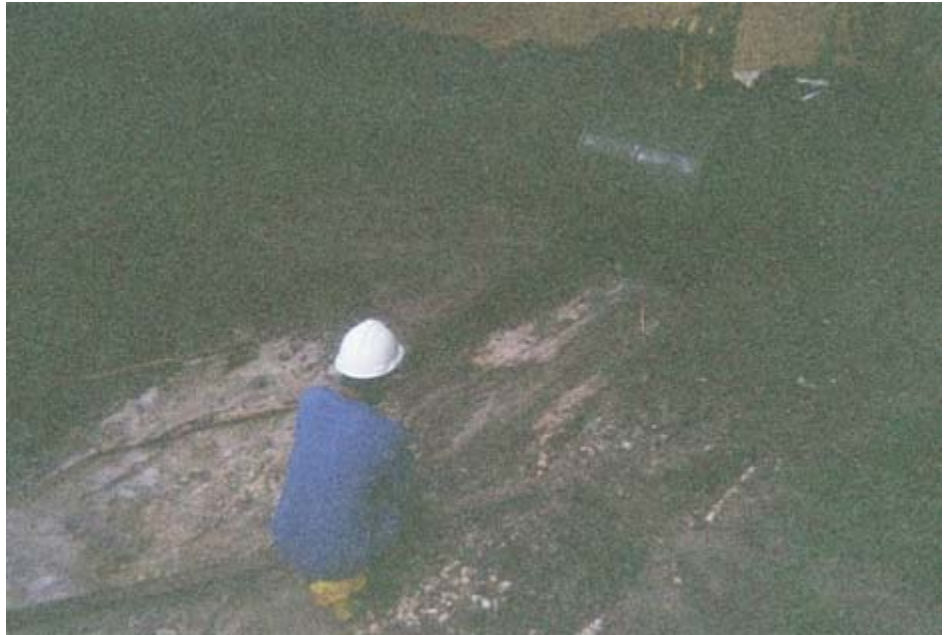
Photograph No. 21

Description: Excavating stained soil in BCC-103.

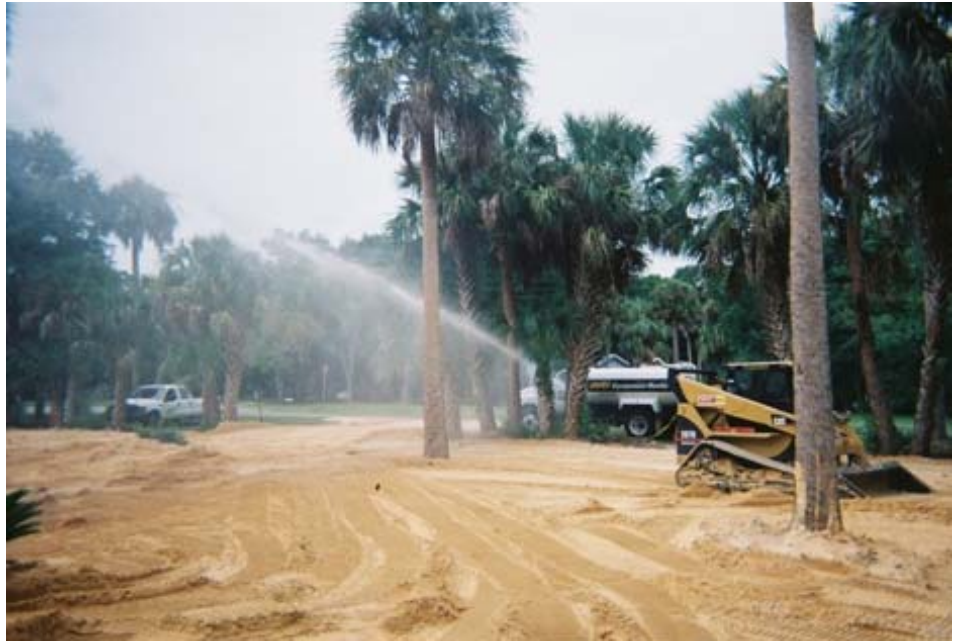
Photograph No. 23

Description: ERRS
conducting dust suppression in
BCC-103.

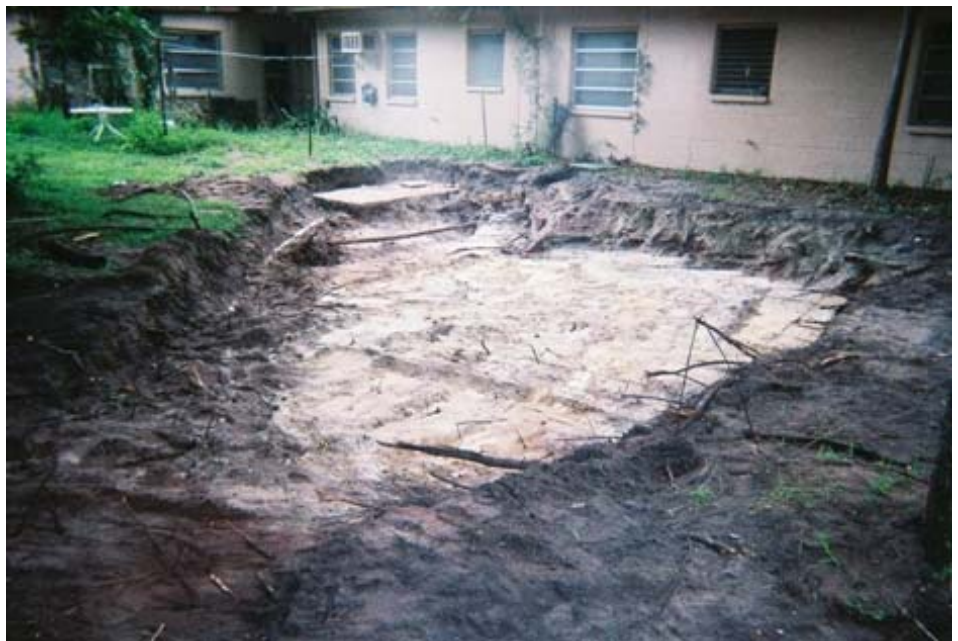
Photograph No. 24

Description: Excavated area
near septic tank in BCC-103.

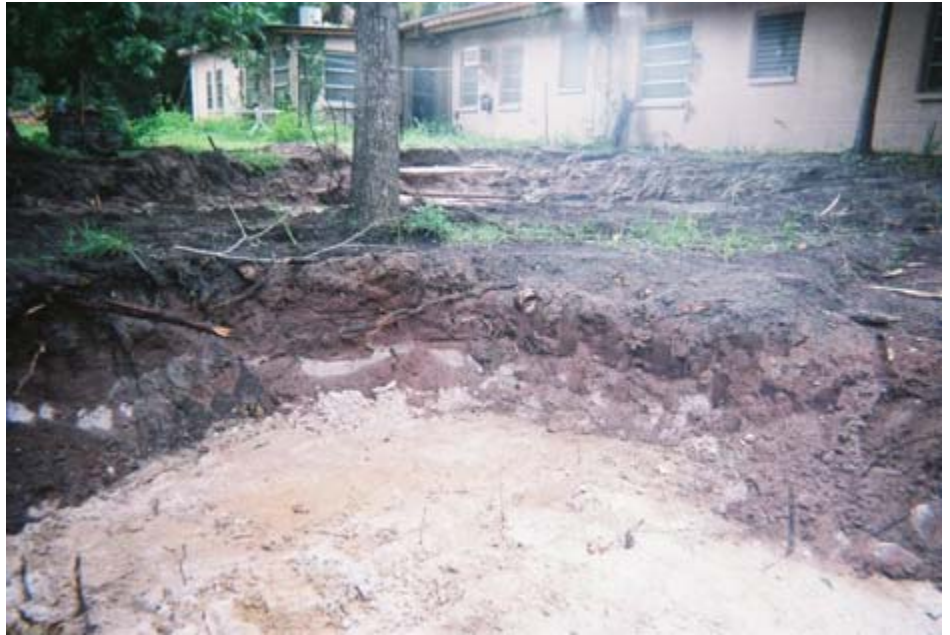
Photograph No. 25

Description: Stained soil near root mat in BCC-103.

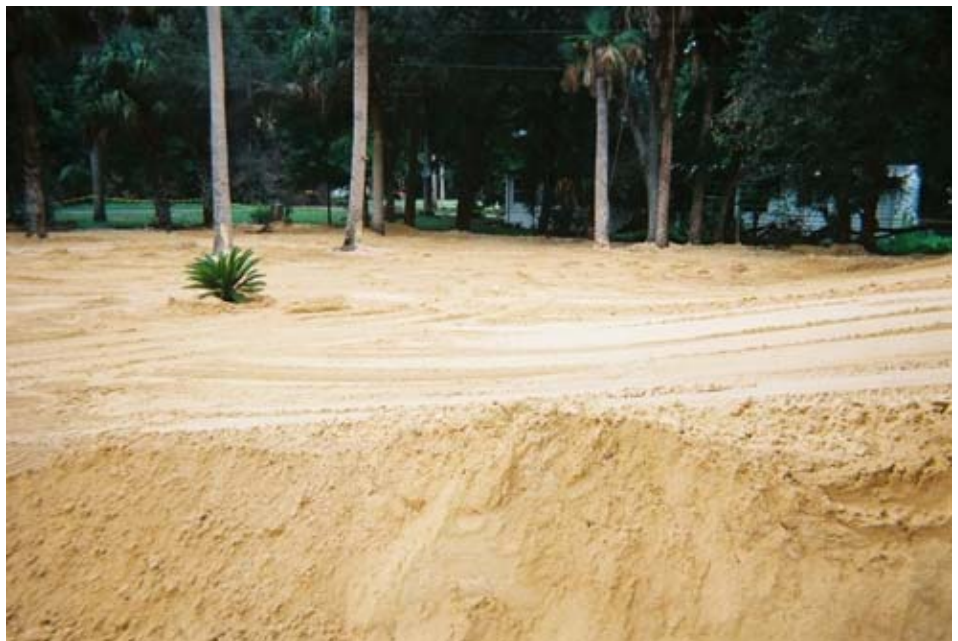
Photograph No. 26

Description: Backfilled area in BCC-103.
