June 15, 2011

**Subject: Final Emergency Response Letter Report
Midville Train Derailment
Midville, Burke County, Georgia
EPA Contract No. EP-W-05-054
TDD No. TTEMI-05-001-0140**

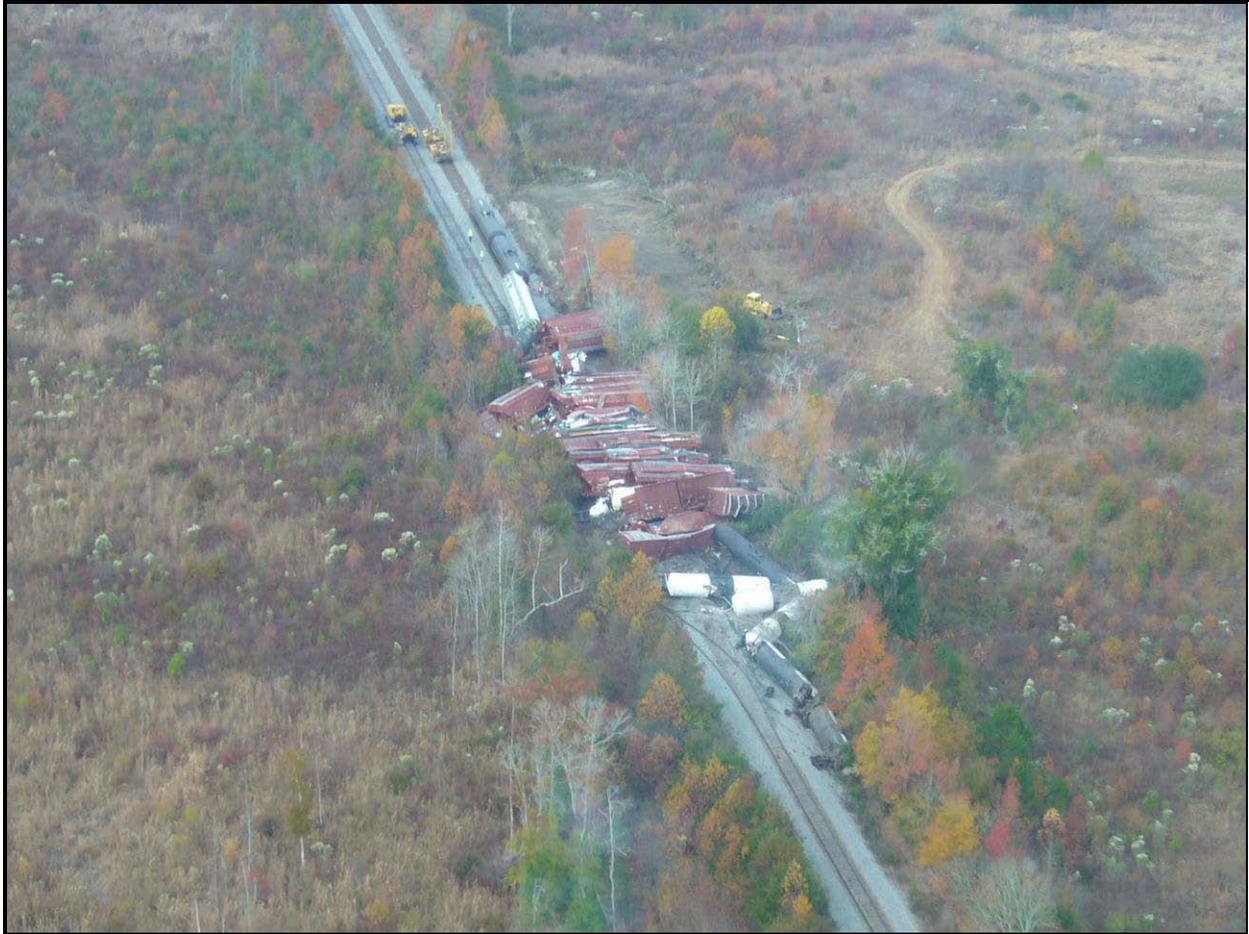
OFFICIAL PHOTOGRAPH NO. 1
U.S. ENVIRONMENTAL PROTECTION AGENCY

Subject: Aerial view of train derailment site photographed from helicopter. Five chlorine cars and one methyl ethyl ketone (MEK) car are visible at the east end of the derailment site, seen at the bottom of the pile up.

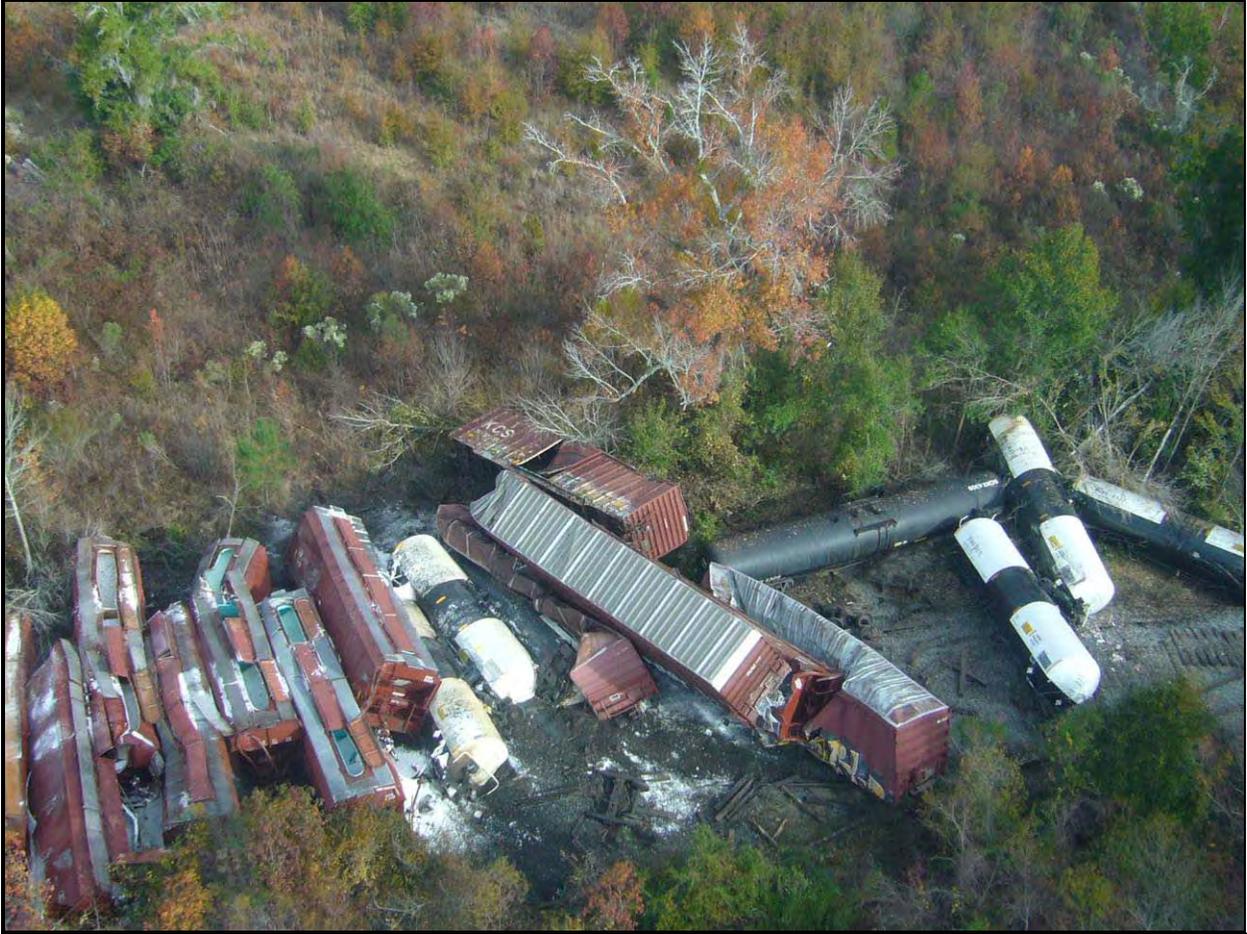
OFFICIAL PHOTOGRAPH NO. 2
U.S. ENVIRONMENTAL PROTECTION AGENCY

Subject: Close up aerial view of train derailment. Three chlorine cars (white with black strip) and one MEK car (black) are visible at the right end of the pile up. Three sodium hydroxide solution cars (white with black strip) are visible at the center of the photograph. Potassium chloride salt cars (rust color) are visible at the left end of the pile up.

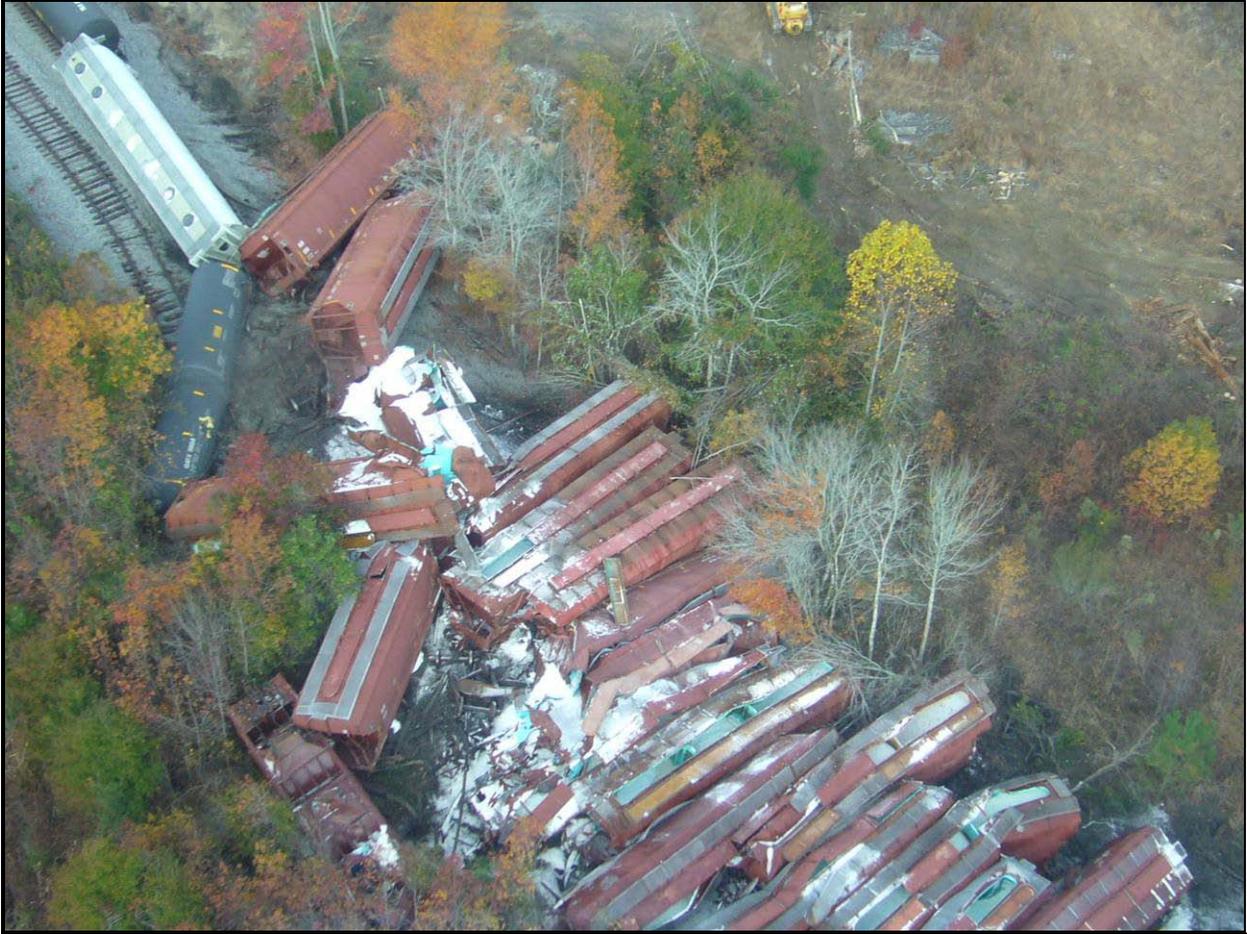
**OFFICIAL PHOTOGRAPH NO. 3
U.S. ENVIRONMENTAL PROTECTION AGENCY**

Subject: Close up aerial view of train derailment. Several potassium chloride salt cars (rust color) are visible at the center of the derailment site. A white tank car containing sodium carbonate peroxyhydrate is visible at the top left end of the pile up.

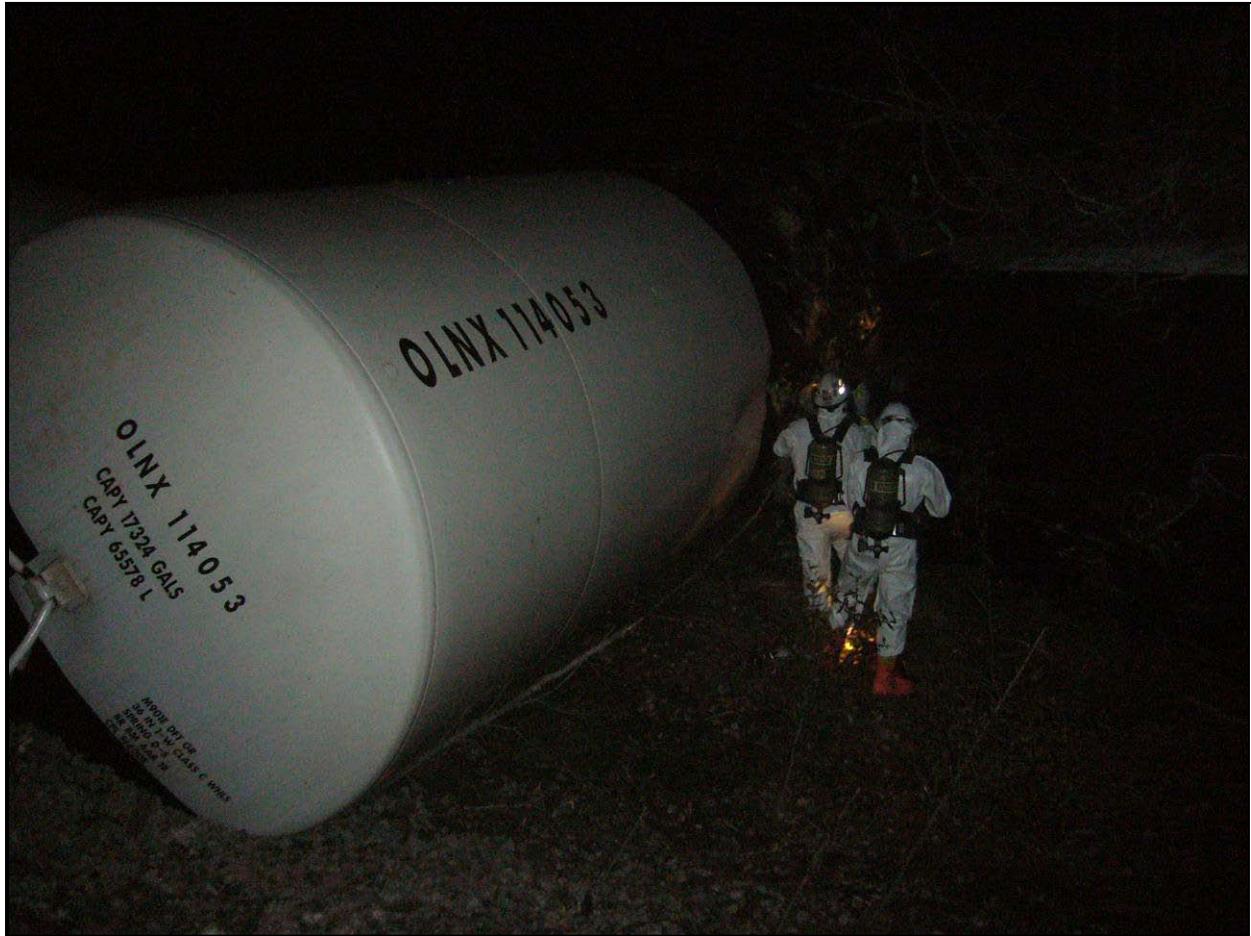
OFFICIAL PHOTOGRAPH NO. 7
U.S. ENVIRONMENTAL PROTECTION AGENCY

Maximum readings obtained at roving locations were detected during the level B entry made from the eastern end of the derailment area to assess the condition of the damaged chlorine railcar (OLNX 114053). During this entry, chlorine concentrations up to 30 ppm were measured by Hepaco representatives at the cut observed in the side of the railcar and VOC concentrations up to 300 ppm were measured by Tetra Tech START in the vicinity of the railcar, presumably attributable to the MEK that was spilled nearby. Table 1 of Appendix A provides a summary of air monitoring results obtained at roving locations. No other air monitoring results obtained by Tetra Tech START at roving locations or fixed perimeter locations indicated concentrations exceeding the AEGLs or OSHA standards.

Subject: Air monitoring team assessing damage on chlorine residue railcar OLNX 114053. Residue refers to the hazmat remaining in the car after its contents have been unloaded and before the car is refilled or cleaned of hazmat and purged to remove any hazardous vapors.

After patching the cut in the damaged chlorine railcar (OLNX 114053), Norfolk Southern uprighted the car and staged it along the northern side of the tracks to facilitate depressurization of the remaining residue. A sodium hydroxide solution was used to depressurize the contents of the car by converting the residual chlorine into a bleach solution, an operation referred to as sparging. Initial readings of the damaged railcar indicated a pressure of approximately 150 pounds per square inch (psi) inside the railcar. The objective of the sparging operation was to reduce the pressure gradually to below 20 psi, and then use air pumped into the railcar to clear out the remaining chlorine vapors. Sparging operations were

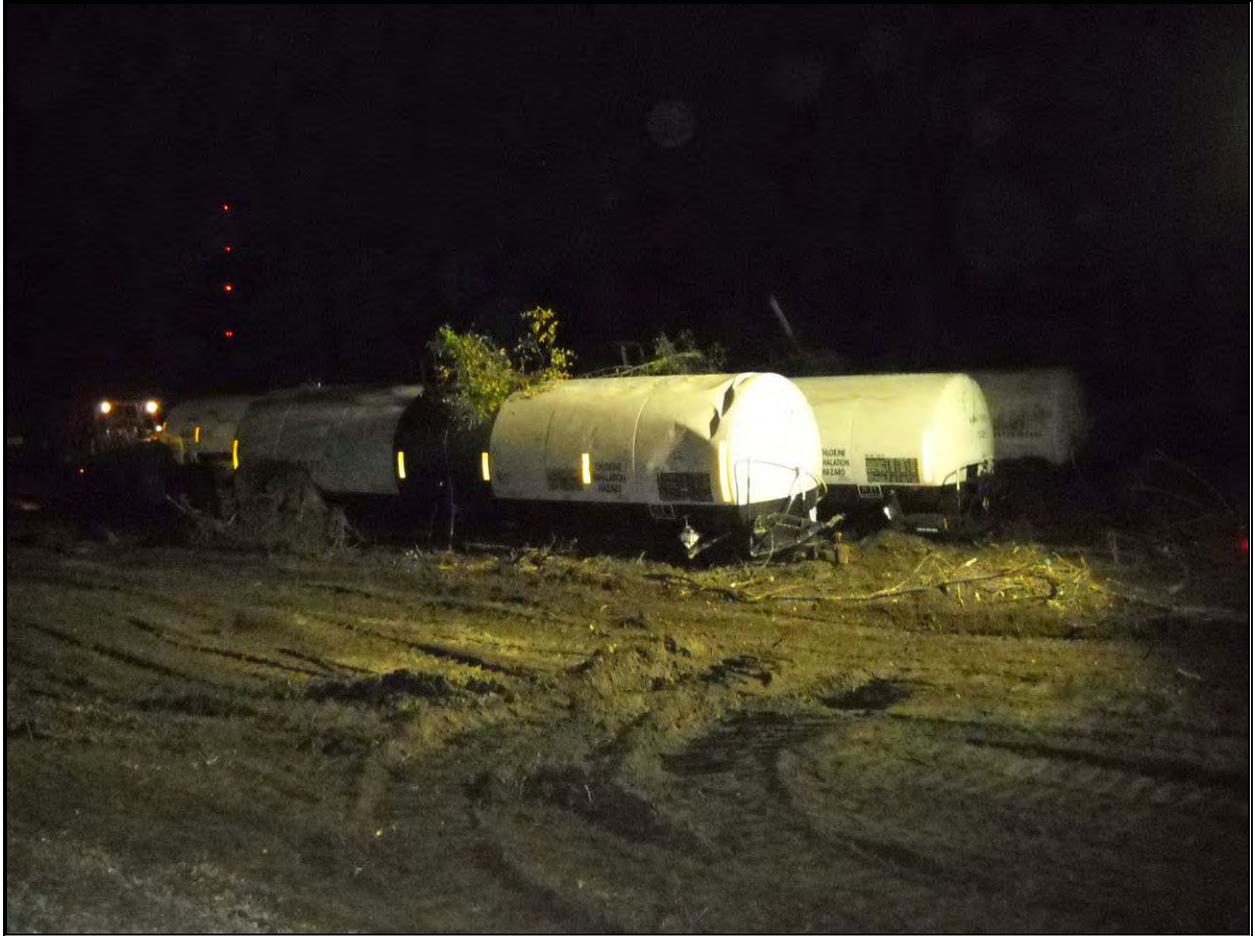
**OFFICIAL PHOTOGRAPH NO. 8
U.S. ENVIRONMENTAL PROTECTION AGENCY**

Subject: Four of five chlorine residue cars located at the east end of the derailment site were segregated away from the railroad tracks. These tank cars were found not to be leaking as a result of the derailment.

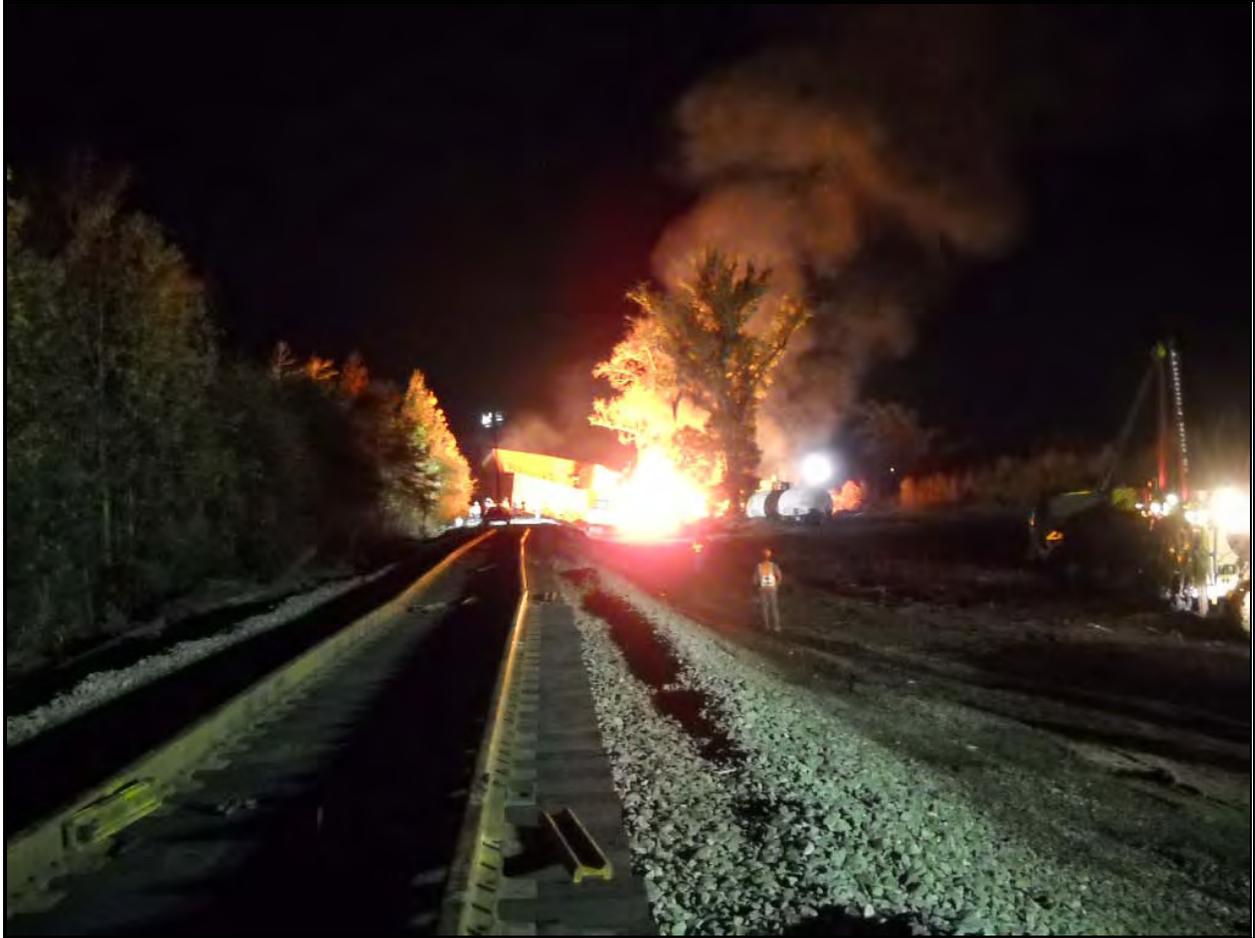
OFFICIAL PHOTOGRAPH NO. 10
U.S. ENVIRONMENTAL PROTECTION AGENCY

TDD Number: TTEMI-05-001-0140 **Location:** Midville Train Derailment
Orientation: West **Date:** November 22, 2010
Photographer: Ingrid Tobar, Tetra Tech **Witness:** Didi Fung, Tetra Tech
Subject: Accidental ignition of spilled MEK around cars occurred at the east side of the
derailment site.

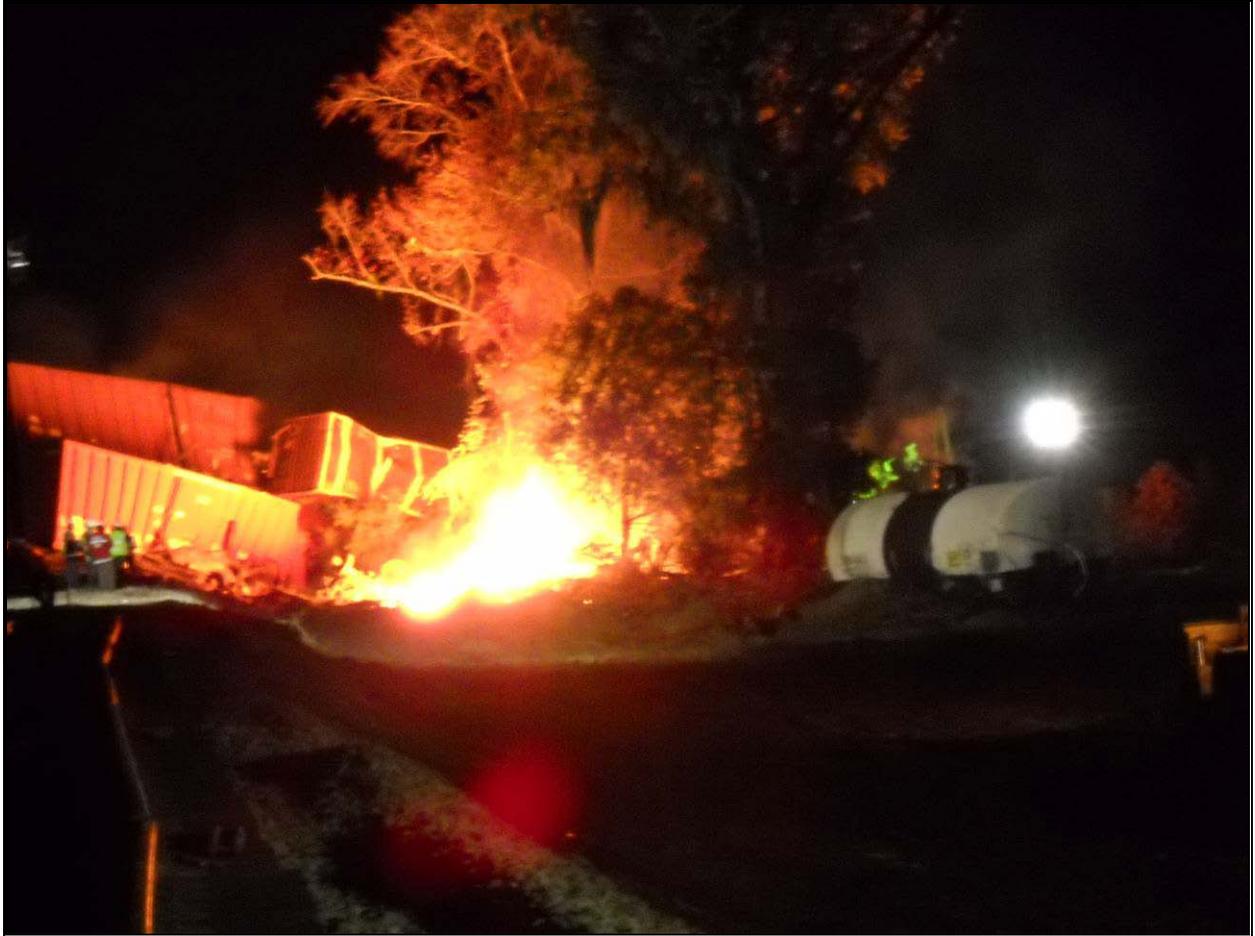
**OFFICIAL PHOTOGRAPH NO. 11
U.S. ENVIRONMENTAL PROTECTION AGENCY**

At approximately 2200 on November 22, OSC Nattis directed Tetra Tech START to the eastern end of the derailment area, where a fire had ignited. Personnel observed flames approximately 20 feet tall in the vicinity of the MEK railcar as well as the damaged chlorine railcar (OLNX 114053) that was actively being depressurized. The fire also burned in a small wooded area around the MEK railcar, where MEK had previously leaked into soil on the northern side of the tracks. Air monitoring results obtained during the incident did not indicate any significantly elevated concentrations at the fixed perimeter locations. Subsequent roving air monitoring conducted at 0141 on November 23 while the fire still smoldered indicated chlorine concentrations up to 0.2 ppm and VOC concentrations up to 2 ppm at a distance of approximately 20 yards from the fire.

Subject: Flames produced by accidental ignition of spilled MEK around cars at the east side of the derailment site. Notice to the right a chlorine residue car staged for sparging operation.

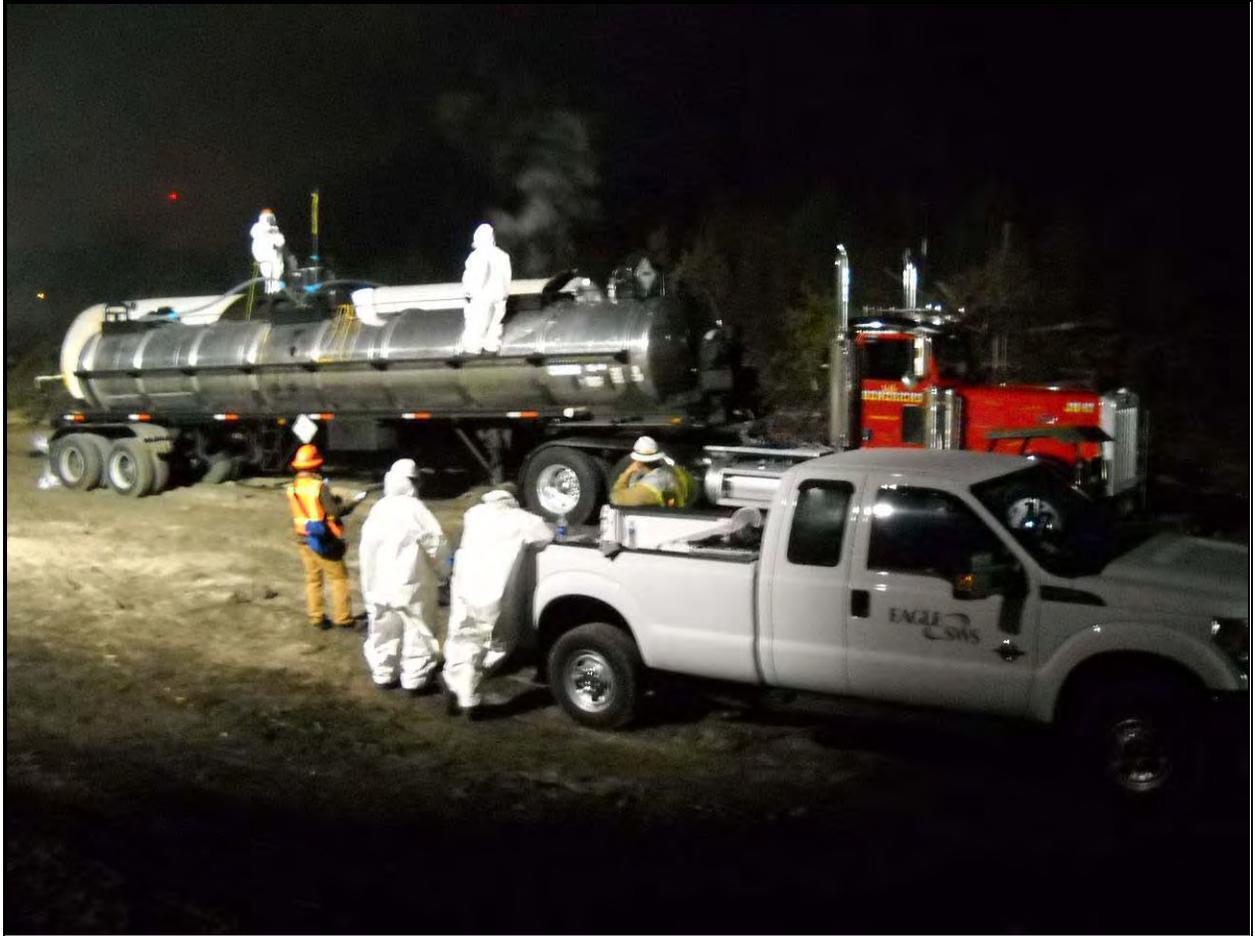
OFFICIAL PHOTOGRAPH NO. 12
U.S. ENVIRONMENTAL PROTECTION AGENCY

TDD Number: TTEMI-05-001-0140 **Location:** Midville Train Derailment
Orientation: Northwest **Date:** November 23, 2010
Photographer: Ingrid Tobar, Tetra Tech **Witness:** Didi Fung, Tetra Tech
Subject: Eagle-SWS crews begin sparging the impacted chlorine residue car with sodium hydroxide solution at the east side of the derailment site.

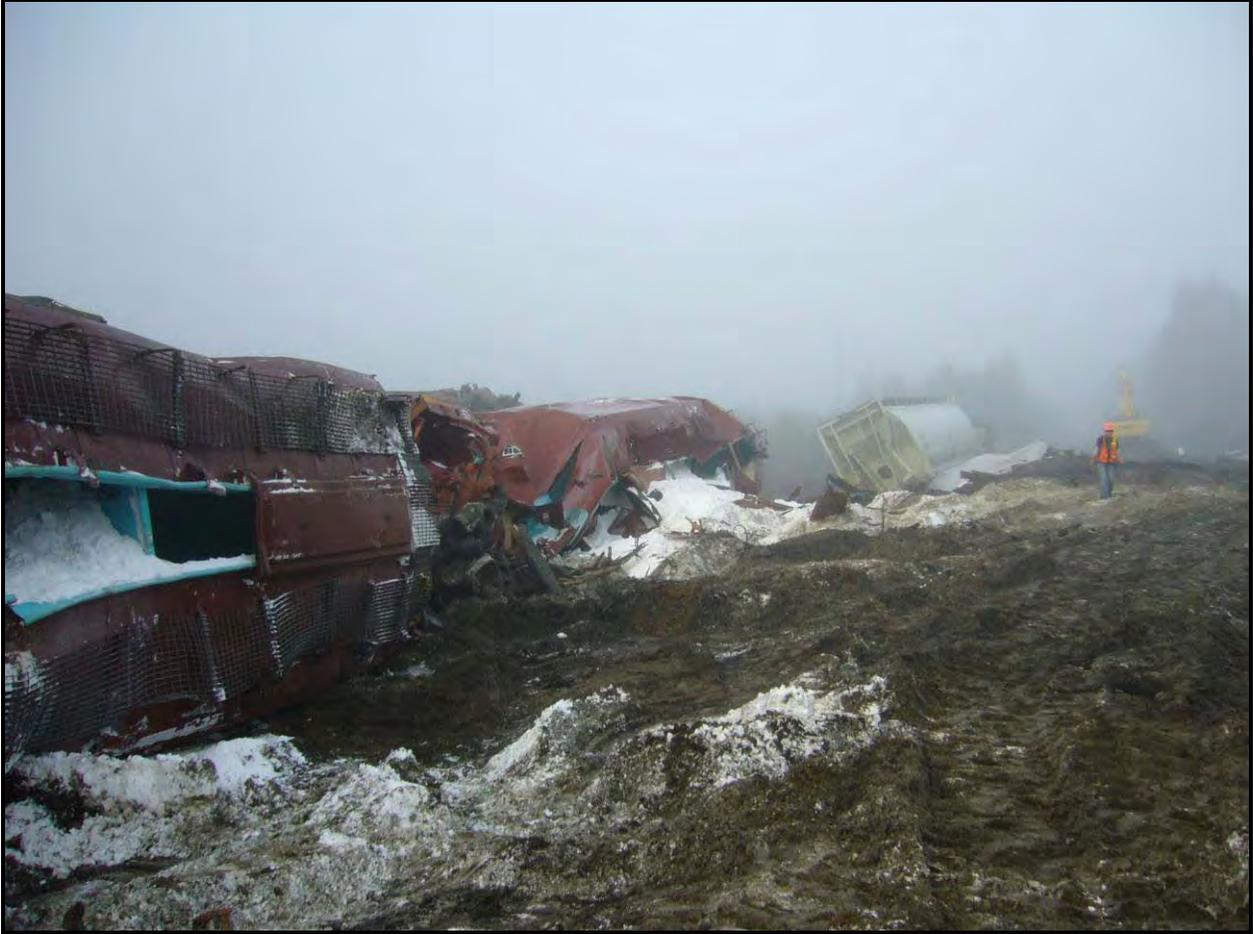
OFFICIAL PHOTOGRAPH NO. 13
U.S. ENVIRONMENTAL PROTECTION AGENCY

Subject: Breached potassium chloride salt cars with contents scattered on the ground.

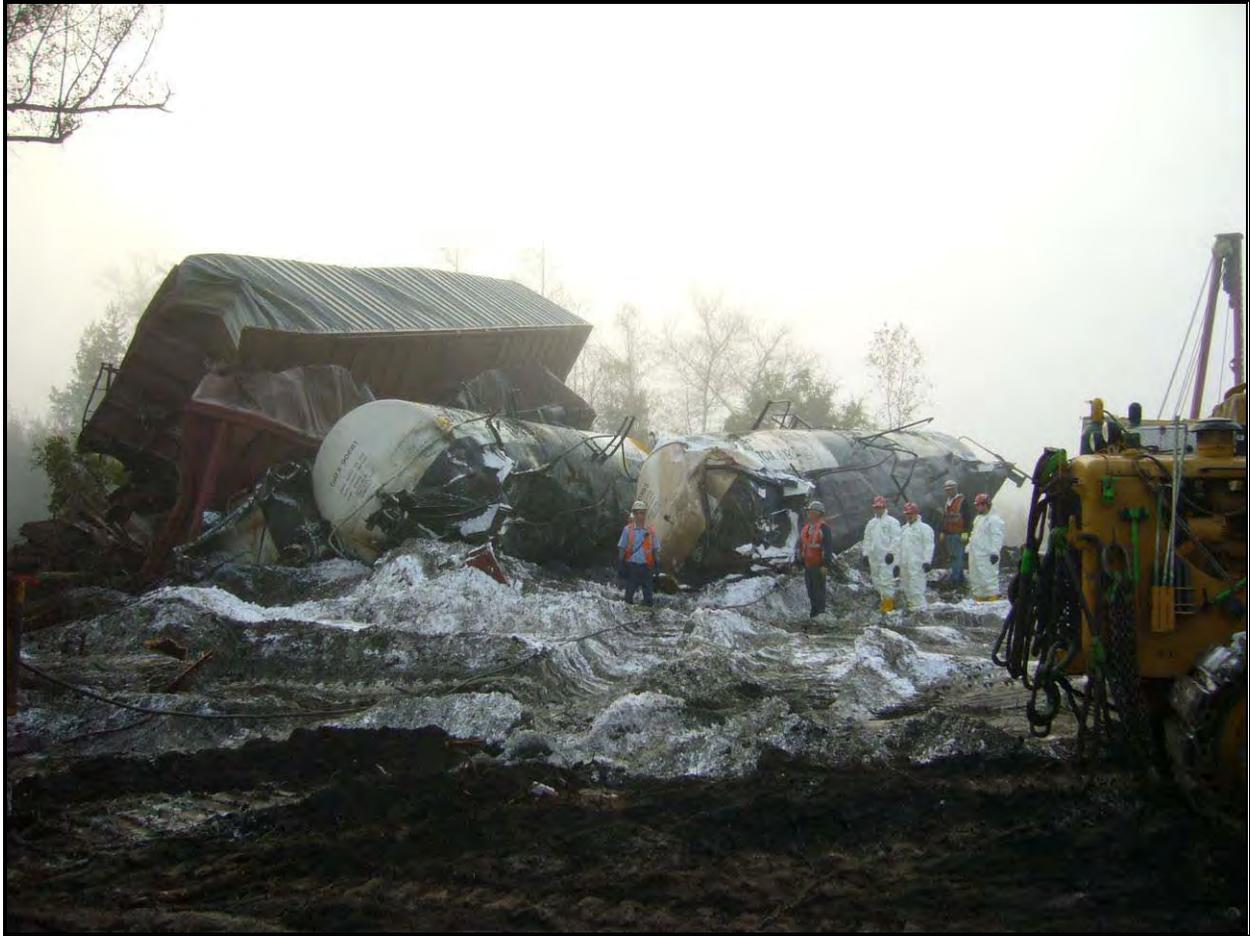
OFFICIAL PHOTOGRAPH NO. 14
U.S. ENVIRONMENTAL PROTECTION AGENCY

Subject: Crews begin segregating three sodium hydroxide solution tank cars (white with black strip). White potassium chloride salt is visible scattered on the ground.

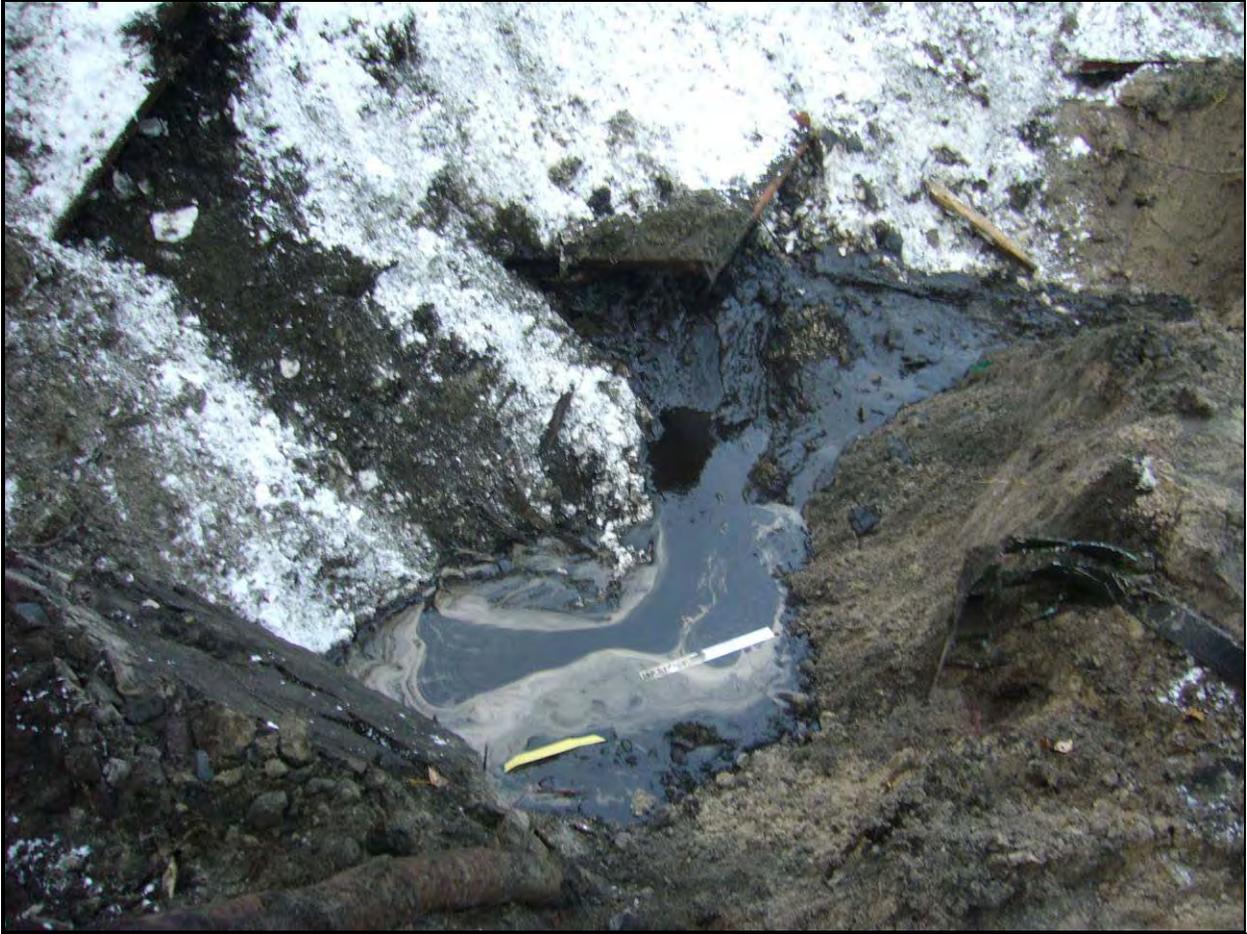
OFFICIAL PHOTOGRAPH NO. 15
U.S. ENVIRONMENTAL PROTECTION AGENCY

Subject: Sludge-like material identified as sodium hydroxide solution with white potassium chloride salt scattered on the ground.

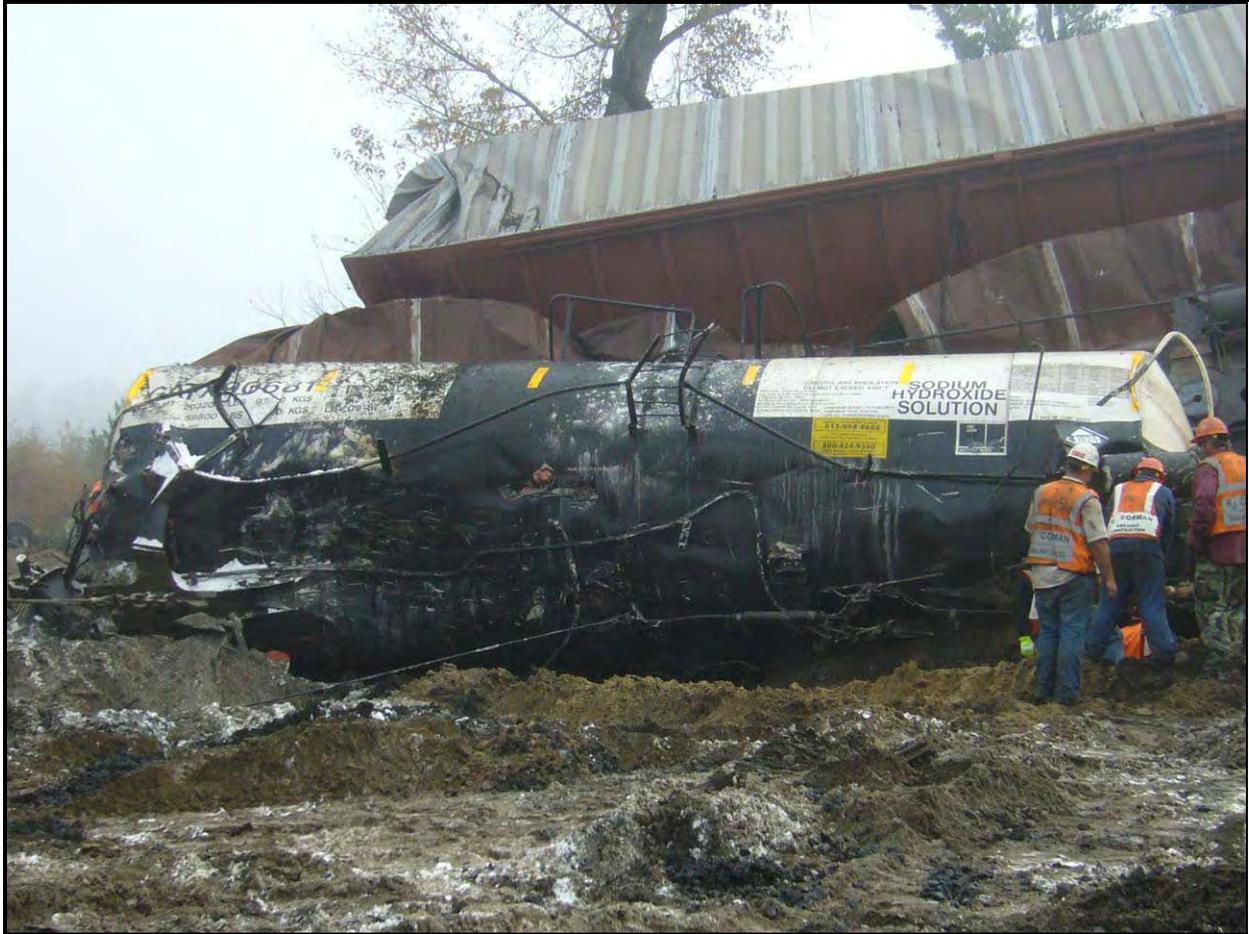
**OFFICIAL PHOTOGRAPH NO. 16
U.S. ENVIRONMENTAL PROTECTION AGENCY**

Subject: Wrecking crew evaluating the damage to the sodium hydroxide solution tank car.

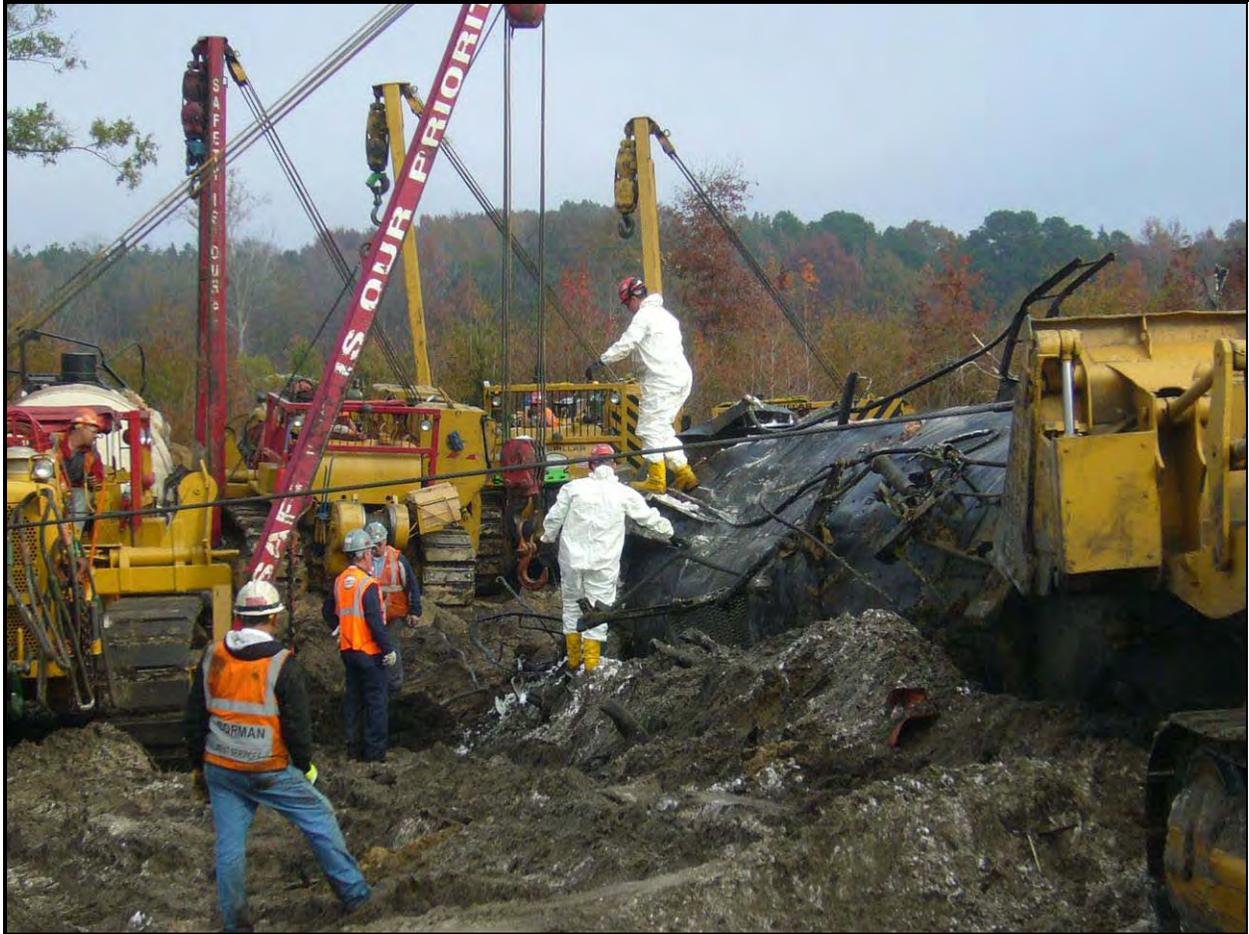
OFFICIAL PHOTOGRAPH NO. 17
U.S. ENVIRONMENTAL PROTECTION AGENCY

Subject: Wrecking crew segregating sodium hydroxide solution tank car into a bermed containment area.

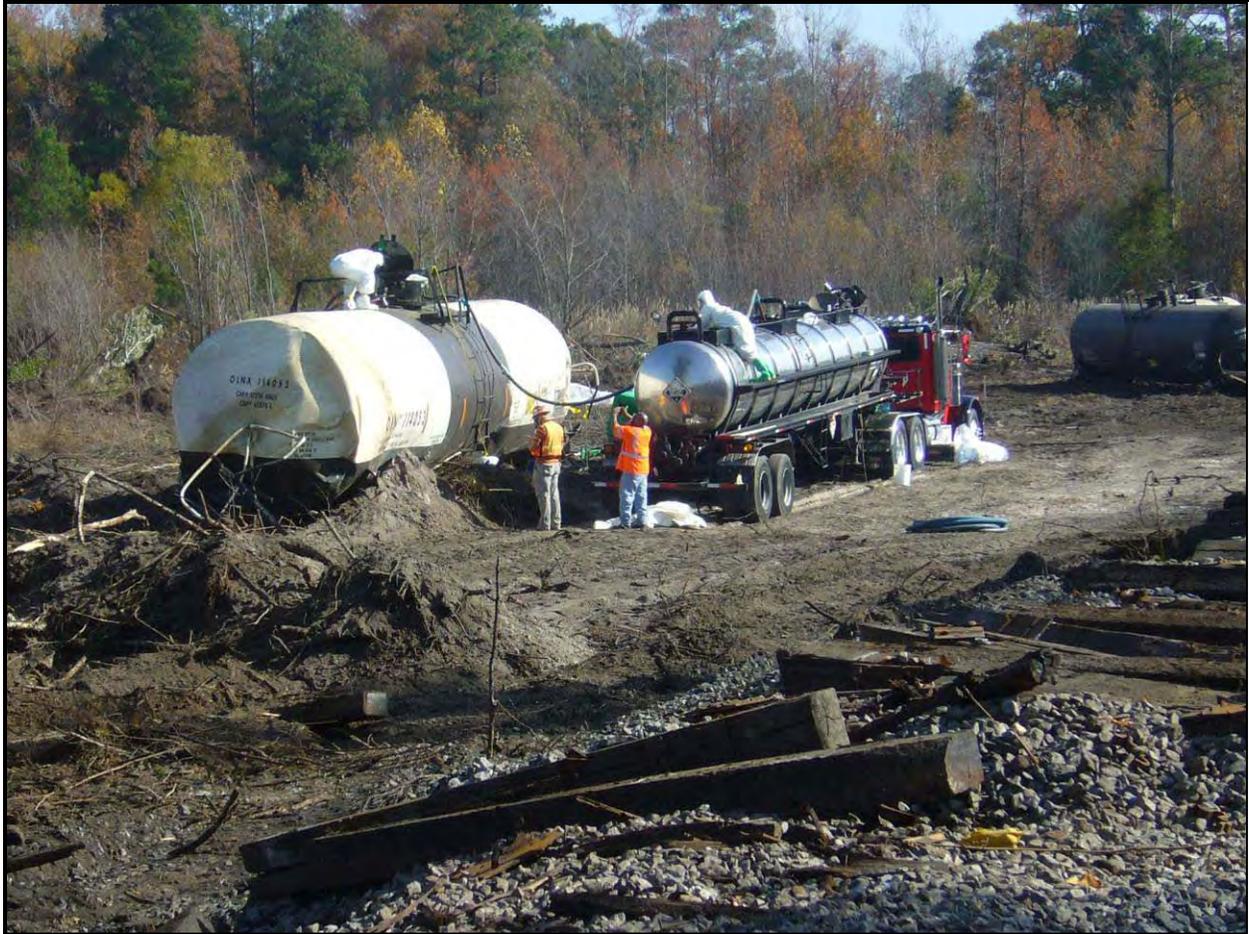
OFFICIAL PHOTOGRAPH NO. 19
U.S. ENVIRONMENTAL PROTECTION AGENCY

- Chlorine sparging operations had reduced the pressure inside the damaged railcar (OLNX 114053) to approximately 19 psi. The four remaining intact chlorine railcars would be loaded onto a flatbed car for transport within 10 to 14 days.

Subject: Eagle-SWS crews finalize sparging the impacted chlorine residue car.

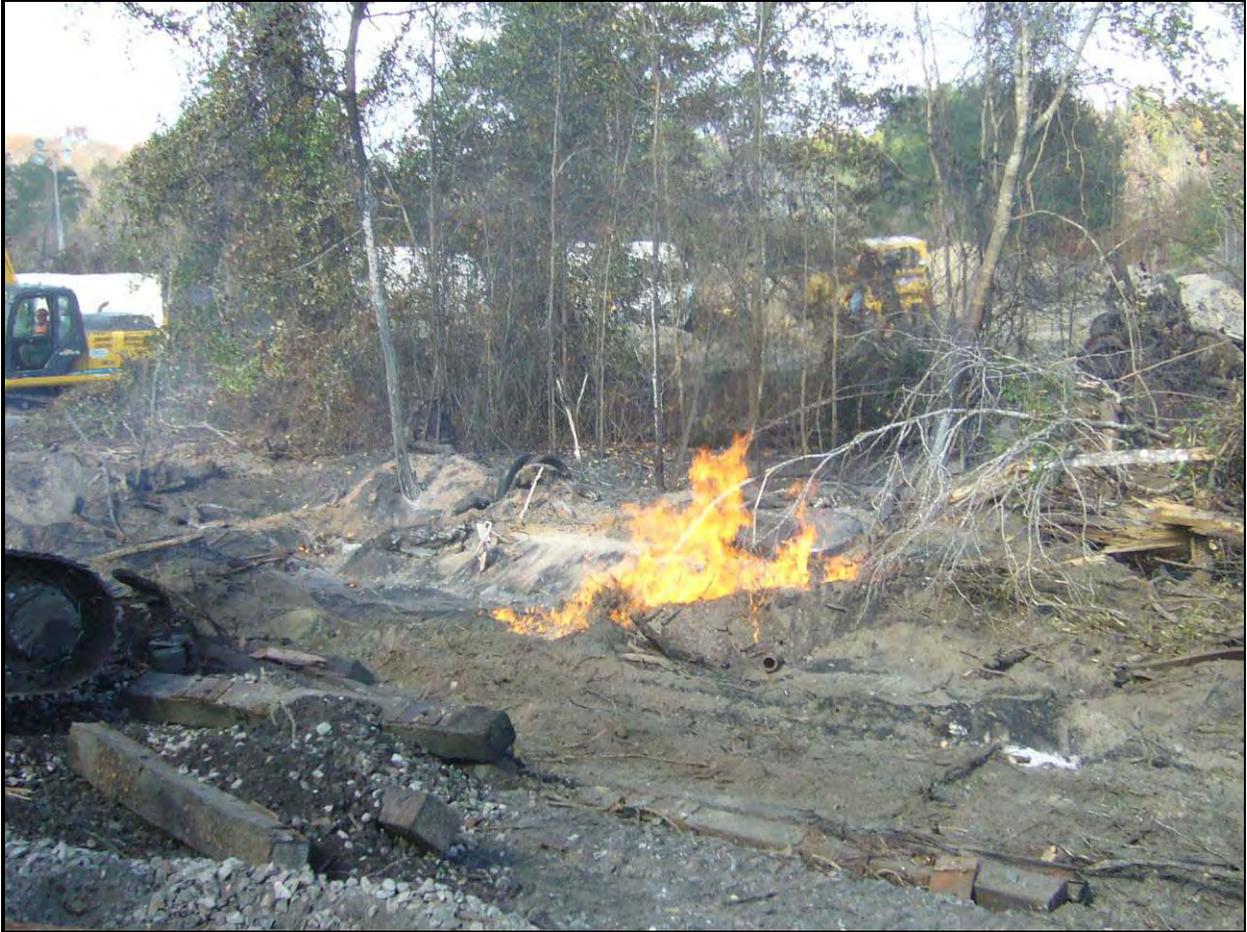
OFFICIAL PHOTOGRAPH NO. 20
U.S. ENVIRONMENTAL PROTECTION AGENCY

Subject: Flames from accidental ignition continue burning fueled by residual MEK that saturated the soil.

0940 START PAYS noticed a small amount of smoke coming from ground south of stacked cars. Also, noticed small fires still burning in track line south of stacked cars. Informed GA EPD of the situation. Spoke to CTEH tech^(P) after they visually inspected the area. It appears to be residual MEK that may still be saturated in the soil.

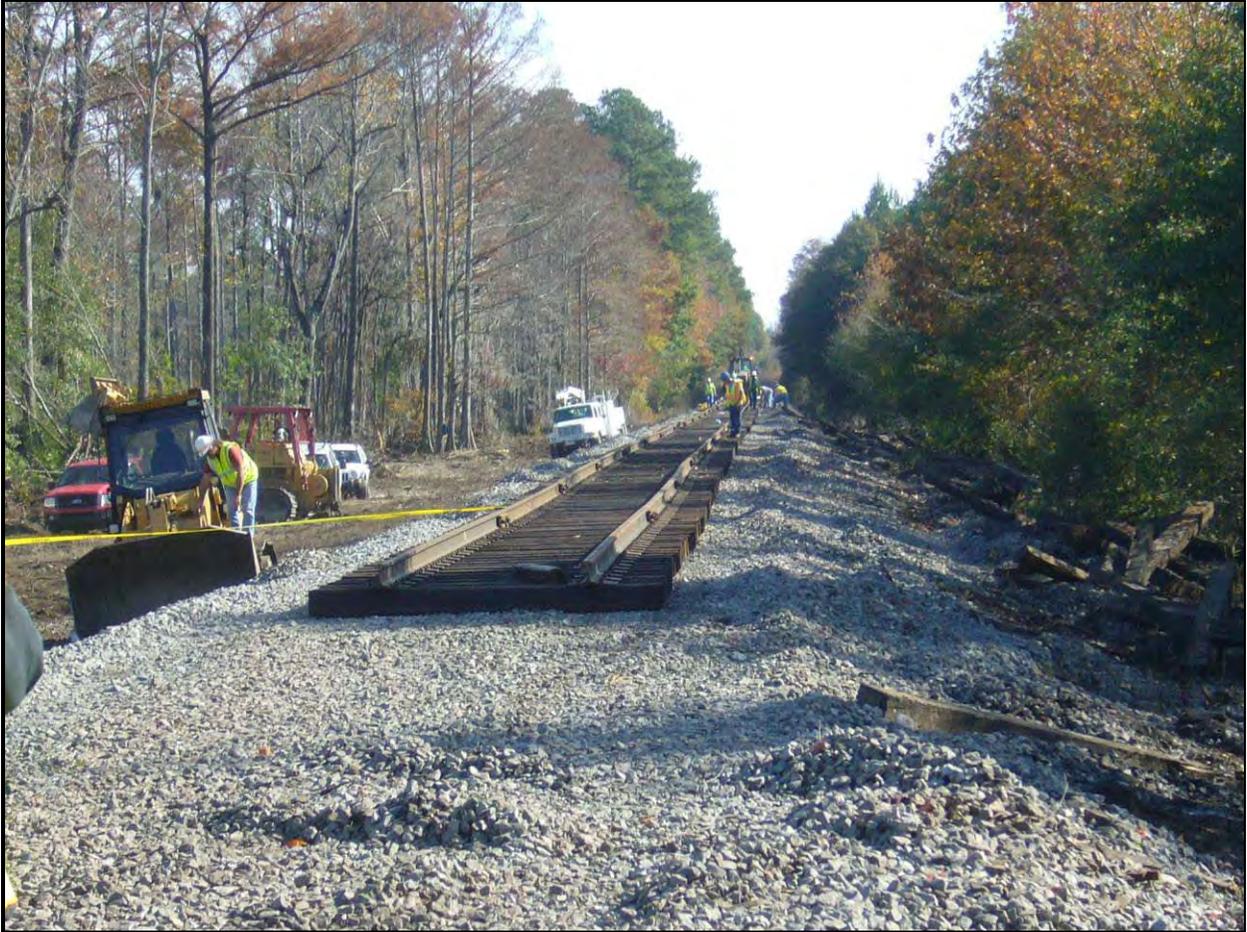
OFFICIAL PHOTOGRAPH NO. 21
U.S. ENVIRONMENTAL PROTECTION AGENCY

Subject: Railroad crews rebuilding railroad track from east end of the derailment.
