UNITED STATES ENVIRONMENTAL PROTECTION AGENCY

**MEMORANDUM**

**SUBJECT:** Request for Approval of a Removal Action and Exemption from the \$2 Million Statutory Limitation at the Scrub-A-Dubb Barrel Co., Lubbock, Lubbock County, Texas

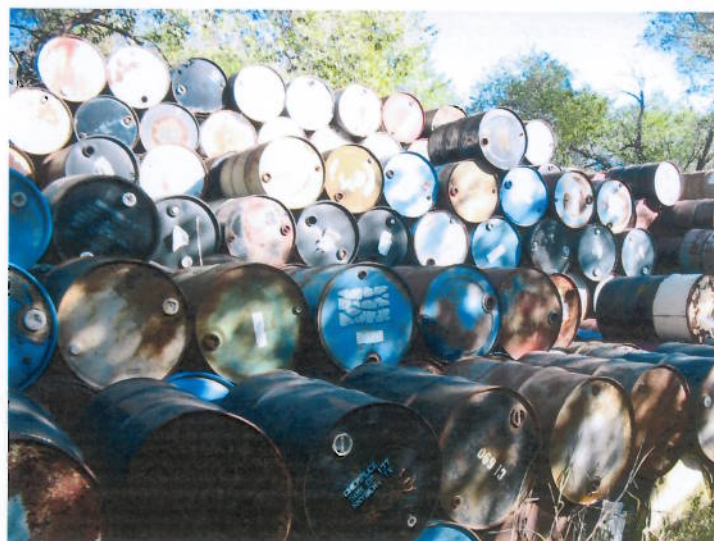
Drums are stacked approximately 7 or 8 drums high over both tracts. The number of drums containing hazardous substances is unknown. Except for some pathways to the back and to enter the Site, the drums cover most of the property. There are an estimated 2,000 to 4,000 drums that have significant amounts of hazardous waste in them. These drums are visible and standing upright on both tracts. Almost all the upright drums assessed had liquid in them. Drums appear to be stacked as they arrived at the Site, with the older ones at the back of the property.

Drums stacked 7 high  
Figure 2

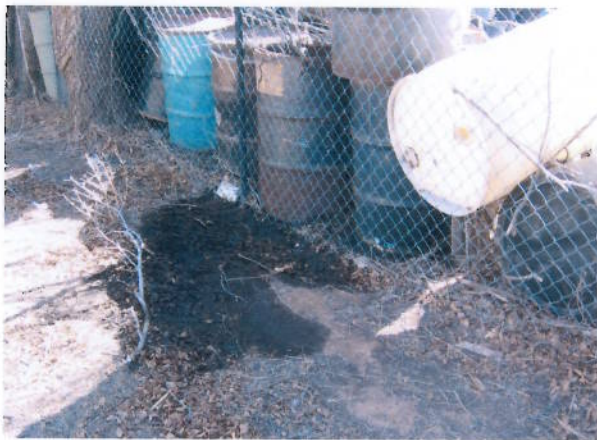
The east portion of the Site is fenced but has been damaged or modified in several areas. The west side, 1201 N Ash, lacks any gates on its multiple access points. Spills and releases from the drums and vats are evident throughout the Site. Releases have been observed from several drums, some migrating offsite. Since the vast majority of drums on site are not visible, it is impossible to estimate the number of drums leaking. It is not necessary for people to enter the Site to potentially come into contact with the released hazardous substances. Figure 4 shows a leaking drum that releases into the alley behind the residential properties to the north. Soils are heavily contaminated in some large areas of the Site. Residue on drums and the contents of failing drums are easily accessible to people entering the Site.

Example of releases from individual drums  
Figure 4

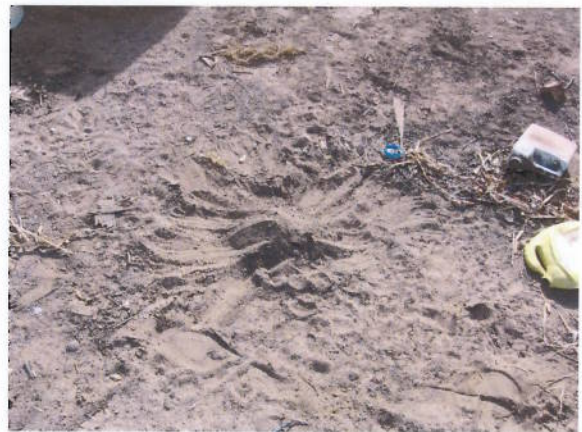
Evidence of children playing on Site  
Figure 5

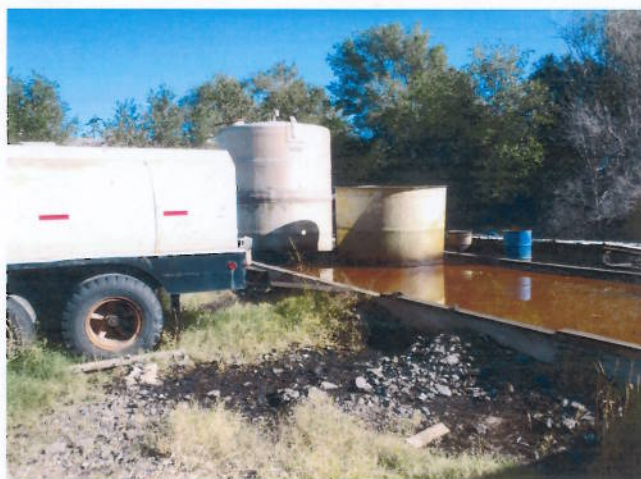
There are numerous visible spills around the drum stacks. Run-off is visible outside the fence and in the run-off pathways. The walls of the wastewater vats have failed and the owners pushed dirt against the walls. Heavily stained soil is all around the vats as seen in Figure 6.

From the responses to the previous spills, the owner piled the excavated contaminated soil near the east side of the Site. Heavy contamination is still visible. SAD did not conduct any disposal of contaminated soil. They simply moved it back on to the Site. No containment was built or any other effort to prevent continued run-off. This run-off contributes to the contamination of the drinking water supplies.

Contaminant Saturated Soil Next to the Waste Water System  
Figure 6

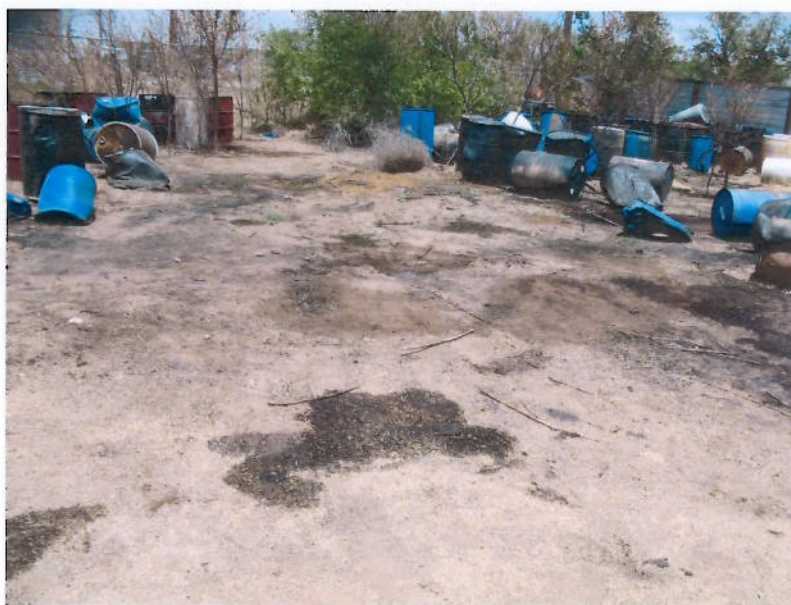
The threat of fire is present as a result of people coming on site to take drums. Sparks resulting from the cutting the top off of drums have caused a fire in a portion of the Site. The dirt roads and bare spots on the Site prevented the fire from reaching larger portions of the Site. The fire melted plastic drums and caused several additional releases. A fire involving a larger area of drums could release very dangerous concentrations of hazardous substances to the water run-off pathway as well as to the adjacent homes. Fires involving drums can lead to boiling liquid expanding vapor explosions (BLEVE). A BLEVE can send a drum rocketing high into the air and land a substantial distance away. BLEVEs can quickly expand the extent of the fire and cause a chain reaction. The high stacks of drums can promote the fire and prevent effective fire-fighting efforts. Partial combustion products of many of the hazardous substances present at the Site are more toxic or dangerous than the original substance. Smoke plumes can reach even farther than the vapors from the leaking drums and spills.

Numerous Visible Spills as a Result of a Fire  
Figure 7
