**KEWEENAW NATIONAL HISTORICAL PARK
QUINCY SMELTER SITE STRUCTURAL ASSESSMENT
M&E Job Number: 036204274.0001.00001**

Author: Michael E. Malenfant, PE (Massachusetts)

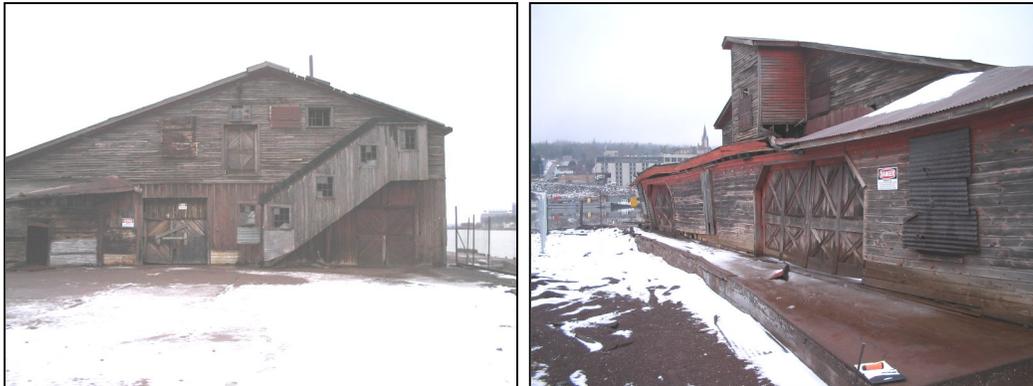
(Left) Figure 1: Dockside Warehouse, west side, showing stair access

(Right) Figure 2: Dockside Warehouse, east wall, showing collapsed shed portion

The overall building is in moderate condition with localized roof and wall failure of the east shed addition. The second story extension on the east side of the main building is unsupported from below due to the shed collapse. This building's condition is threatened by its location relative to the Reverberatory Furnace Bypass Stack.

The east side shed addition and the cantilevered extension should have temporary support of the east line wall (seen in figure 2, above) during removal of the collapsed roof. The east line wall may either remain supported during abatement operations or may be demolished prior to asbestos removal. If the cantilevered extension and the shed wall are braced temporarily, the temporary support may be removed after asbestos abatement and the wall allowed to fall naturally or the wall may be demolished.

Perform Reverberatory Furnace Bypass Stack remediation prior to commencement of asbestos abatement in this structure.

Remove loose corrugated metal roofing and patch any open roof openings, remove loose window glass, and provide temporary shoring to any stairs used during abatement operations. Remove east side shed addition for access to asbestos under collapsed roof.

If the building is to be preserved for future access, construction of a wood frame wall along the east side of the structure is recommended prevent weather damage of the structure.

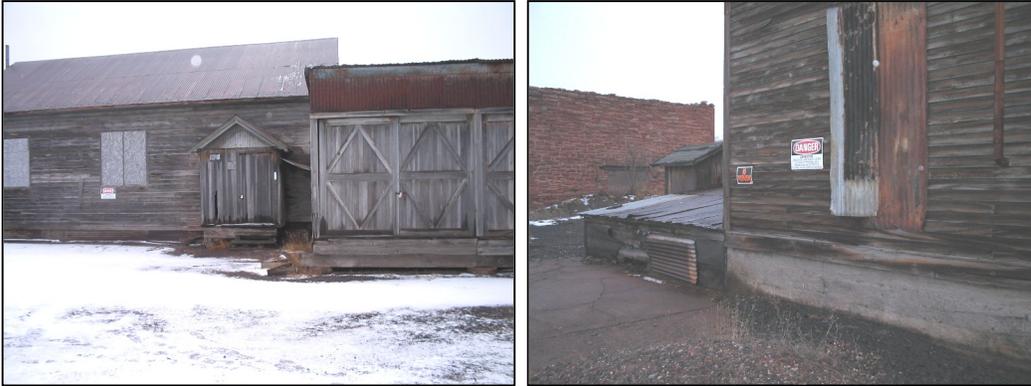
(Left) Figure 3: Laboratory, east side

(Right) Figure 4: Laboratory, south wall showing below grade portion and south wall

The overall building is in moderate condition with localized wall failure of the south portion of the low wall as seen in figure 4, above. This building's condition is threatened by its location relative to the Reverberatory Furnace Bypass Stack.

Perform Reverberatory Furnace Bypass Stack remediation prior to commencement of asbestos abatement in this structure.

Remove loose corrugated metal roofing and patch any open roof openings, and remove loose window glass. Provide temporary support of the south side wall that is buckling inward during any abatement operations in the room immediately adjacent to the wall. Remove loose brick from the west side chimney to prevent loose bricks from falling during abatement operations adjacent to the chimney.

If the building is to be preserved for future access either a replacement load bearing wall should be constructed for the south wall that is buckling inward or the wall should be shimmed to prevent further movement of the wall inward.

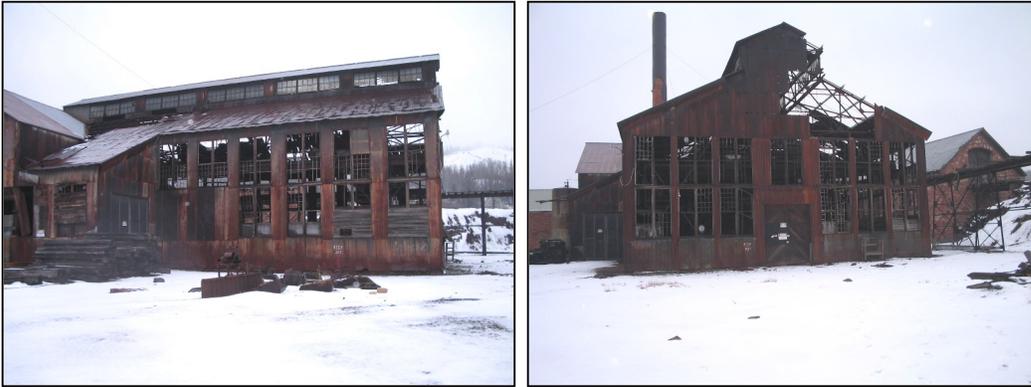
(Left) Figure 5: Casting Plant, south side, showing failed windows and intact south roof

(Right) Figure 6: Casting Plant, north wall, showing deteriorated roof and window framing

This structure was not entered due to hazardous conditions present at the time of inspection. Based on an exterior examination of the structure the overall building is in poor condition with many missing roof and window panels. The structural skeleton appears to have experienced localized corrosion of structural members that do not appear to immediately threaten the stability of the structure. This building's condition is threatened by its location relative to the Reverberatory Furnace Bypass Stack.

Perform Reverberatory Furnace Bypass Stack remediation prior to commencement of asbestos abatement in this structure.

Remove loose corrugated metal siding and roofing and loose window glass. Remove loose timbers from trestle on north side of structure if abatement personnel will require access within 10 feet of trestle. Do not perform abatement operations in winds of excess of 15 miles per hour.

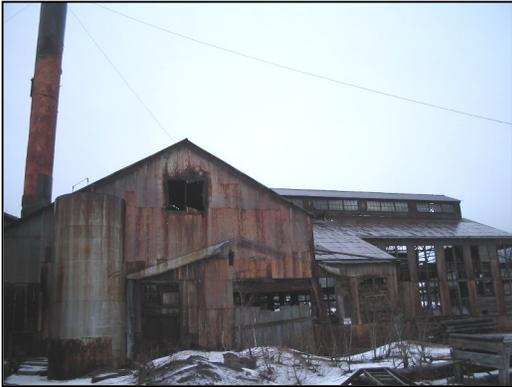
Figure 7: No. 5 Reverberatory Furnace Building (located in the center of the photo), south side, showing failed windows and intact south roof

This structure was not entered due to hazardous conditions present at the time of inspection. Based on an exterior examination of the structure the overall building is in poor condition with many missing roof and window panels. The structural skeleton appears to have experienced localized corrosion of structural members that do not immediately threaten the structure. This building's condition is threatened by its location relative to the Reverberatory Furnace Bypass Stack.

Perform Reverberatory Furnace Bypass Stack remediation prior to commencement of asbestos abatement in this structure.

Remove loose corrugated metal siding and roofing and loose window glass. Remove loose timbers from trestle on north side of structure if abatement personnel will require access within 10 feet of trestle. Do not perform abatement operations in winds of excess of 15 miles per hour.

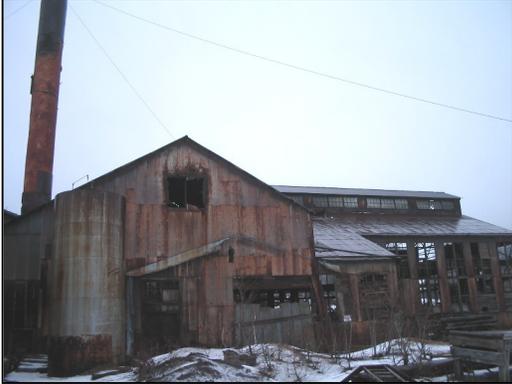
(Left) Figure 8: Reverberatory Furnace Building (located to the left of the photo), south side, showing failed windows and intact south roof

The overall building is in poor condition with many missing roof and window panels on the structure. The structural skeleton appears to have experienced localized corrosion of structural members that do not immediately threaten the structure. The interior stack is precariously resting against roof members and threatens the building structure. This building's condition is threatened by its location relative to the Reverberatory Furnace Bypass Stack.

Perform Reverberatory Furnace Bypass Stack remediation prior to commencement of asbestos abatement in this structure.

Remove loose corrugated metal siding and roofing and loose window glass. Remove loose timbers from trestle on north side of structure if abatement personnel will require access within 10 feet of trestle. Do not perform abatement operations in winds of excess of 15 miles per hour.

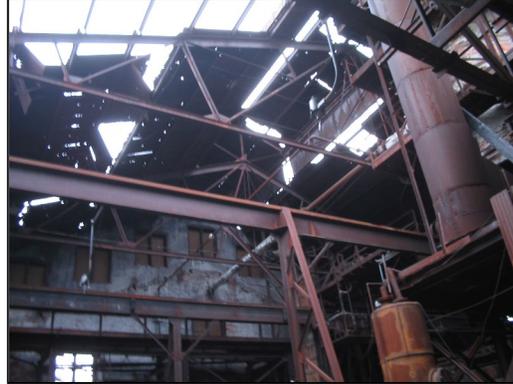
(Right) Figure 9: Reverberatory Furnace Building, interior looking south

Provide temporary shoring of the interior stack or remove the interior stack prior to commencement of asbestos abatement in this structure. If catwalks are to be used or are located within 10 feet of asbestos abatement operations the catwalks should undergo a structural assessment, be shored or removed.

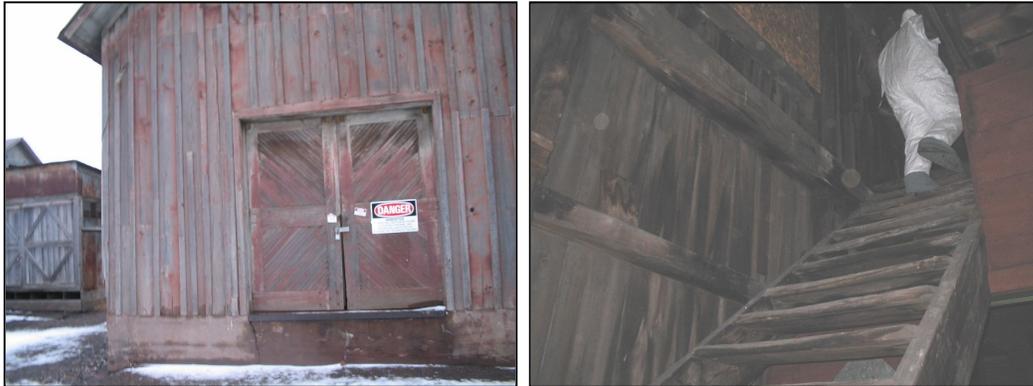
(Left) Figure 10: Cooper Stock Building, east wall

(Right) Figure 11: Cooper Stock Building, interior stairwell

The overall building is in good condition with an intact roof and very little loose material present.

Remove loose corrugated metal siding and roofing and loose window glass if present at the time of abatement operations.

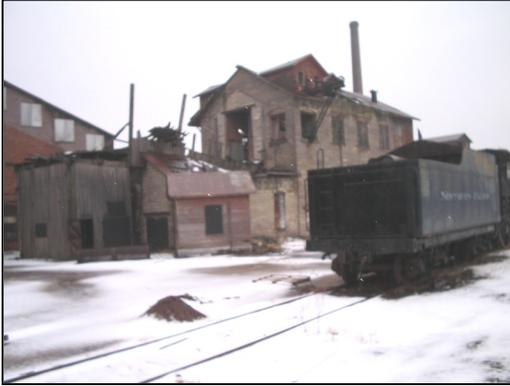
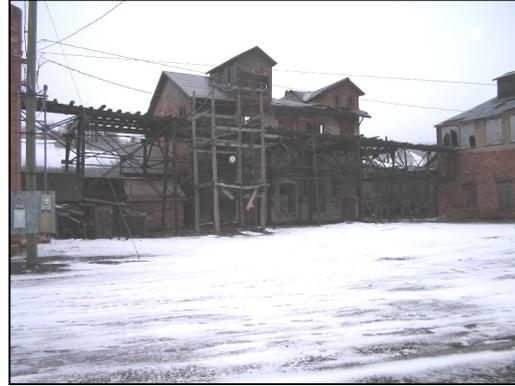
(Left) Figure 12: Briquette Plant (right side of photo) looking at east and north walls
(Right) Figure 13: Briquette Plant, south wall, showing trestle on south side of wall

The overall building is in poor condition with many missing roof and window panels on the north side of the structure. The structural skeleton appears unstable with localized failure of roof and upper floor structural members. Numerous mechanical components are still in the building that are either hung from the unstable roof, upper floor, or the walls of the structure. This building's condition is threatened by its location relative to the Reverberatory Furnace Bypass Stack.

Perform Reverberatory Furnace Bypass Stack remediation prior to commencement of asbestos abatement in this structure.

Remove loose corrugated metal roofing, first floor timber beams and planks, mechanical components that will have asbestos abatement personnel under those components, and loose window glass. Provide temporary shoring of north masonry/stone wall. Remove loose timbers from trestle on south side of structure if abatement personnel will require access within 10 feet of trestle. Do not perform abatement operations in winds of excess of 15 miles per hour.

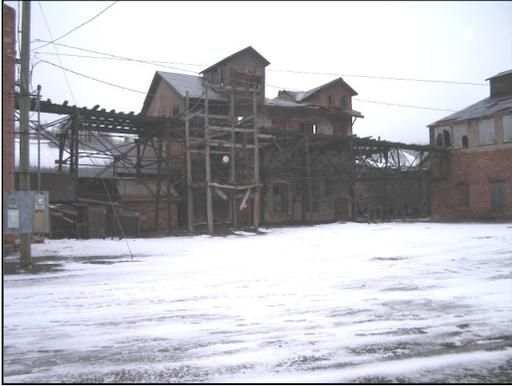
(Left) Figure 14: Crushing Plant (left side of photo, behind electrical structure), south wall, showing trestle on south side of wall

The overall building is in poor condition with many missing roof and window panels on the north side of the structure. The structural skeleton appears to be in poor condition with localized failure of roof and upper floor structural members. This building's condition is threatened by its location relative to the Reverberatory Furnace Bypass Stack.

Perform Reverberatory Furnace Bypass Stack remediation prior to commencement of asbestos abatement in this structure. Perform Briquette Plant remediation prior to asbestos abatement operations in this structure. The ladder access from the Briquette Plant should be avoided and replaced with a new (temporary) ladder.

Remove loose corrugated metal roofing, first floor timber beams and planks, mechanical components that will have asbestos abatement personnel under those components, and loose window glass. Provide temporary shoring of north masonry/stone wall. Remove loose timbers from trestle on south side of structure if abatement personnel will require access within 10 feet of trestle. Do not perform abatement operations in winds of excess of 15 miles per hour.

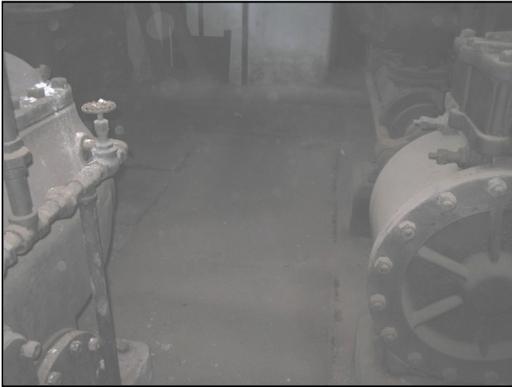
Figure 15: Pump House, interior, plate in floor

The overall building is in good condition with an almost complete roof structure. This structure is threatened by the adjacent Copula Building.

Perform Reverberatory Furnace Bypass Stack remediation prior to commencement of asbestos abatement in this structure. Perform Briquette Plant remediation prior to asbestos abatement operations in this structure.

Remove loose corrugated metal roofing and loose window glass if present at the time of asbestos remediation efforts. Provide temporary shoring of pipes that will undergo asbestos abatement operations. Remove loose timbers from trestle on south side of structure if abatement personnel will require access within 10 feet of trestle.

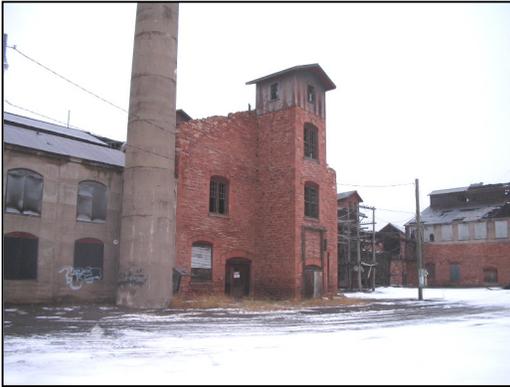
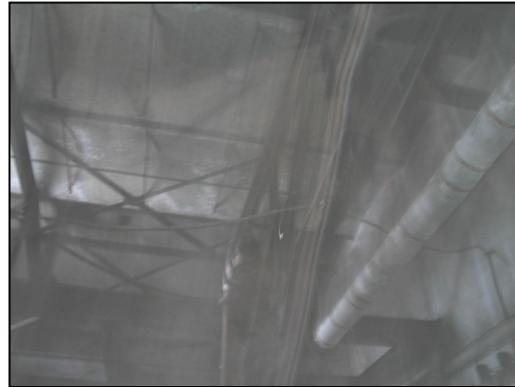
(Left) Figure 16: Cupola Building, South wall

(Right) Figure 17: Cupola Building, interior roof of north side of structure

The overall building is in poor condition with localized roof and wall failure of the south roof and wall. No interior assessment of the south portion of the building was performed due to hazardous conditions as the structural skeleton appears to have experienced localized failure of structural members that threaten the structure and those in the vicinity. North portion of structure is in good condition.

Remove loose corrugated metal roofing and loose window glass if present in the area of asbestos abatement operations. Provide temporary shoring of east, west, and south walls that are unsupported due to roof failure and remove loose blocks from top of wall. If any loads are to be placed on the existing timber floor opening covers it is recommended that the covers be replaced with a structural plate capable of carrying the applied load. Do not perform abatement operations in winds of excess of 15 miles per hour.

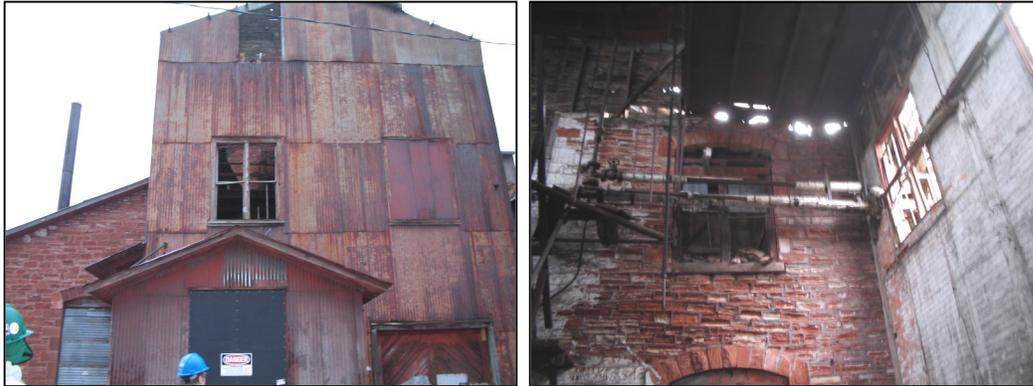
(Left) Figure 18: Boiler House, west wall

(Right) Figure 19: Interior of Boiler House, looking east - sandstone wall is shared with the cupola building

The overall building is in poor condition with localized roof and wall failure of the north and west roof and wall and loose window glass. The structural skeleton appears to have experienced localized corrosion of structural members that do not immediately threaten the structure. Window in the common wall with the Cupola Building has a failing arch. Numerous mechanical components and catwalks remain in this structure that exhibit corrosion due to exposure to the environment. This structure is threatened by the adjacent Copula Building.

Remove loose corrugated metal roofing, mechanical components that will have asbestos abatement personnel under those components, and loose window glass. Provide temporary shoring of unsupported walls due to roof failure and remove loose blocks from top of wall. Provide temporary shoring of window opening in east wall that is common with the Cupola Building. Do not perform abatement operations in winds of excess of 15 miles per hour.

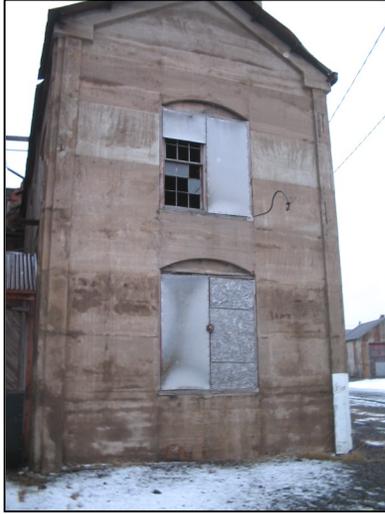
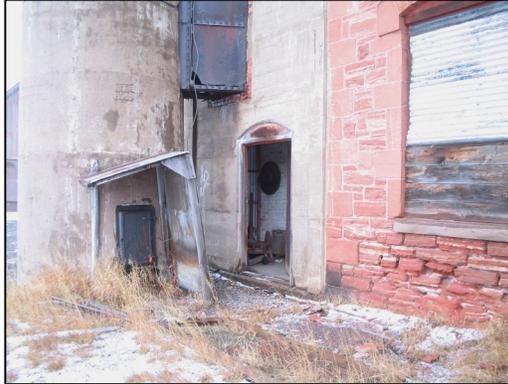
(Left) Figure 20: Baden Hausen Boiler Building, west wall

(Right) Figure 21: Baden Hausen Boiler Building (left portion of photo), south wall - sandstone wall is the cupola building

The overall building is in good condition with loose corrugated metal roof panels and loose window glass. Both the building and the reinforced concrete stack appear to be in good shape with localized spalling of concrete revealing exposed reinforcing steel. This structure is threatened by the adjacent Copula Building.

Remove loose corrugated metal roofing, mechanical components that will have asbestos abatement personnel under those components, and loose window glass. Remove wood walkway planks that are above the finished floor elevation. Do not perform abatement operations until building remediation efforts for the Boiler House are complete.

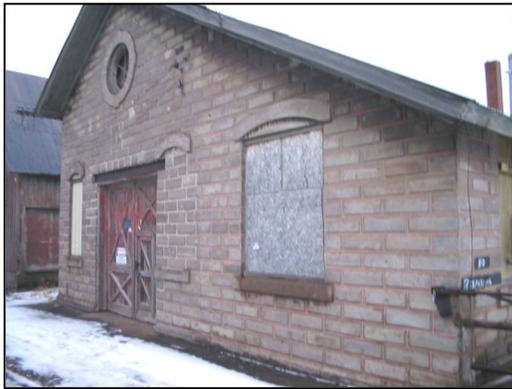
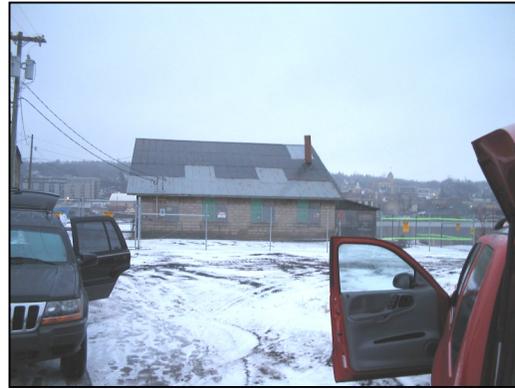
(Left) Figure 22: Machine Shop, east wall

(Right) Figure 23: Machine Shop, north wall

The overall building is in good condition with loose corrugated metal roof panels and broken window glass. The north side chimney appears to be tilting to the east and may be in danger of collapse.

Remove loose corrugated metal roofing, loose window glass, and loose brick from the top of the chimney.

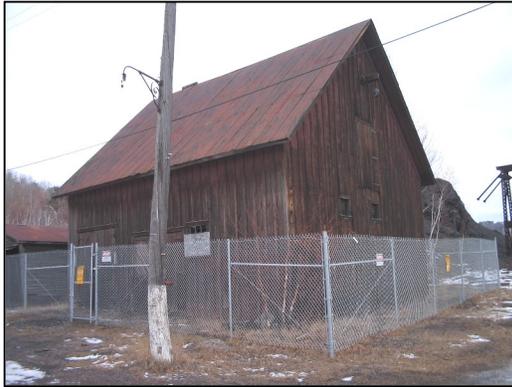
Figure 24: Barn, west wall

The Barn is a two story wood frame structure with corrugated metal roof panels. The structure is attached to the adjacent Garage structure with three cables (to the left in Figure 24, above), apparently to prevent collapse of the Garage.

The overall building is in good condition with loose corrugated metal roof panels and broken window glass. It is endangered by the potential for collapse of the adjacent Garage structure due to the attachment of the Garage to the Barn.

Remove loose corrugated metal roof panels and broken glass. It is recommended that continuous monitoring of the cable attachments of this structure to the adjacent garage is maintained during asbestos abatement operations. If it appears that the Garage is in imminent danger of collapse the cables should be removed to prevent either the failure of the garage from damaging the barn or cable breakage injuring nearby personnel. Removal of the cable attachments to the Garage may lead to failure of the Garage, in which case temporary shoring of the Garage is recommend to prevent the failure of that structure.

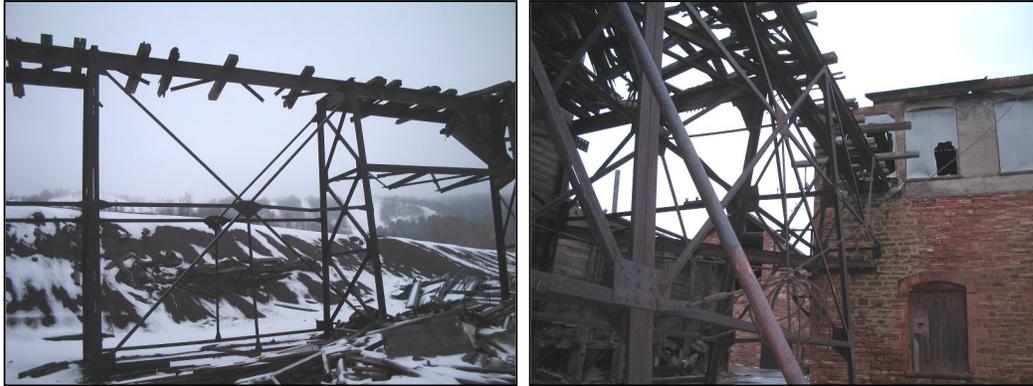
Figure 25: Trestle on northeast side of Casting Plant

Figure 26: Trestle on south side of Briquette Building

The trestle is in moderate condition, with structural steel members removed or damaged in various locations. As the trestle will not experience the full design load during the remaining lifetime of the structure it is anticipated that the few damaged or missing structural members pose a low risk to life or the trestle.

No asbestos is required to be removed from the trestle, however the structure is included in this report as asbestos abatement personnel will be working in the vicinity of the structure. It is recommended that loose ties or other loose portions of the structure be removed in the area of personnel access prior to working adjacent to the trestle.

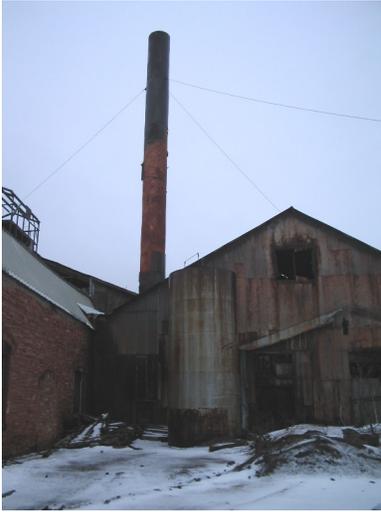
Figure 27: Stack, looking north

The stack is in extremely poor condition and in danger of imminent collapse. The three remaining guy wires are slack and it appears that loose bricks continue to fall from the structure. The stack is visibly leaning to the north and the foundation of the stack may be in poor condition, although this could not be verified due to the dangerous conditions in the immediate vicinity of the foundation. The base of the stack was observed as resting on four lattice (built-up) columns which may be in various states of corrosion based upon the general condition of other structural steel members in the vicinity.

No asbestos is required to be removed from the stack; however abatement efforts in adjacent structures are impacted due to the poor condition of the structure. None of the remediation efforts proposed in the 2002 report by the International Chimney Corporation have been enacted, including roping off the adjacent area the posting of warning signs.

It is strongly recommended that the remediation efforts in the 2002 report by the International Chimney Corporation be followed prior to any work occurring in the adjacent structures that lie within the failure radius of the stack. It is recommended that if the stack remains in place that the four lattice foundation columns be strengthened by welding additional plates on the columns.

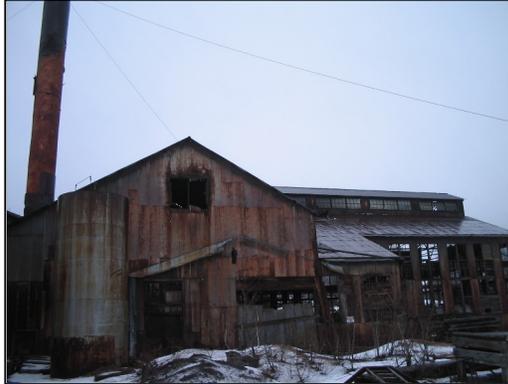
Figure 28: Stack, Close-up looking north, indicating slackness in cables and overall tilt of stack
