*KEWEENAW NATIONAL HISTORICAL PARK - CALUMET, MICHIGAN  
QUINCY SMELTER REVERBERATORY FURNACE SMOKESTACK*

## SPECIALTY SERVICES BULLETIN

Subject: Exterior Inspection  
Keweenaw National Historical Park  
Quincy Smelter Reverberatory Furnace Bypass Stack  
Hancock, Michigan

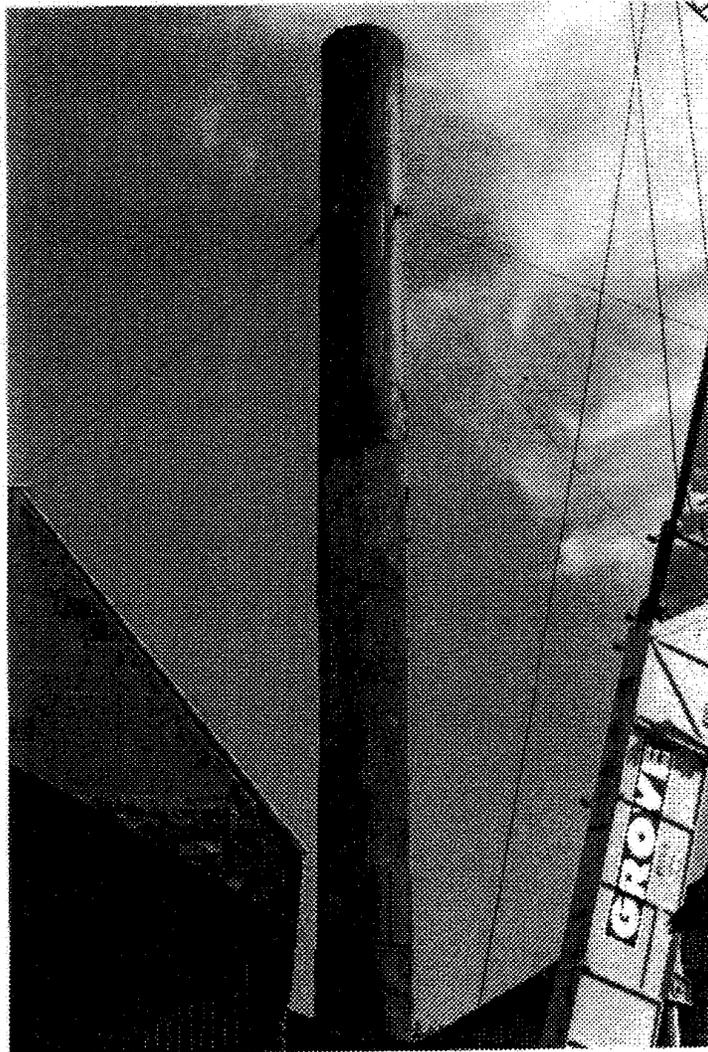
- Photo 1 Overall view of stack indicating where the stack plate is in place and where the lining brickwork is exposed, as well as the three guy wires approximately 15' below top of stack.

Photo # 1: View looking at stack above roof elevation, south quadrant.

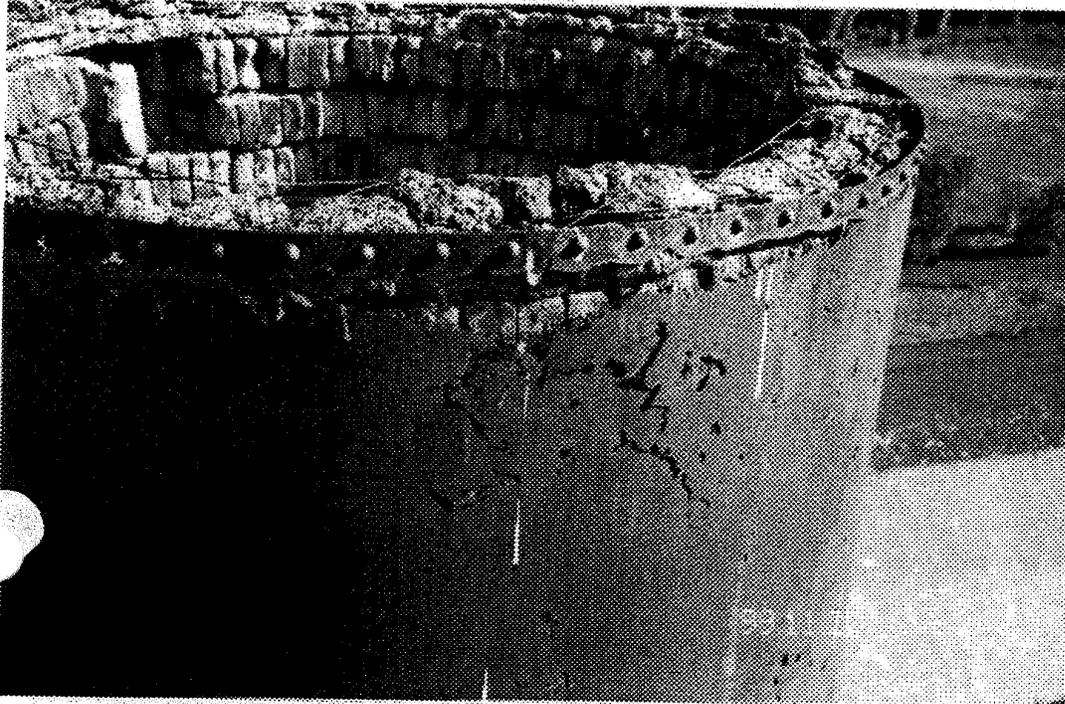
- Photos 2 & 3 Typical condition of steel shell throughout the upper portion of the stack, which is also the condition of the balance of the steel shell.

Photo # 2: Close up view of top of stack.

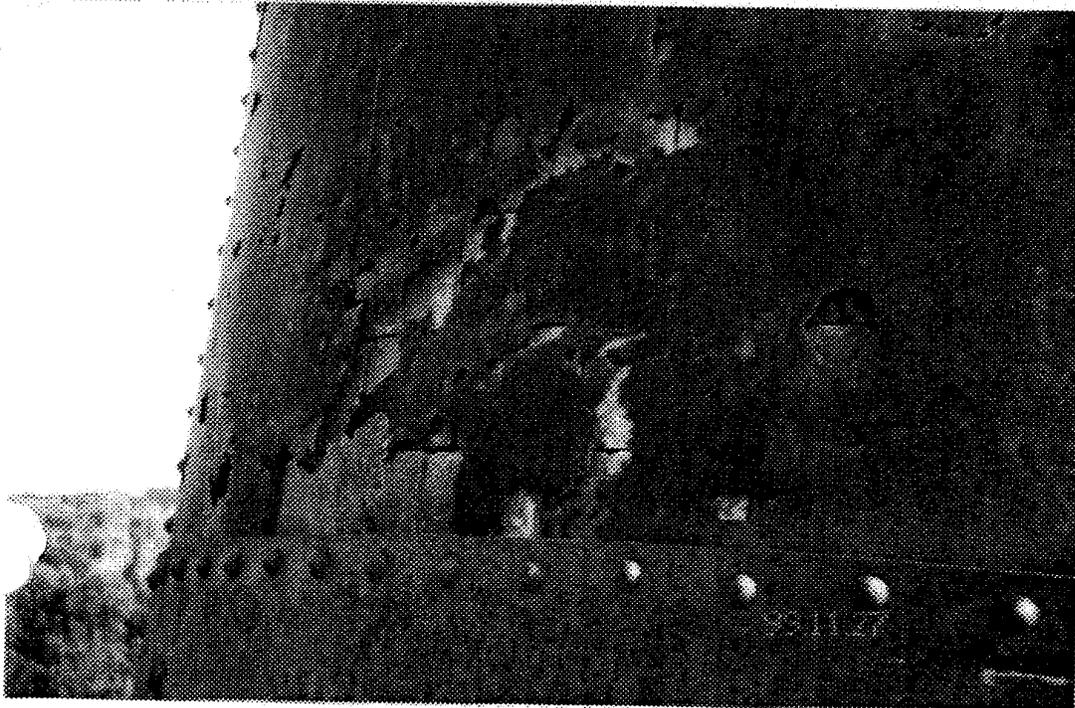
Photo # 3: Typical condition of uppermost plate.

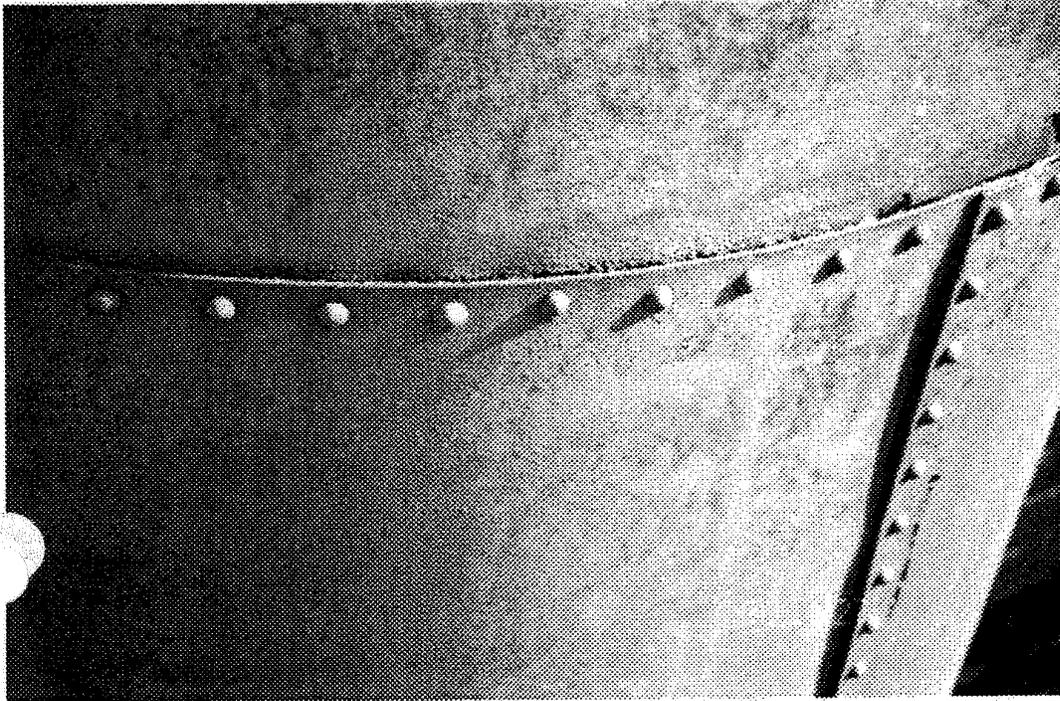
- Photos 4 & 5 Shows stack plate and rivets which clearly indicates that the stack has separated at the rivets and the firebrick lining is exposed. Photo #5 shows that a firebrick has been pushed outward in order to maintain an annular space between firebrick and steel shell, which is also the area where the grout was installed and has disintegrated and ultimately fallen out.

Photo # 4: Top of #3 plate  
± 10' below top of stack.

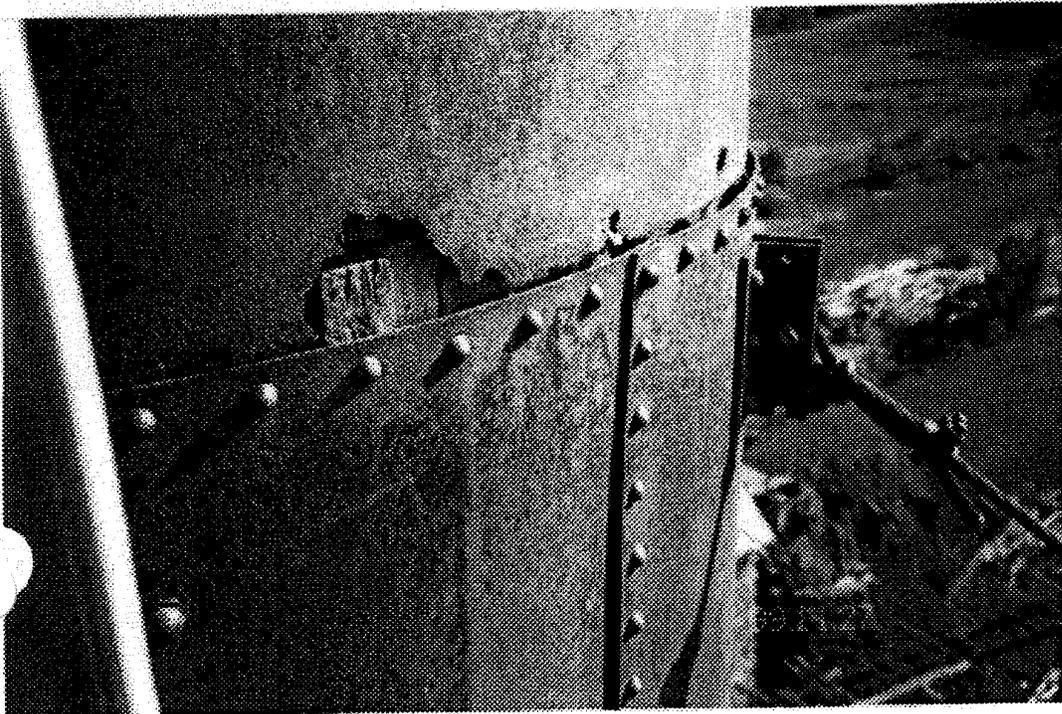
Photo # 5: Top of #4 plate  
± 15' below top of stack.

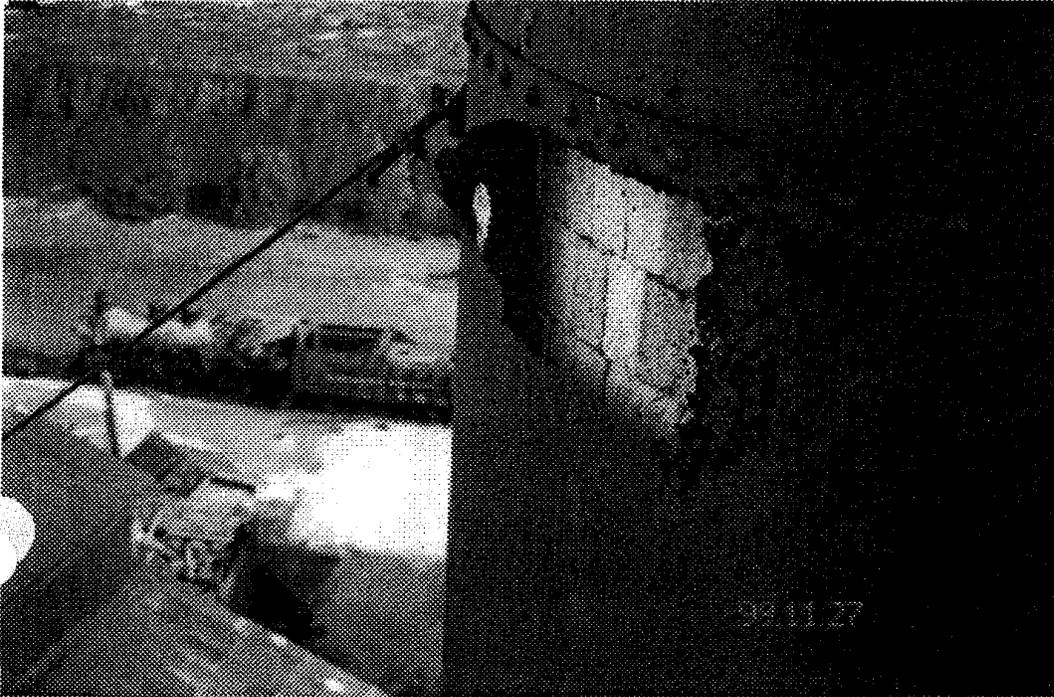
- Photos 6 & 7 Shows the stack shell and exposed portion of the firebrick. In this area at one time, was a guy wire, but due to the deterioration of the stack shell the guy wire fell off.

Photo # 6: Hole in steel plate noted  $\pm$  15' below top of stack, west quadrant.

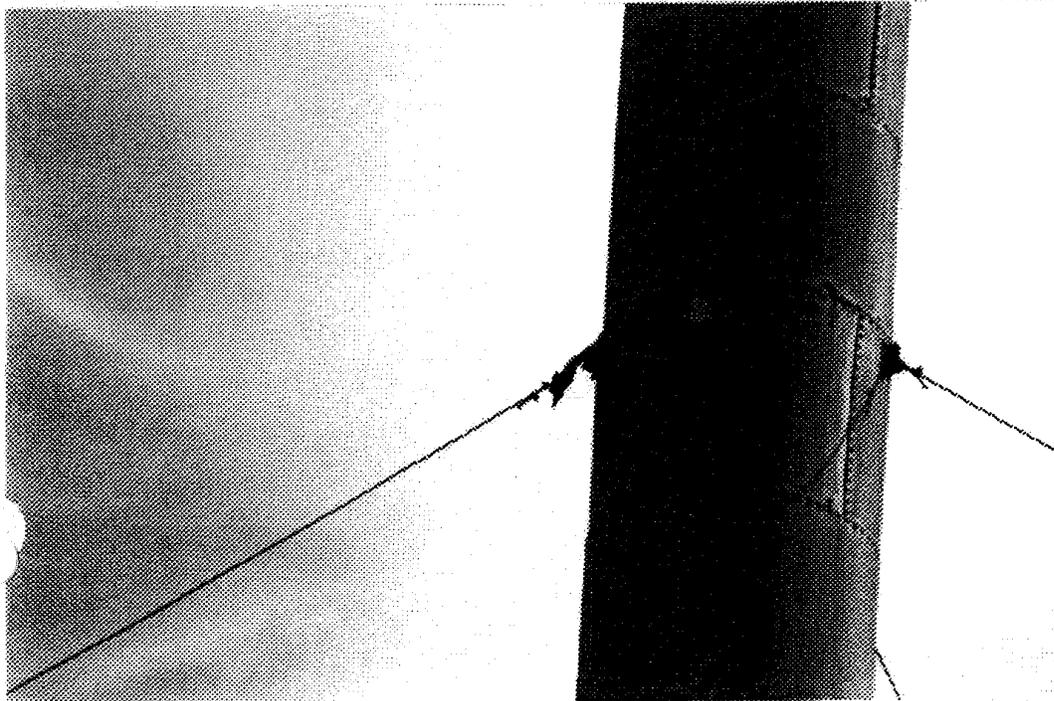
Photo # 7: View looking up at guy wires, south quadrant.

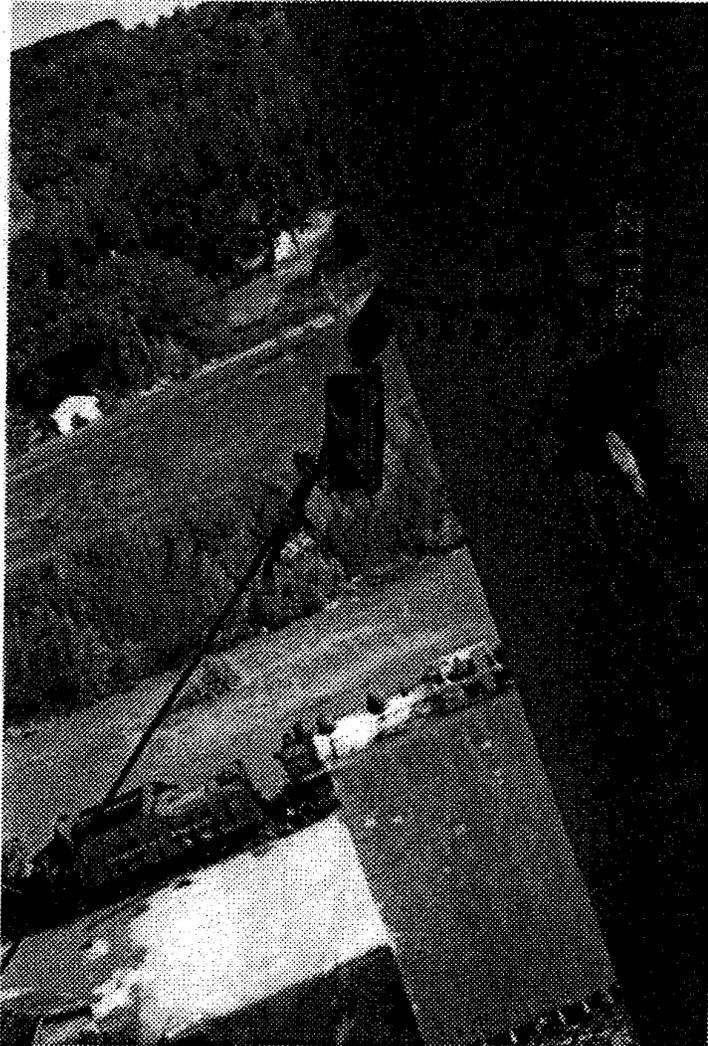
Only three guy wires are in existence. The guy wires are located approximately 15' below the top of the stack attached to the existing stack shell on the east, northeast and southwest quadrants. The guy wire on the southwest quadrant are only connected by approximately a 1/2" to 3/4" steel plate. This steel plate is heavily corroded and suspect that this guy wire will not be in place much longer.

- Photo 8 Shows a close up of the southwest guy wire and only approximately 3/4" of the connection is in place. As previously stated, this could break off at any time, especially during high winds from the southwest.

Photo # 8: Close up view of  
guy wire  $\pm$  15' below top of  
stack, west quadrant.

The uppermost three guy wires should be replaced with new guy wires to secure the stack. A crane will have to be supplied at no cost to I.C.C.

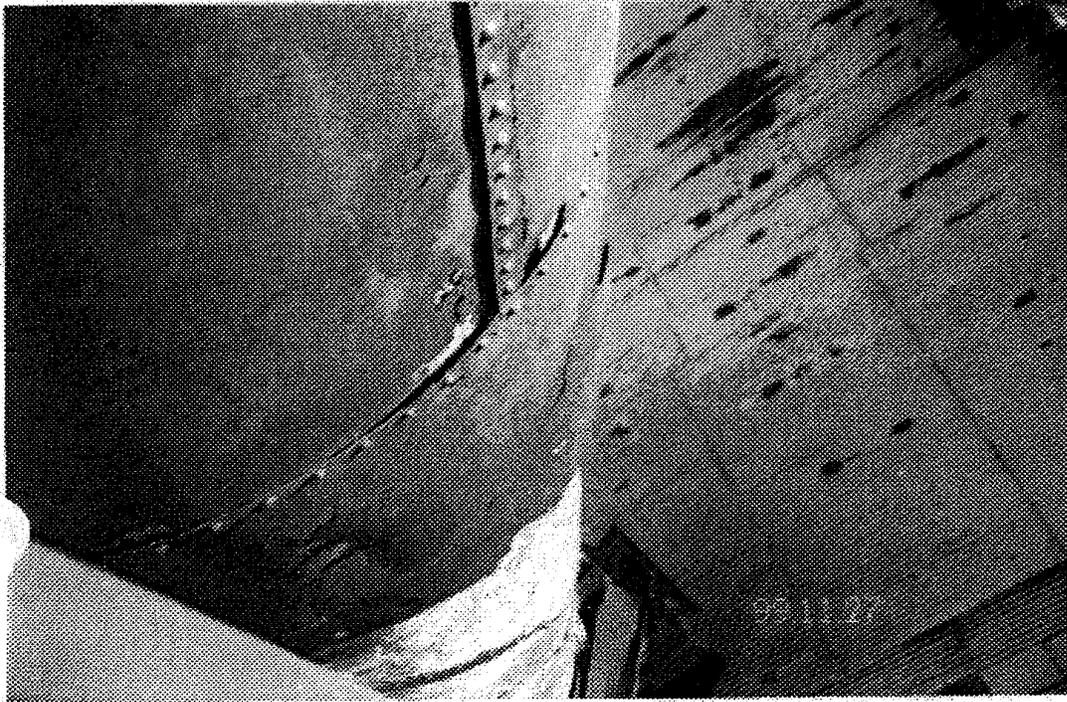
- Photos 9 & 10 Shows the exposed portion of the brickwork and deteriorated steel plate.
- Photo 11 Shows the exposed portion of the lining brickwork. Please note the one kicker brick. This is also the brick provided the spacer for the steel shell and ultimately to apply the grout.

Photo # 9: View looking down east quadrant of stack from 30' below top.

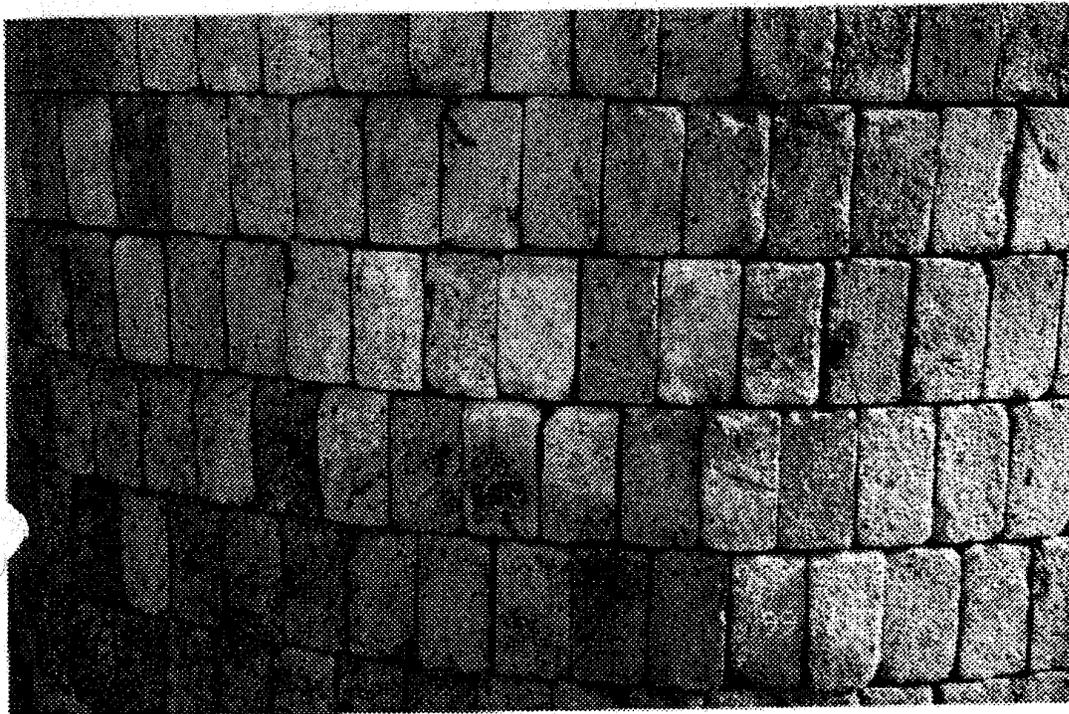
Photo #10: View of exposed portion of lining brickwork from  $\pm$  32' below top of stack down to 10' above roof.

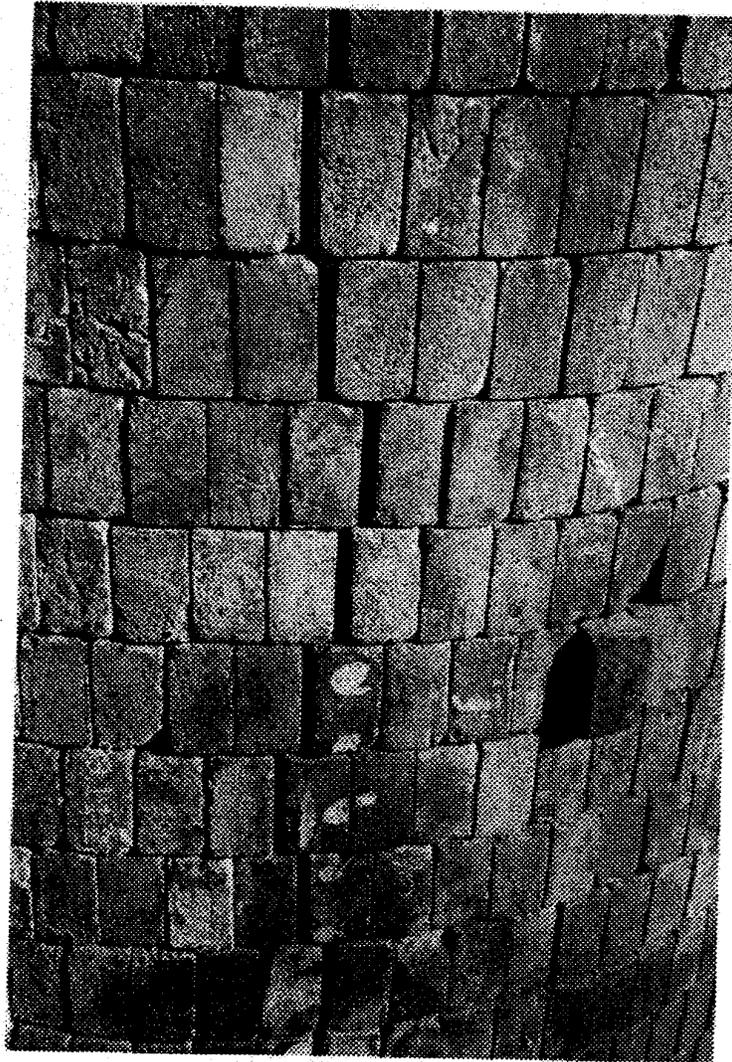
Photo #11: View of exposed portion of lining brickwork from  $\pm$  32' below top of stack down to 10' above roof.

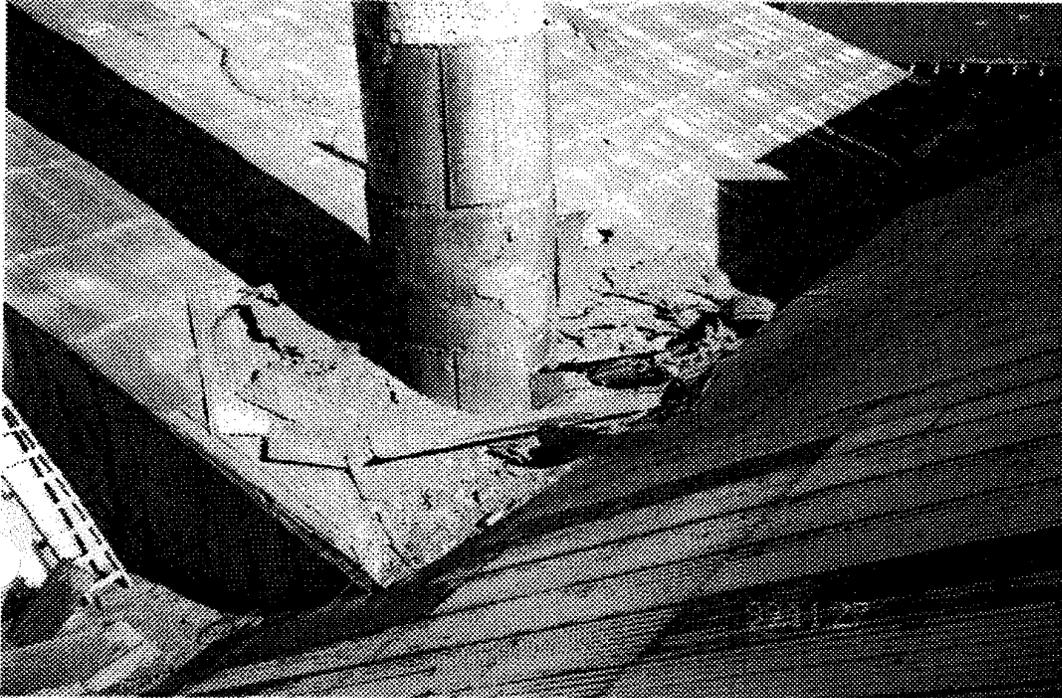
- Photo 12 & 13 Shows the stack above and below roof elevation. Please note the steel plates and debris laying on top of the roof, as well as guy wires. Photo #13 shows the condition of the corrugated metal roof and stack shell below roof.

Photo #12: View of stack at roof elevation. Note steel debris laying on roof.

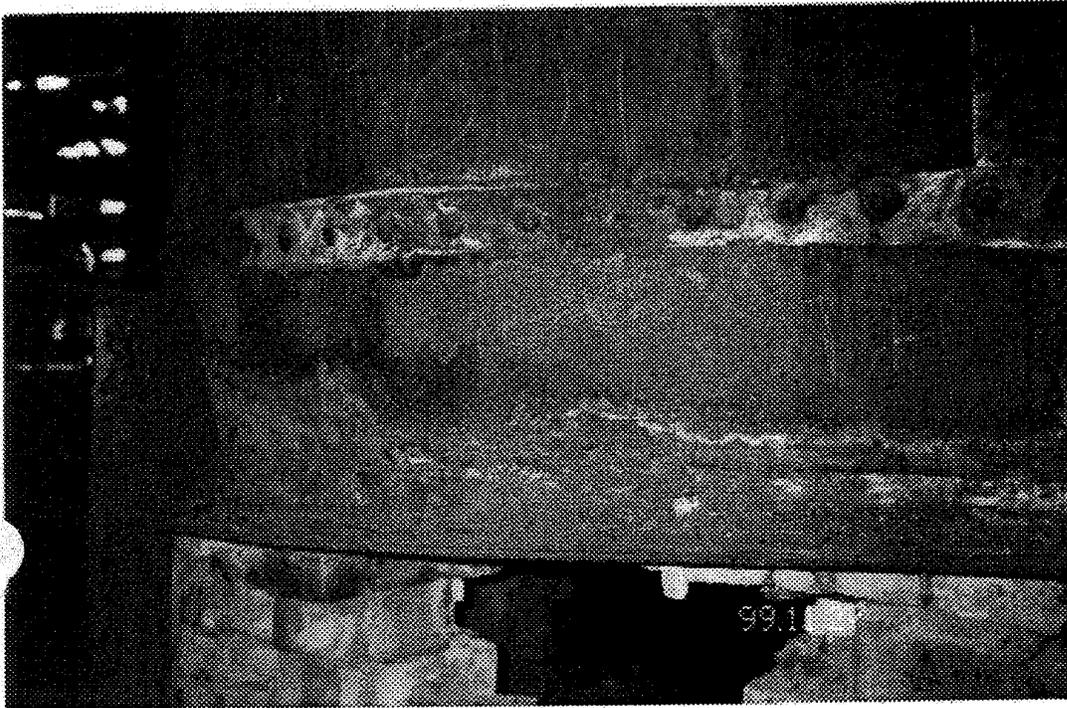
- Photos 14 & 15 Again show the stack below roof and deterioration of the roof joists and support steel.
- Photo 16 Shows the area above the breeching duct and brickwork beyond.

**Photo #16:** View of stack at breeching duct elevation.

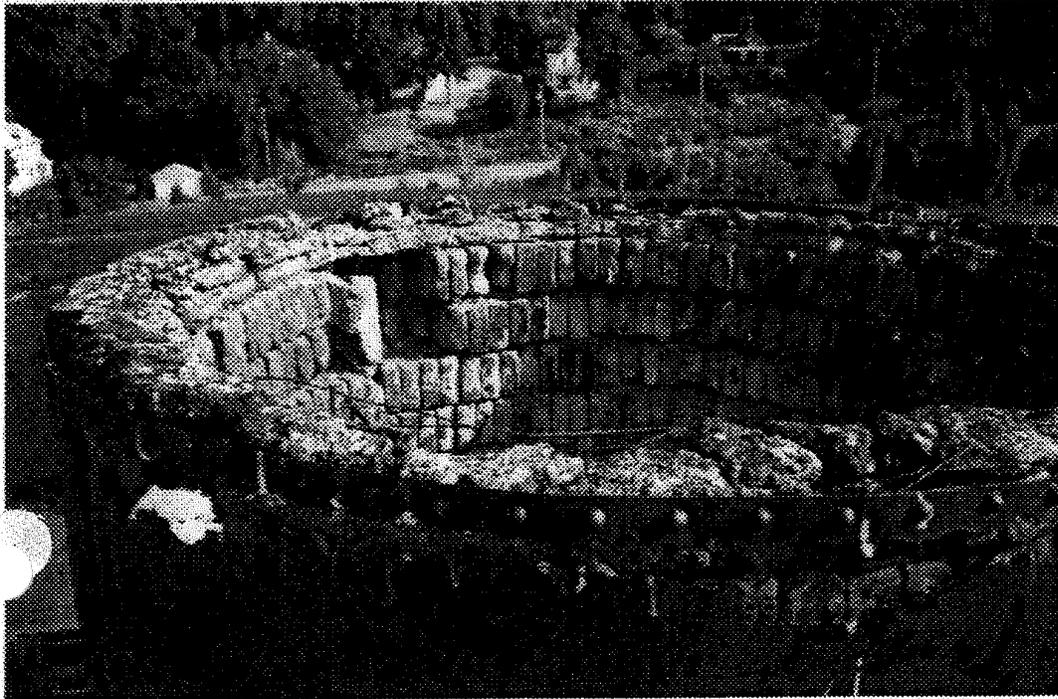
**Photo # 1: View of lining  
brickwork at top of stack.**

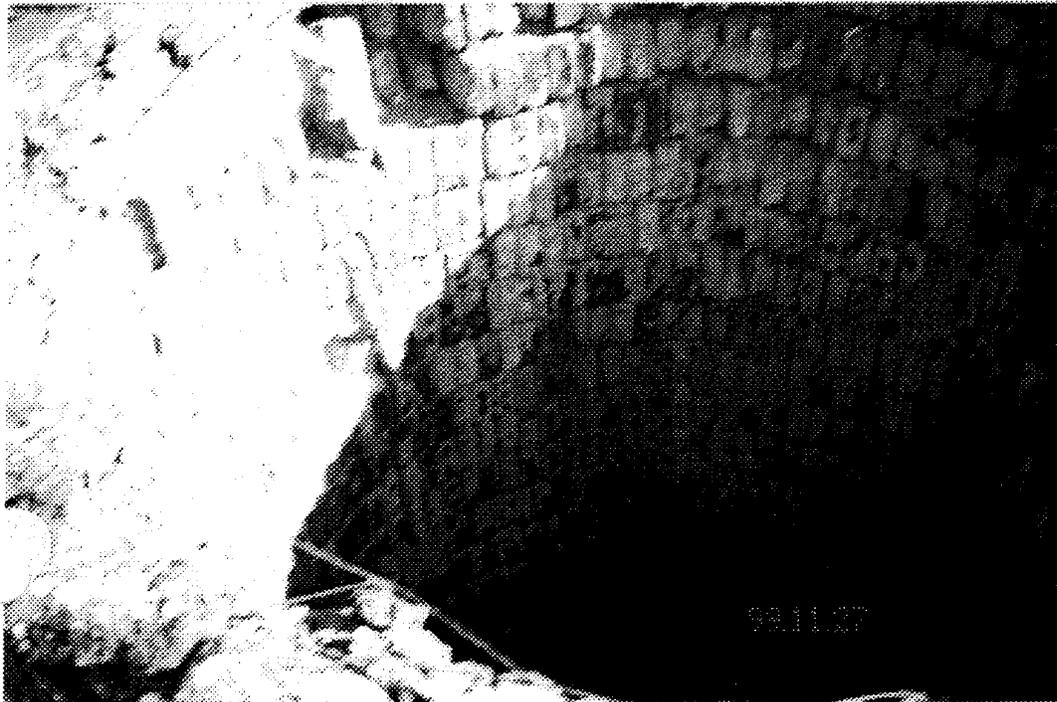
**Photo # 2: View of top  
± 10' of lining brickwork.**

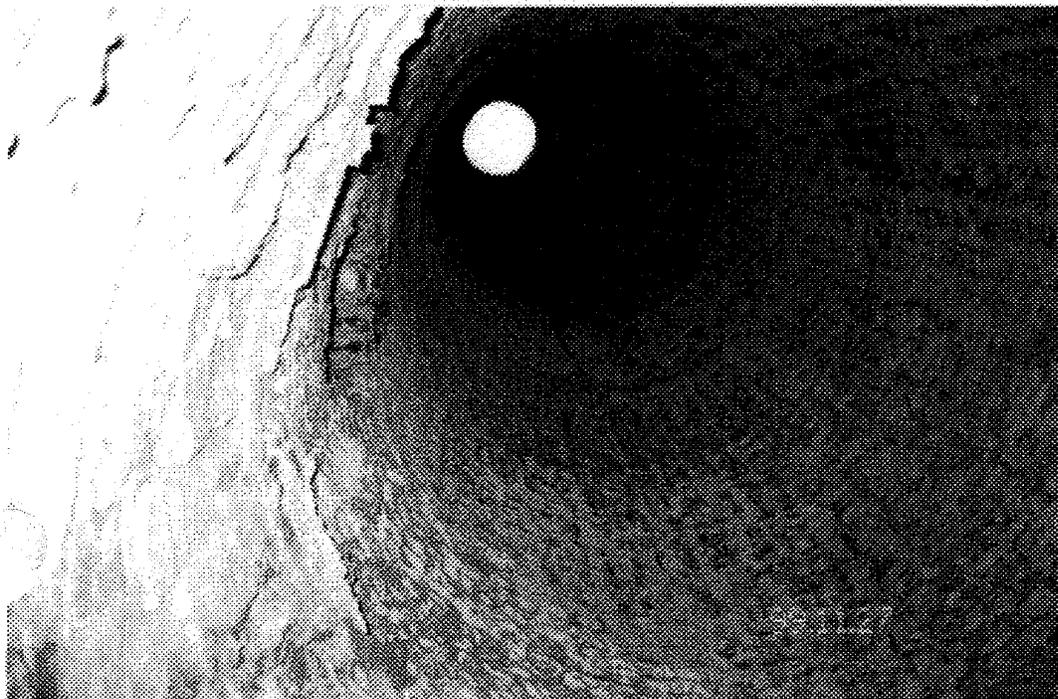
Photo # 3: View looking up lining brickwork from base of stack.

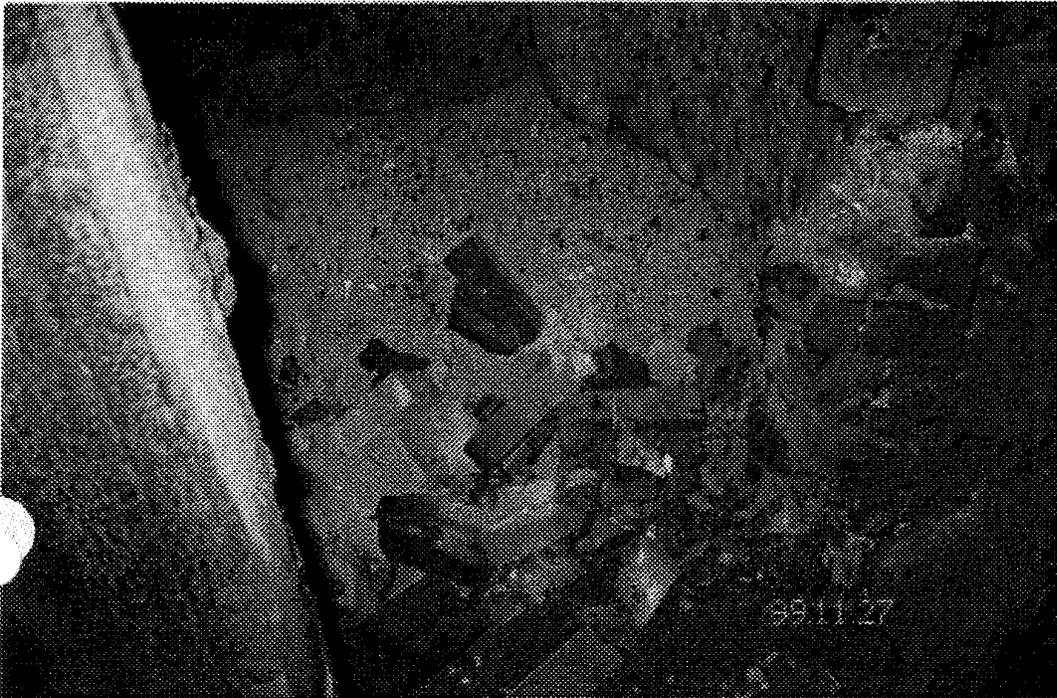
**Photo # 5:** View of breaching duct opening at base of liner.

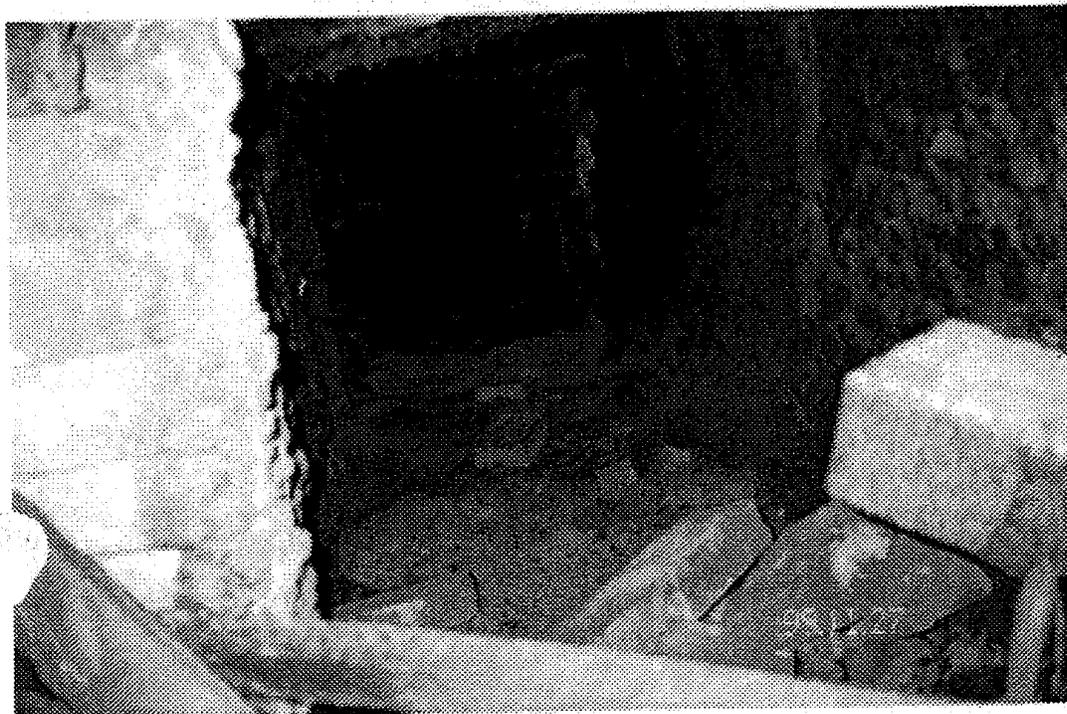
Photo # 7: View looking into breaching duct.

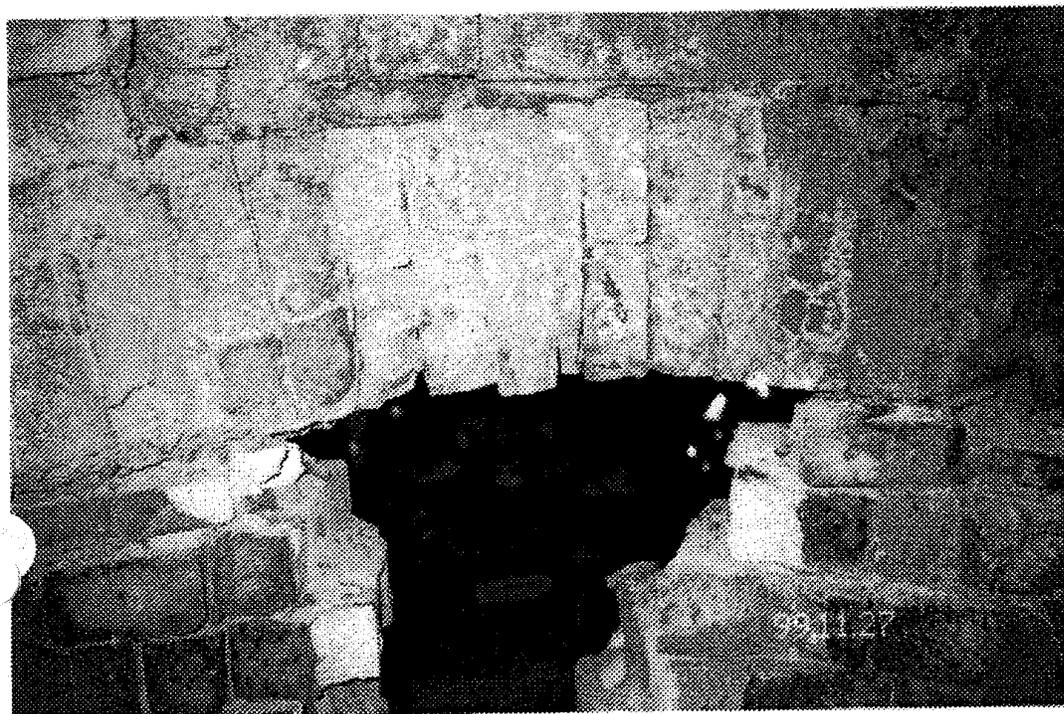
Photo # 8: View of brick arch over cleanout door.
