SITE: Quincy Smelter **DATE:** December 7, 2004 **SUBJECT:** Exterior, west side of Building 11. ACM pipe wrap at elevation along wall.
PHOTO NO: 1 **DIRECTION:** Southeast
PHOTOGRAPHER: S. Meyer

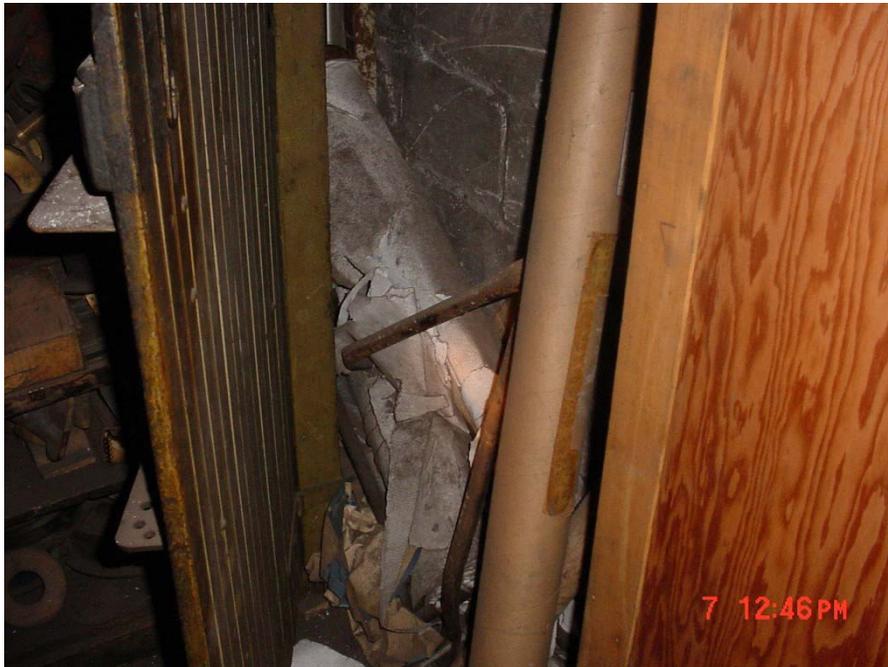
SITE: Quincy Smelter **DATE:** December 7, 2004 **SUBJECT:** ACM paper on floor in second-floor loft of Building 20.
PHOTO NO: 2 **DIRECTION:** Northeast
PHOTOGRAPHER: S. Meyer

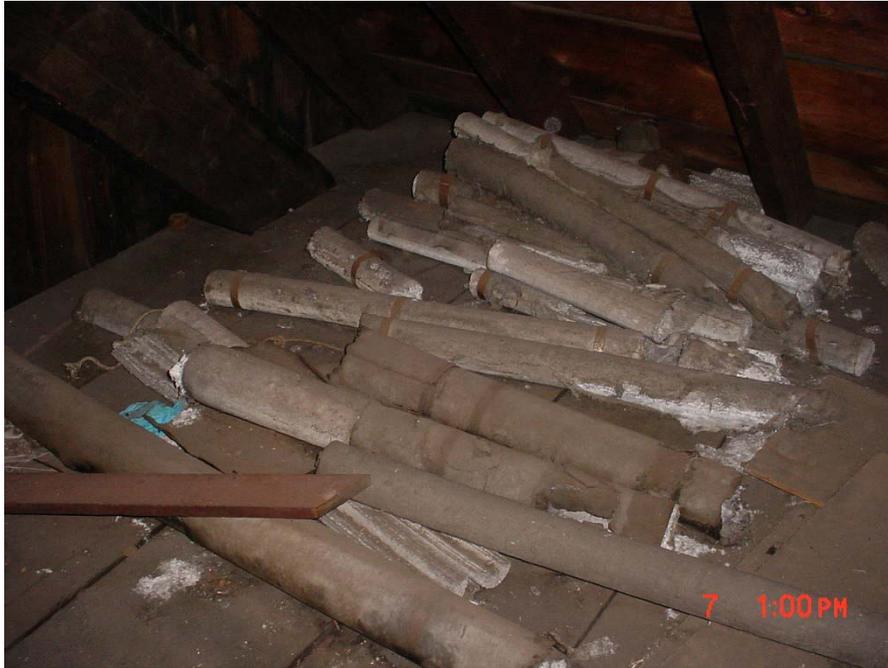
SITE: Quincy Smelter **DATE:** December 7, 2004 **SUBJECT:** ACM pipe wrap on floor, northwest corner of second floor of Building 11
PHOTO NO: 3 **DIRECTION:** North
PHOTOGRAPHER: S. Meyer

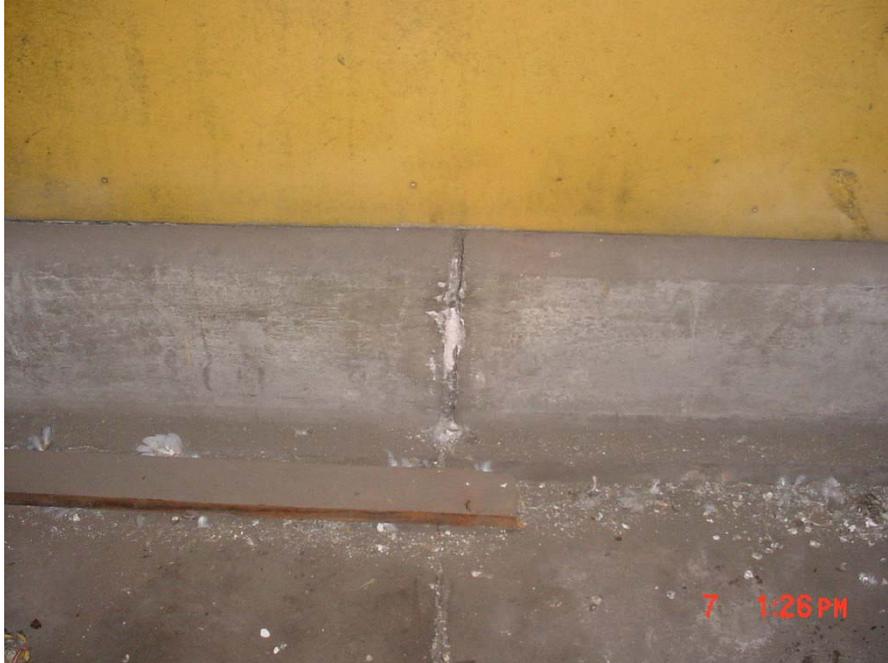
SITE: Quincy Smelter **DATE:** December 7, 2004 **SUBJECT:** ACM in a base board seam of floor of the east and central rooms of the upstairs locker room in Building 2.
PHOTO NO: 4 **DIRECTION:** South
PHOTOGRAPHER: S. Meyer

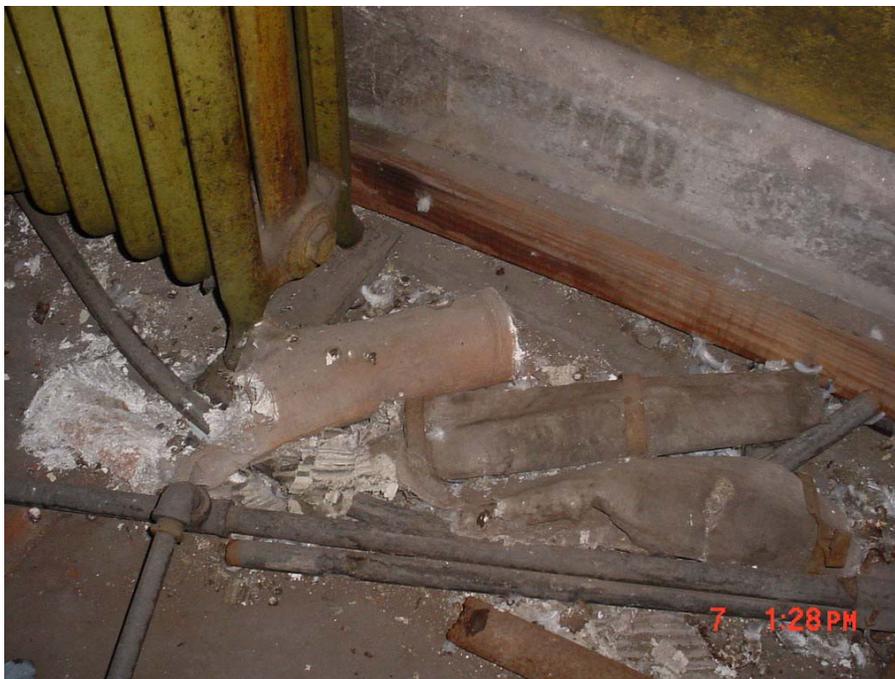
SITE: Quincy Smelter
PHOTO NO: 5
PHOTOGRAPHER: S. Meyer

SUBJECT: ACM pipe insulation on floor along the east wall of the east room of the upstairs locker room in Building 2.

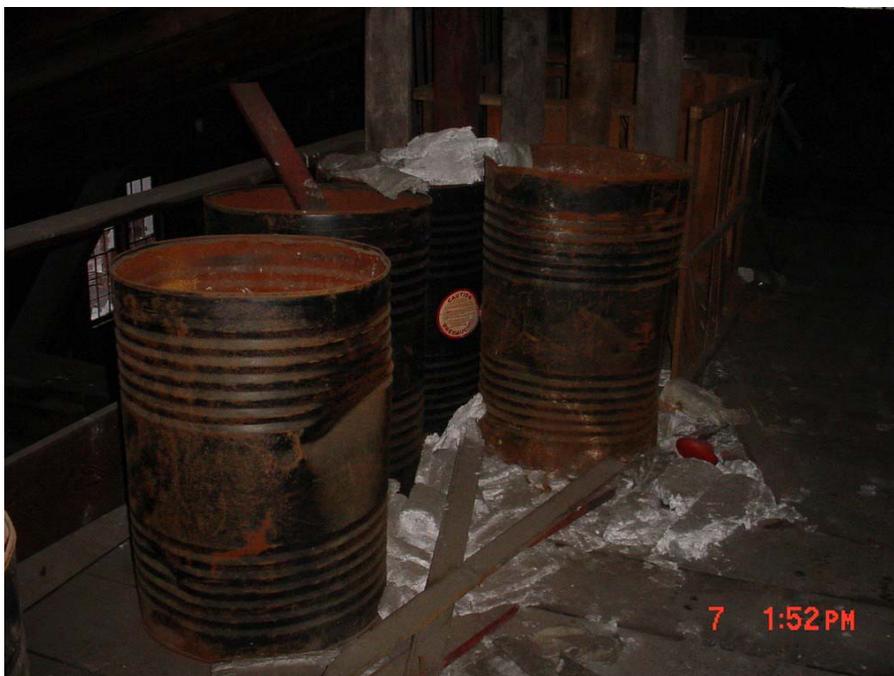
SITE: Quincy Smelter
PHOTO NO: 6
PHOTOGRAPHER: S. Meyer

SUBJECT: ACM pipe wrap on floor and in drums in second floor loft of Building 2.

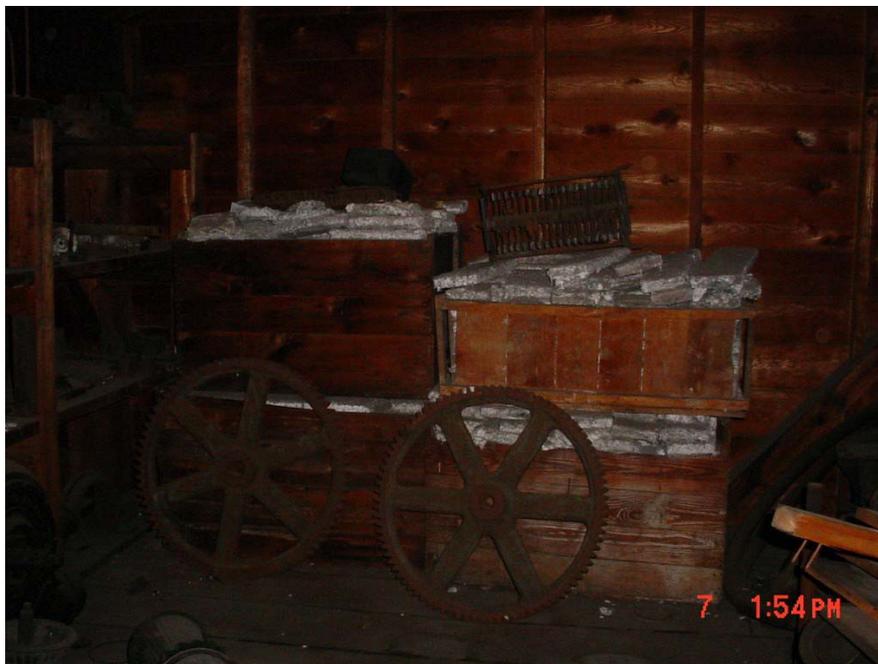
SITE: Quincy Smelter **DATE:** December 7, 2004 **SUBJECT:** ACM insulation in crates at south end of second floor loft of Building 2.
PHOTO NO: 7 **DIRECTION:** East
PHOTOGRAPHER: S. Meyer

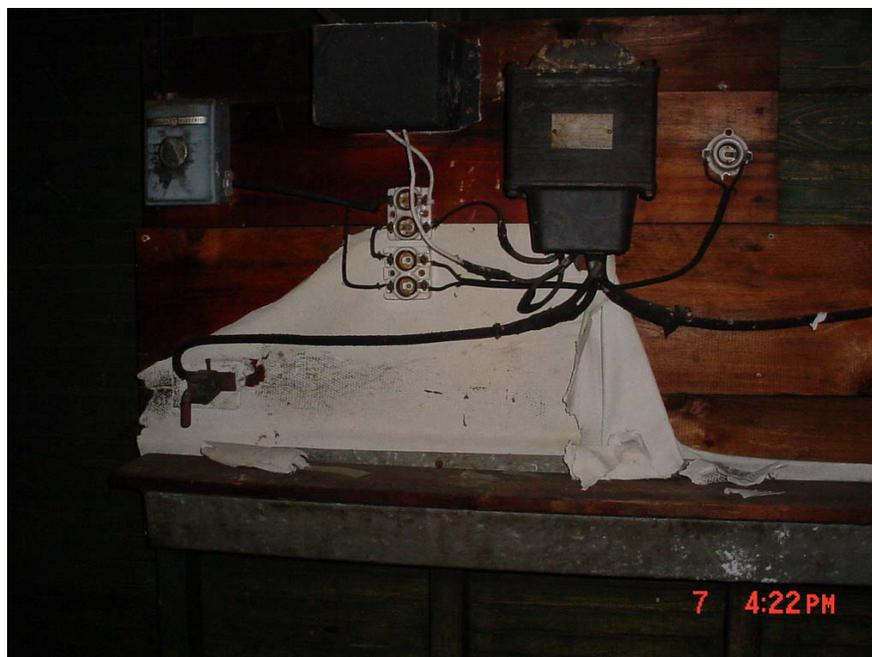
SITE: Quincy Smelter **DATE:** December 7, 2004 **SUBJECT:** ACM paper/heat shield on east wall of northwest room of Building 3.
PHOTO NO: 8 **DIRECTION:** East
PHOTOGRAPHER: S. Meyer

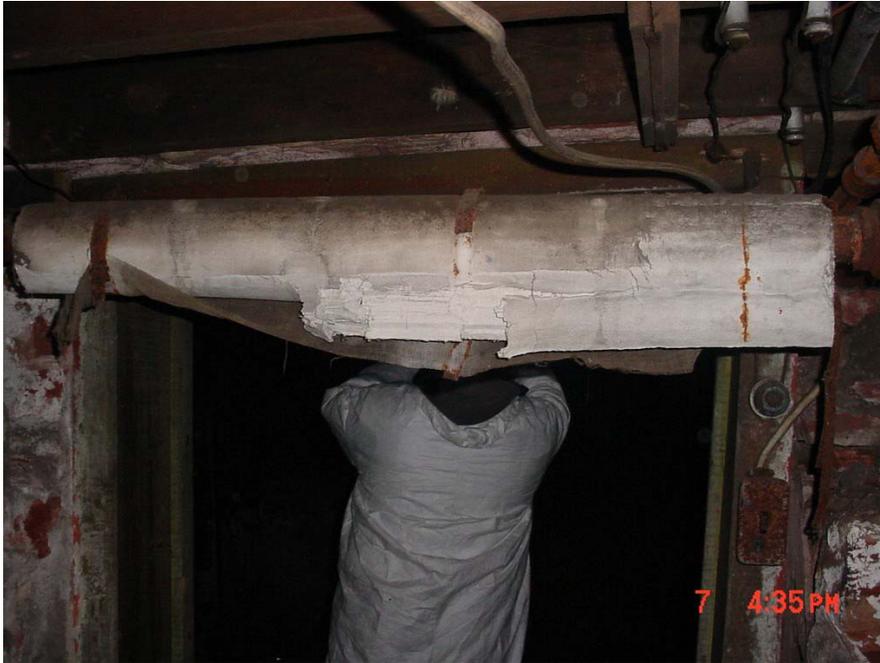
SITE: Quincy Smelter **DATE:** December 7, 2004 **SUBJECT:** ACM pipe wrap hanging in central area of
PHOTO NO: 9 **DIRECTION:** East basement of Building 3.
PHOTOGRAPHER: S. Meyer

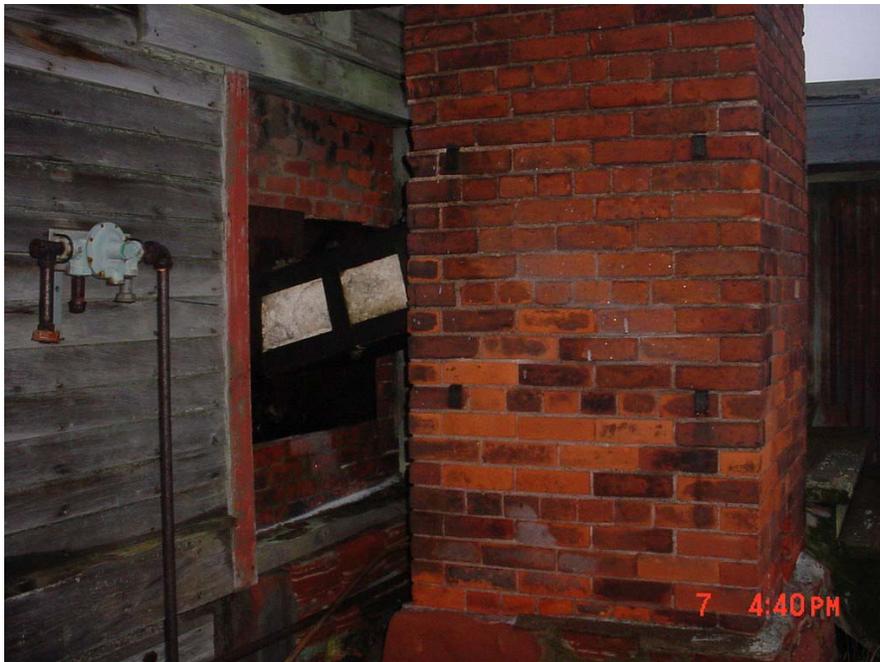
SITE: Quincy Smelter **DATE:** December 7, 2004 **SUBJECT:** ACM chimney chute insulation at the west
PHOTO NO: 10 **DIRECTION:** South side of Building 3.
PHOTOGRAPHER: S. Meyer

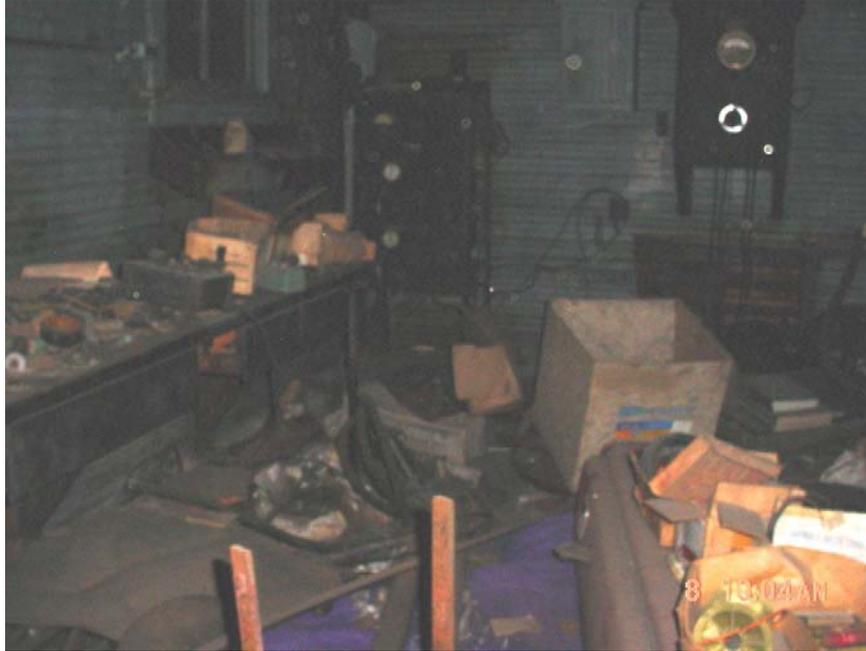
SITE: Quincy Smelter **DATE:** December 8, 2004 **SUBJECT:** Interior of the eastern shed attachment to Building 3; debris on floor. View from doorway.
PHOTO NO: 11 **DIRECTION:** Southwest
PHOTOGRAPHER: S. Meyer

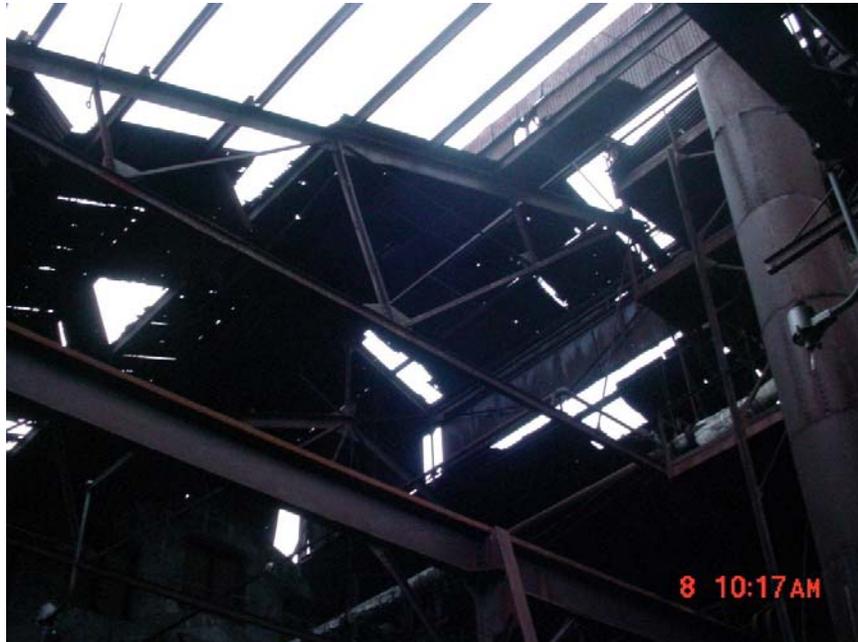
SITE: Quincy Smelter **DATE:** December 8, 2004 **SUBJECT:** Roof conditions over northwest portion of Building 7; falling and missing panels are visible.
PHOTO NO: 12 **DIRECTION:** Up, Northeast
PHOTOGRAPHER: S. Meyer

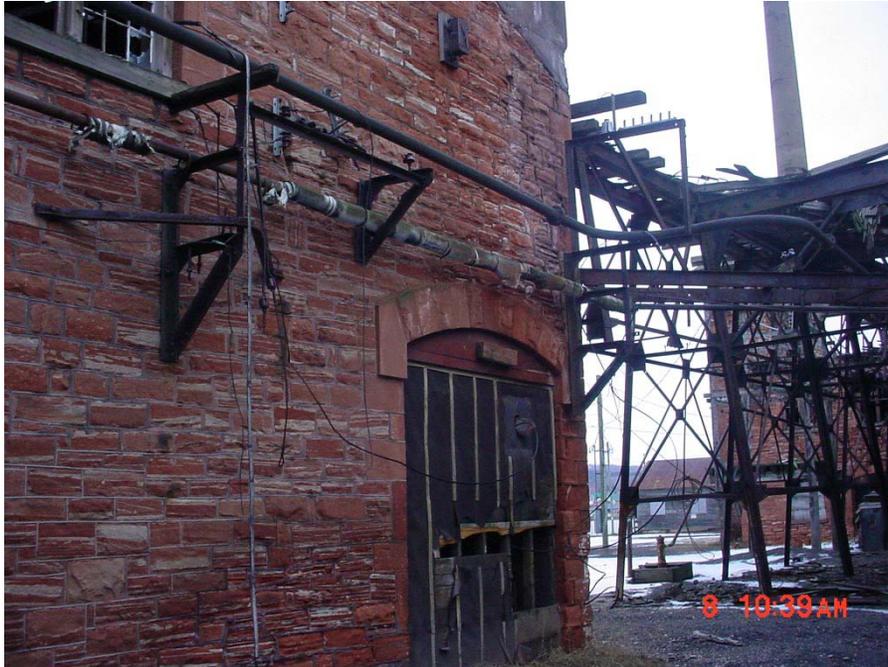
SITE: Quincy Smelter **DATE:** December 8, 2004 **SUBJECT:** ACM pipe wrap at elevation along north exterior wall of Building 7.
PHOTO NO: 13 **DIRECTION:** Southwest
PHOTOGRAPHER: S. Meyer

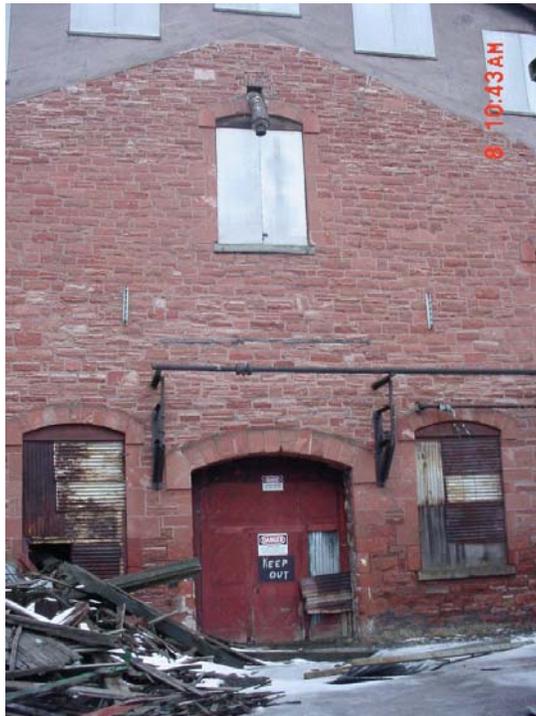
SITE: Quincy Smelter **DATE:** December 8, 2004 **SUBJECT:** ACM pipe wrap at elevation along north exterior wall of Building 7; wrapped pipe running left to right through photo, and wrapped pipe stub above upper window.
PHOTO NO: 14 **DIRECTION:** South
PHOTOGRAPHER: S. Meyer

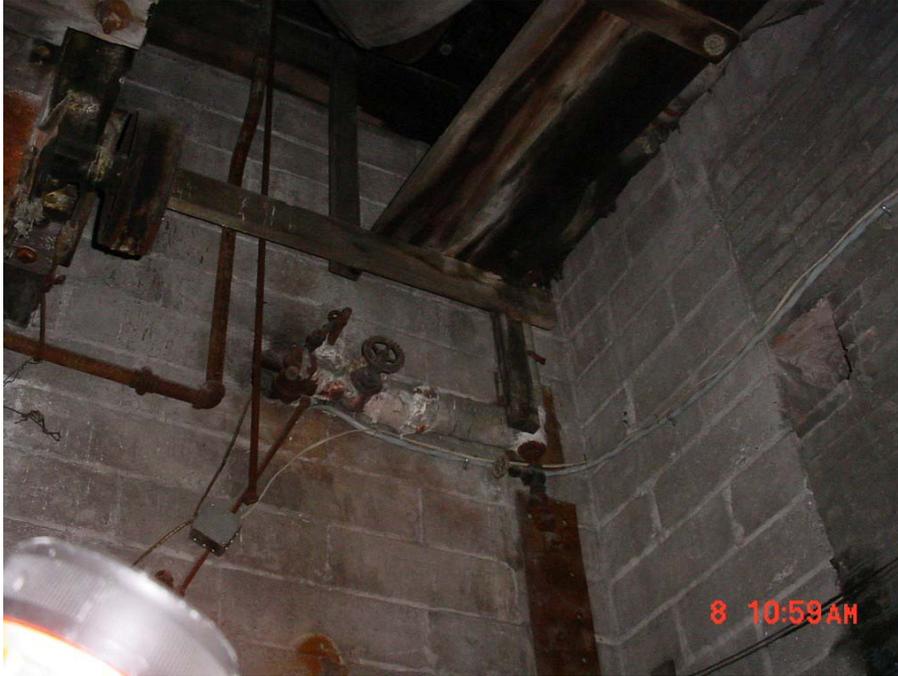
SITE: Quincy Smelter **DATE:** December 8, 2004 **SUBJECT:** ACM pipe wrap at elevation along south interior wall of Building 14, above man door.
PHOTO NO: 15 **DIRECTION:** Southwest
PHOTOGRAPHER: S. Meyer

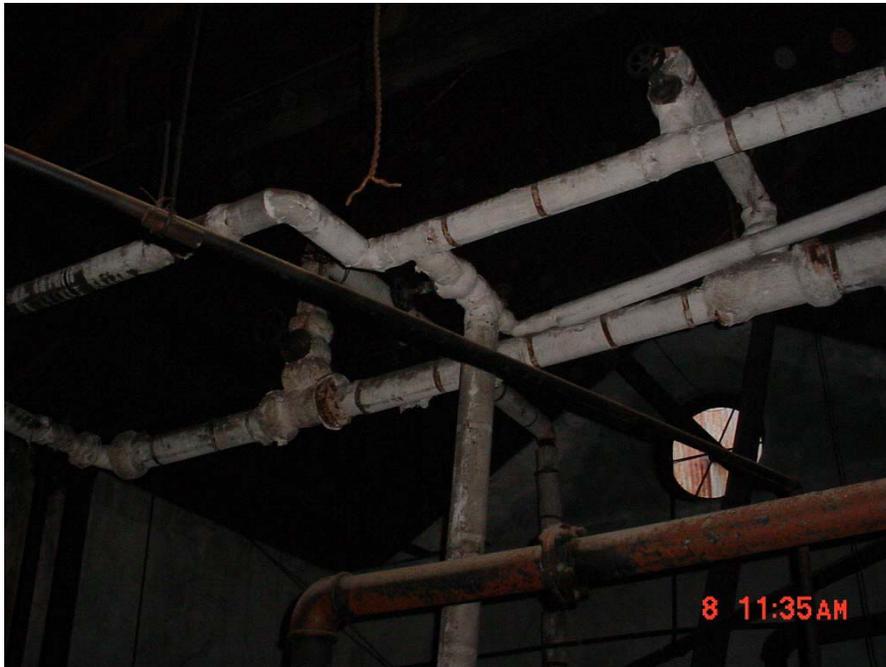
SITE: Quincy Smelter **DATE:** December 8, 2004 **SUBJECT:** ACM pipe wrap at elevation along ceiling of Building 16.
PHOTO NO: 16 **DIRECTION:** Northwest
PHOTOGRAPHER: S. Meyer

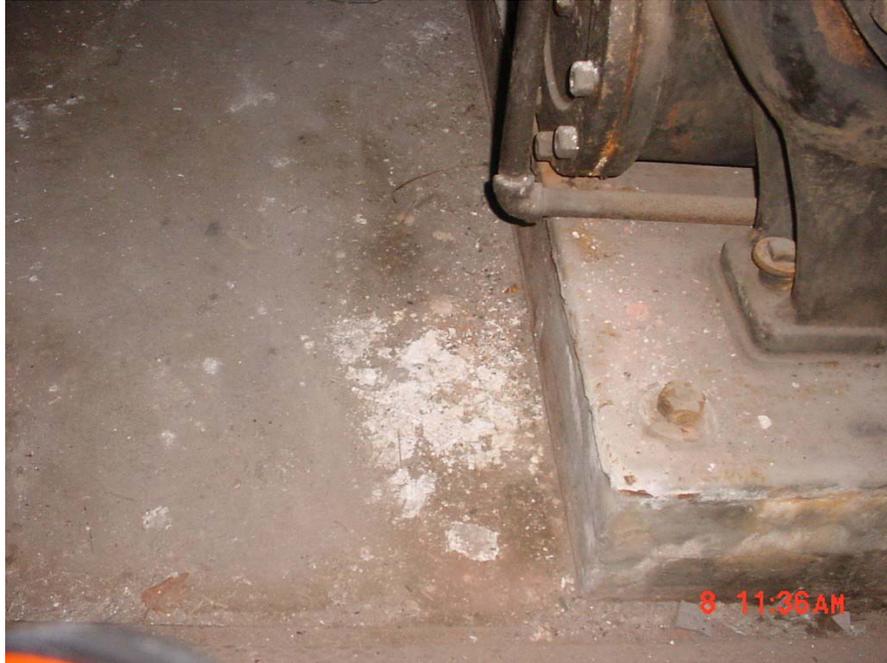
SITE: Quincy Smelter **DATE:** December 8, 2004 **SUBJECT:** ACM debris on floor of Building 16; many similar patches on floor throughout Building 16.
PHOTO NO: 17 **DIRECTION:** Down
PHOTOGRAPHER: S. Meyer

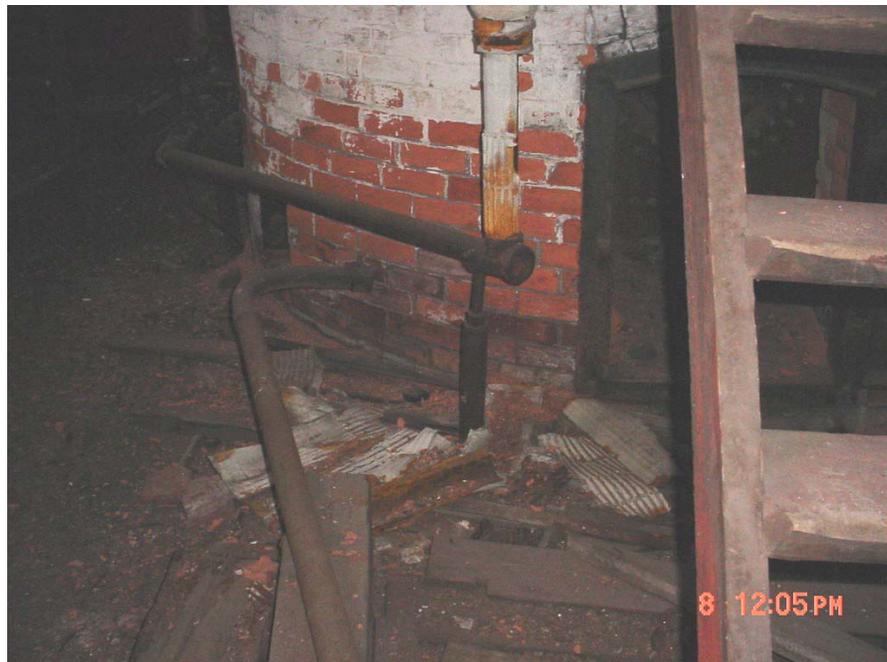
SITE: Quincy Smelter **DATE:** December 8, 2004 **SUBJECT:** ACM pipe wrap on floor at base of central, interior stack of Building 18; east side of stack.
PHOTO NO: 18 **DIRECTION:** West
PHOTOGRAPHER: S. Meyer

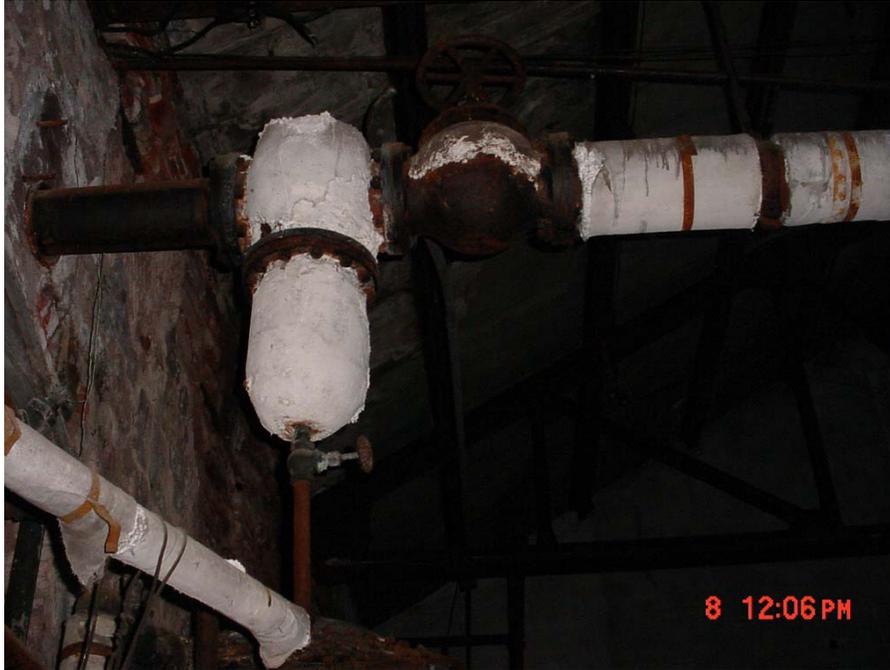
SITE: Quincy Smelter **DATE:** December 8, 2004 **SUBJECT:** ACM pipe and valve wrap along west wall of Building 17, north room.
PHOTO NO: 19 **DIRECTION:** North
PHOTOGRAPHER: S. Meyer

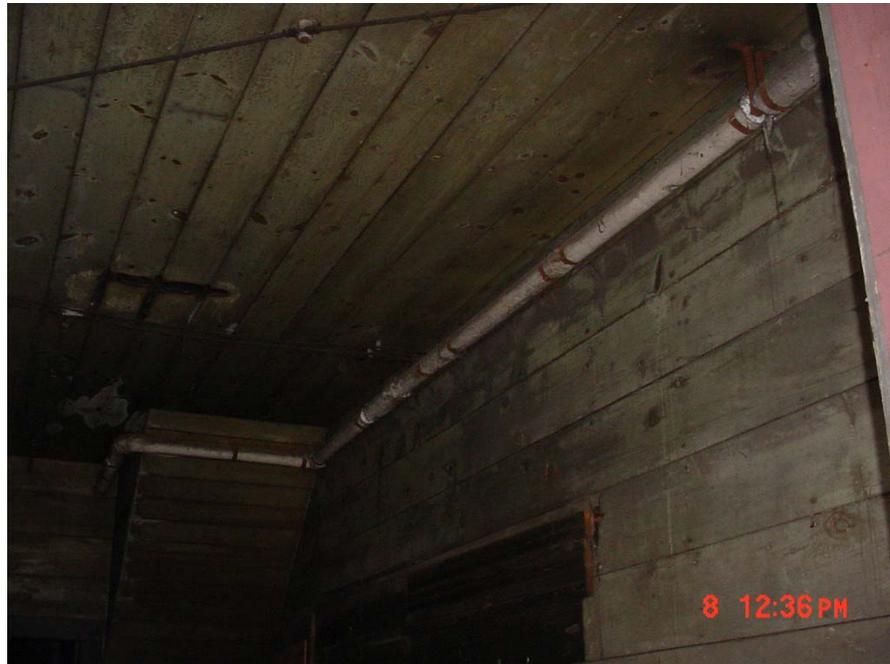
SITE: Quincy Smelter **DATE:** December 8, 2004 **SUBJECT:** ACM pipe wrap at elevation along south interior wall of the north room of Building 24.
PHOTO NO: 20 **DIRECTION:** Southeast
PHOTOGRAPHER: S. Meyer

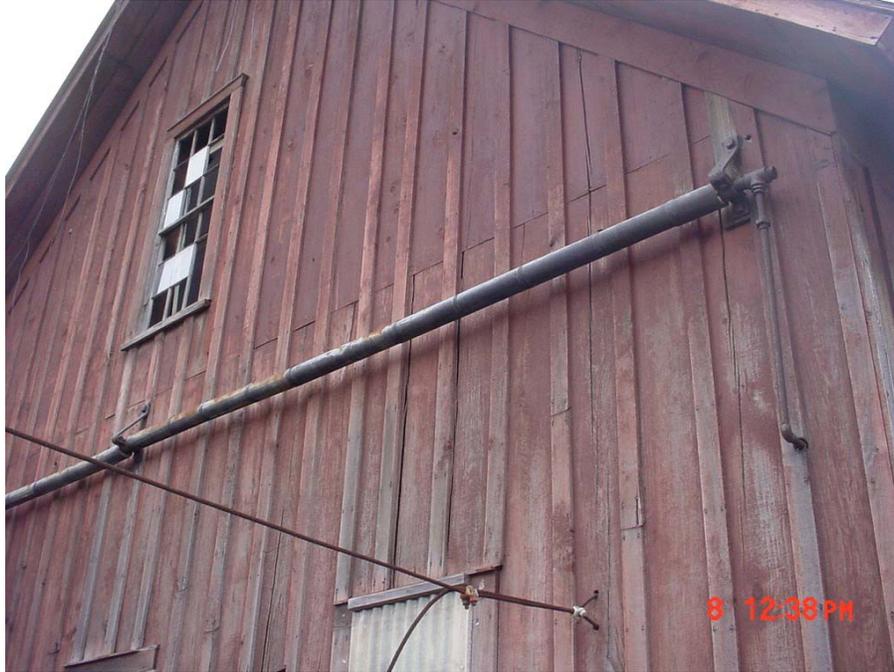
SITE: Quincy Smelter **DATE:** December 8, 2004 **SUBJECT:** ACM pipe wrap at elevation along north exterior wall of Building 24.
PHOTO NO: 21 **DIRECTION:** Southwest
PHOTOGRAPHER: S. Meyer

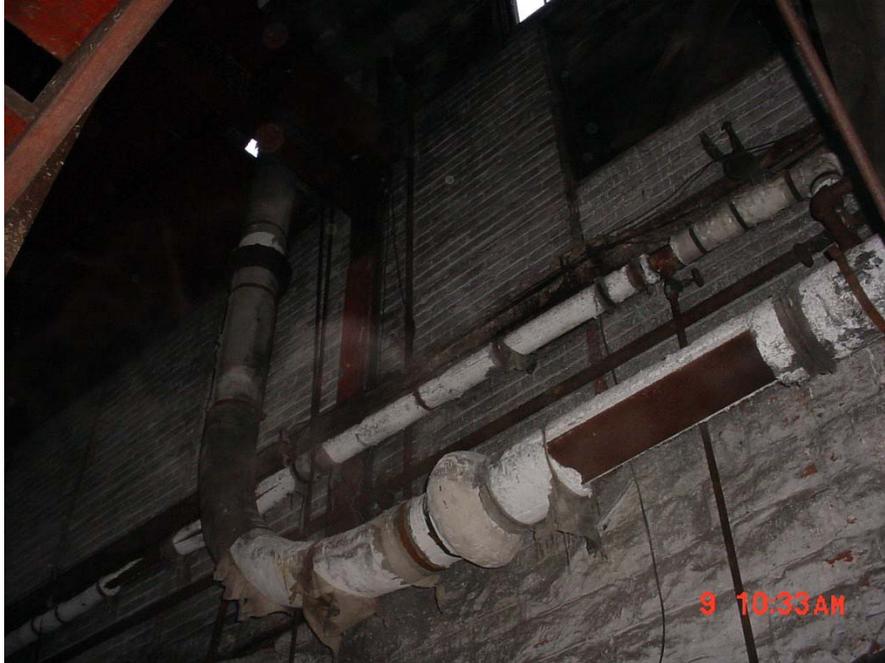
SITE: Quincy Smelter **DATE:** December 9, 2004 **SUBJECT:** Several runs of ACM pipe wrap at elevation along south interior wall of Building 18.
PHOTO NO: 22 **DIRECTION:** Up, North
PHOTOGRAPHER: S. Meyer

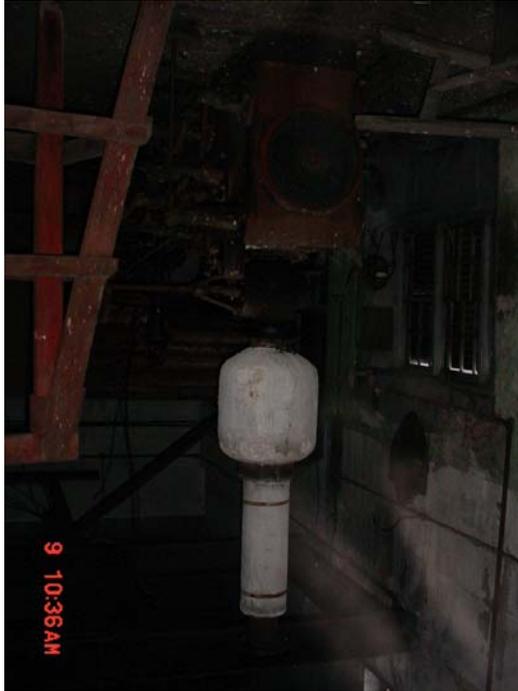
SITE: Quincy Smelter **DATE:** December 9, 2004 **SUBJECT:** ACM valve wrap on machine on the floor of the north room of Building 17.
PHOTO NO: 23 **DIRECTION:** East
PHOTOGRAPHER: S. Meyer

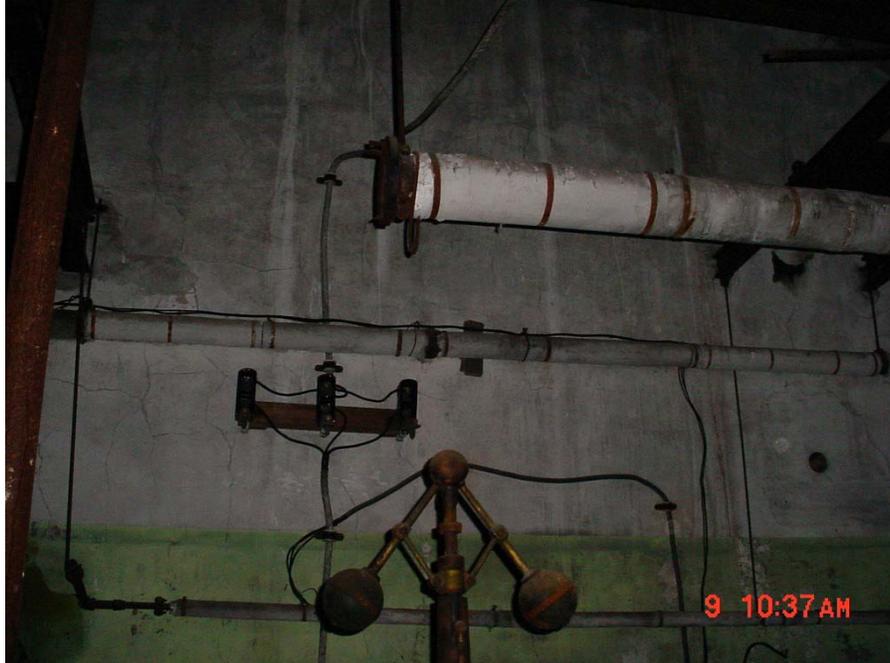
SITE: Quincy Smelter **DATE:** December 9, 2004 **SUBJECT:** Several runs of ACM pipe wrap along south interior wall of the north room of Building 17.
PHOTO NO: 24 **DIRECTION:** South
PHOTOGRAPHER: S. Meyer

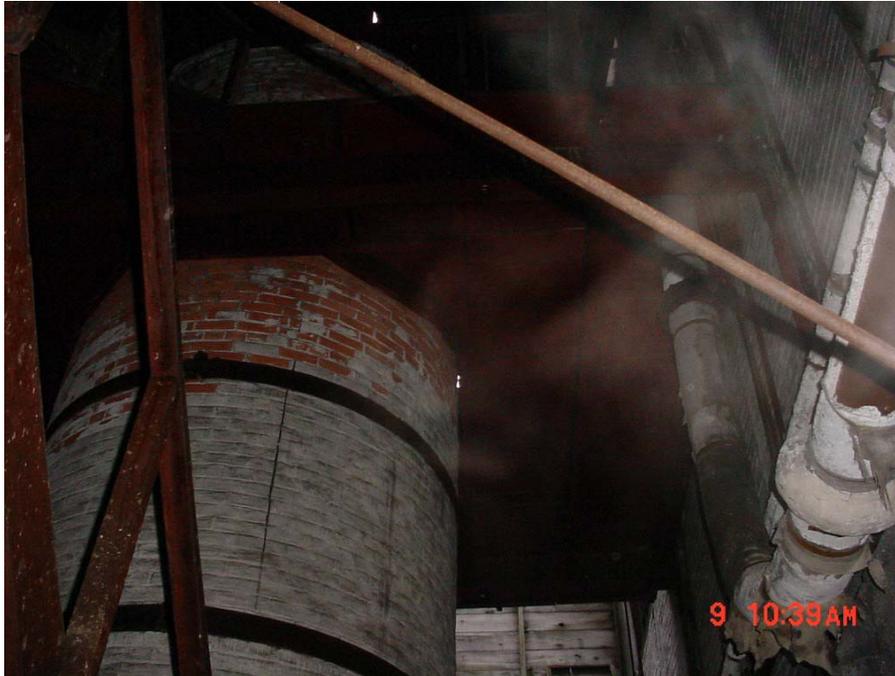
SITE: Quincy Smelter **DATE:** December 9, 2004
PHOTO NO: 25 **DIRECTION:** West
PHOTOGRAPHER: S. Meyer

SUBJECT: ACM pipe wrap on pipes along north wall of Building 18 and elevated wooden stack access platform surrounding interior smoke stack of Building 18.
