**AFTER-ACTION LETTER REPORT FOR
HASTINGS GASOLINE SPILL
EMERGENCY RESPONSE
8805 BEDFORD ROAD (M-37)
DOWLING, BARRY COUNTY, MICHIGAN
TDD: S05-0308-014**

4 November 2003

**UNITED STATES ENVIRONMENTAL PROTECTION AGENCY
Emergency Response Branch**

Hastings Gasoline Spill Emergency Response
8805 Bedford Road (M-37)
Dowling, Barry County, Michigan
TDD: S05-0308-014

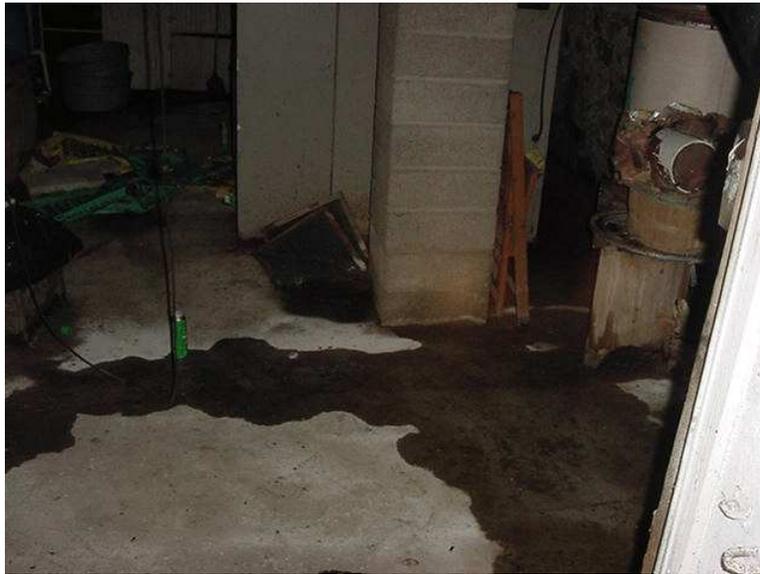
PHOTO NO: 005

On 27 August 2003, at 2130 hours (all times are approximations), an HRJ, Inc. tanker truck carrying 13,400 gallons of gasoline was traveling northbound on State Road M-37 (Bedford Road) when it lost control and capsized. The truck came to rest in the front yard of 8805 Bedford Road, fewer than 50 feet from the occupied home. A breach in the truck's tank caused by the accident resulted in the release of 5,900 gallons of gasoline. The gasoline spread over an area of 15,000 square feet, killing the grass and soaking into the ground, with resulting migration to catch basins and a buried storm drain to the east and north. The gasoline also seeped into the basement of the home on the property, forming puddles of gasoline on the dirt floor. The

SUBJECT: Basement of 8805 Bedford Road, with gas visible on the floor.

On 2 September, based on air monitoring results and continued pooling of gasoline in the basement of 8805 Bedford, the U.S. EPA required the removal of gasoline saturated soil under the home. After on-site discussions between HRJ, the homeowner, the homeowner's attorney (via phone), the homeowner's insurance agent, and HRJ's insurance agent, HRJ elected to demolish the home based on the cost of other possible removal options. At 2000 hours, demolition of the home at 8805 Bedford Road was initiated by Taplin. Before demolition, an asbestos inspection was conducted by FTCH. A small amount of friable asbestos-containing material was removed from the house by Taplin, and asbestos-containing flooring was wet down prior to demolition to reduce dust formation. The structure was leveled by the Taplin crew in approximately 45 minutes using an excavator. Debris clearing and staging continued through the night and into the next morning.

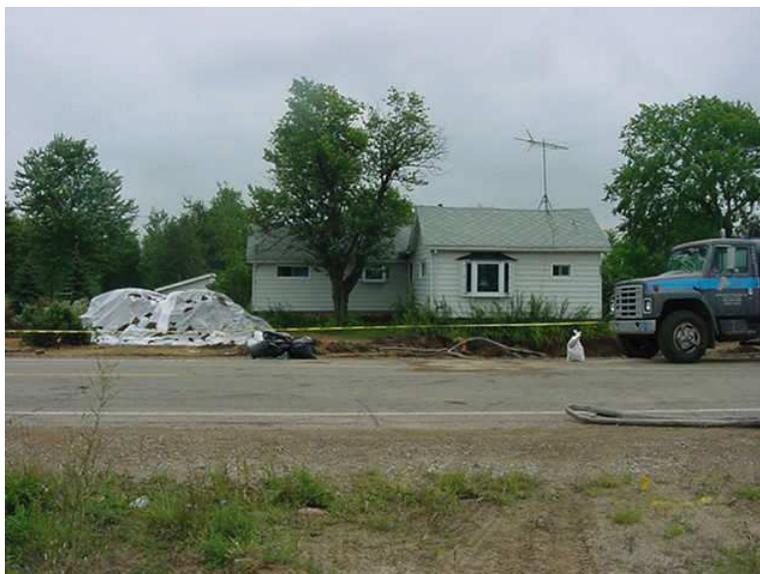
PHOTO NO: 013

SUBJECT: Initial excavation looking east at 8805 Bedford Road residence.

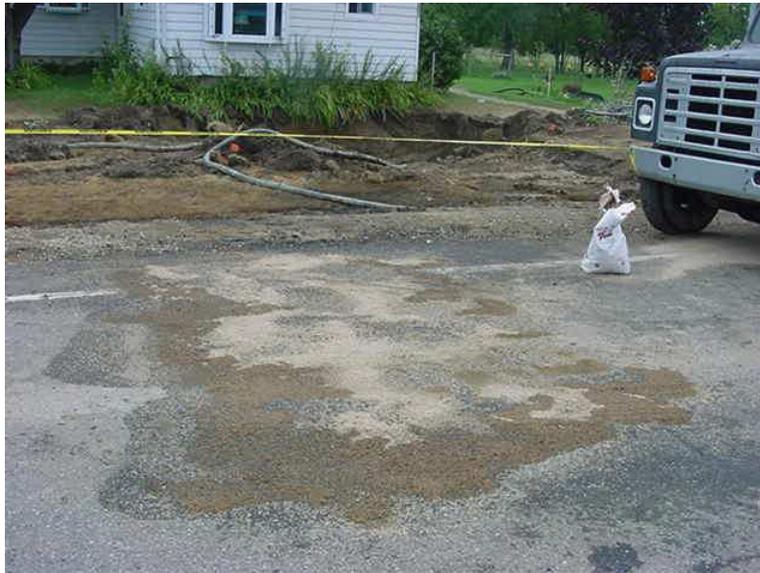
PHOTO NO: 014

SUBJECT: Spilled gas on Bedford Road looking east at 8805 Bedford Road residence.

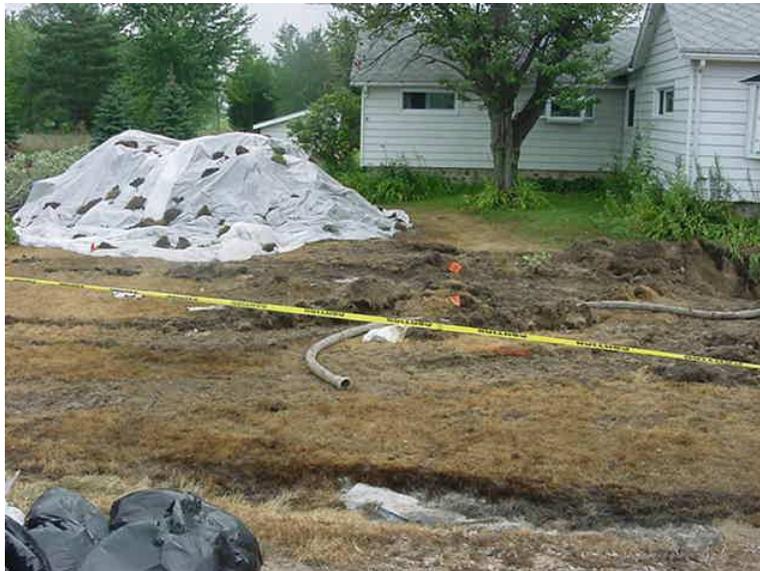
PHOTO NO: 015

SUBJECT: Initial excavation looking east at 8805 Bedford Road residence.

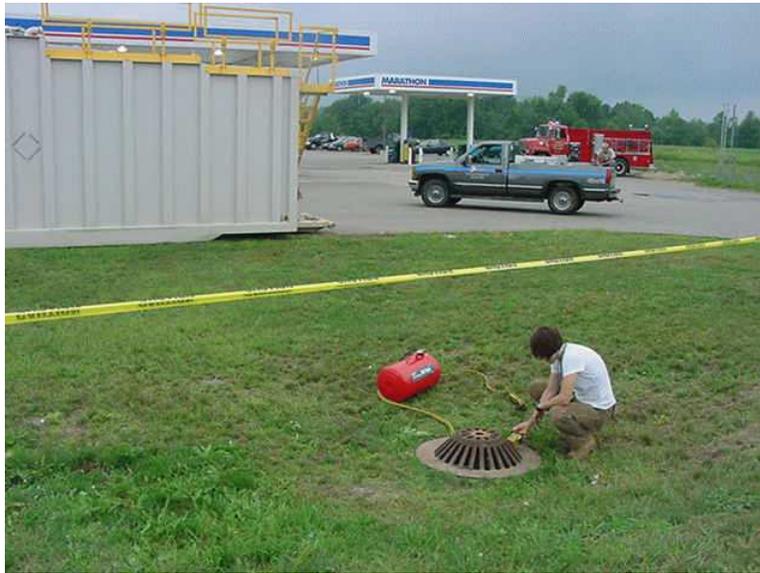
PHOTO NO: 017

SUBJECT: Air monitoring at Catch Basin #3.

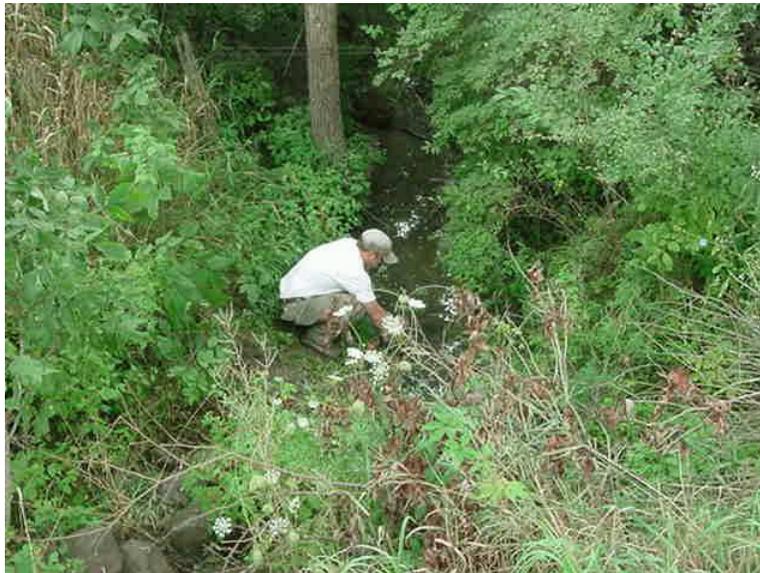
PHOTO NO: 018

SUBJECT: Air monitoring at Culvert #1.

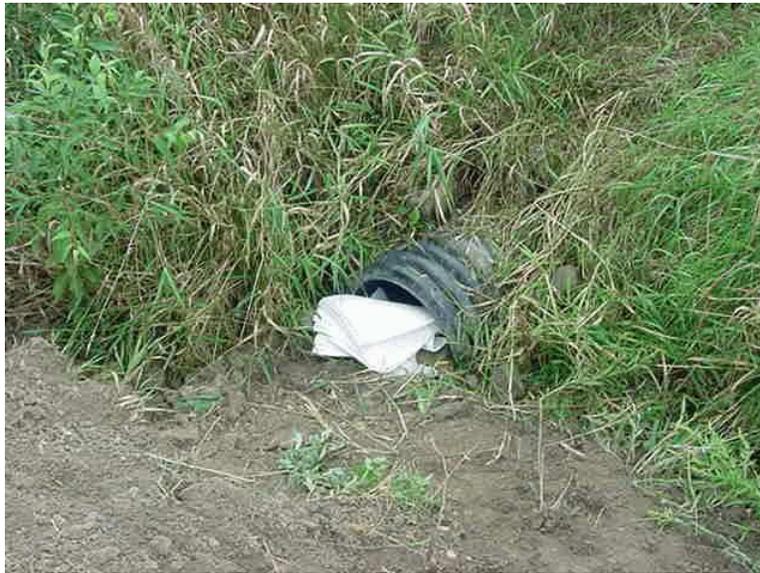
PHOTO NO: 019

SUBJECT: View of Discharge #1 and edge of berm.

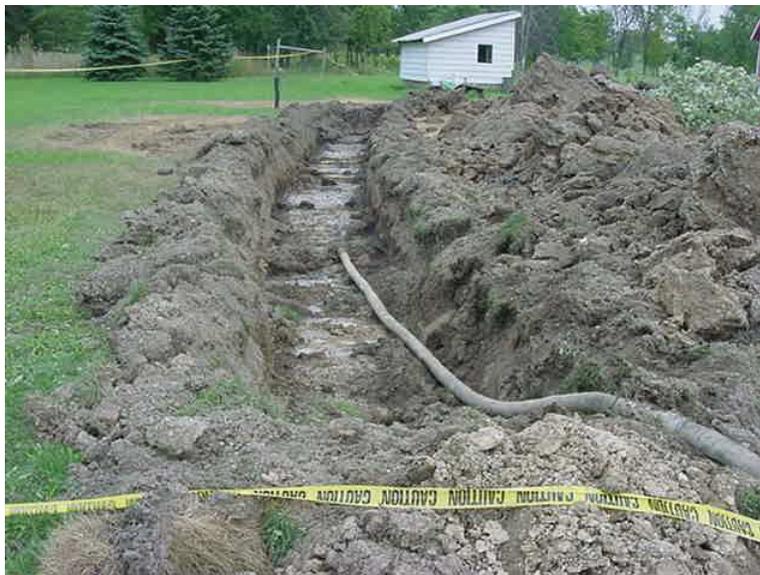
PHOTO NO: 023

SUBJECT: Northern collection trench.

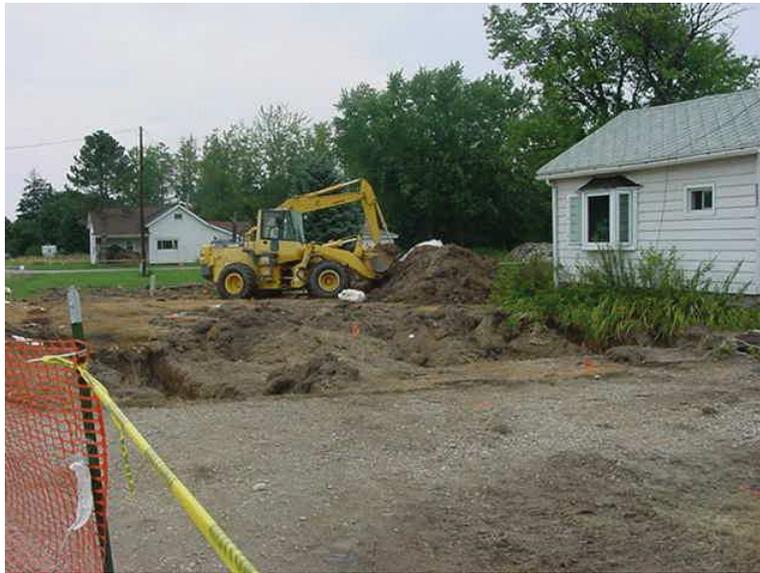
PHOTO NO: 031

SUBJECT: Initial excavation.

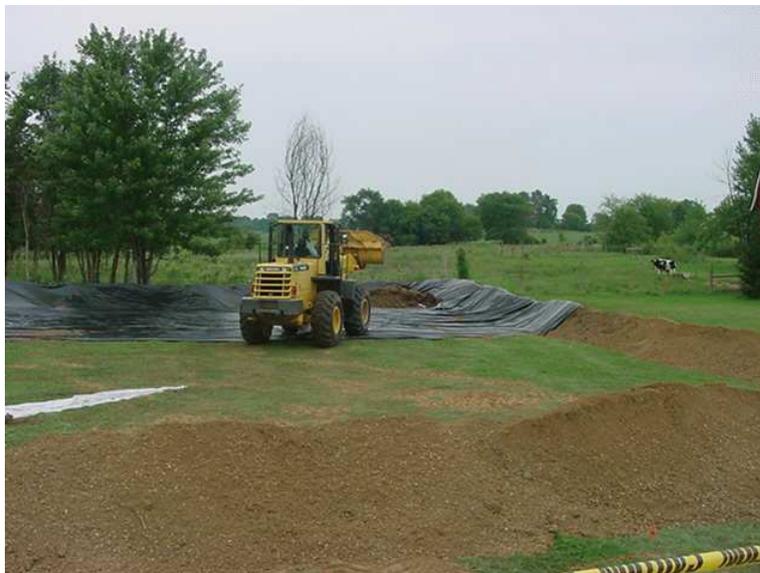
PHOTO NO: 032

SUBJECT: Construction of stockpile area for contaminated soil.

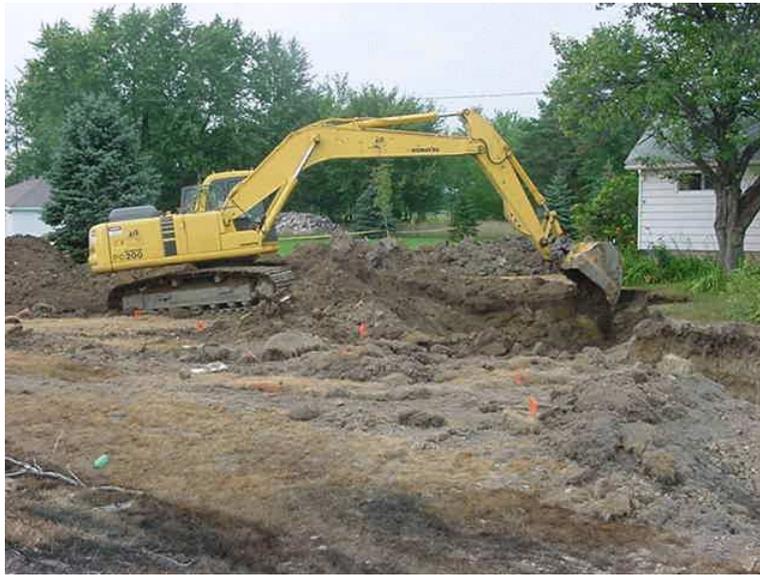
PHOTO NO: 033

SUBJECT: Excavation activities to west of 8805 Bedford Road residence.

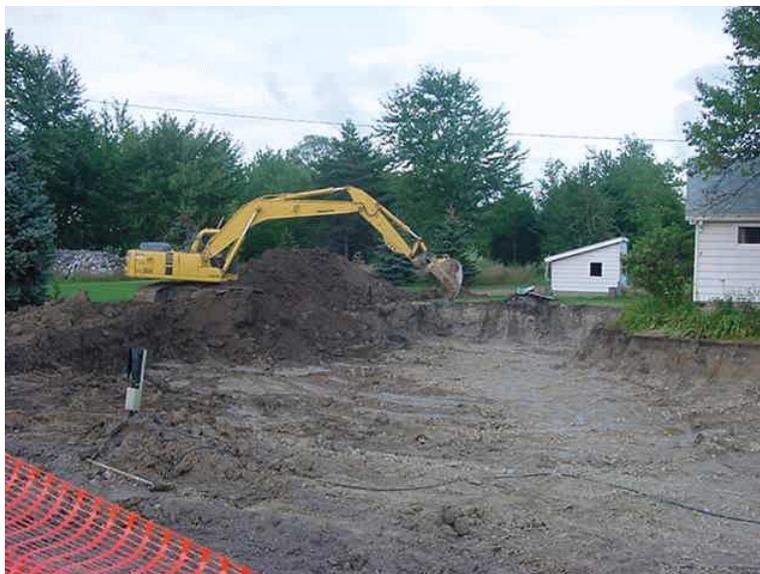
PHOTO NO: 042

SUBJECT: Excavation activities to north and west of 8805 Bedford Road residence.

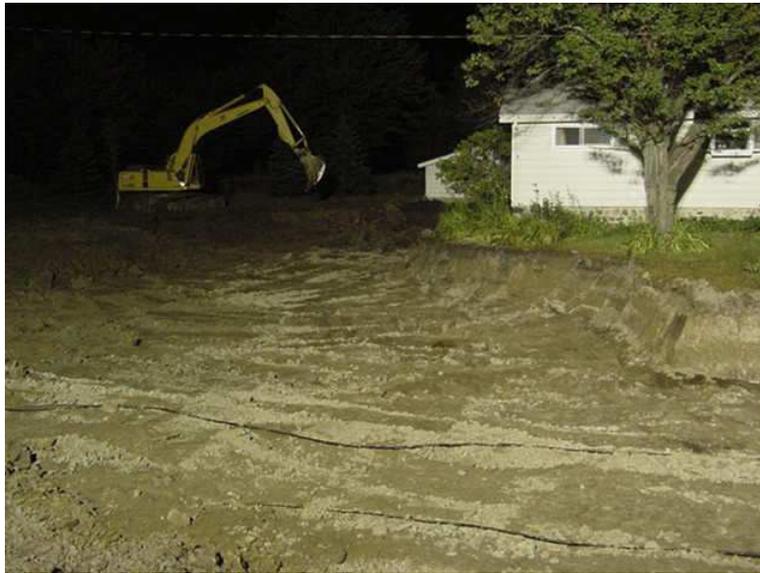
PHOTO NO: 043

SUBJECT: Night excavation looking east

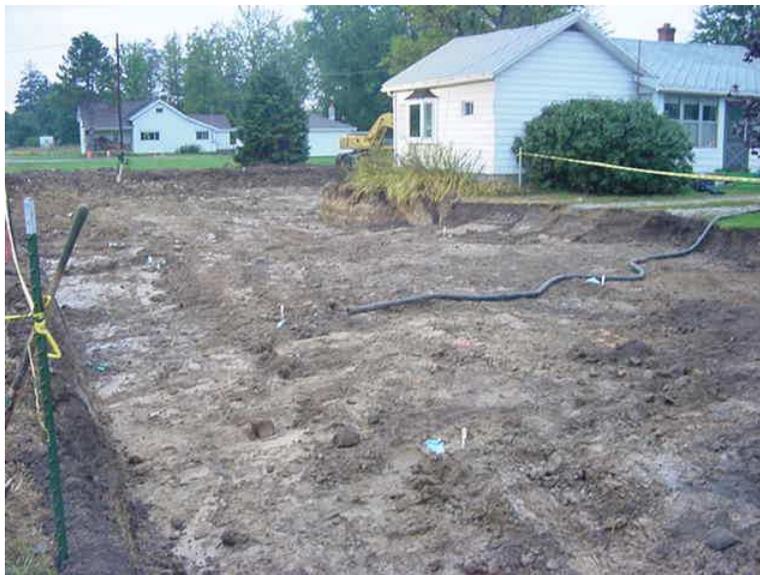
PHOTO NO: 046

SUBJECT: Excavation east of 8805 Bedford Road residence.

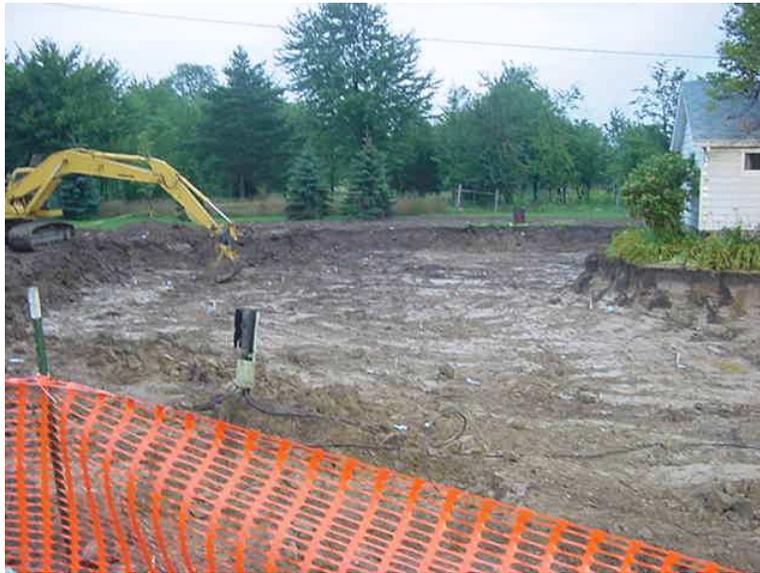
PHOTO NO: 047

SUBJECT: Excavation north of 8805 Bedford Road residence, looking east

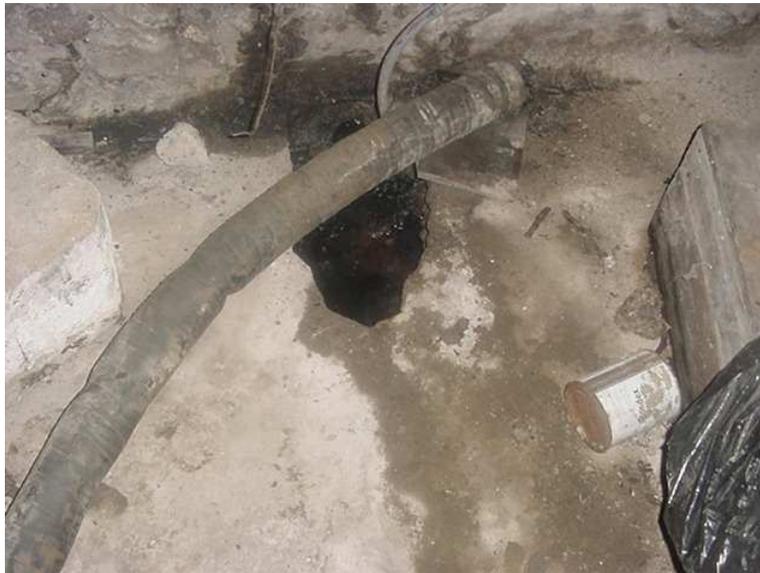
PHOTO NO: 049

SUBJECT: Sump in basement of 8805 Bedford Road residence.

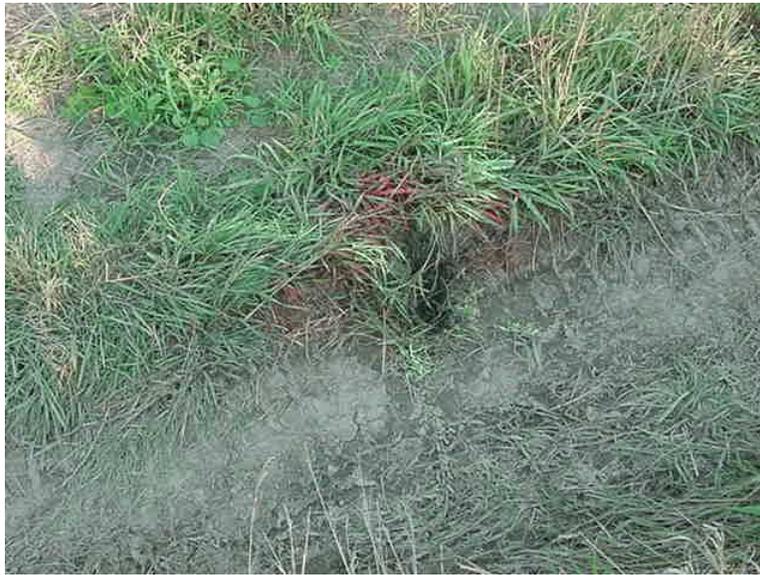
PHOTO NO: 057

SUBJECT: Sink hole in field east of spill site, downstream from affected catchbasins, upstream of outfall to Mack and Manning Drain.

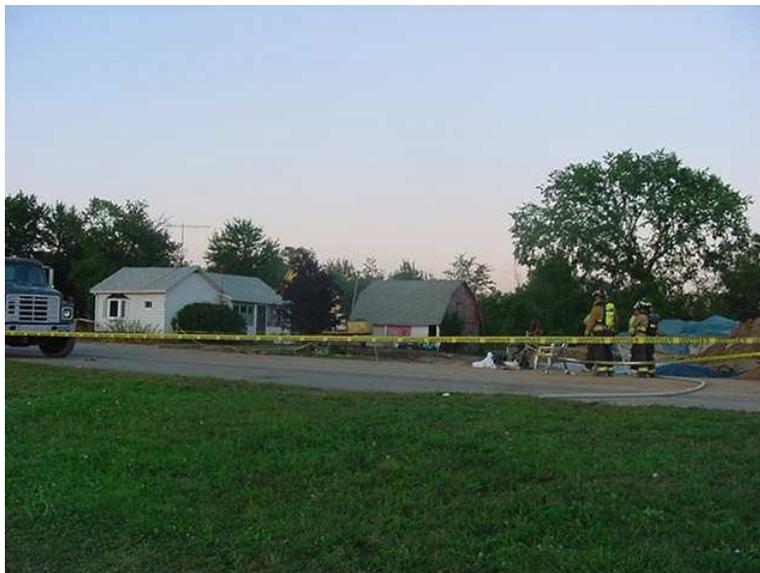
PHOTO NO: 062

SUBJECT: View of 8805 Bedford Road residence and Fire Department standing by for demolition.

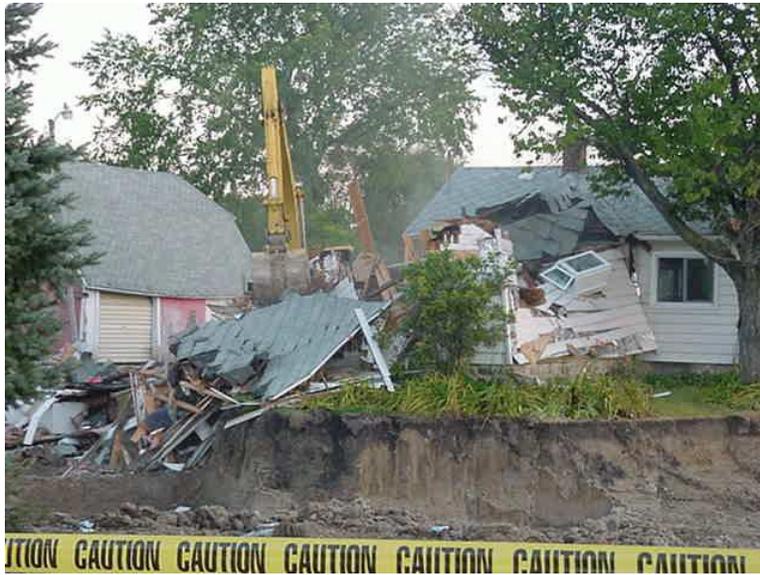
PHOTO NO: 066

SUBJECT: Demolition of 8805 Bedford Road residence.

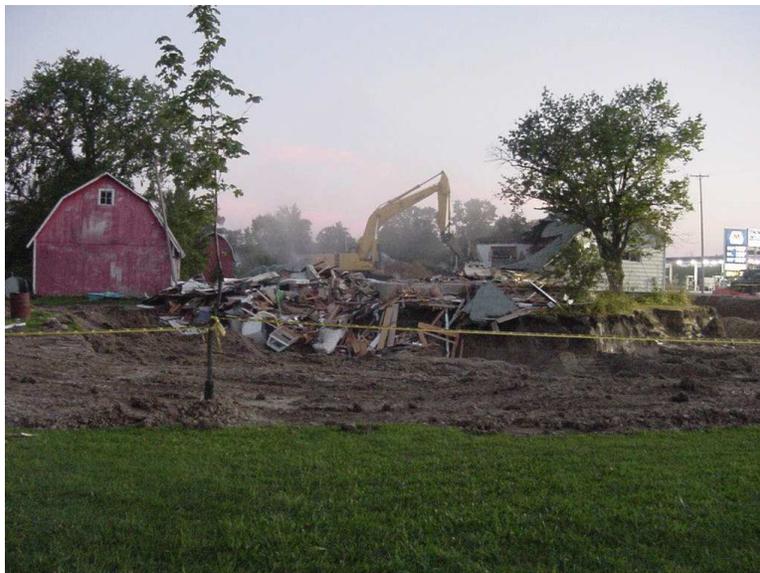
PHOTO NO: 073

SUBJECT: Demolition of 8805 Bedford Road residence.

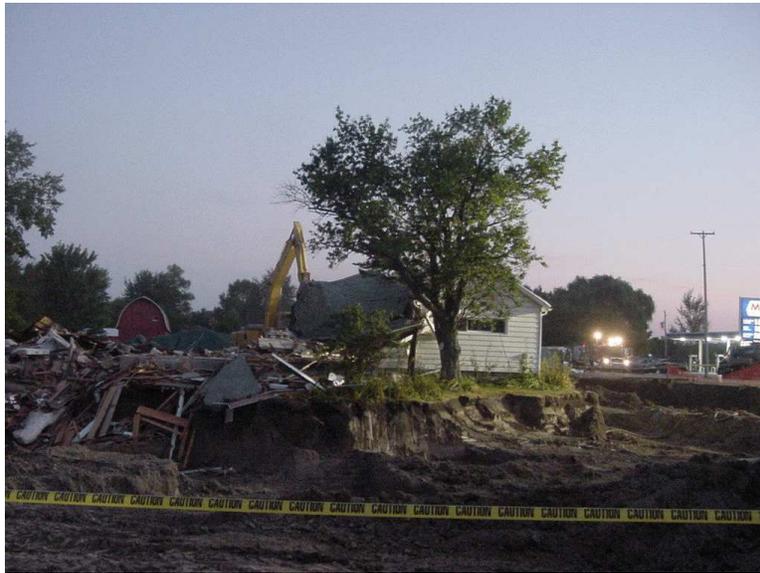
PHOTO NO: 076

SUBJECT: Demolition of 8805 Bedford Road residence.

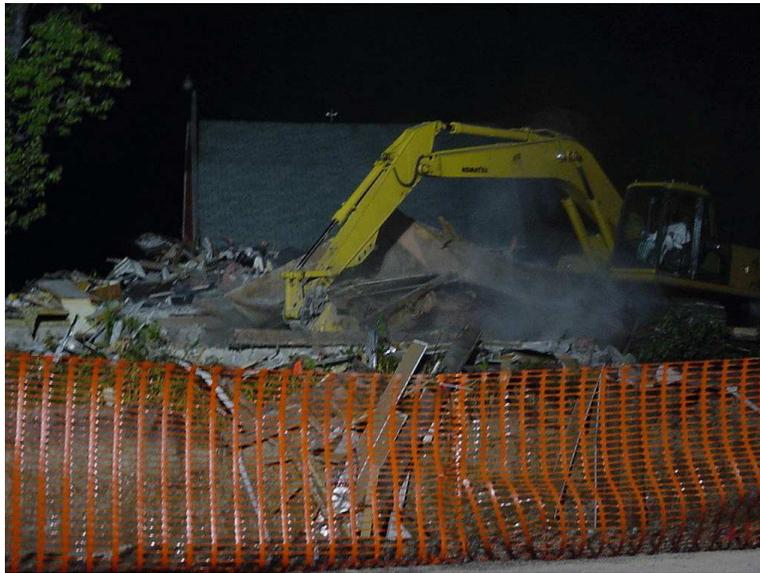
PHOTO NO: 082

SUBJECT: Debris clearing at site of demolished 8805 Bedford Road residence.

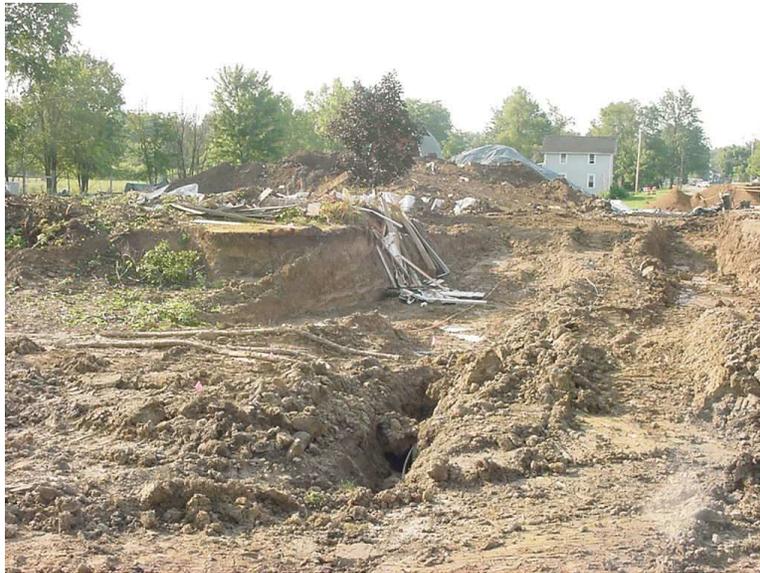
PHOTO NO: 089

SUBJECT: Excavation site.

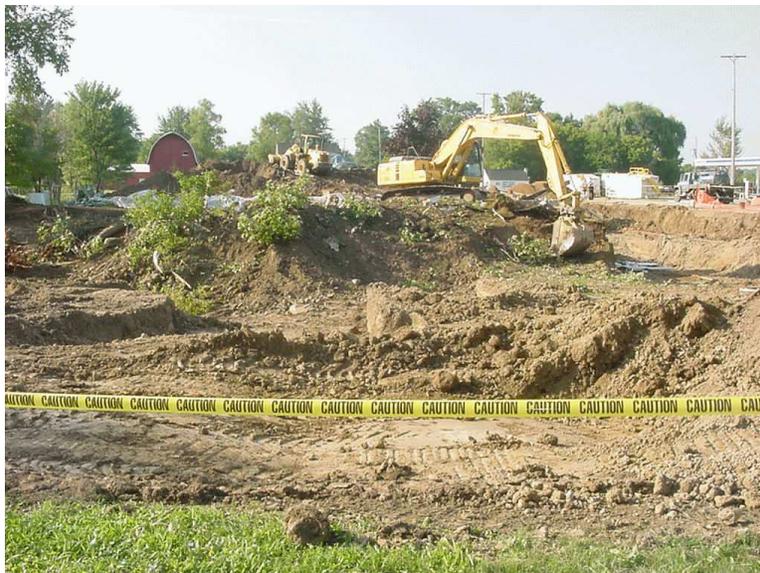
PHOTO NO: 091

SUBJECT: Excavation site looking southwest.

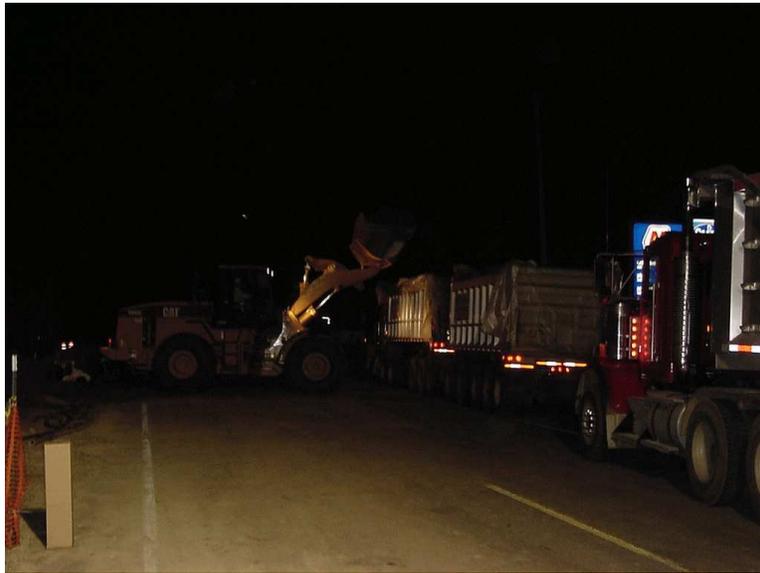
PHOTO NO: 095

SUBJECT: Loading trucks for disposal.

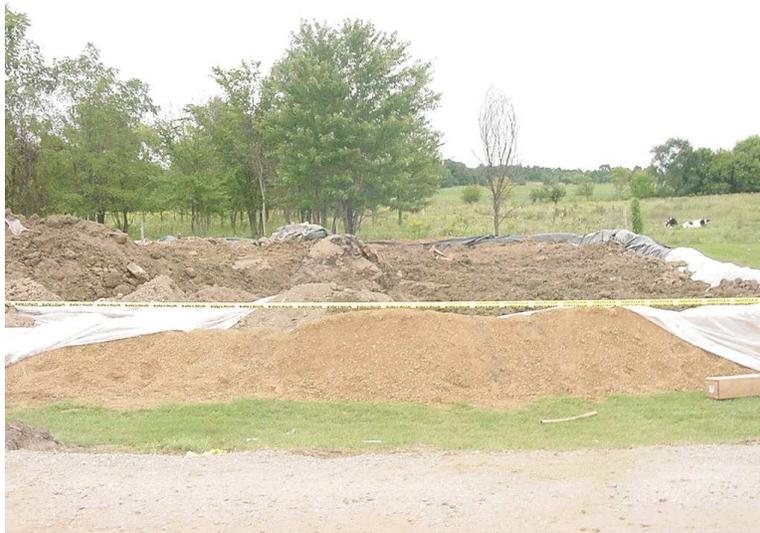
PHOTO NO: 103

SUBJECT: View of soil stockpile (east).

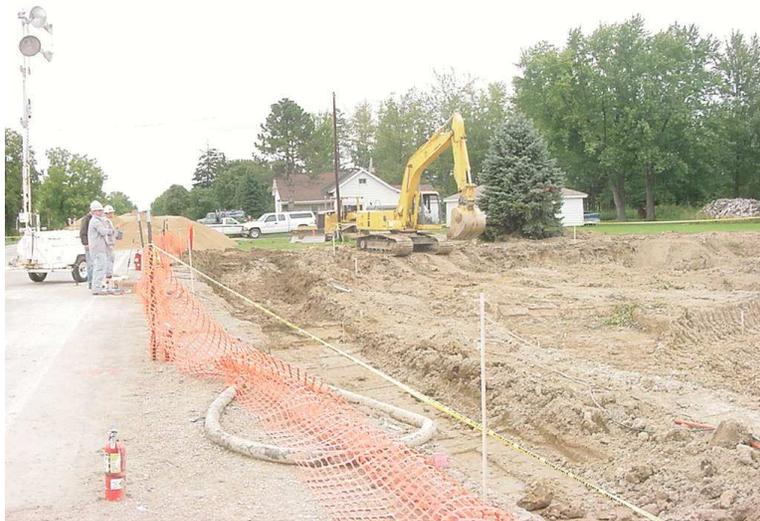
PHOTO NO: 106

SUBJECT: View of excavation and soil removal.

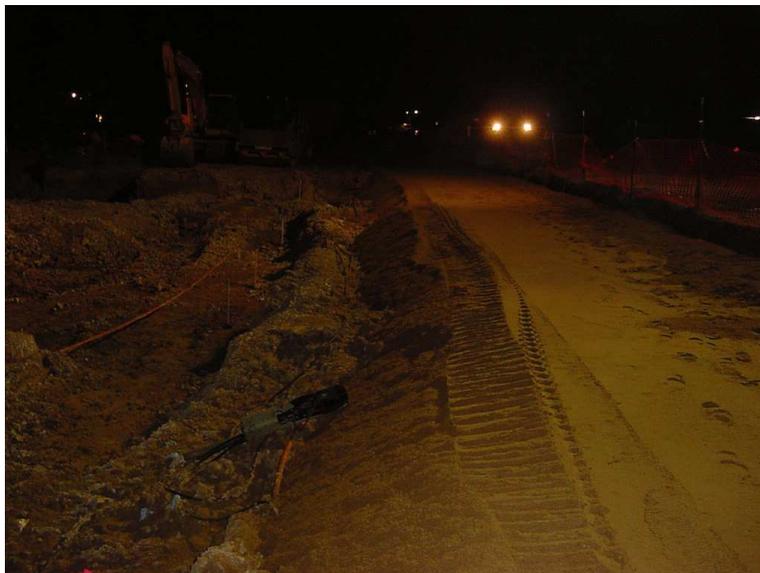
PHOTO NO: 109

SUBJECT: Compacted clean fill placed along Bedford Road.
