Technical Memorandum

TO: Brian M. Kelly, Acting Chief, Region V United States Environmental Protection Agency
FROM: Bryan Mullins, LATA-KEMRON Remediation, LLC.
SUBJECT: Proposed Path Forward at the Chevy in the Hole Site – Parcel A, Flint, Michigan
DATE: November 7, 2011

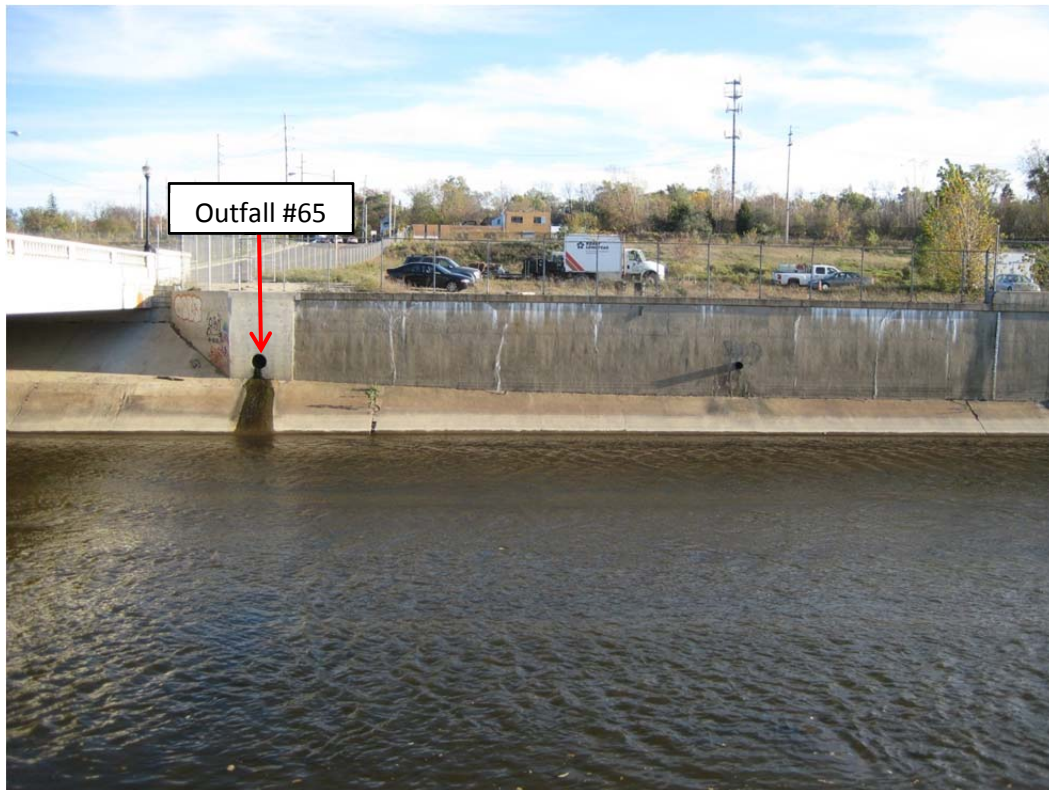
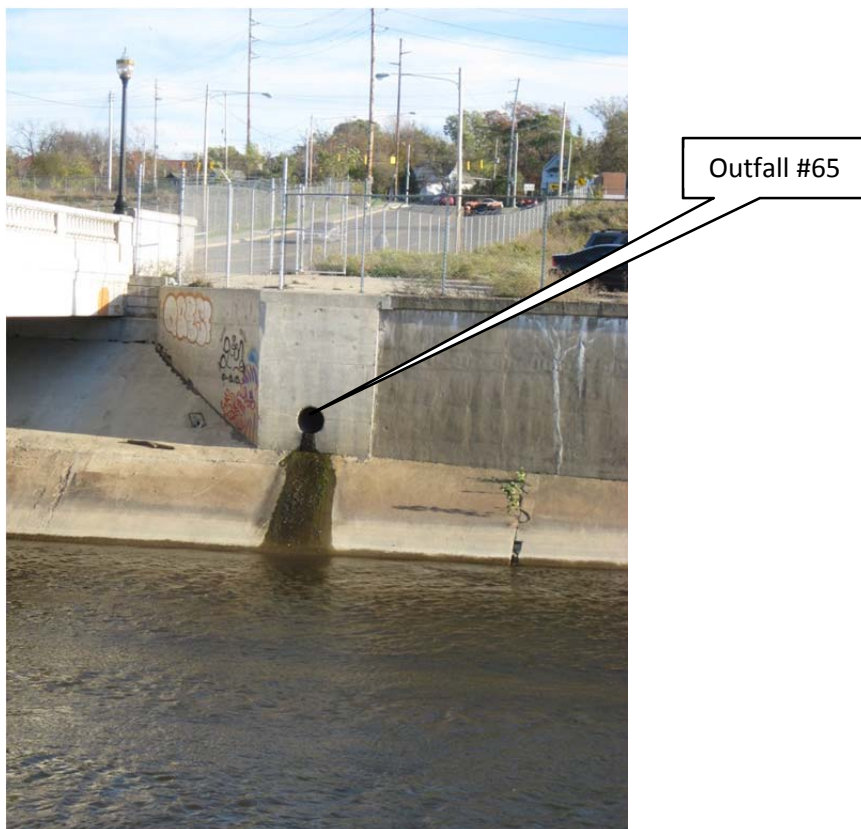
Outfall #65 Photos:

Current Observations: No sheen, staining, or fluorescence observed on the Flint River during site investigation. No booms/socks in river. Flow observed from outfall during rainy conditions.

Proposed Action: No action. Leave in place.

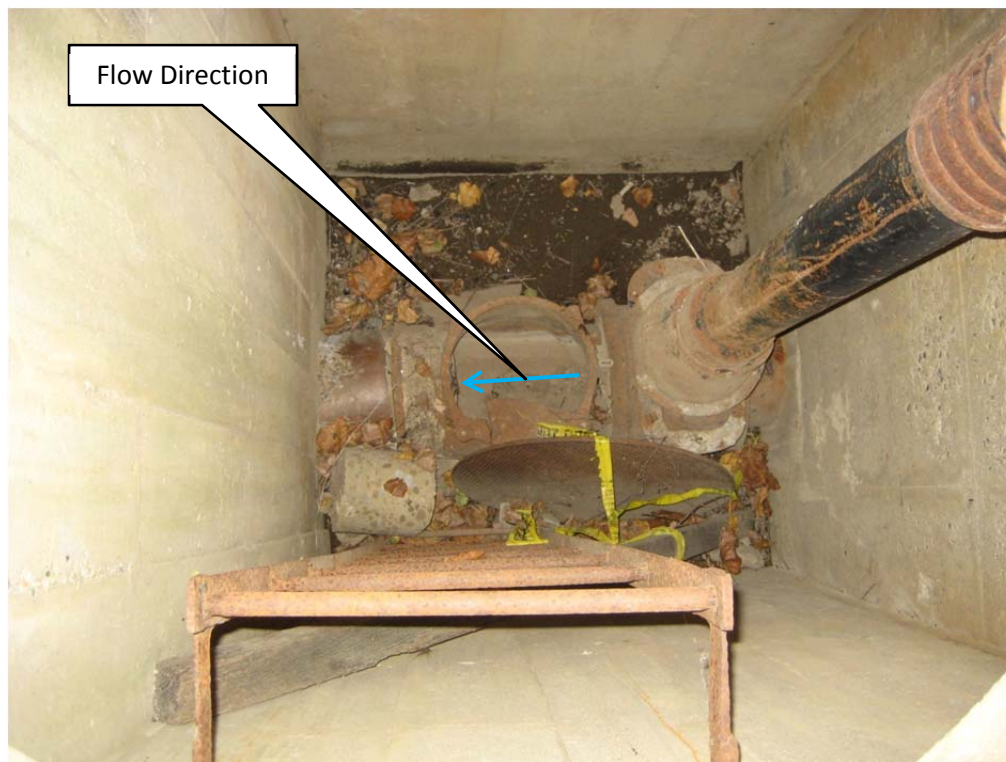
Photos:

Current Observations: No sheen observed on the Flint River during site investigation. No booms/socks in river. Opened two manholes associated with Outfall #66. Manhole directly adjacent to floodwall was dry. Manhole south of floodwall appeared to be a sump for the previous plant. Oily sheen present in the bottom of the sump as well as an absorbent sock. Absorbent sock fluoresced blue under ultra violet (UV) light. No off-site, active utilities appear to be routed to Outfall #66.

Proposed Action: Excavate and remove. Fill in excavation with compacted clay and plug hole with adobe bricks, hydraulic cement, and mortar facing.

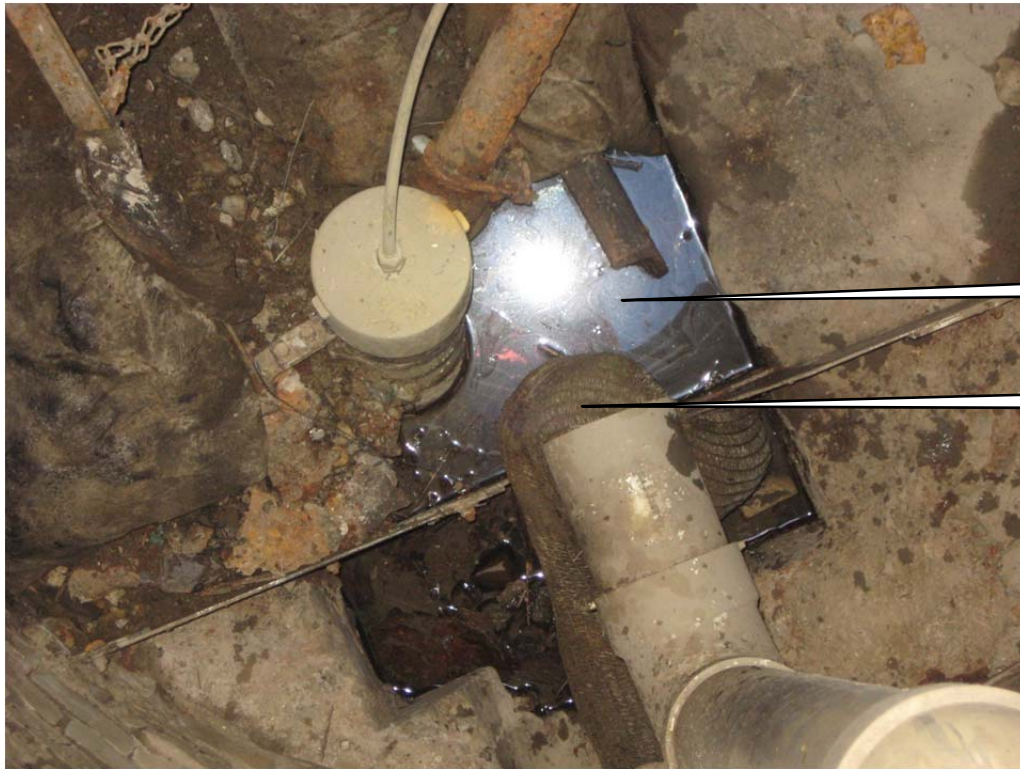
Manhole south of
floodwall (sump)

Oily sheen

Absorbent Sock

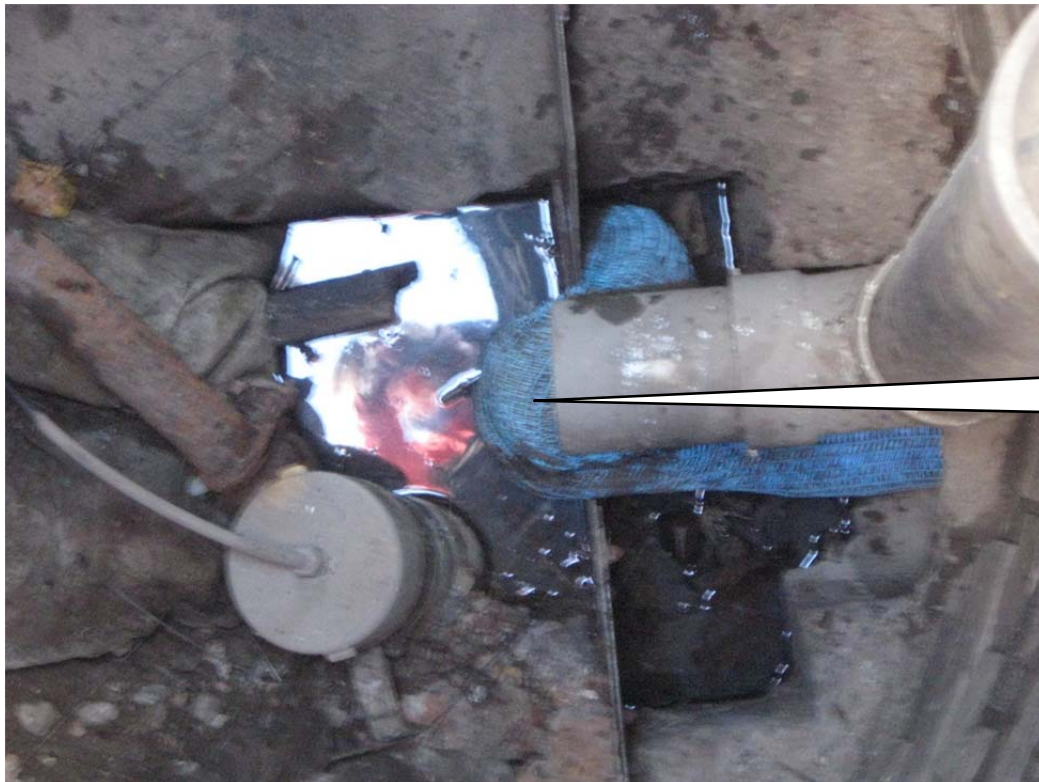
Manhole south of
floodwall (sump)

Absorbent Sock
fluorescing under
UV spotlight

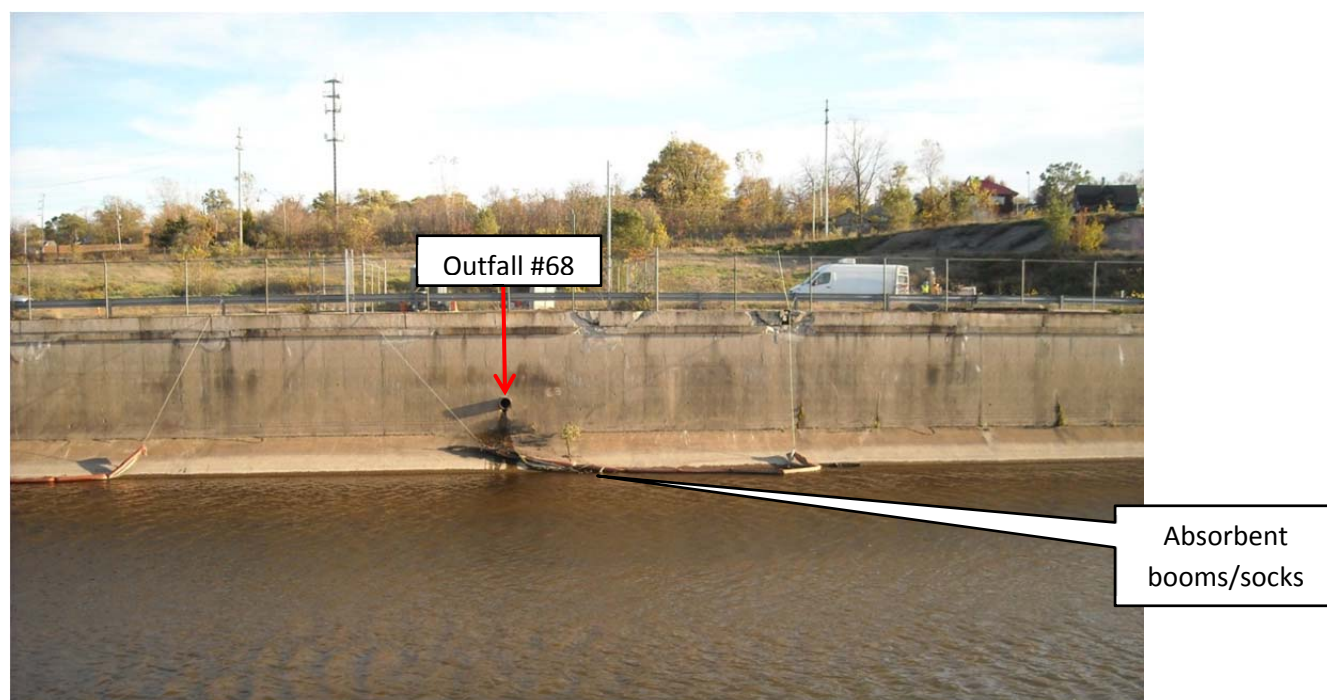
Photos:

Historical Observations: Occasional sheen observed on the Flint River. Dye test conducted by City in June/July 2011 indicate outfall is active and drains storm sewer along Garden Street. Dye test also indicated that the pipe may be compromised – the dye took a relatively long time to reach the outfall and the clay pipe appears cracked when looking in from the outfall side.

Current Observations: No sheen observed on the Flint River during site investigation. Staining on the floodwall and fluorescence on the floodwall and piping were observed during inspection. Booms/socks present in the river adjacent to the outfall. High flow from outfall not seen during rainy conditions, indicating either minimal flow and/or compromised pipeline. Catch basin located off-site south of Garden Street observed during rainy conditions – surface water flow off of Garden Street appears to mainly infiltrate into grassy area before the catch basin. Gallon jug of what appeared to be used oil found near off-site catch basin. City employee reported the inlet area was formerly used as a residential dumping area, thereby increasing likelihood of oil dumping into the inlet. Opened manhole for Garden Street Storm Sewer immediately south of the outfall. No UV fluorescence observed.

Proposed Action: Inquire with City to either abandon this pipeline or reroute storm water to another outfall, so that it can be removed at wall. Otherwise, excavate and replace compromised piping that runs through the NAPL plume.

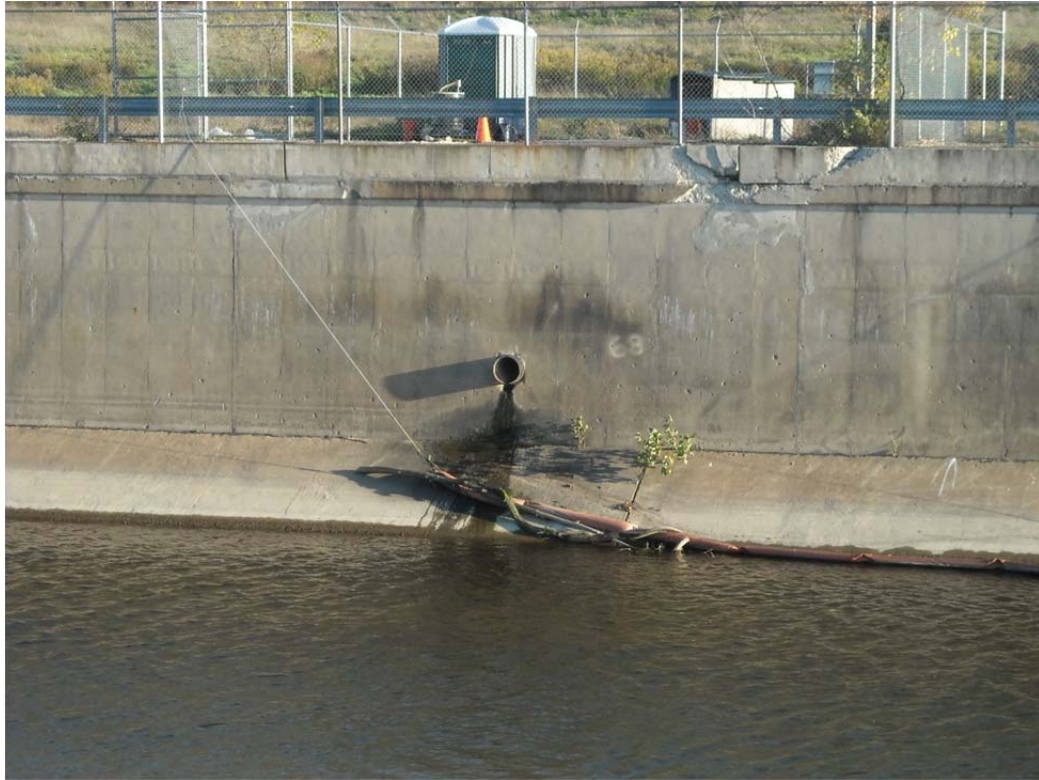
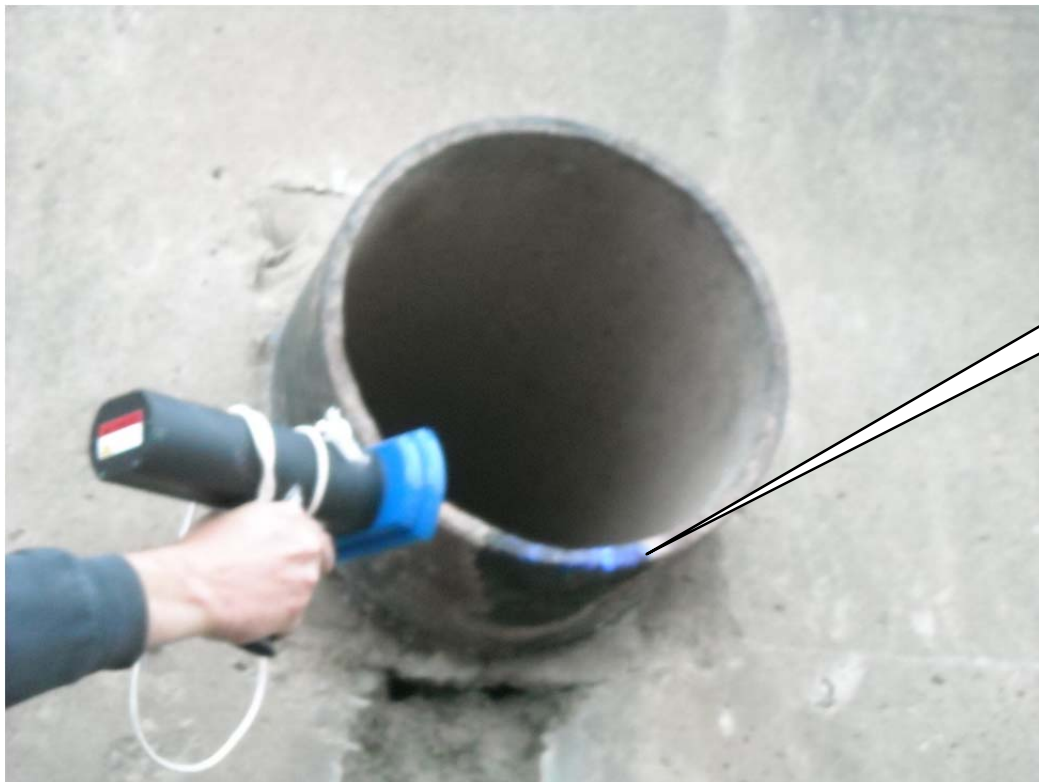
UV fluorescence
on outfall piping

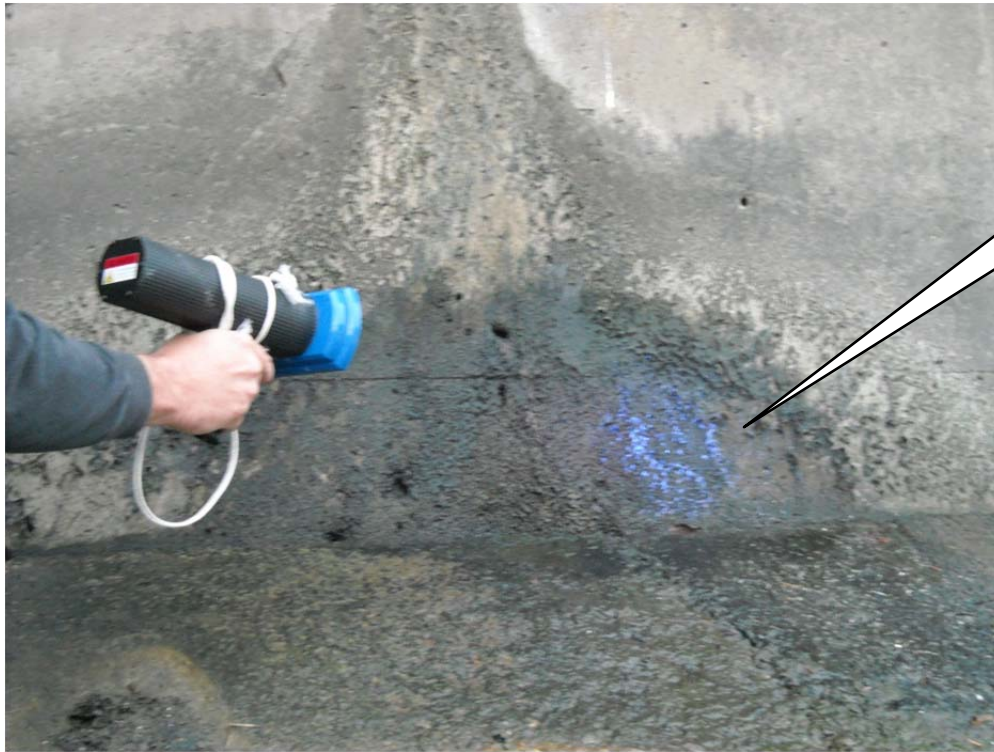
UV fluorescence on
wall below outfall

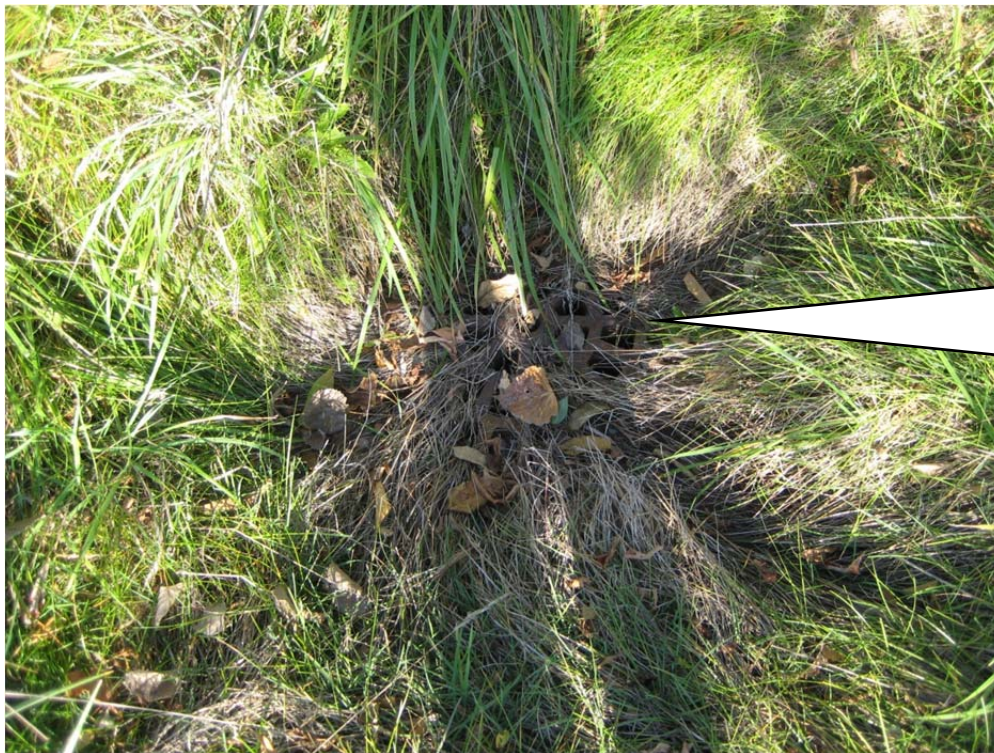
Off-site catch basin for
Garden Street Storm
Sewer located in
grassy overgrowth; jug
of spent motor oil
found nearby.

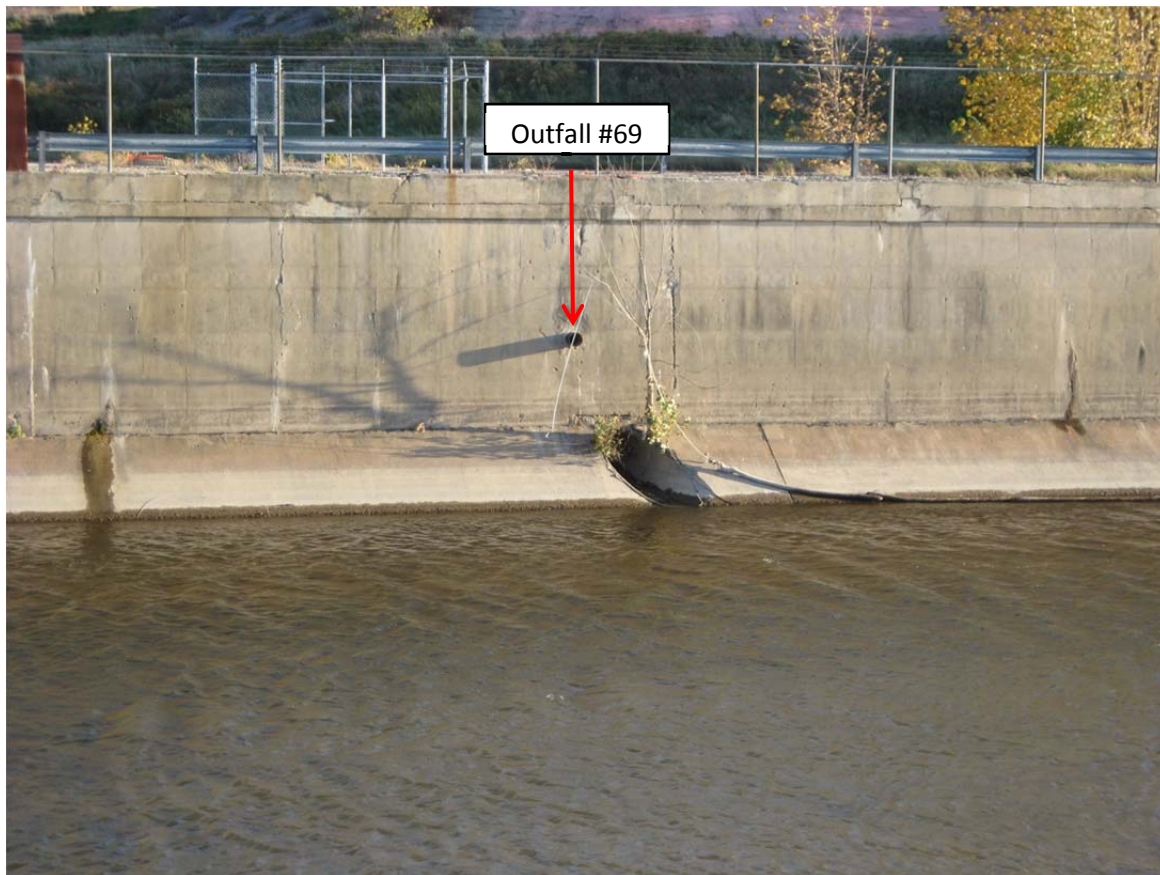
Photos:

Current Observations: No sheen observed from outfall during site investigation. No staining or UV fluorescence noted during inspection.

Proposed Action: Excavate and remove. Fill in excavation with compacted clay and plug hole with adobe bricks, hydraulic cement, and mortar facing.

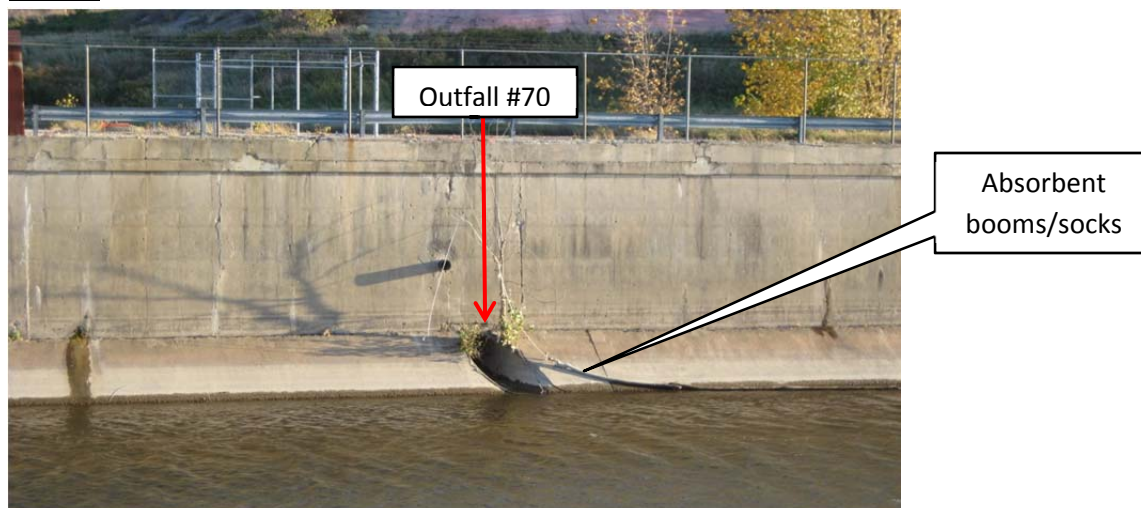
Photos:

Current Observations: Sheen observed coming from outfall every day of the site investigation. The outfall was 2/3 filled with sediment. Remnants of a sand bag were present at the outfall entrance into the river. Any weight on sandbag and sediments caused sheen to emanate from the outfall. UV spotlight shown into outfall lit up a path of light blue fluorescence noted from the entrance to the farthest visible extent. Digging into the sediment showed contamination throughout the depth. Staining on the walls of the piping also fluoresced a light blue. Booms are located near Outfall #70, but do not absorb a majority of the sheen that flows from the outfall. The City opened the slab of the sanitary sewer vault but could not see the bypass valve for the outfall pipe (possibly underwater). City does not have records of opening bypass valve since installed in 1925. Other than one fluorescing rag, no UV fluorescence observed within the vault. A smoke test of the vault did not result in smoke exiting at any outfalls, including #70 (although smoke test did confirm above-ground vents are connected). Information and tests seem to indicate that the bypass pipe valve is closed and that NAPL is leaking into the pipe at a location between the vault and outfall. Storm water ponding (and subsequent infiltration) in this area likely contributes to NAPL sheen near the vault because the valve is believed to be shut and the lowest groundwater elevation occurs near the vault. City personnel have indicated that they are planning to jet the pipe out and investigate the integrity of the pipe using photos and video.

Proposed Action: To be decided following further investigation by the City. Possible abandonment or repair/replacement depending on the results of the City investigation. Remove vegetation at outfall. Recommend test pit to look for compromised joint or pipe; seal as required. Test pit to include some soil removal/exploratory excavation adjacent to and west of the sanitary sewer vault.

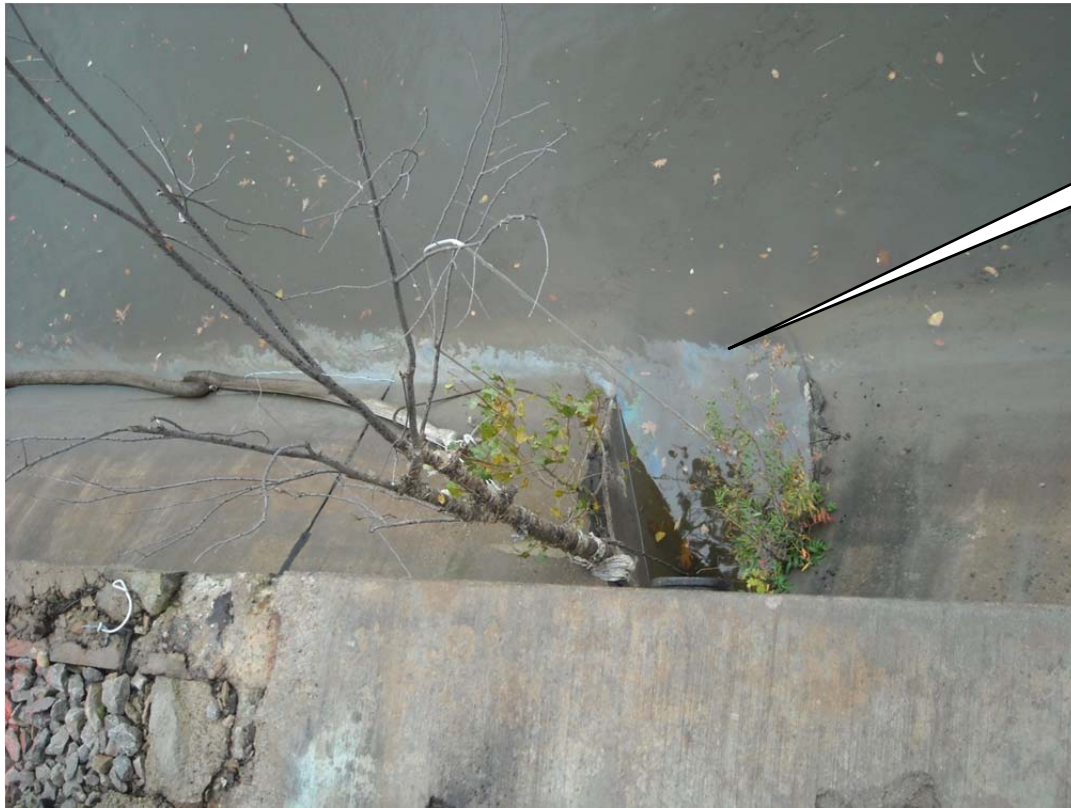
Sheen emanating
from Outfall #70

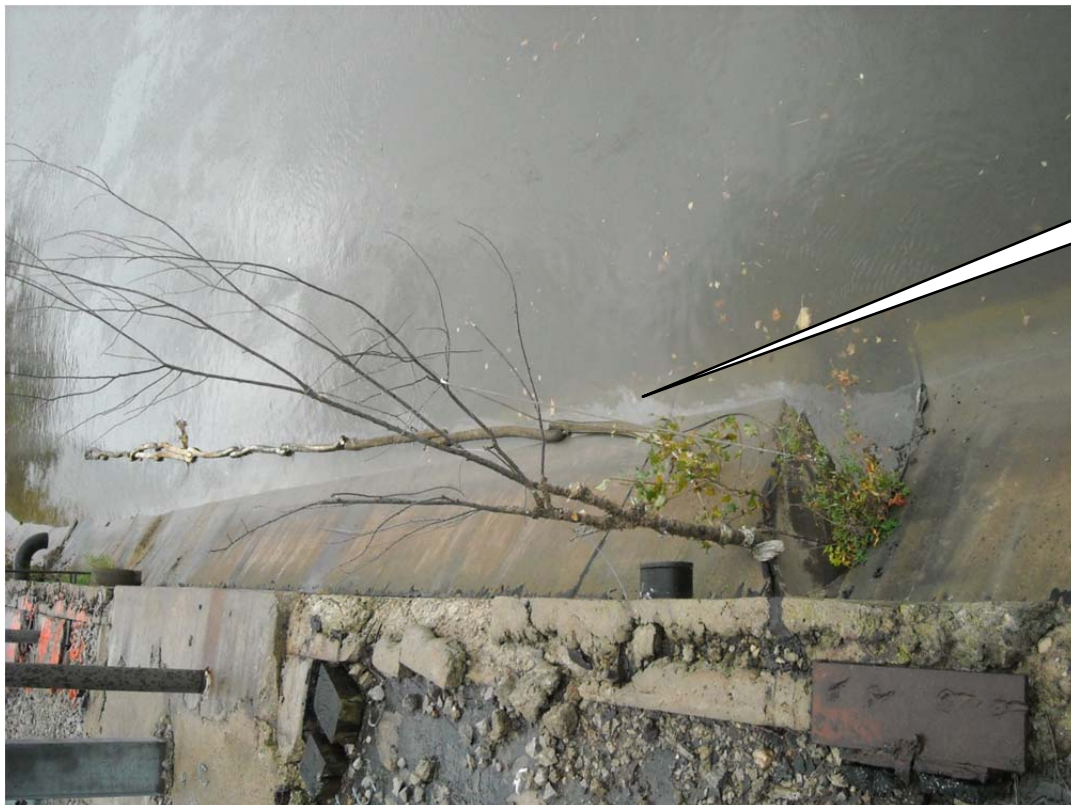
Sheen emanating
from Outfall #70

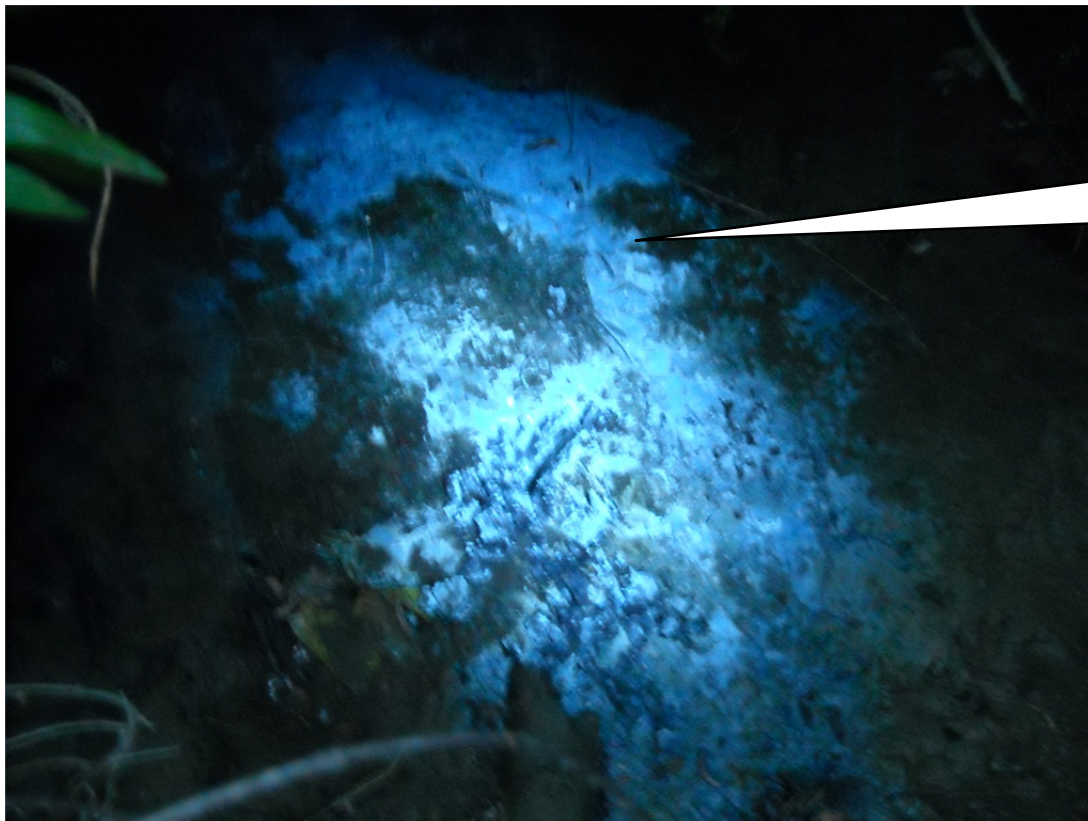
NAPL pathway
fluorescing on
sediment within
Outfall #70

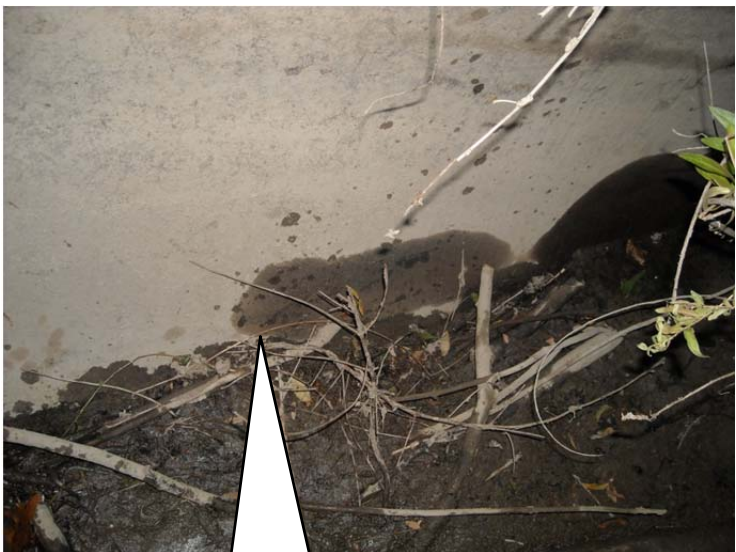
Staining on wall of Outfall
#70 piping (No UV spotlight)

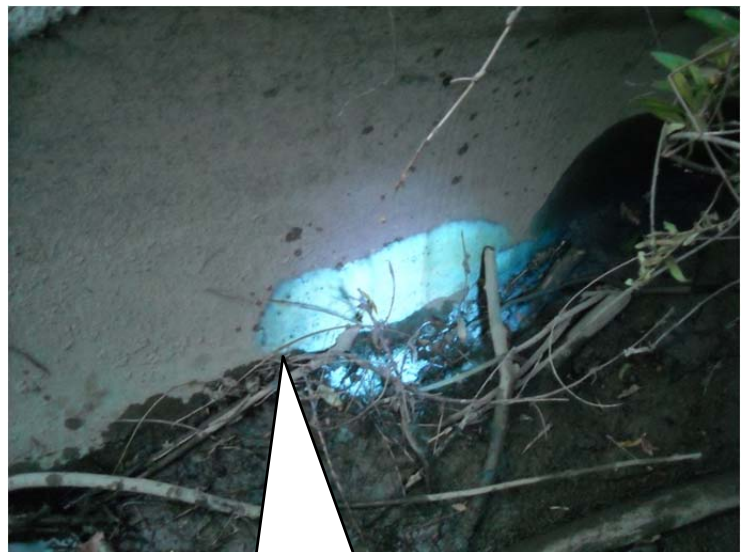
Staining on wall of Outfall #70 piping
fluorescing under UV spotlight

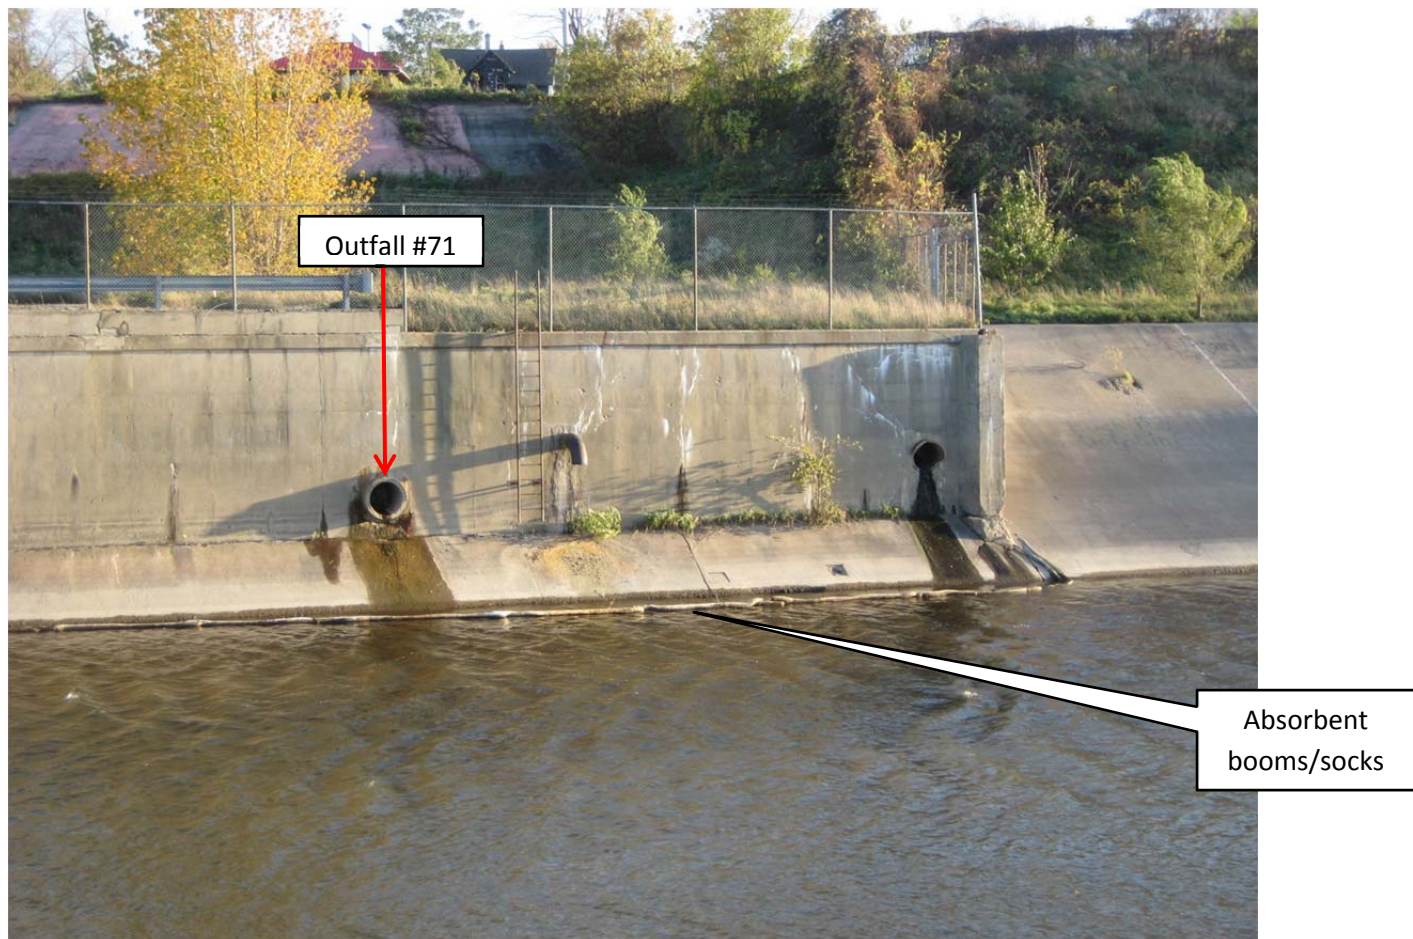
Photos:

Current Observations: No sheen observed from outfall during site investigation. Booms/socks present in the river adjacent to the outfall. Outfall was filled with sand bags. Appeared to be some light blue fluorescence within a joint located directly inside the outfall entrance into the river. The sand bags also appeared to slightly fluoresce a light blue/violet (uncertain if this was biological growth or hydrocarbon contamination).

Proposed Action: Excavate and remove. Fill in excavation with compacted clay and plug hole with adobe bricks, hydraulic cement, and mortar facing.

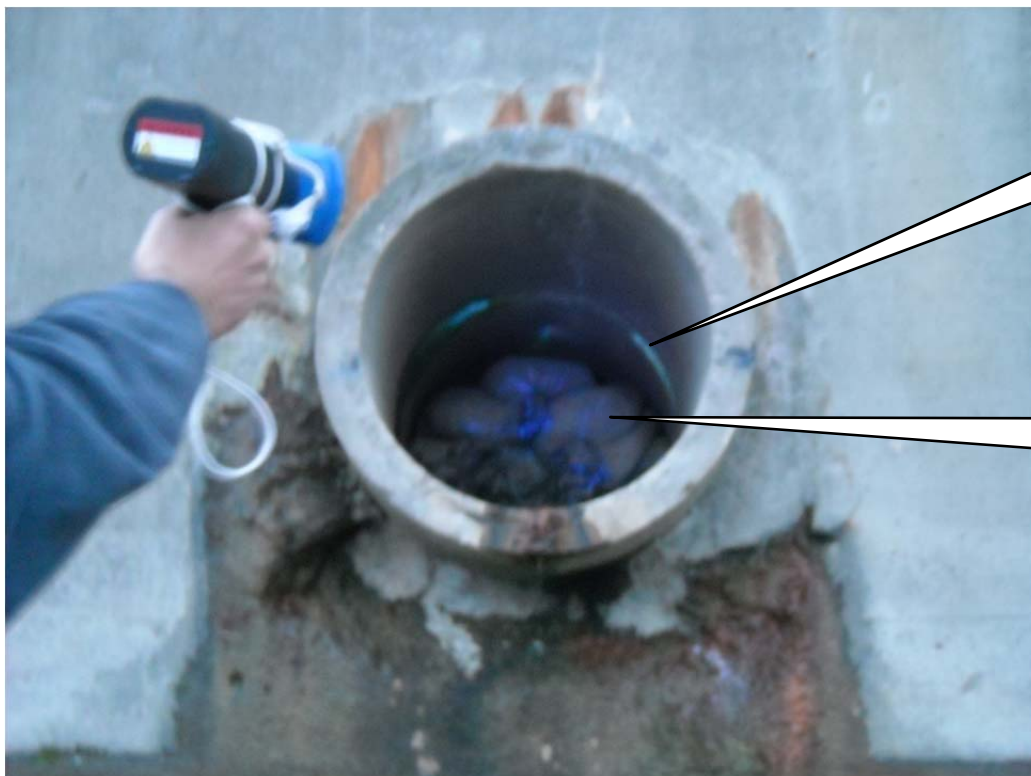
Light blue
fluorescence within
joint of piping

Sand bags
fluorescing
blue/violet.

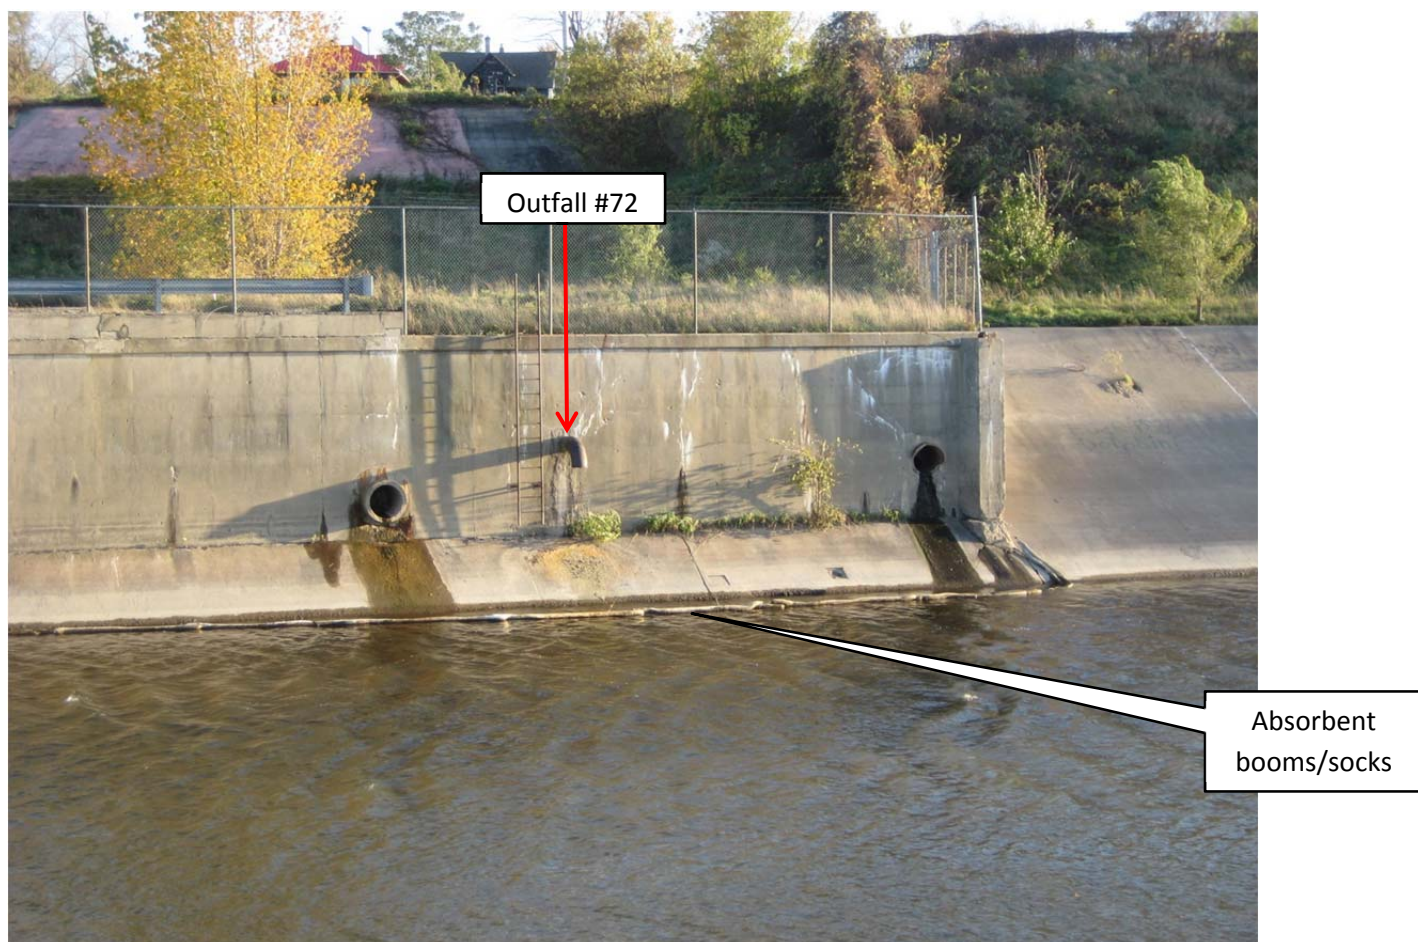
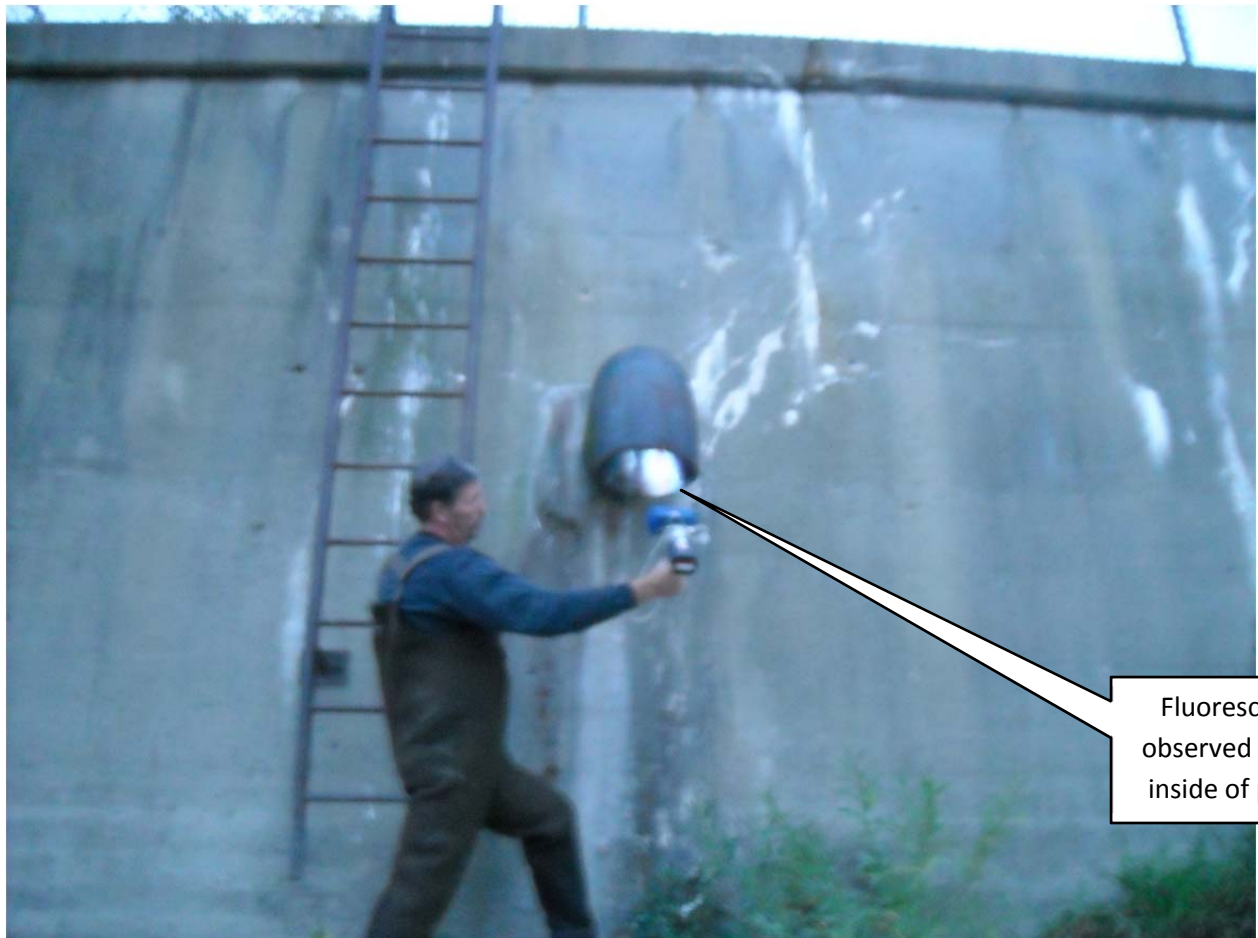
Photos:

Current Observations: No sheen observed from outfall during site investigation. Booms/socks present in the river adjacent to the outfall. Appeared to be some light blue fluorescence within the piping of the outfall.

Proposed Action: To be decided following installation of a test pit. If damage to piping is extensive, excavate and remove. Fill in excavation with compacted clay and plug hole with adobe bricks, hydraulic cement, and mortar facing. If pipeline is salvageable, possibly fix any damage or replace and use for stormwater control.

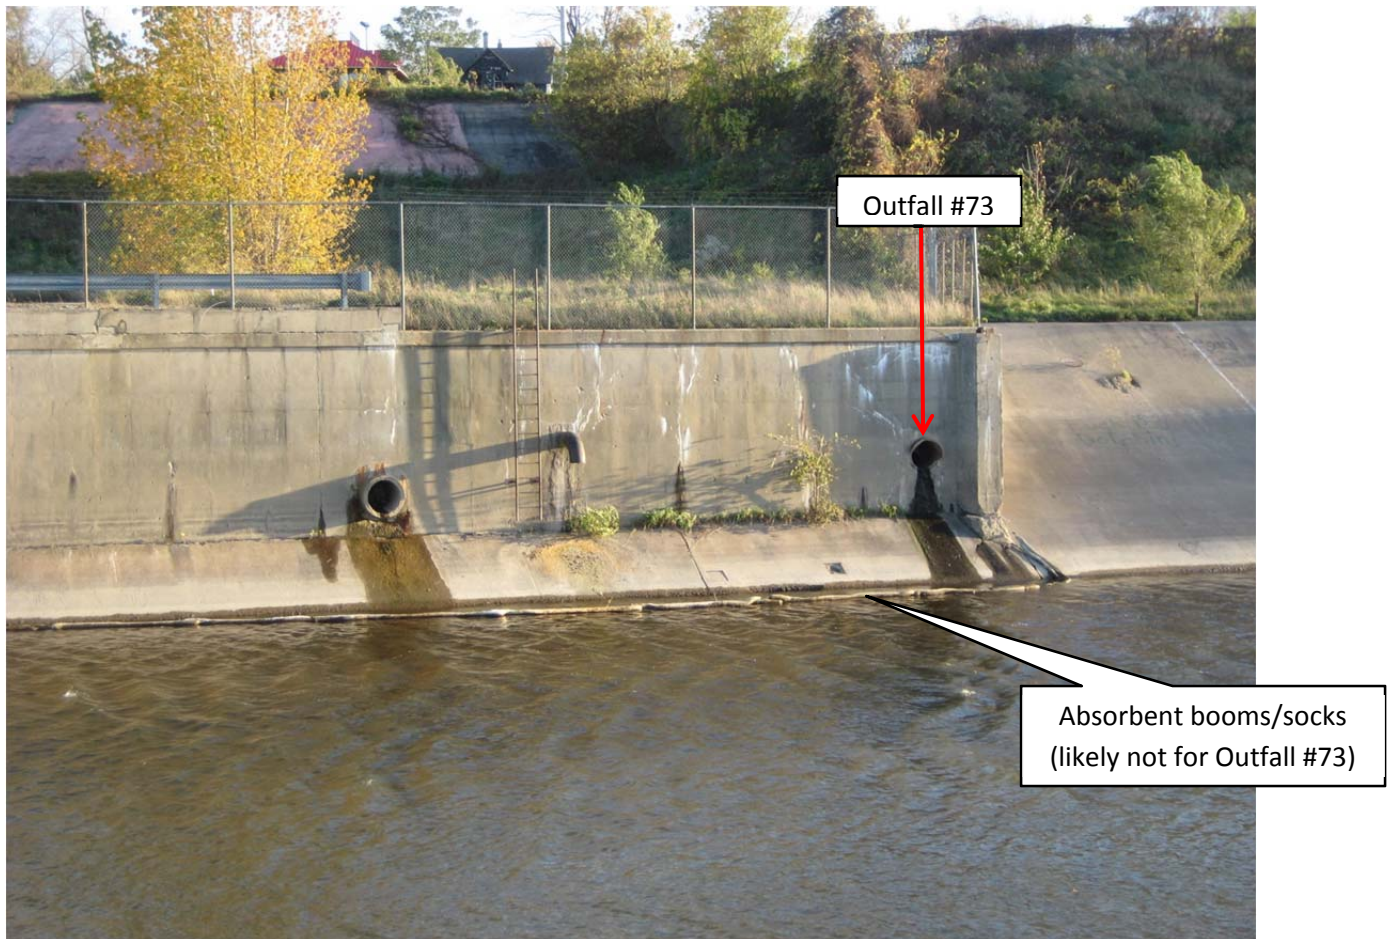
Photos:

Current Observations: No sheen, staining, or fluorescence observed on the Flint River during site investigation. Booms/socks in river adjacent to outfall – likely for Outfalls #70 – #72. Flow observed from outfall during rainy conditions.

Proposed Action: No action. Leave in place. Monitor.

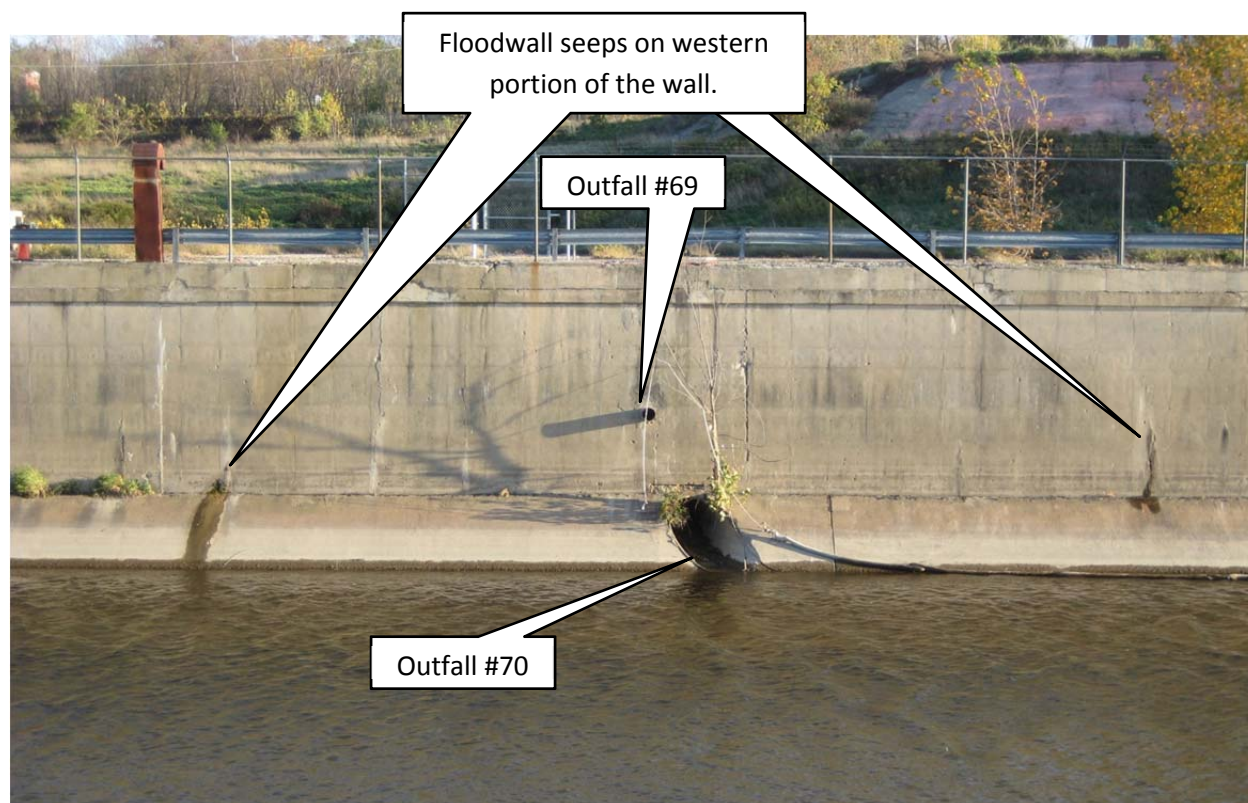
Photos:

Observations: Cracks located on the lower half of the western portion of the floodwall were wet and appeared to be seeping groundwater into the river. No NAPL was observed leaking from the seeps during site investigation. No UV fluorescence was associated with seeps. Vegetation and/or algae were observed growing in and around several seeps. Cracks located on the upper half of the western portion and on the entire eastern portion of the wall appeared dry.

Proposed Action: Seal the floodwall cracks (both seeping and dry) to eliminate possible migration pathways for NAPL.

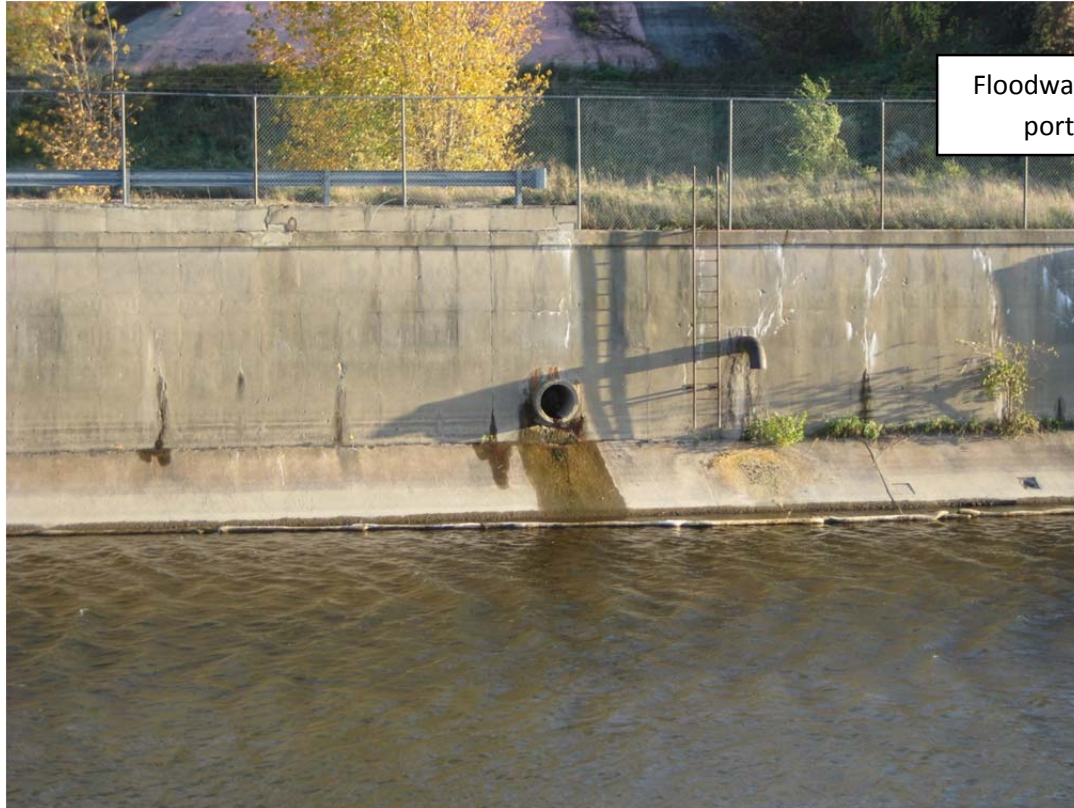
Floodwall seeps on western portion of the wall.
