Technical Memorandum

TO: Brian M. Kelly, Acting Chief, Region V United States Environmental Protection Agency
FROM: Bryan Mullins, LATA-KEMRON Remediation, LLC.
SUBJECT: Proposed Path Forward at the Chevy in the Hole Site – Parcel A, Flint, Michigan
DATE: November 7, 2011

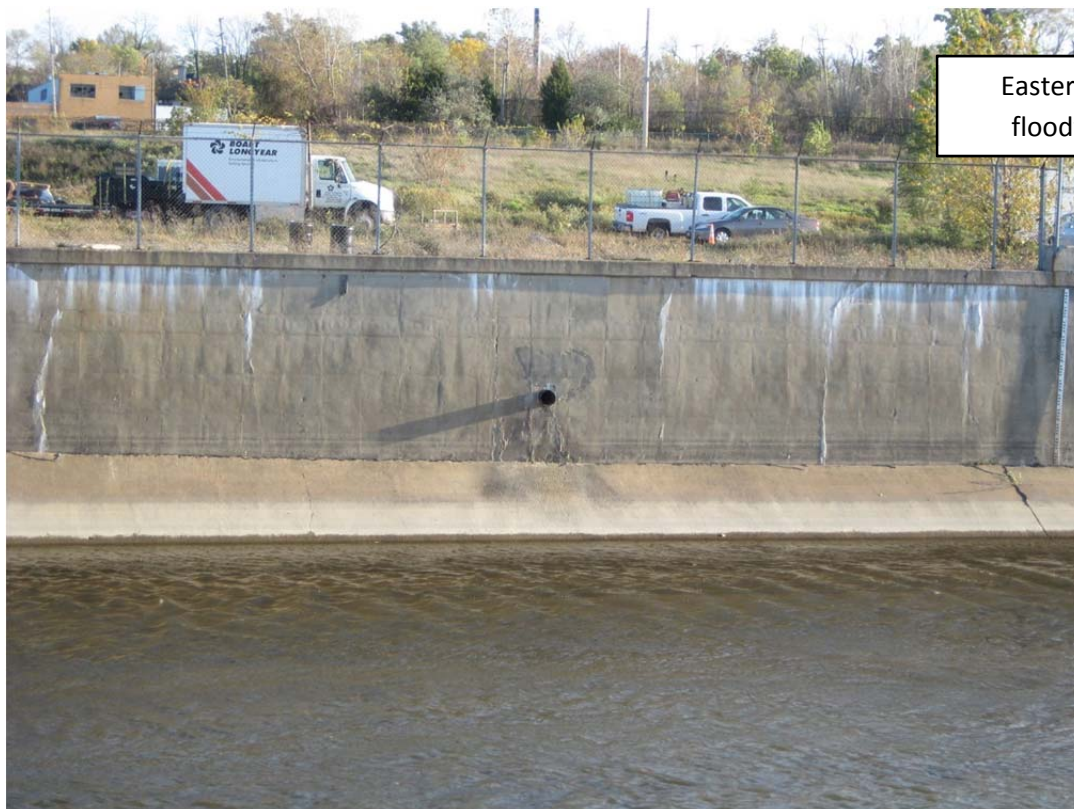
Eastern portions of the floodwall notably dry

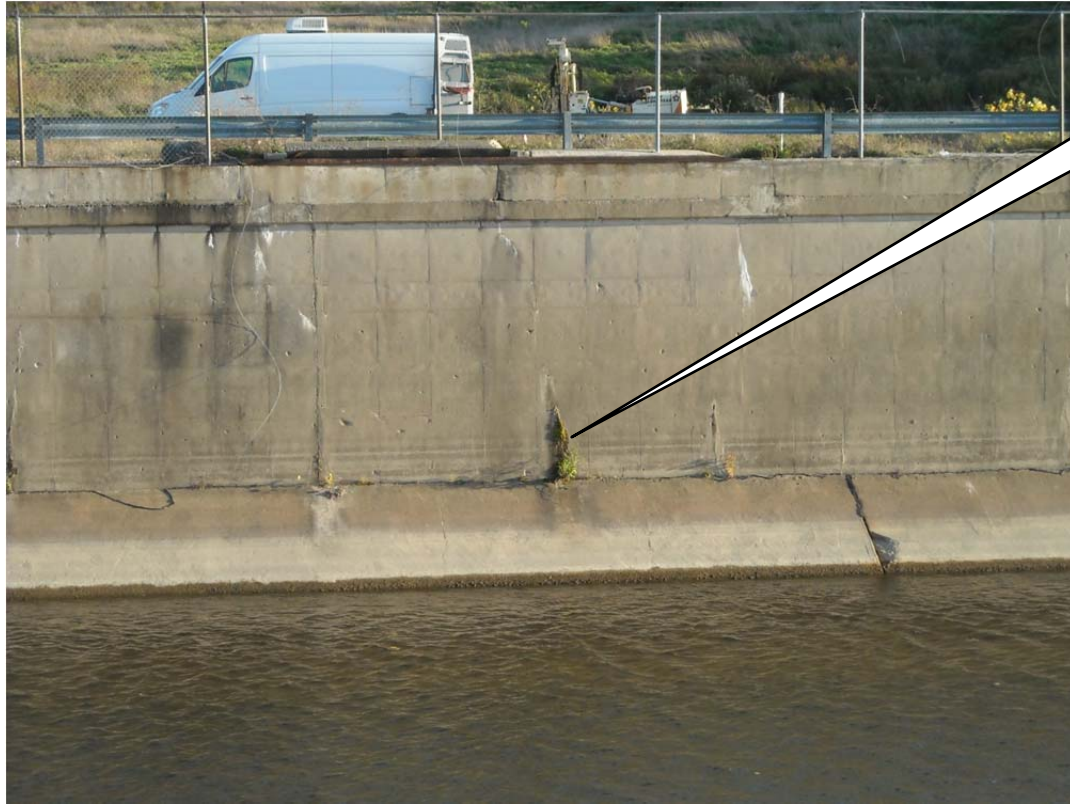
Vegetation/algae
growing in seeps

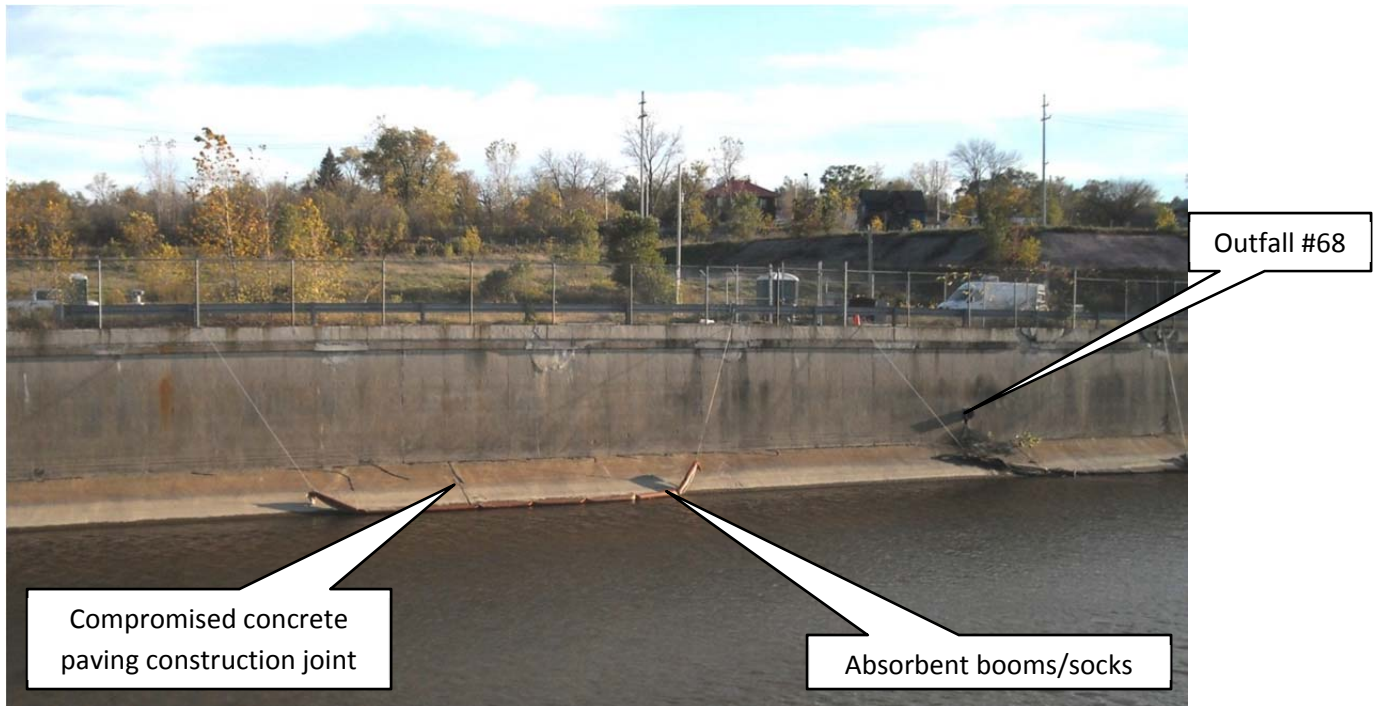
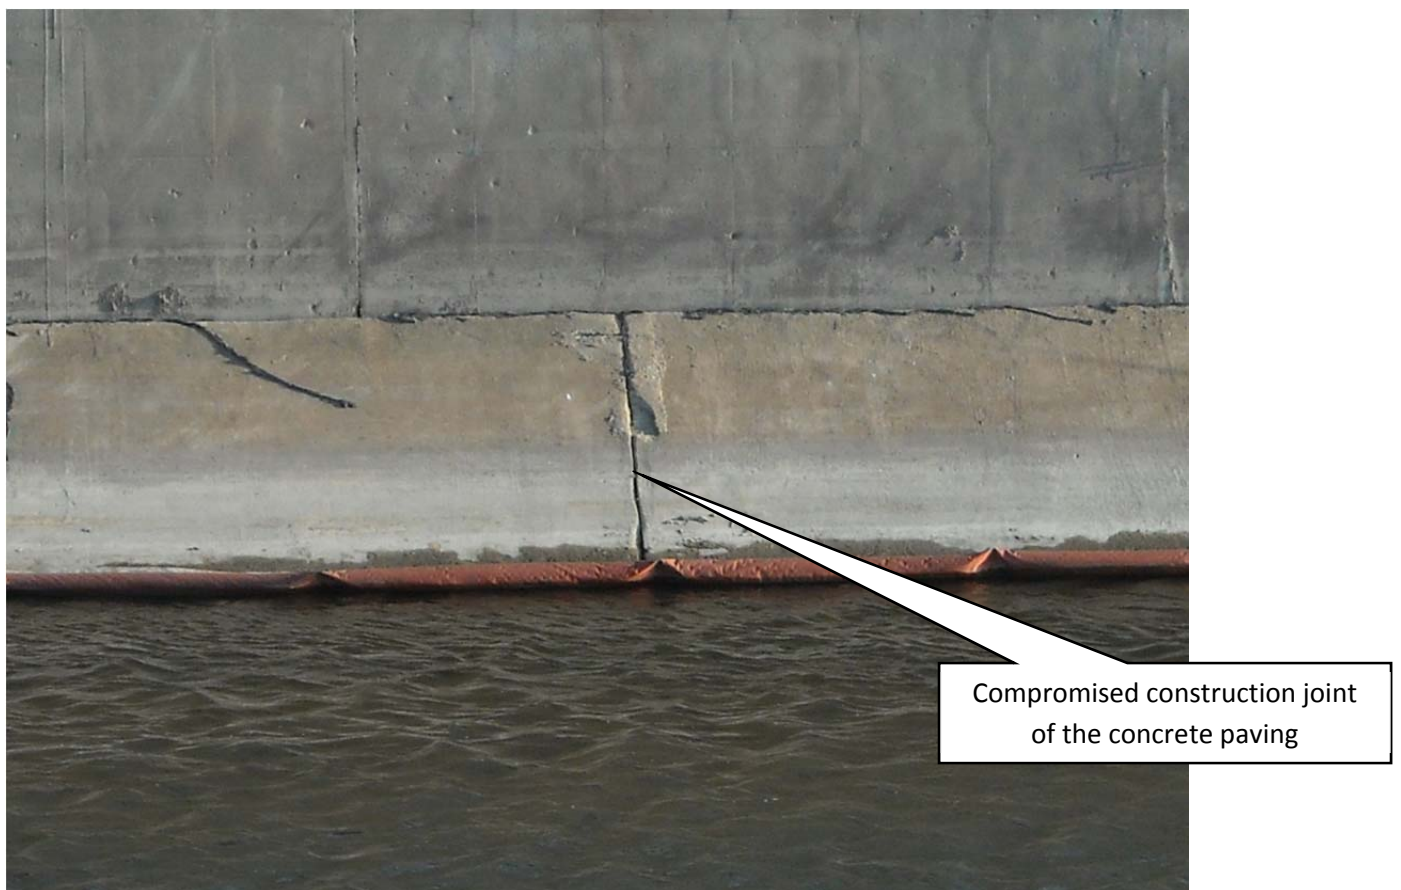
Photos:

Observations: A majority of the caulking/sealing agent were found to be missing from horizontal and vertical construction joints of the concrete paving. Several joints were visibly eroding with vegetation growing in them. Absorbent booms/socks installed at construction joint located between Outfalls #67 and #68. When flushed with river water, oily sheen flowed from the joint into the river. The same occurred for all vertical construction joints located west of the booms installed at the joint between Outfalls #67 and #68. Because the floodwall and concrete paving are distinct structures, the sheen at the concrete paving joints indicates that NAPL has migrated either beneath or through the floodwall and pooled in the space between the water side of the floodwall and the bottom of the concrete paving. See the detail below from the USACE Channel As-Built.

Proposed Action: Seal all construction joints of the wall adjacent to Parcel A. Joints that are leaking oily sheen will be sealed to prevent on-going NAPL migration into the river, and joints that are not currently leaking oily sheen will be sealed to prevent future migration of NAPL into the river.

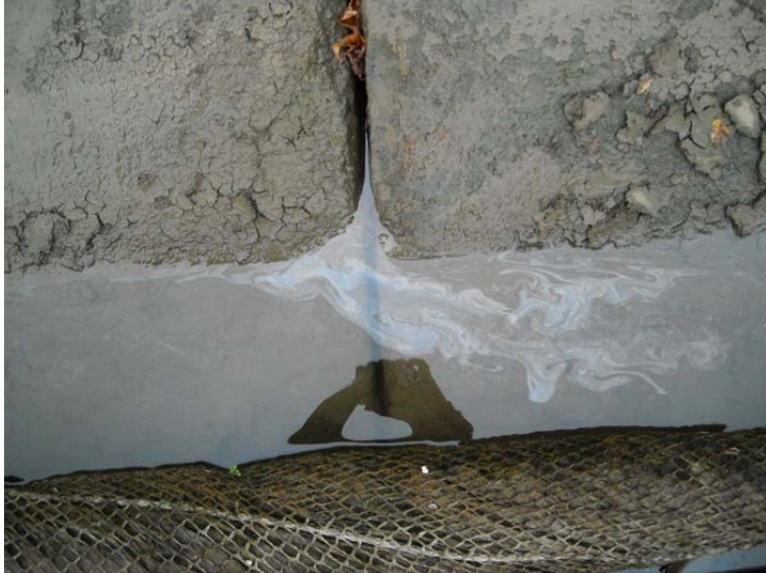
Compromised concrete paving joint (pictured above) leaking oily sheen

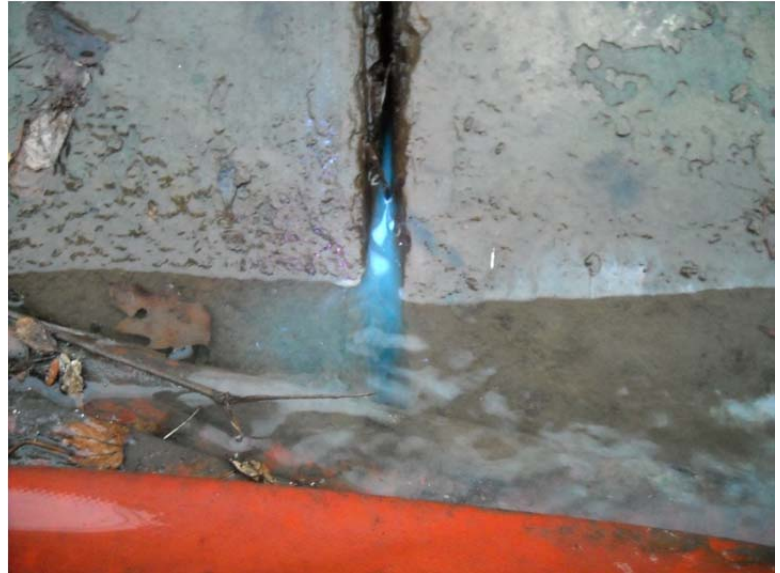
Compromised concrete paving joint (located west of joint pictured above) leaking oily sheen. Fluoresced under UV spotlight.

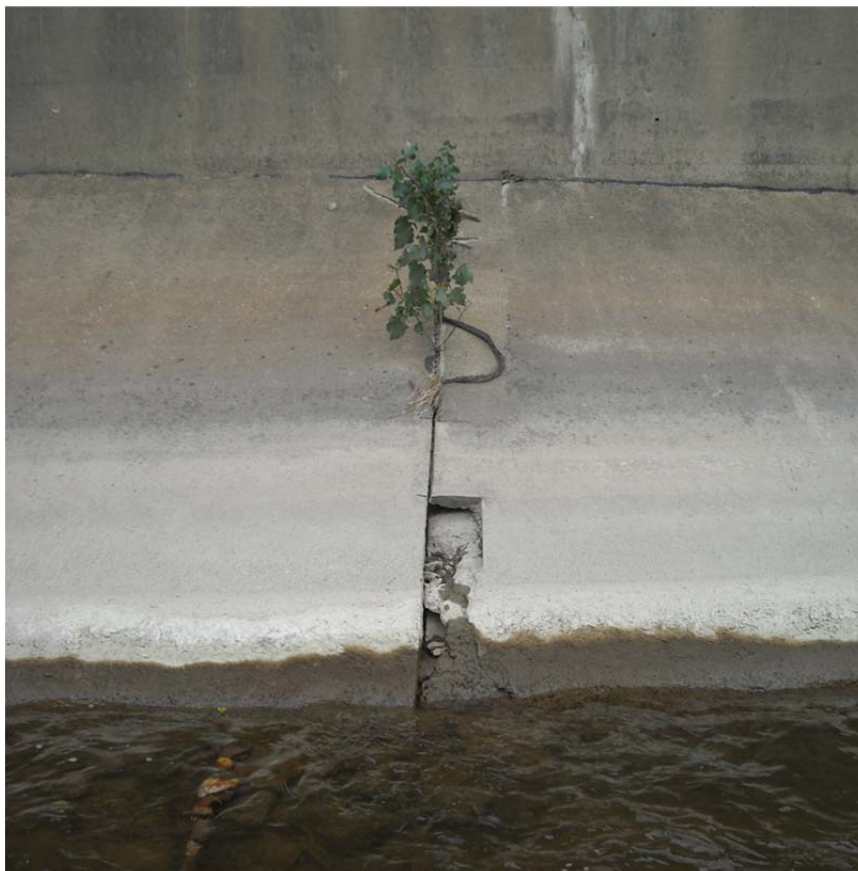
Compromised concrete paving joint with vegetation.

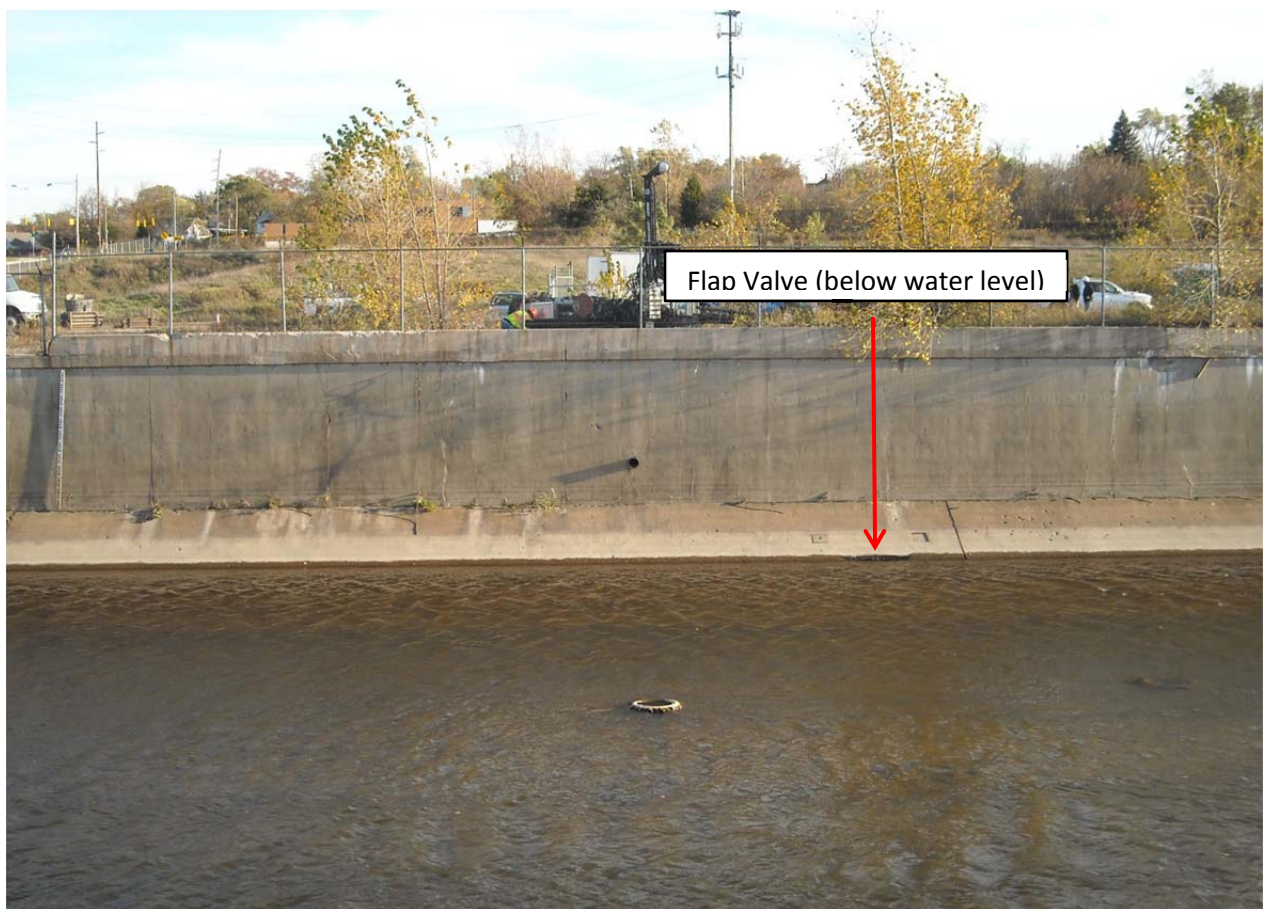
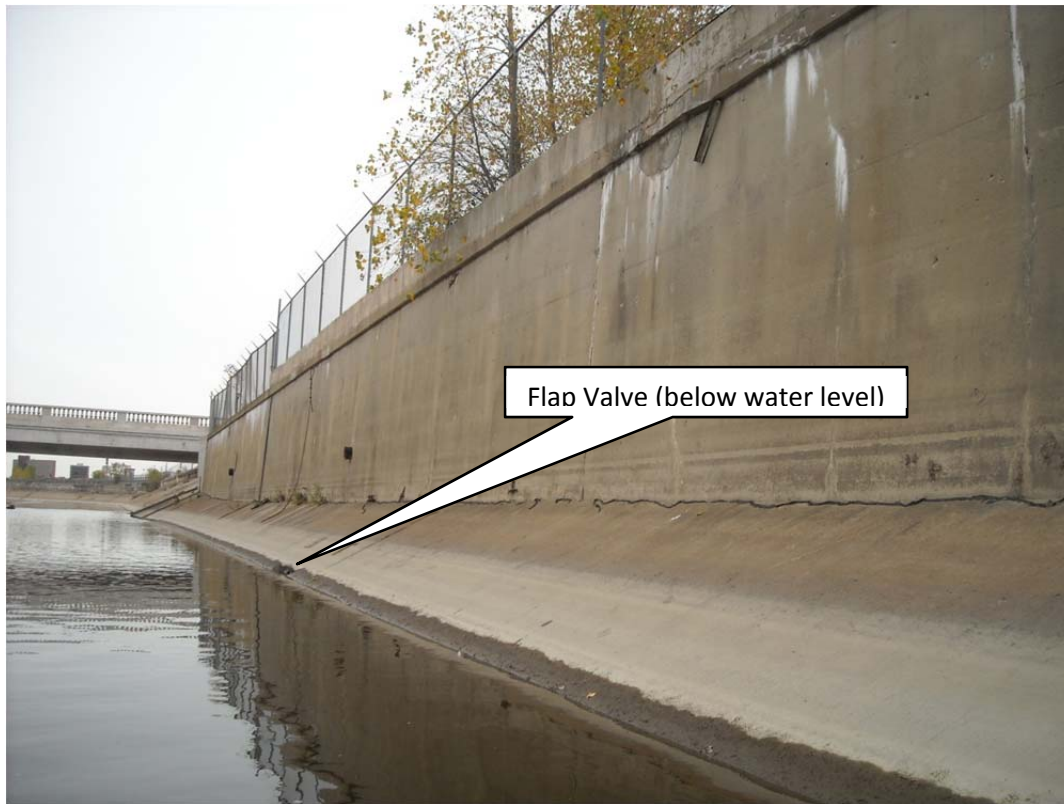
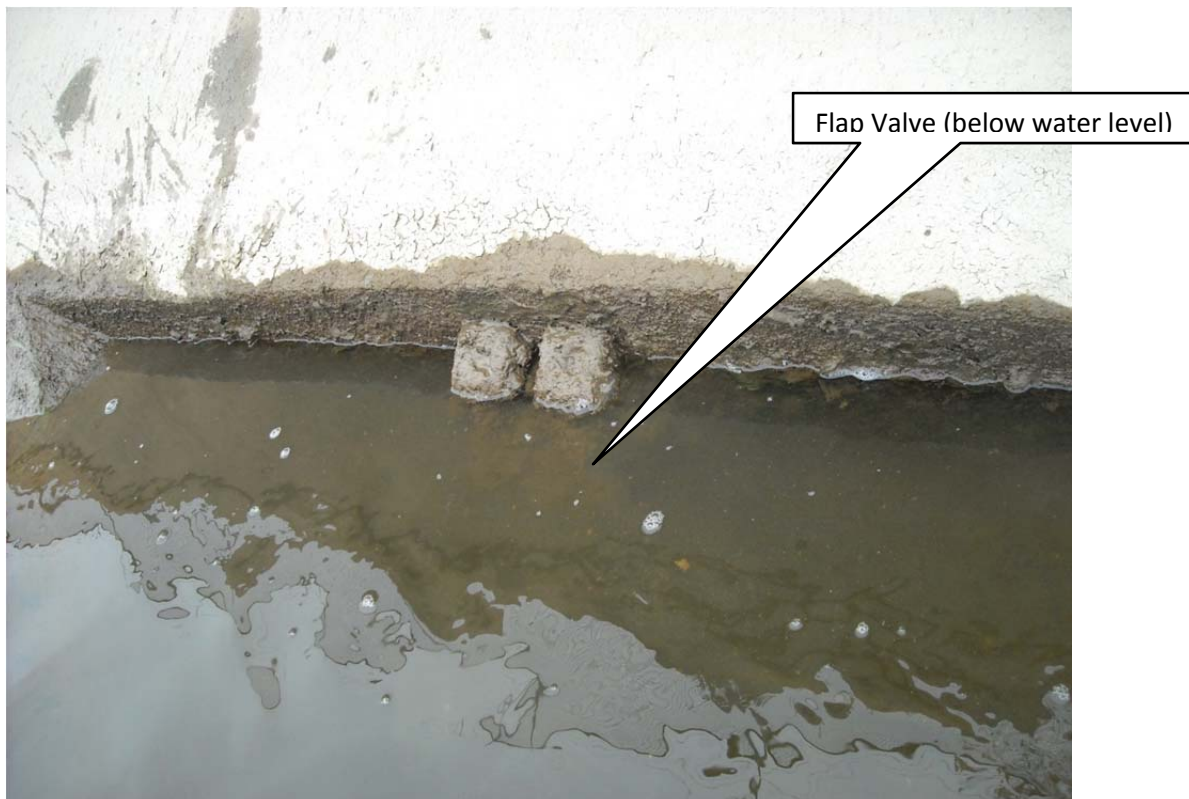
Photos:

Observations: Three flap valves were observed along the base of the floodwall adjacent to Parcel A. The flap valve located between Outfalls #72 and #73 is inoperable. The second flap valve located approximately 50-ft downstream of Outfall #68 is inoperable. The valve is open and moves slightly but is plugged with a log. The third flap valve located approximately 20-ft downstream of Outfall #67 is closed and inoperable.

Proposed Action: Replace the three flap valves with working equipment such that pressure following high river levels may be relieved through the drains, as opposed to cracks and joints that may be sealed as part of the site removal action. Replacement of the flap valves would minimize flushing of river water through cracks and joints.

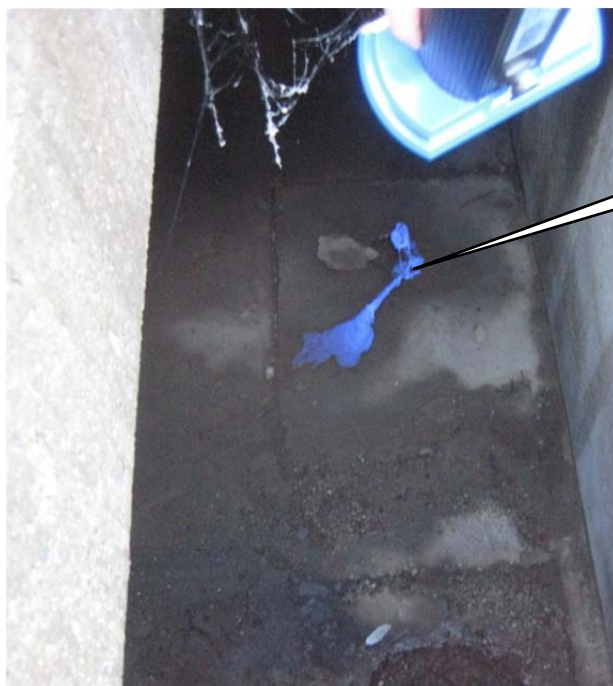
Rag in sewer vault fluorescing under UV spotlight

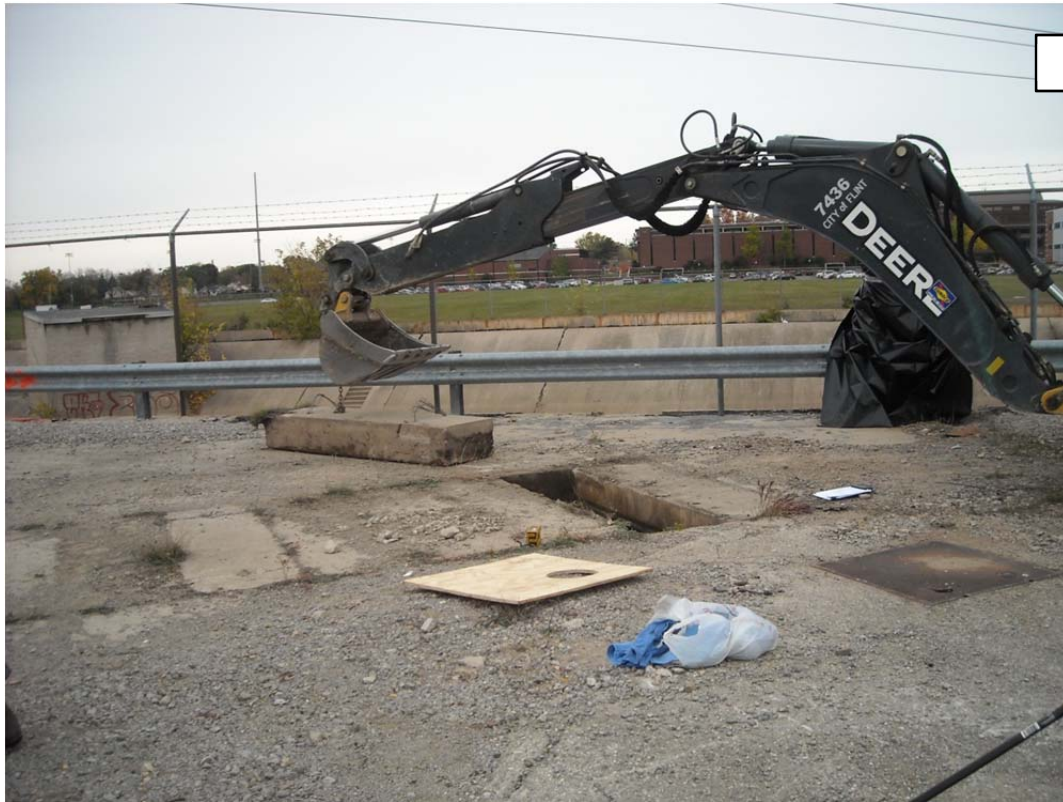
Vault with slab removed

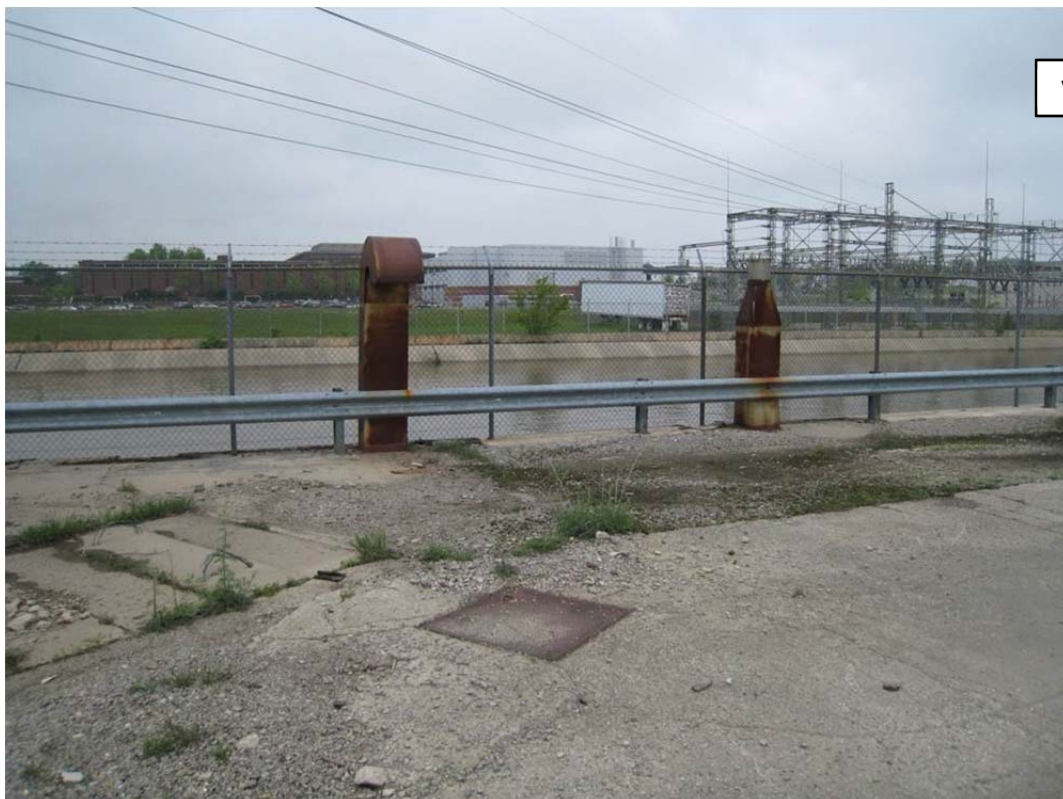
Vents connected to vault

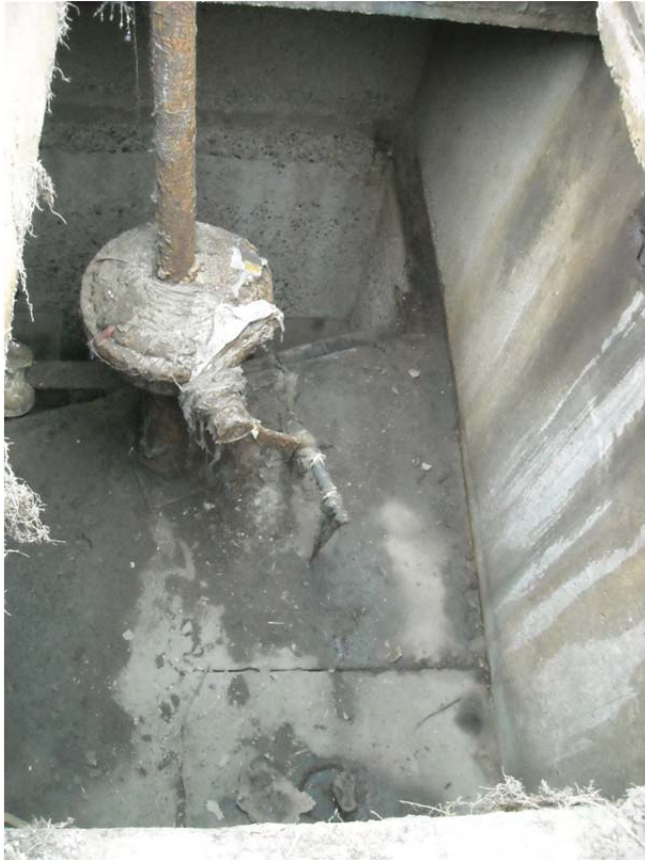
Hand cranks associated
with sanitary sewer valves
located below
