MAINE DEPARTMENT OF ENVIRONMENTAL PROTECTION
OIL & HAZARDOUS MATERIALS REPORT

Spill Number: P-534-2011

Subject/Owner: COLUMBIA MILL (FORMER) - -

Location Type Business - Industrial {ID}
Name COLUMBIA MILL (HERITAGE PARK)
Street Address 3 MILL ST @ ANDROSCOGGIN RIVER
MCD Town LEWISTON
Local Name LEWISTON
State/Province ME

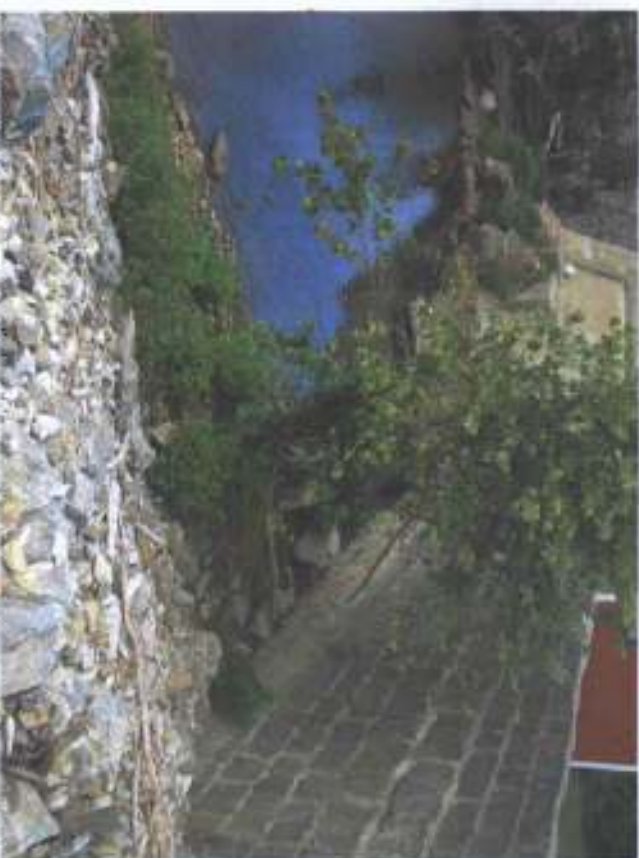
1. Tues. 7/12/11: During MDEP initial response looking down on the oil-sheen area below the retaining wall of the former Columbia Mill.

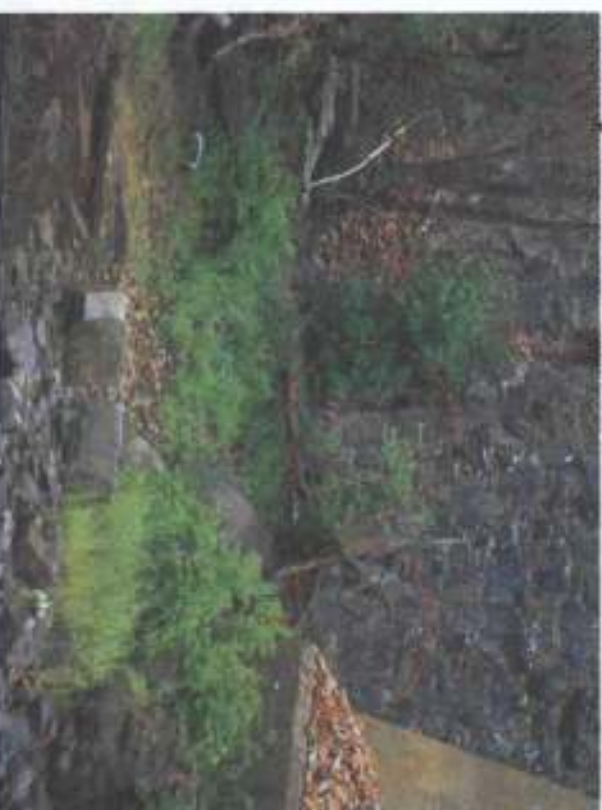
2. 8/16/11 photo of the retaining wall below the former Cowan Mill to the north. Visible at the base of the wall are apparent old bricked-up penstock outlets visible in historical photos and similar to that at the oil seep from the Columbia Mill wall.

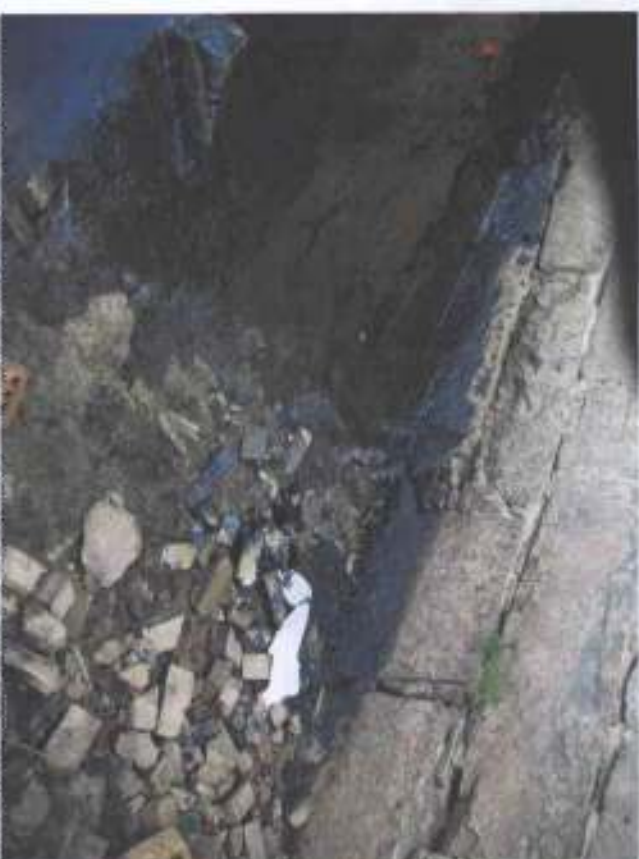
3. Tues. 7/12/11: the 1.5' high smear (bathtub ring) of black oil up the side of the retaining wall from fluctuating water level. A 15" clay drain outlet is at upper left.

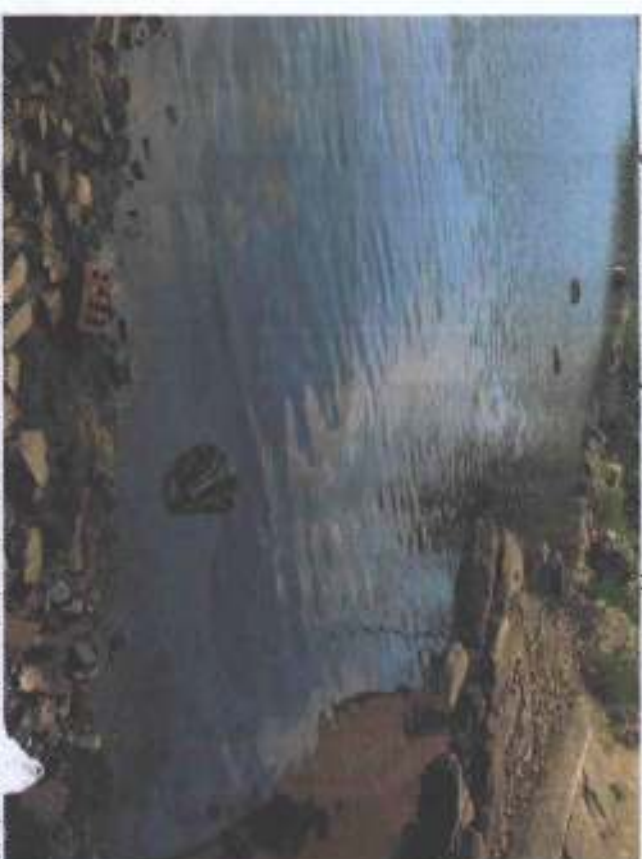
4. Tues. 7/12/11: View looking N from the shore at the sheen in the water, accompanied by blobs of free black oil.

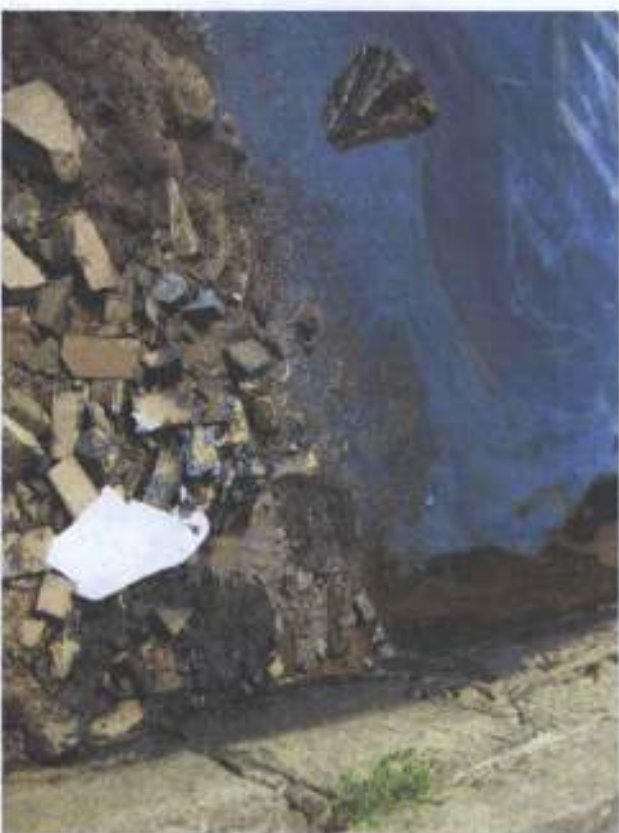
5. Tues. 7/12/11: Close-up of the oil sheen in the water, understood to be from oil covering the rocks and from continuing discharge from the drain pipe.

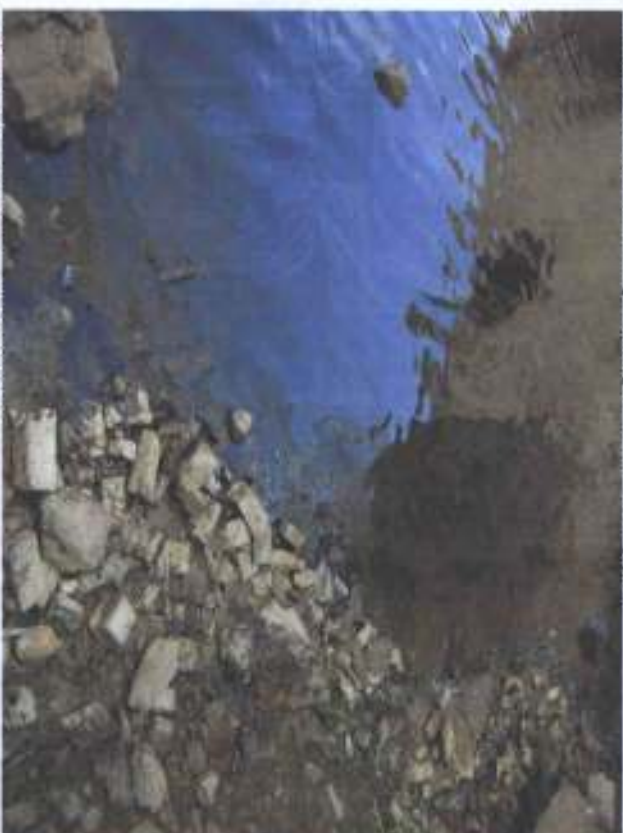
6. Tues. 7/12/11: Oil sheen on the river water.

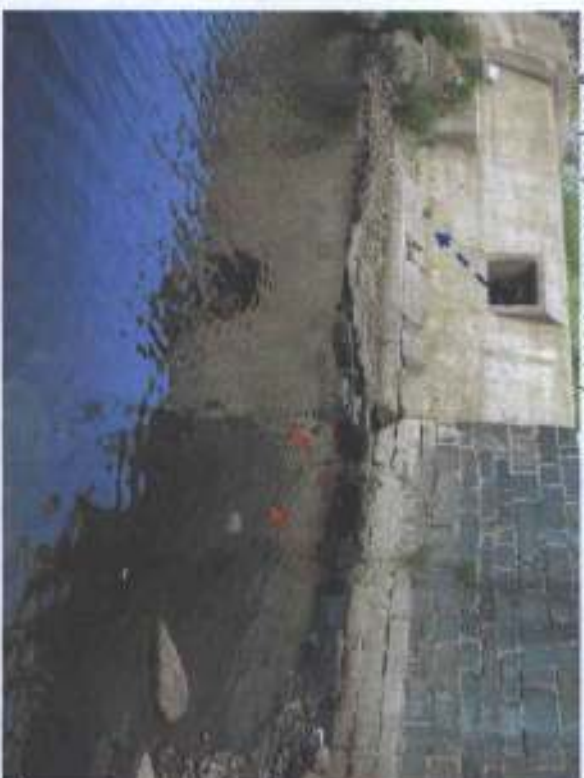
8. 7/12/11: The red arrows show the large, partially bricked-up outlet and the smaller 15" drain pipe. This wall is part of the former Columbia Mill. At upper left is another old major penstock from the former Libbey Mill complex and the location of Cowan Pond in historical plans.

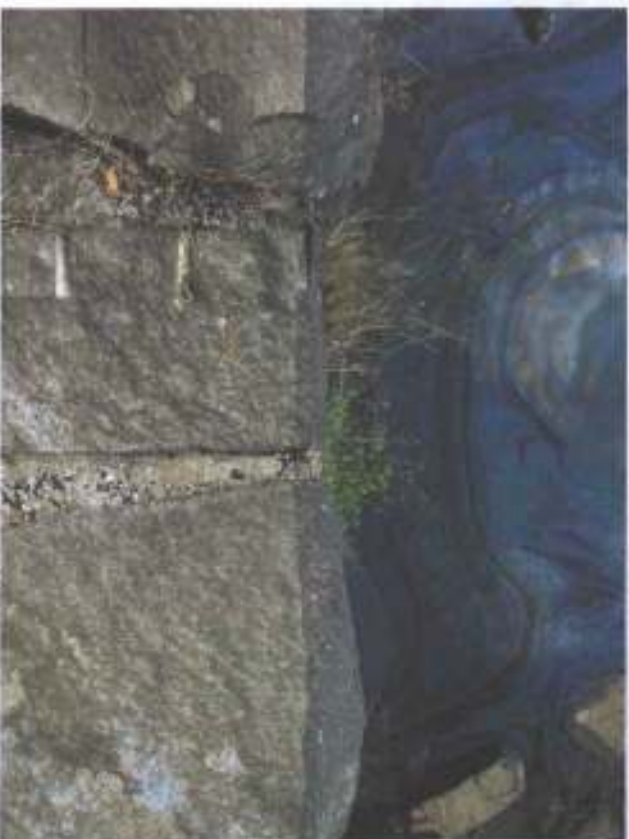
9. Tues. 7/12/11: Looking down at the oil sheen on the river 20' below the top of the wall.

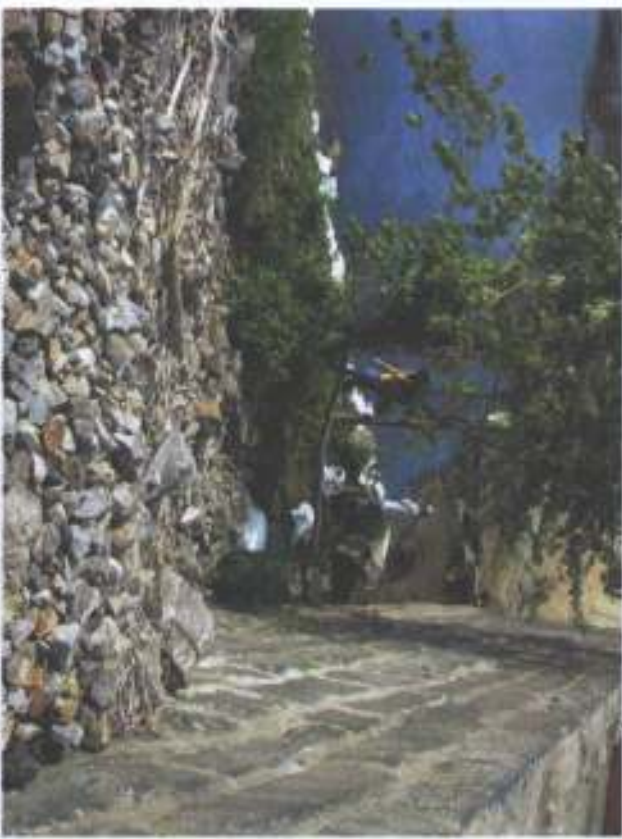
10. Tues. 7/12/11: EPI and MDEP applying sorbent boom and pads to the discharge on the river, and wiping off oiled rocks. The retaining wall was part of the former Columbia Mill razed about 1972.

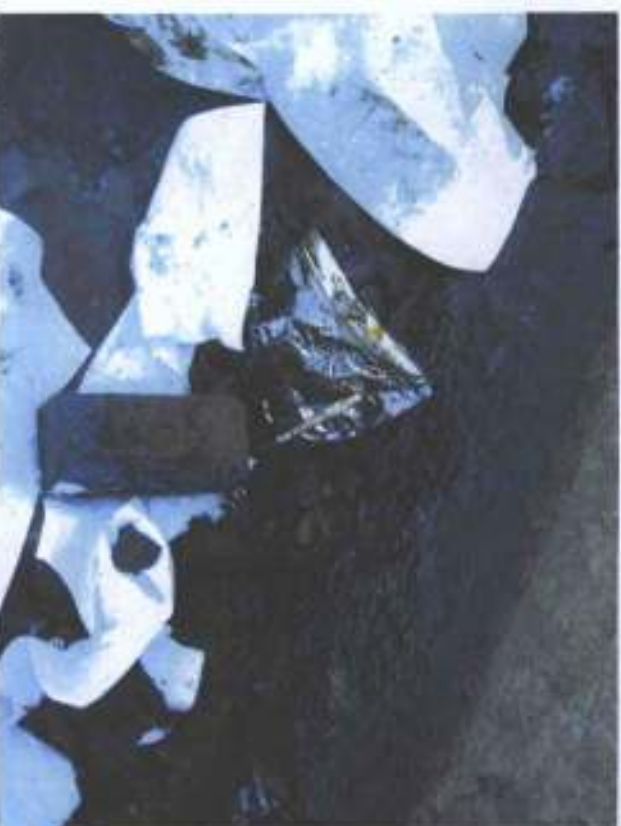
11. Wed. 7/13/11: Close up view of the oiled wall and rocks, and sample S-2 (in silver sample bag) of oil scraped off the rocks.

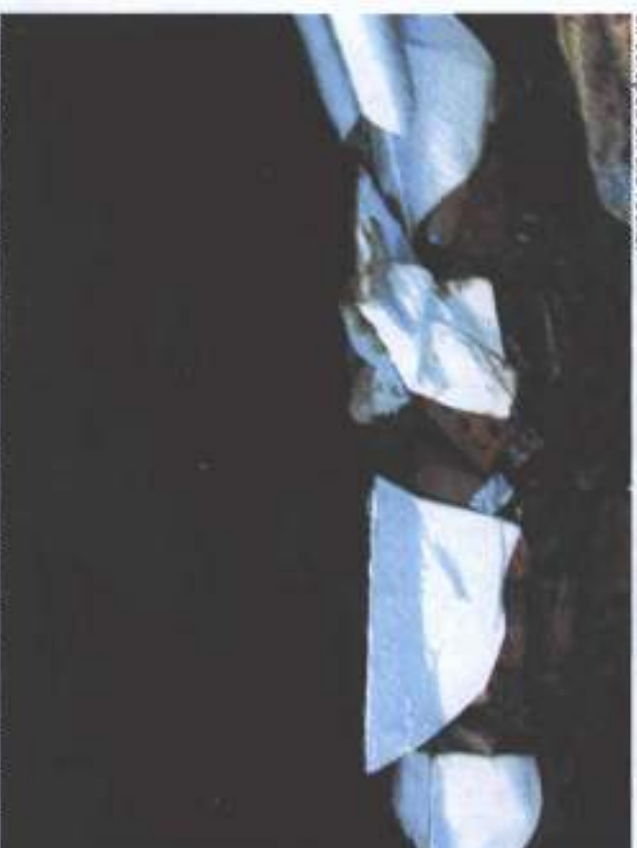
12. Wed. 7/13/11: Inside the 5' diameter large drain outfall from the former mill with oil-contaminated bricks lying in the water.

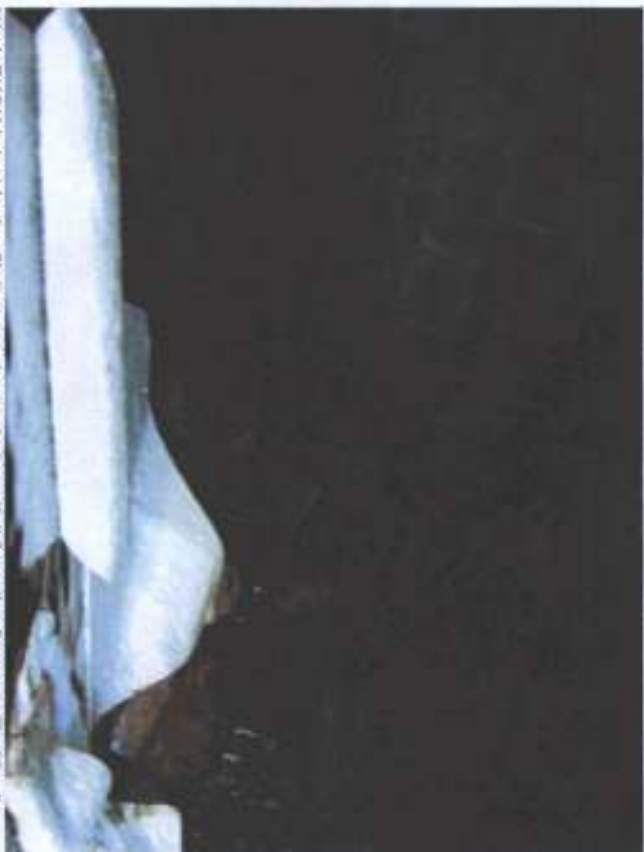
13. Wed, 7/13/11: Inside the 5' diameter large drain outfall from the former mill with oil-contaminated bricks lying in the water. Note the intact brick construction of the outfall. This chamber lies under FPL's red building.

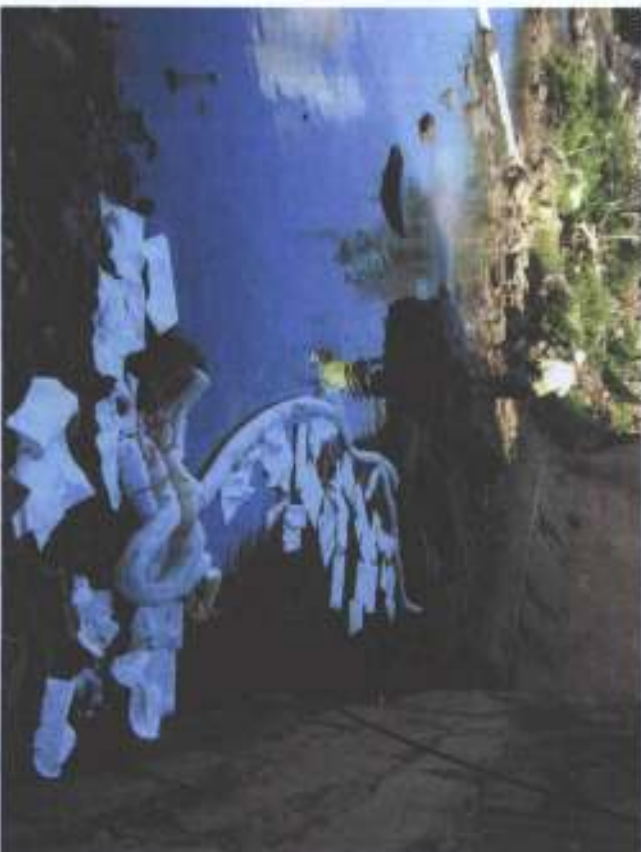
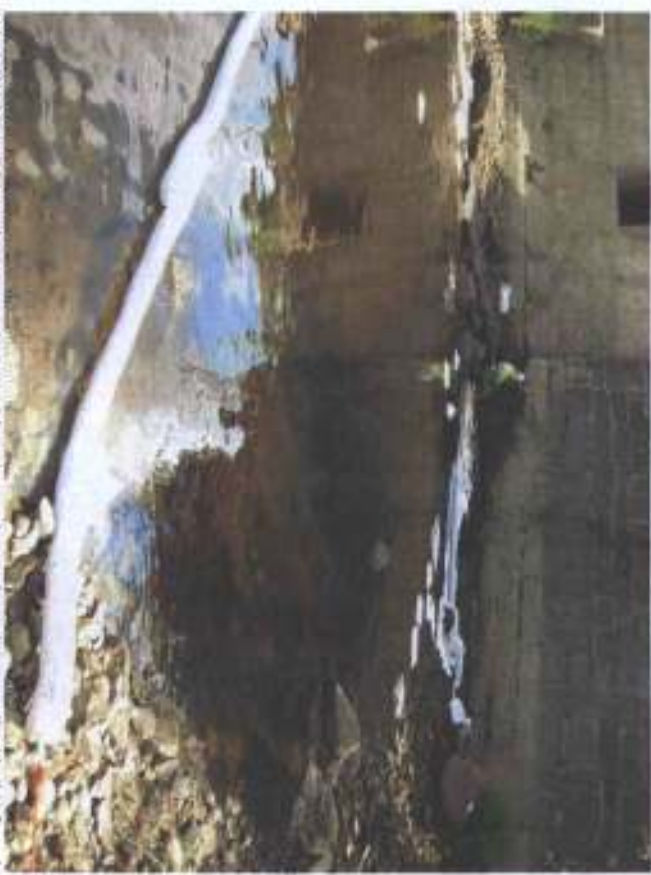
14. Wed, 7/13/11: EPI worker power hot-washing the rocks and retaining wall with the freed oil caught by the sorbent pads and boom.

15. Wed, 7/13/11: EPI worker power hot-washing the rocks and retaining wall with the freed oil caught by the sorbent pads and boom.

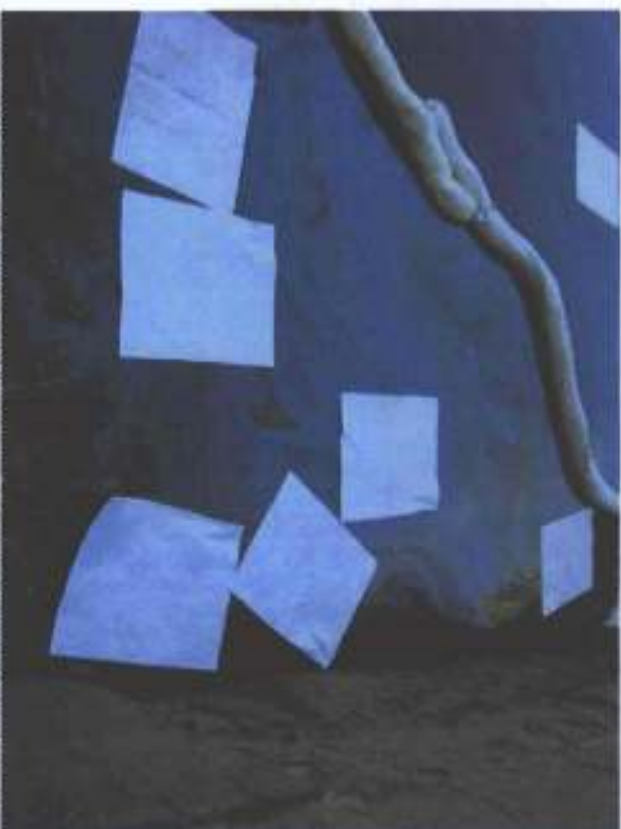
17. Thurs. 7/14/11: Fresh sorbent pads have been laid down; heavy oil sheen again on the river water behind the inner boom. Free oil appeared to be emanating from the 10" diameter drain pipe.

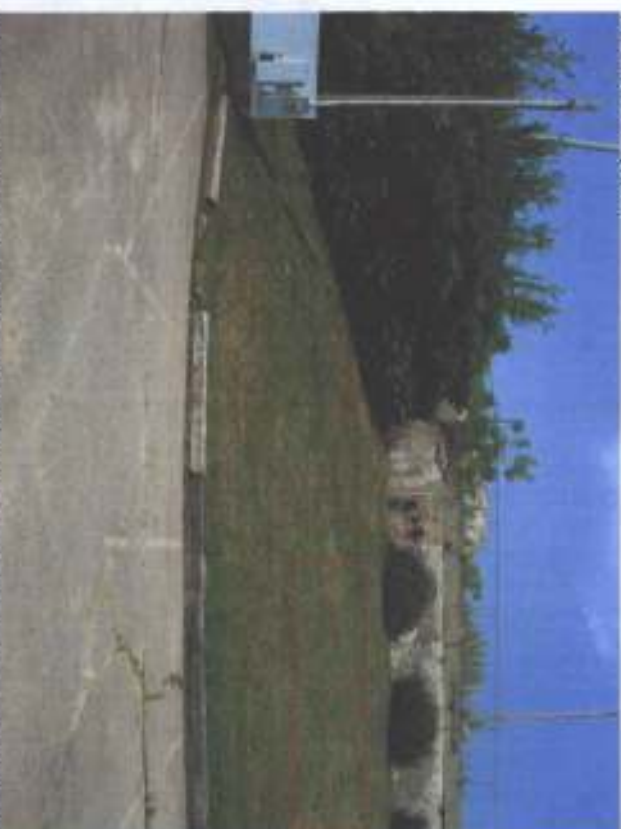
18. Tues. 7/12/11: Looking NE up at the 'mystery' out-of-service #6 oil piping coming out of the hillside above the location of the reported #6-oil UST removed in March 2000. Note the dark oil stain on the concrete wall below the pipe.

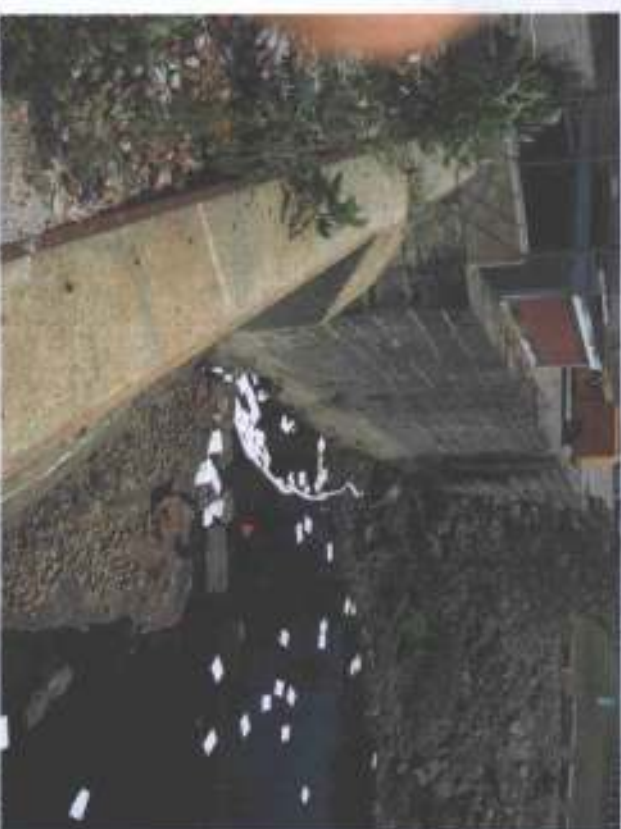
19. Tues. 7/19/11: Looking south from the former Cowan Mill site down at the former Columbia Mill location (Heritage Park) and the oil discharge from the river from under the former Columbia mill building.

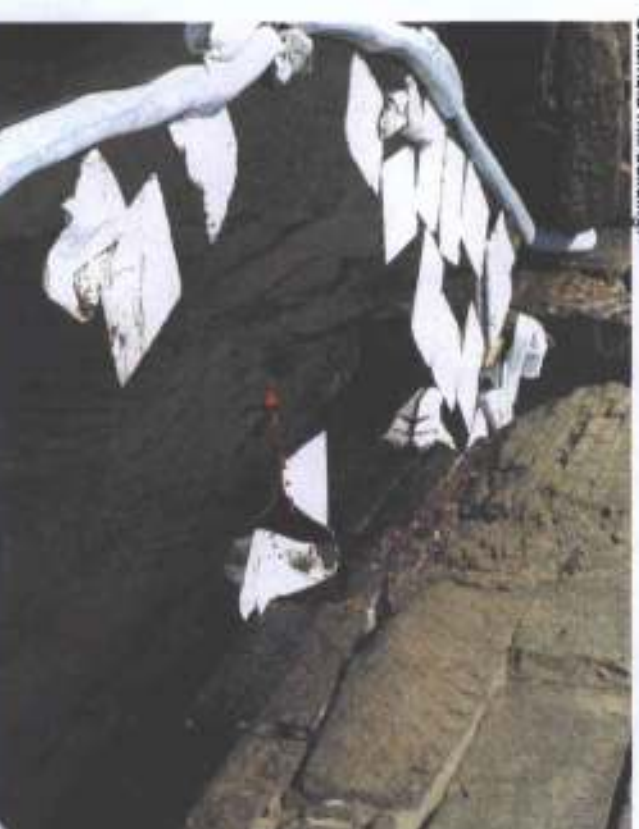
20. Tues. 7/19/11: There is heavy oil sheen and blobs of free oil behind this inner sorbent boom.

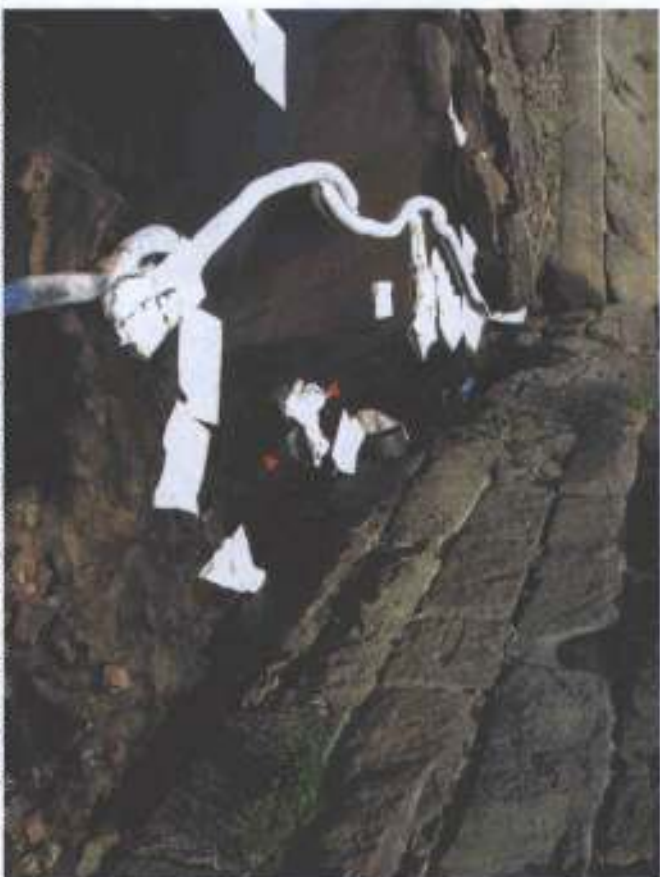
21.

Mon. 8/1/11: On this day little oil was found inside the 10" pipe and I noted oil sheen appeared to be seeping out between joints in the rock wall suggesting the discharge is exiting via the old Columbia Mill raceway. Behind this wall is a chamber, beneath the red FPL shed. The wall is coated with fresh oil despite the power wash on 7/13/11.

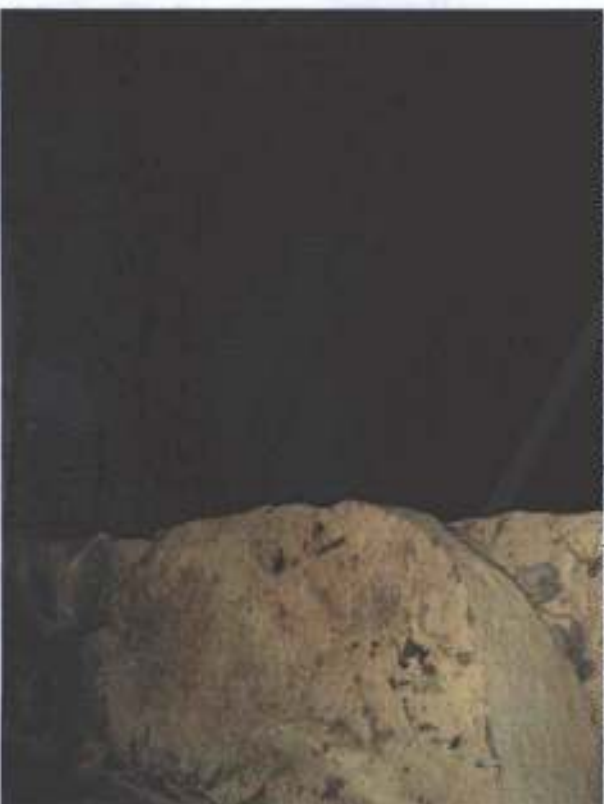
22.

Fri. 8/5/11: Looking down into chamber under red shed at brick debris from Columbia Mill demolition.

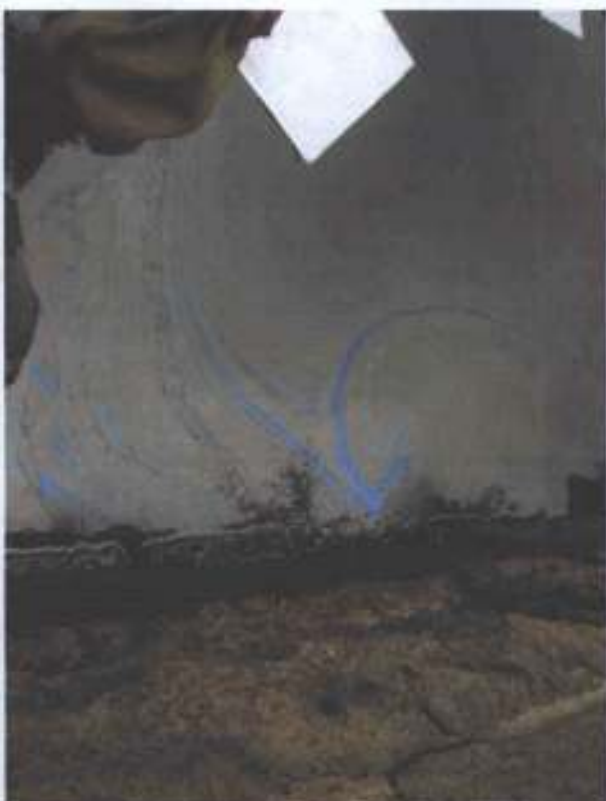
23.

Fri. 8/5/11: Swirls and lobes of oil that appear to be seeping from joints in the wall blocks.

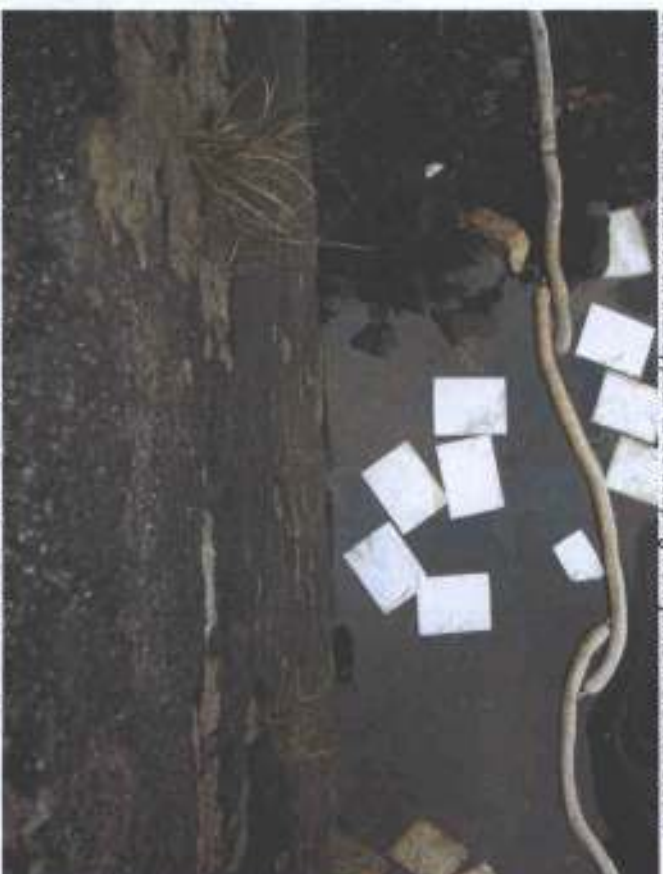
24.

Fri. 8/5/11: Looking down on oil sheen from Columbia mill retaining wall.

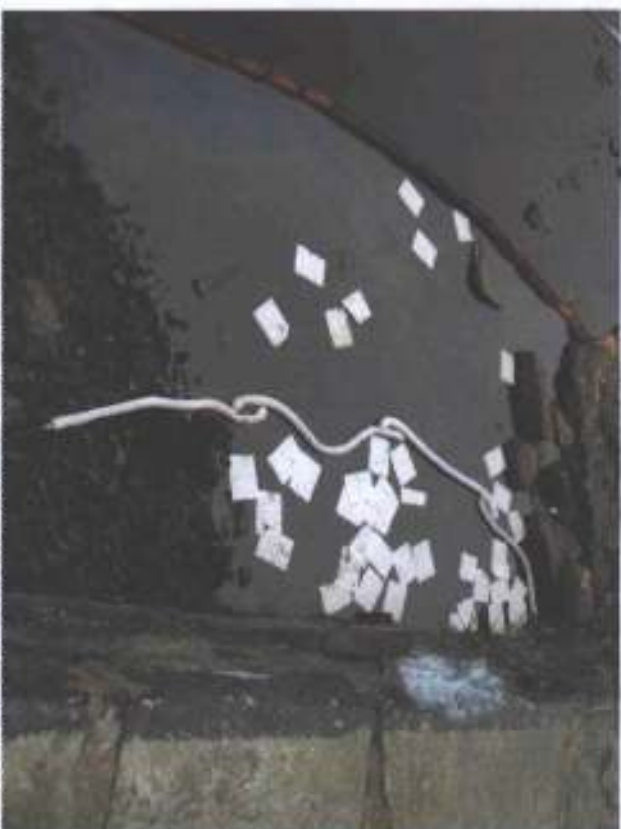
25.
Thurs, 8/11/11: Heavy oil sheen on water. Hard 12' boom has been deployed outside of the sorbent boom.

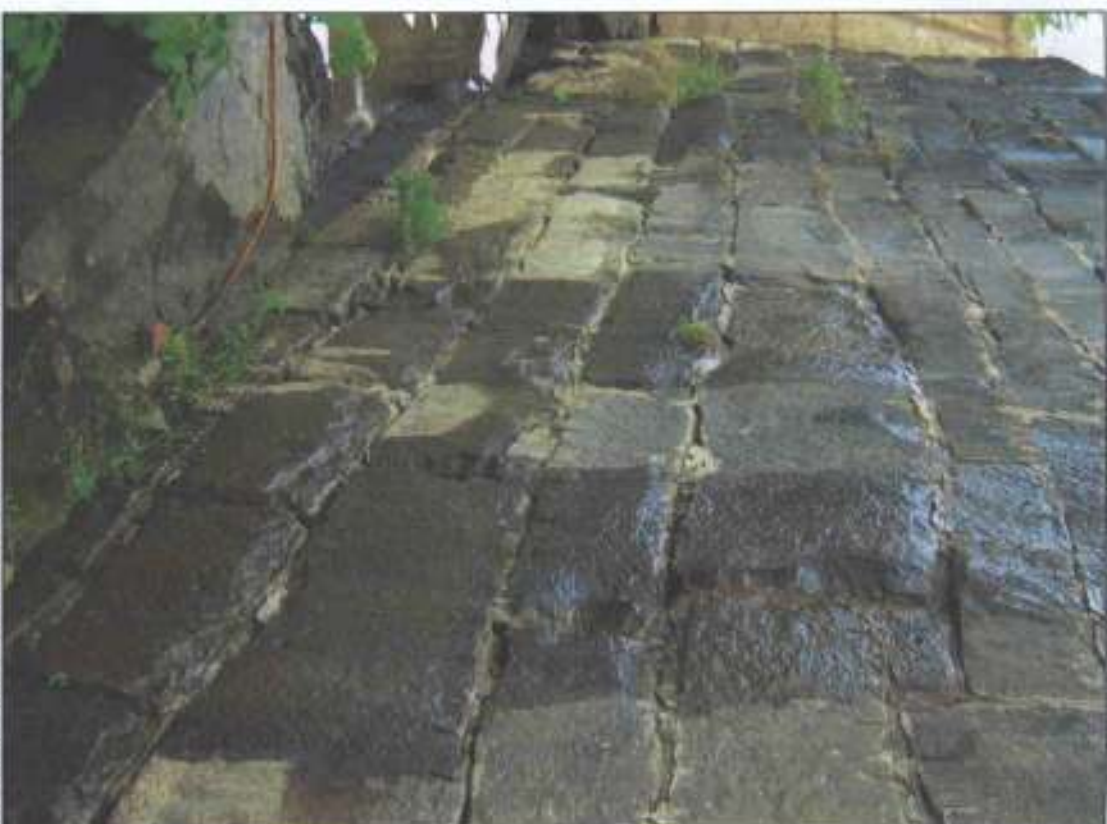
26.
8/15/11: Morning photos by EPI staff of surface water draining down through ground and out retaining wall. Lewiston-Auburn Water Department was flushing their water lines into the parking lot above.
Mon.

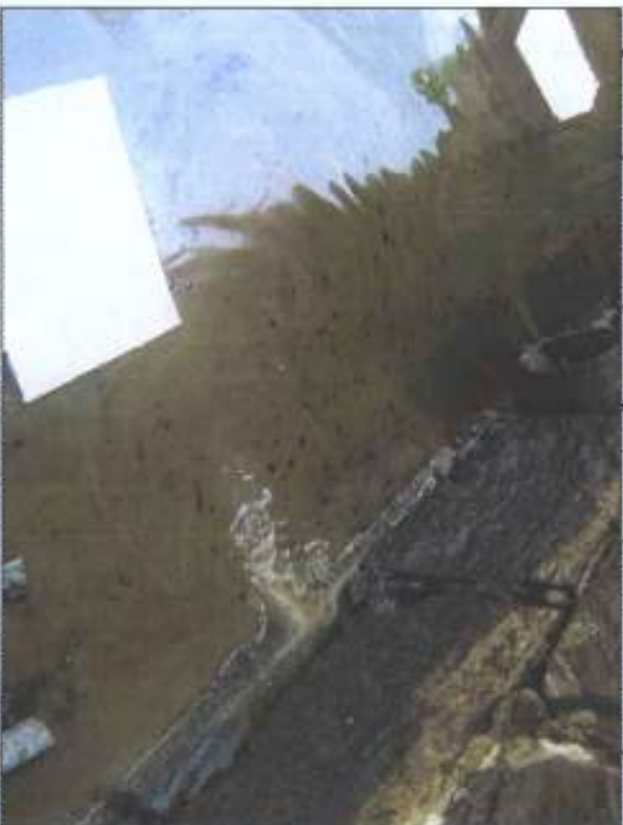
28. Mon. 8/15/11: Water and #6-oil droplets being flushed out of rock wall into Androscoggin River by the water from the L-A water Department; significantly more oil than before. Photo by EPI staff.

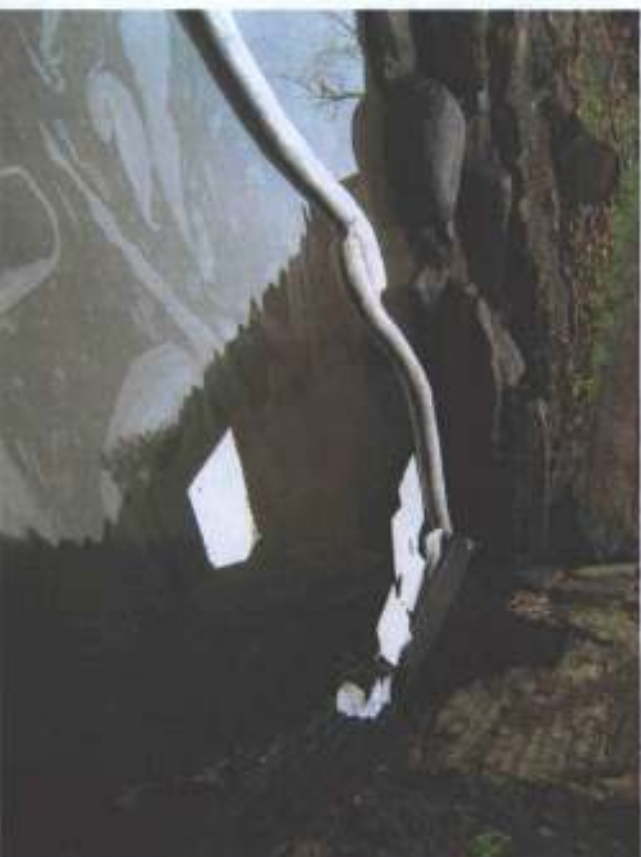
29. Mon. 8/15/11: Photo by EPI staff, heavy oil sheen and droplets flushed into the river.

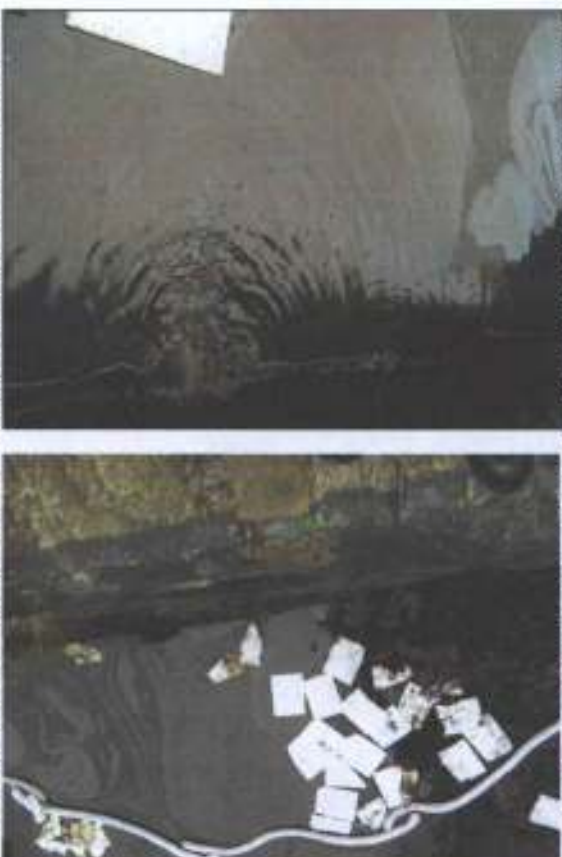
30. Mon. 8/15/11: Photos by EPI staff. Blobs of black oil being washed into the river and creating a heavier than normal oil sheen.

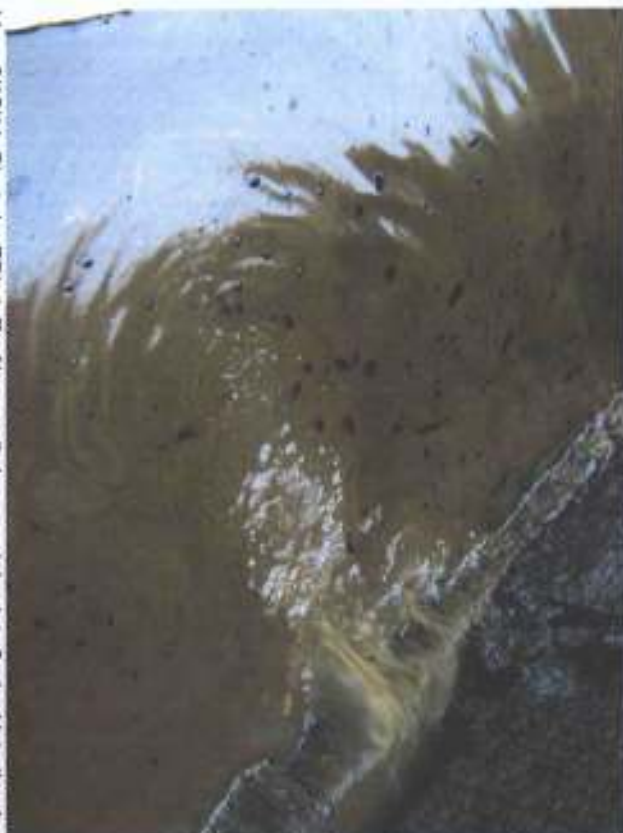
31. Mon. 8/15/11: Photo by EPI staff, of heavy oil sheen and droplets flushed into the river.

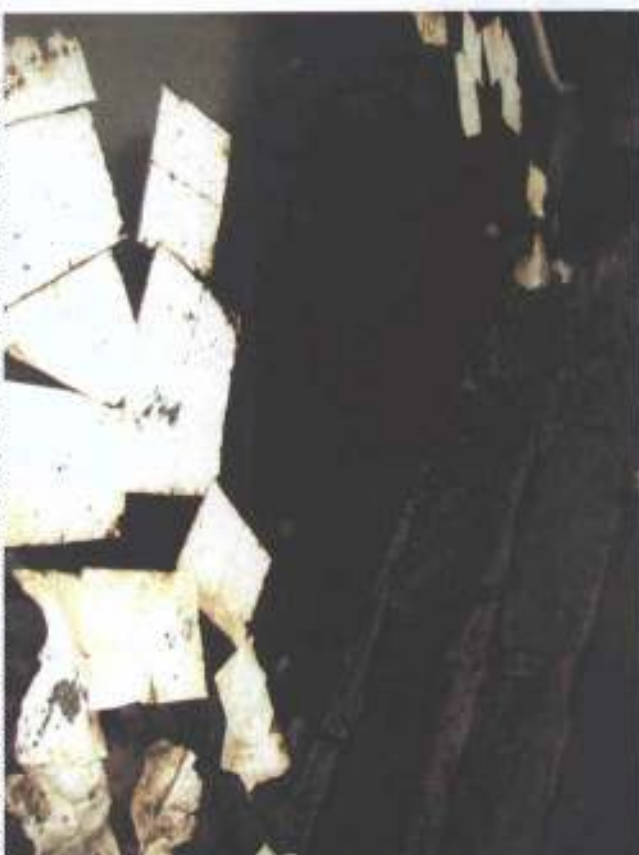
33. Tues. 8/16/11: Black oil seeping largely out of the joints between the granite blocks right (south) of the 15" clay pipe. Recent rain may have added to the water system flushing of the previous day. During very high water levels in the river we suspect that the water pressure inhibited the oil from seeping out and may have acted to recharge groundwater table.

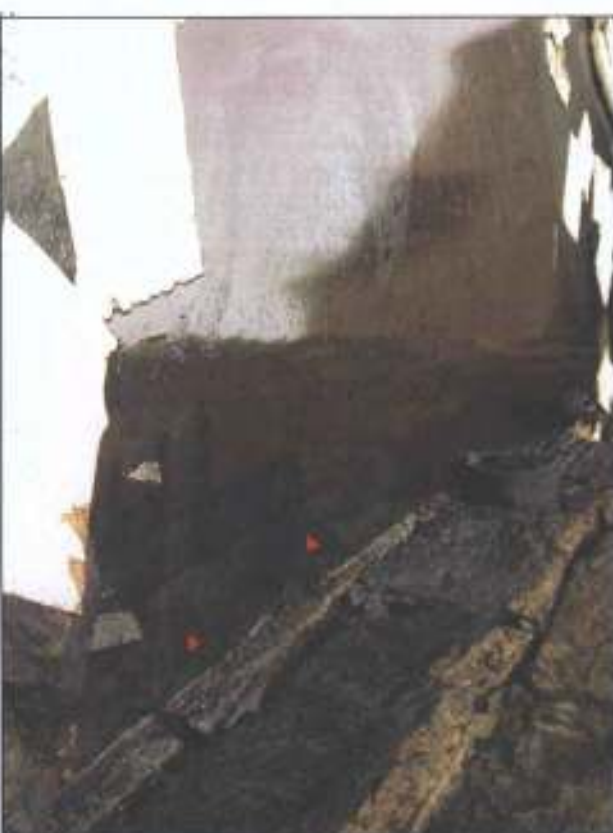
32. Tues. 8/16/11 MDEP photo showing a significant increase in oil seeping out with most all I noted coming out of cracks between the granite blocks rather than out the pipes and penstock outlet. Sorbent pads laid yesterday have been supplemented by fresh pads. Compare this with photos 17 and 23 above.

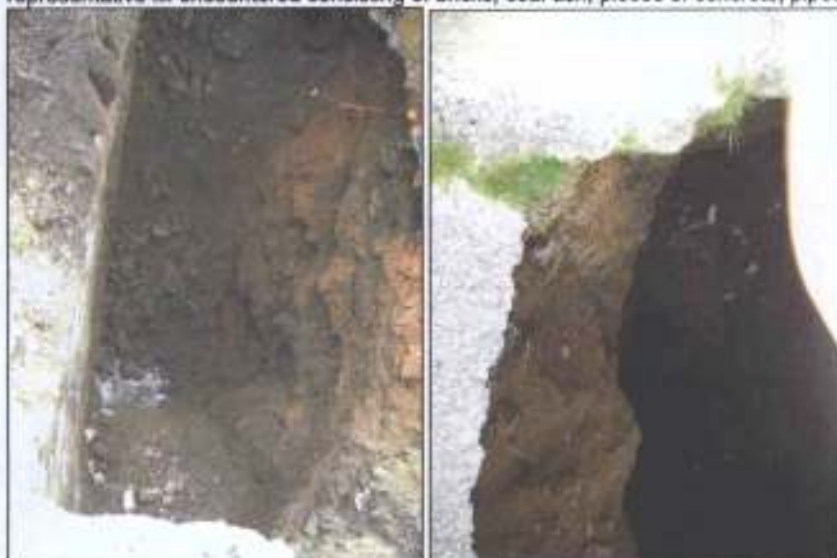
35. Thurs. 8/11/11: Test pits TP-2 showing soil profiles. In left photo is a concrete slab or footer to the left side. No oil found on groundwater at 17' below grade. TP-2 and TP-3 merged into one large test pit.

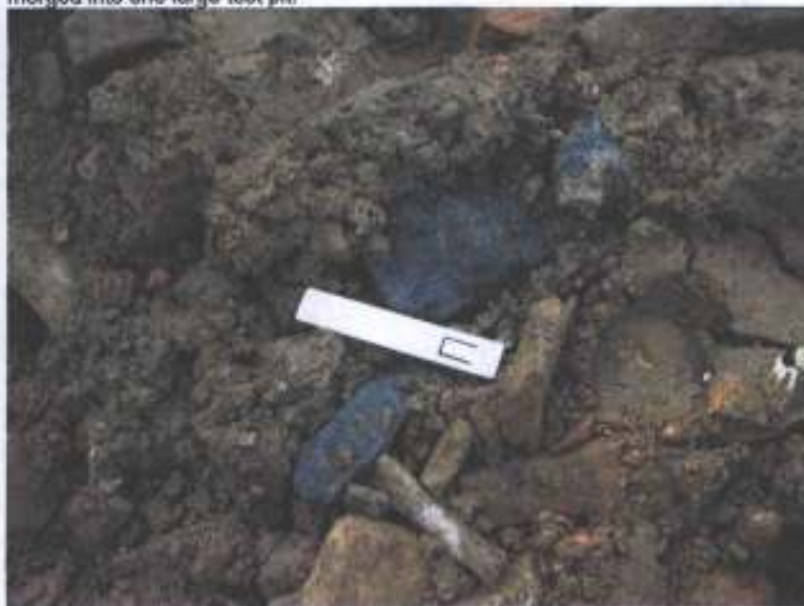
36. Thurs. 8/11/11: In the center is so black/gray wet ash material that looked like black oil though was water soluble and not sticky like oil.

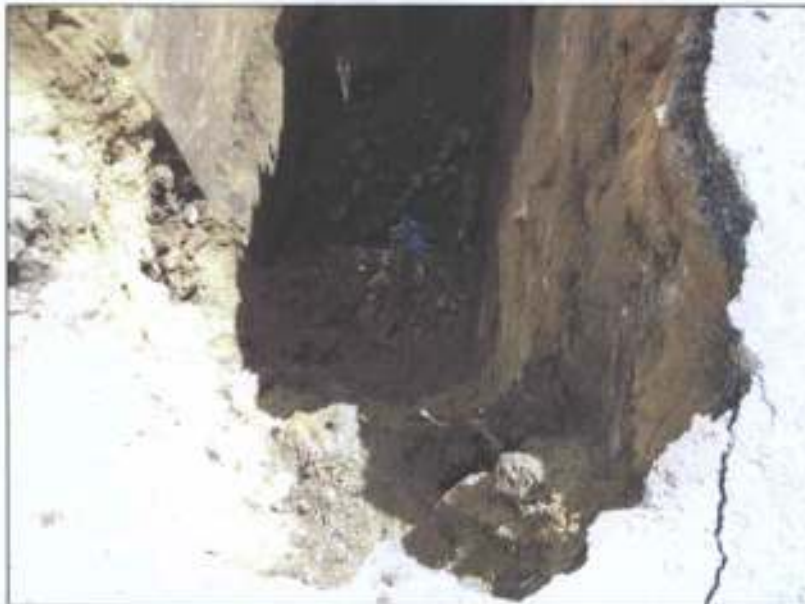
37.

Thurs. 8/11/11: **Test pit TP-3**, east of the red shed, dug down between two vertical walls of concrete that were loose, a concrete shelf-like footer is visible. Black coal ash but no oil found and no penstock or pipes into the chamber under the shed.

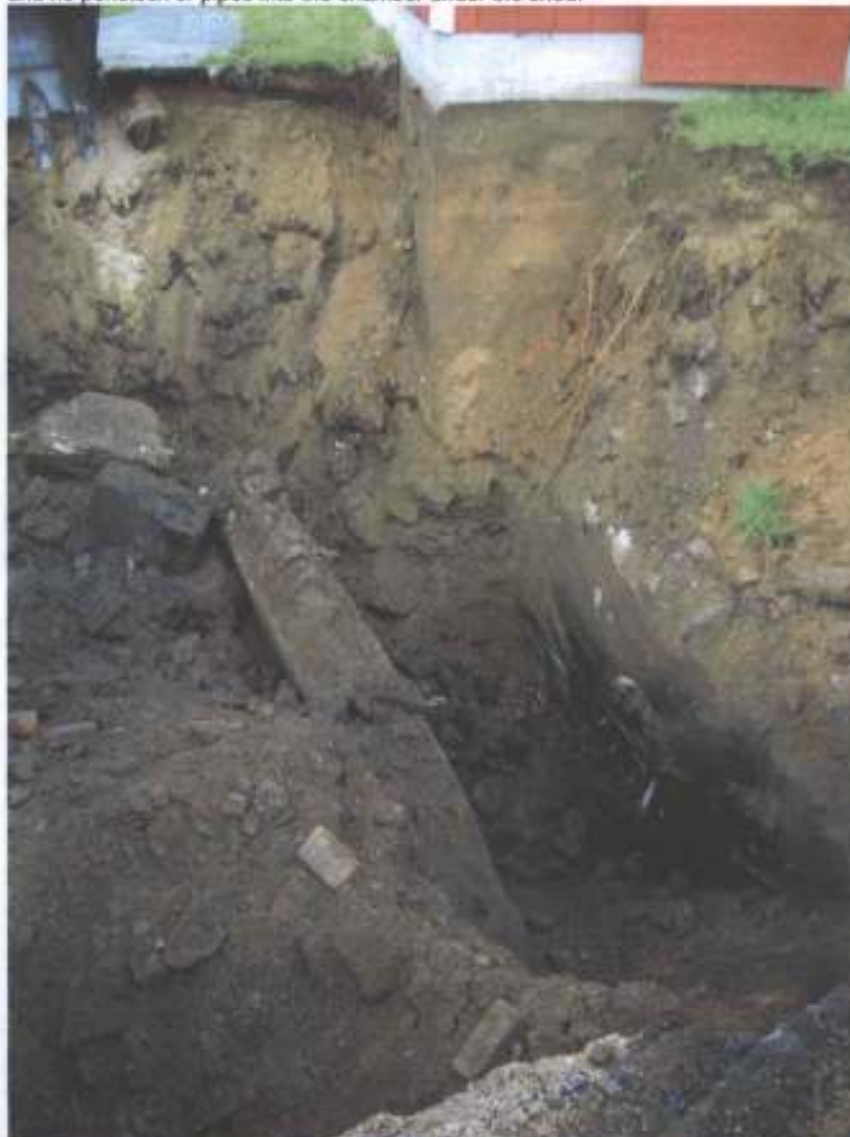
38.

Thurs. 8/11/11: Looking down into TP-3 with TP-2 to the left being filled in. At upper right is the post Columbia Mill red shed; visible below the shed is the concrete chamber that a Columbia Mill penstock appears to have fed into. This chamber is where the #6-oil is leaking out of and through the stone retaining wall into the river. No piping of evidence of oil contamination was found in these test pits.

John Cressey of Summit Env. was concerned about PAH levels found in the ash.

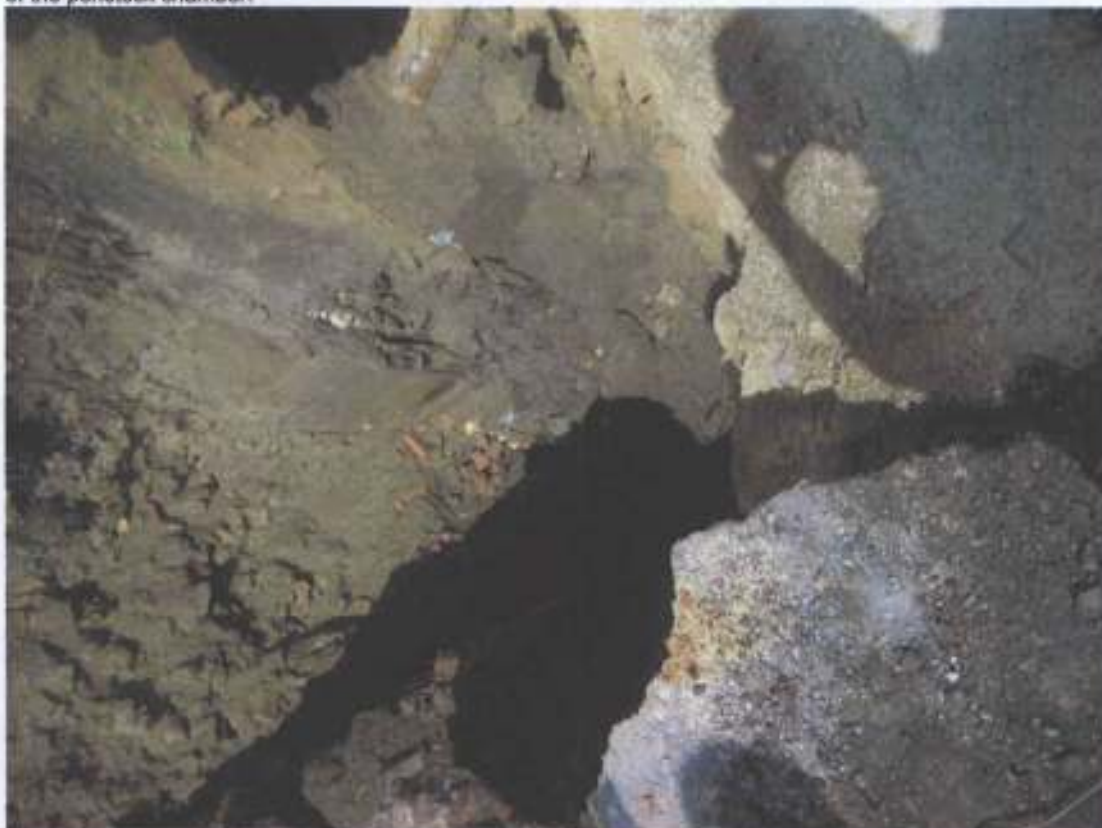
42.

into the excavation. Black coal ash was noted. Groundwater at 17' bg appeared to have an oil-like sheen, but no free oil like that seeping into the river or like what was found in test pits TP-5 and TP-6 to the east.

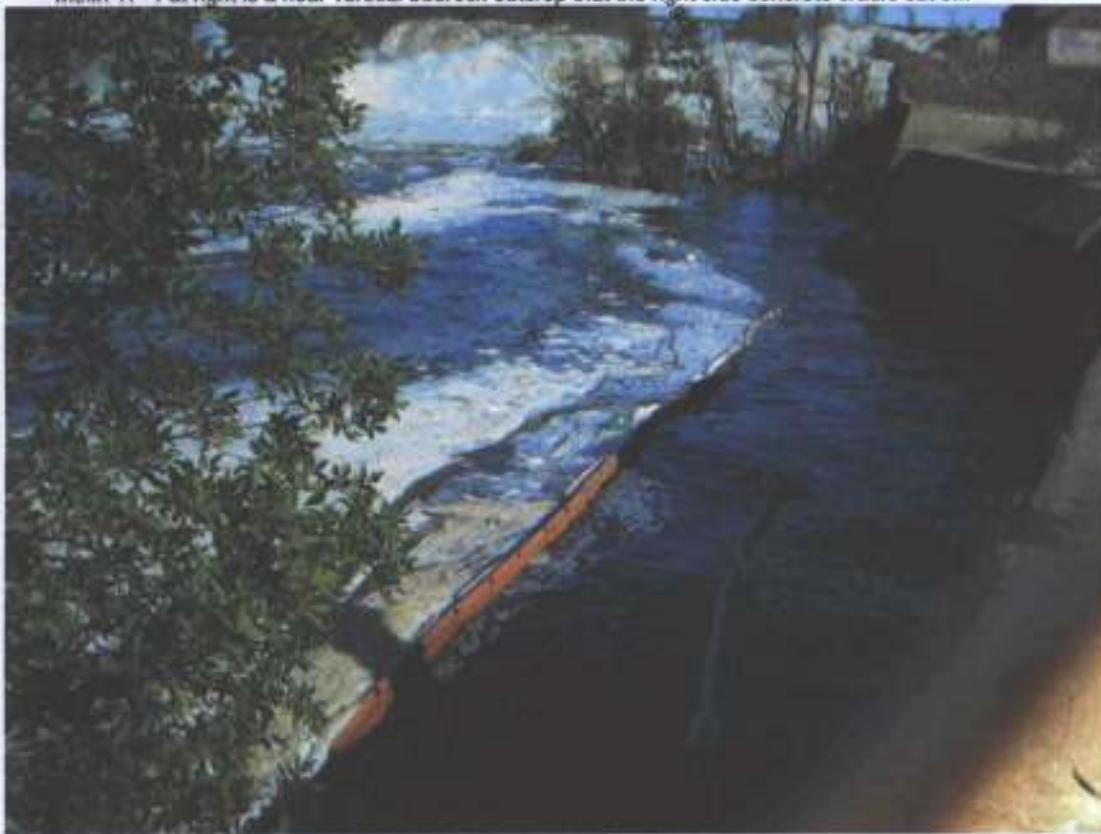
8/29/11: High river

water in the oil-seep area below retaining wall with little sheen in the river, it is suspected that water 4' to 8' higher than in July acts to recharge groundwater inhibiting oil from seeping out.
