MAINE DEPARTMENT OF ENVIRONMENTAL PROTECTION
OIL & HAZARDOUS MATERIALS REPORT

Spill Number: P-534-2011

Subject/Owner: COLUMBIA MILL (FORMER) - -

Location Type Business - Industrial {ID}
Name COLUMBIA MILL (HERITAGE PARK)
Street Address 3 MILL ST @ ANDROSCOGGIN RIVER
MCD Town LEWISTON
Local Name LEWISTON
State/Province ME

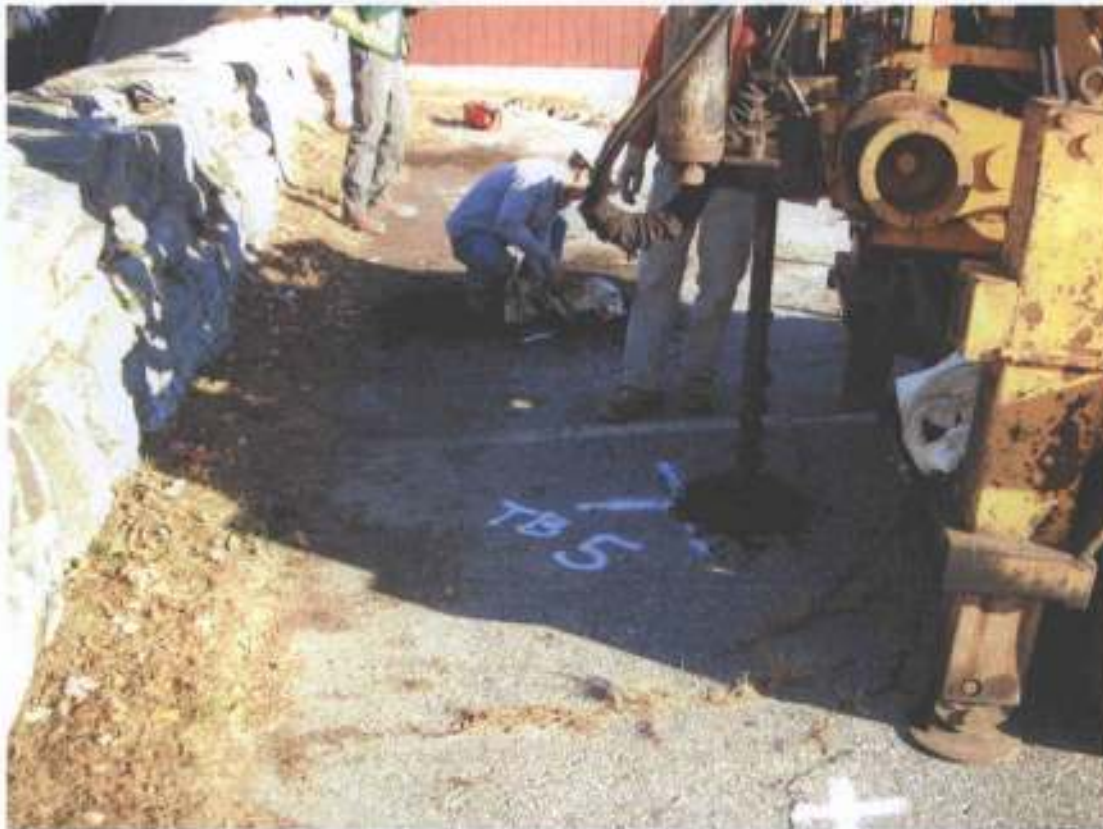
59. Mon. 10/17/11:
Boring Test Boring TB-5 with TB-4 the next boring in the background. TB-4 came up with 6-oil saturated soil and had refusal (bedrock) at 22.5'; while TB-5 encountered refusal at 4.5' at what appeared to be scrap metal. TB-11 is located 5' to the right (east) of TB-5 had no evidence of oil, though TB-12 located 10' east of TB-5 had oil odor but no free product oil.

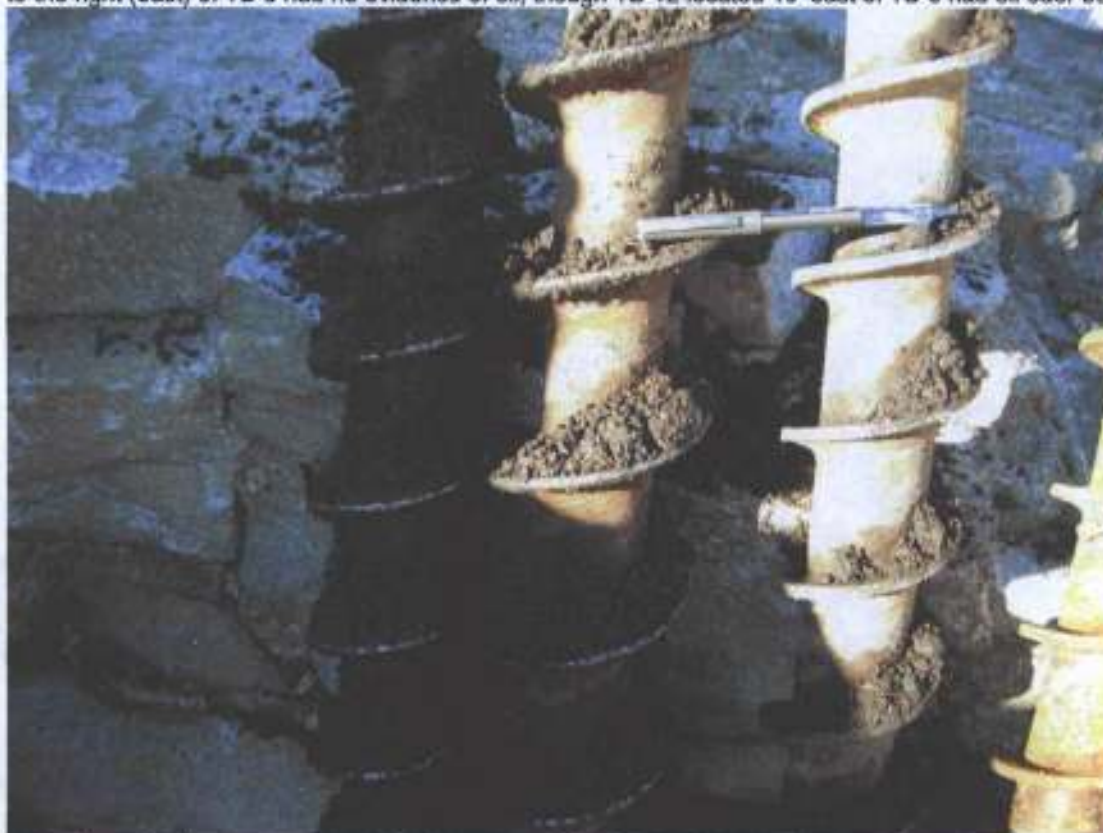
60. Mon. 10/17/11: Oil-contaminated soil on auger stems from the area of TB-14 located next to the retaining wall.

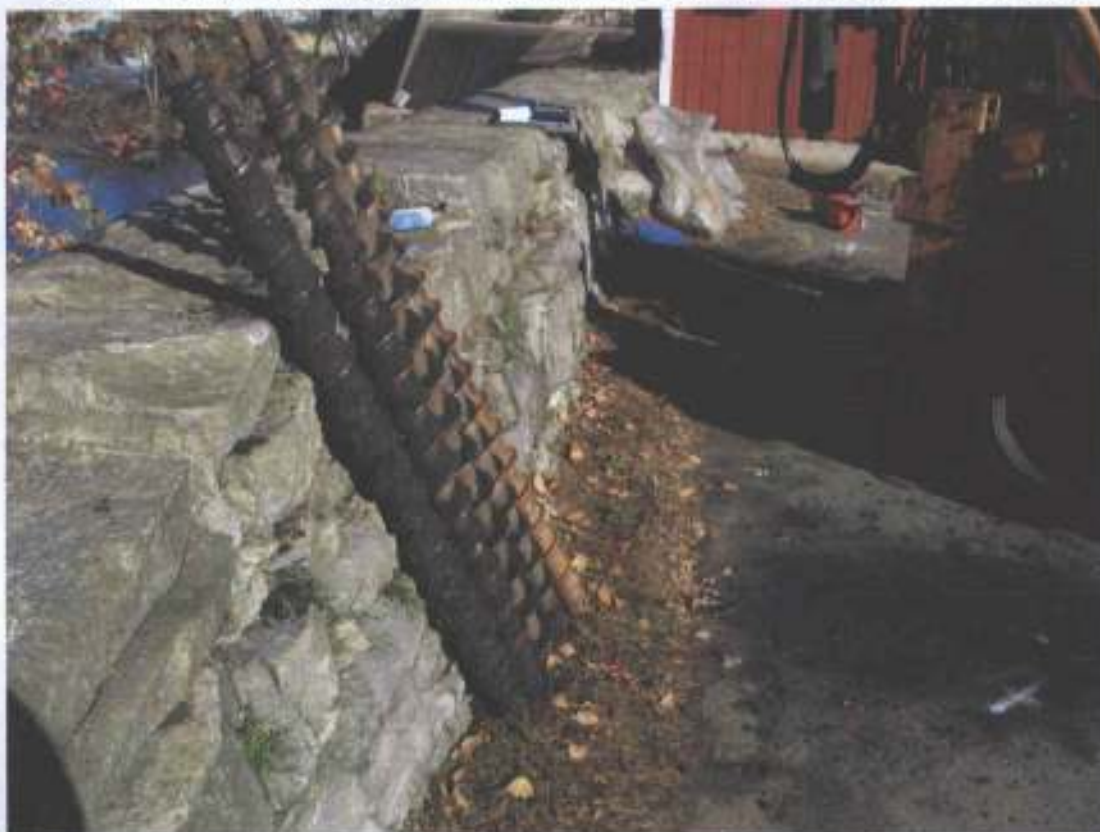
61.

Boring TB-14 located at lower right corner of the photo with the four auger stems, the stem in the foreground has sticky oil-saturated soil believed to be from the 17' to 25' zone below grade (bg). Bedrock refusal in TB-14 was noted at 27' bg. A soil sample from the drill stem was measured to have 3.1-ppm "qualitatively similar to #6 Fuel Oil" (Analytics Environmental Laboratory).

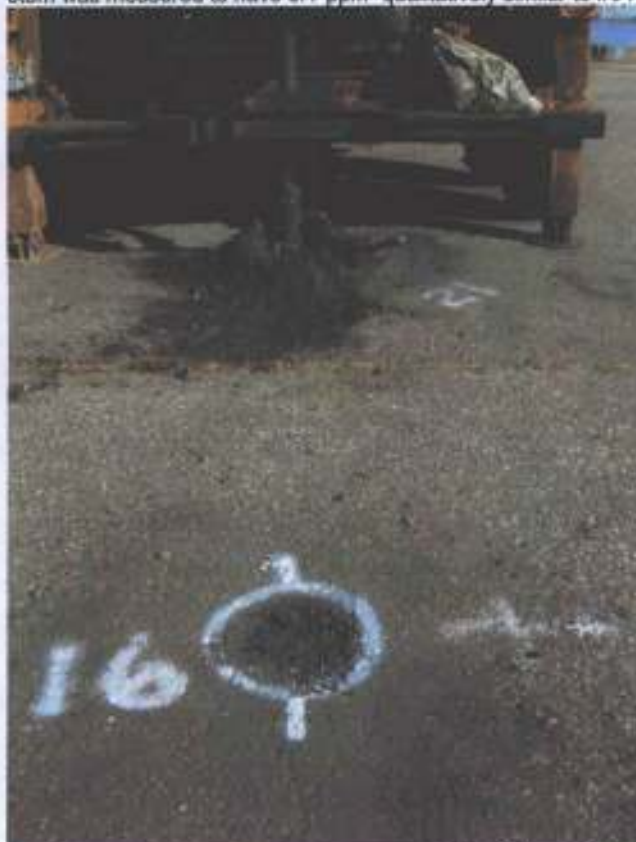
62.

Mon. 10/17/11: Looking east, drilling of TB-21 which hit refusal at

27.2' bg and an oil-saturated zone between 13' to 27' bg. [Groundwater fluctuation due to seasons and river level appears to have created a large smear zone for the oil contamination.]

TB-16 in the foreground hit refusal at 28.9' bg and was oil-contaminated from 18' down to 25' bg but contained less free oil-saturation than TB-4, TB-21 and TB-17.

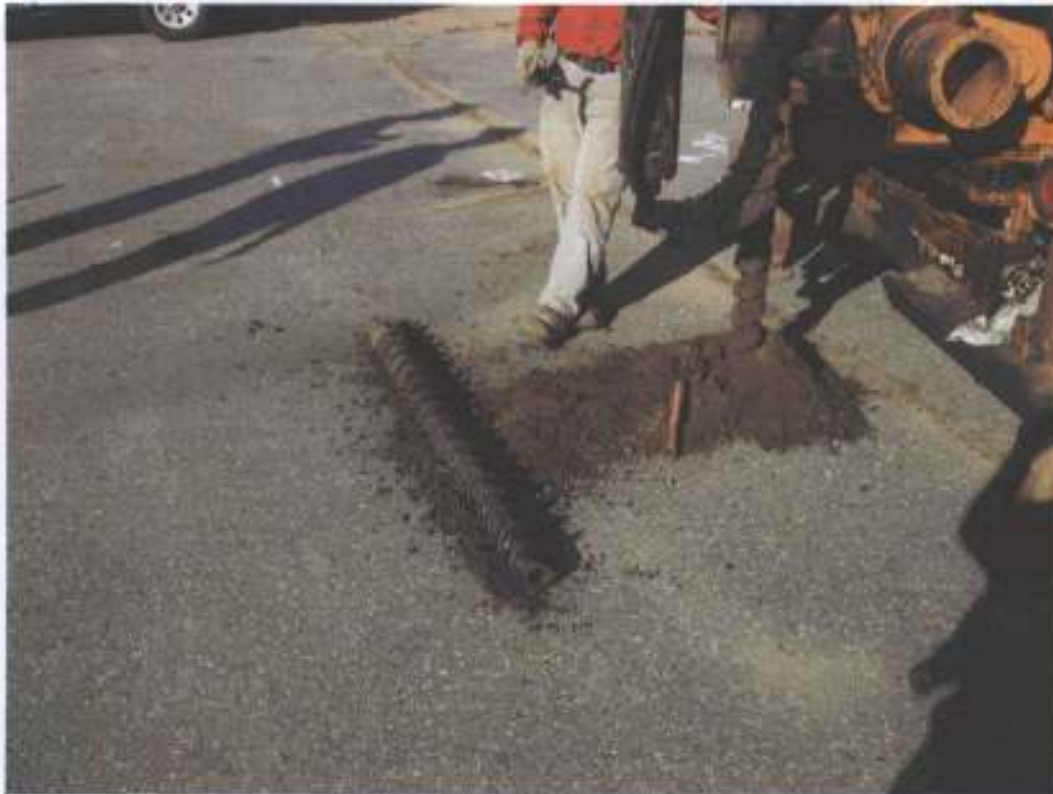
63.

TB-24 in the center of the parking lot, TB-23 is in the background. Refusal was encountered at 21.3' bg; oil-saturated soil was noted below 13' bg.

In TB-23 we encountered refusal at 17.2' bg and no oil-contamination. A lab sample from TB-22 located to the east by TP-6 was measured to have 9.9-ppm "qualitatively similar to #6 Fuel Oil"

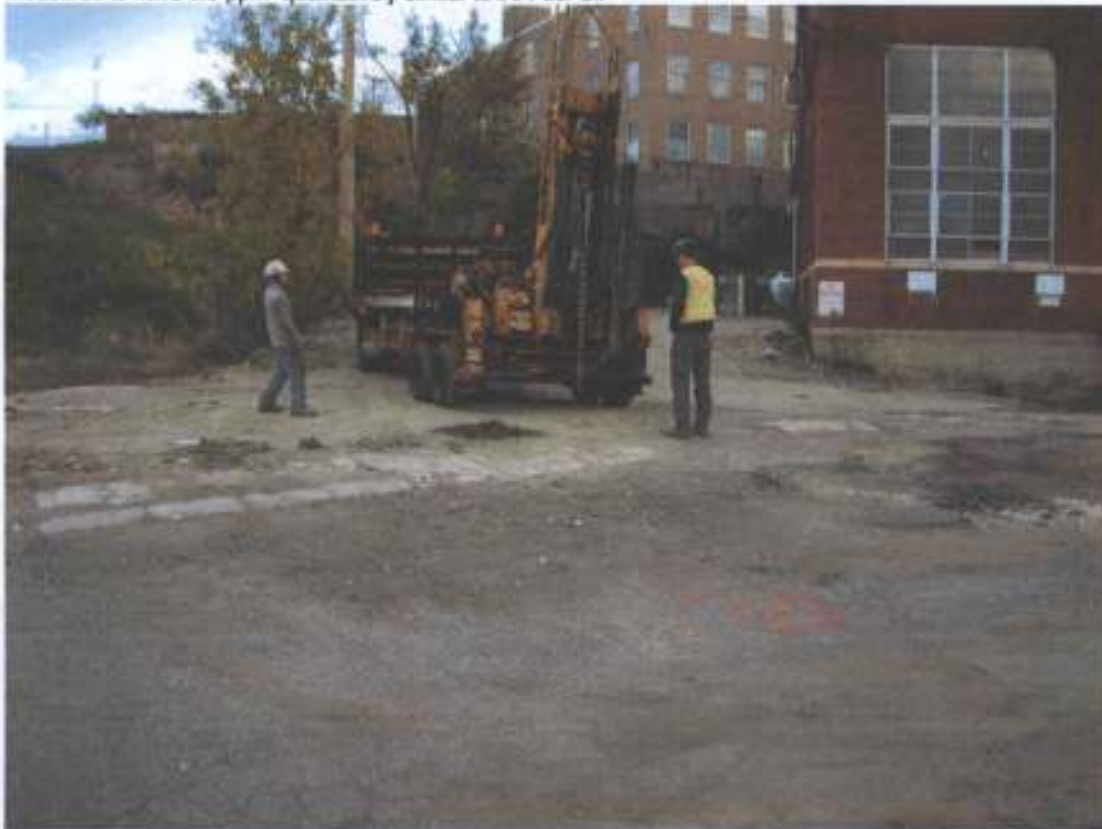
64.

Preparing to drill TB-26 or TB-27 on City of Lewiston property and just west of monitoring well BR-2. TB-26 encountered soil with an oil odor but no oil-saturated soil. TB-25, TB-26 and TB-27 encountered refusal (bedrock) at 11.5' bg, 12.9' bg, and 10' bg respectively. BR-2 drilled on 9/20/11 (located behind the drill rig in this photo) went through the silt-clay layer encountered in the test pits and found #6-oil saturated soil below the clay and atop bedrock. Free-product oil was noted on the bedrock surface at 12.3' bg. BR-2 was drilled into bedrock to 24' bg.
