Incident 2350477
Kings Tire Recycler Facility Fire
ERT Photo Log (pm) 08/18/12

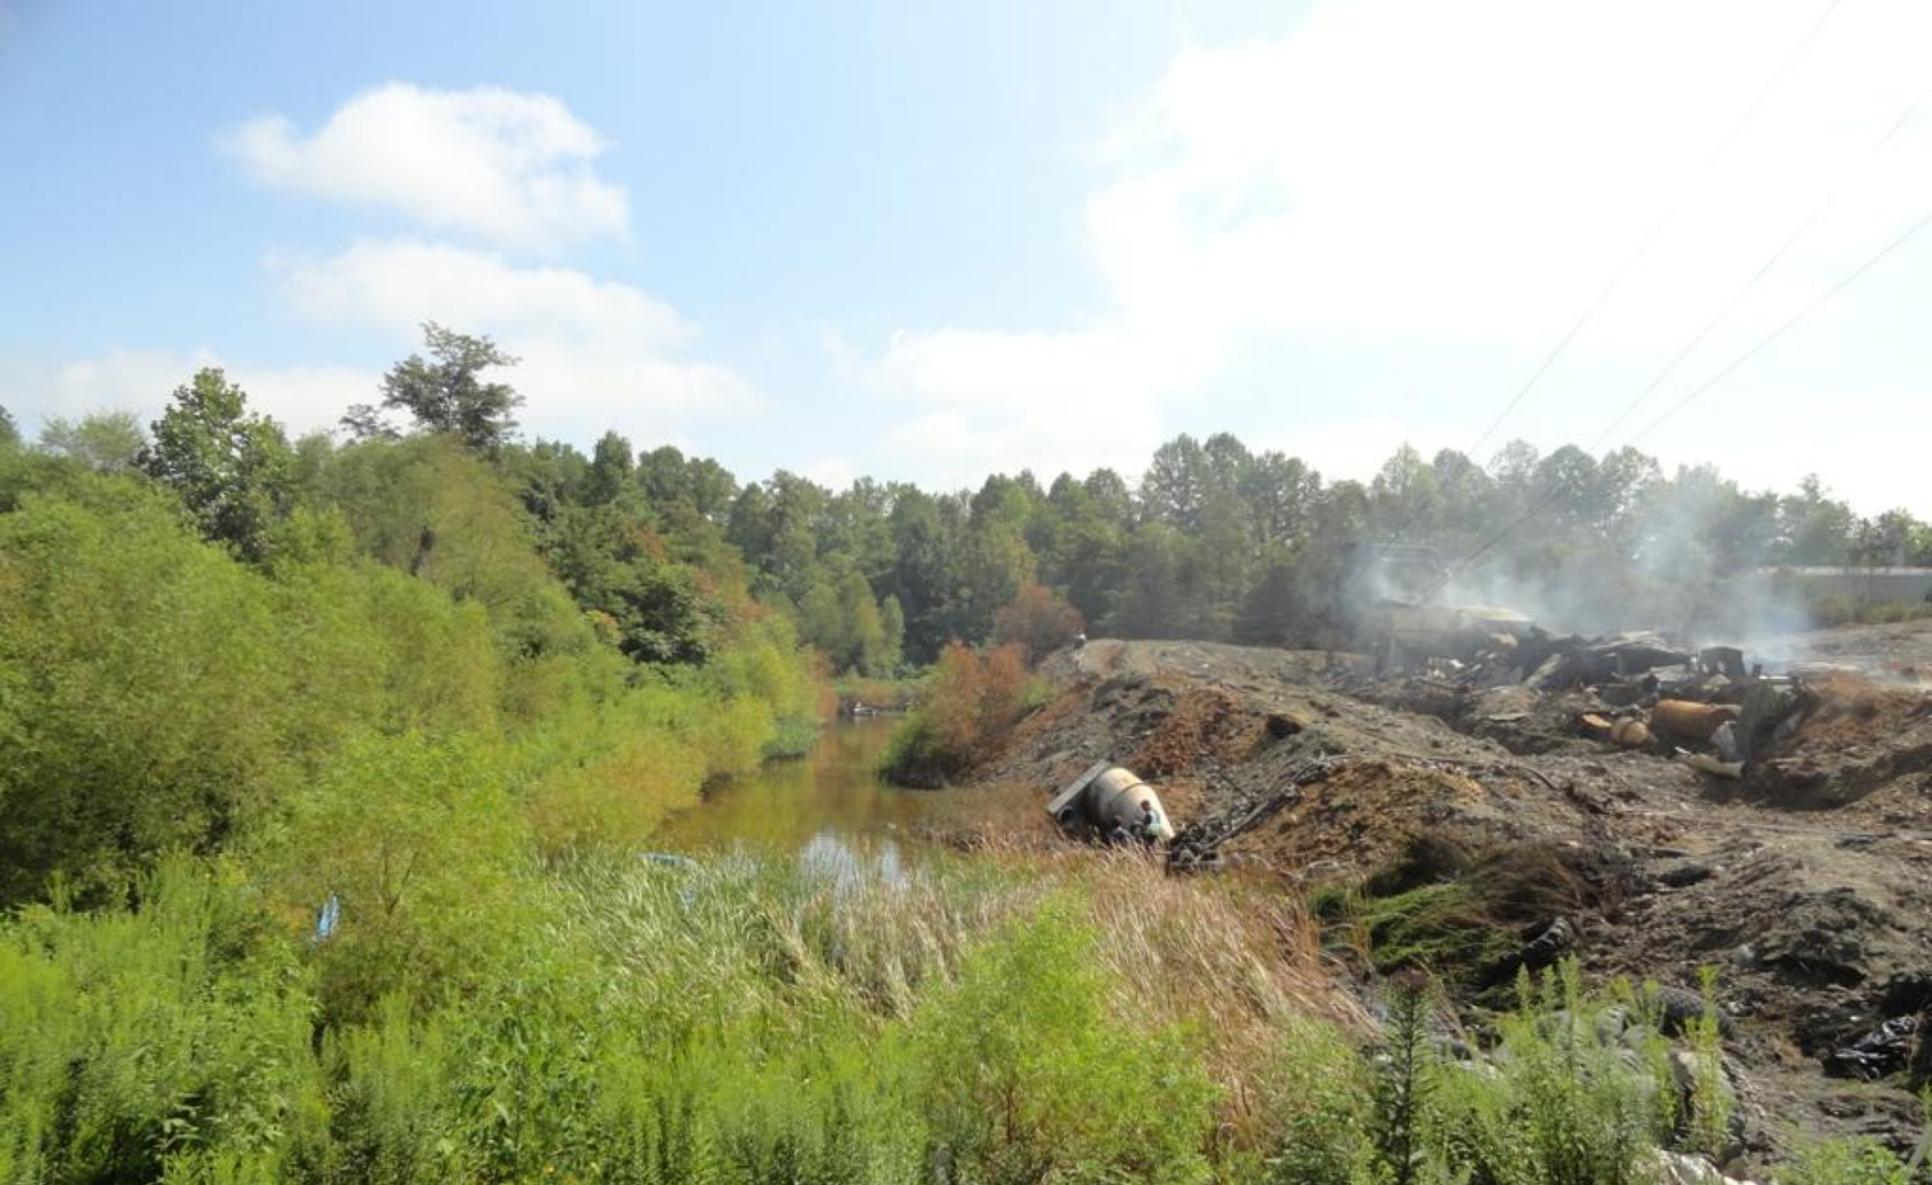
Photo of the retention pond from atop a windrow of chipped tires (facing east). The oil is daylighting along the southern wall of the pond with the majority of oil currently appearing at the southeastern corner of the pond.

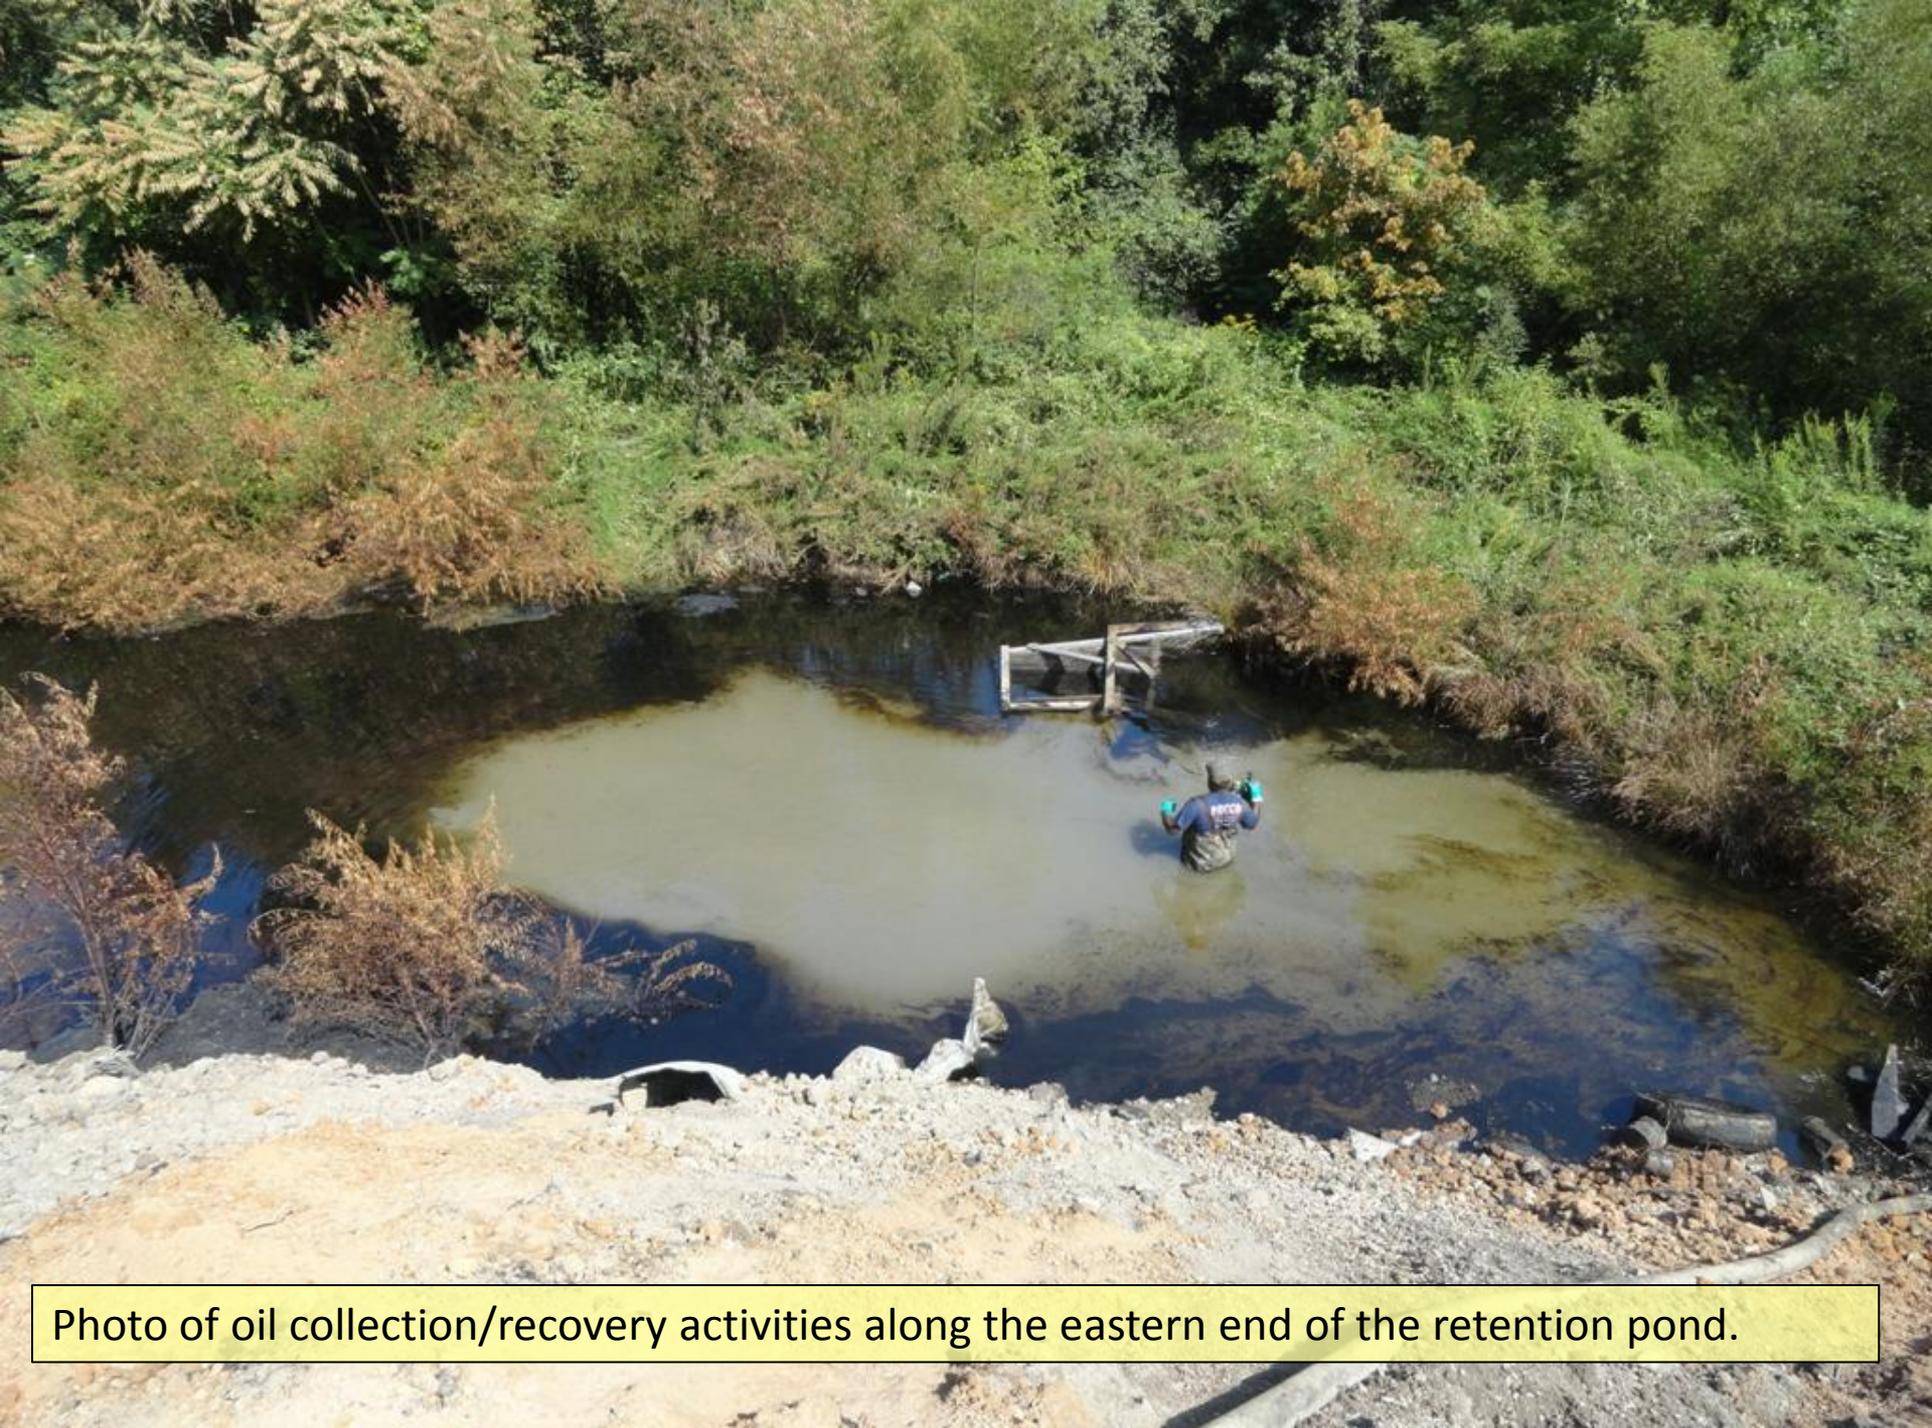
Photo of oil collection/recovery activities along the eastern end of the retention pond.

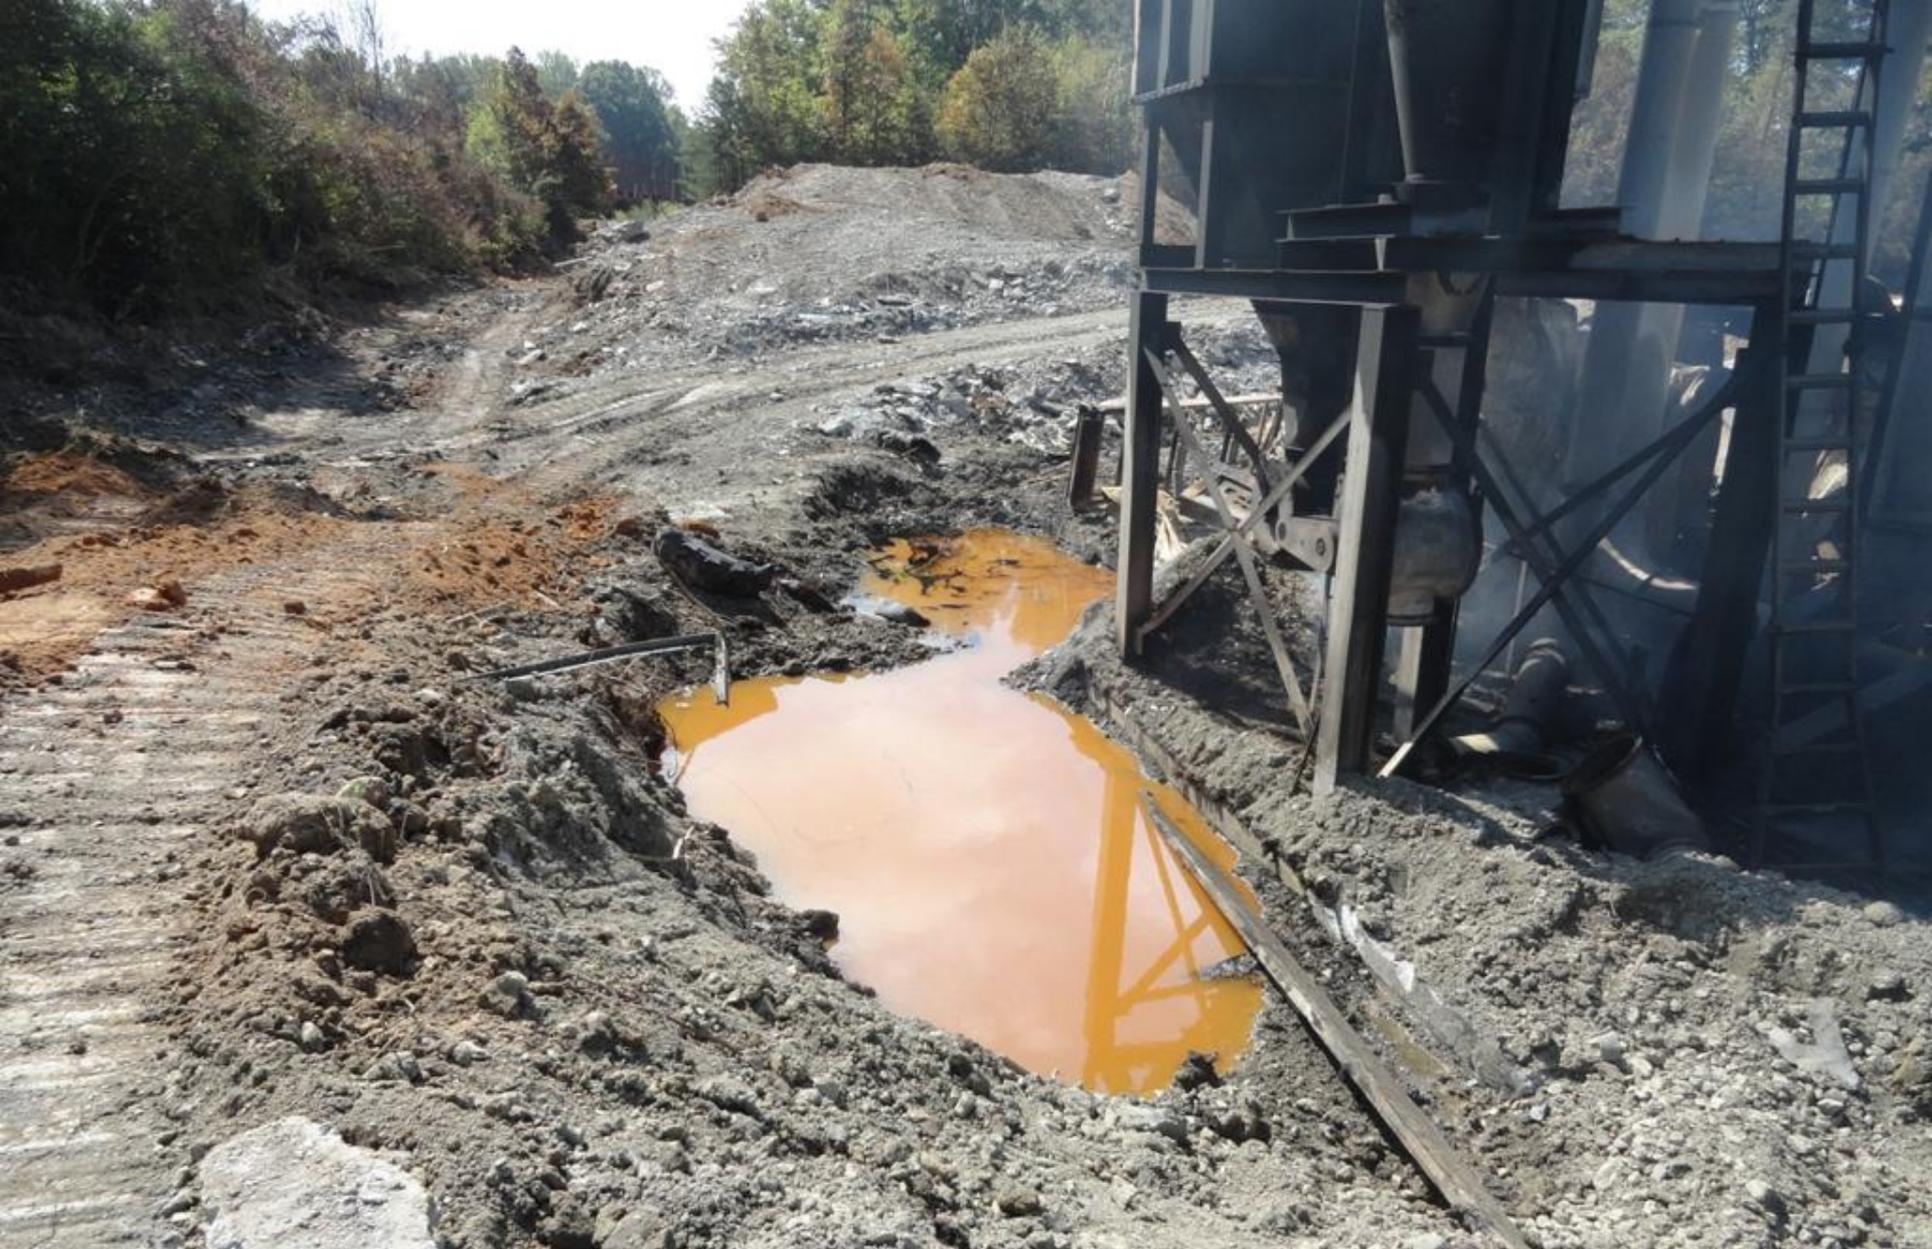
Collection Point 2 at the rear of the facility structure. Water is orange in color with oil weeping from the southern wall of the pit.

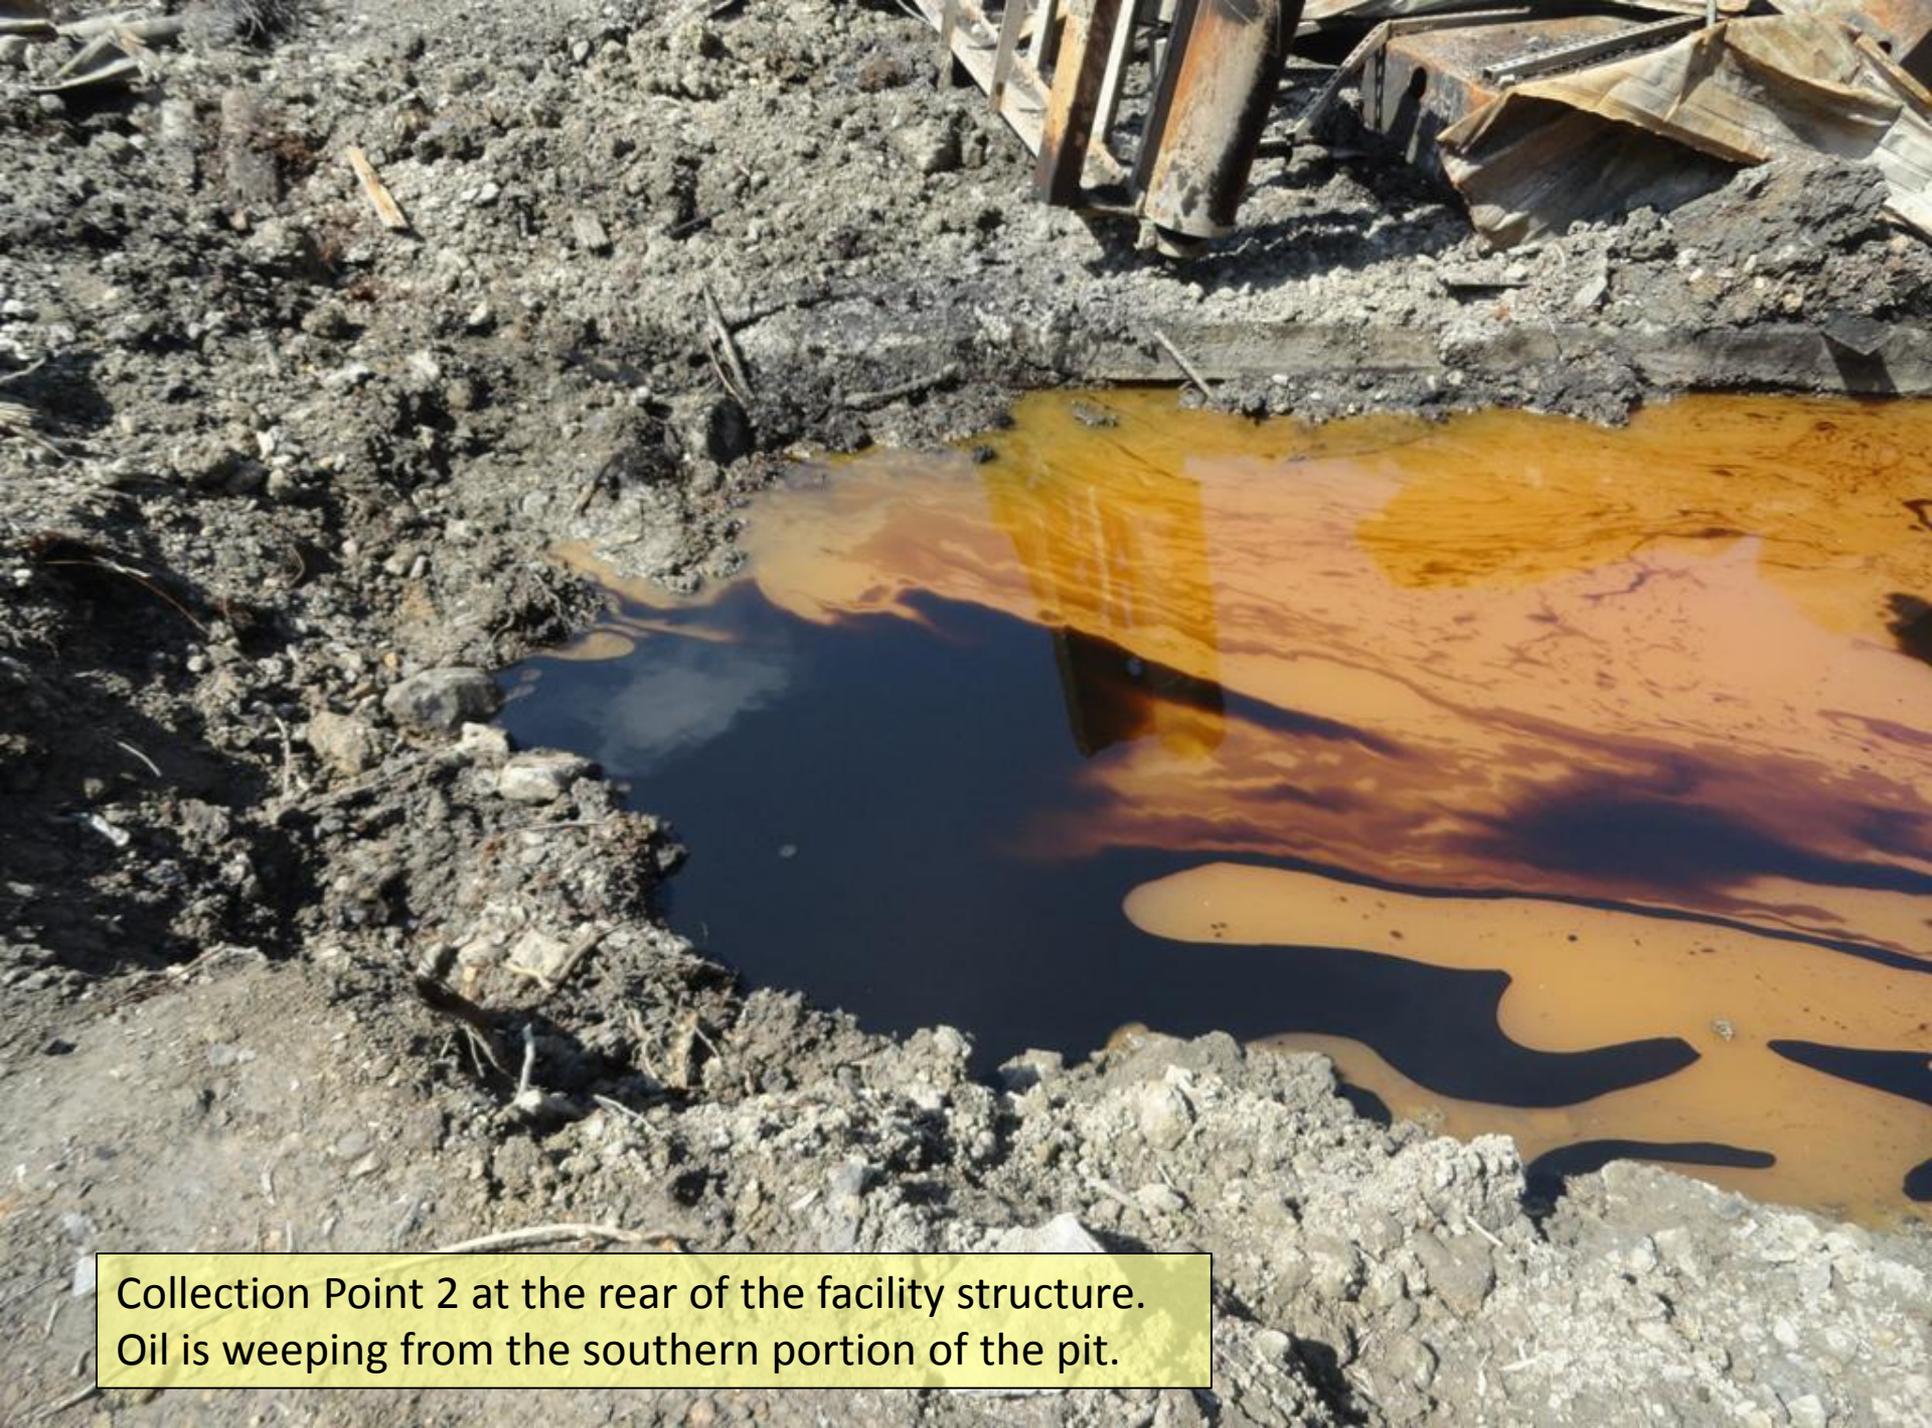
Collection Point 2 at the rear of the facility structure.
Oil is weeping from the southern portion of the pit.

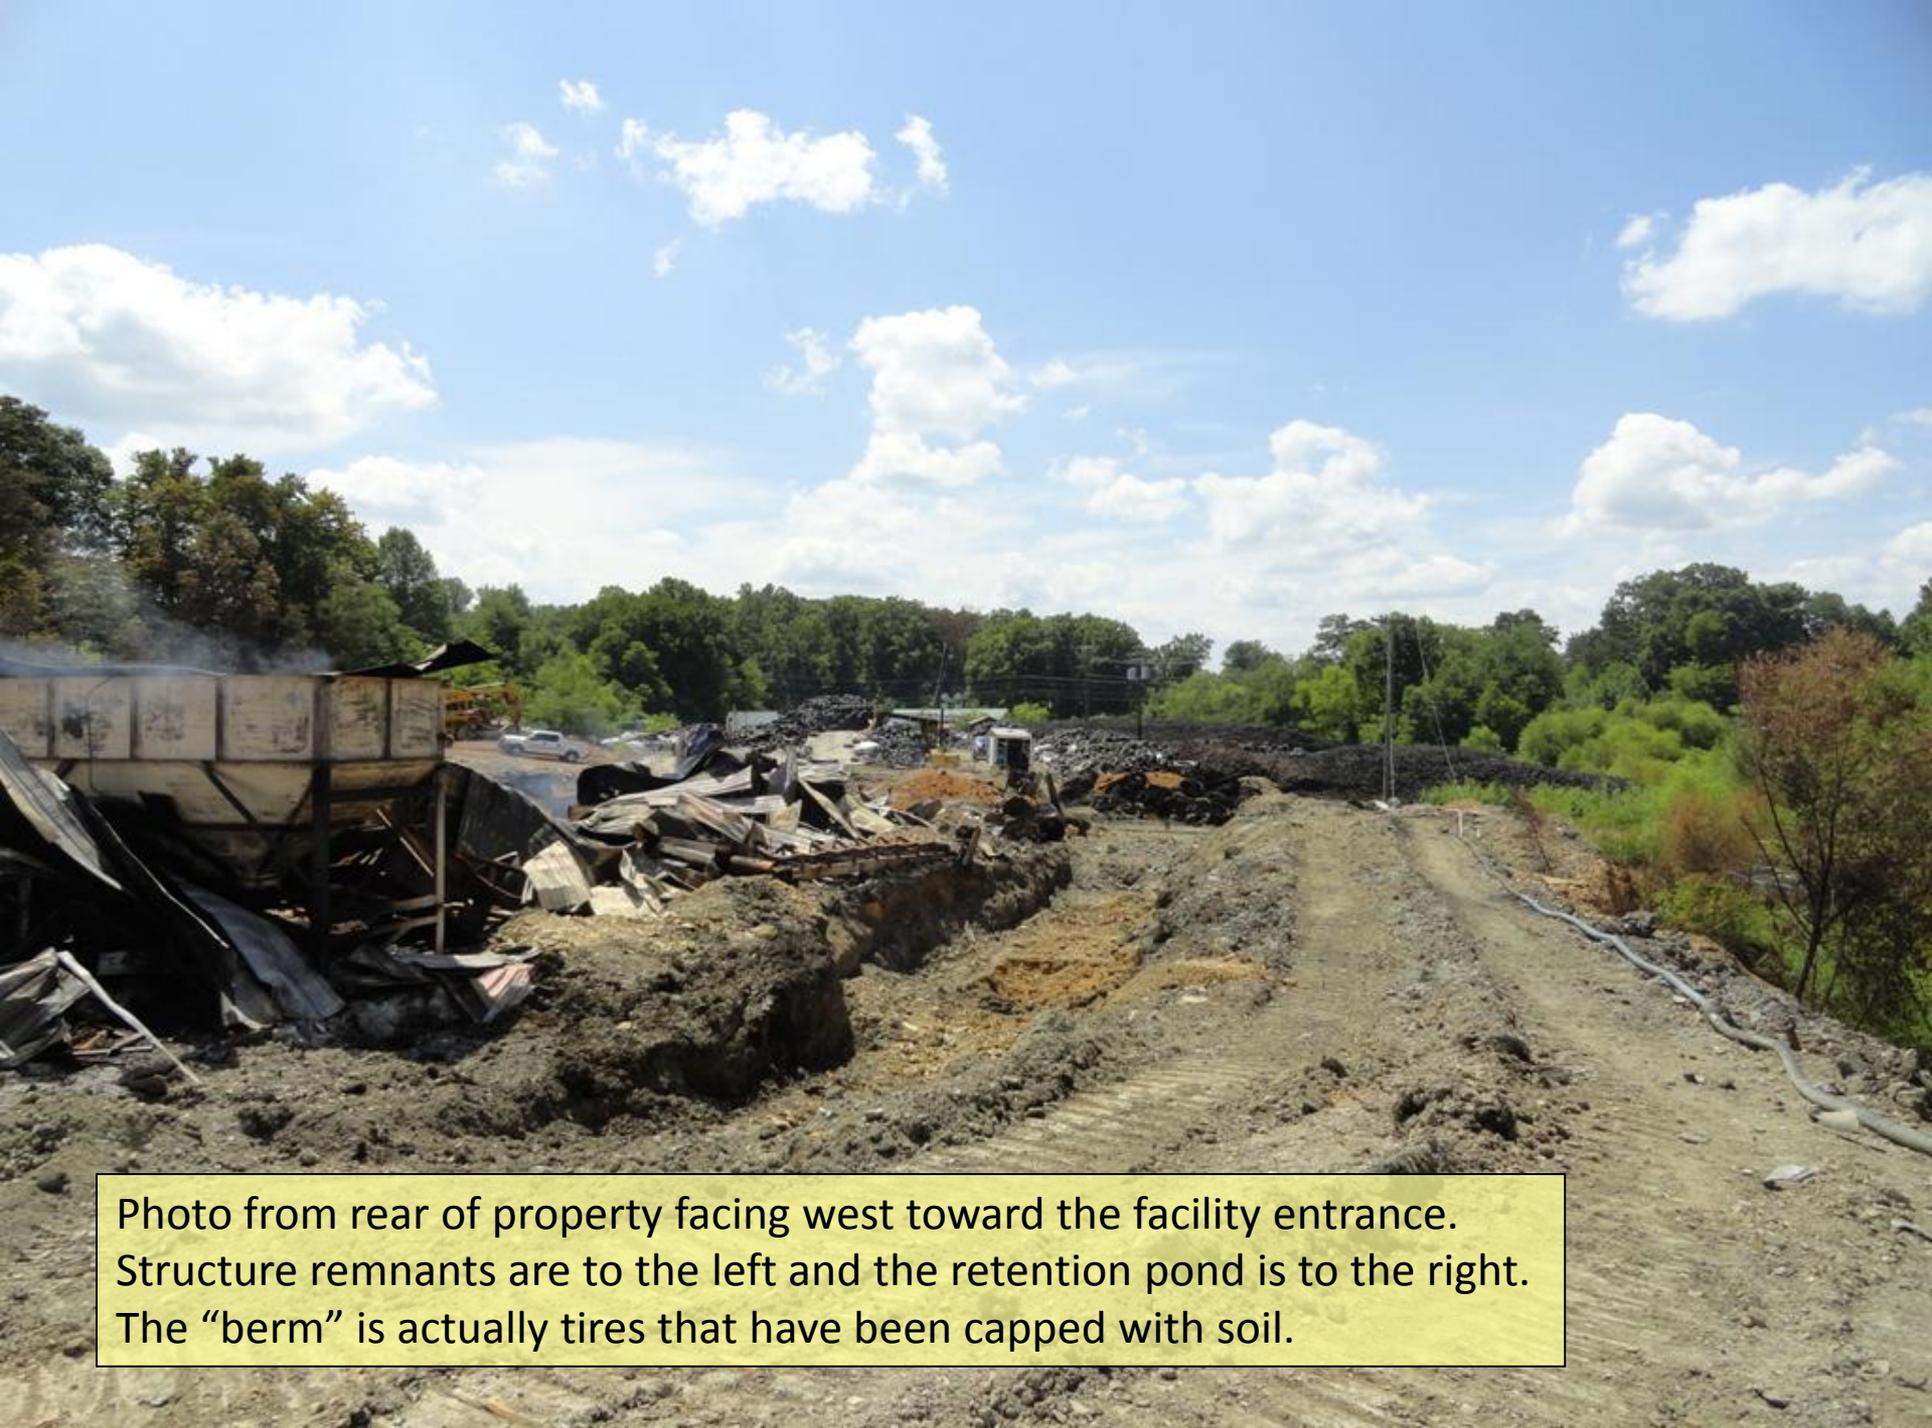
Photo from rear of property facing west toward the facility entrance. Structure remnants are to the left and the retention pond is to the right. The “berm” is actually tires that have been capped with soil.

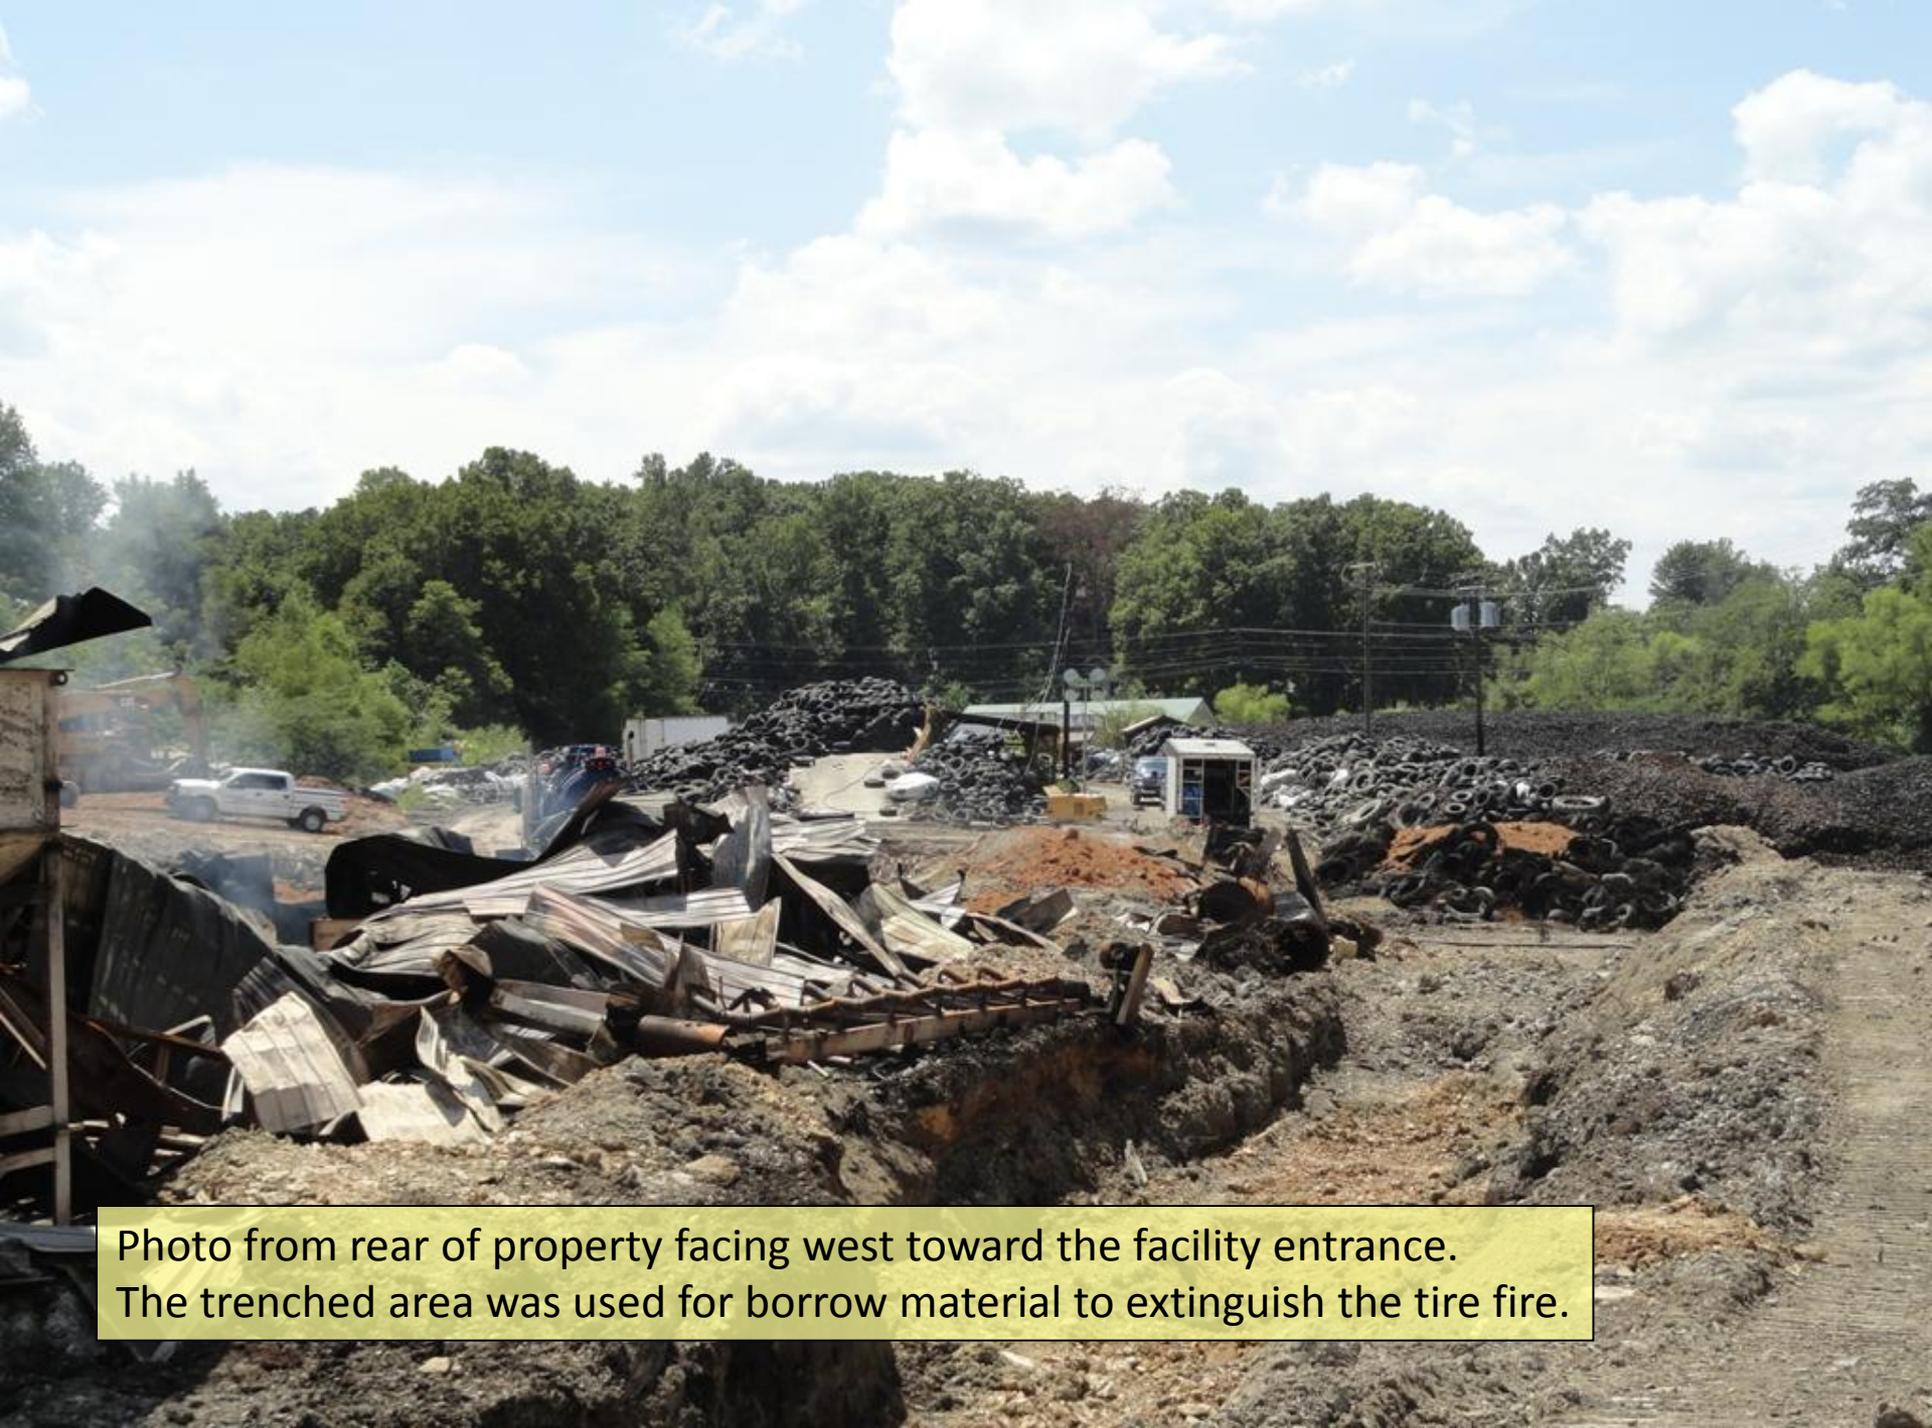
Photo from rear of property facing west toward the facility entrance.
The trenched area was used for borrow material to extinguish the tire fire.

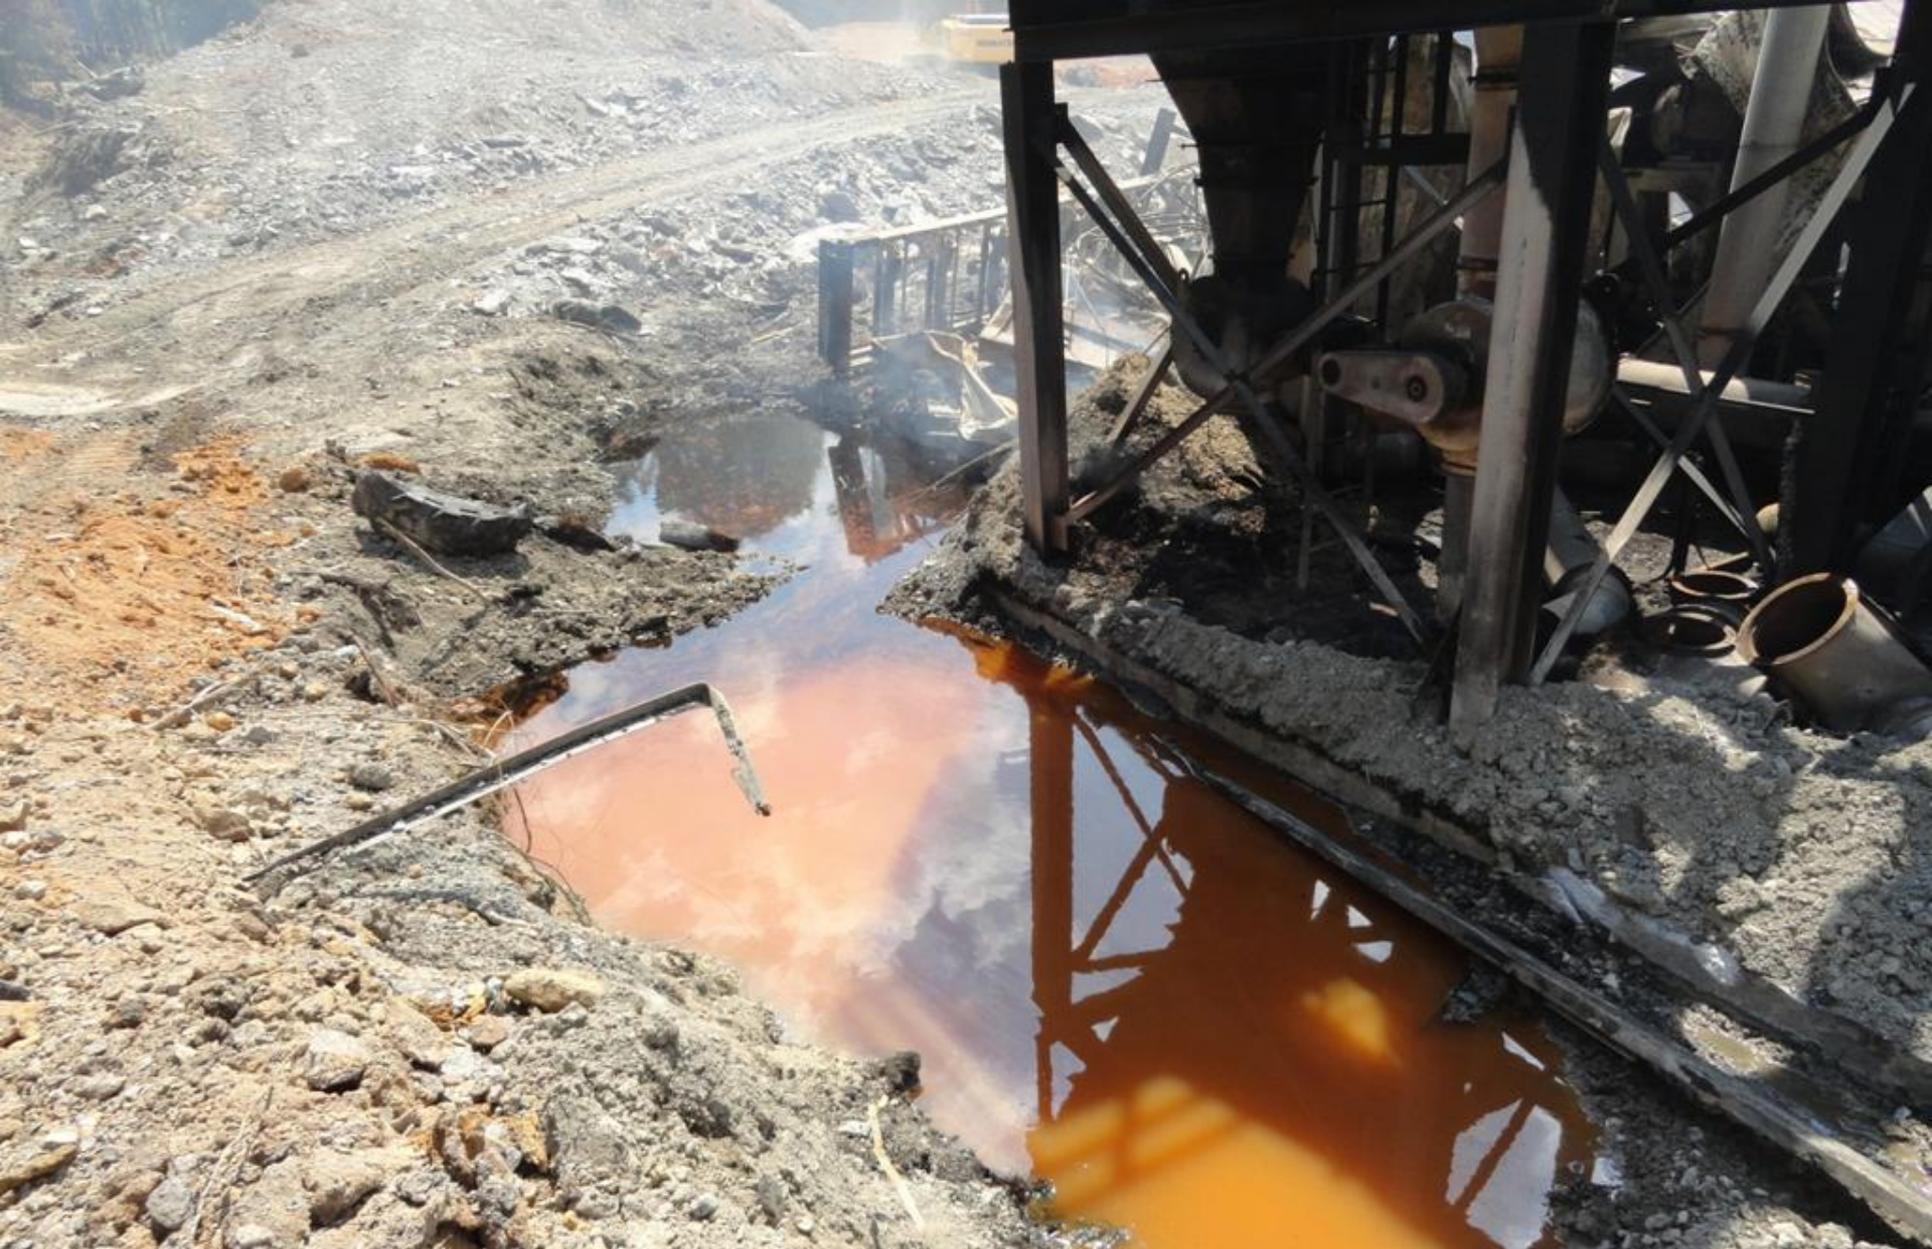
Collection Point 2 at the rear of the facility structure. Water is orange in color with oil weeping from the southern wall of the pit.

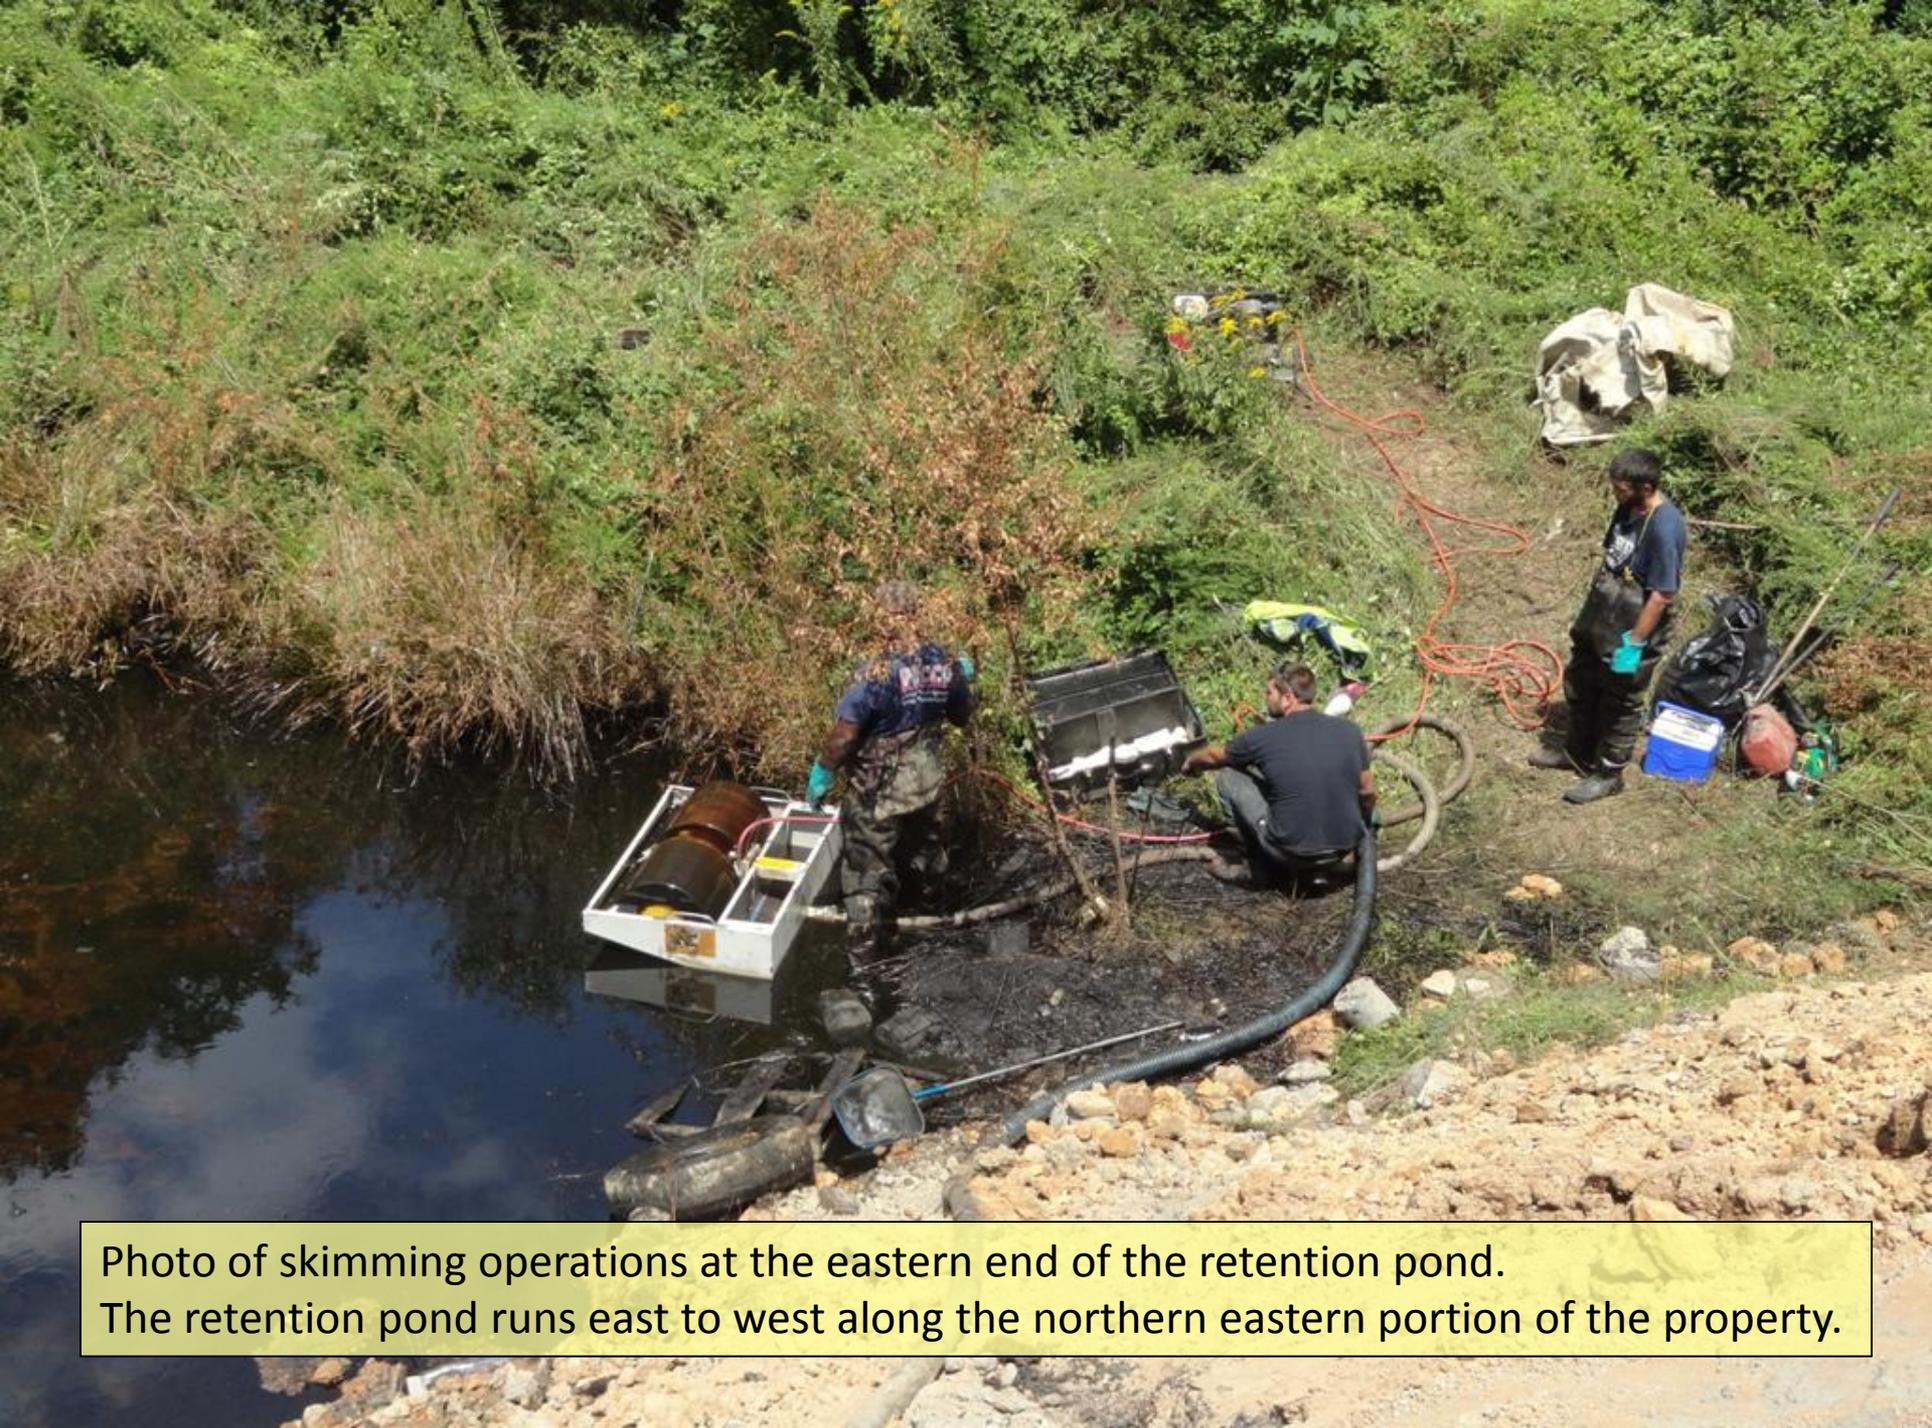
Photo of skimming operations at the eastern end of the retention pond. The retention pond runs east to west along the northern eastern portion of the property.
