August 11, 2008

Subject: Powerhouse And Water Treatment Structures Asbestos Survey Report
Former Liberty Fibers Site; Lowland, Tennessee
A.C.T. Services Proposal No. 08.17.001

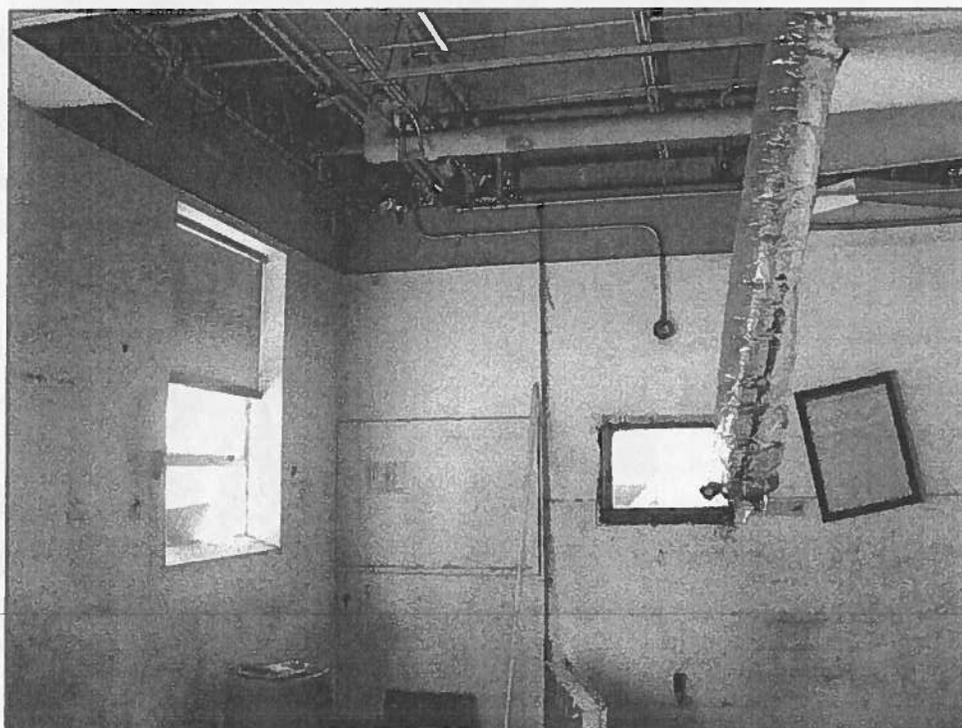
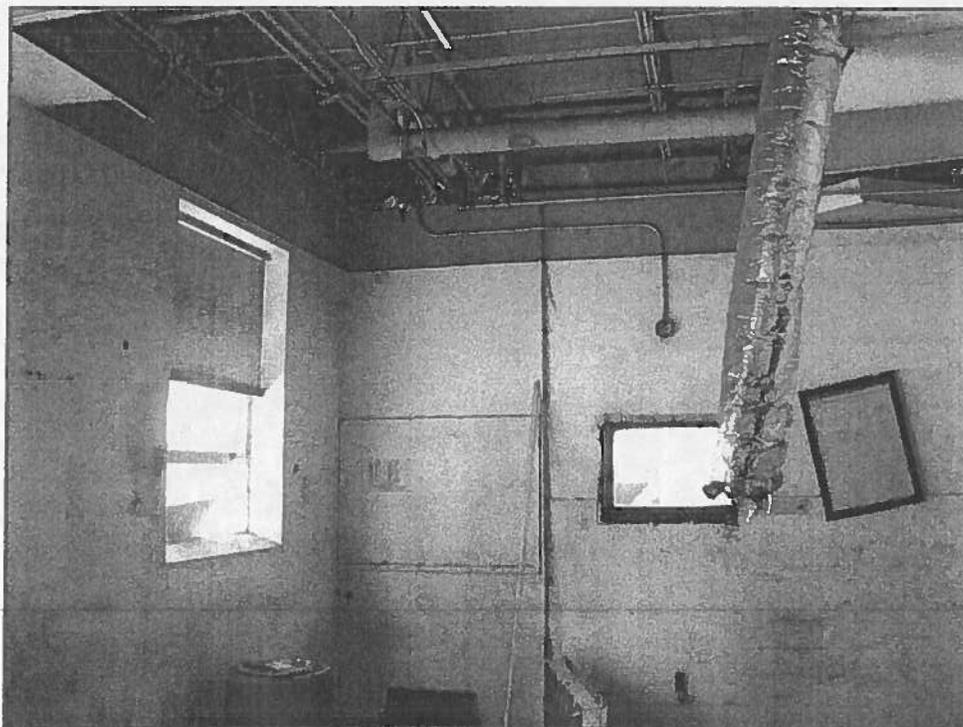
Water Treatment Locker Room – Hot Water ACM Pipe Insulation & Drywall Construction

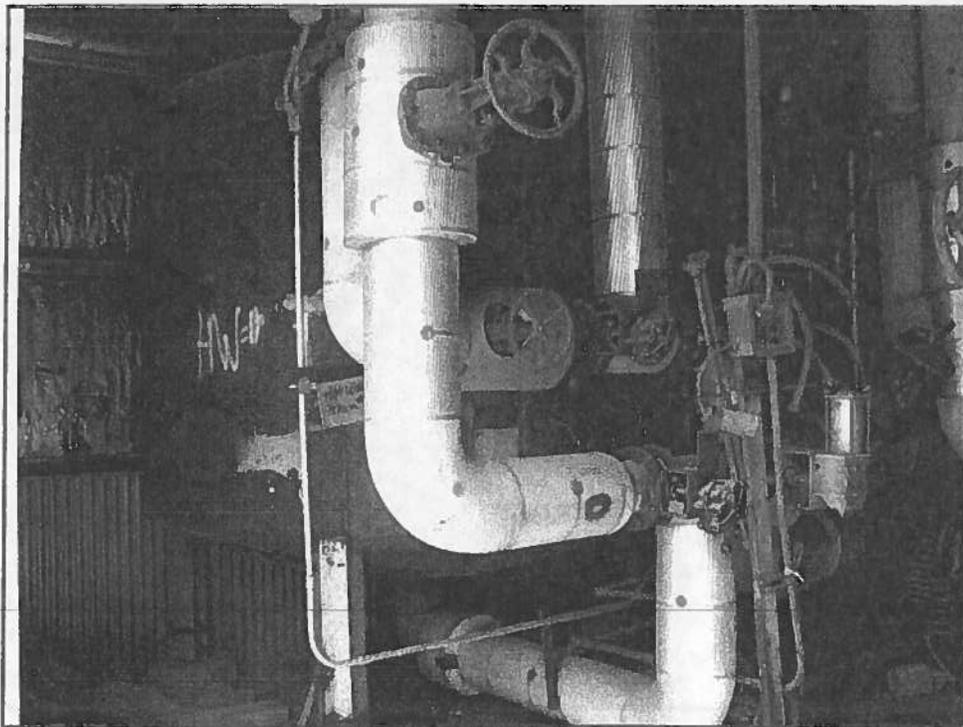
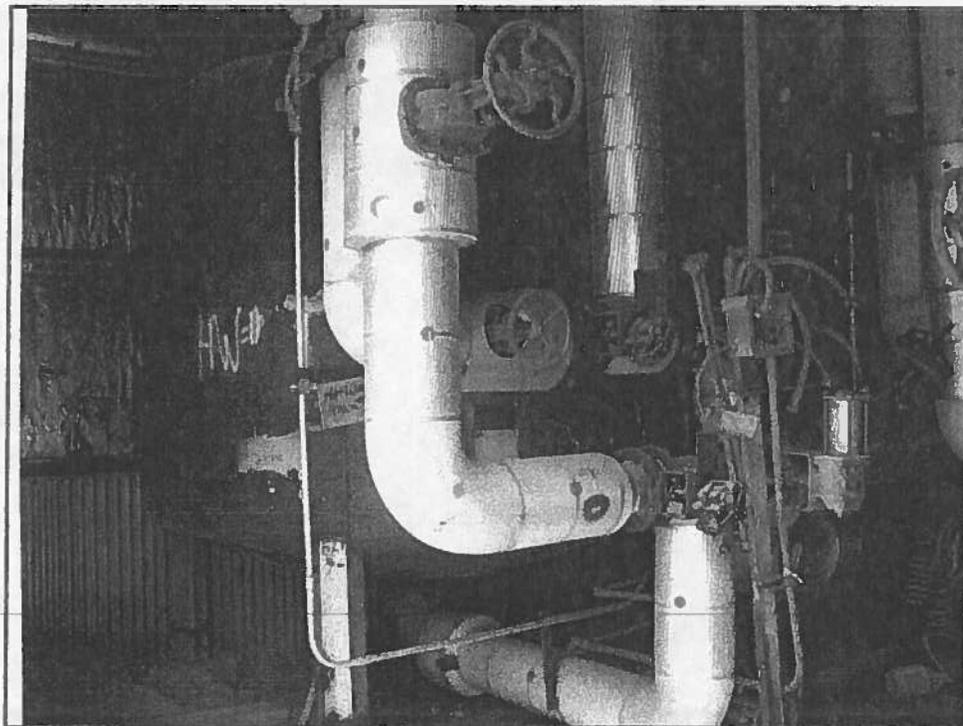
Water Treatment Plant – TSI ACM Hot Water Tank & Pipe Insulation

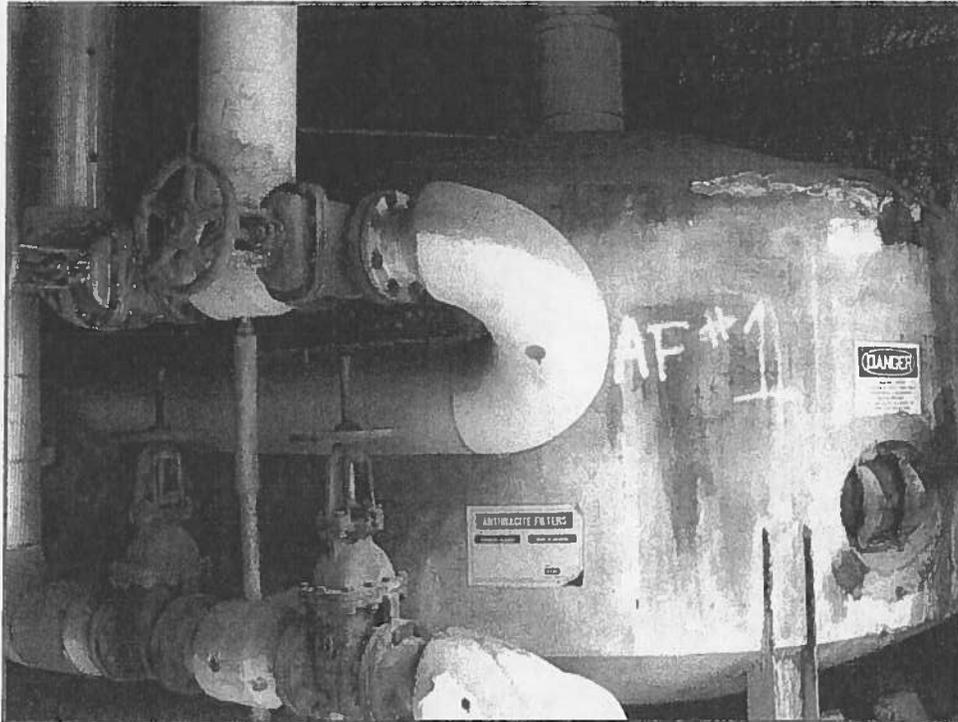
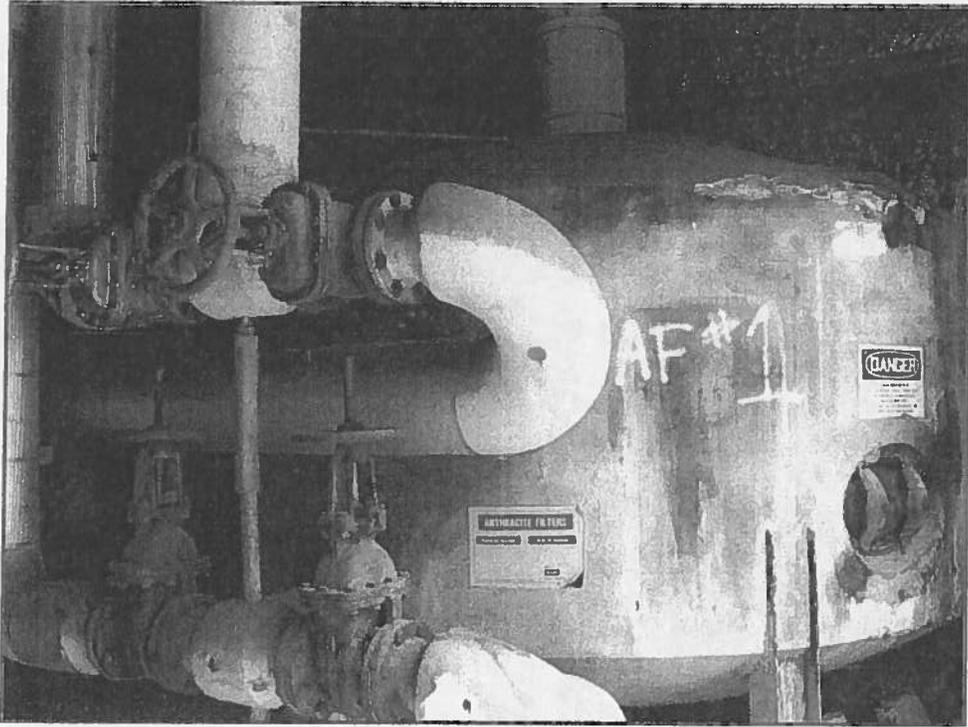
Water Treatment Plant – TSI ACM Anthracite Filter Tank & Pipe Insulation

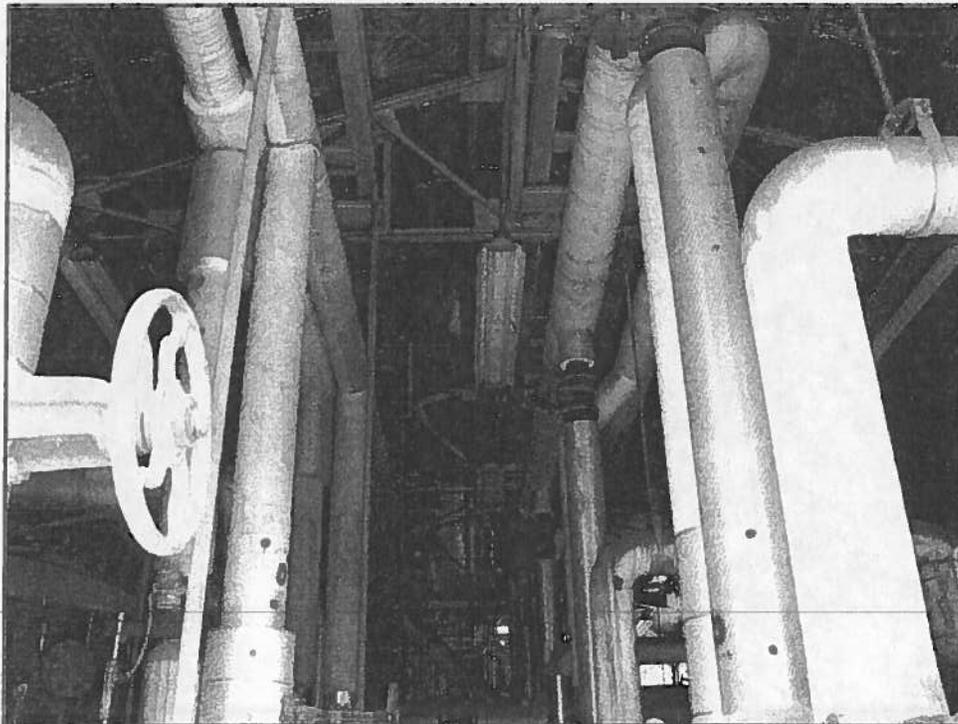
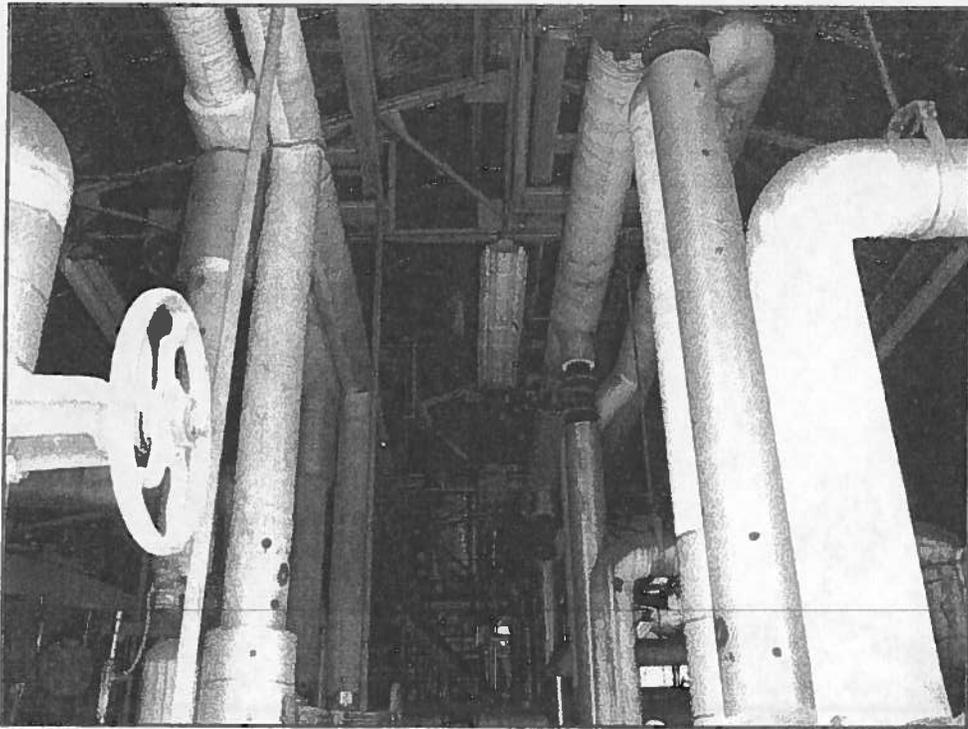
Water Treatment Plant – ACM TSI Pipe Rack Between Tanks

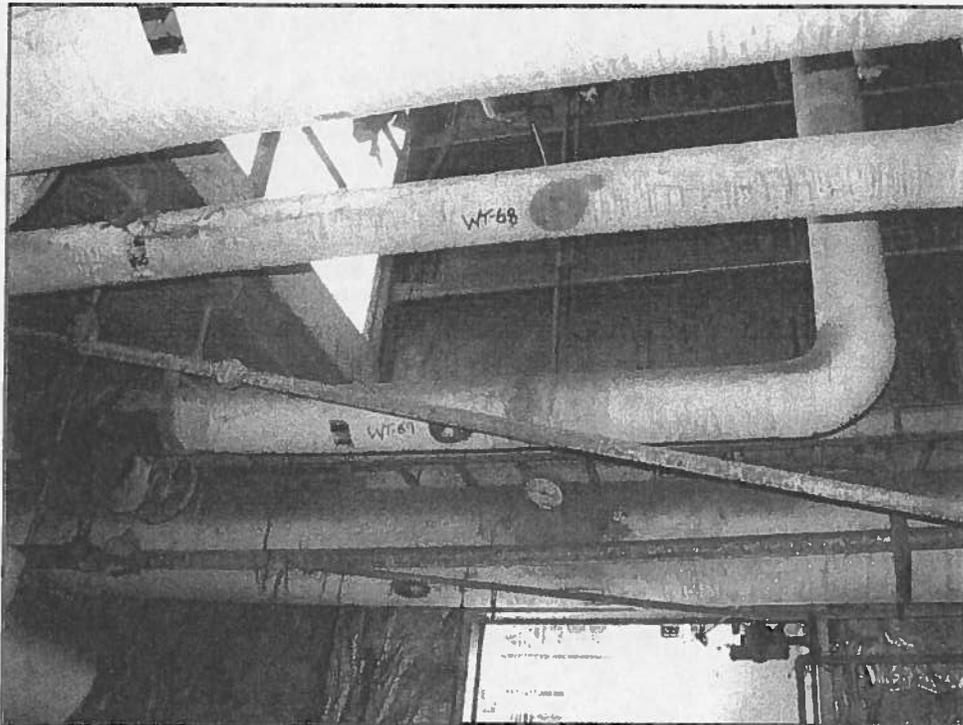
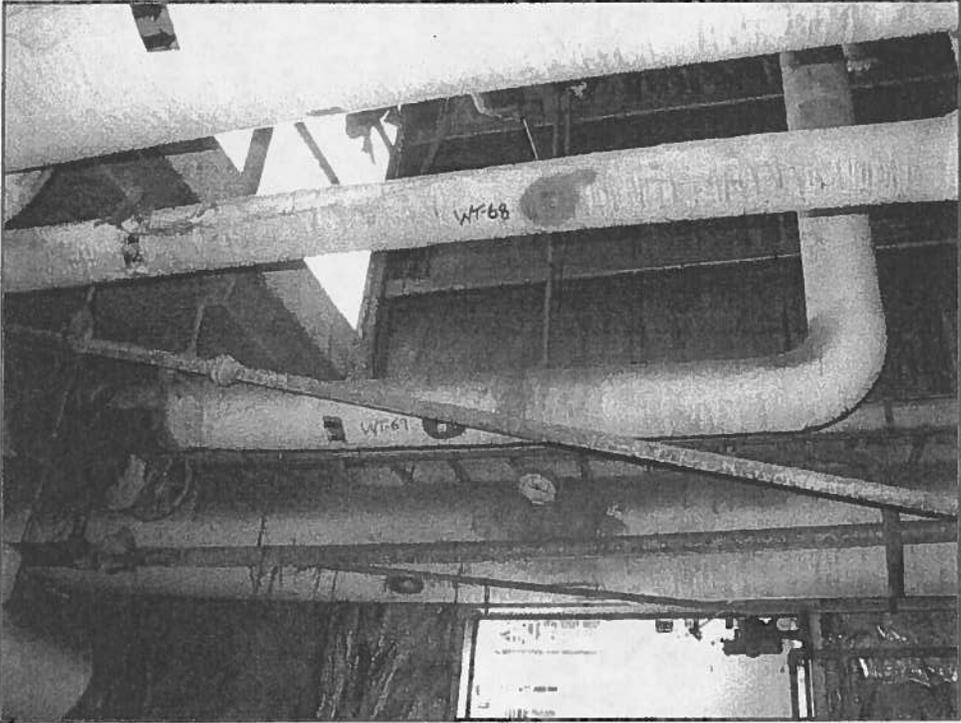
Water Treatment Plant – ACM TSI East End Pipe Rack

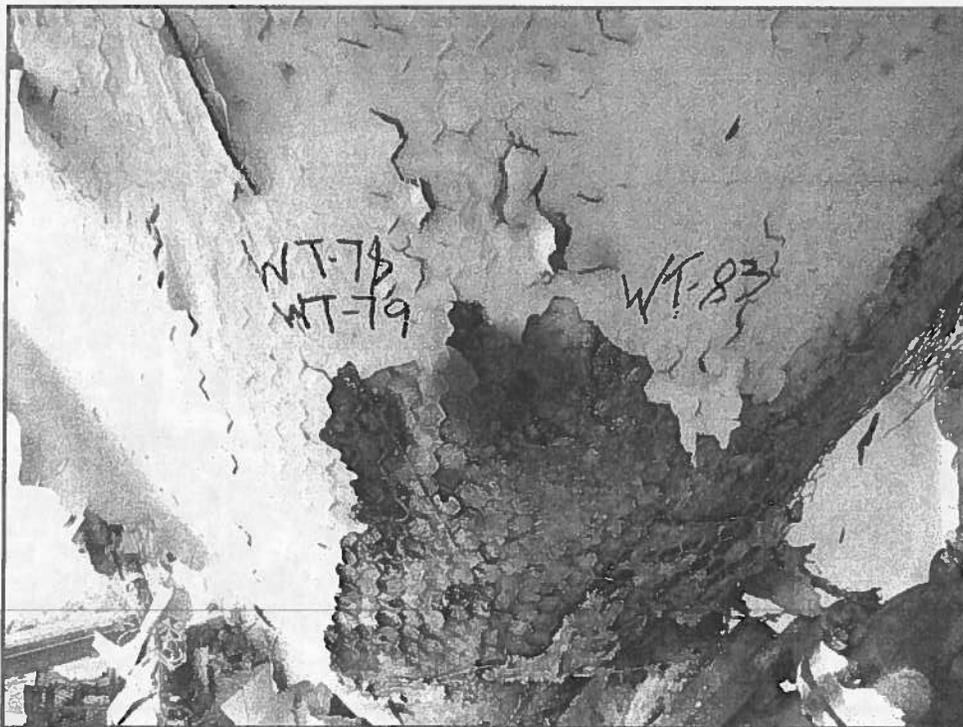
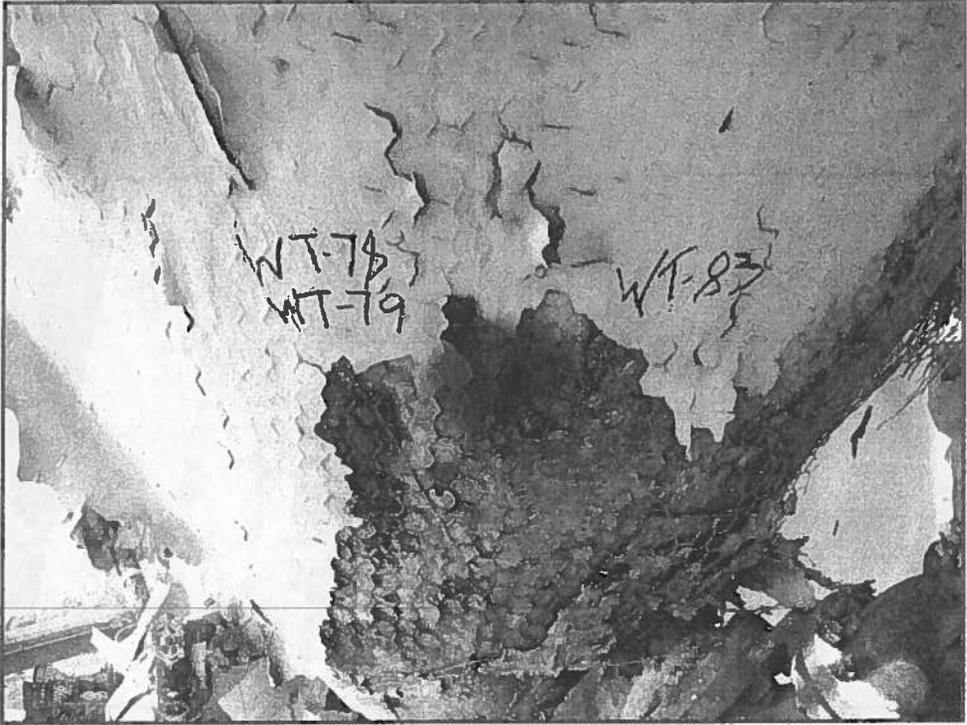
Water Treatment Plant – Exterior ACM Hot Water Storage Tank TSI

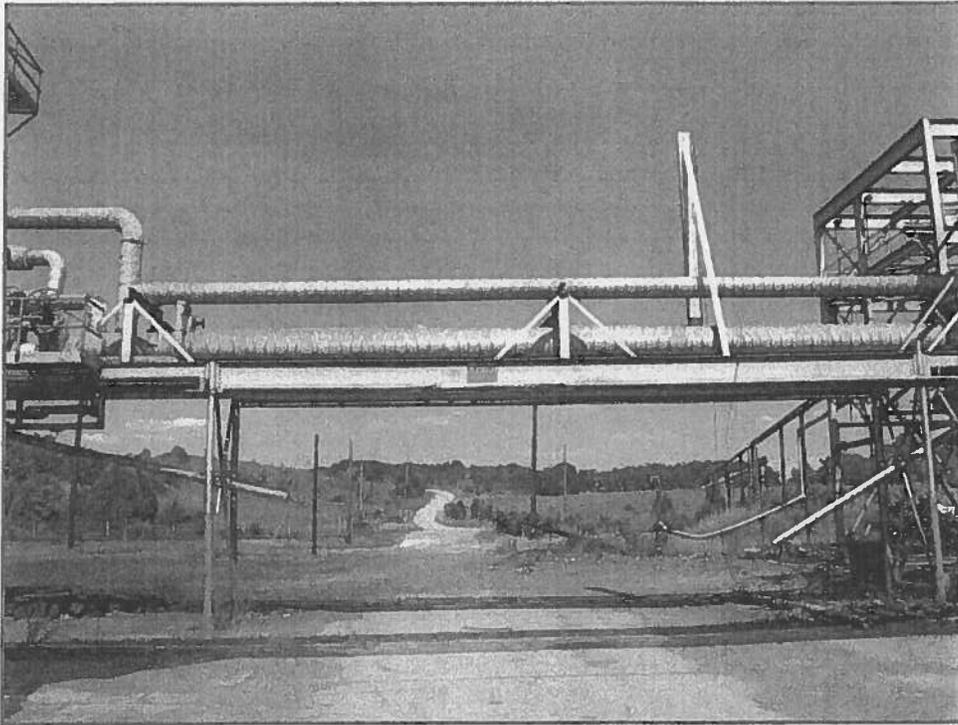
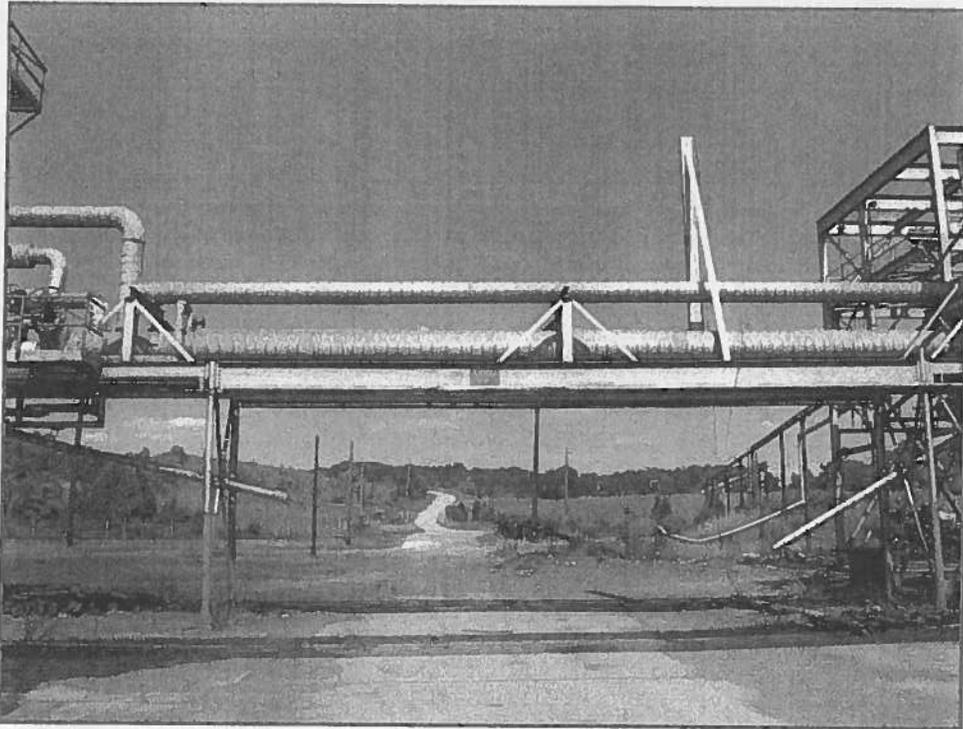
Power House Pipe Rack – ACM TSI Steam & Hot Water Pipe

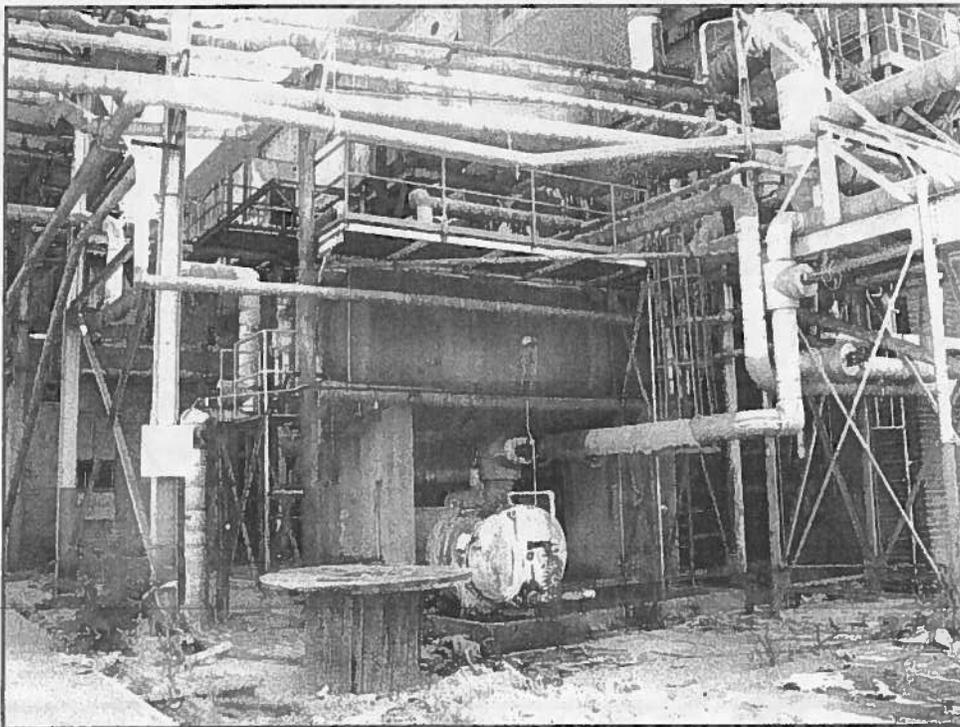
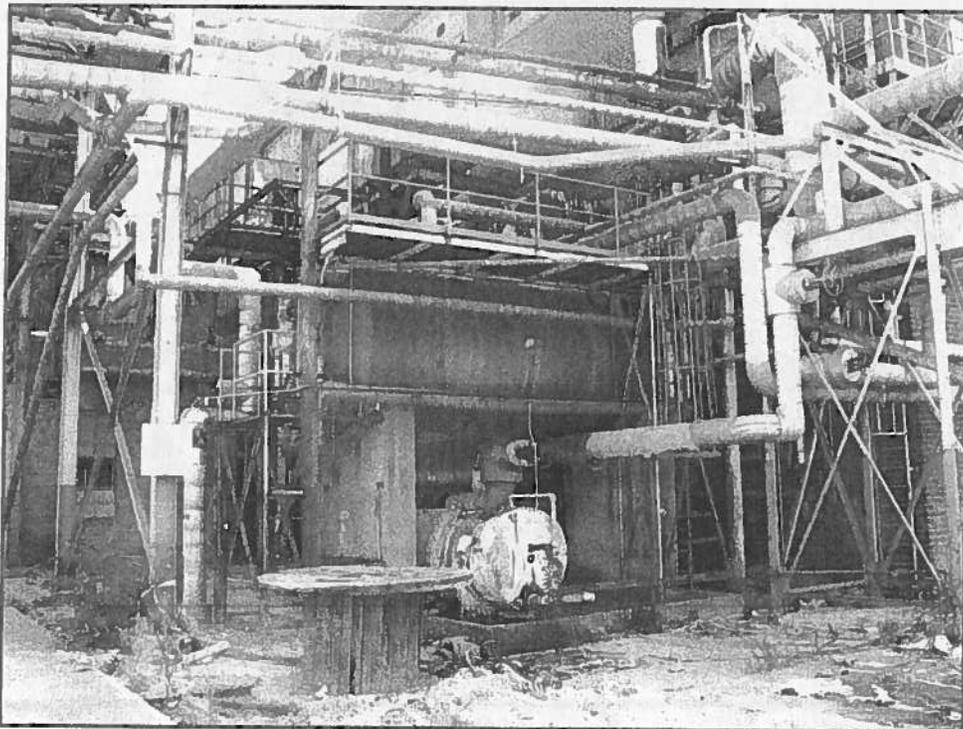
Precipitator Area – ACM TSI Hot Well Tank No. 1 & Associated Pipe In Racks

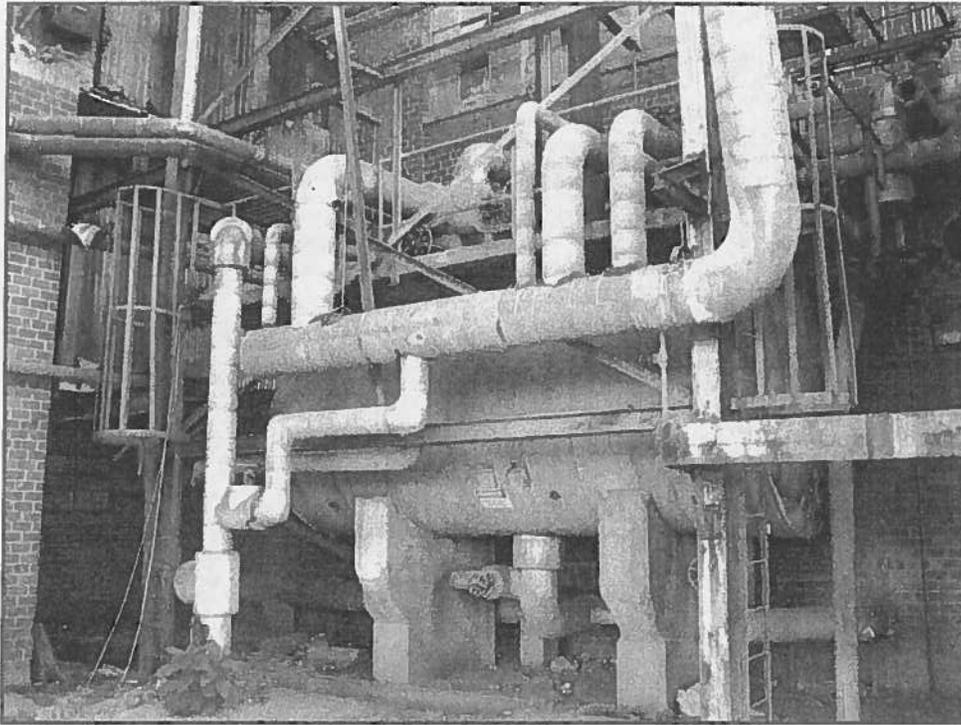
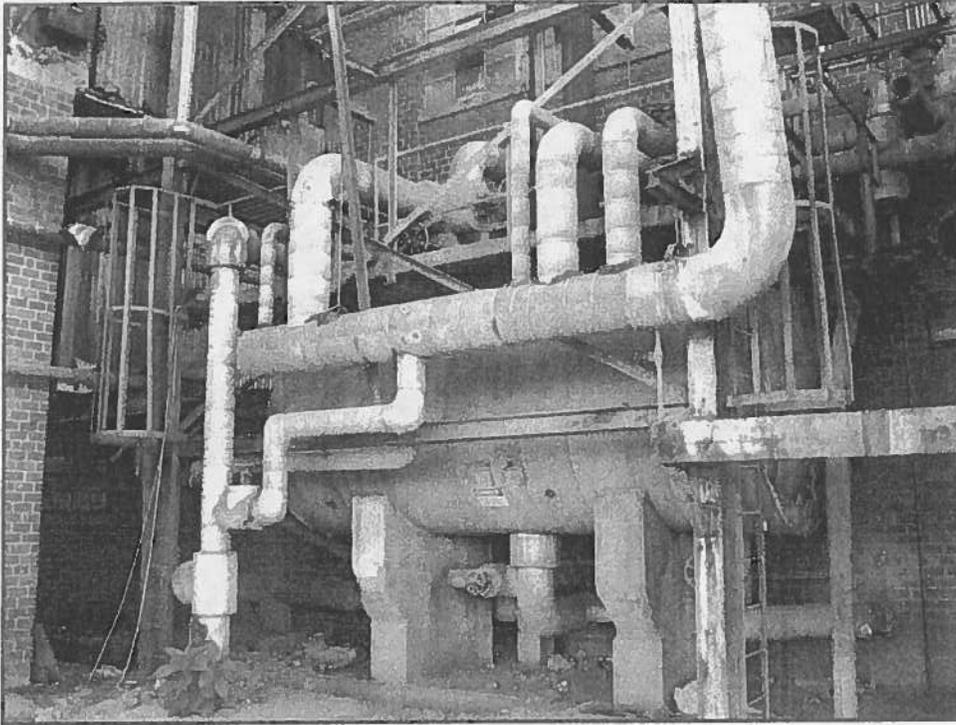
Precipitator Area – ACM TSI Hot Well Tank No. 2 & Associated Pipe In Racks

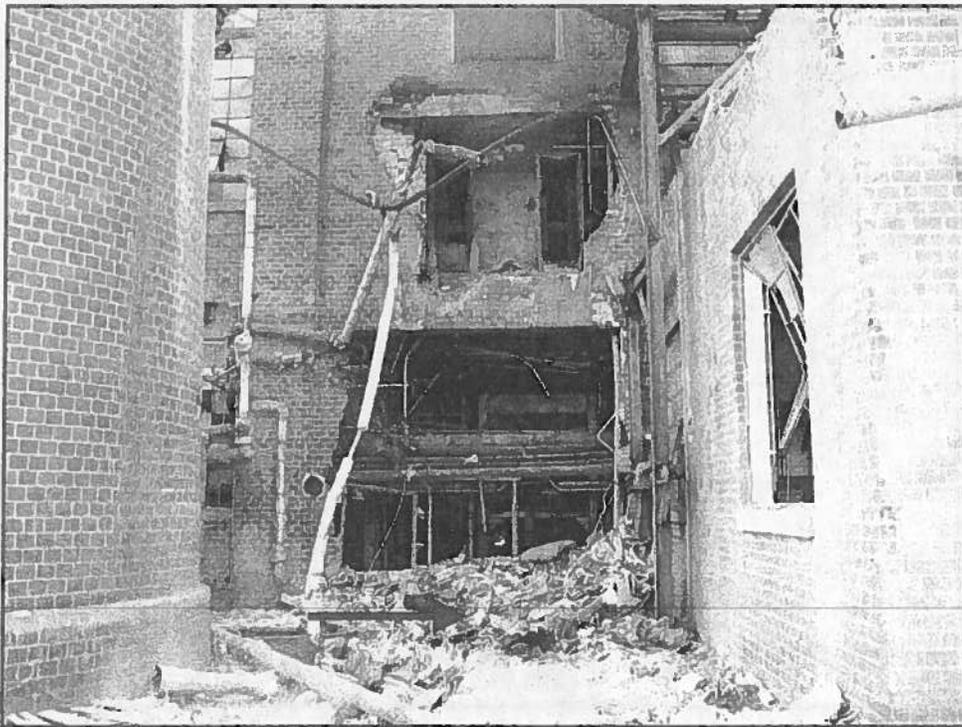
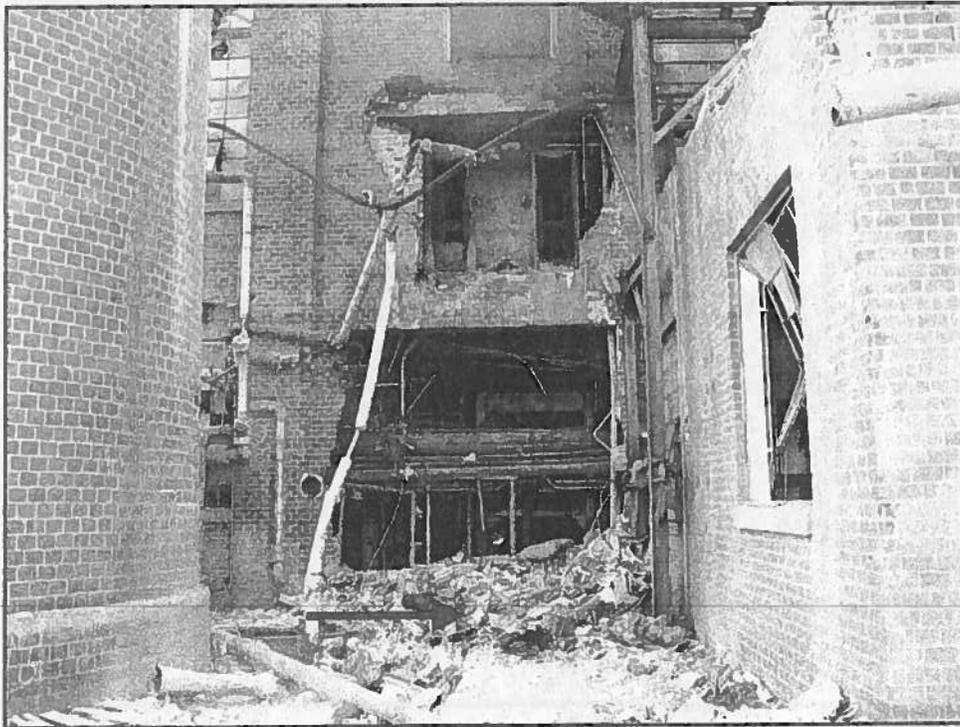
Boiler Room Exterior – TSI Debris and General Demolition Rubble

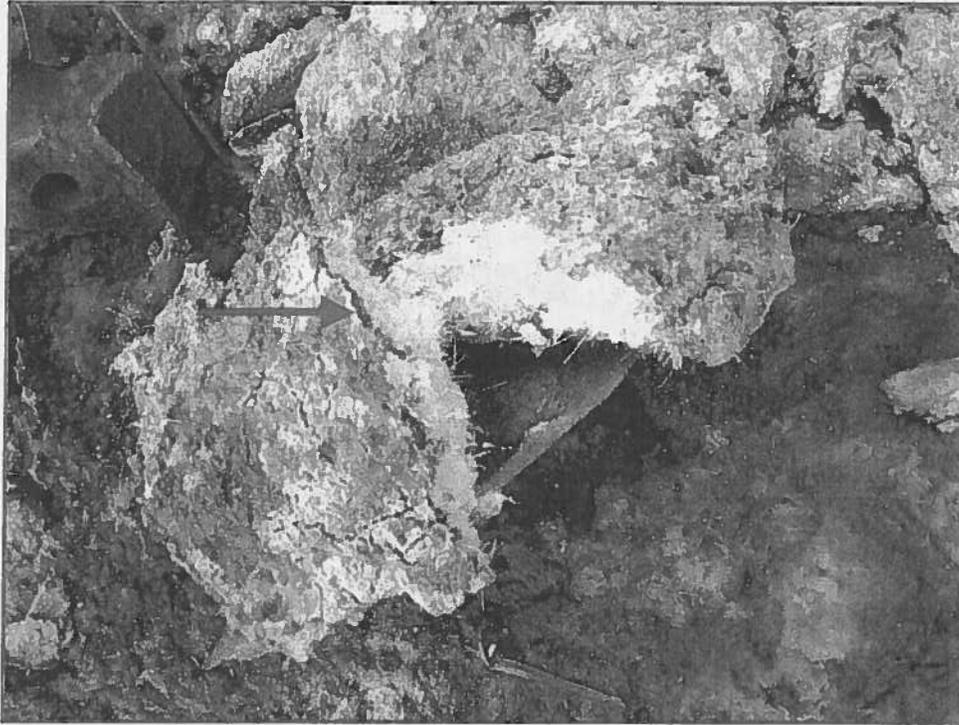
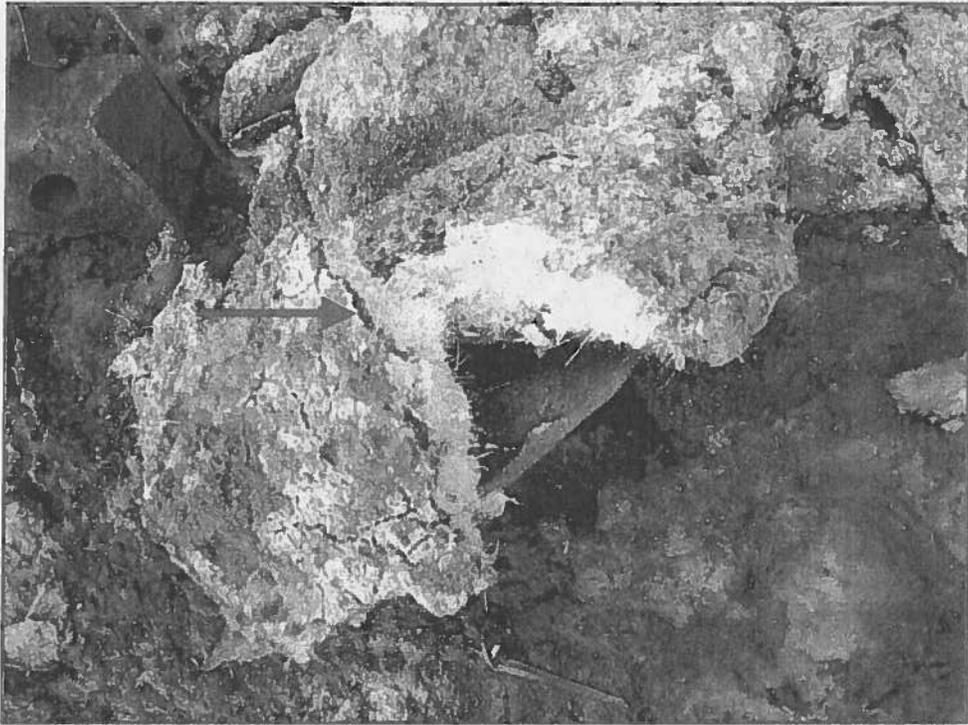
Boiler Room Exterior – ACM TSI Debris Mixed In Demolition Rubble

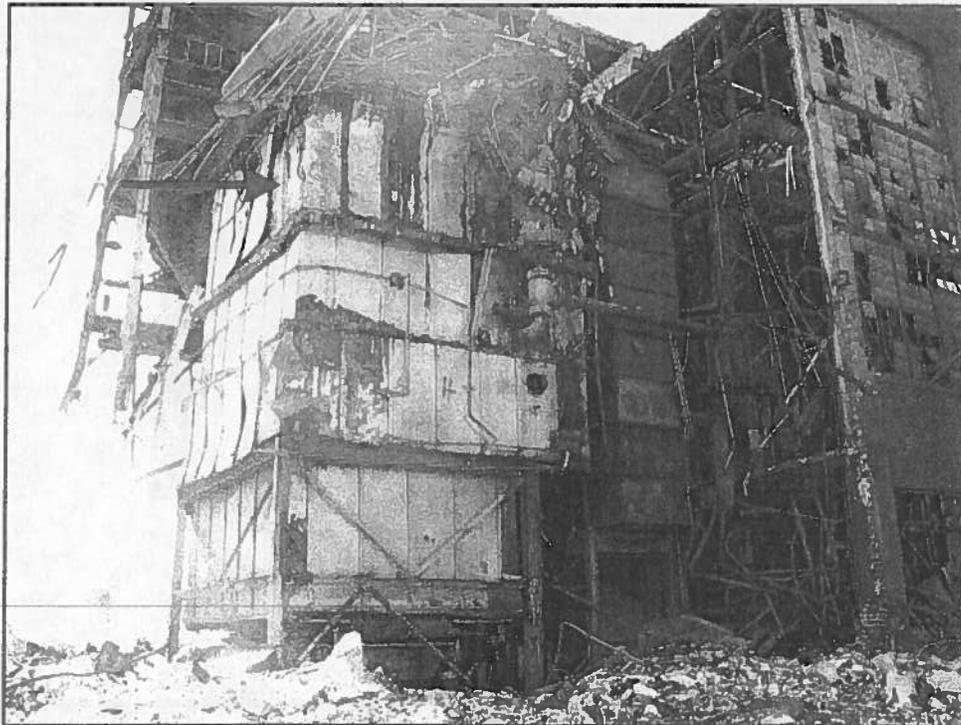
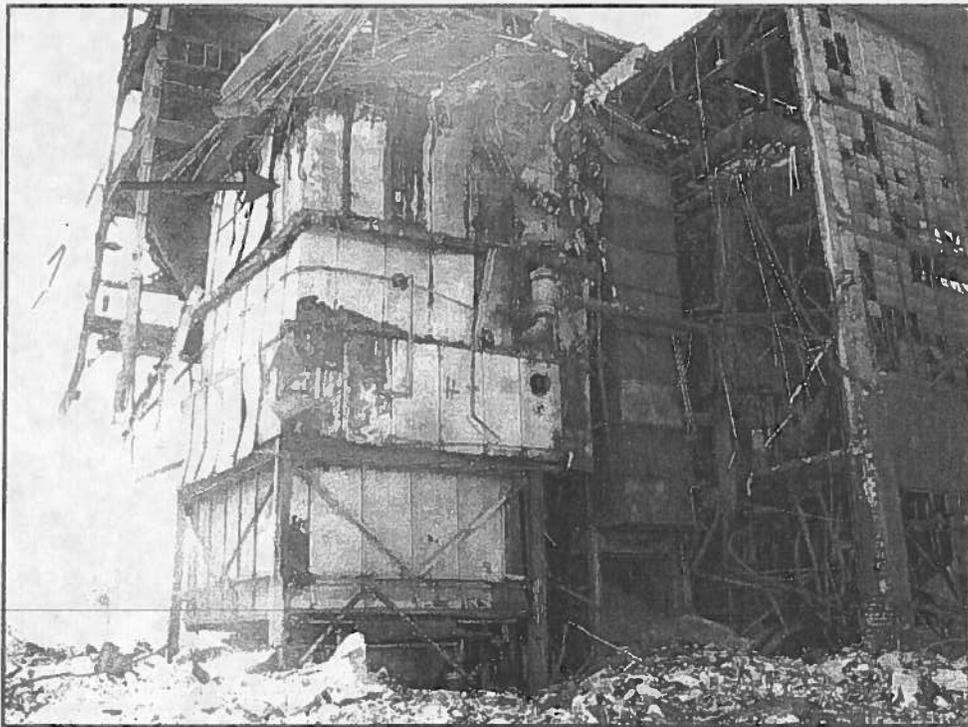
Boiler Room Unit 4 – External View of ACM TSI Behind Metal Jacket

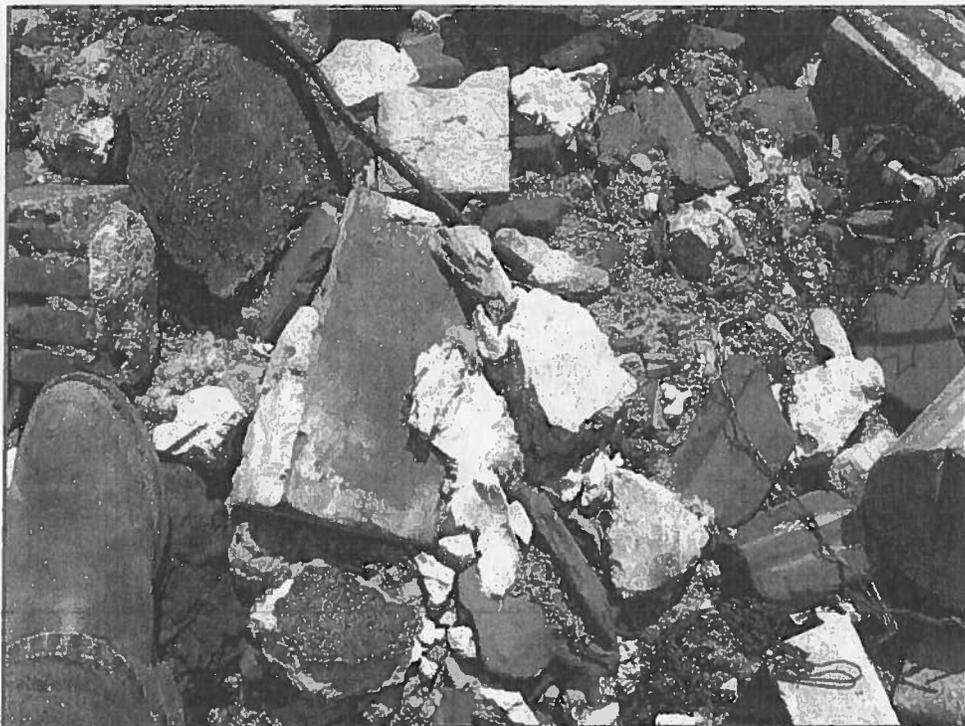
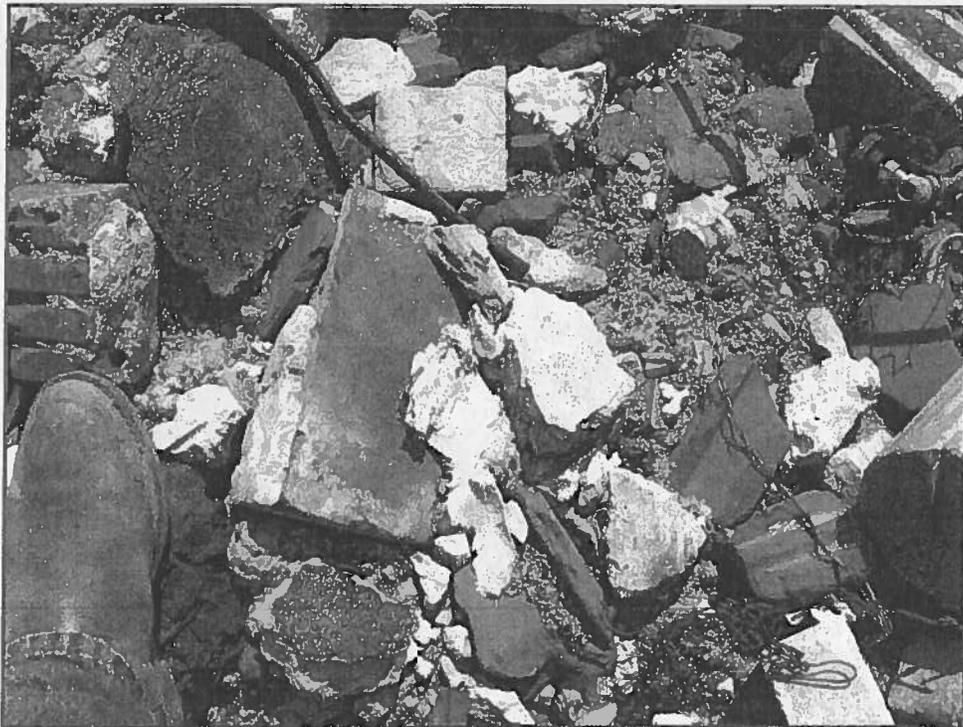
Boiler Room Exterior – ACM Debris in Demolition Rubble South Side of Unit 4

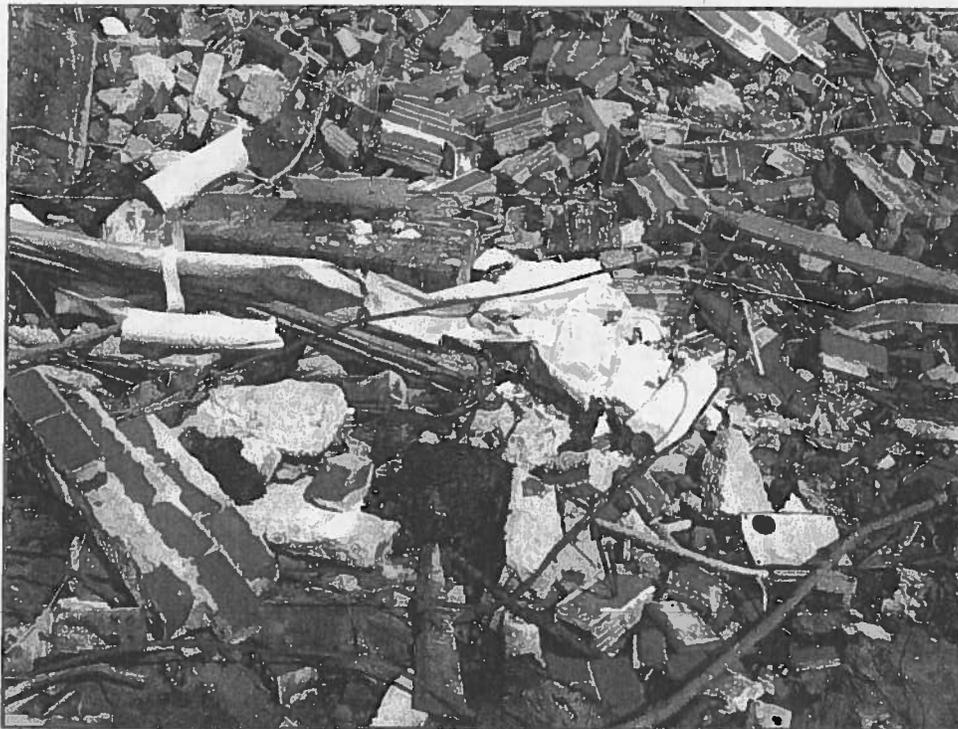
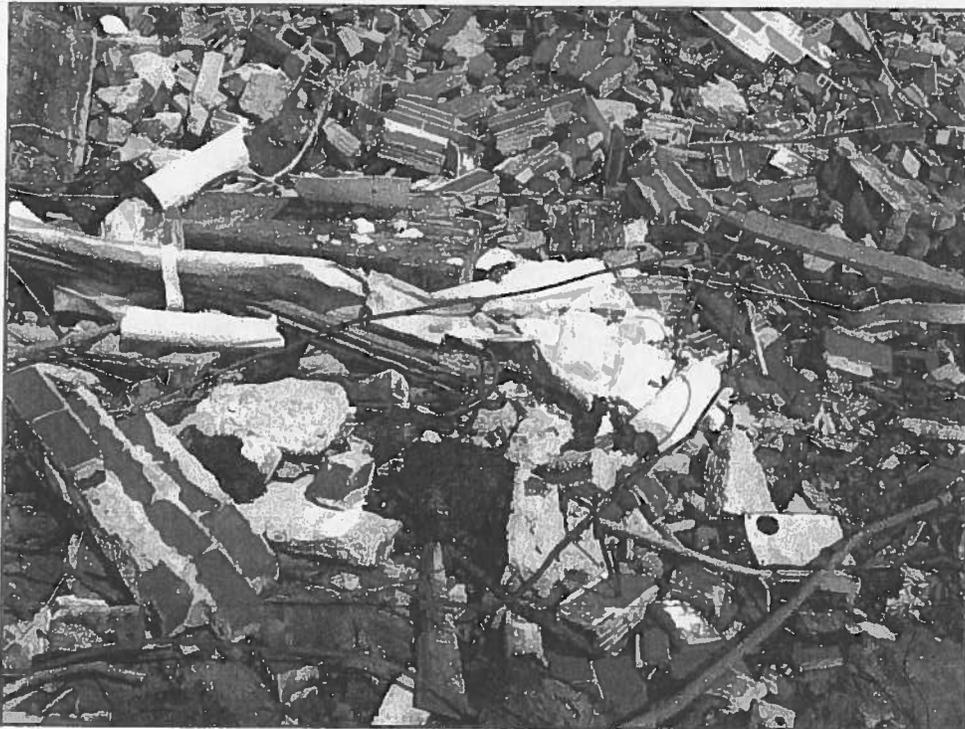
Power House – Pump Room Area TSI Debris Placed On Top of Debris Field

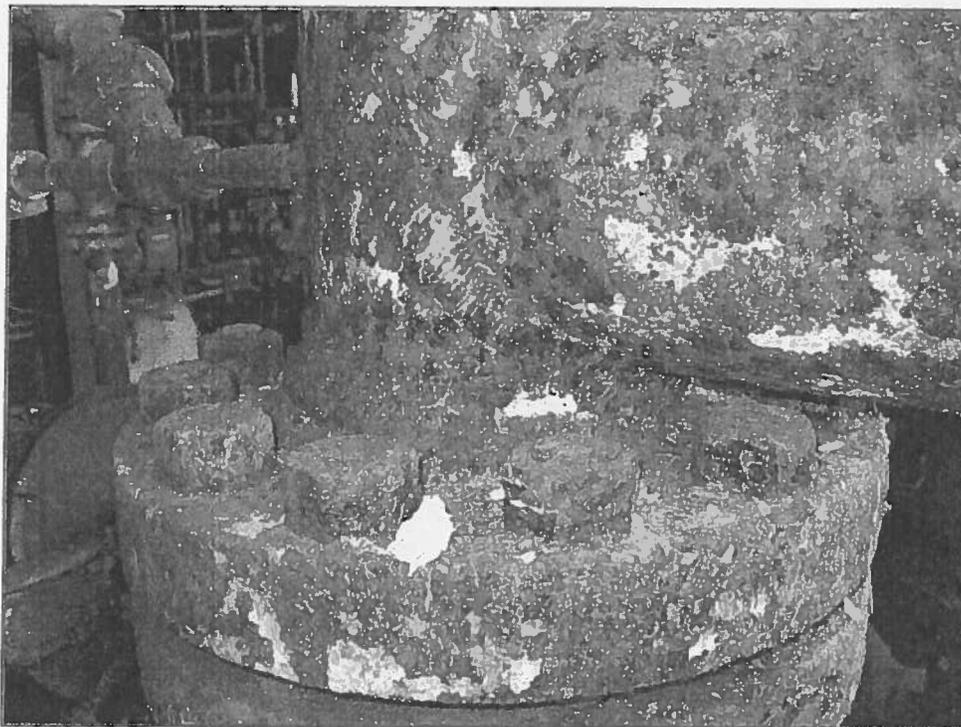
Boiler Room Operating Floor – Steam Header ACM TSI Debris

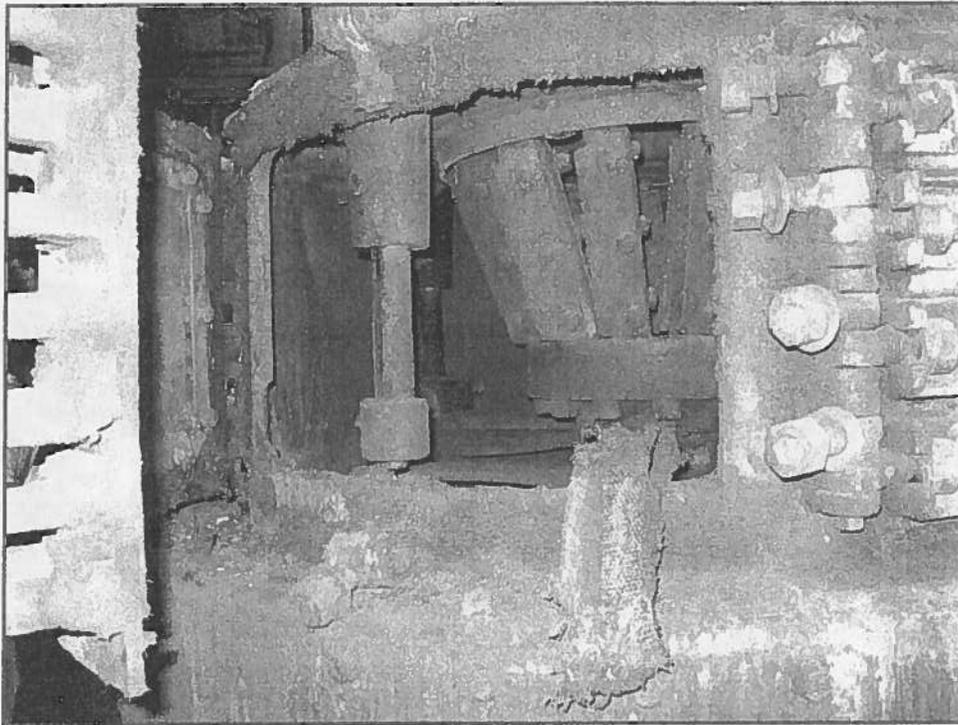
The friable asbestos-containing boiler equipment access panel woven gasket material, in place and in good condition, is considered as RACM by NESHAP definition, and must be removed prior to the planned demolition. The friable asbestos-containing boiler equipment access panel woven gasket material, in its present condition and location, pose a medium potential for airborne asbestos fiber exposure.

Boiler Room Ground Floor – Coal Pulverizer Access Panel Woven Gasket

The removal of friable and non-friable asbestos-containing mechanical gasket material should be performed by a qualified asbestos abatement contractor under properly controlled conditions in accordance with EPA, TDEC and OSHA removal and disposal regulations.

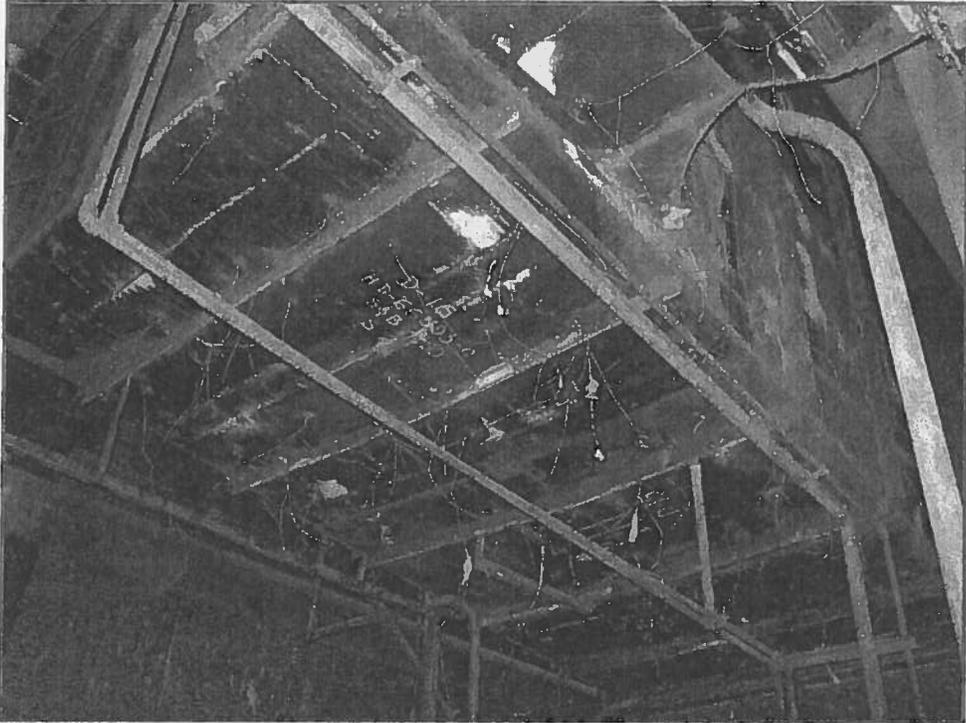
Boiler Room Operating Floor – Air Heater Duct ACM TSI Debris

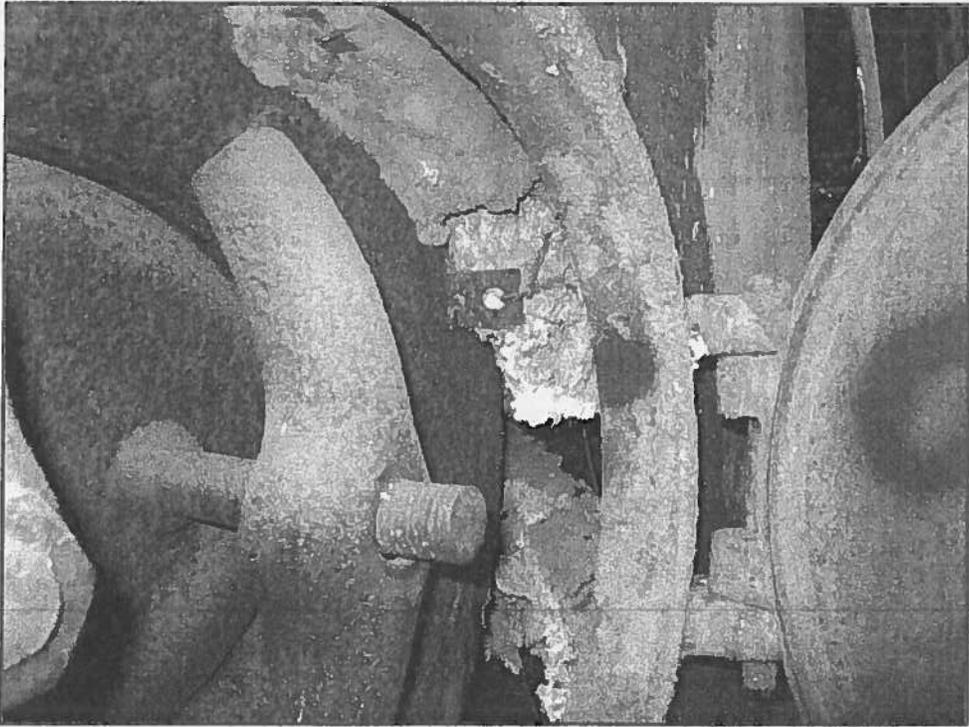
Boiler Room Operating Floor – Typical View of ACM Mud Drum Insulation
