August 11, 2008

Subject: Powerhouse And Water Treatment Structures Asbestos Survey Report
Former Liberty Fibers Site; Lowland, Tennessee
A.C.T. Services Proposal No. 08.17.001

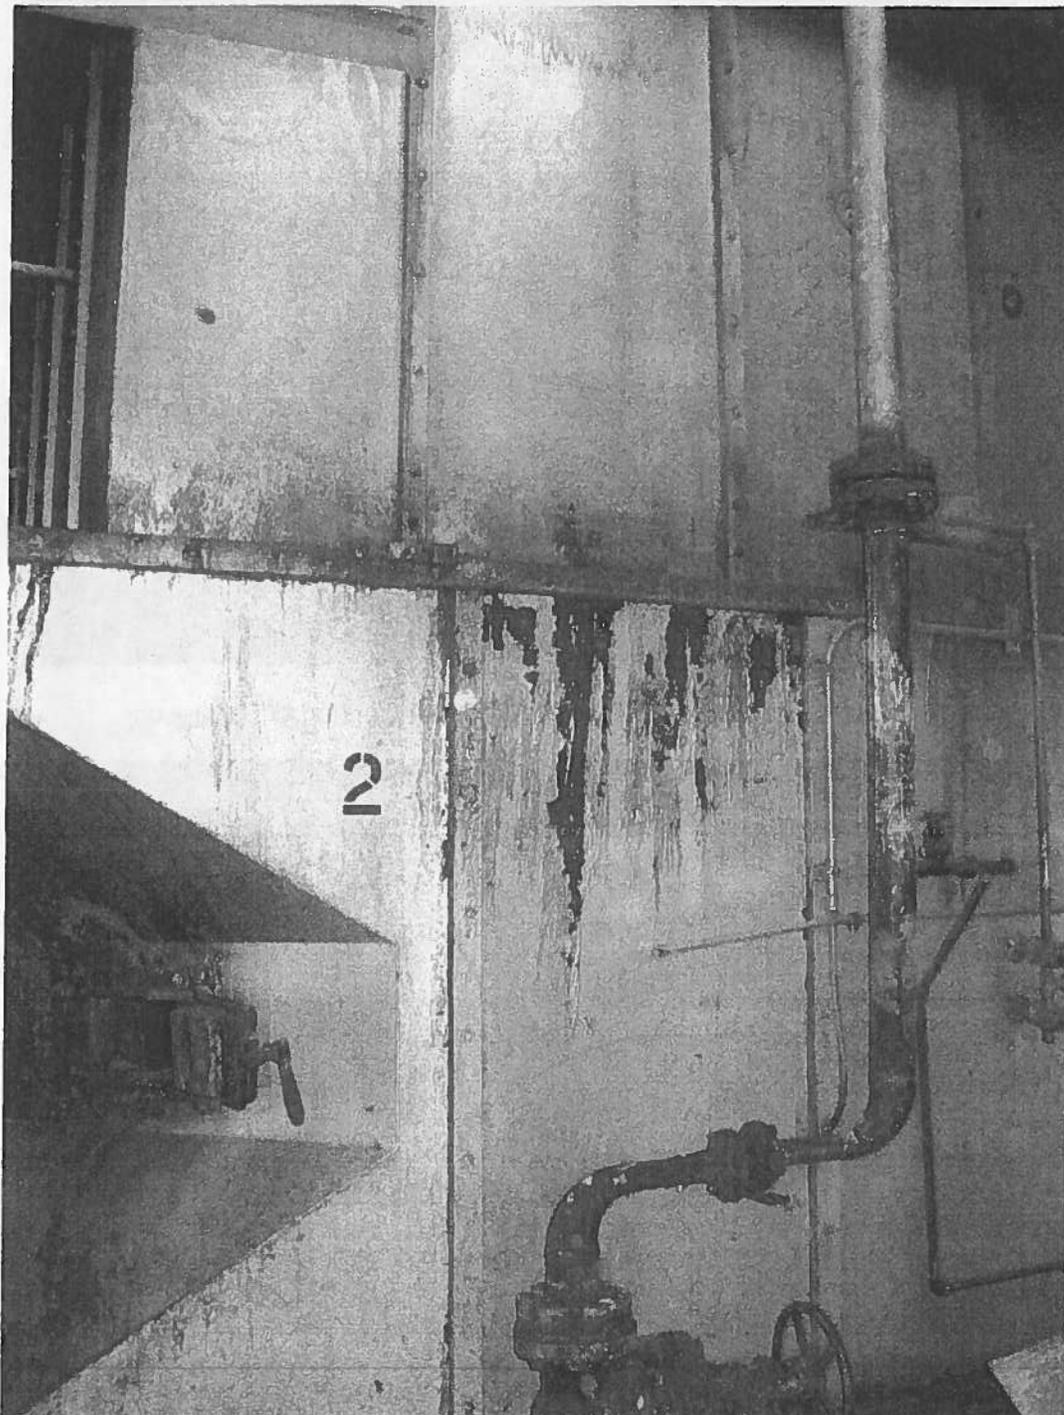
Boiler Room Operating Floor – Typical View of Metal Jacket Over ACM Boiler Insulation

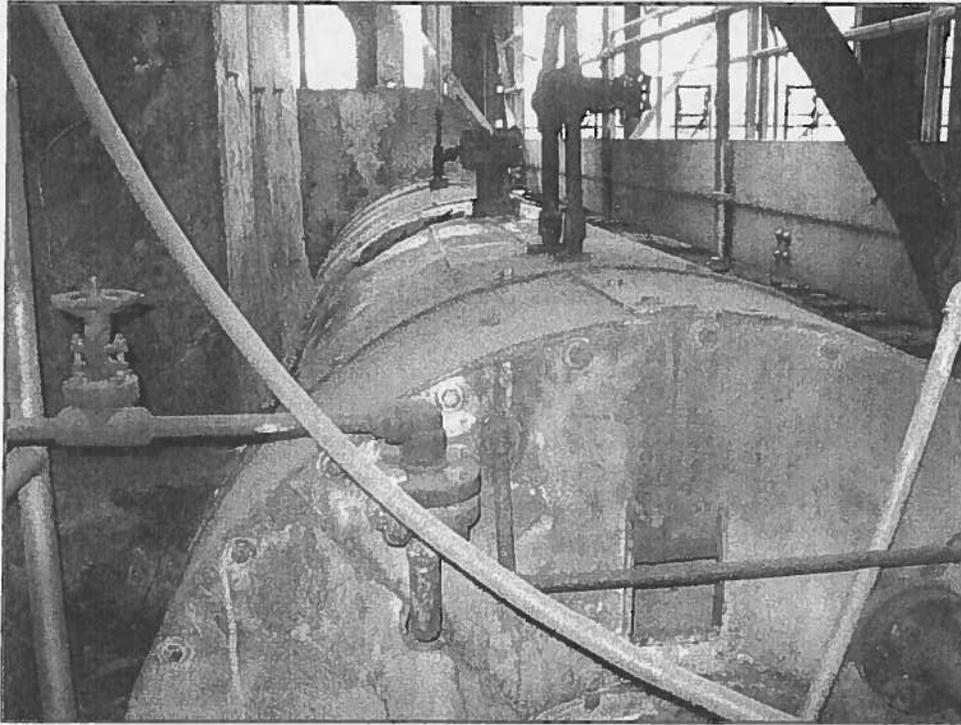
Boiler Room Operating Floor Upper Level – ACM Under Steam Drum Metal Jacket

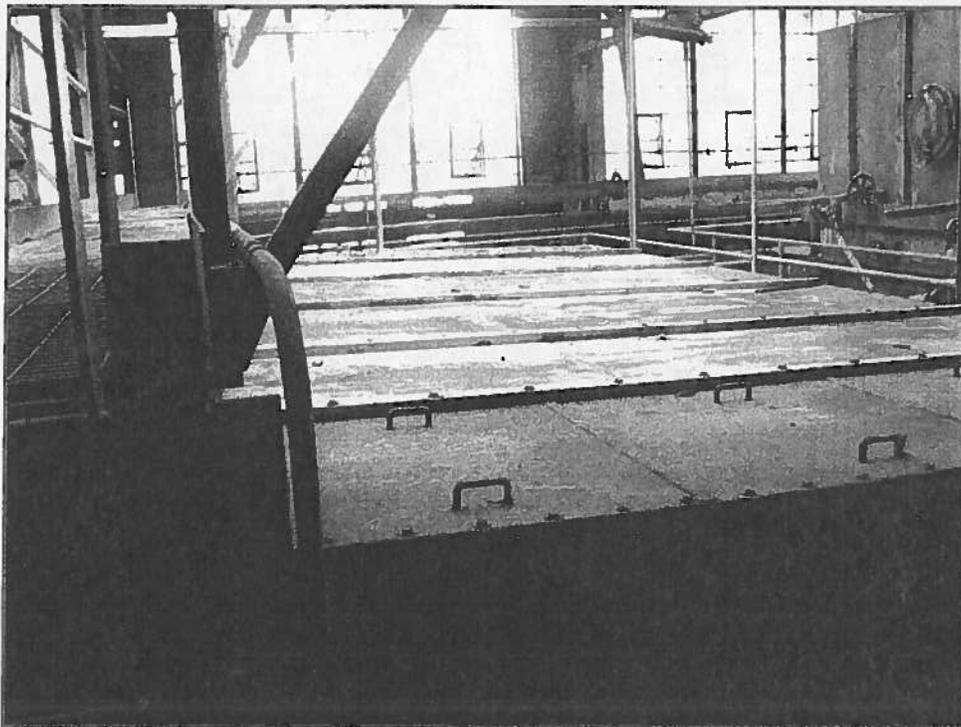
Boiler Room Operating Floor Upper Level – ACM Under Boiler Roof Metal Jacket

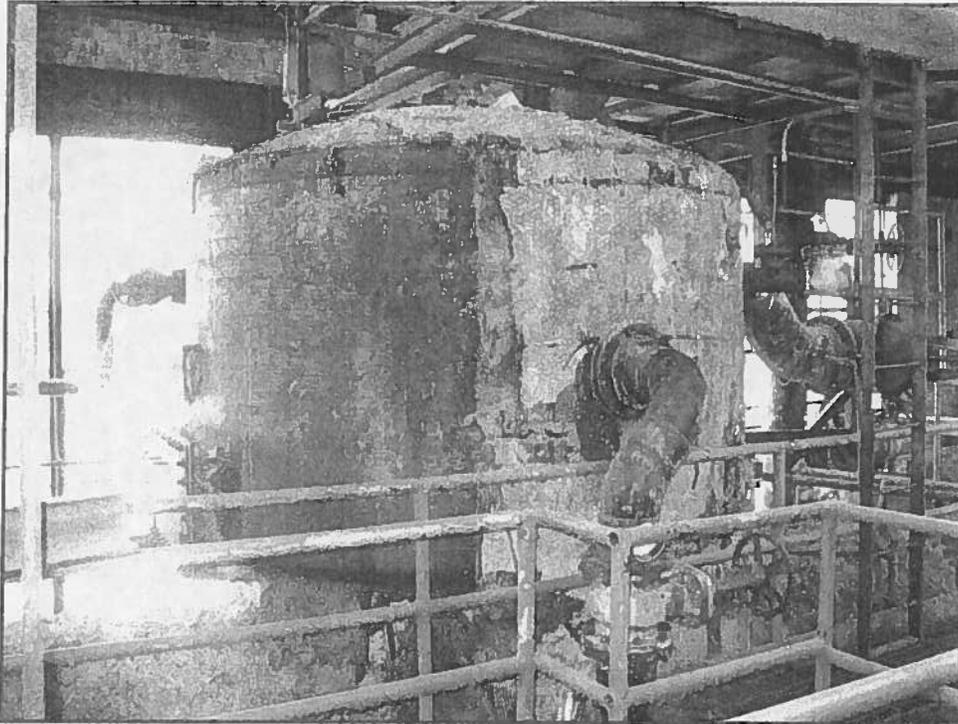
Boiler Room Operating Floor Upper Level – ACM De-Aerator Tank Insulation

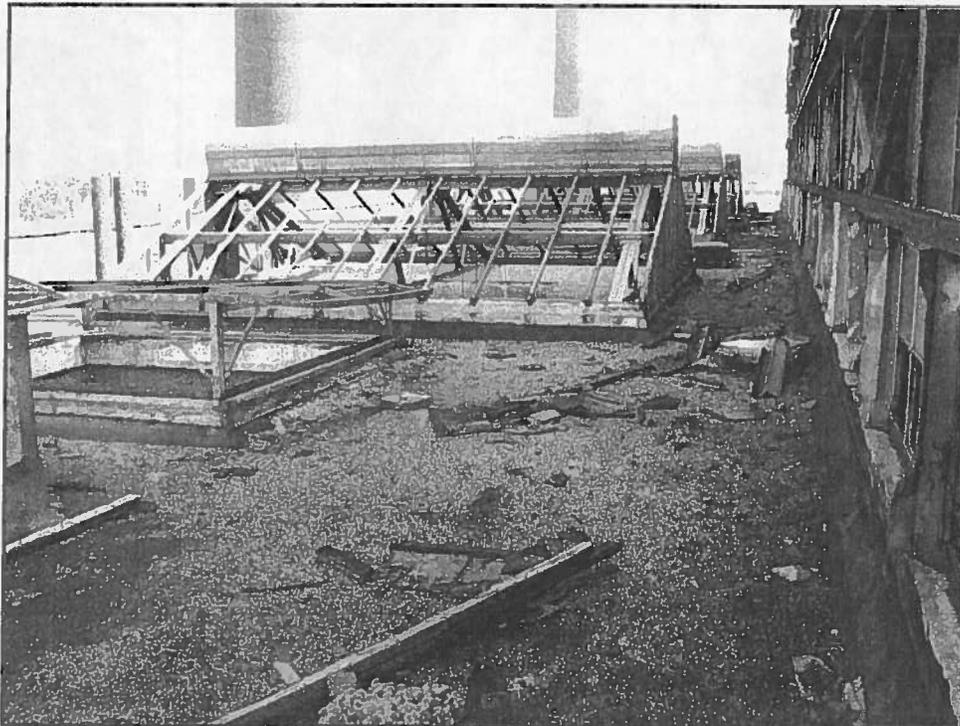
Boiler Room Roof – View of Demolition Debris & ACM Roof Membrane

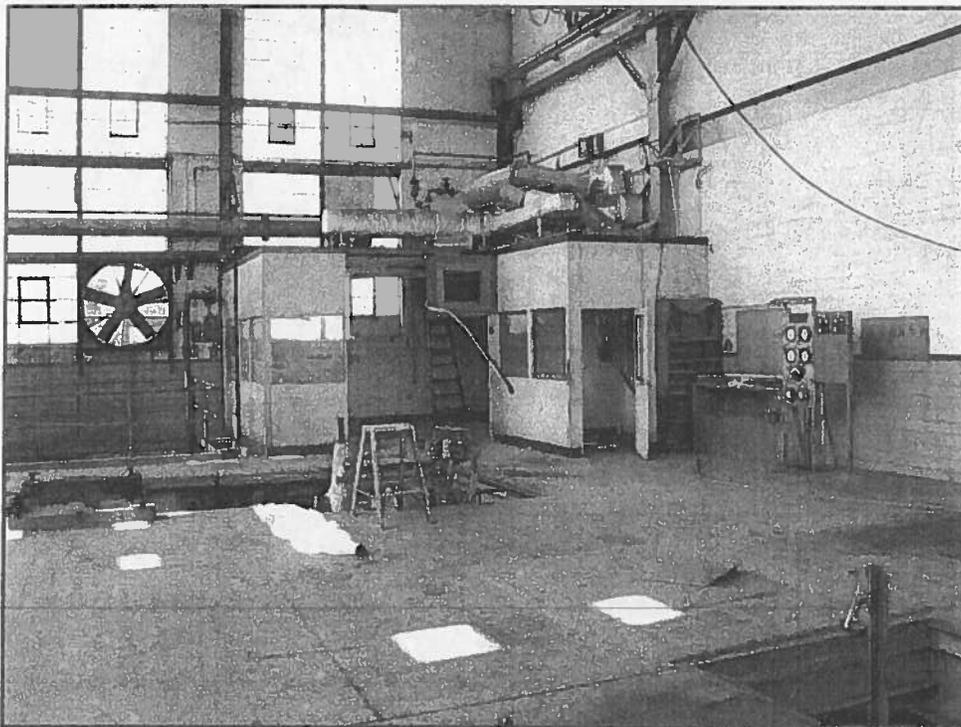
Turbine Room Operating Floor – Northeast View of Office with ACM Floor Tile

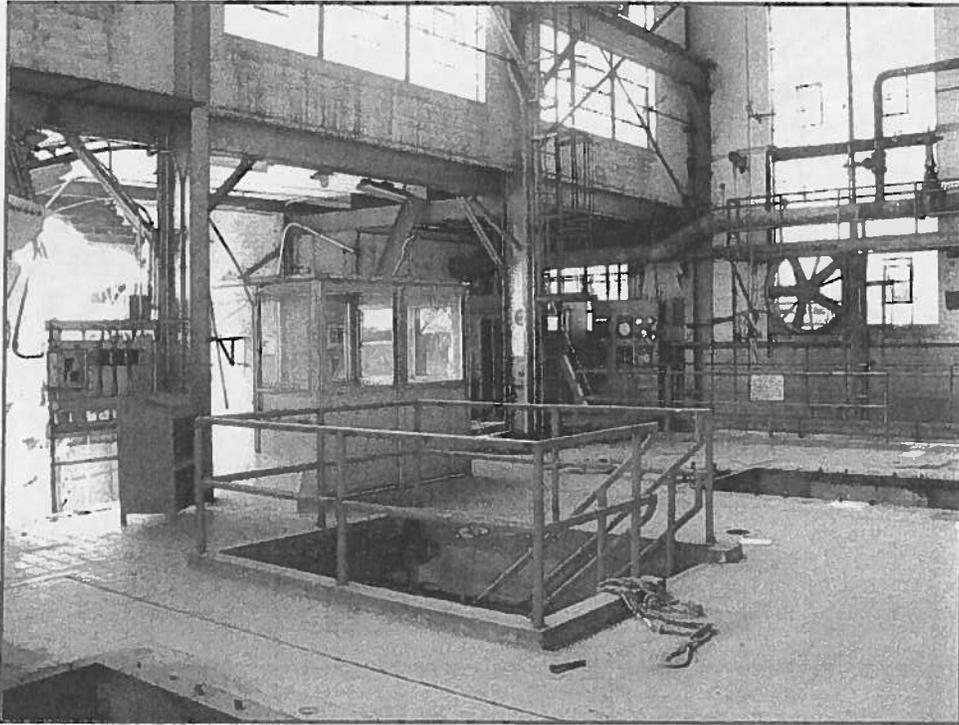
Turbine Room Operating Floor – Northwest View of Lift Well & TSI Debris

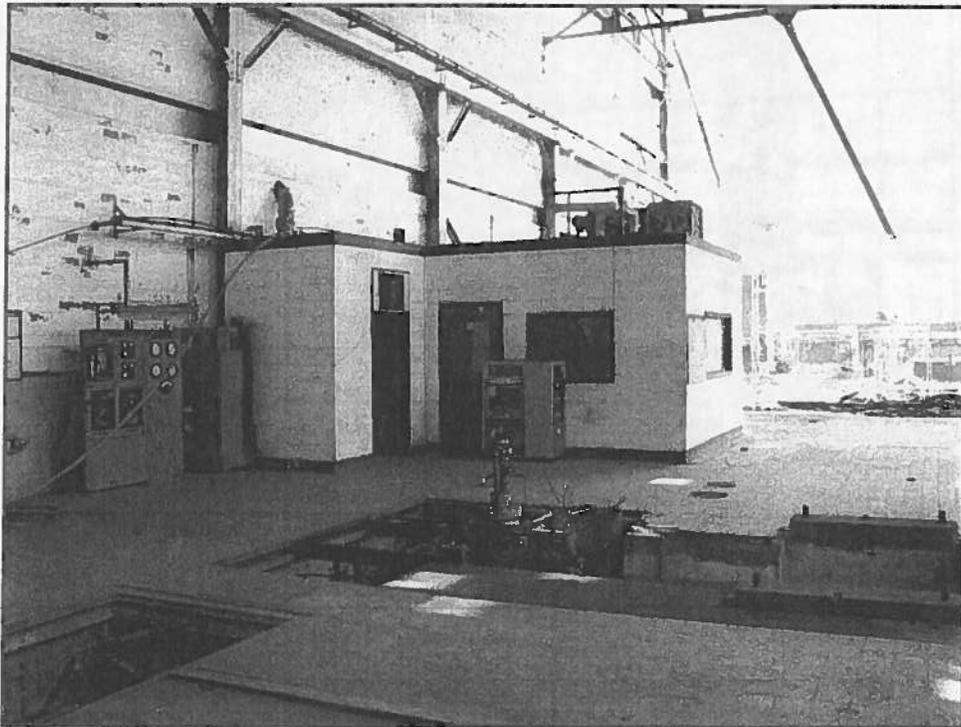
Turbine Room Operating Floor – South View of Offices Containing ACM Flooring

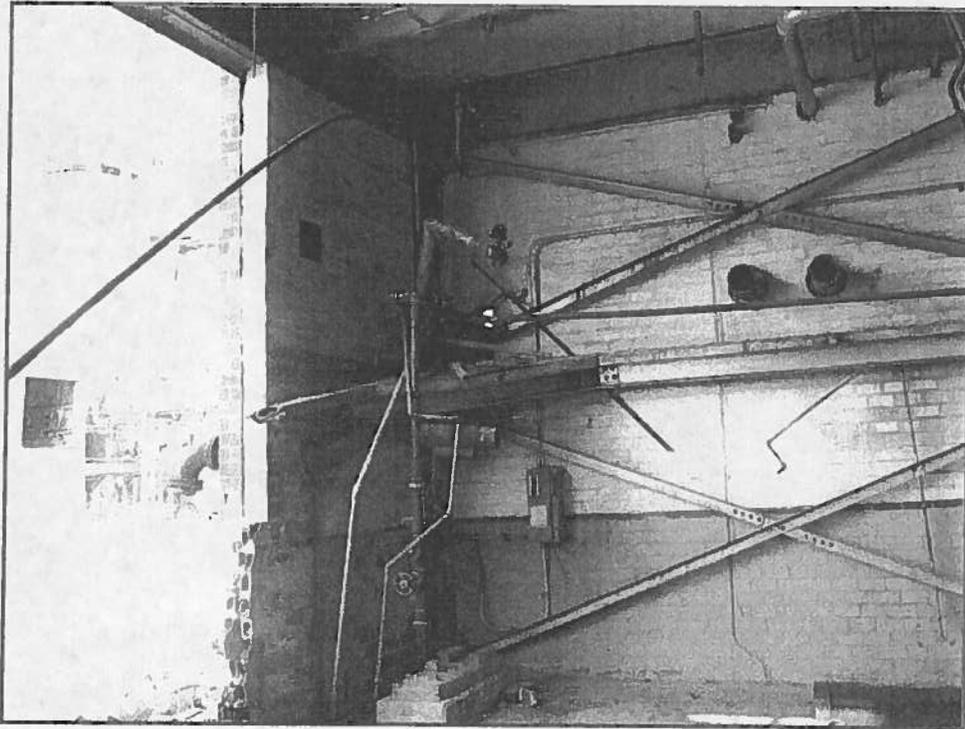
Turbine Room Ground Floor – Northeast Corner ACM Pipe Insulation

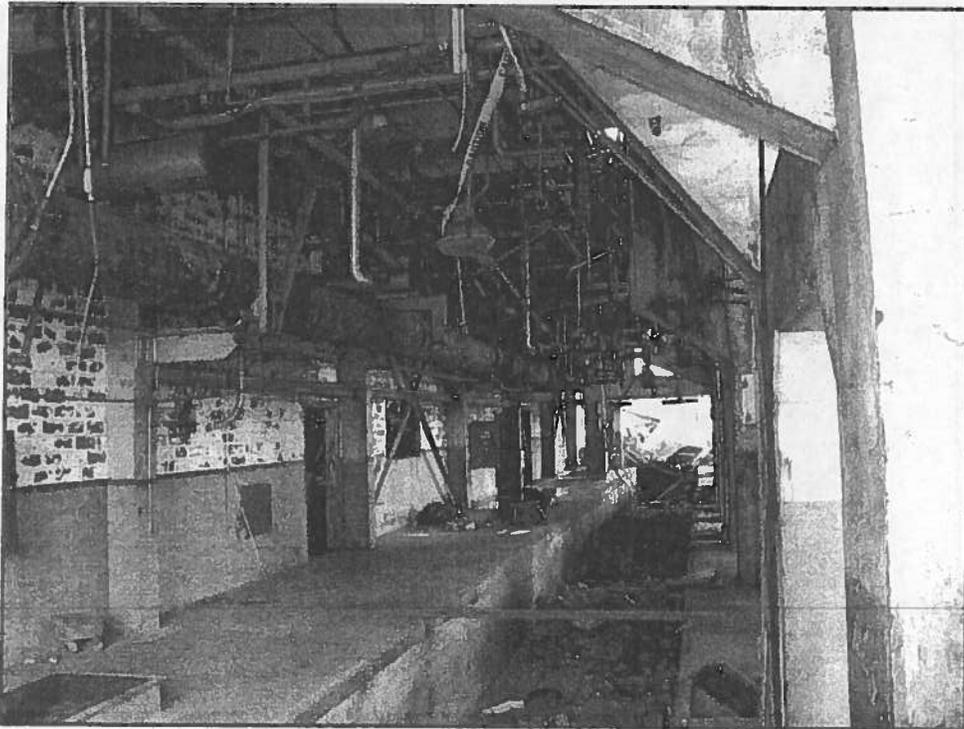
Turbine Room Ground Floor – South View of 24" Steam Line ACM Flange Gasket

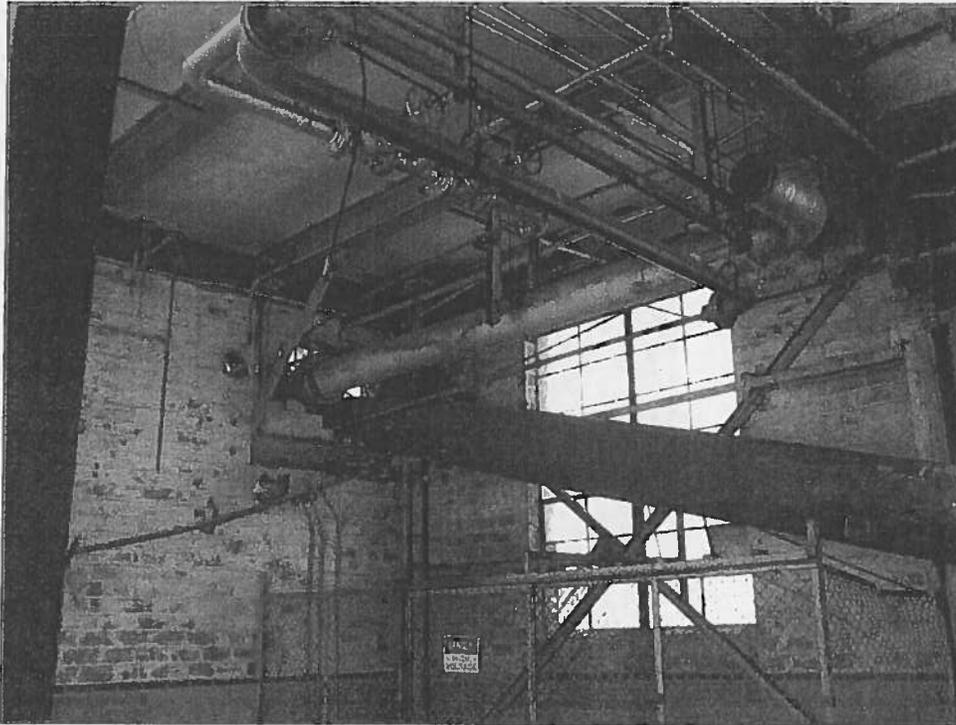
Pump Room Ground Level – Northwest View of ACM Pipe Insulation

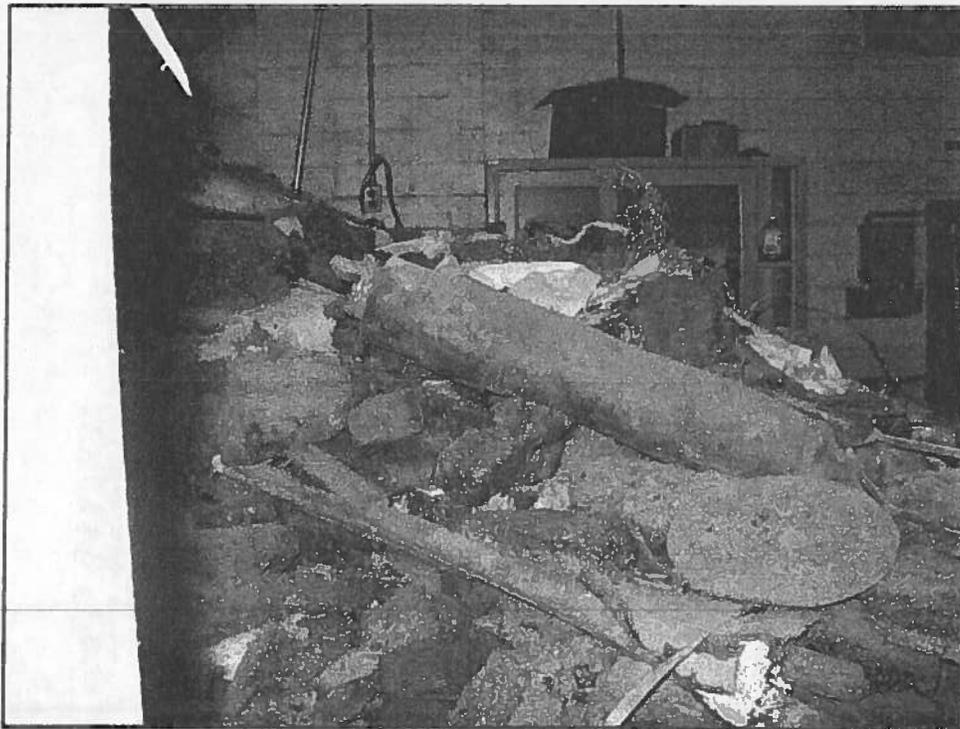
Boiler Room Ground Floor – North End Locked Room ACM TSI Debris

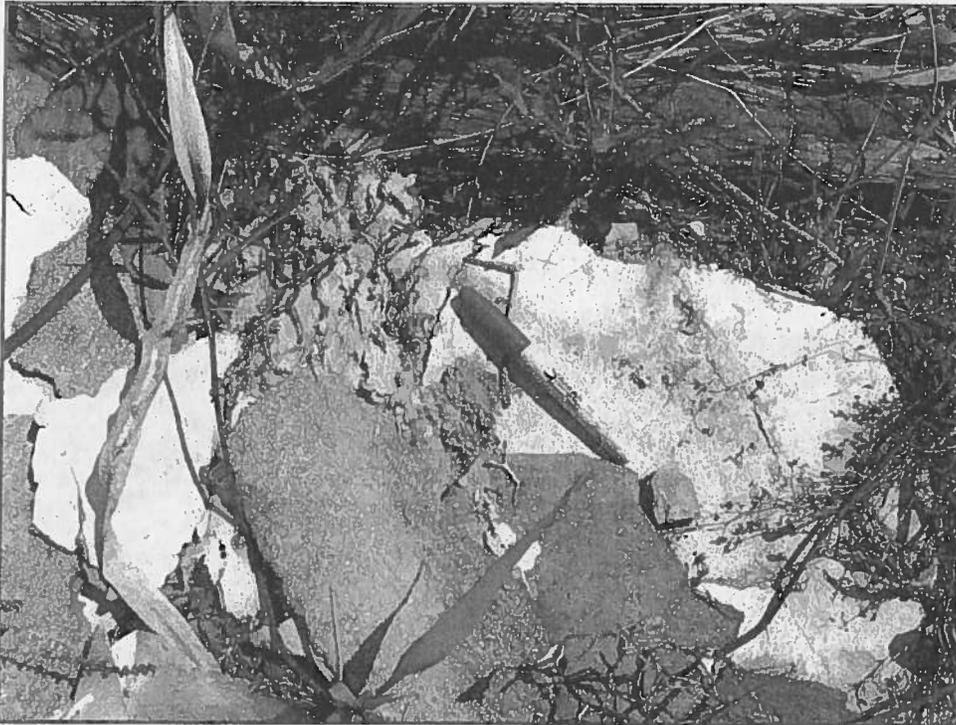
East-West Surveyors Line Sample No. DB-01 – Non-friable ACM TSI Mastic Debris
