January 18, 2011

**Subject: Final Site Reconnaissance Letter Report
Liberty Fibers Site
Lowland, Hamblen County, Tennessee
EPA Contract No. EP-W-05-054
TDD No. TTEMI-05-003-0041**

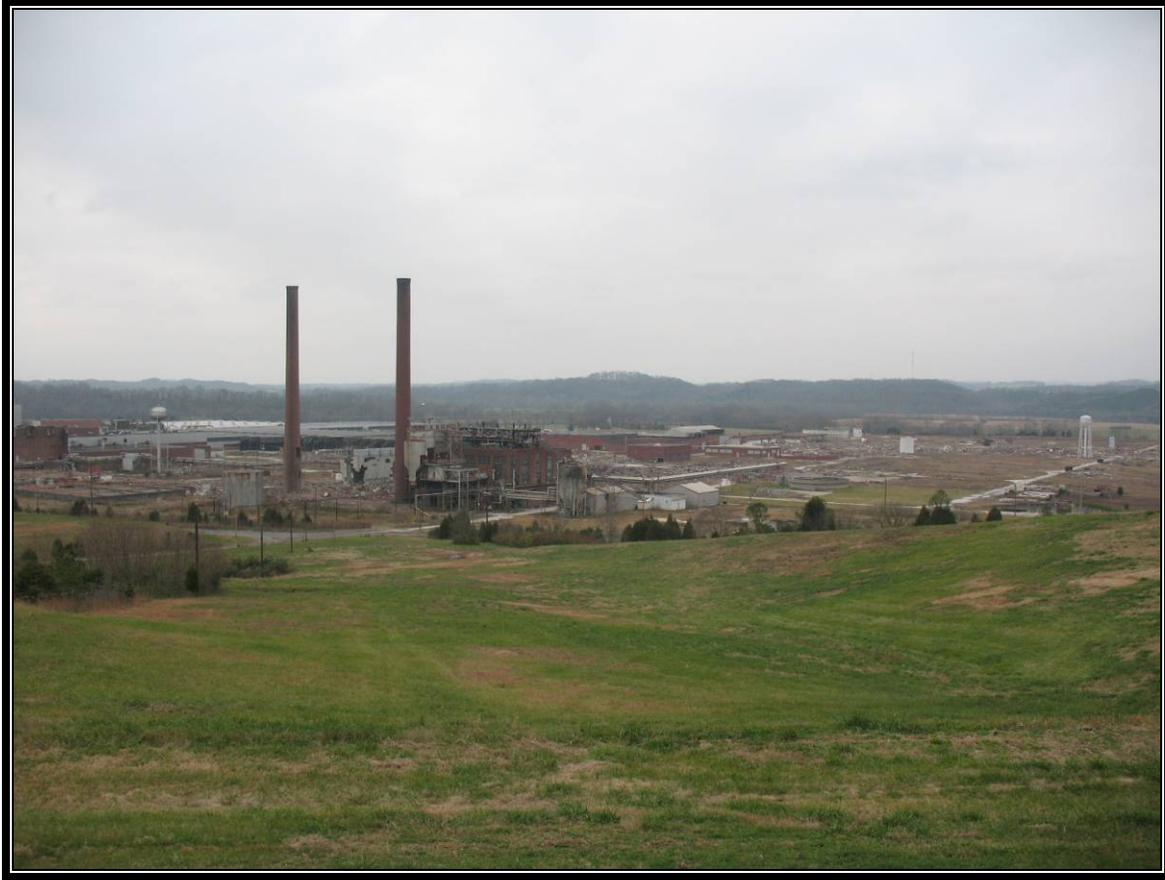
OFFICIAL PHOTOGRAPH NO. 1
U.S. ENVIRONMENTAL PROTECTION AGENCY

Subject: Limited overview of Liberty Fibers Site as seen from atop a closed landfill located at the northeastern corner of the facility.

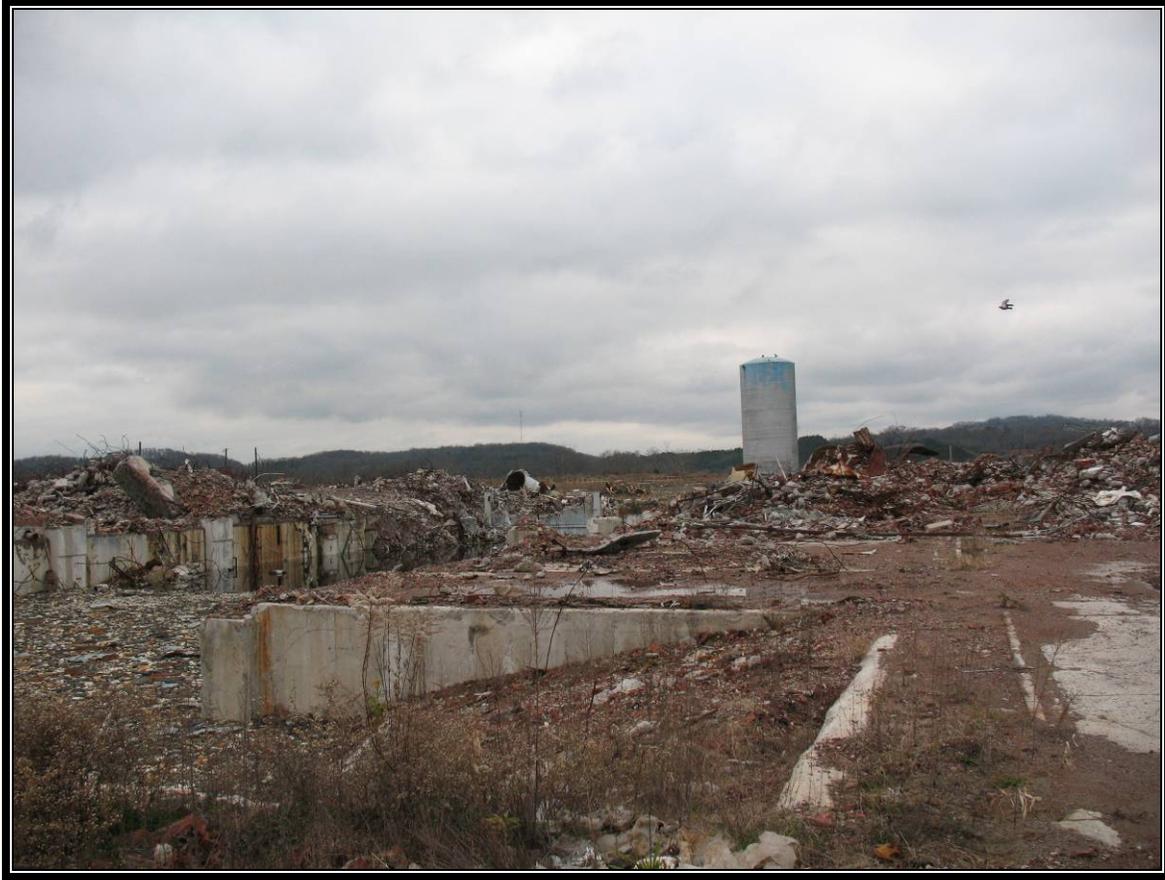
OFFICIAL PHOTOGRAPH NO. 2
U.S. ENVIRONMENTAL PROTECTION AGENCY

- The 50,000-gallon sulfuric acid storage tank located on the western side of the site was suspected to contain about 8 inches of product.
- Mr. Sawyer stated that approximately 10 to 20 PCB transformers had been sold to Booher Industries. Eleven transformers remained on site: four had been left on a truck, three in the pump house, one on-line at the Administration Building with a spare next to it, and two in storage.

Subject: Building demolition debris on northwestern side of property with the 50,000-gallon sulfuric acid storage tank visible in the background. The owner estimated the storage tank contained approximately 8 inches of product.

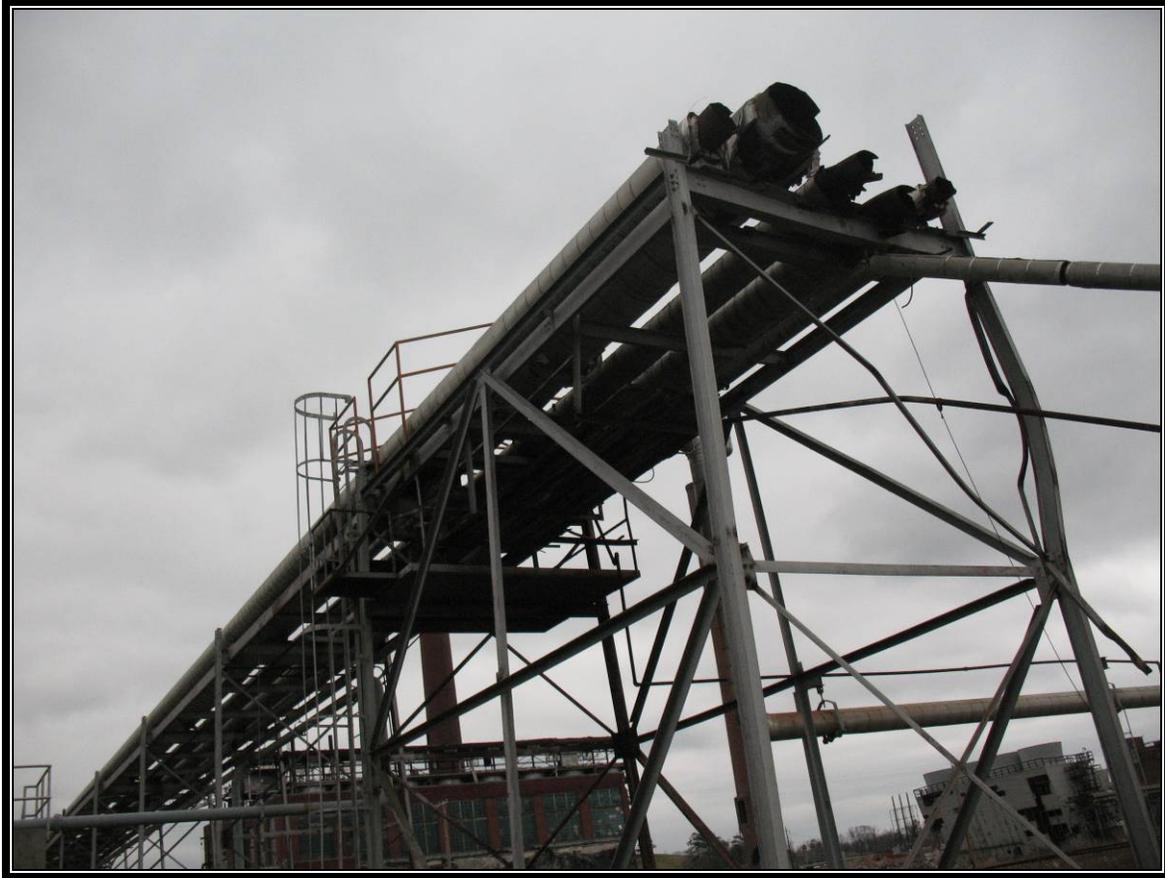
**OFFICIAL PHOTOGRAPH NO. 3
U.S. ENVIRONMENTAL PROTECTION AGENCY**

Subject: Aboveground pipe run with suspect asbestos-containing pipe insulation appeared to be damaged during building demolition.

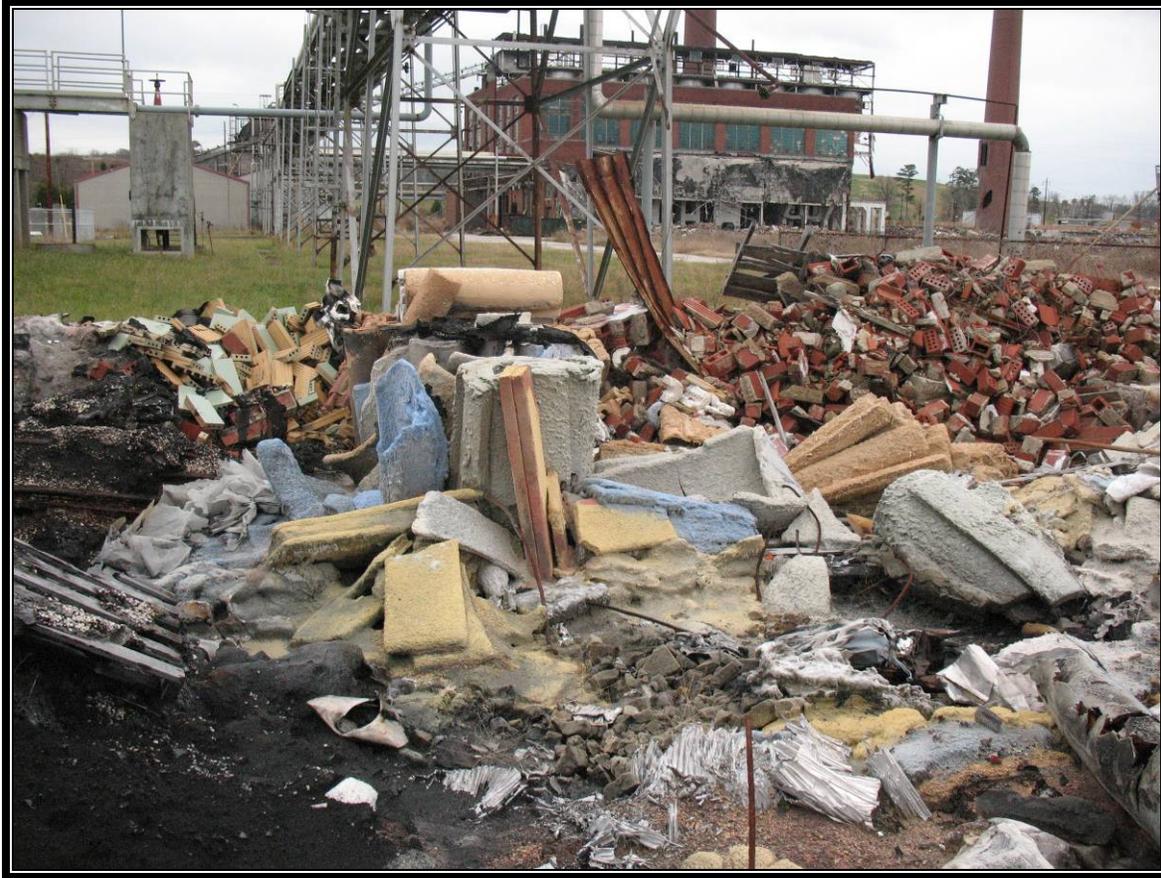
**OFFICIAL PHOTOGRAPH NO. 4
U.S. ENVIRONMENTAL PROTECTION AGENCY**

Subject: Suspect asbestos-containing pipe insulation mixed with building demolition debris.

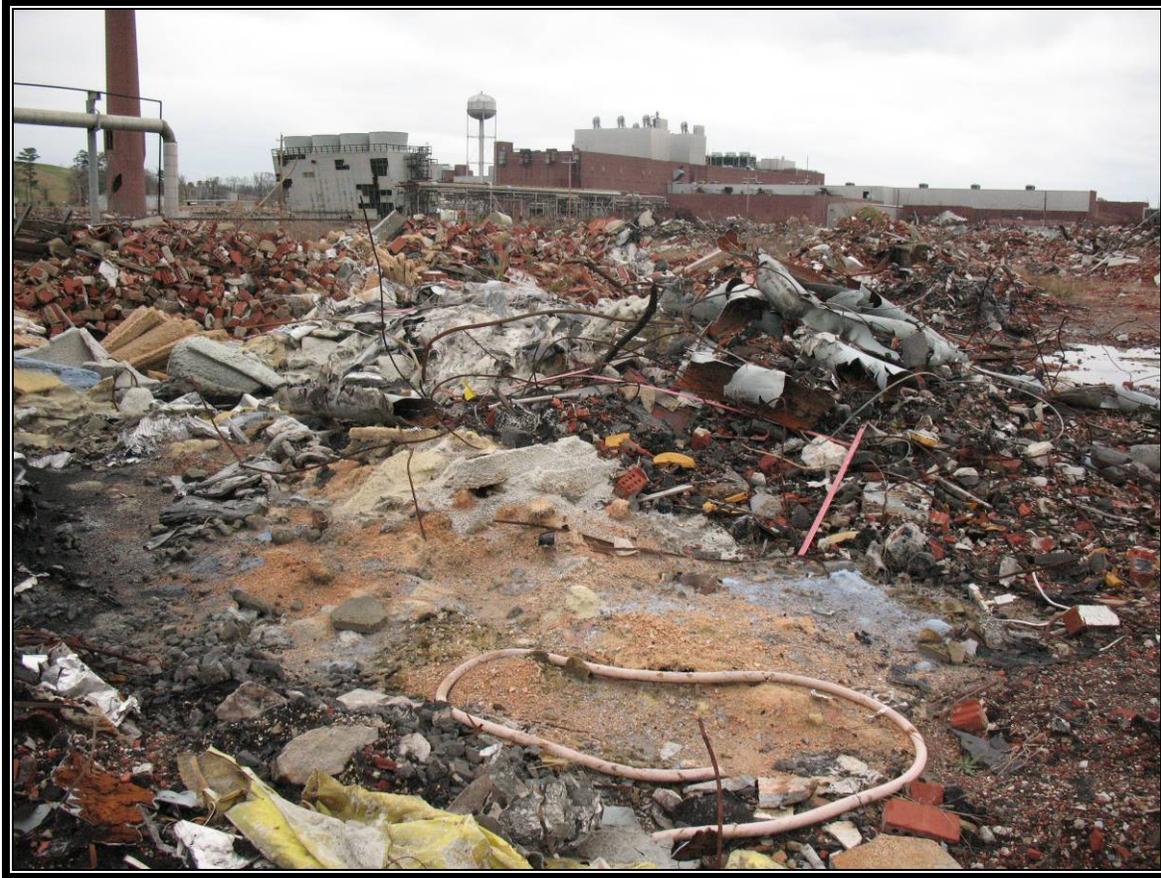
**OFFICIAL PHOTOGRAPH NO. 5
U.S. ENVIRONMENTAL PROTECTION AGENCY**

Subject: Weathered suspect asbestos-containing pipe insulation mixed with building demolition debris.

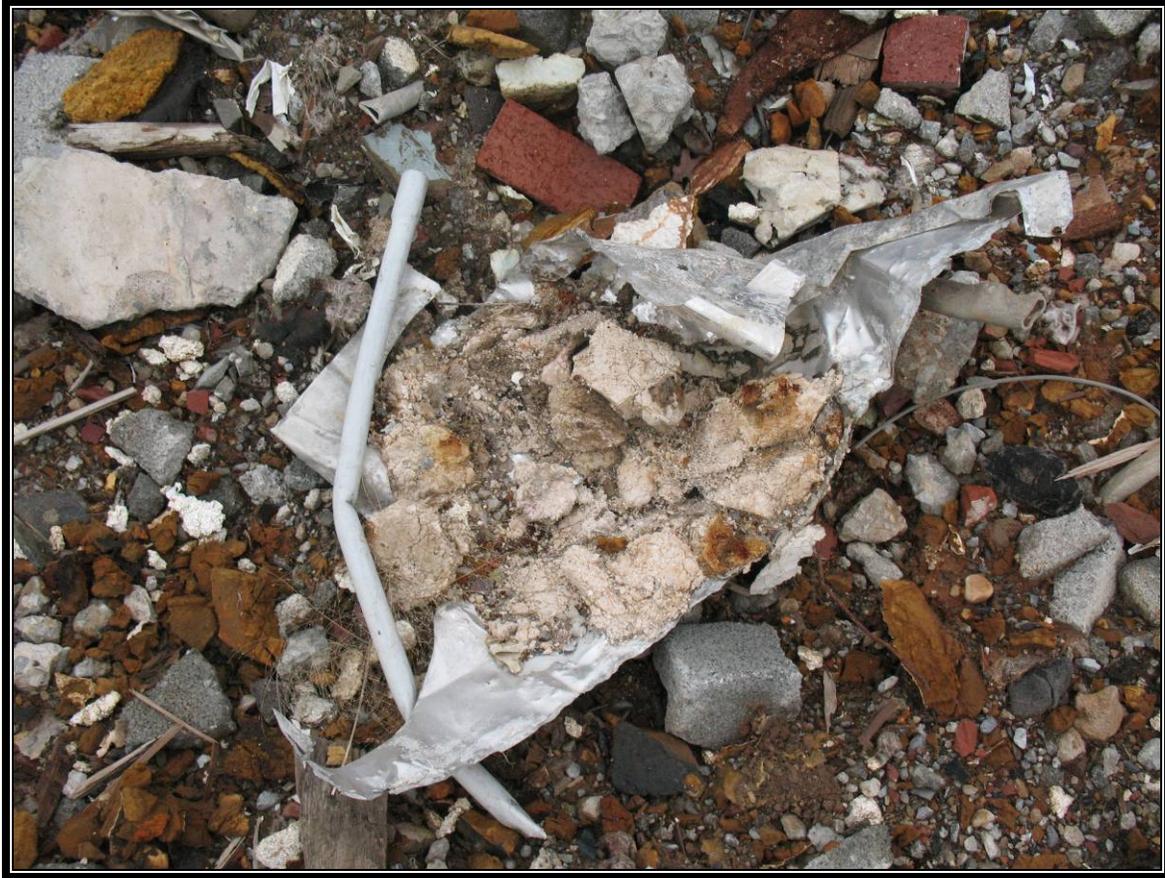
**OFFICIAL PHOTOGRAPH NO. 6
U.S. ENVIRONMENTAL PROTECTION AGENCY**

Subject: Suspect asbestos-containing pipe insulation inside damaged metal jacket mixed with building demolition debris.

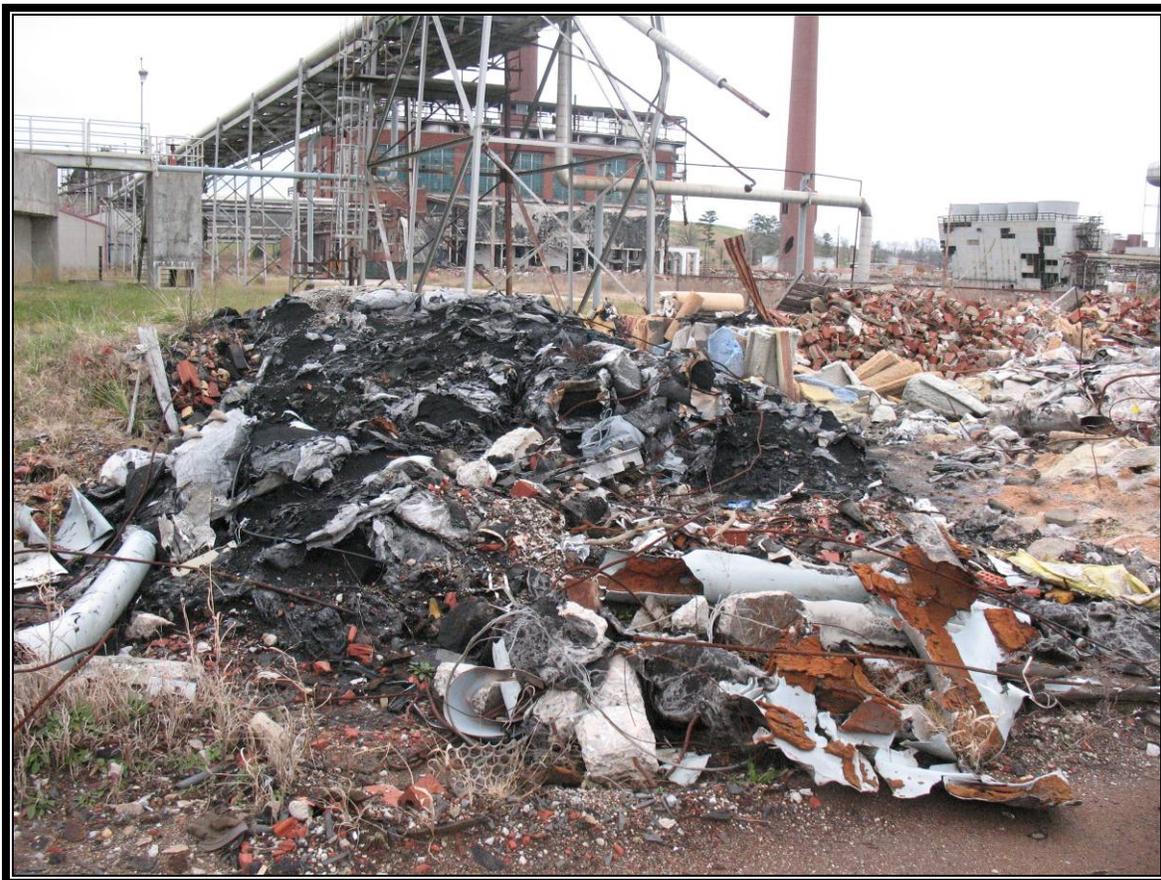
**OFFICIAL PHOTOGRAPH NO. 7
U.S. ENVIRONMENTAL PROTECTION AGENCY**

Subject: Suspect asbestos-containing roofing material mixed with building demolition debris.

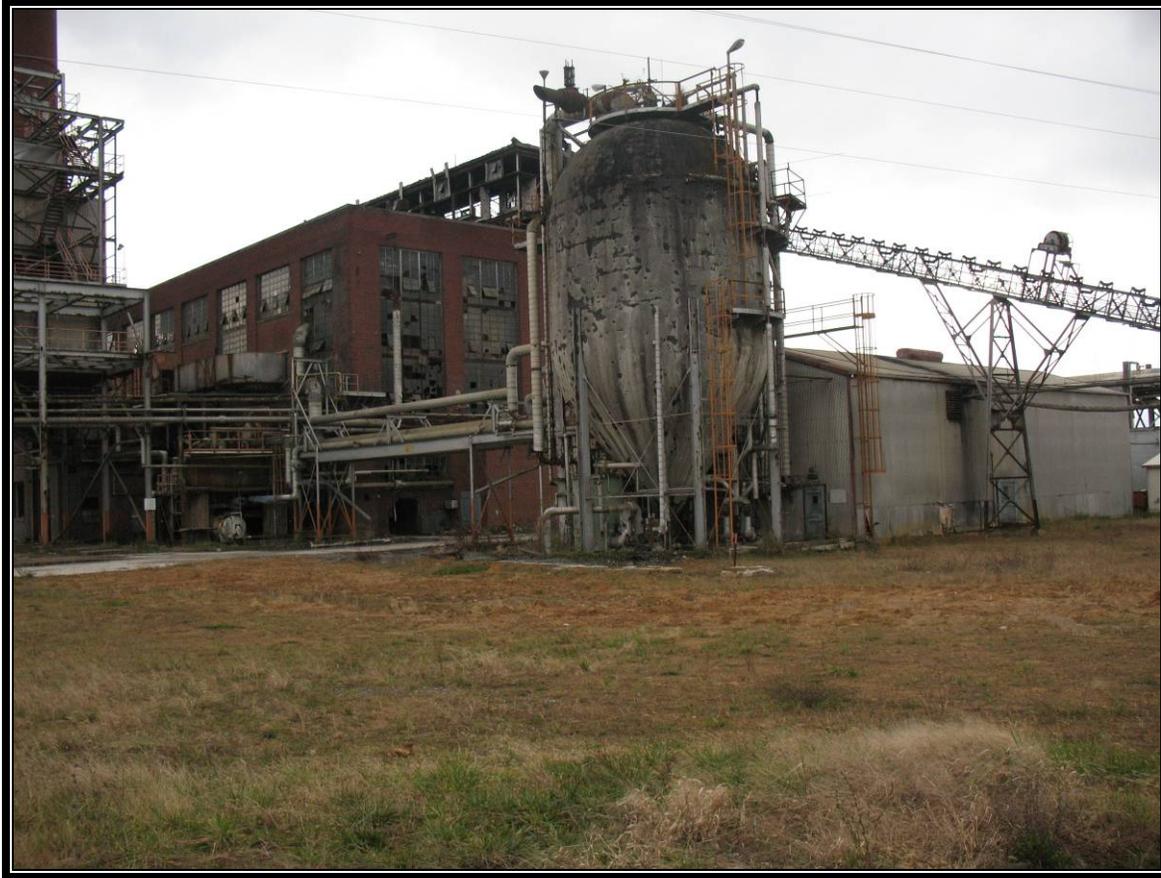
**OFFICIAL PHOTOGRAPH NO. 8
U.S. ENVIRONMENTAL PROTECTION AGENCY**

Subject: Power House and associated afterburner. Suspect asbestos-containing materials are associated with the Power House and the afterburner.

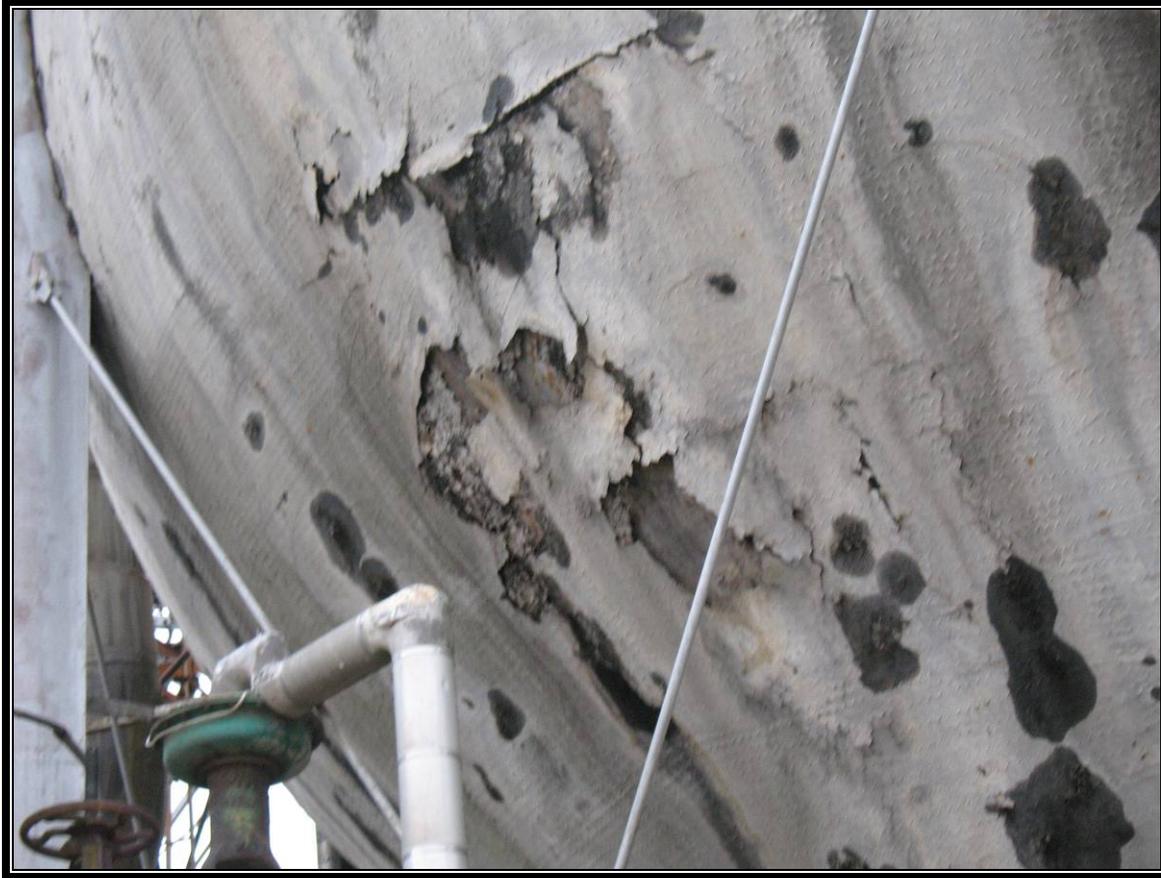
OFFICIAL PHOTOGRAPH NO. 9
U.S. ENVIRONMENTAL PROTECTION AGENCY

Subject: Damaged suspect asbestos-containing insulation covering the Power House afterburner.

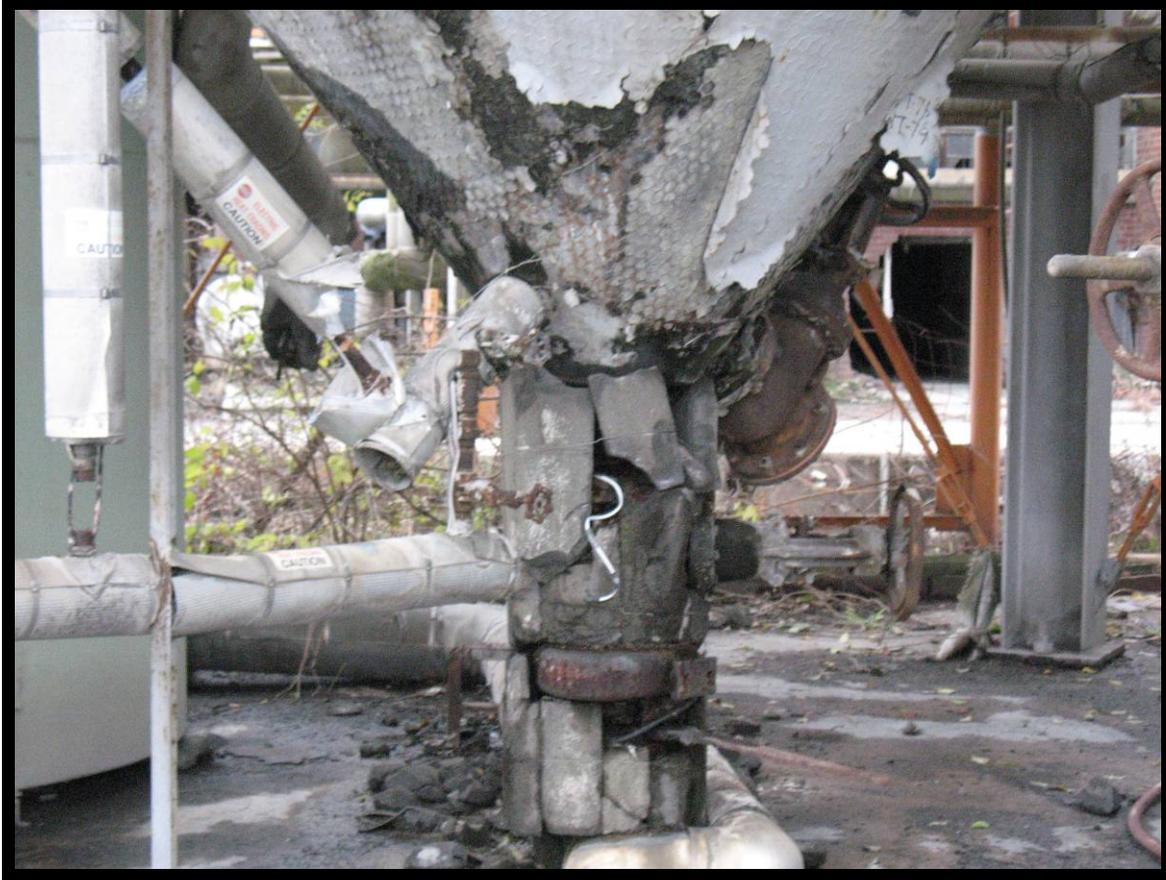
OFFICIAL PHOTOGRAPH NO. 10
U.S. ENVIRONMENTAL PROTECTION AGENCY

Subject: Damaged suspect asbestos-containing insulation beneath the Power House afterburner.

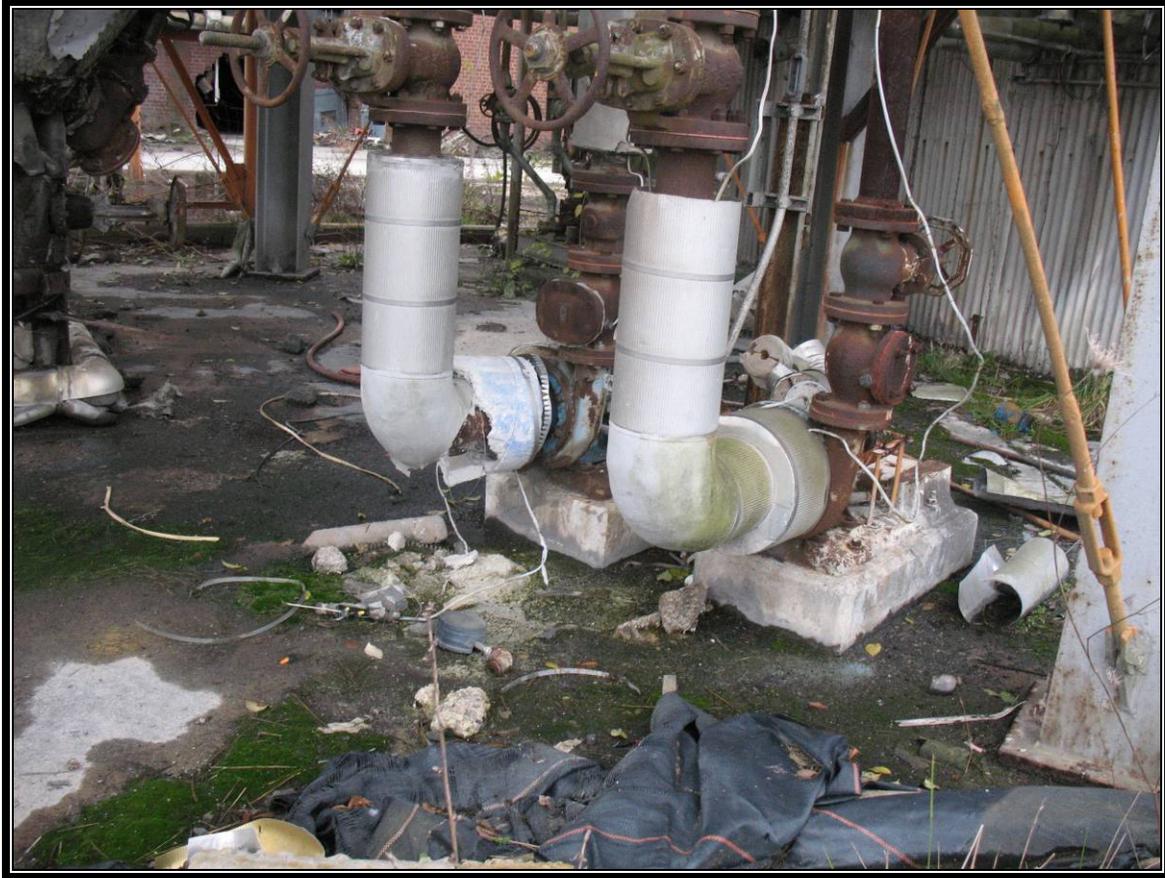
OFFICIAL PHOTOGRAPH NO. 11
U.S. ENVIRONMENTAL PROTECTION AGENCY

Subject: Damaged suspect asbestos-containing pipe insulation beneath the Power House afterburner.

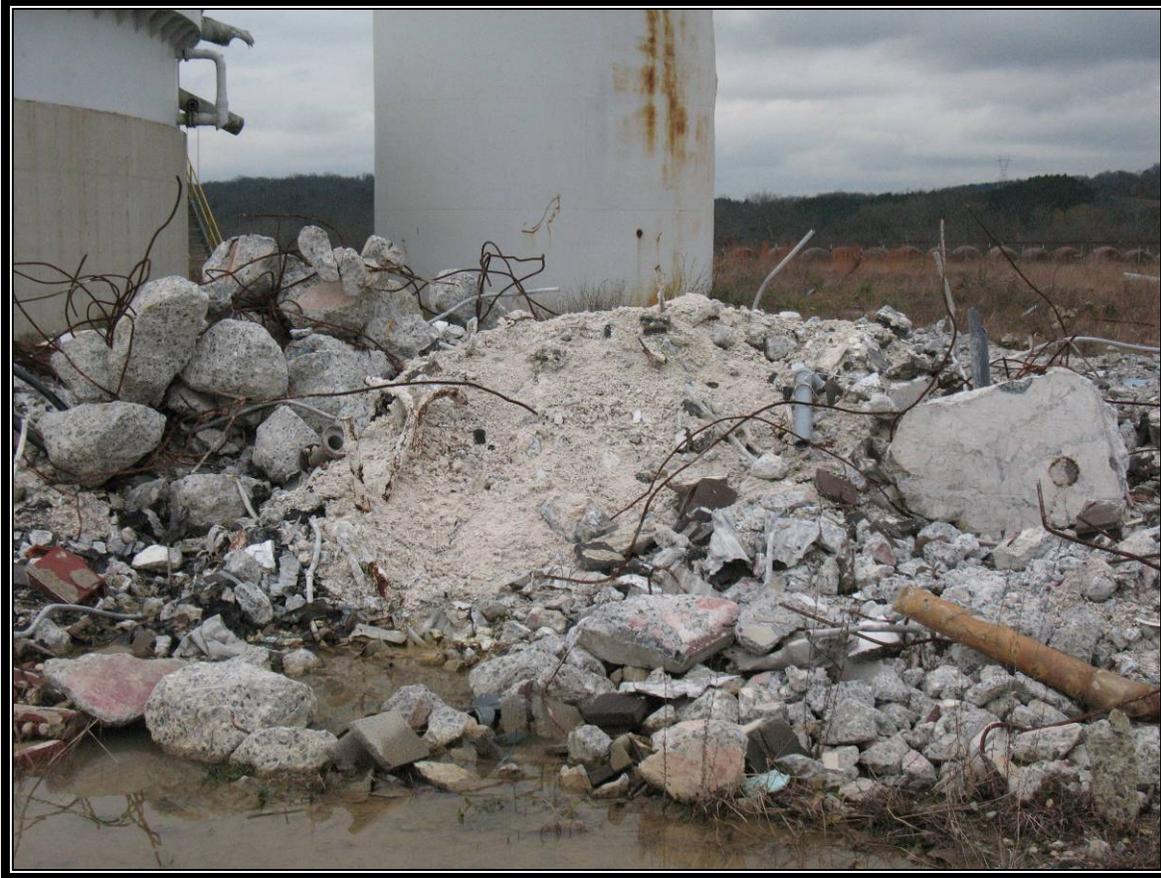
OFFICIAL PHOTOGRAPH NO. 12
U.S. ENVIRONMENTAL PROTECTION AGENCY

- Dirt mounds located around a demolished clarifier tank on the western side of the facility were suspected to contain buried asbestos materials from the site.

Subject: Weathered suspect asbestos-containing material mixed with demolition debris near clarifier located on the western side of the property.

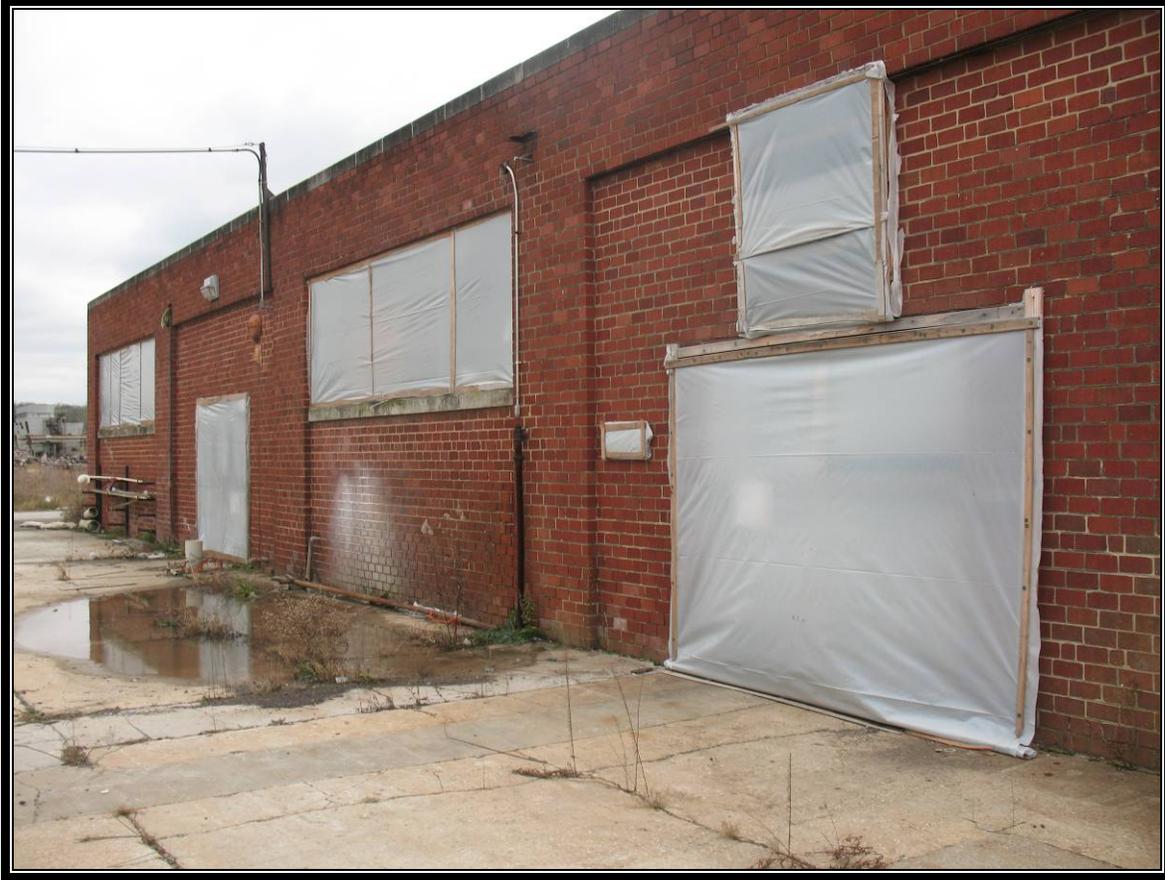
**OFFICIAL PHOTOGRAPH NO. 13
U.S. ENVIRONMENTAL PROTECTION AGENCY**

- A building identified as the Power Mechanical Shop – Rayon Staples contained a large number of full asbestos disposal bags with generator labels. All windows and doors were covered with polyethylene sheeting and secured with wooden slats. The disposal bags were located at the northern end of the building.

Subject: Northern end of Power Mechanical Rayon Staple building used to store bags of asbestos waste for disposal. Wood slats and polyethylene sheeting was used to seal the entrances and windows of the building.

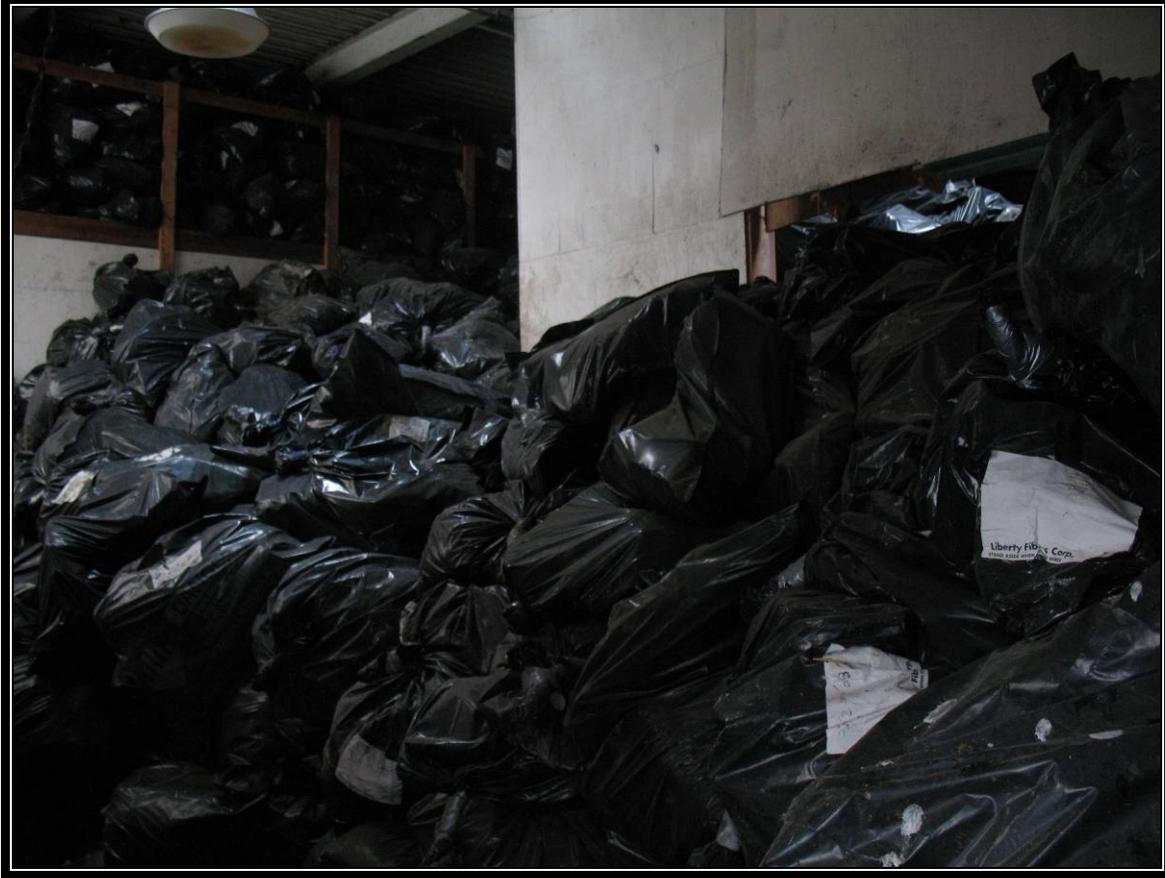
OFFICIAL PHOTOGRAPH NO. 15
U.S. ENVIRONMENTAL PROTECTION AGENCY

Subject: Bagged asbestos waste stored inside the Power Mechanical Rayon Staple building awaiting disposal.

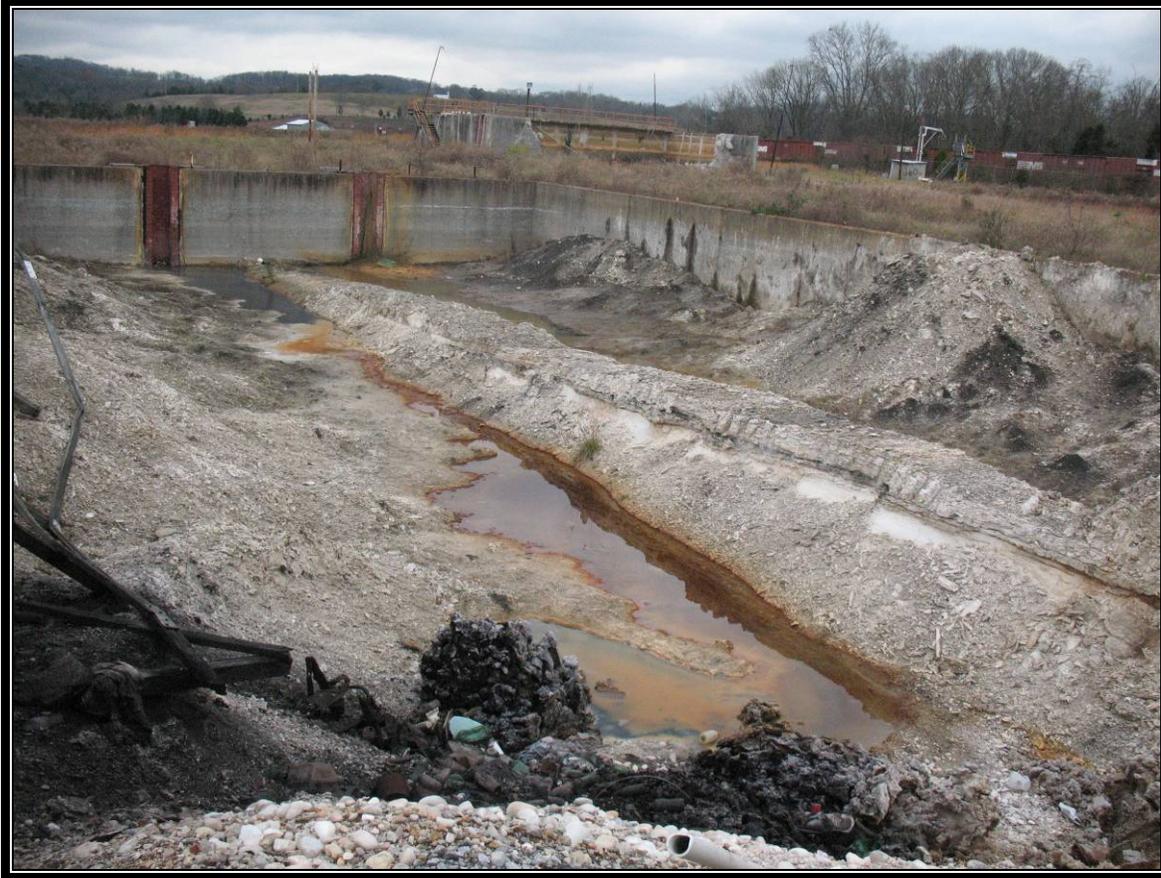
OFFICIAL PHOTOGRAPH NO. 15
U.S. ENVIRONMENTAL PROTECTION AGENCY

- Two neutralization basins located on the western side of the facility were suspected to contain waste from lye neutralization processes conducted at the facility.

Subject: One of two neutralization pits located in the northwestern portion of the property. The contents of both pits are unknown.

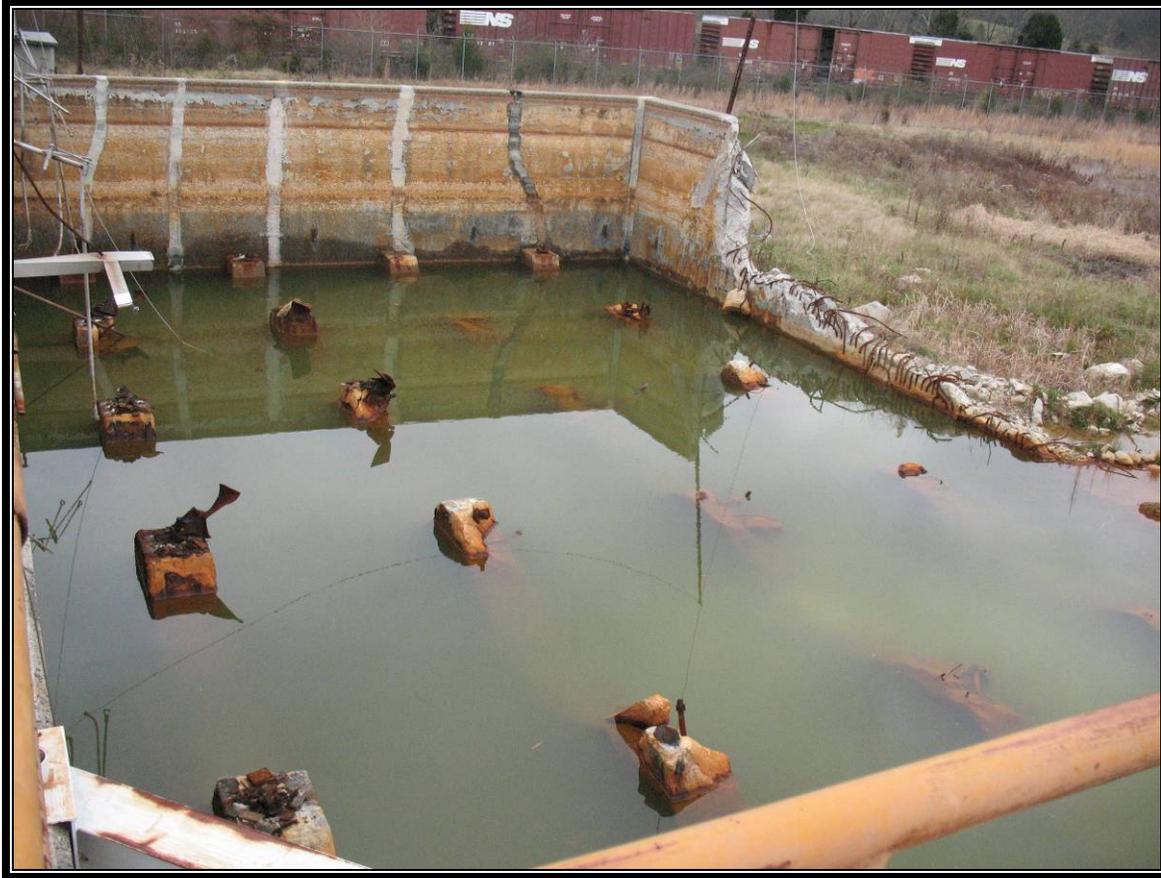
OFFICIAL PHOTOGRAPH NO. 16
U.S. ENVIRONMENTAL PROTECTION AGENCY

- The carbon disulfide tank vault observed in the northwestern corner of the property did not contain any carbon disulfide tanks. According to Mr. Sawyer, the carbon disulfide tanks were removed around spring 2009 because of concern for explosion and were sold for scrap metal. Mr. Sawyer also indicated that the tanks did not contain carbon disulfide at the time of removal. During the site reconnaissance, the water that submerged the tanks remained in the vault.

Subject: Concrete vault that previously held six 10,000-gallon carbon disulfide tanks submerged in water. Owner removed east side of vault wall to salvage tanks. Therefore, the contents of the vault appear to be leaking onto the ground surface on the eastern side of the vault.

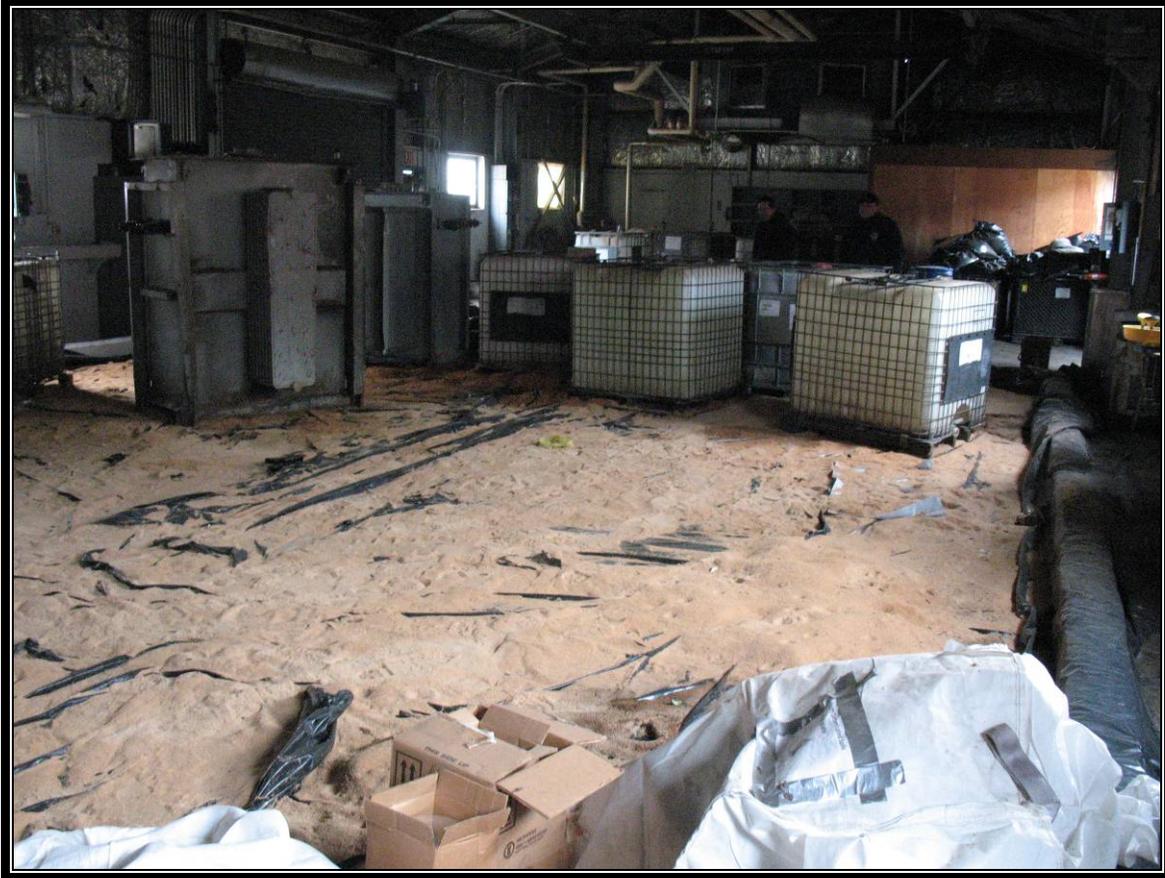
OFFICIAL PHOTOGRAPH NO. 17
U.S. ENVIRONMENTAL PROTECTION AGENCY

- The Welding Shop contained two PCB transformers, 89 capacitors in three lined totes, two plastic totes labeled "PCB Oil," and two super sacks labeled, respectively, "Mercury Contaminated Equipment" and "Mercury Contaminated Soil" in a containment area. The containment area was observed to be constructed of a 6- to 8-inch high concrete berm and concrete floor; the concrete floor was lined with black polyethylene sheeting and saw dust. Approximately 200 square feet (ft²) of sawdust under transformers and totes was visibly wet. The plastic totes located at the southern end of the building were labeled "Waste Oil" and appeared to be empty. Seven 55-gallon plastic drums were located at the northern end of the building. Two drums were labeled "Corrosive," two drums were labeled "Cooling Water Treatment Solutions," and three drums were not labeled but appeared to contain waste oil.

Subject: Polychlorinated biphenyl (PCB)-contaminated transformers and plastic totes containing PCB oil inside the containment area located inside the Welding Building. The containment area has a 6- to 8-inch high berm, concrete floor, and is lined with black polyethylene sheeting. Saw dust is located on top of the polyethylene sheeting as an absorbent.

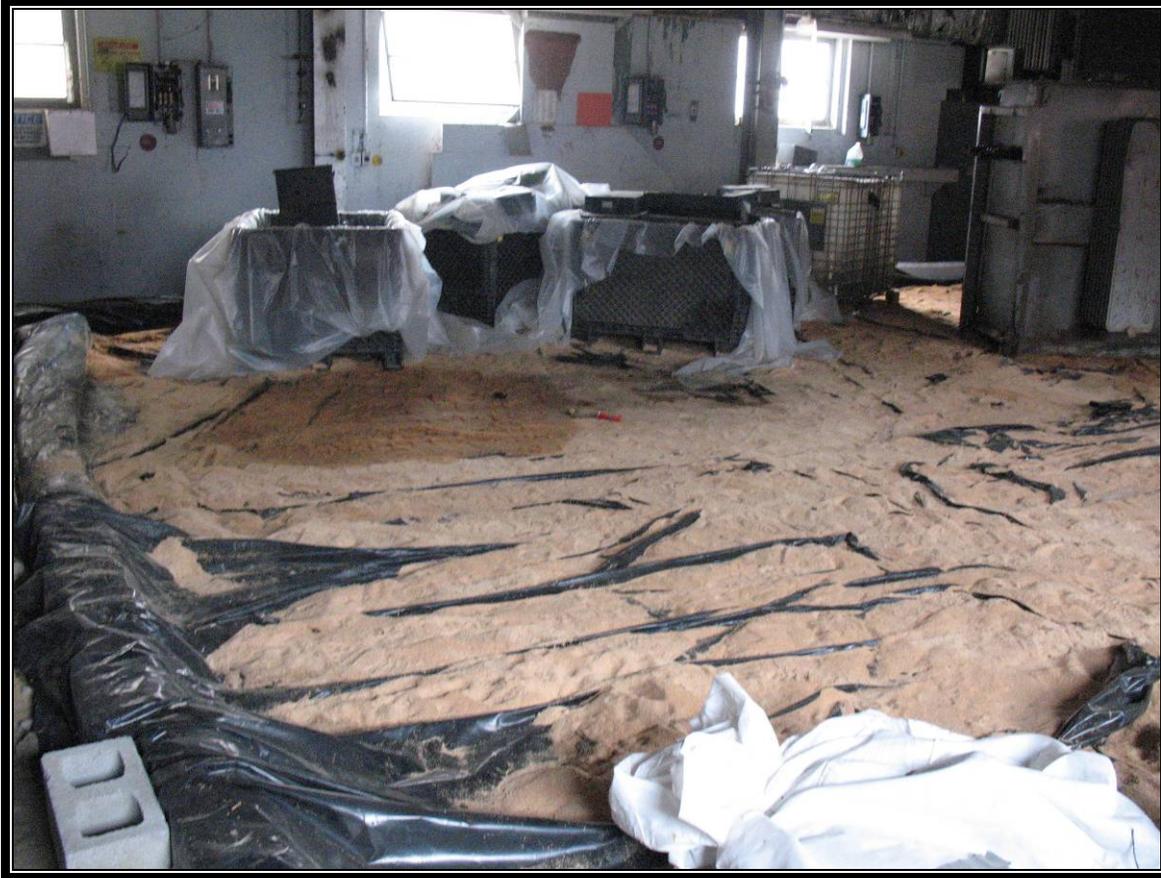
OFFICIAL PHOTOGRAPH NO. 18
U.S. ENVIRONMENTAL PROTECTION AGENCY

Subject: Three lined, plastic totes with PCB-contaminated capacitors inside the containment area located in the Welding Building. A small area in front of one of the totes appears to be wet.

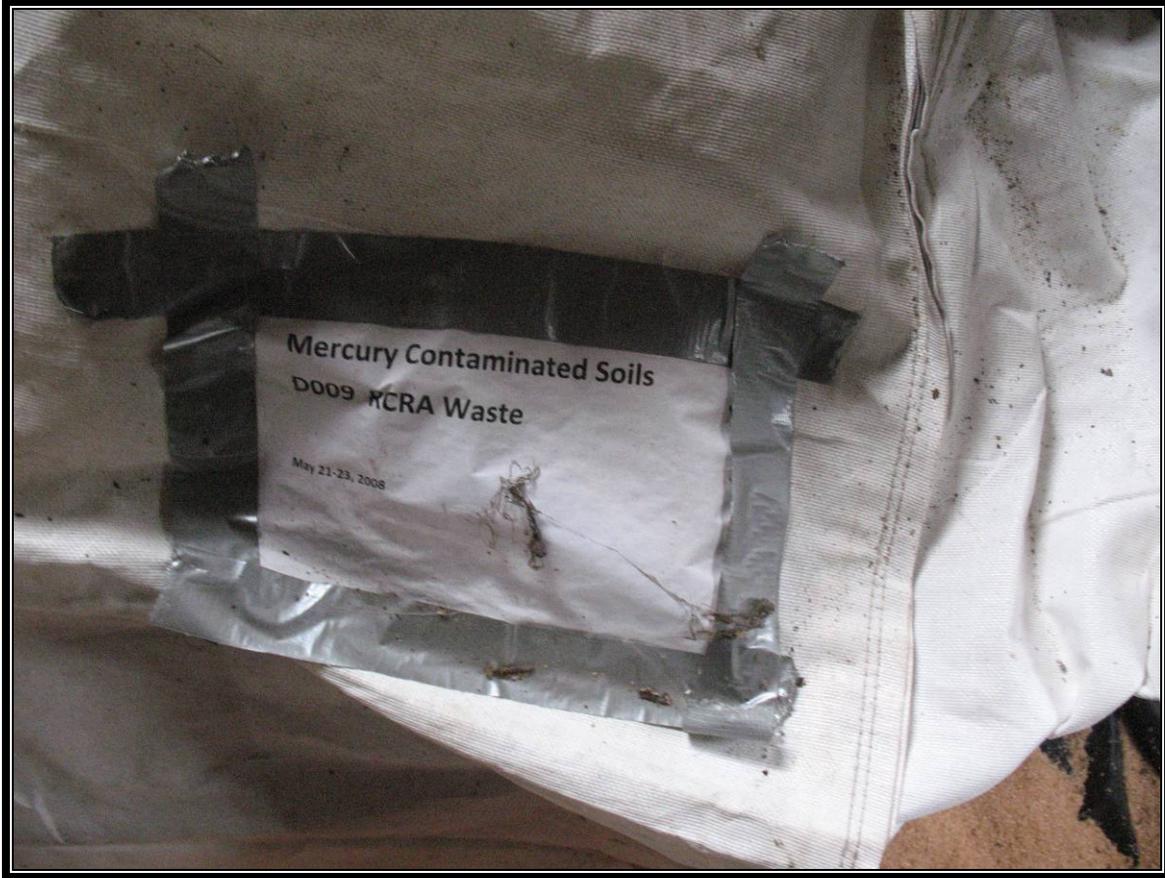
OFFICIAL PHOTOGRAPH NO. 19
U.S. ENVIRONMENTAL PROTECTION AGENCY

Subject: Mercury-contaminated soil stored inside a super-sack in the containment area located in the Welding Building.

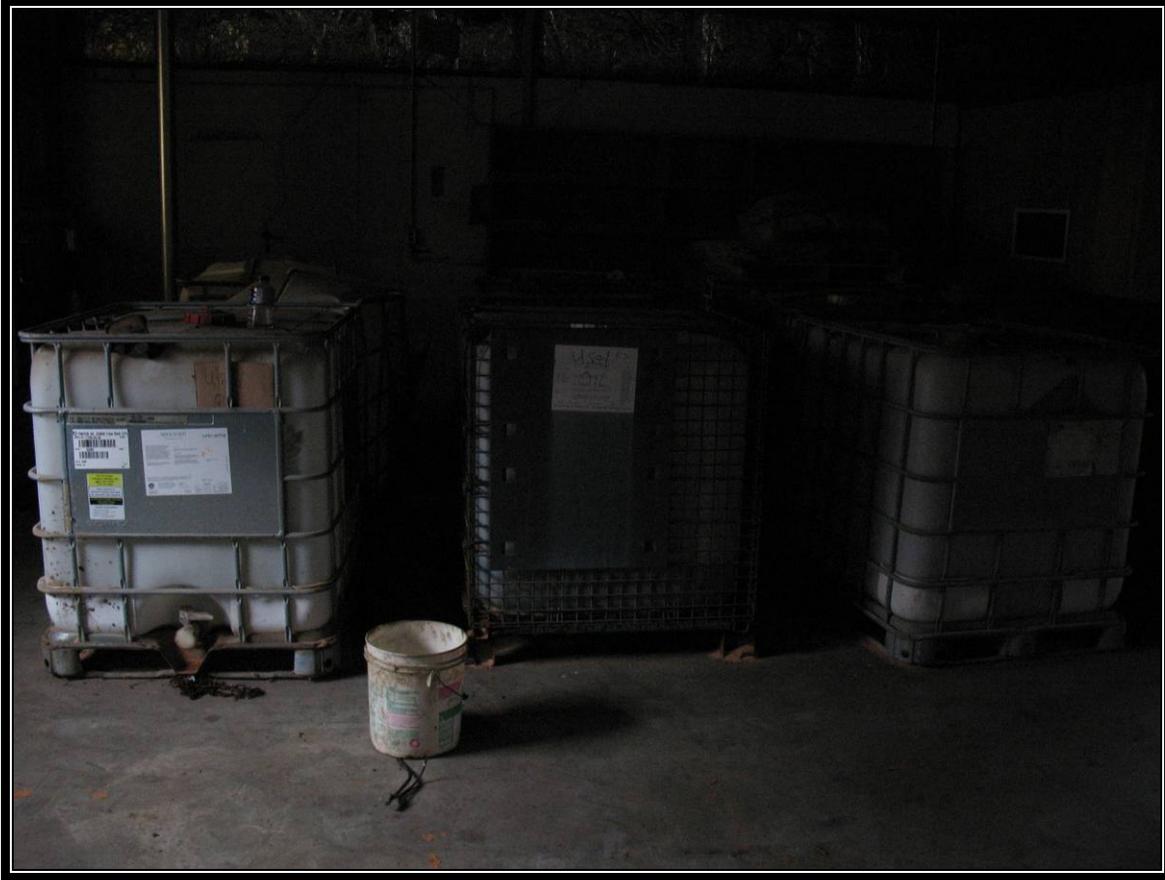
**OFFICIAL PHOTOGRAPH NO. 20
U.S. ENVIRONMENTAL PROTECTION AGENCY**

Subject: Plastic totes labeled "Waste Oil" staged at the southern end of the Welding Building.
