January 18, 2011

**Subject: Final Site Reconnaissance Letter Report
Liberty Fibers Site
Lowland, Hamblen County, Tennessee
EPA Contract No. EP-W-05-054
TDD No. TTEMI-05-003-0041**

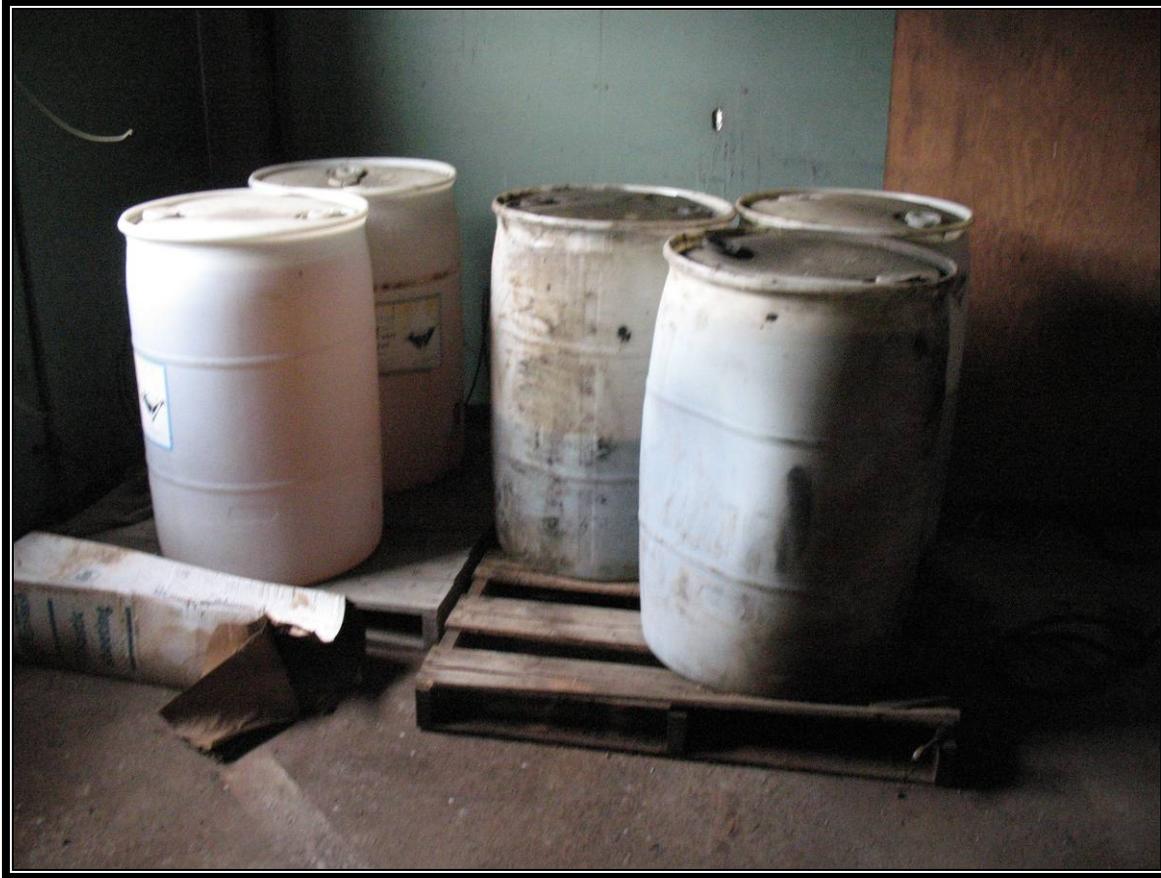
**OFFICIAL PHOTOGRAPH NO. 21
U.S. ENVIRONMENTAL PROTECTION AGENCY**

Subject: Plastic 55-gallon drums stored on pallets at the northern end of the Welding Building. The two drums on the left are labeled "Cooling Water Treatment." The three drums on the right appeared to contain waste oil.

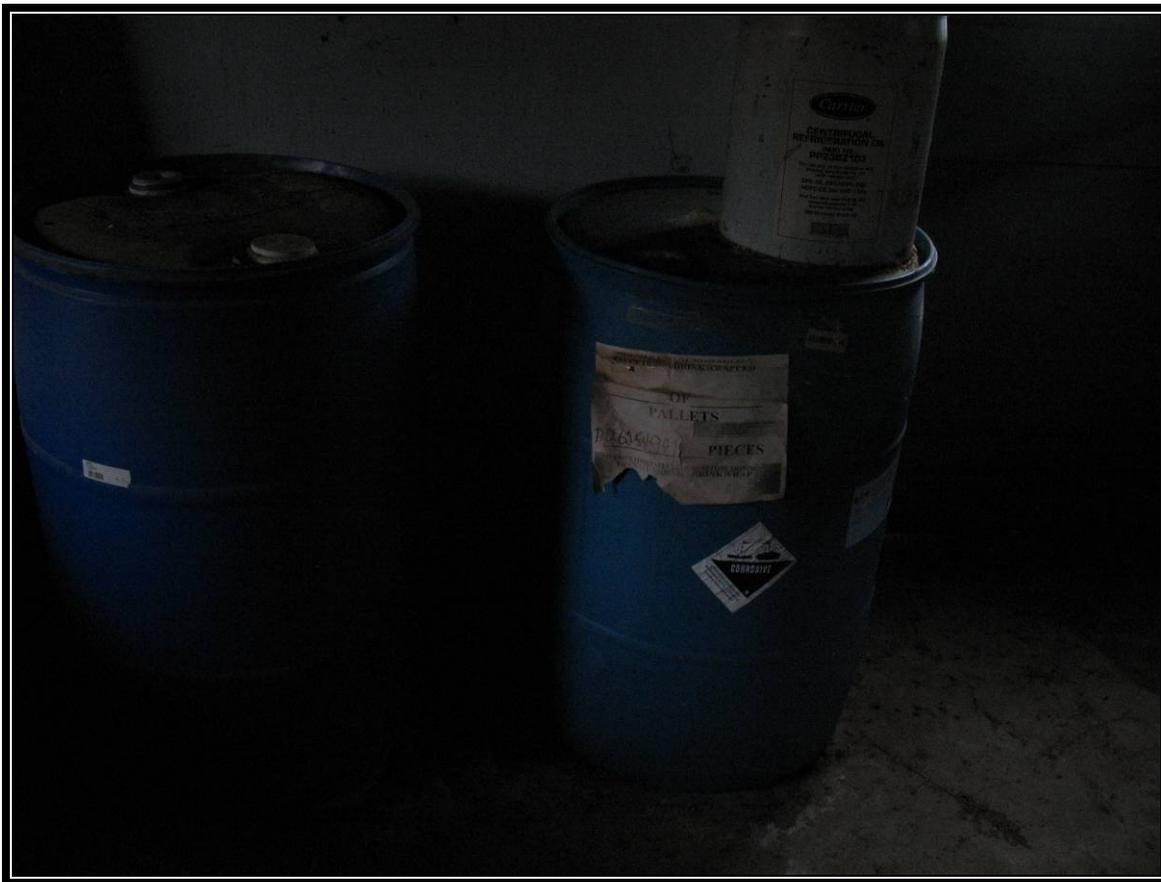
OFFICIAL PHOTOGRAPH NO. 22
U.S. ENVIRONMENTAL PROTECTION AGENCY

Subject: Two 55-gallon drums labeled "Corrosive" located at the north end of the Welding Building. The drums were not stored on pallets.
