**Environmental and Occupational  
Consulting and Training, Inc.**

**PHOTOS-**

Boiler Building and  
Turbine Building  
Main floor  
Cogswell Property LLC  
431 Helen Ave.  
Otsego, MI 49078

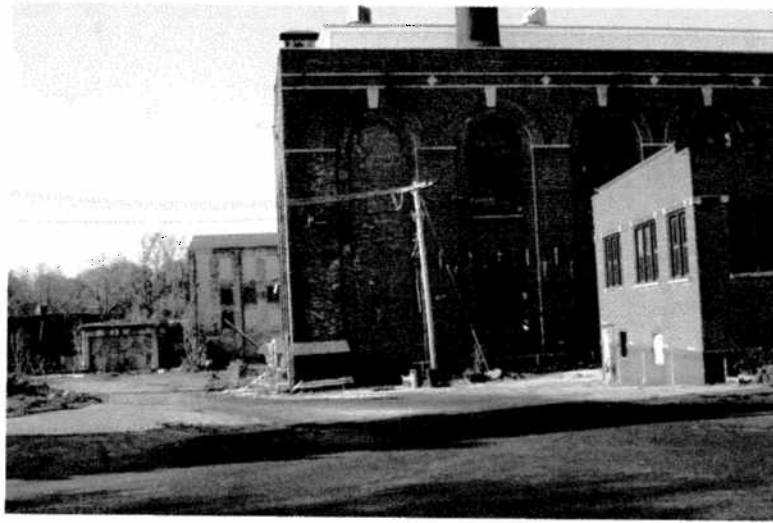
7495-01 Looking south at the boiler house & turbine building and the entrance used to enter the building. The arrow indicates the best entrance for set-up of a decontamination unit.

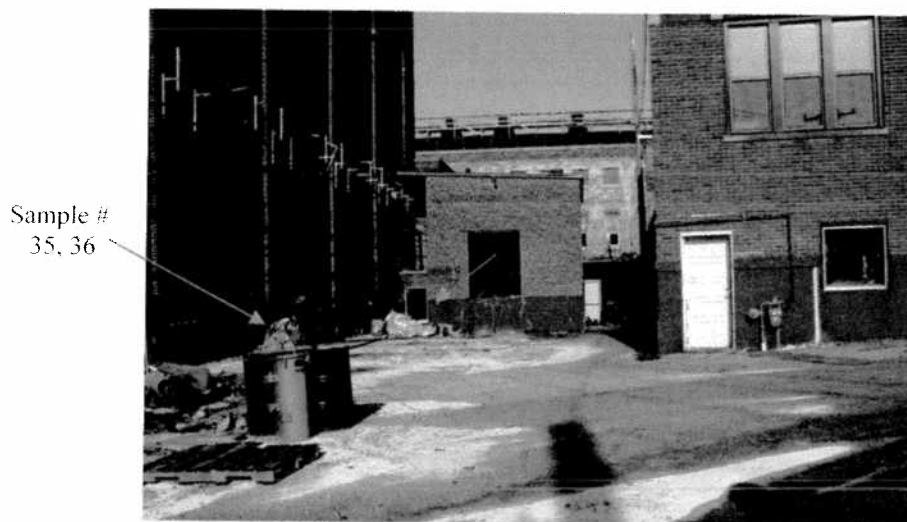
7495-02 Looking east toward the turbine building track bay entrance and roll-up door which is missing. The arrow in this picture also indicated a good placement for an entrance/exit decontamination unit especially for clean-up of the turbine basement. All debris is negative for asbestos except for feed line penetration sample # 35 & 36.

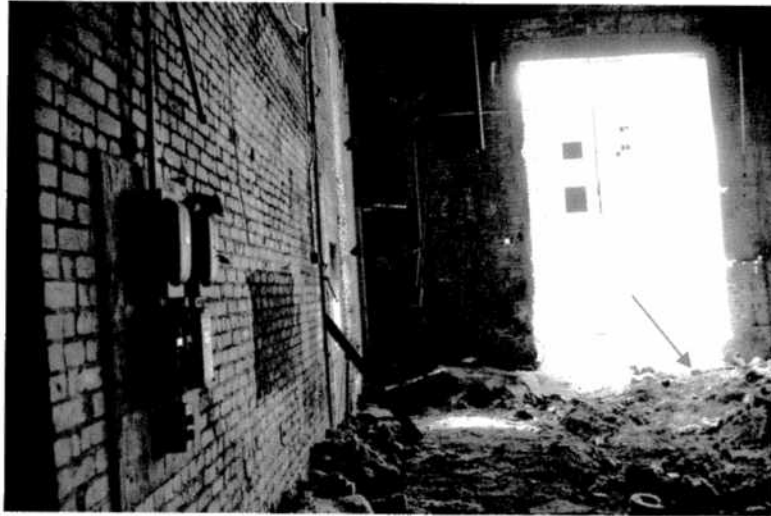
7495-03 After entering and climbing the stairs to the main floor looking south toward a former roll-up door which is missing leaving the floor open to the outside environment. Notice the asbestos containing debris on the floor.

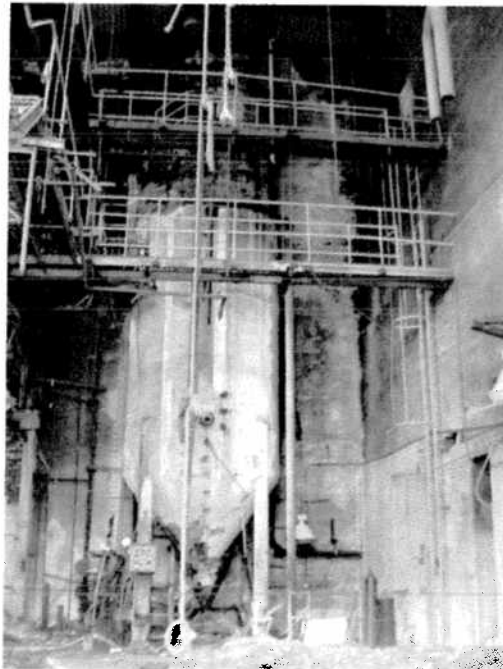
7495-04 Looking from the roll-up door back at the stairs and entrance to the boiler building. Tank is covered in asbestos insulation which is damaged. It is approximately 10 ft in diameter and 40 ft high. Take note of the mounds of asbestos contaminated debris on the floor. The ladder to the top is only firmly attached at the top and should not be used.

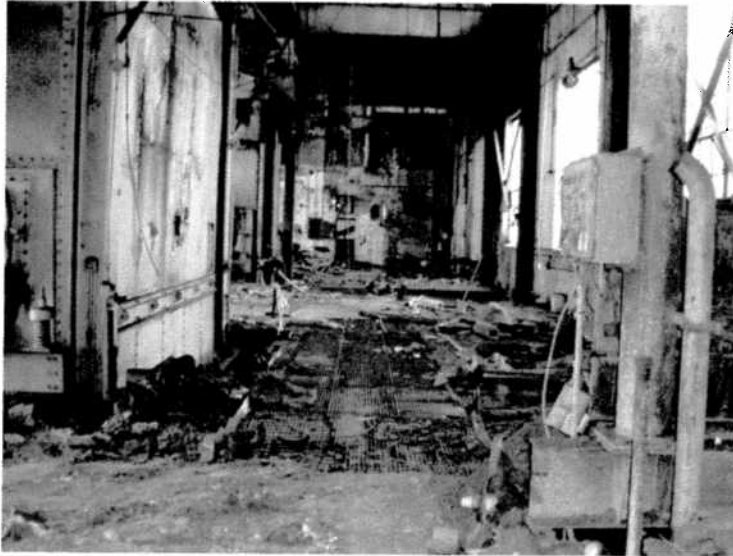
7495-05 On the main floor of the boiler building looking east. Notice the damaged grating on the floor. There are numerous open holes and damaged grating throughout floor area.

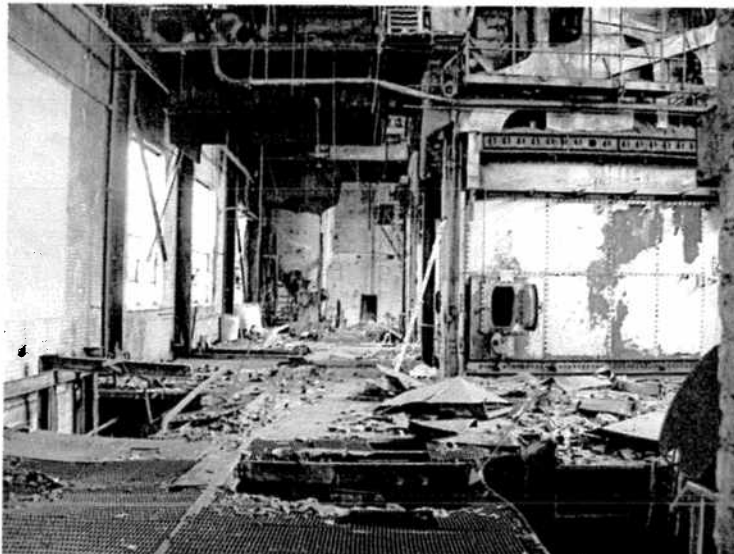
7495-06 On the main floor looking west. Notice the damaged grating on the floor. There are numerous open holes and damaged grating throughout floor area.

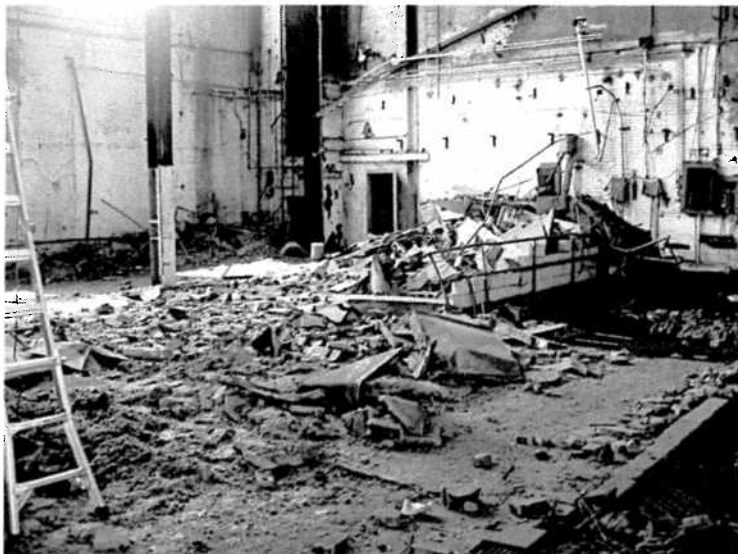
7495-07 On the main floor looking south west. More asbestos contaminated debris west of Boiler number 2.

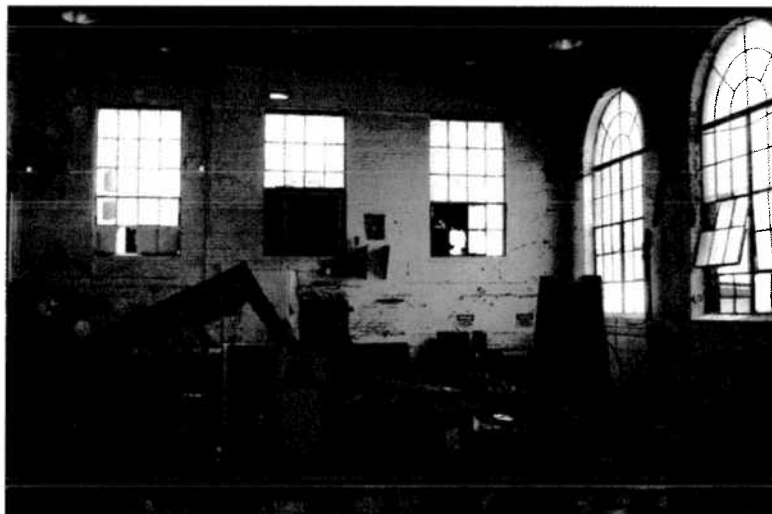
7495-08 Looking across the main floor of the turbine buildings main room the pit exposing the basement is in the foreground and debris is located in the background.

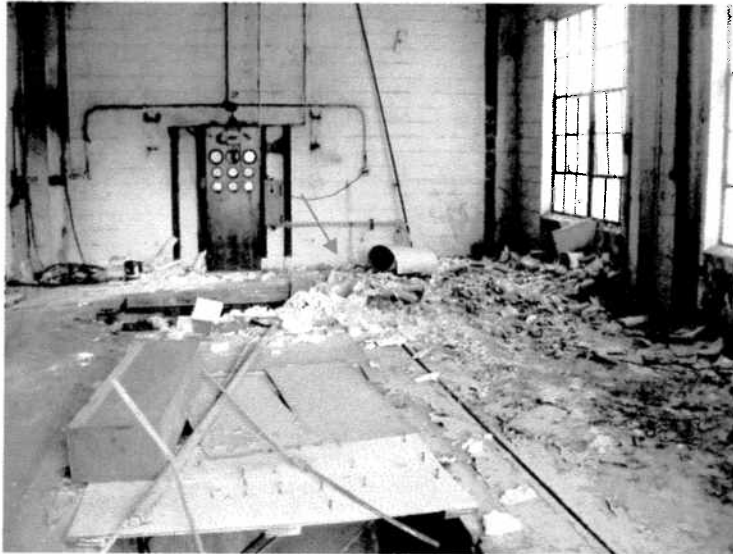
7495-09 Looking west from the north turbine room roll-up door . Notice the asbestos contaminated debris field in the picture. The half covered open pit has allowed some material to fall to the basement also hiding hidden open holes to the floor below.

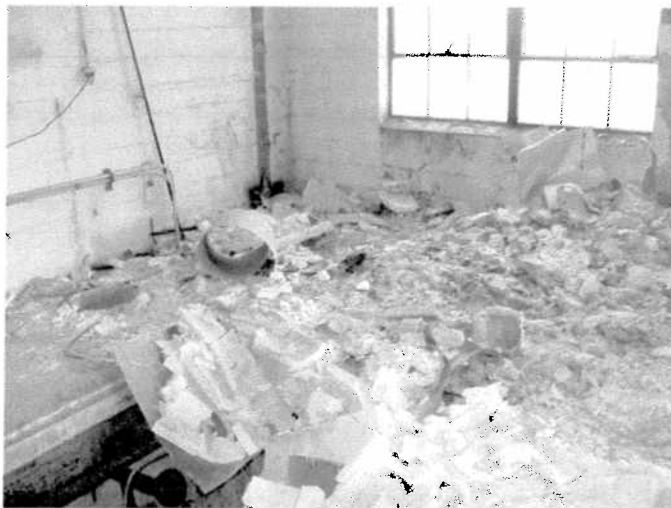
7495-10 Looking north northwest in the north room of the turbine building at the asbestos debris field from the previous picture. The half covered open pit in the bottom left of the picture has allowed material to fall to the basement.

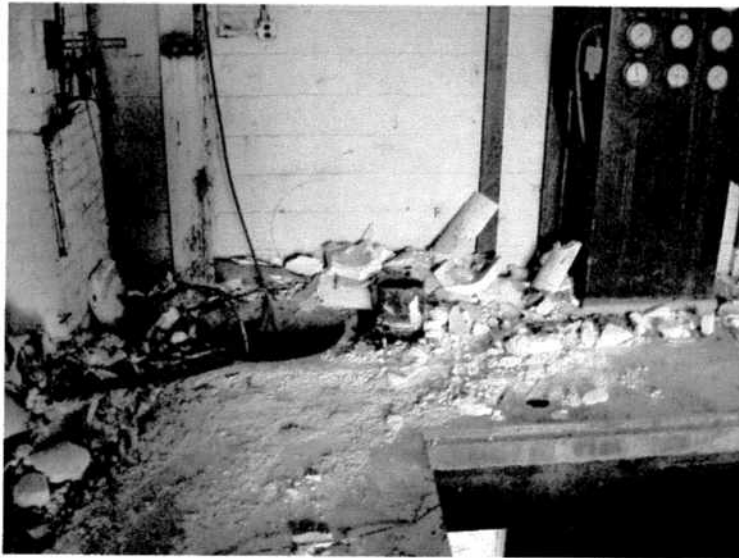
7495-11 Looking east on the south side of the pit in the north room of the turbine building on the main floor. The debris pile is asbestos containing waste material.

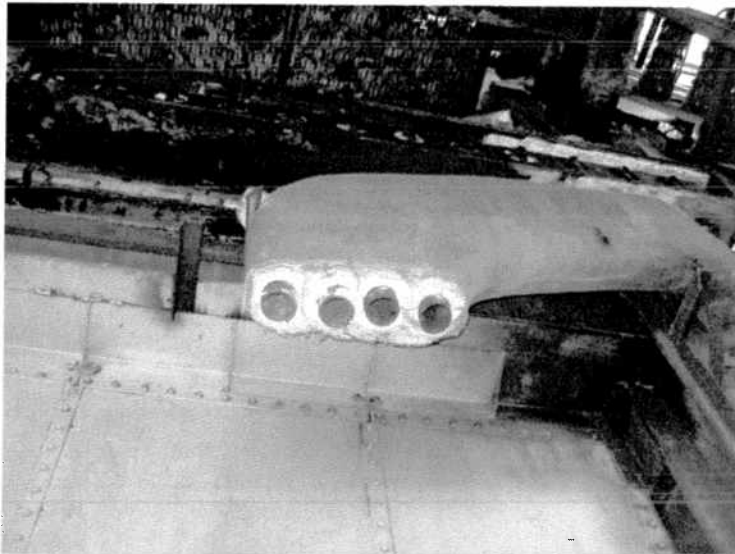
7495-12 In the boiler building on the boiler #2 the wrapped pipes have asbestos insulation and are damaged and need to be abated after the main floor is cleaned.

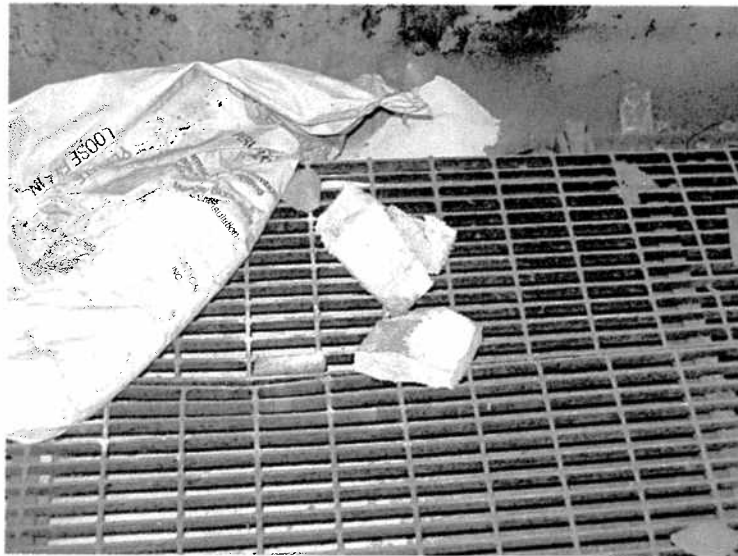
7495-13 In the boiler building by the boiler #2 on the north side asbestos insulation from the wrapped pipes above has fallen down.

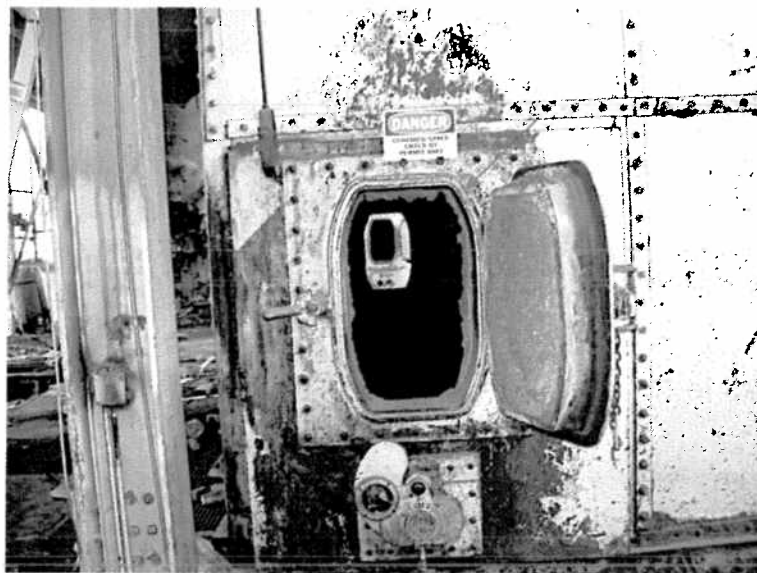
7495-14 The gaskets lining the doors of both of the boilers are positive for asbestos .

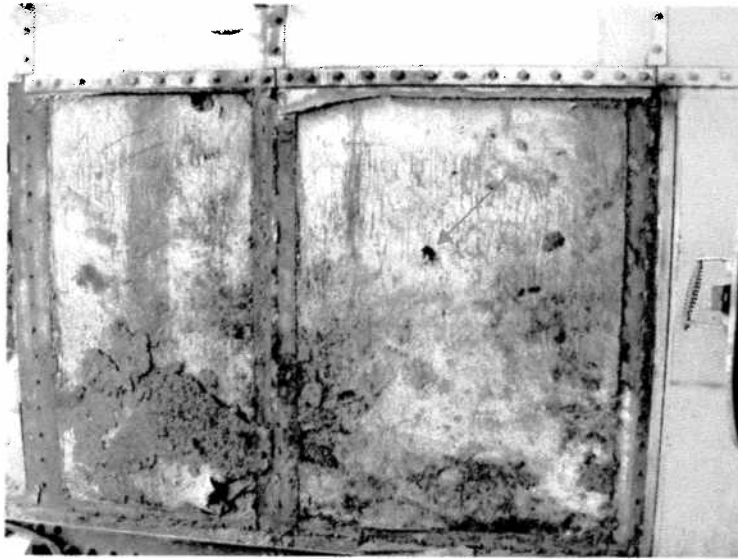
7495-15 In the boiler building on boiler #2 on the east side showing asbestos insulation under the paneling which is present on all sides of the boilers.

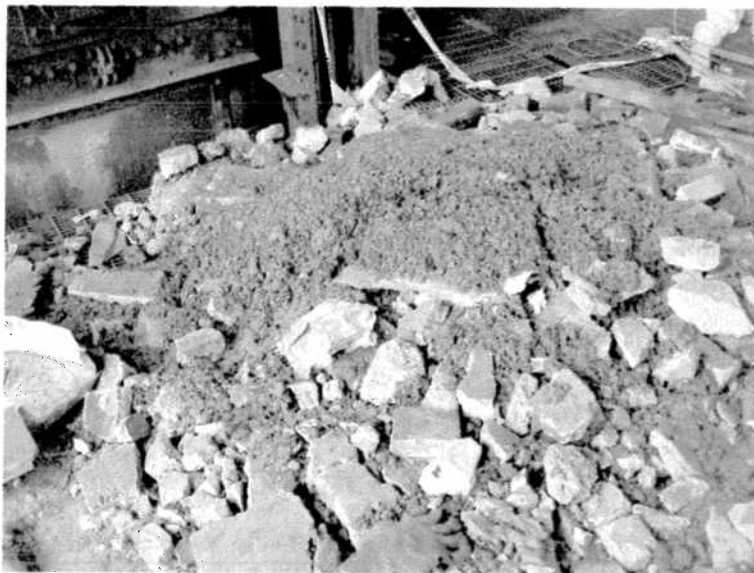
7495-16 In the boiler building near boiler #2 on the east side showing asbestos containing debris pile.

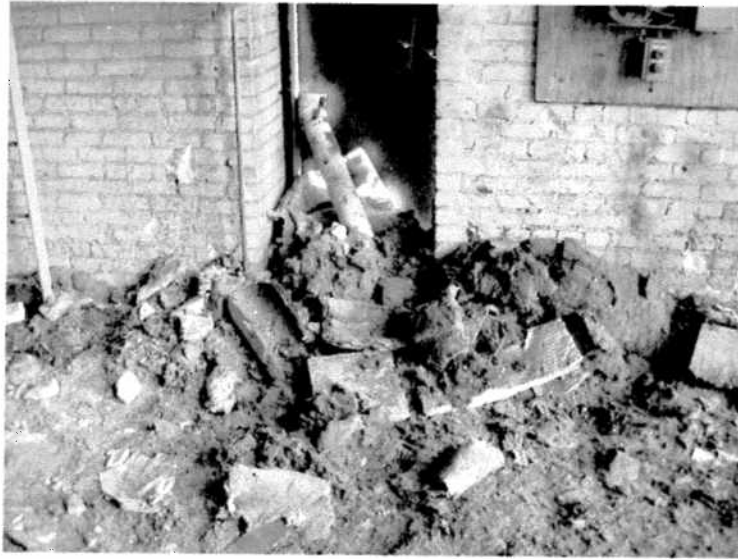
7495-17 On the main floor in the boiler building where samples 102 & 103 in the debris pile were taken and are positive for asbestos.

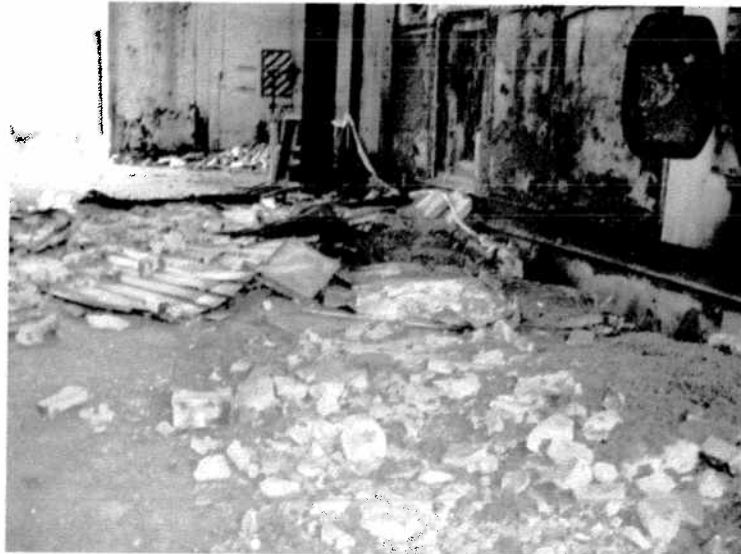
7495-18 On the main floor in the boiler building the piles of debris are positive for asbestos.

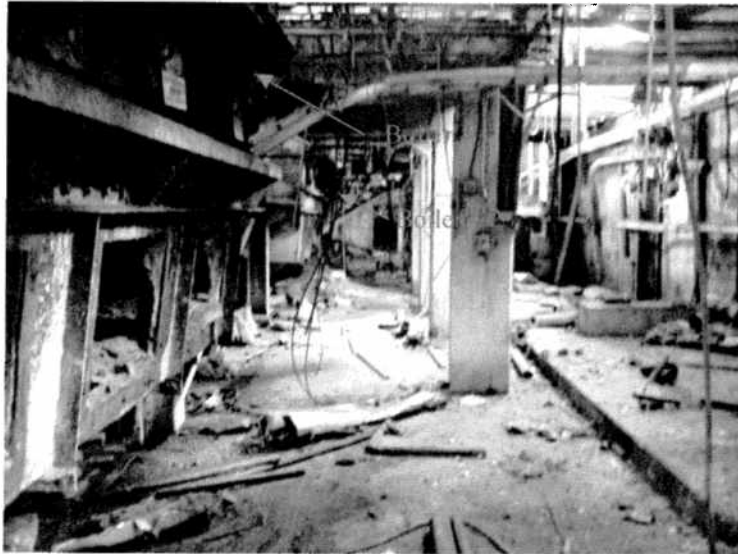
7495-19 In the basement of the boiler building looking west on the north side. The boiler drums insulation is asbestos containing and is still installed on boiler #2 and the asbestos is exposed and damaged.. In boiler #1 the panels are off and the asbestos is missing.

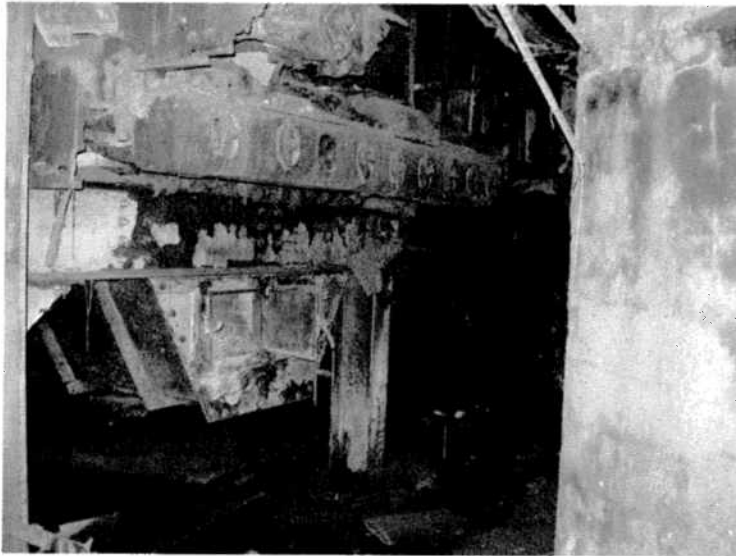
7495-21 In the basement of the boiler building under the boilers. Notice minimal debris under boiler.

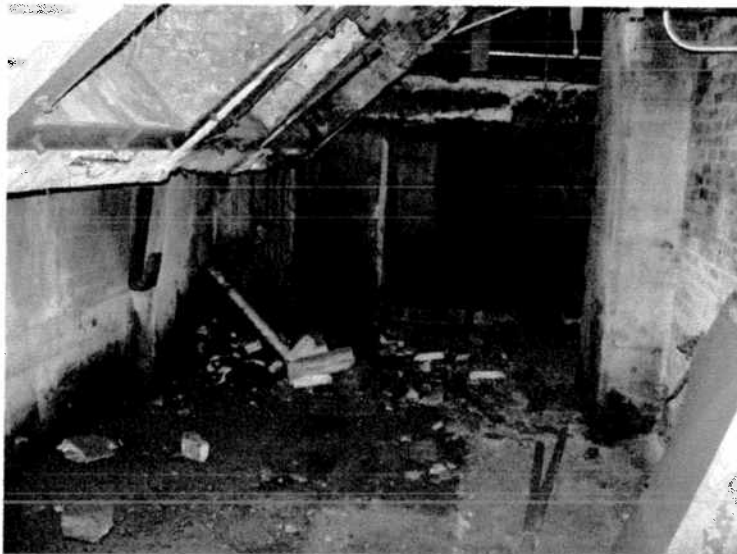
7495-22 In the basement of the boiler building looking East at the ash cleanout ports. Notice minimal debris.

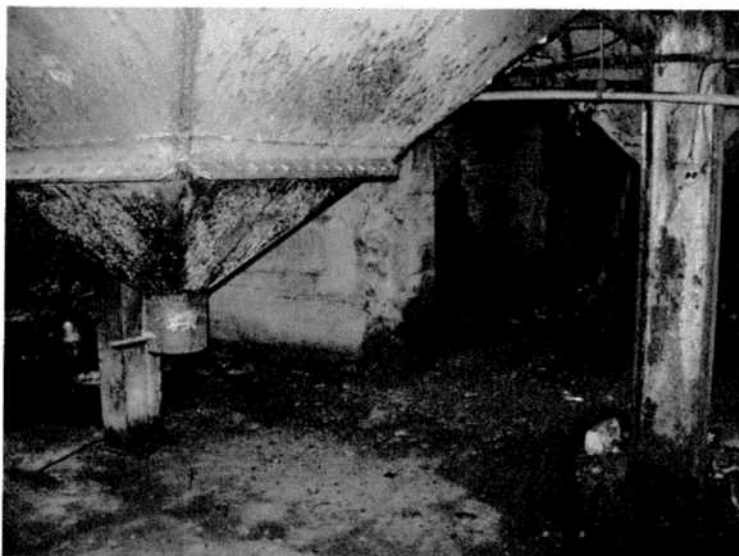
7495-23 In the basement of the boiler building under the boiler notice the lack of debris. Not much fell from above but still some fell.

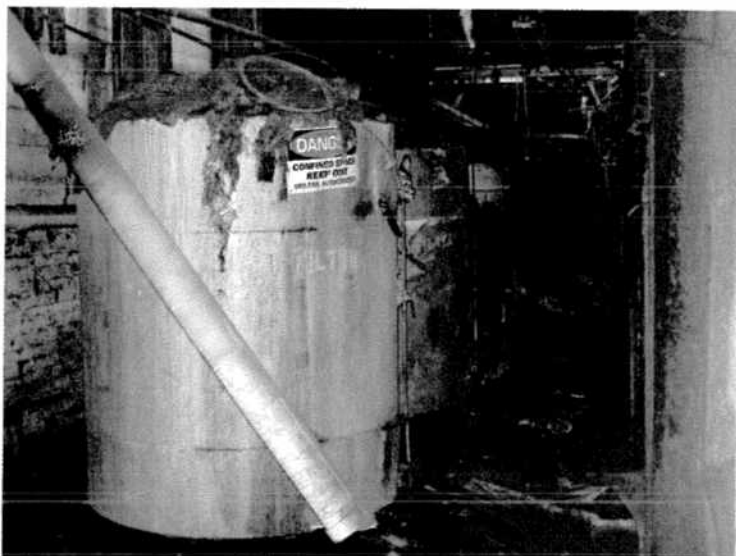
7495-24 In the basement of the boiler building looking east at the tanks 1, 2 and 3 on the north wall. The tanks do not contain asbestos insulation.

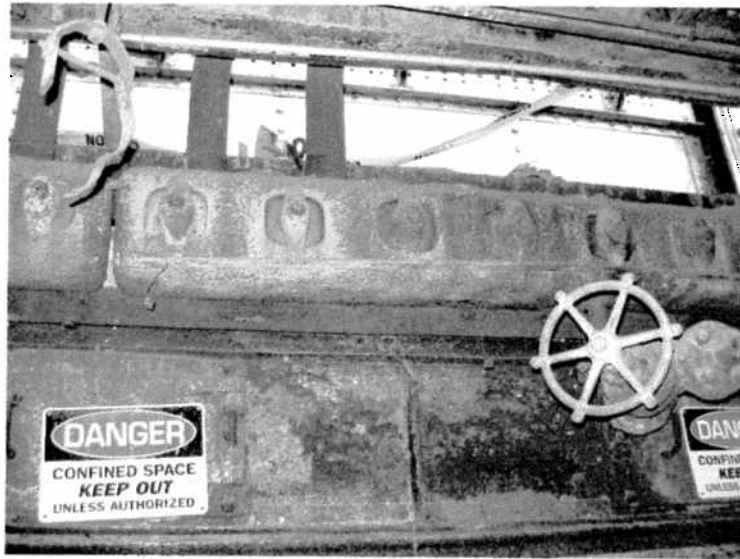
7495-25 In the basement of the Boiler building looking at the Boiler #1 base. Ports are missing asbestos insulation present on boiler #2.

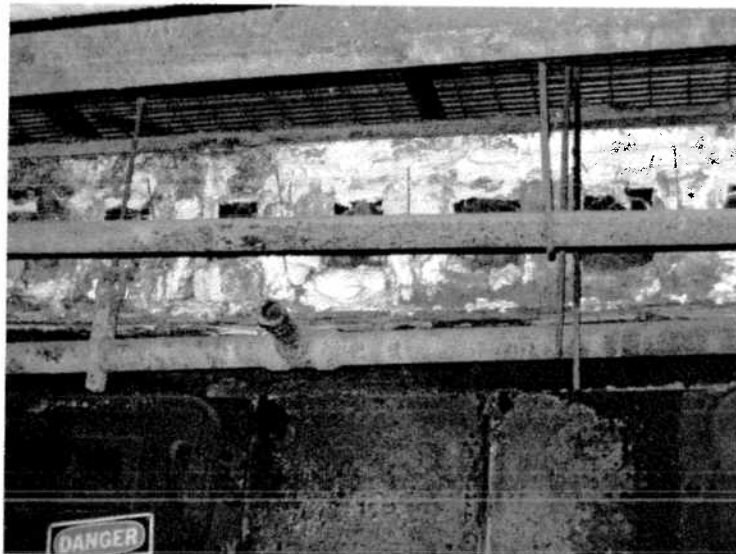
7495-26 In the basement of the boiler building looking at the boiler #2 base. Ports with exposed asbestos insulation which is severely damaged.

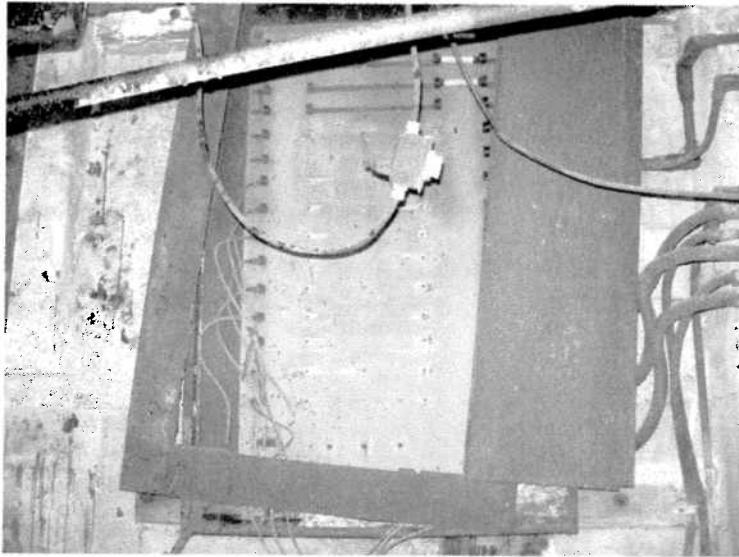
7495-27 An electrical panel on the south side of the basement of the boiler building it was found to be slate and not transite.

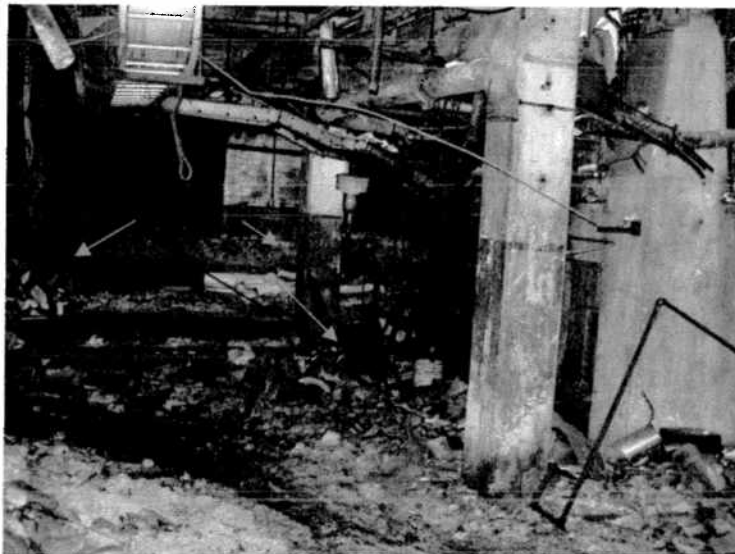
7495-28 The basement of the turbine building looking south from the north wall of the main room. The floor is completely covered with asbestos containing debris from piping above. Several piles of debris have asbestos stickers in them.

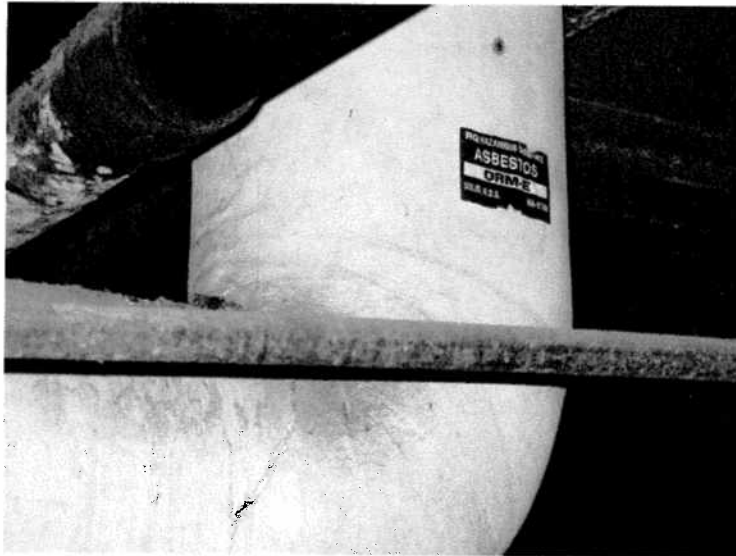
7495-29 In the basement of the turbine building this is an elbow that clearly shows a asbestos sticker on the south side of the main room and under the locker room above.

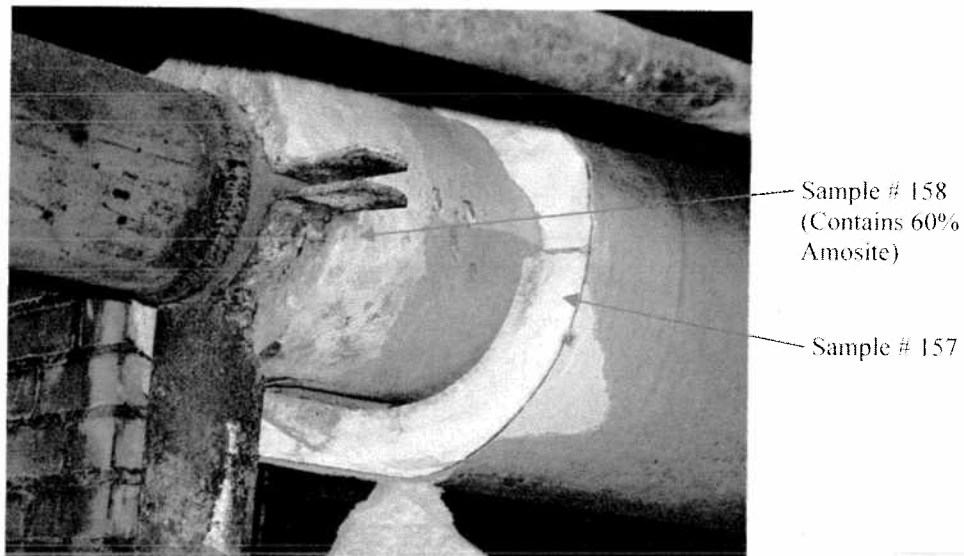
7495-30 In the basement of the turbine building on the south side of the main room and under the locker room above continuation from the picture above showing 2 layers of insulation. Sample # 157 outer layer and sample # 158 inner layer.

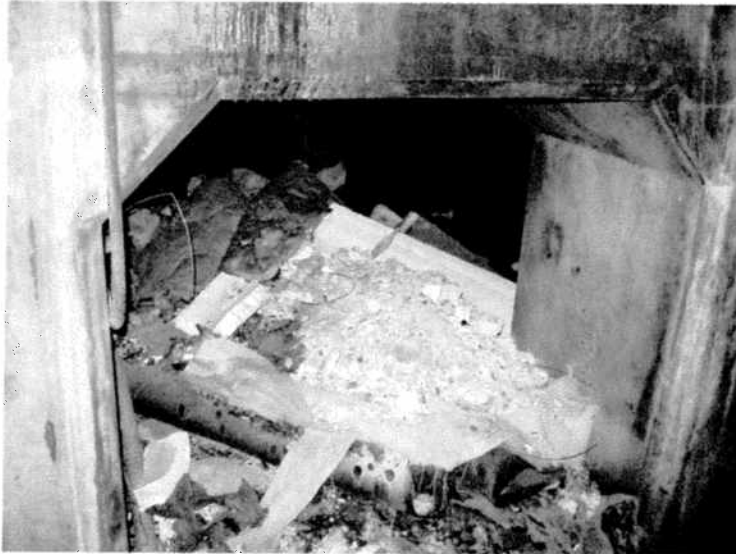
7495-31 In the turbine building basement under the north turbine room. The raised platform for the pit has asbestos debris piled under it. Sample # 159 was taken in this location.

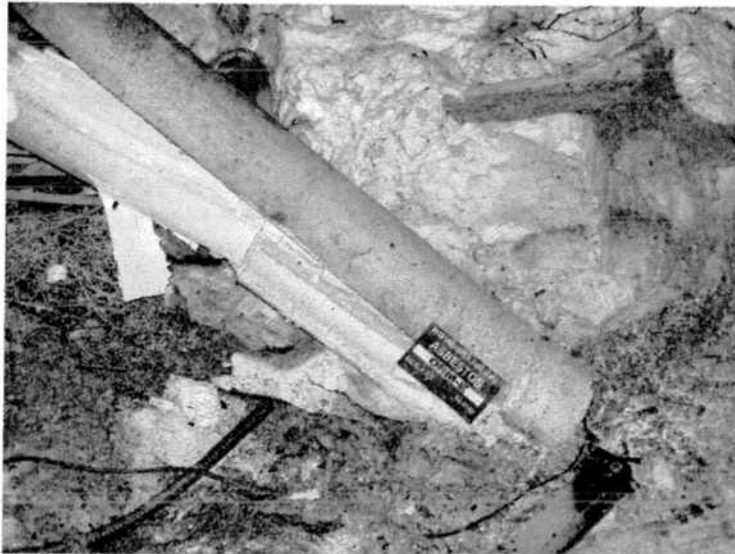
7495-32 This is another picture of debris on the floor of the turbine building basement clearly showing an asbestos label still on the insulation.

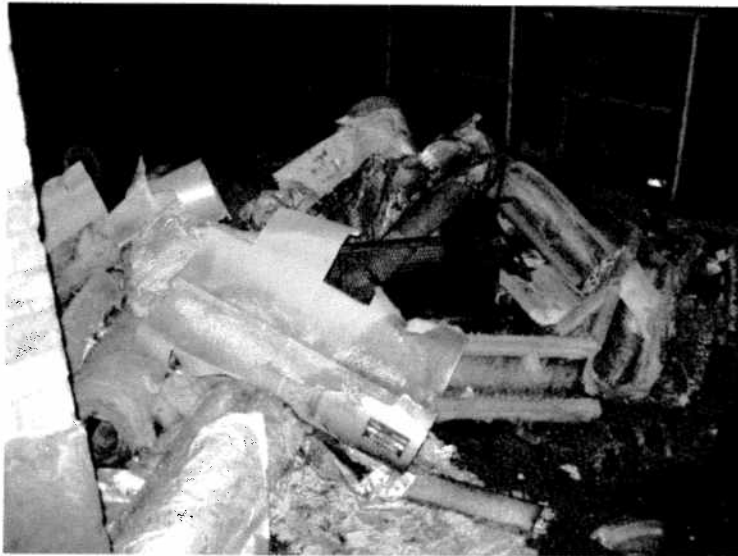
7495-33 This is another debris pile in the turbine building basement with a mix of insulation materials some of which are asbestos containing.

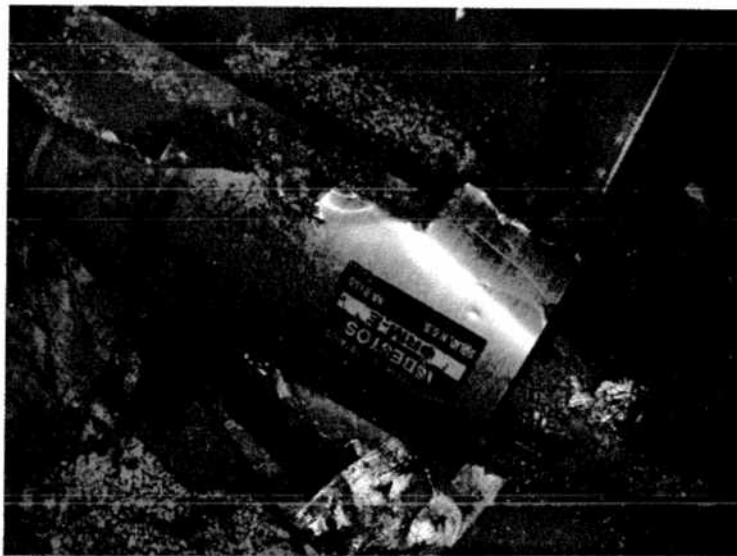
7495-34 This is a close-up of the picture 7495-31 showing another asbestos label on insulating materials that was torn off.

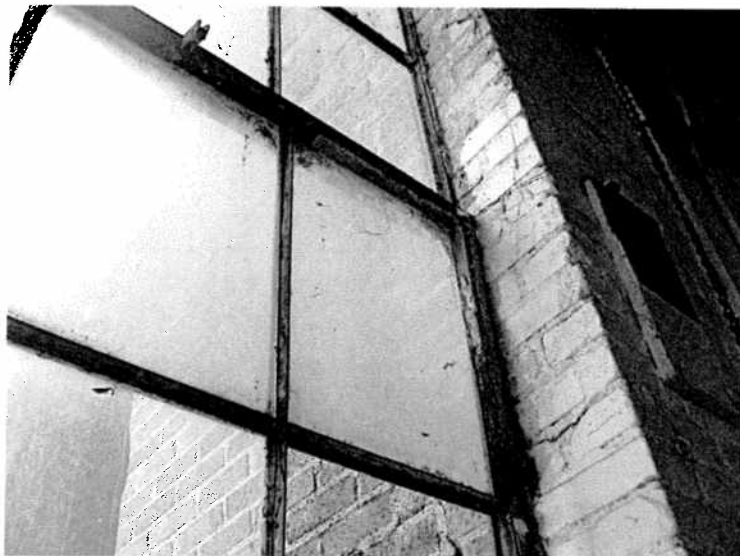
7495-35 This is a picture of the window putty in the turbine building main floor main room. The window putty sample # 136 is asbestos containing and damaged.

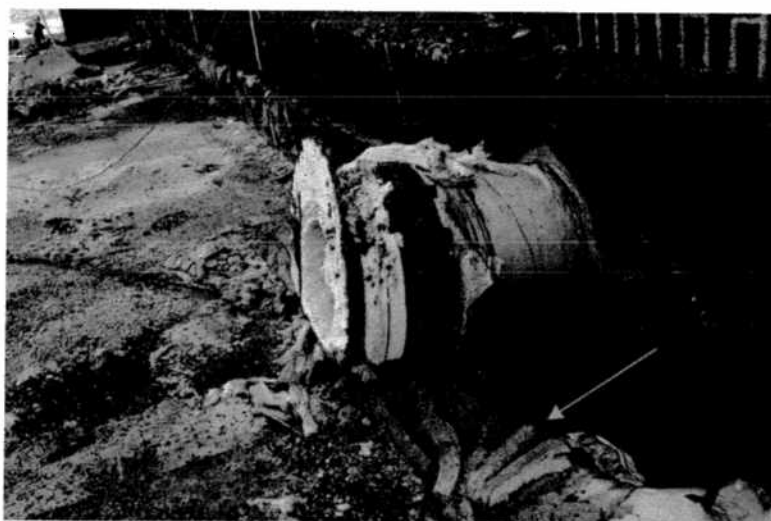
7495-36 This is a picture of the piping exiting the boiler building on the north side of the building with insulation on it. The insulation at the penetration and under it on the ground is positive for asbestos.

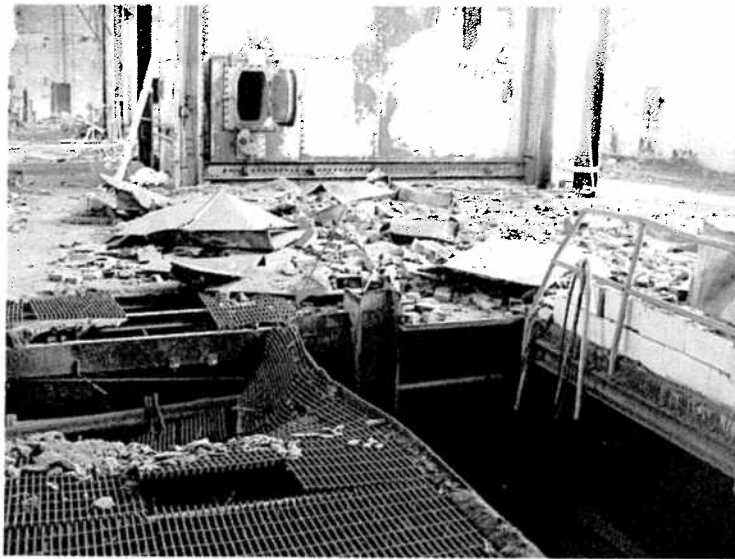
7495-37 This picture shows a closer look at some of the damaged grating within the boiler buildings main floor area.

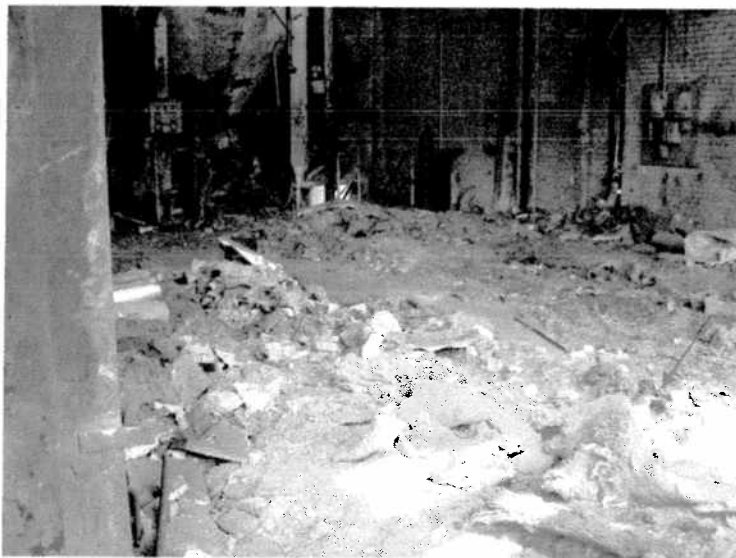
7495-38 This picture shows within the boiler buildings main floor area a debris field filled with asbestos contamination and also numerous holes that go to the floor below and are a hidden hazard for travel through the area.
