**Site:** Detroit Windshield Survey (1539 E Grand Blvd)

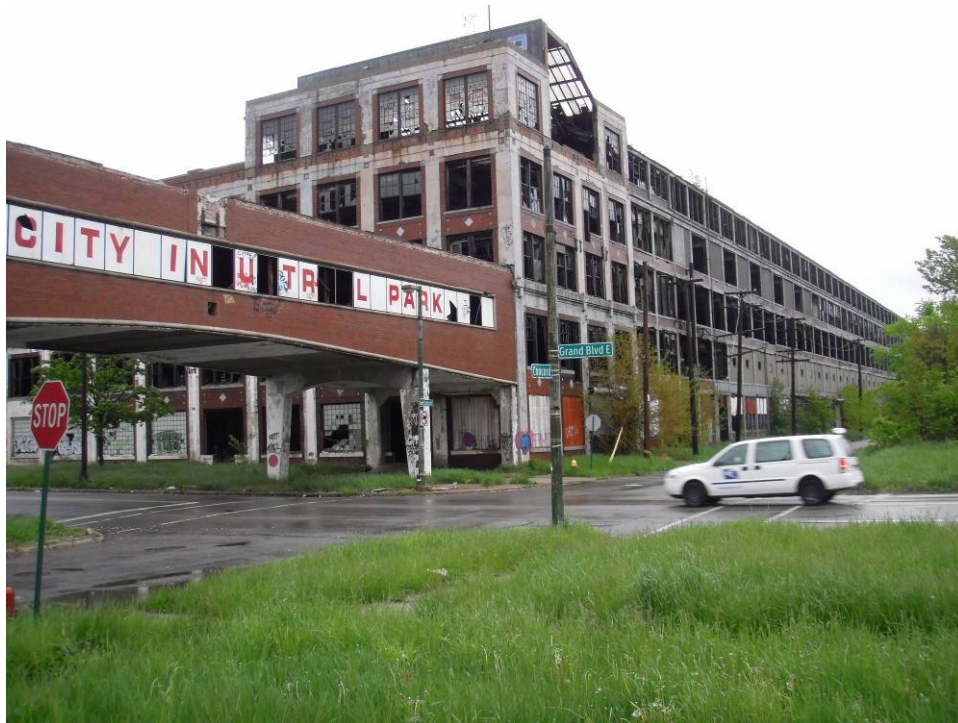
**Photograph No.:** 1

**Subject:** East building frontage (North Series) along E Grand Blvd and Concord Street.

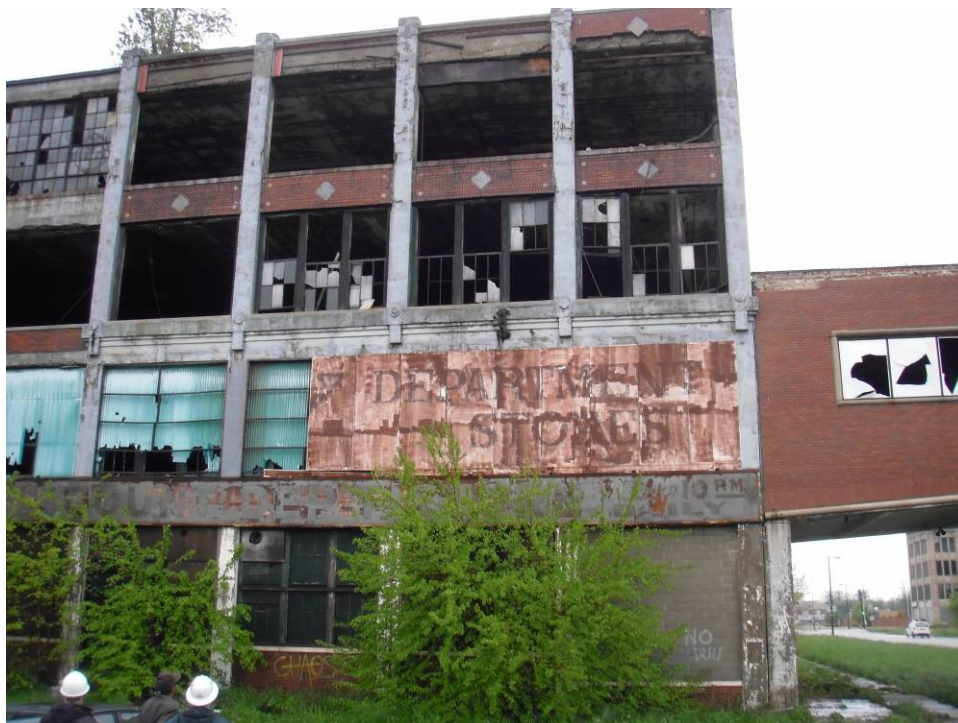
**Photograph No.:** 2

**Subject:** East building frontage (Middle Series) at the corner of E Grand Blvd and Concord Street.

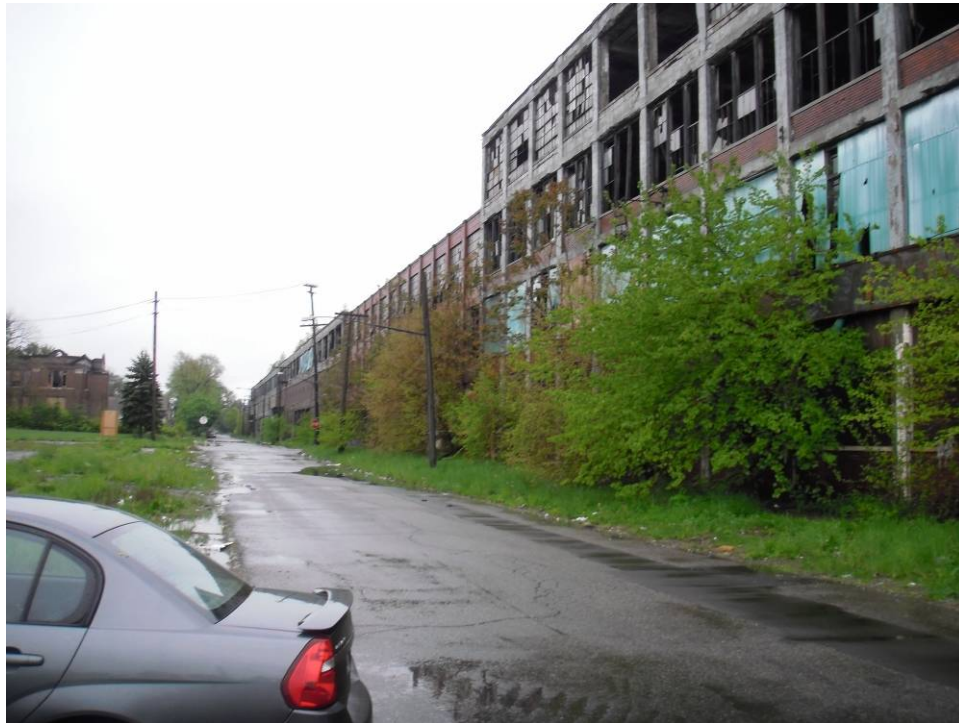
**Photograph No.:** 3

**Subject:** East building frontage (Middle Series and South Series) along Concord Street.

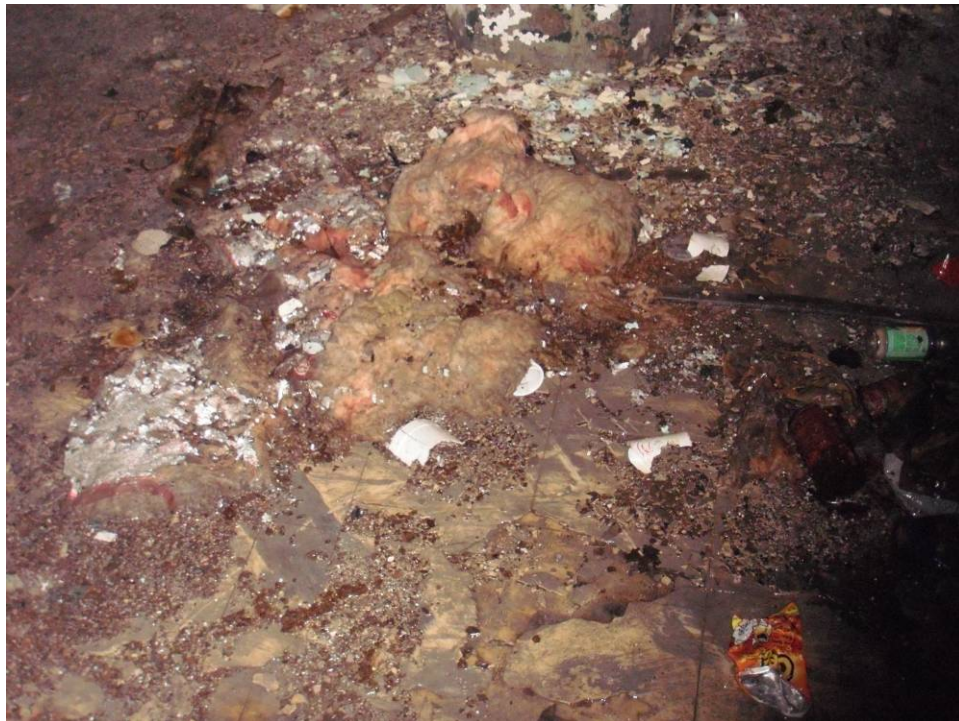
**Photograph No.:** 4

**Subject:** Pile of trash and deteriorated building materials in a Middle Series building.

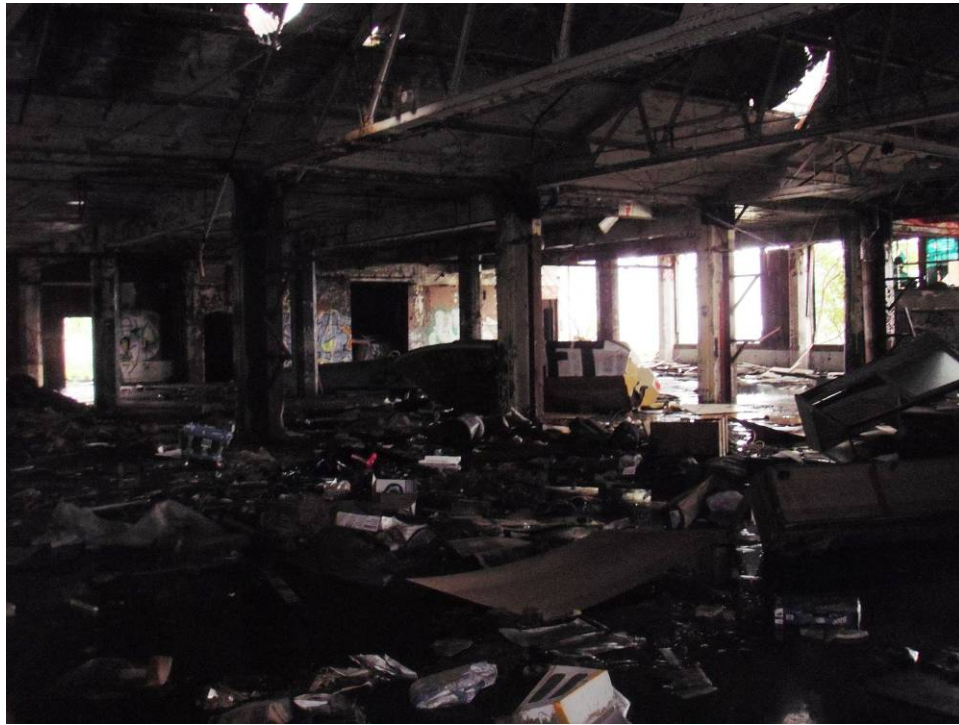
**Photograph No.:** 5

**Subject:** Trash and bulk debris in a Middle Series Building

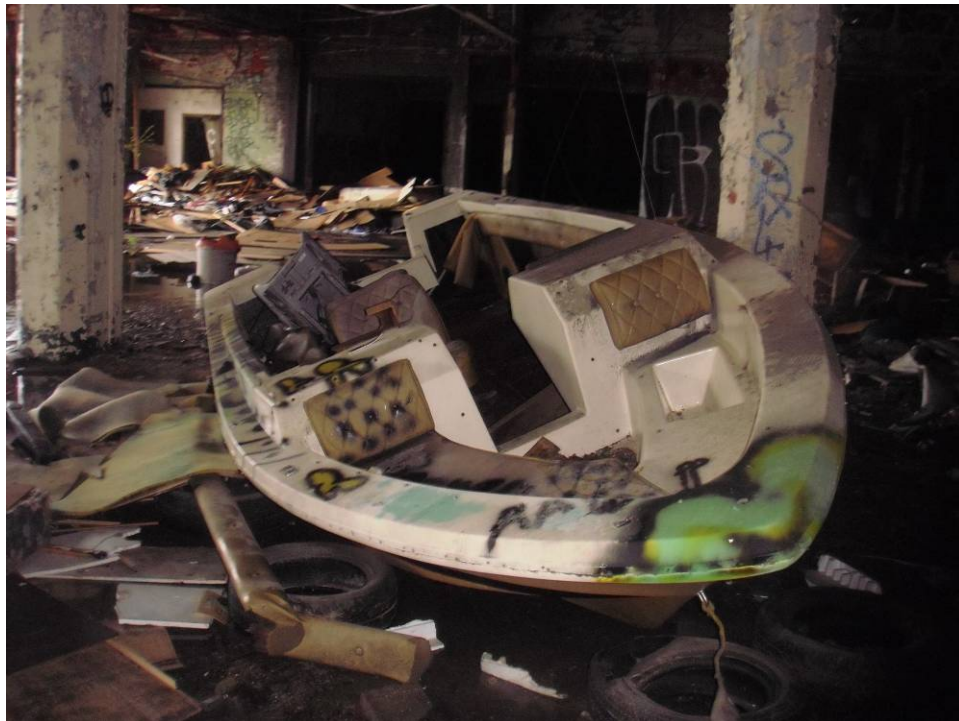
**Photograph No.:** 6

**Subject:** Boat and other trash and bulk debris in a Middle Series building.

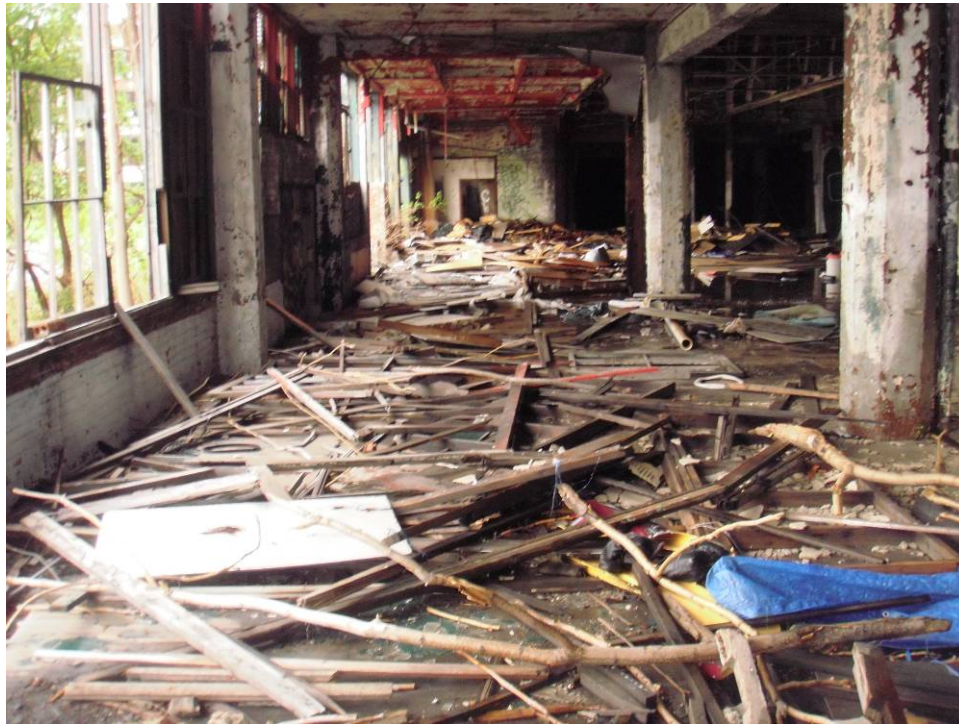
**Photograph No.:** 7

**Subject:** Trash and bulk debris in a North Series building.

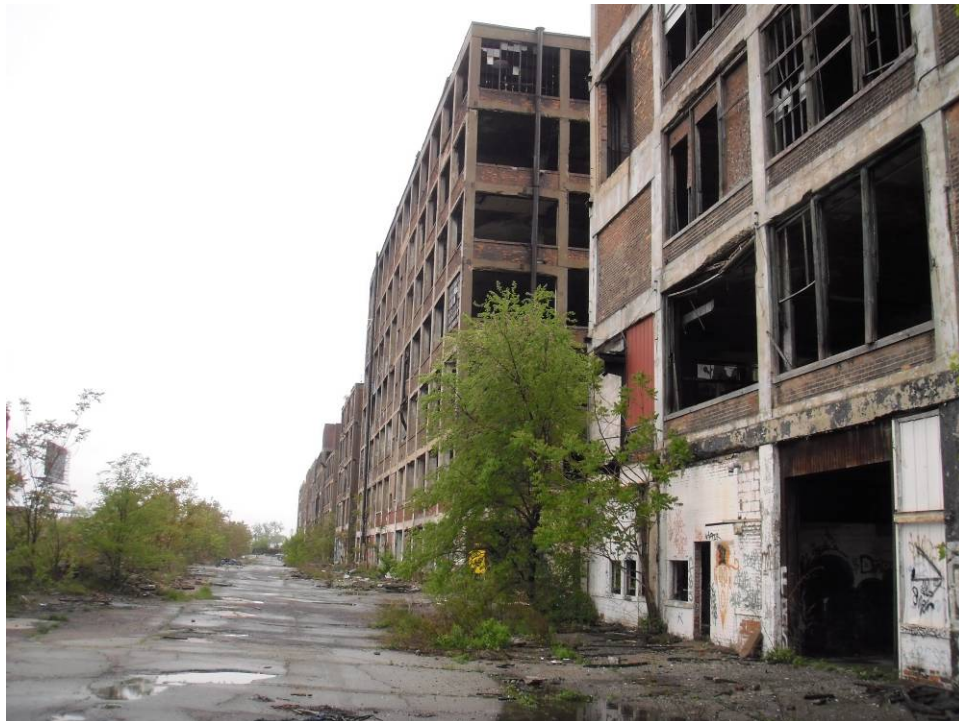
**Photograph No.:** 8

**Subject:** West building frontage (North Series) along an unnamed alley.

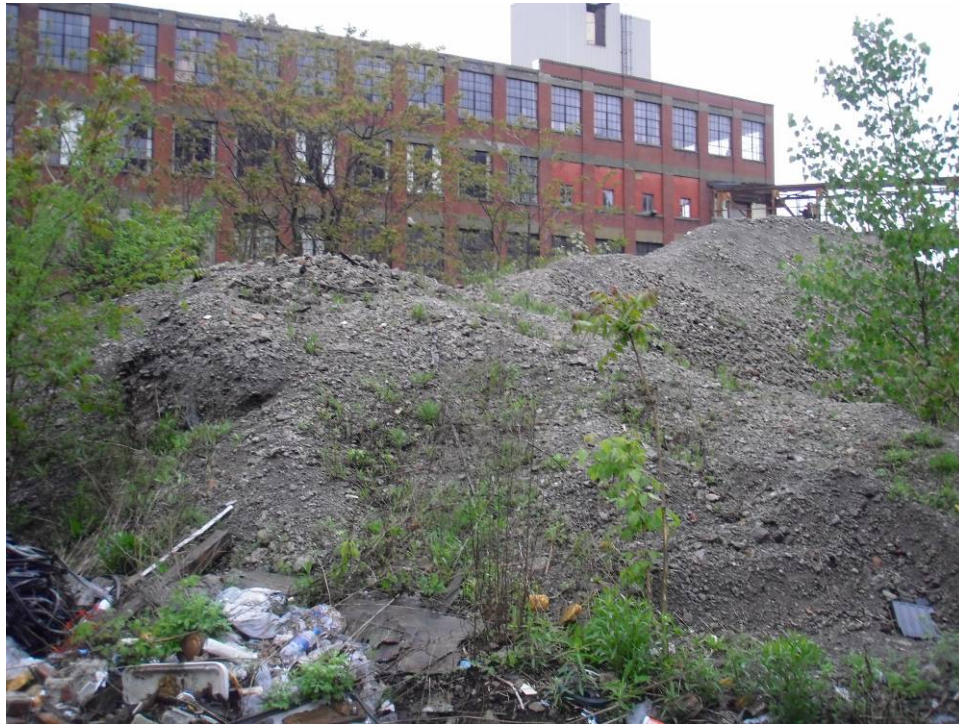
**Photograph No.:** 9

**Subject:** Piles of dirt and crushed building materials west of the North Series buildings.

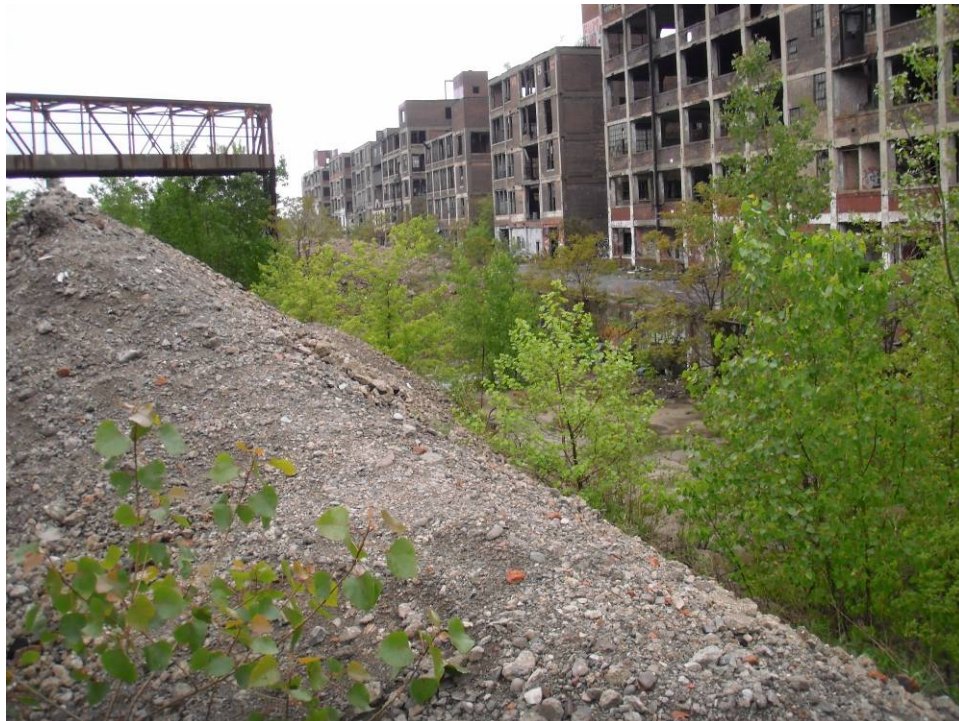
**Photograph No.:** 10

**Subject:** Piles of dirt and crushed building materials west of an exposed basement and the North Series buildings.

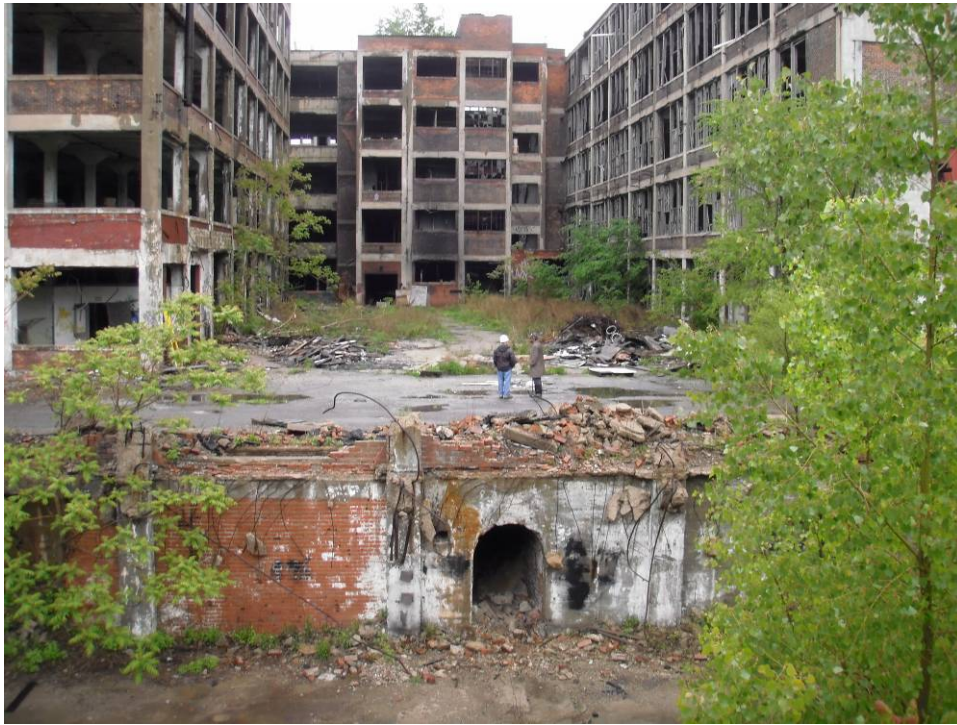
**Photograph No.:** 11

**Subject:** Utility tunnel entrance from the exposed basement west of the North Series buildings.

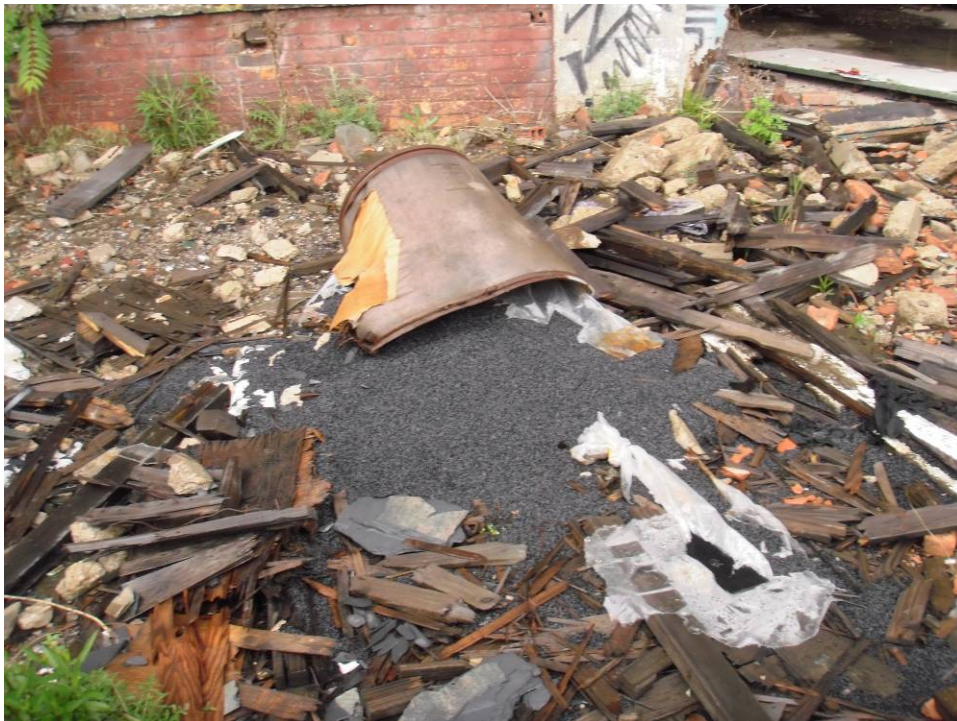
**Photograph No.:** 12

**Subject:** Spilled material from a 55-gallon fiber drum west of the North Series buildings.

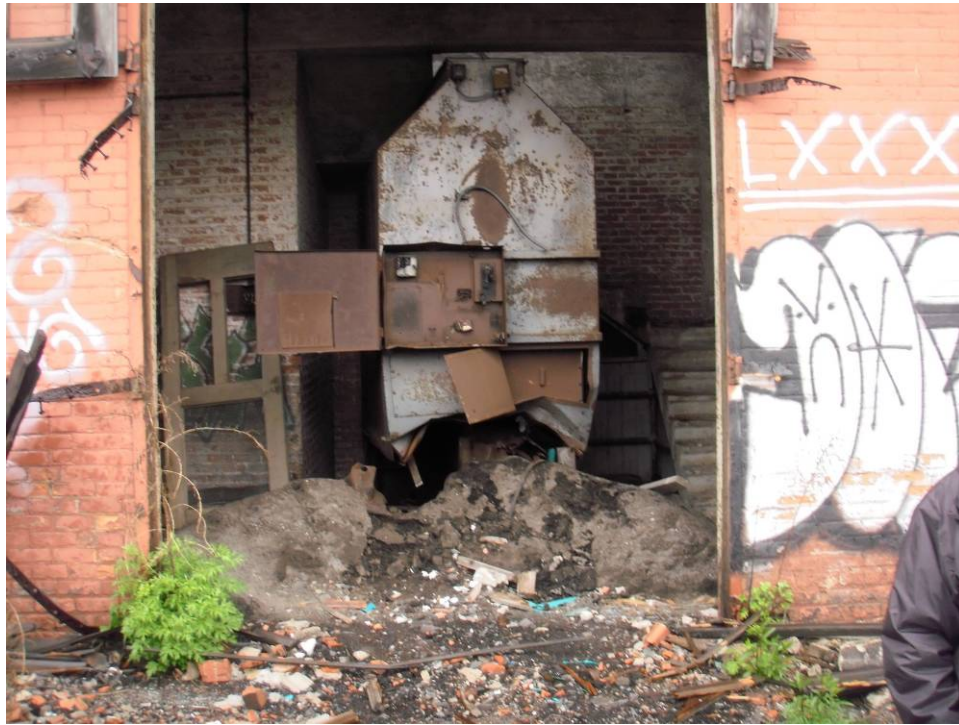
**Photograph No.:** 13

**Subject:** Pile of ash near an old furnace along the west side of a North Series building.

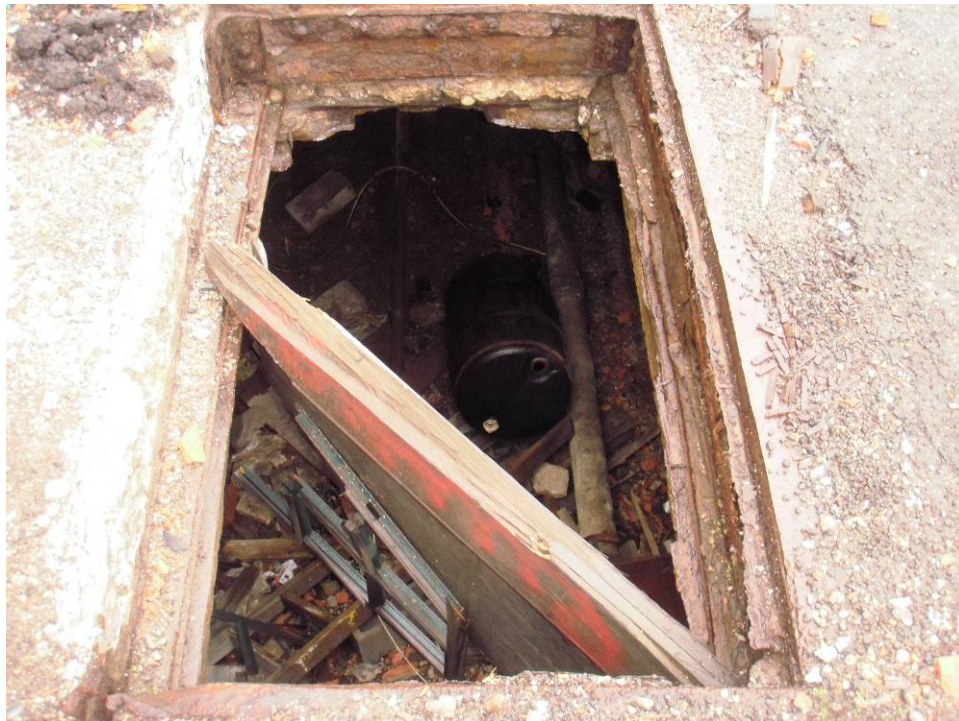
**Photograph No.:** 14

**Subject:** Drum and pile of unknown material in a utility tunnel west of the North Series buildings.

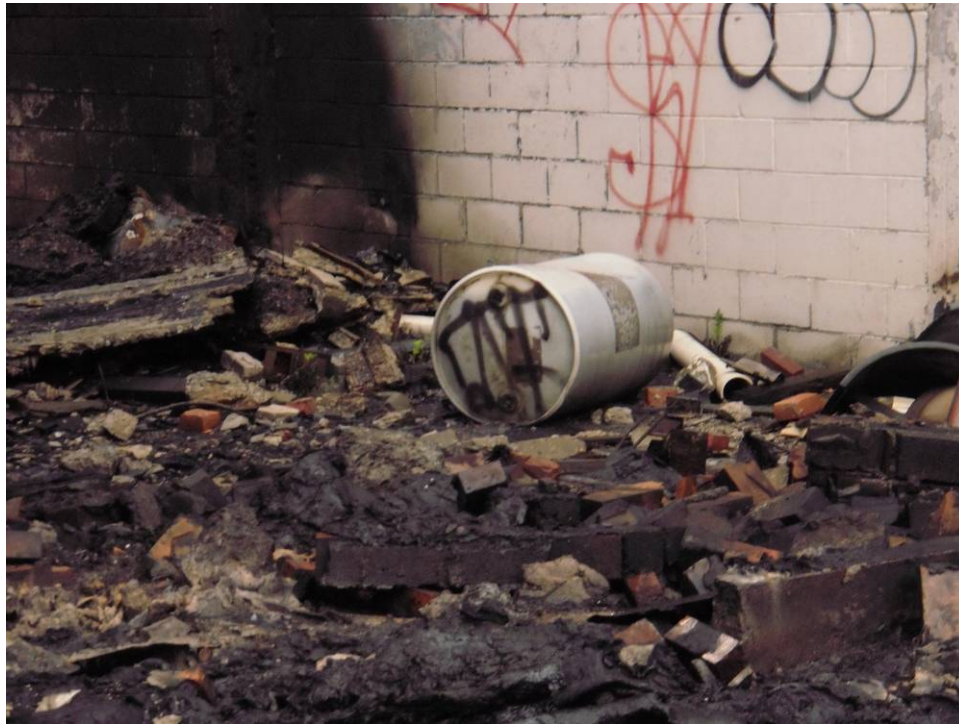
**Photograph No.:** 15

**Subject:** Drum with unknown liquid contents along the west side of a North Series building.

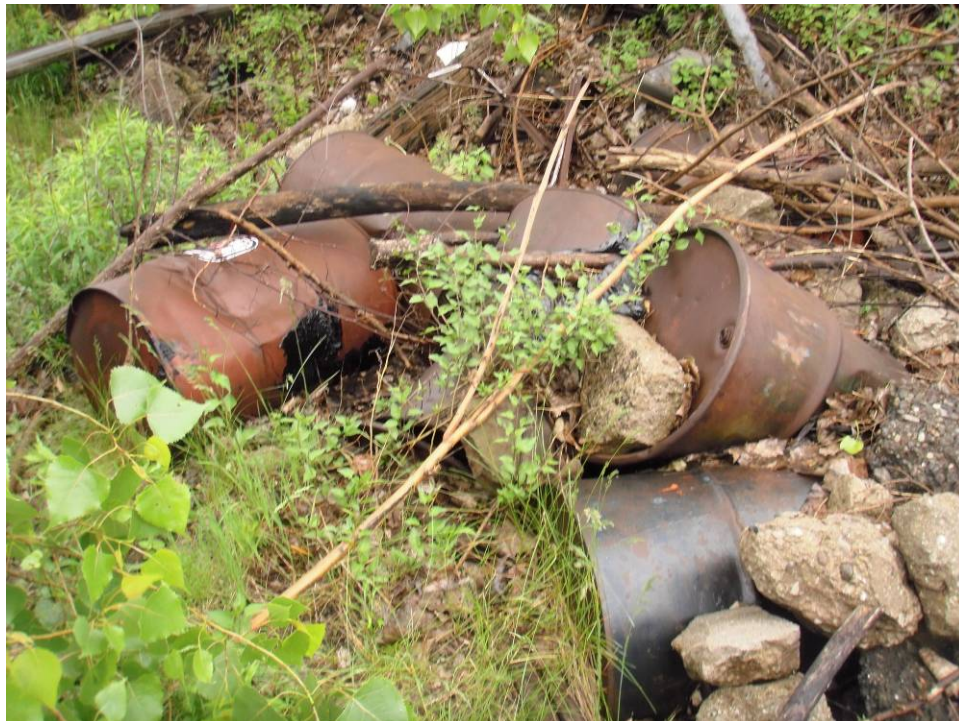
**Photograph No.:** 7

**Subject:** Partially buried drums in the northwest corner of the property.
