**EXPANDED PRELIMINARY ASSESSMENT AND SITE CLOSURE
REPORT USING RISK BASED CONTAMINANT LEVELS FOR
MR. MILTON BROWN**

Former Schooner Creek Boat Works

**North Pier 99/North Marine Drive
Portland, Oregon**

December 30, 2003
SECOR PN: 15OT.09417.02.0002

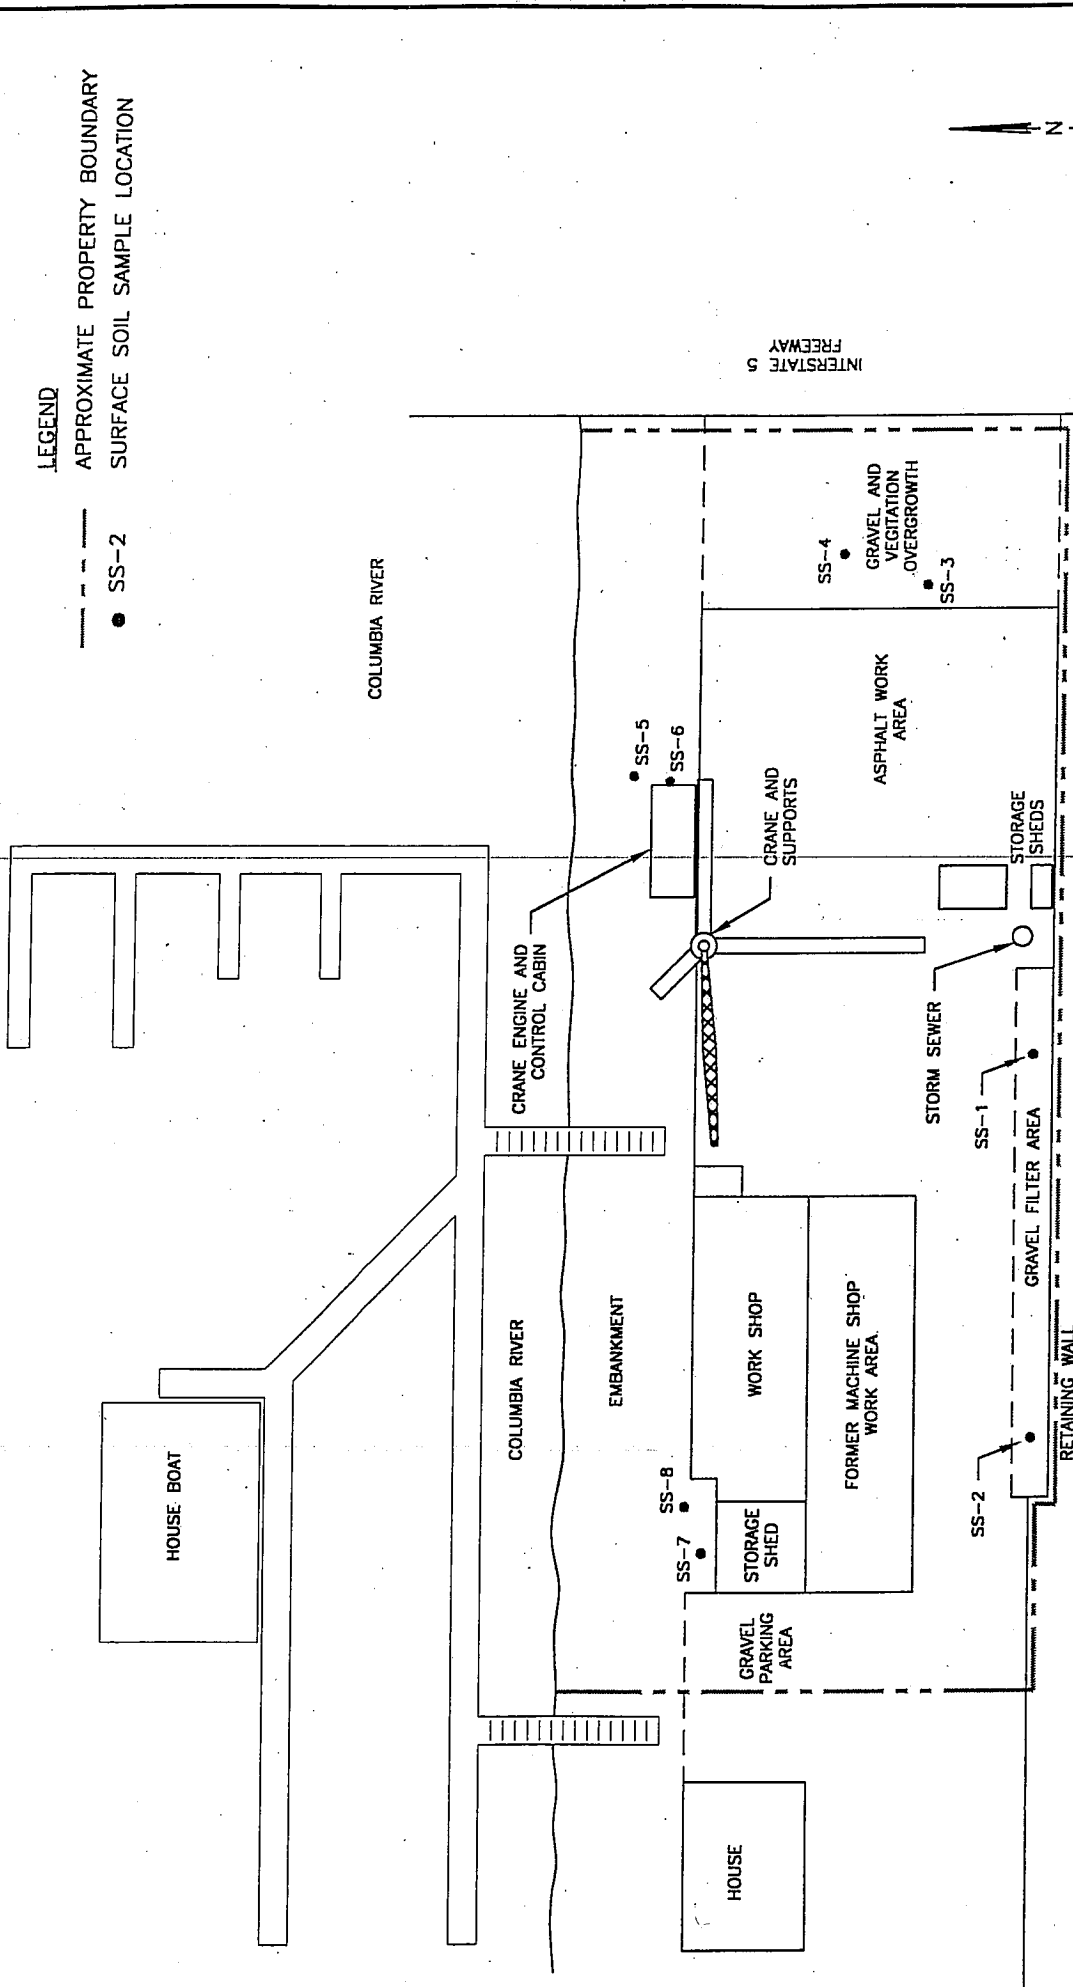
Laboratory analysis indicates that TPH-DRO and TPH-ORO in sample SS-5 were 2,230 mg/kg dry and 2,550 mg/kg dry, respectively. Leachable barium was detected at a concentration of 0.800 milligrams per liter (mg/L). Total lead was detected at a concentration of 628 mg/kg dry.

TPH-DRO and TPH-ORO were detected in sample SS-6 at concentrations of 7,540 mg/kg dry and 42,400 mg/kg dry, respectively. Leachable barium was detected at a concentration of 0.663 mg/l. Total lead was detected at a concentration of 86.5 mg/kg dry.

Laboratory analysis indicates that styrene was detected in sample SS-3 at a concentration of 157 µg/kg dry; and 1,2,4-Trimethylbenzene was detected in sample SS-3 at a concentration of 101 µg/kg. However, quality control from the laboratory analysis indicates that 1,2,4-Trimethylbenzene was not detected above MRLs; rather, the results were raised based on

Leachable lead and barium were detected in sample SS-4 at concentrations of 0.108 mg/l and 0.449 mg/l, respectively. Total lead was detected at a concentration of 36.0 mg/kg dry. Concentrations were below laboratory MRLs for VOC constituents.

Soil samples SS-7 and SS-8 were collected from the northwest corner of the former storage shed and work shop (Figure 2). Soil samples at a depth of 12 inches bgs exhibited no visual signs of contamination, based on field observations. Laboratory analysis indicates that concentrations were below MRLs for all VOC constituents, including Methyl Ethyl Ketone, in samples SS-7 and SS-8.

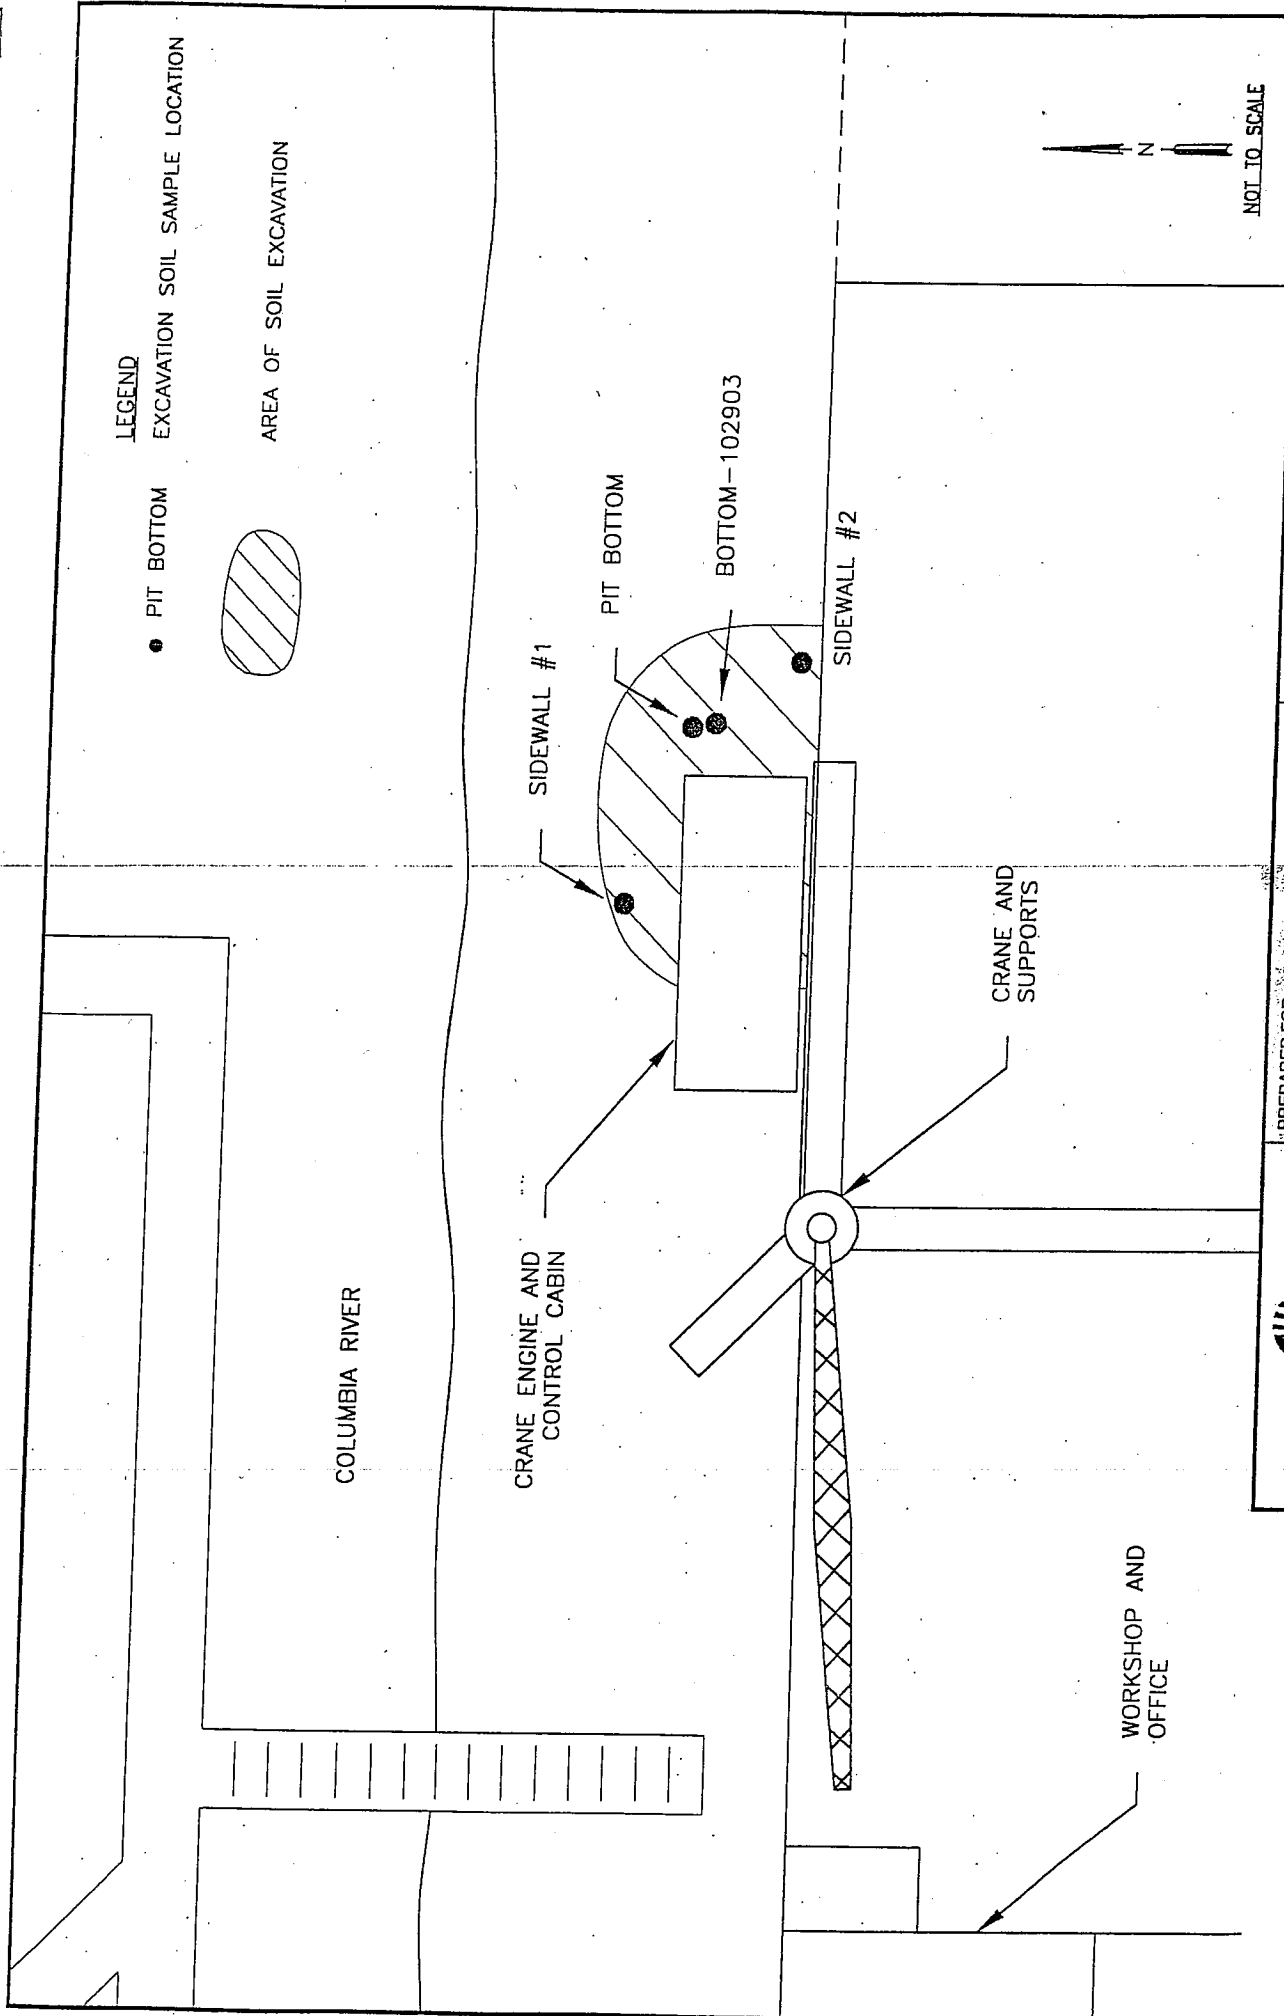
On October 15, 2003, approximately 21.5 cubic yards of soil contaminated with diesel and heavy oil range hydrocarbons was removed from the east, northeast, and southeast sides of the existing crane housing concrete foundation. Soil was removed to a total depth of approximately 7 feet bgs using a backhoe, and placed into lined containers for disposal. The total depth of the concrete foundation, approximately 4 feet, was exposed during the excavation. Soil at depths greater than 7 feet was left in place due to the potential unstable slope conditions that would have been created. The extent and location of the excavation is shown on Figure 3.

Laboratory analysis indicates that the concentrations of BTEX were less than the laboratory MRLs of 0.05 mg/kg dry (0.1 mg/kg dry for total xylenes). 1,2,4-TMB and 1,3,5-TMB were not detected above laboratory MRLs of 0.1 mg/kg dry and 0.05 mg/kg dry, respectively. MTBE and naphthalene were not detected above laboratory MRLs of 0.2 mg/kg dry. 1,2-dibromoethane, 1,2-dichloroethane and n-propylbenzene were not detected above laboratory MRLs of 0.05 mg/kg dry. Isopropylbenzene was not detected above the laboratory MRL of 0.2 mg/kg dry. Laboratory analytical data is summarized on Tables 4 and 5.

Based on the calculated RBCs above, combined diesel and heavy oil range hydrocarbon laboratory analytical concentrations from the pit bottom (at a depth of 7.0 feet bgs) of 2,576 mg/kg, and the conservative estimated depth of contaminant as compared to the depth to water (less than 161 mg/kg at a depth of 20 feet bgs), SECOR recommends that the Site be considered for closure by the DEQ.
