Re: Final Trip Report for the Yakima Pipe Bomb Mercury Site  
Contract Number EP-S7-13-07, Technical Direction Document Number 13-08-0010

**FINAL TRIP REPORT**

**Yakima Pipe Bomb Mercury Site**

**TDD: 13-08-0010**

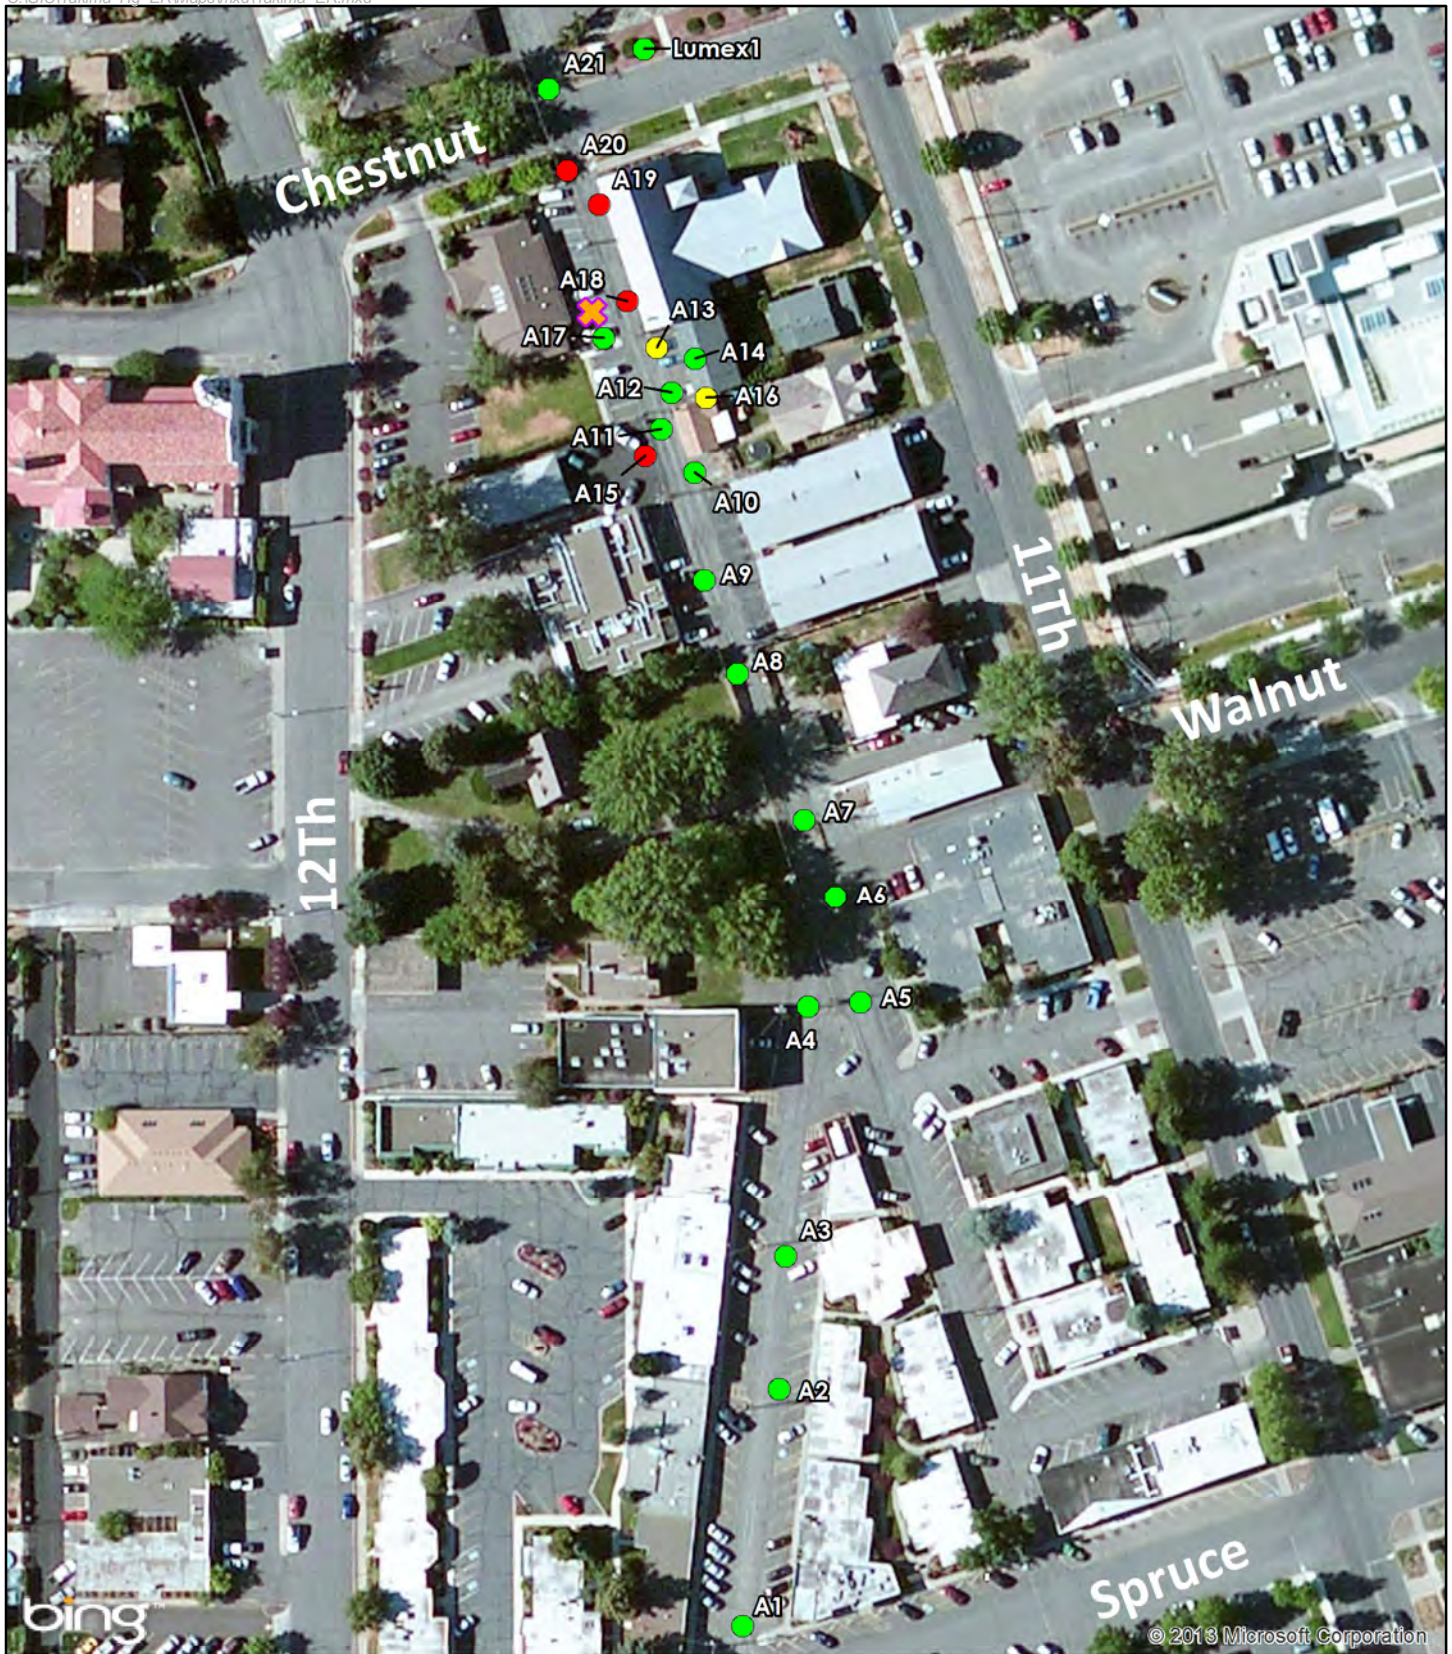
Figure 1  
Yakima Pipe Bombs Mercury Spill  
Lumex Monitoring Results  
August 2013

Mercury Monitoring Results

- < 3,000 ng/m<sup>3</sup>
- 3,000 - 10,000 ng/m<sup>3</sup>
- > 10,000 ng/m<sup>3</sup>
- ✱ Detonation Point

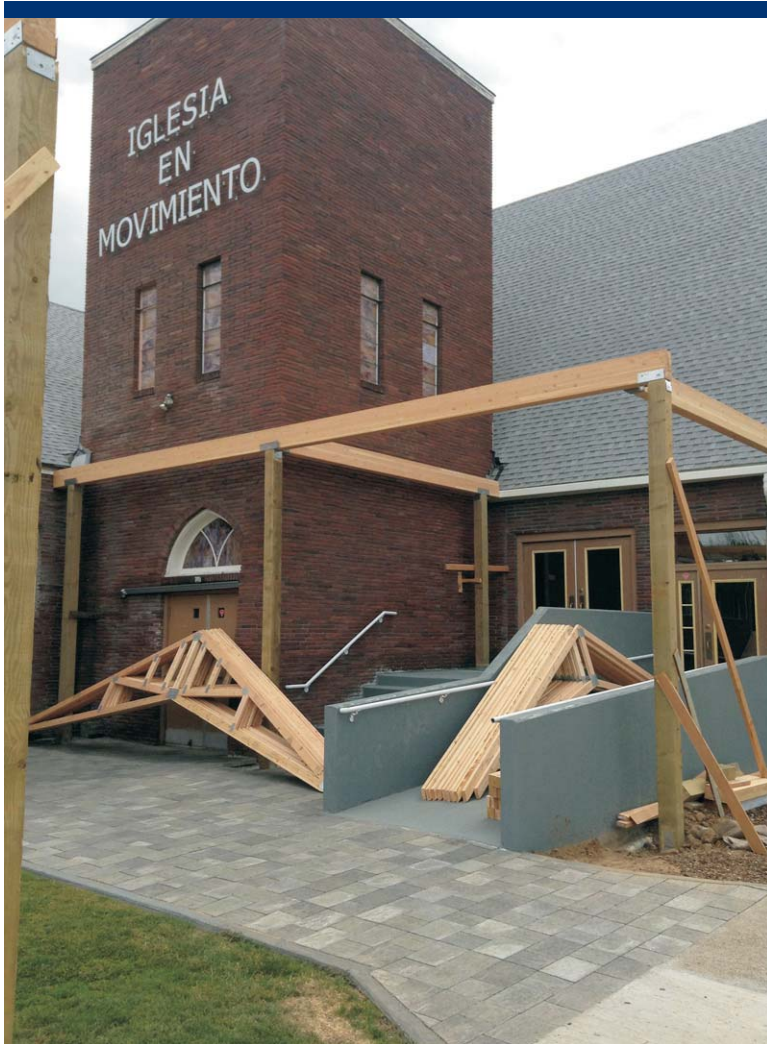
Photo 1 View of the church located at 101 South 11th Street Yakima, Washington.

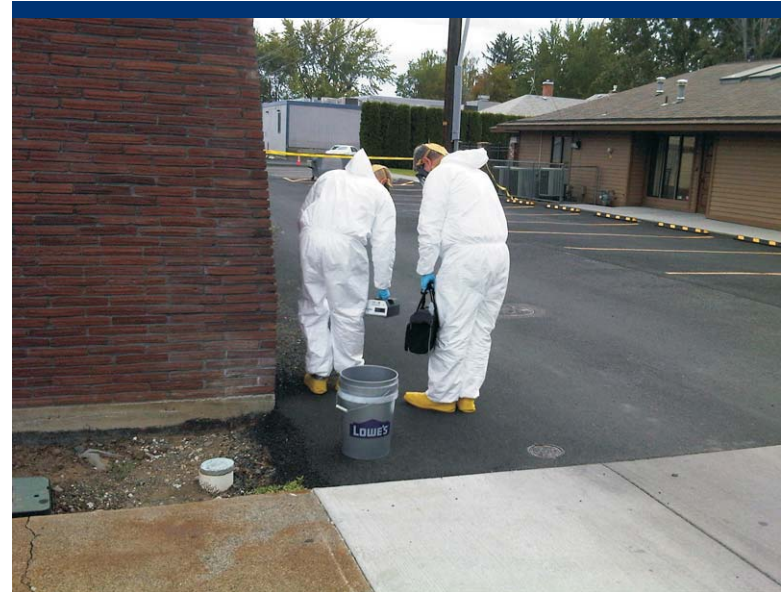
Photo 2 START using the Lumex and Jerome to assess contamination in the exclusion zone

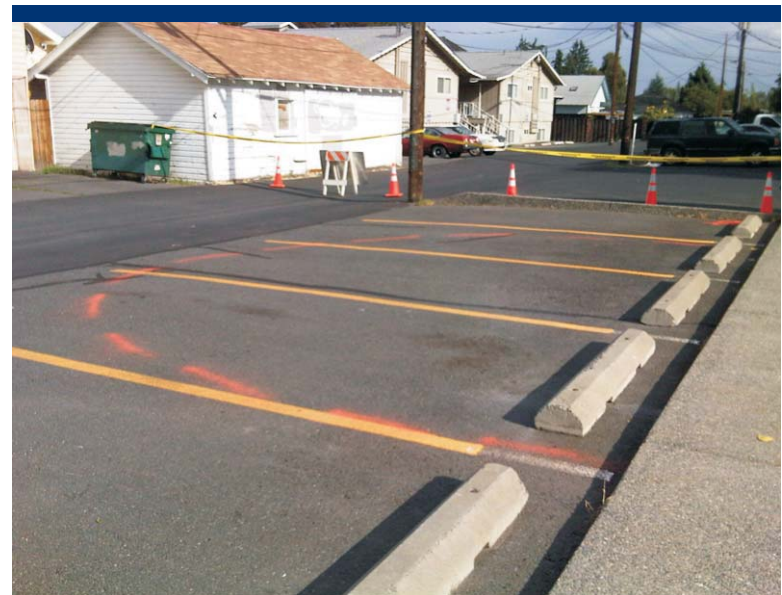
Photo 3 Paint showing area of visible mercury beads in the parking lot.

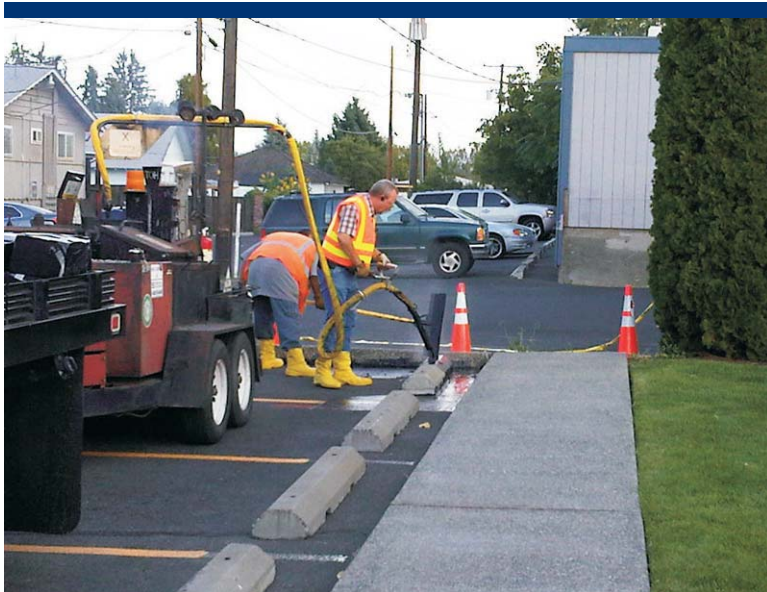
Photo 4 City of Yakima workers applying slurry sealant in parking lot.

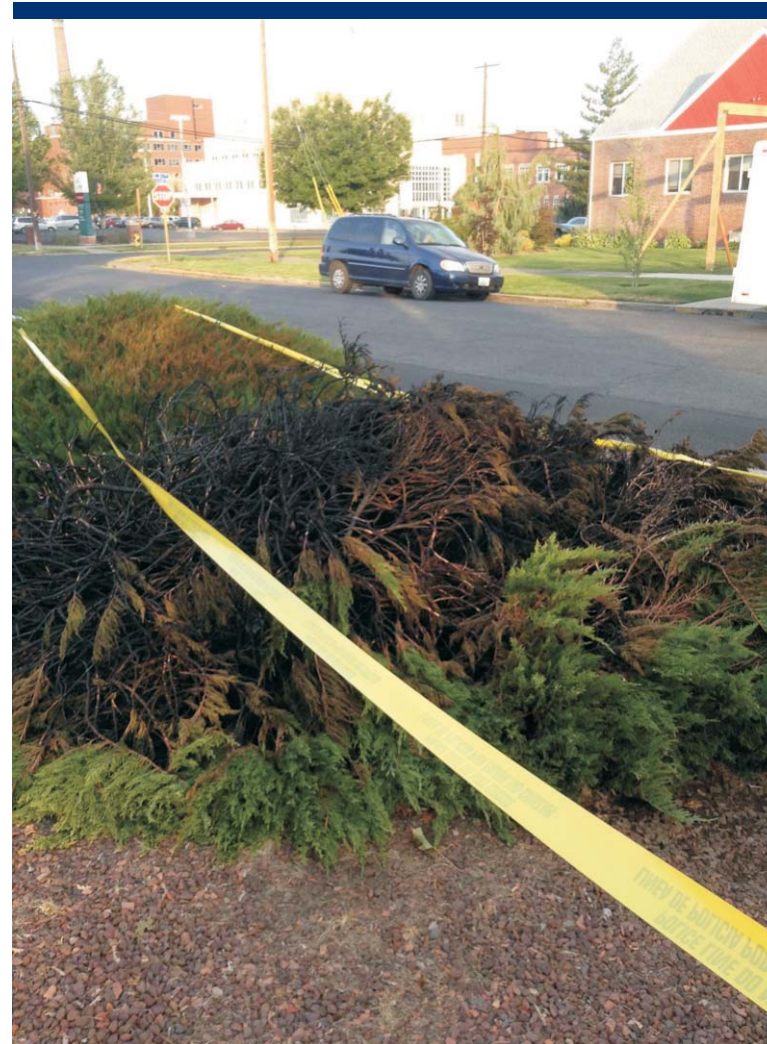
Photo 5 View of the burnt bush located north of the church which initiated the response.

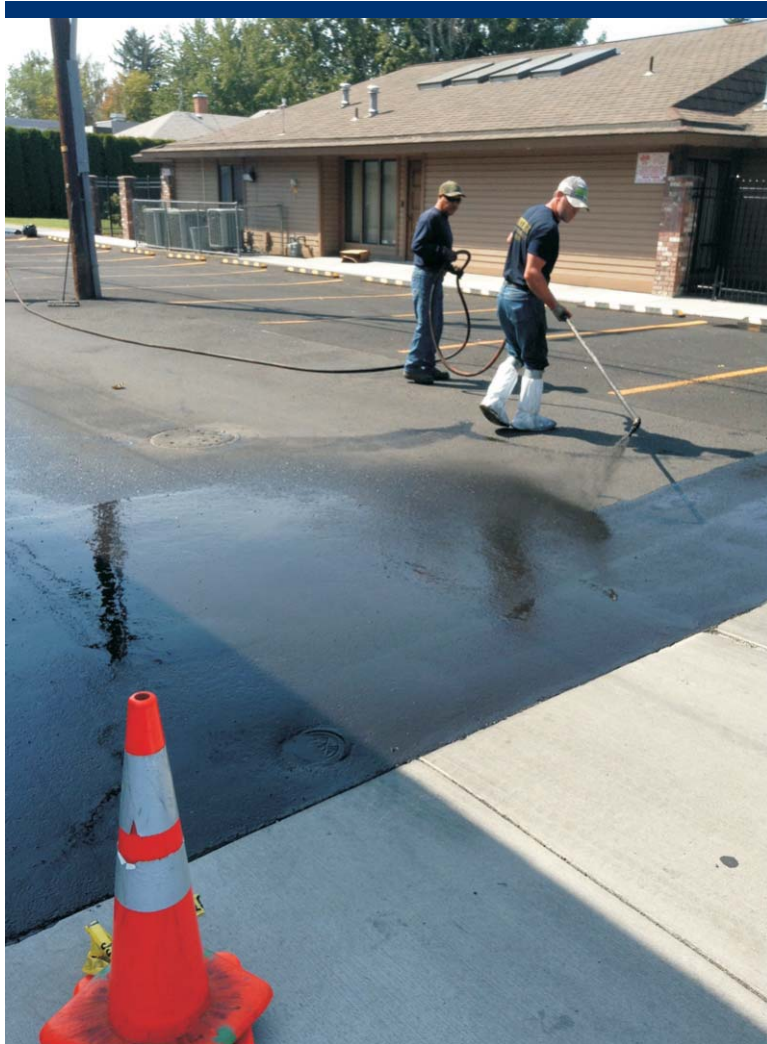
Photo 6 ERRS applying the cold asphalt sealant being applied to the extent of the exclusion zone.

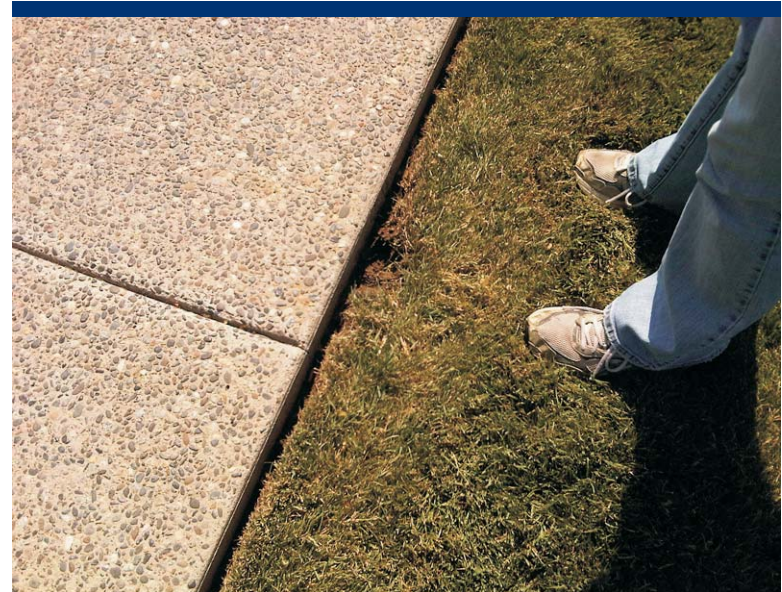
Photo 7 Area of visible mercury beads interstitial space between the sidewalk and the lawn.

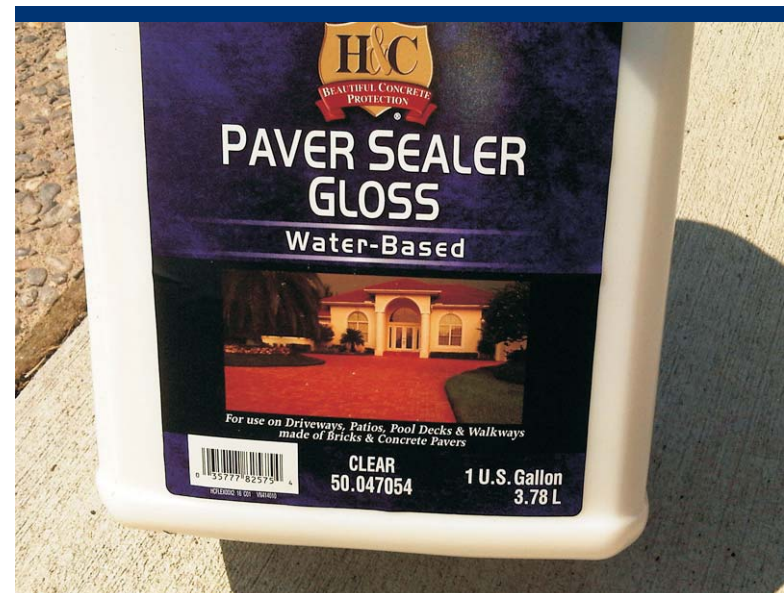
Photo 8 Concrete sealant used on sidewalk.

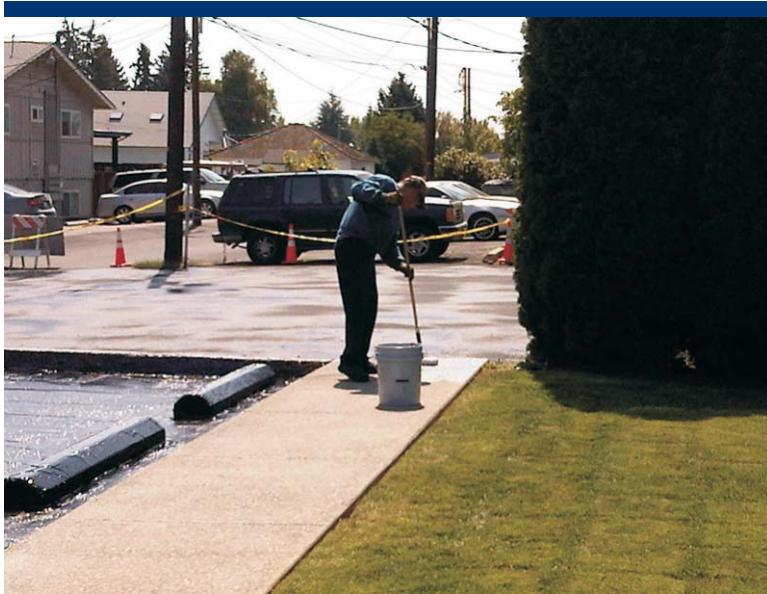
Photo 9 Application of sealant on sidewalk.

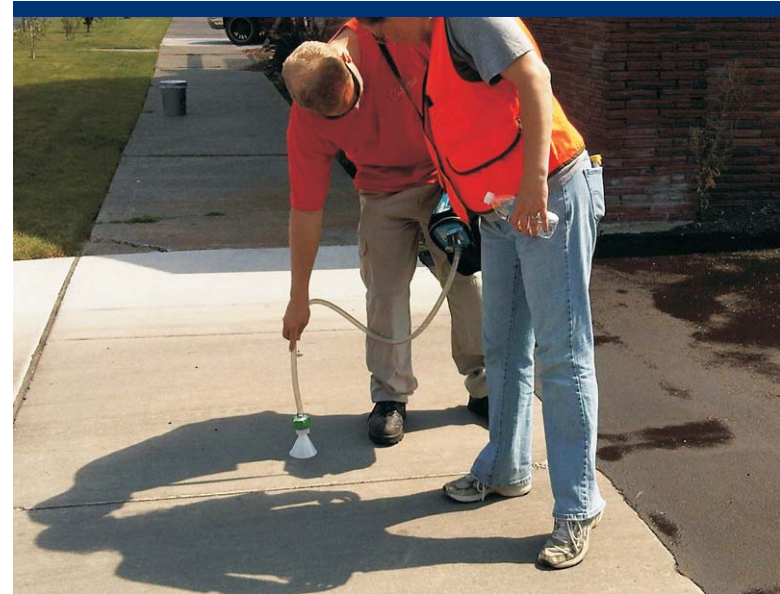
Photo 10 START using Lumex to assess contamination after sealant has been applied.

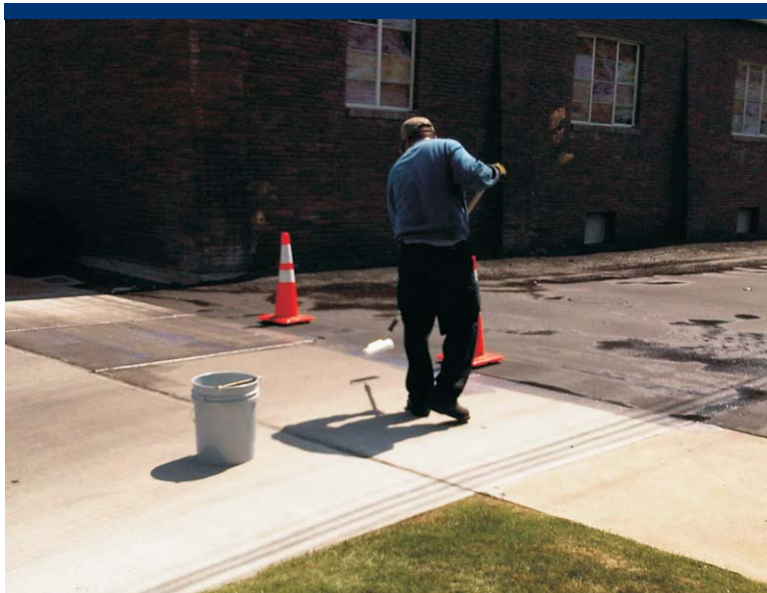
Photo 11 Application of concrete sealant on public sidewalk.

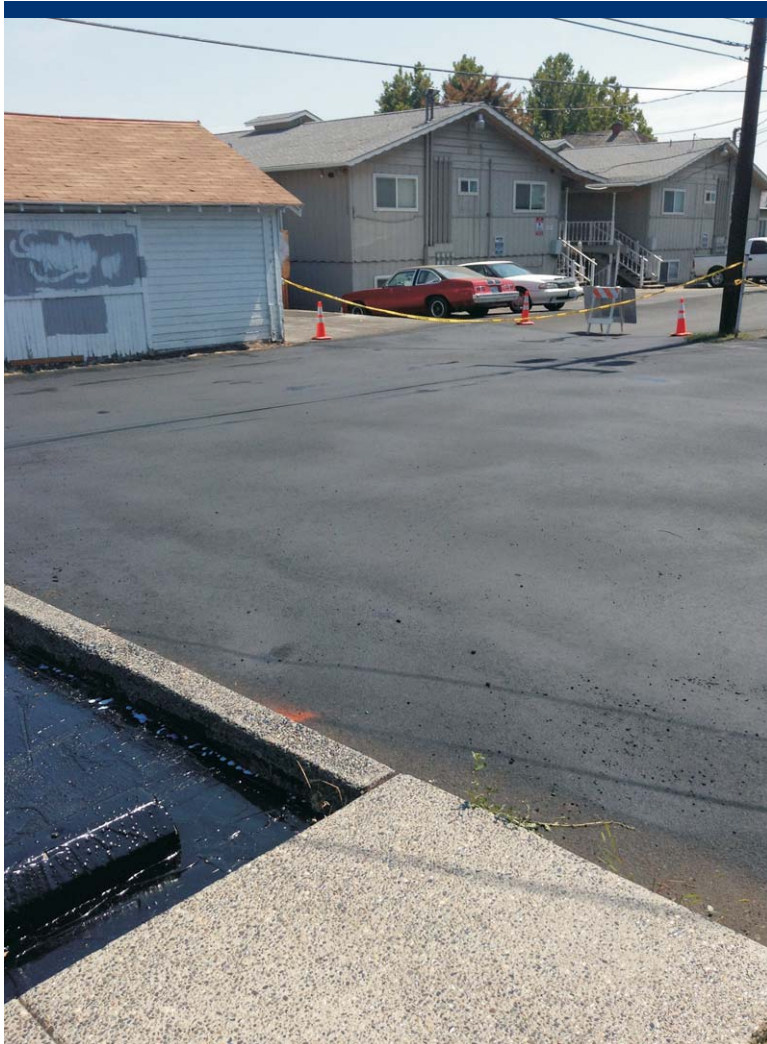
Photo 12 View of the applied cold asphalt sealant on the southern portion of the exclusion zone.

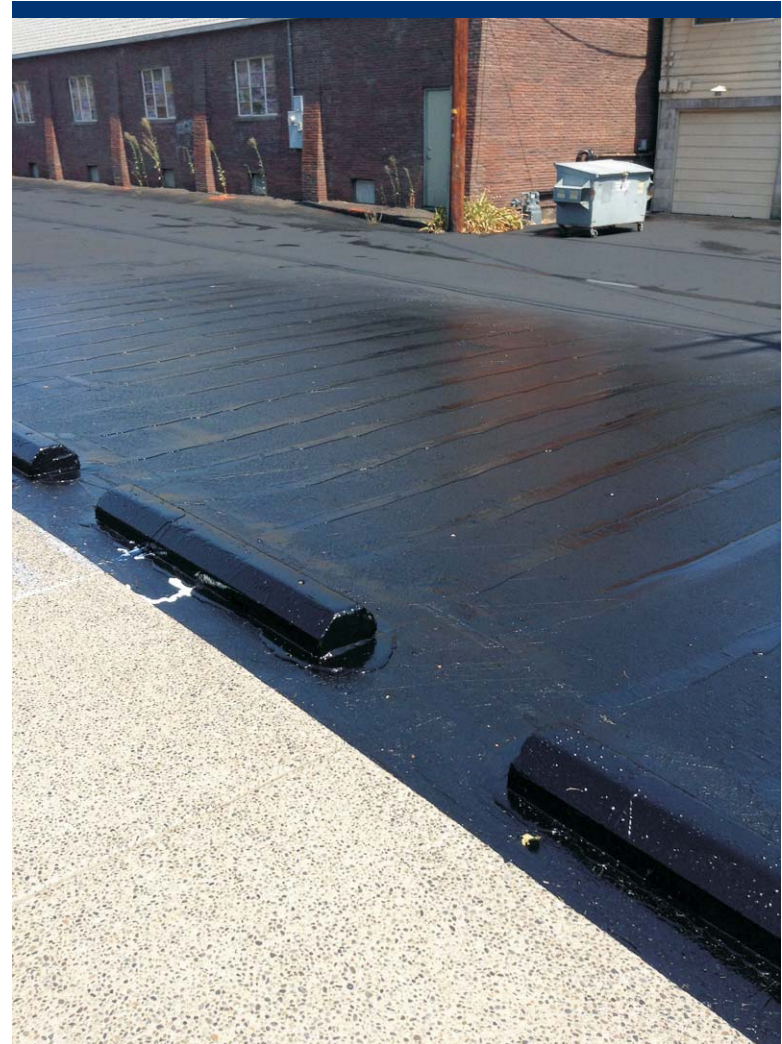
Photo 13 City of Yakima crew applying the hot asphalt treatment adjoining the detonation point; the highest readings were detected in this area.

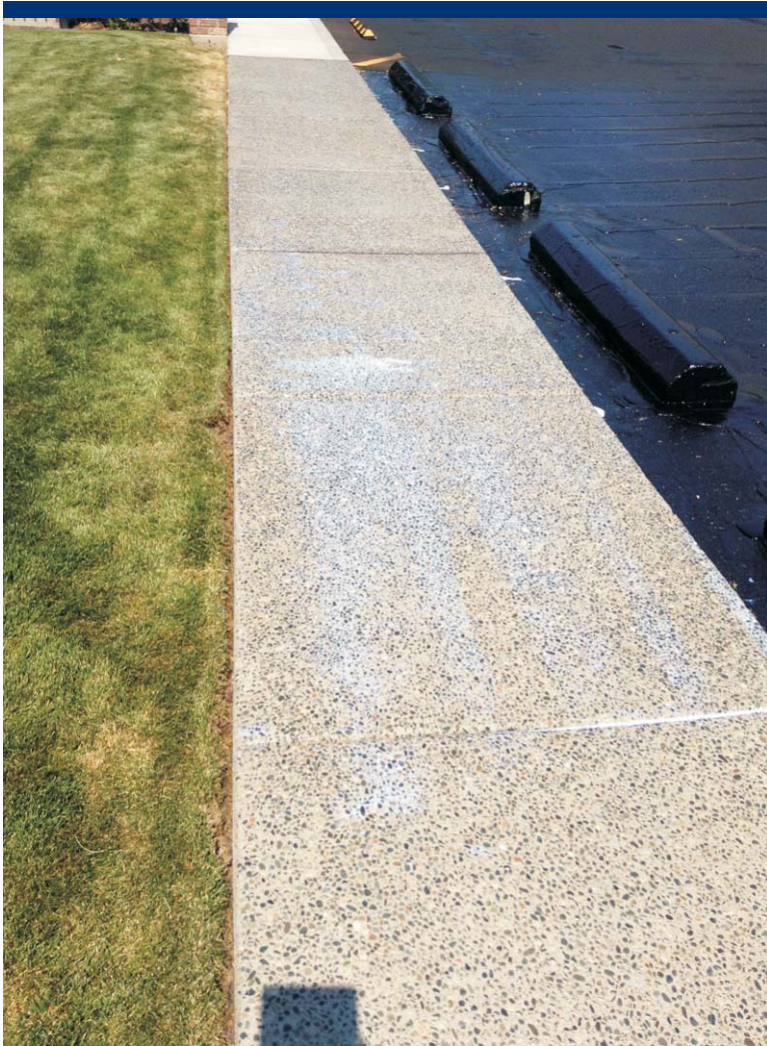
Photo 14 View of the slurry sealant applied to the sidewalk section at the detonation point.

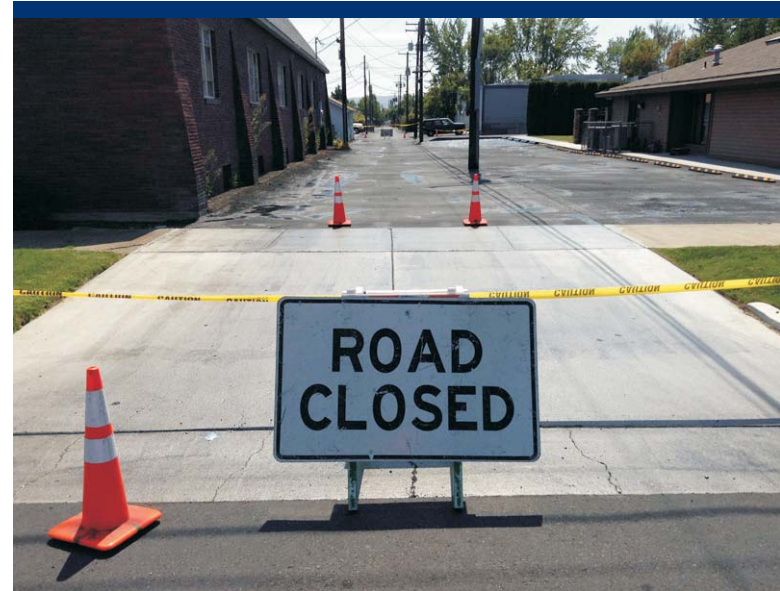
Photo 15 View along the length of the exclusion zone behind the church.
