## **SCAT Survey**

**January 9, 2014**

### **Moon-Hines Flowline Spill**

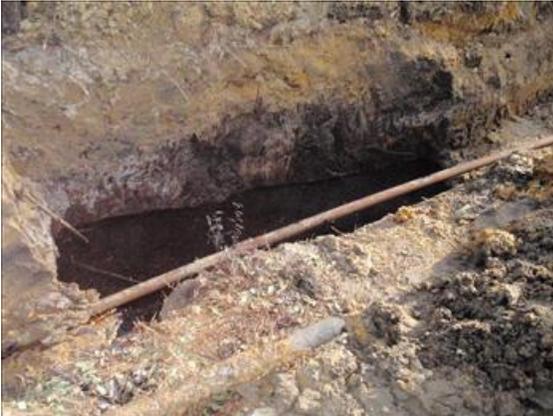
**Photo 1: Pipe Break**

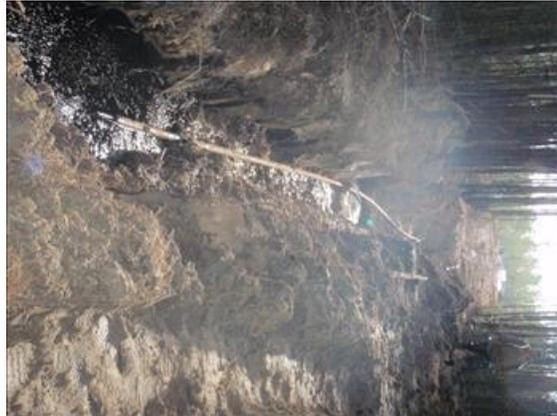
**Photo 2: Pipe Break**

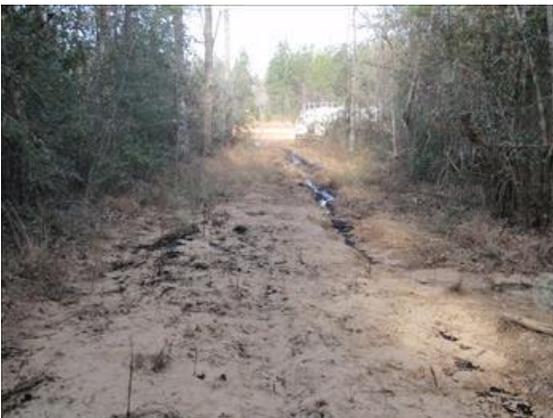
**Photo 3: Down Stream of Release**

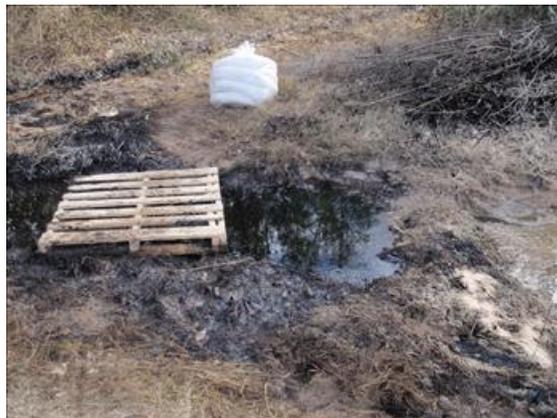
The SCAT team followed the oil from the source downstream to an access road. Once at the access road, the oil was pooled at a collection point via an underflow dam (Photo 4). The underflow dam discharged to a culvert that went under the access road (Photo 6). Once on the other side of the road, the oil followed a ditch channel. In the ditch channel, there was oiled vegetation, portions of pooled oil, and oiled bank and soil. In this area, there were crews using oil gator, absorbent pads, and oil snares to collect the oil. The crews were also raking vegetation and placing it in bags. From 31.75397 N 88.85132 W until 31.75555 N 88.85078 W, the oil relatively stayed along the ditch area with most of the coverage being in a 5 yard band and some coverage up to a 20 yard band (Photo 7 – Photo 15).

**Photo 4: Underflow**

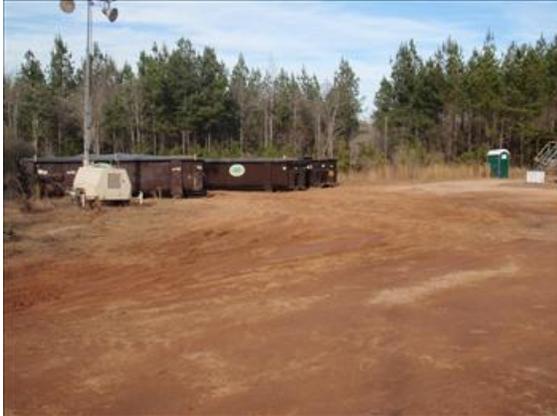
**Photo 5: Roll-off Staging Area**

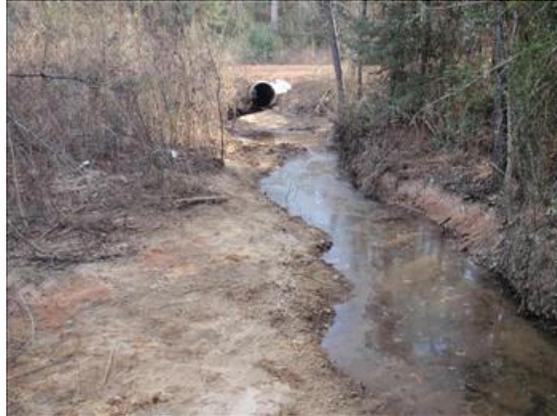
**Photo 6: Culvert**

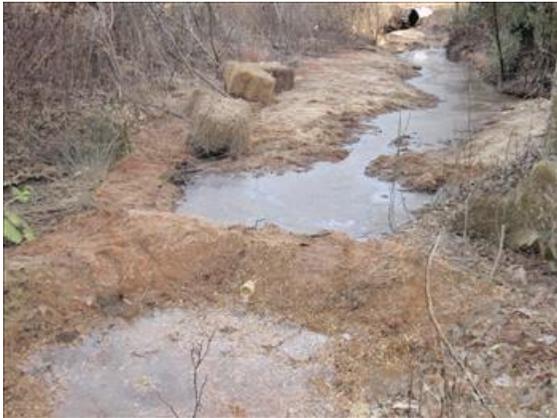
**Photo 7: Underflow**

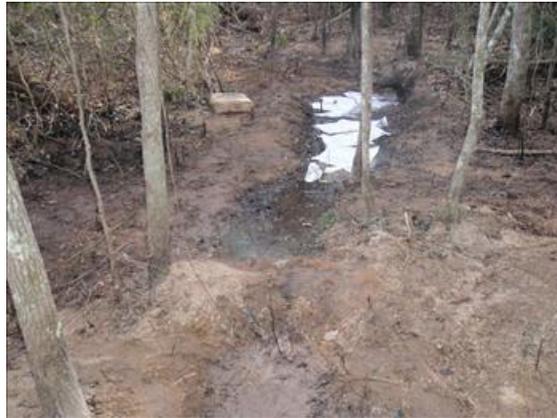
**Photo 8: Absorbent Pads**

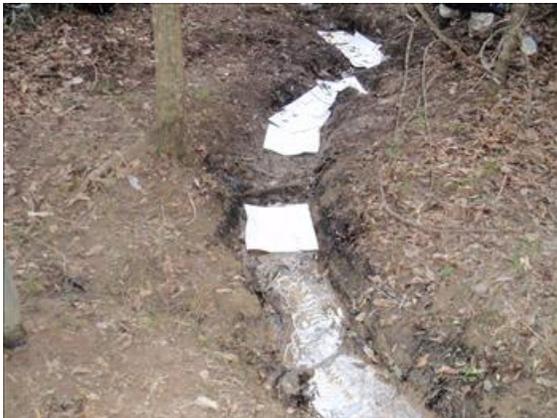
**Photo 9: Absorbent Pads**

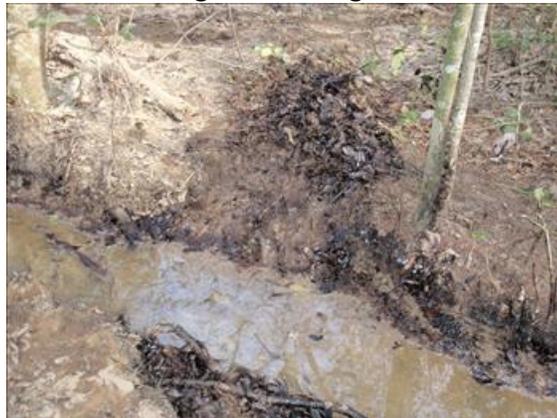
**Photo 10: Raking of Oiled Vegetation**

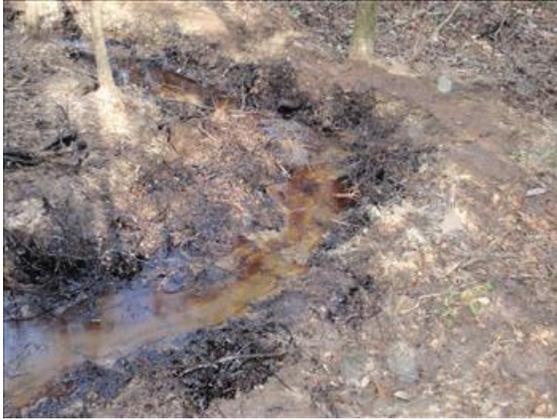
**Photo 11: Pooled Oil**

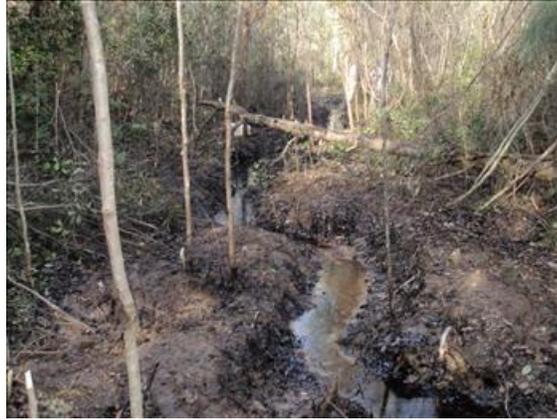
**Photo 12: Oil in Ditch**

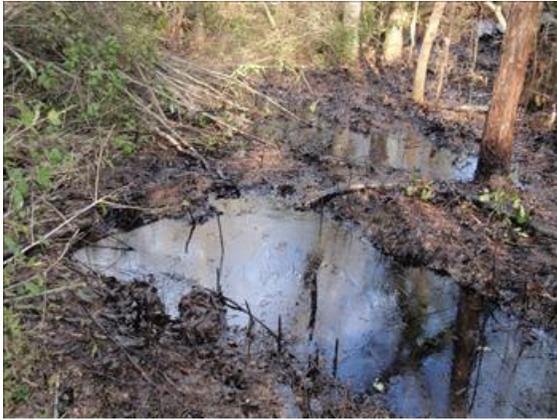
**Photo 13: Underflow & Vacuum**

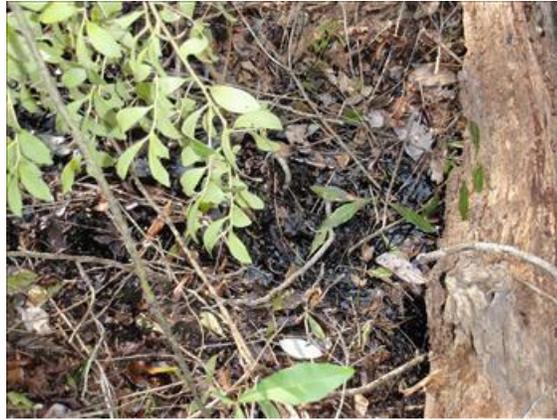
**Photo 14: Undisturbed Oiled Vegetation**

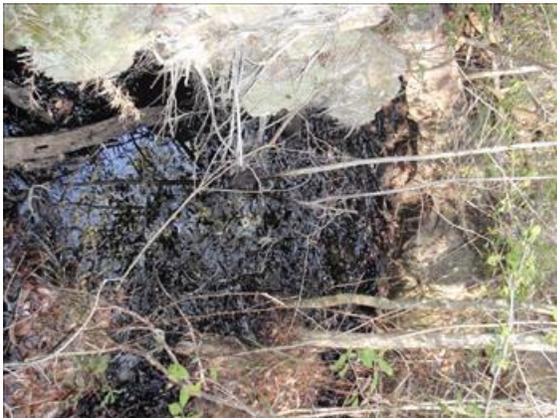
**Photo 15: Pooled Oil**

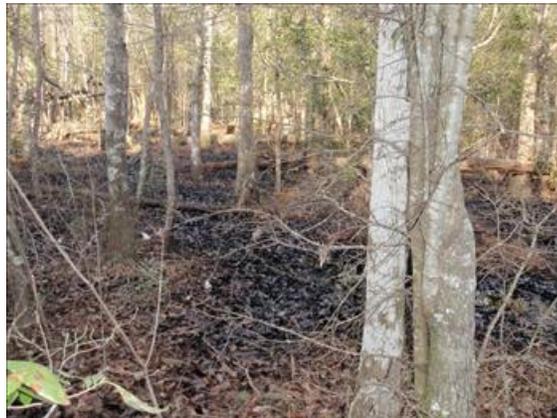
At 31.75571 N 88.85072, the oil reached a bottom with a small, shallow ditch (Photo 16). At this point, the oil spread out into a larger band (approximately 50 yards) because the ditch did not have the capacity to carry the oil and the grade of the terrain was relatively flat. The band included oiled vegetation on the ground and some pooled oil in the shallow ditch and low natural collection places in the terrain. At 31.75604 N 88.85073, there is a collection point for collected oil. At this location, there is also a vacuum truck that is vacuuming the pooled oil from the small ditch (Photo 18). From 31.75604 N 88.85073 to 31.75834 N 88.85136 W, the crews were using the same techniques in this area for clean-up as they were in the previous section with the addition of sock boom and hay (Photo 19 – Photo 24).

**Photo 16: Start of Bottom**

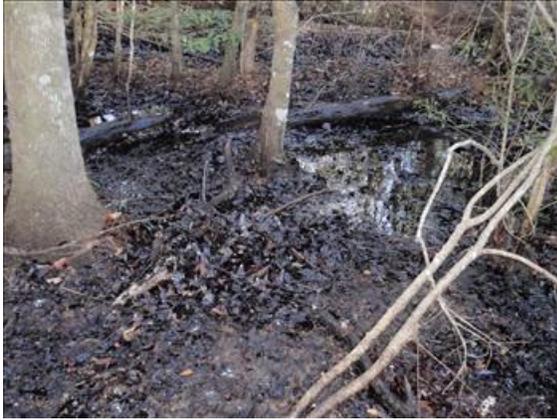
**Photo 17: 50 Yard Band**

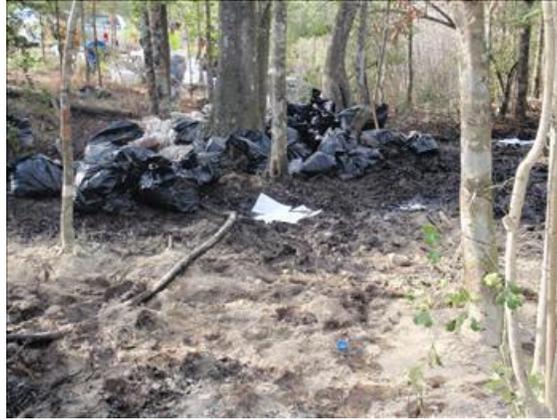
**Photo 18: Debris Staging Area**

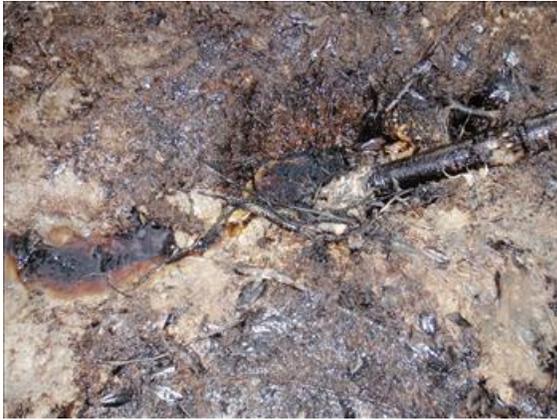
**Photo 19: Oiled Soil**

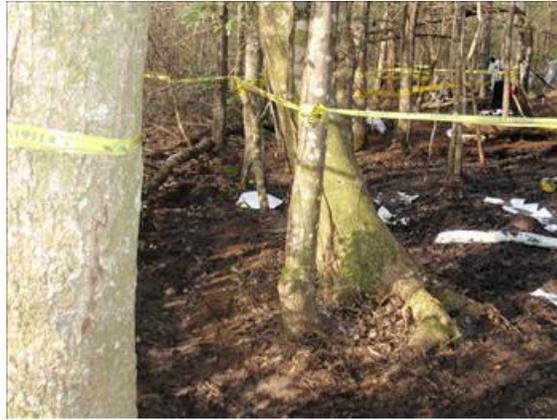
**Photo 20: Travel Area**

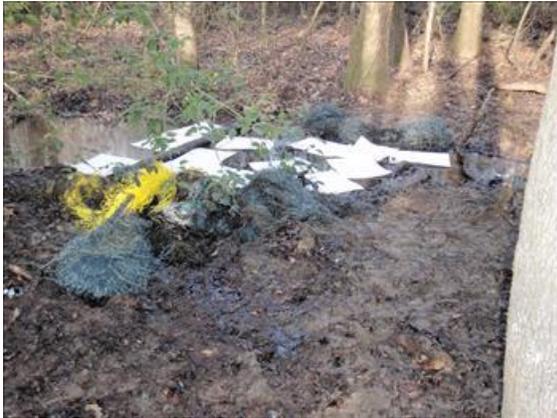
**Photo 21: Snares and Absorbent Rag**

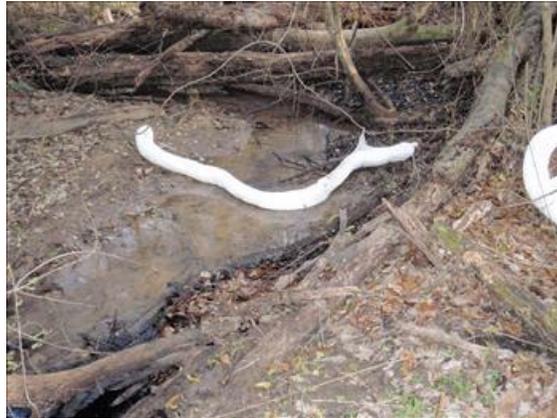
**Photo 22: Sock Boom**

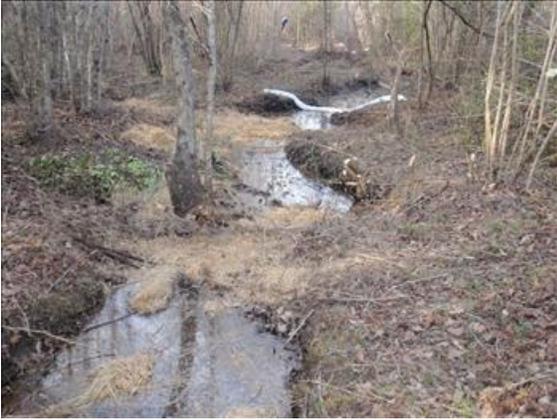
**Photo 23: Hay**

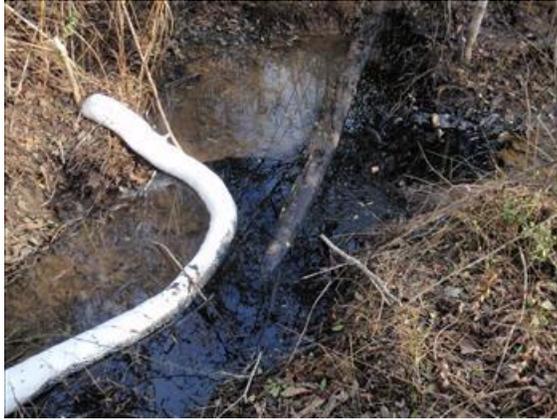
**Photo 24: Pooled Oil**

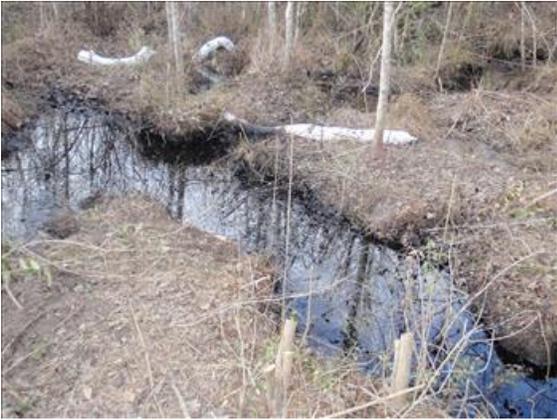
At 31.75834 N 88.85136 W, there was a crew cutting access to get to last control, where the oil is contained, in order to be able to get the equipment needed to recover the collected oil (Photo 25). From 31.75834 N 88.85136 W to 31.76157 N 88.85402 W, there were no recovery operations due to the limited access (Photo 26 – Photo 34). The terrain remained a relatively flat bottom and the oil was observed in the same approximate 50 yard band. The final control was at 31.76087 N 88.85349 W which is a hard and sock boom to collect the oil. No oil was observed past this section of boom. At 31.76157 N 88.85402 W, there was a beaver dam which had water backed up.

**Photo 25: Pooled Oil**

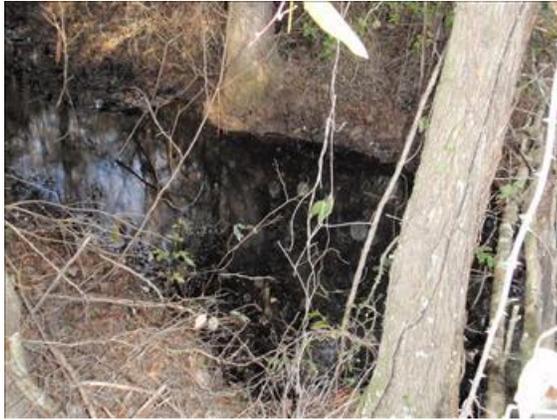
**Photo 26: Pooled Oil/Cutting End**

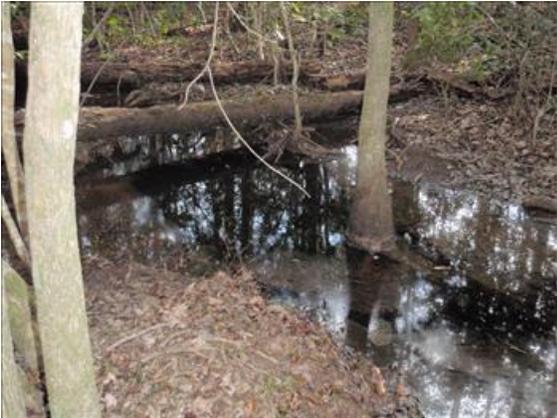
**Photo 27: Undisturbed Oiling**

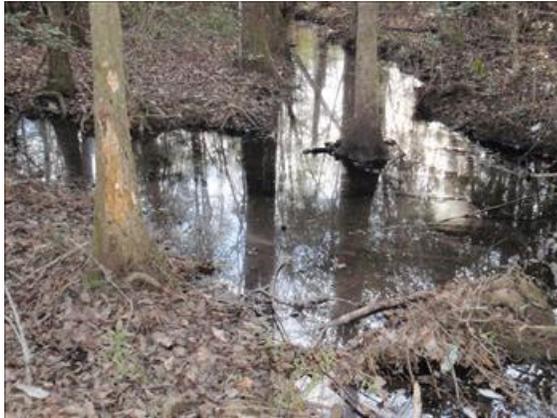
**Photo 28: Pooled Oil**

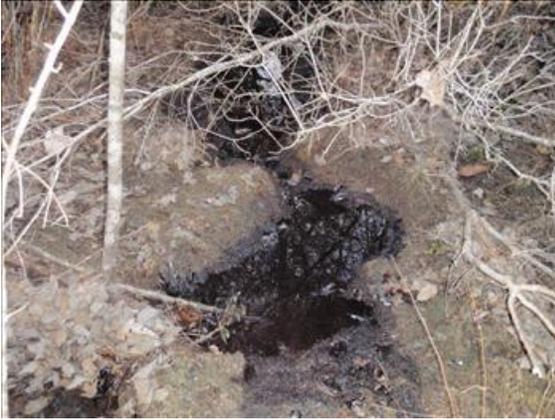
**Photo 29: Pooled Oil**

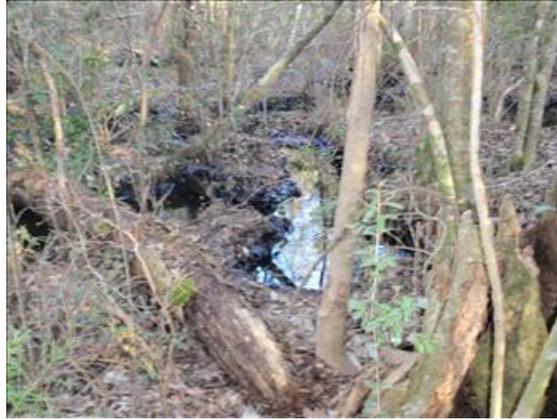
**Photo 30: Oiling in Ditch**

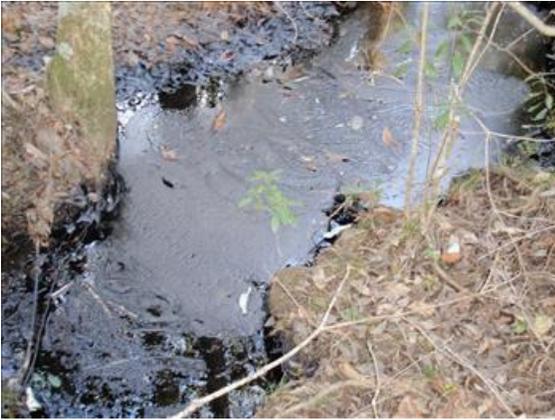
**Photo 31: Emulsified Oil**

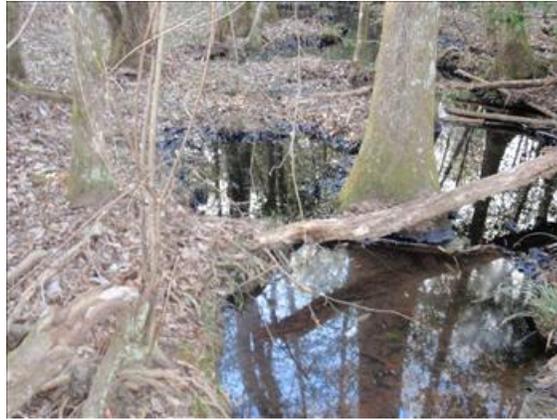
**Photo 32: Pooled Oil**

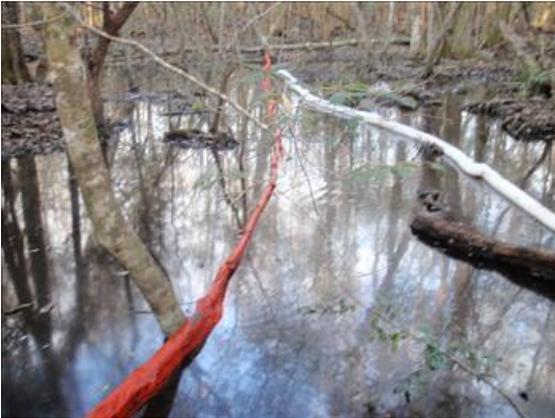
**Photo 33: Last Control**

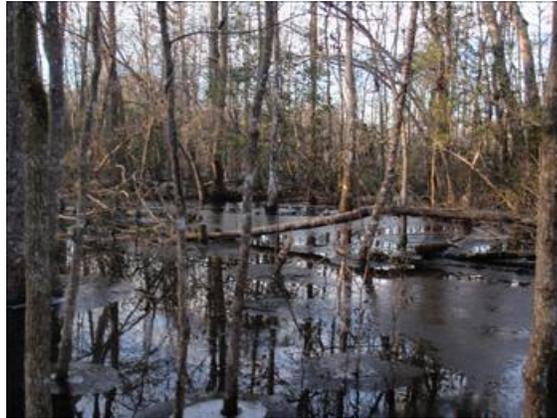
**Photo 34: Beaver Dam**
