SCAT Survey

January 17, 2014

Moon-Hines Flowline Spill

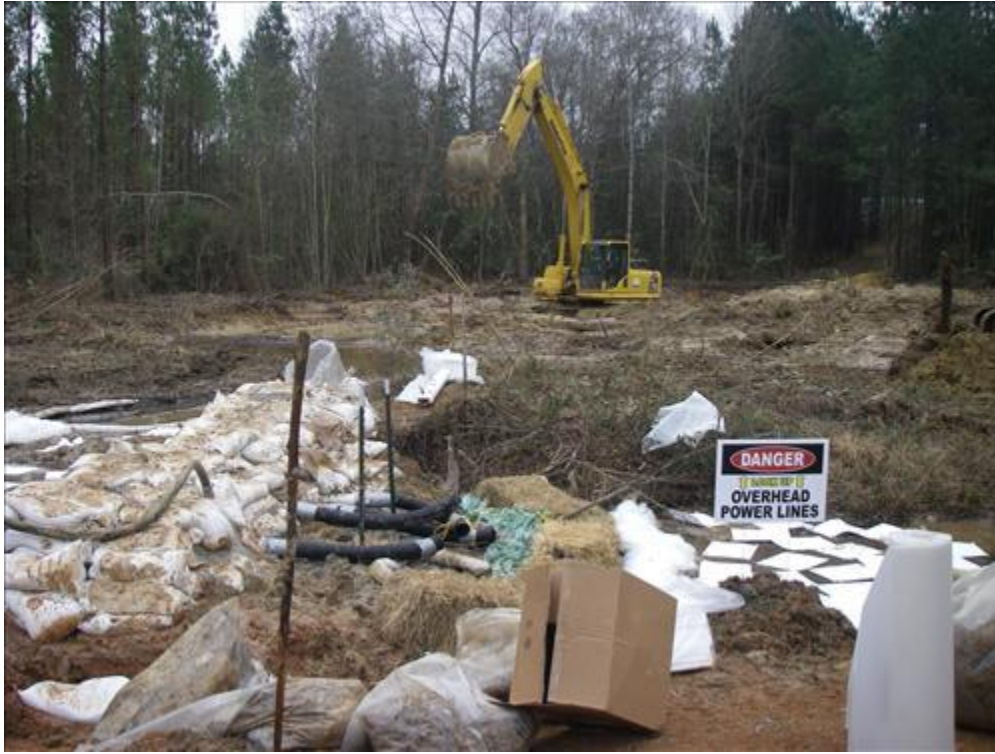
Soil excavation was being conducted near the source of the spill. The excavated area was designated as "the dig". An area down gradient of the source had been cleared to allow free flowing oil and surface water to collect at an underflow dam (Photo 2). The SCAT team followed the oil from the source downstream to an access road. Water flow traveled to a culvert that went under the access road (Photo 3). Once on the other side of the road, the oil followed a ditch channel. Standing oil and oiled vegetation had been removed from the immediate area of the ditch channel as compared to the January 9th SCAT survey. The soil surrounding the ditch channel had been covered with Oil Gator. Oil was seeping from the soil (Photo 5) in several areas around the root systems of trees and bushes. The entire area affected by the spill had been divided into Zones A through E (Table 1). Zone A included the area north of the culvert, Area E encompassed the area at the northern most area where the spilled oil was contained.

Photo 1: Head of Spill “The Dig” (N31°45.223', W088°51.089')

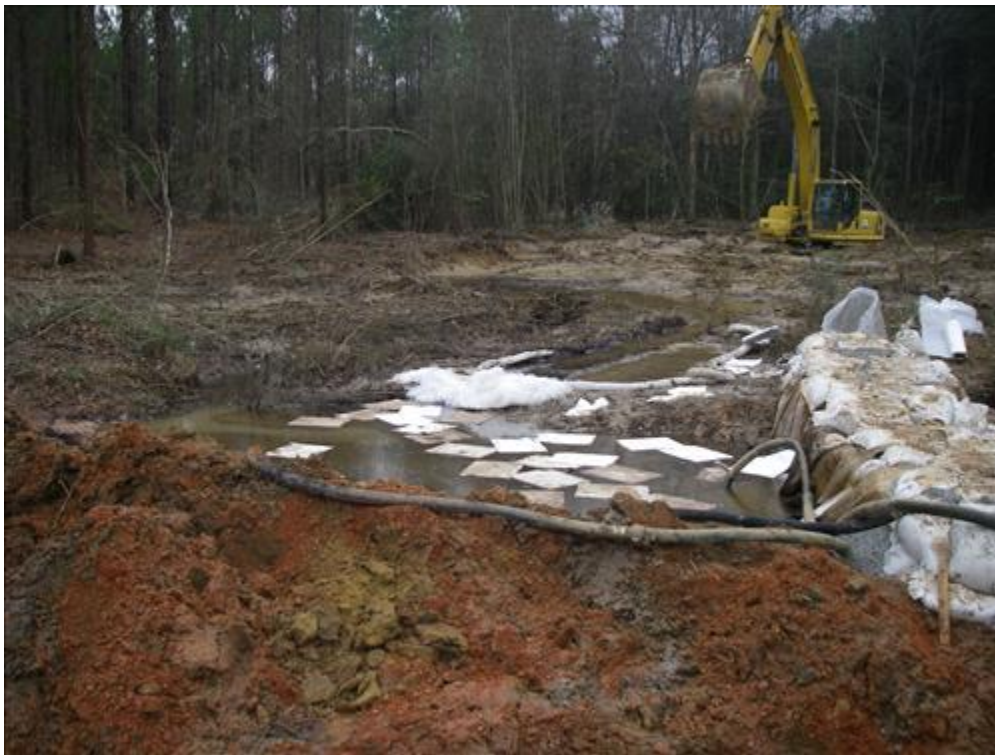
Photo 2: Temporary Underflow Dam

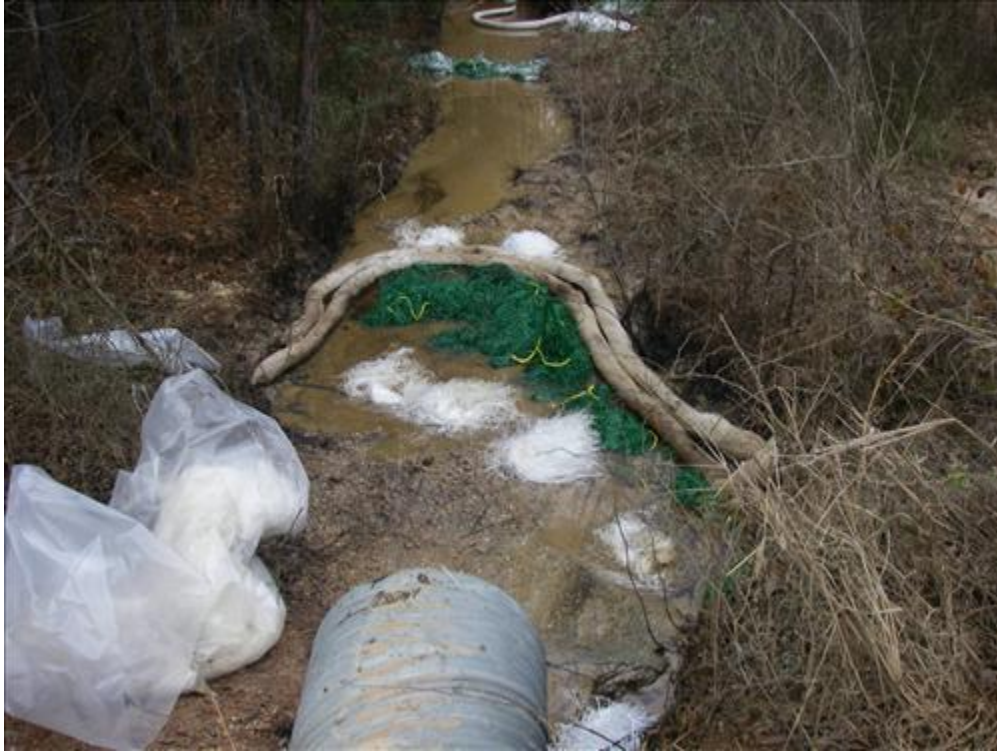
Photo 3: Culvert: (N31°45.227', W088°51.085')

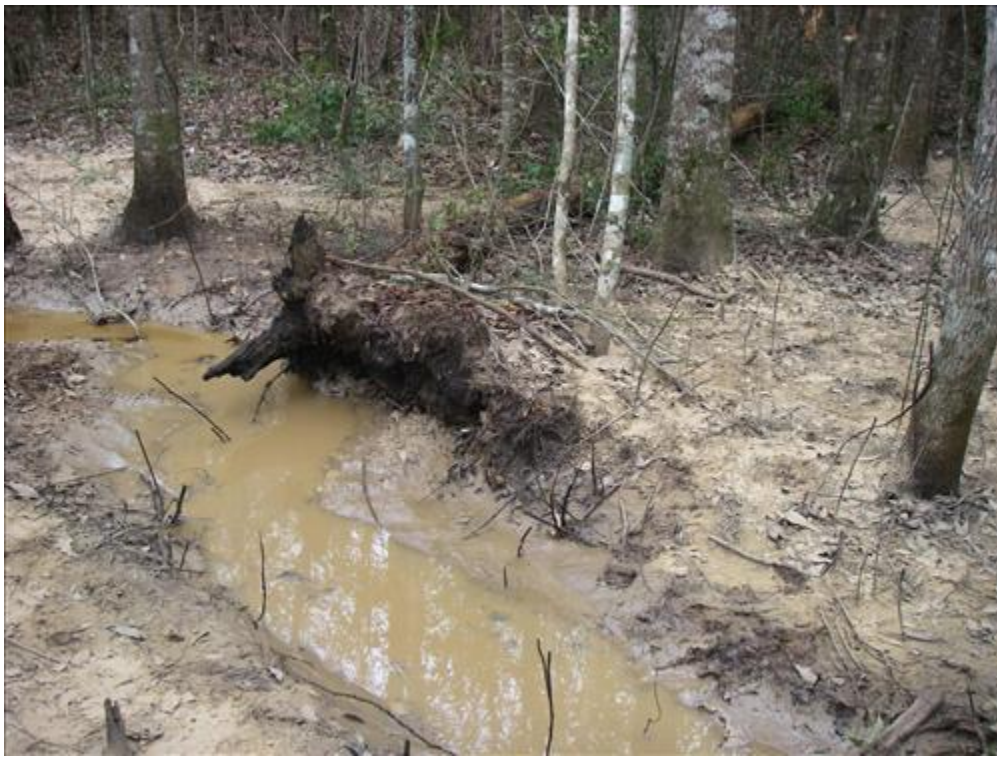
Photo 4: Creek Channel (N31°45.245', W088°51.091')

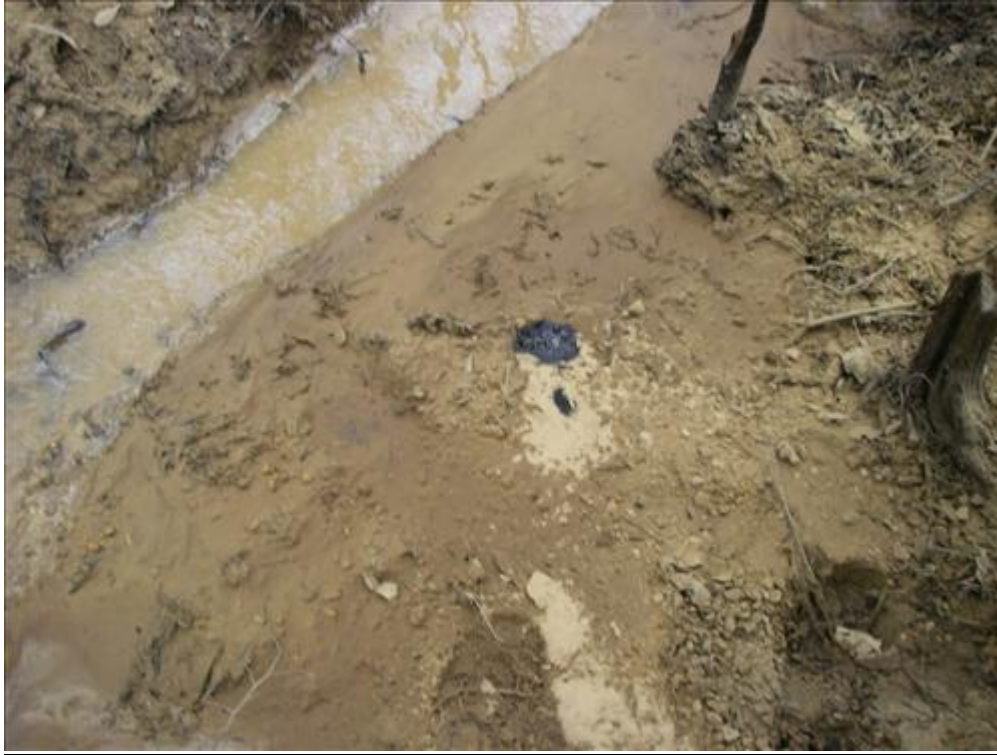
Photo 5: Oil Seeping (N31°45.262', W088°51.086')

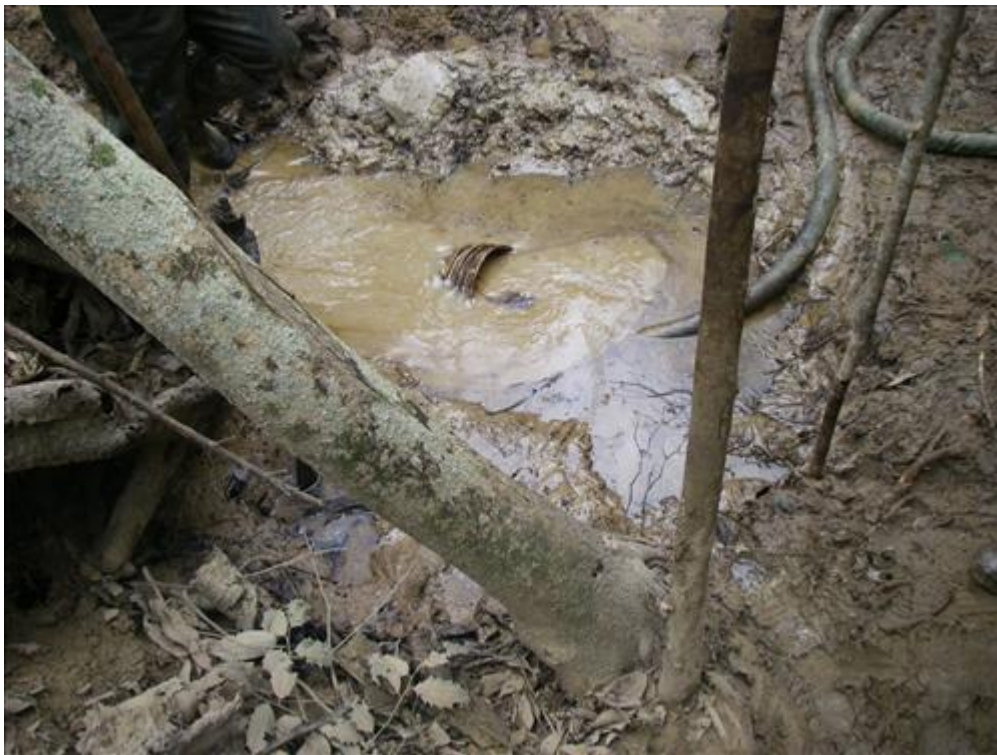
Clean up personnel was using oil gator, absorbent pads, and oil snares to collect the oil. The crews were also raking vegetation and placing it in bags in Zones A through E. Oil traps were being utilized to prevent recontamination of cleaned areas in Zone A. The traps consisted of a collection point and a pump. Surface water and oil was pumped around cleaned areas to prevent the re-contamination of the area. Oil in Zone A relatively stayed along the ditch area with most of the coverage being in a 5 yard band and some coverage up to a 20 yard band.

Photo 6: Oil Trap (N31°45.279', W088°51.084')

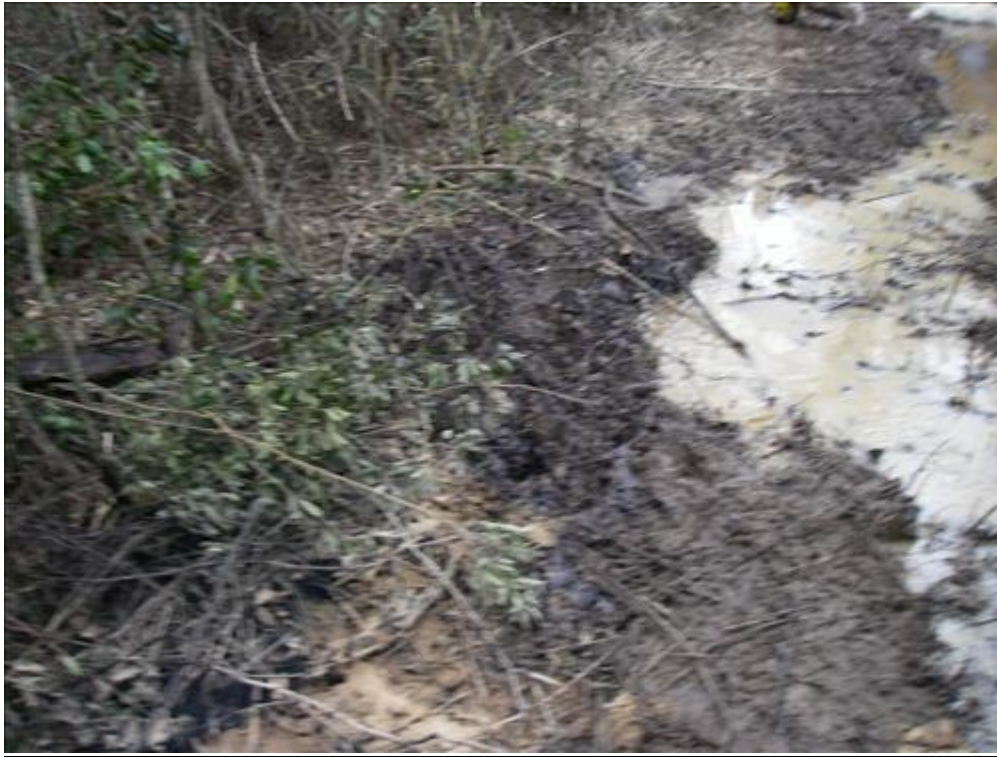
The ditch became less defined in Zone B ((N31°45.038', W088°51.065')). Oiled vegetation on the periphery of the spill was being collected as part of Phase One of the clean up (Photo 7). In Zone B, the oil spread out into a larger band (approximately 50 yards) because the ditch did not have the capacity to carry the oil and the grade of the terrain was relatively flat. Pooled oil had largely been removed as compared to the January 9th, survey. An oil collection curtain had been constructed from a material known as Nylon 66. The curtain stretched approximately 50 yards perpendicular to the water flow in the spill area. Surface water flowed under the curtain while oil was skimmed from the surface of the water by the curtain (Photo 8). Zone B included areas where oil had collected in the soil near the base of fallen trees and stump holes (Photo 9). These areas are to be flushed with water during Phase 2 of the clean-up.

Photo 7: Oiled Vegetation: (N31°45.315', W088°51.055')

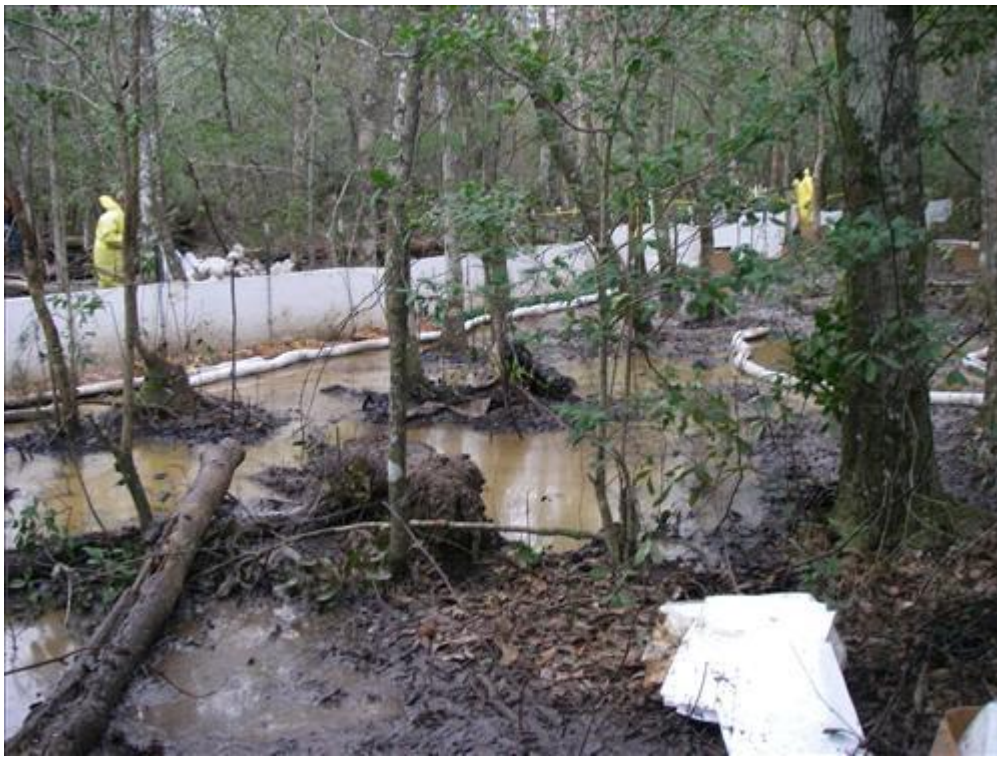
Photo 8: Nylon 66 Oil Curtain (N31°45.339', W088°51.051')

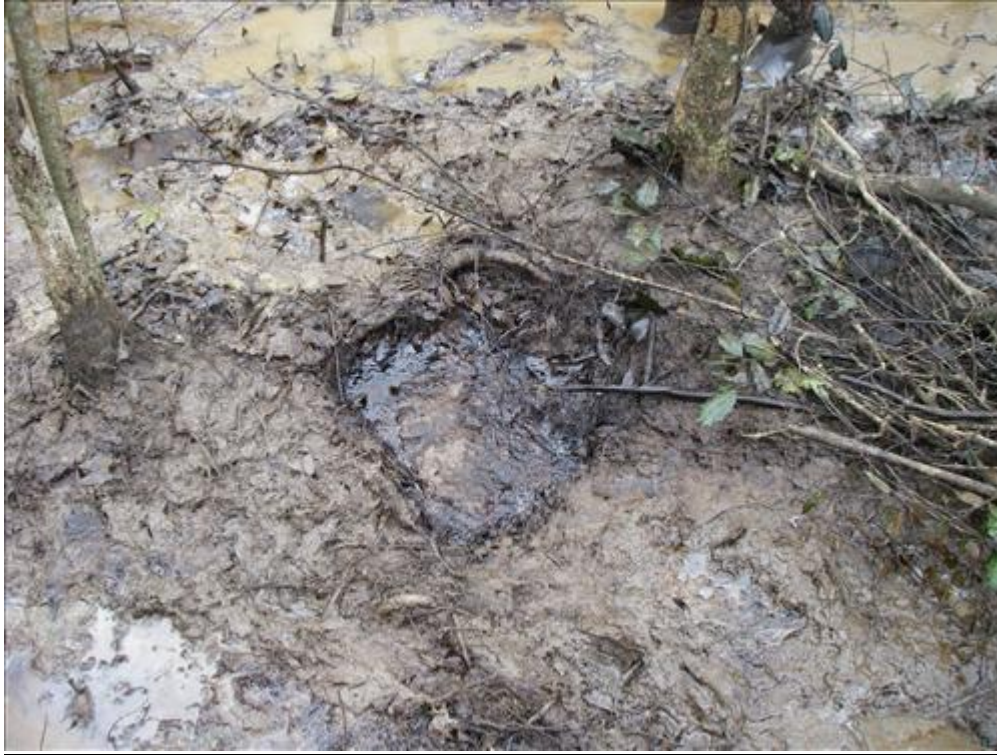
Photo 9: Typical oil seep from soil near vegetation roots (N31°45.334', W088°51.049')

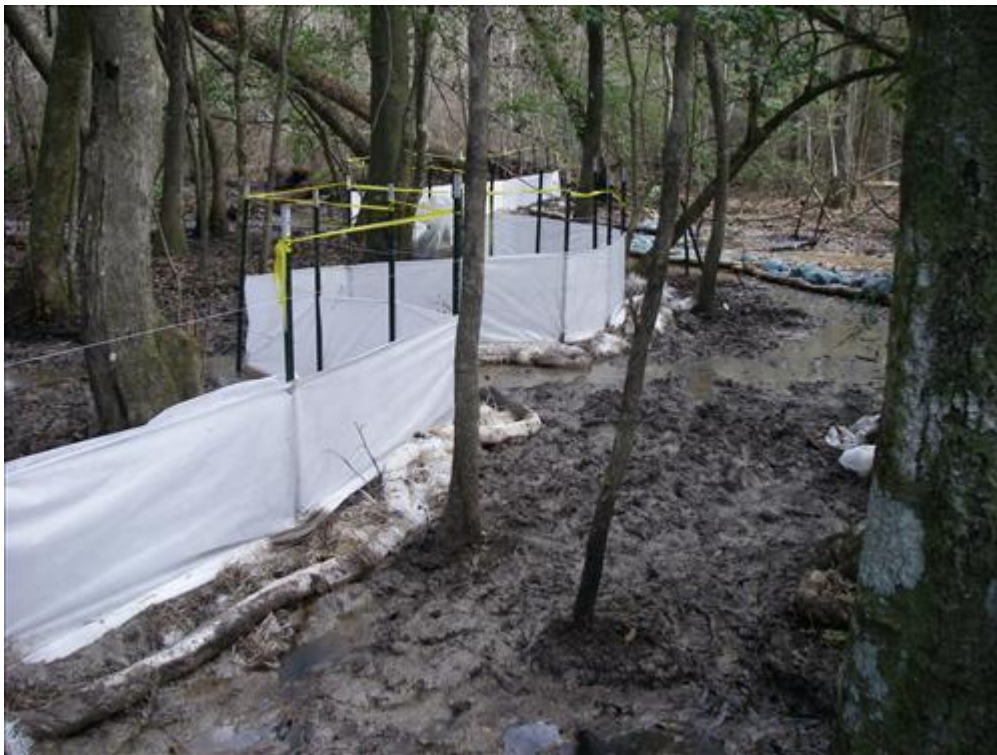
Photo 10: Second Curtain (N31°45.389', W088°51.048')

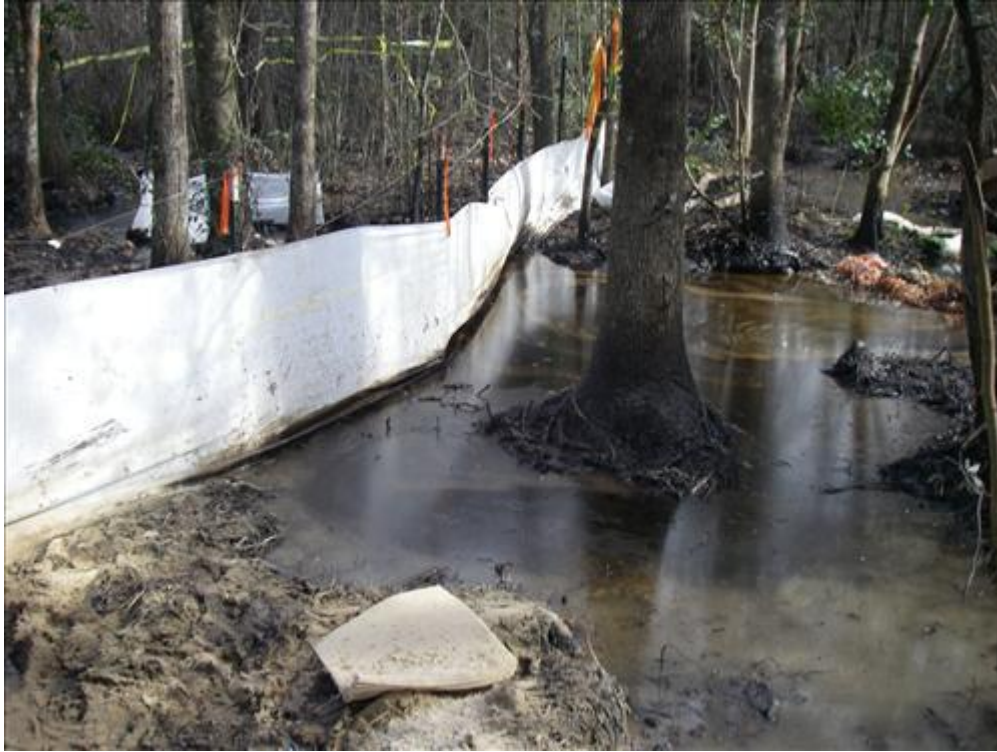
The third curtain was located at the boundary of Zones B and C. The water flow through the area was not well defined. Clean up personnel periodically collect pooled oil collected up gradient of the curtain. The band of oil in Zone C included oiled vegetation on the ground and some pooled oil in the shallow ditch and low natural collection places in the terrain.

Photo 11: Third Curtain Zone B-C Boundary ((N31°45.400', W088°51.064')

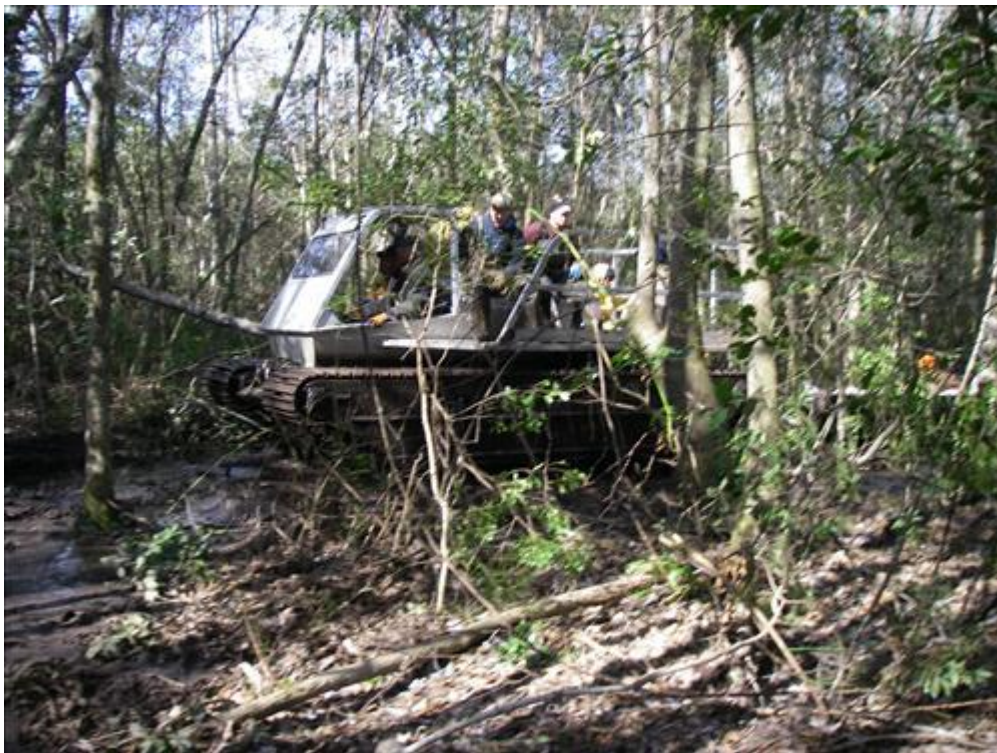
Photo 12: Marsh Master Material Transport Vehicle

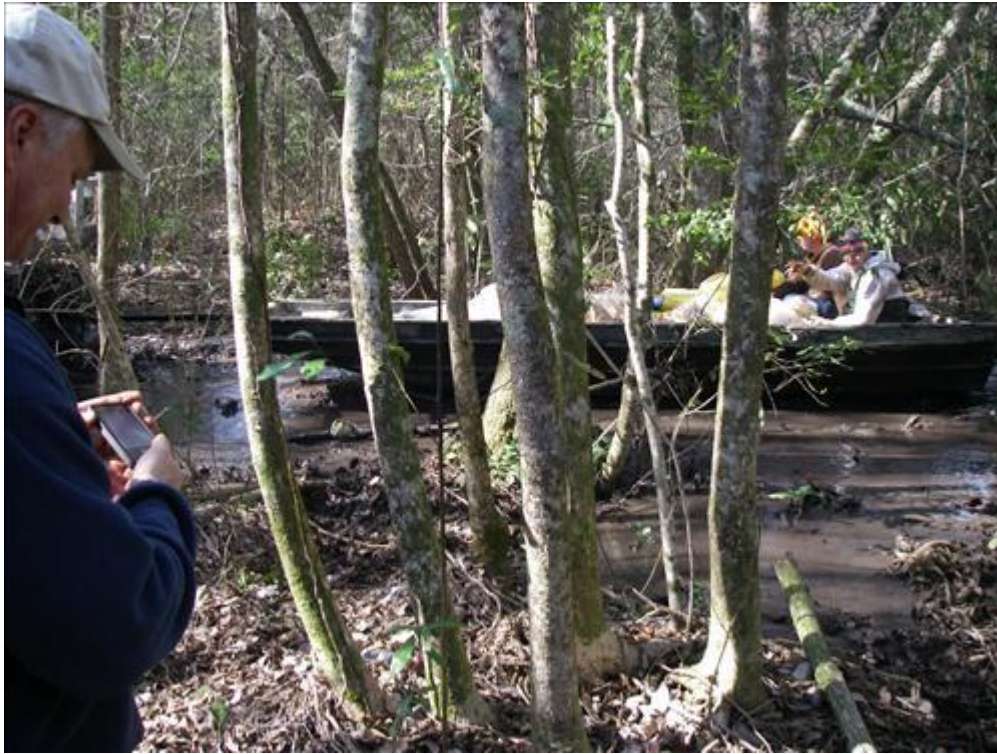
Photo 13: Material Transportation

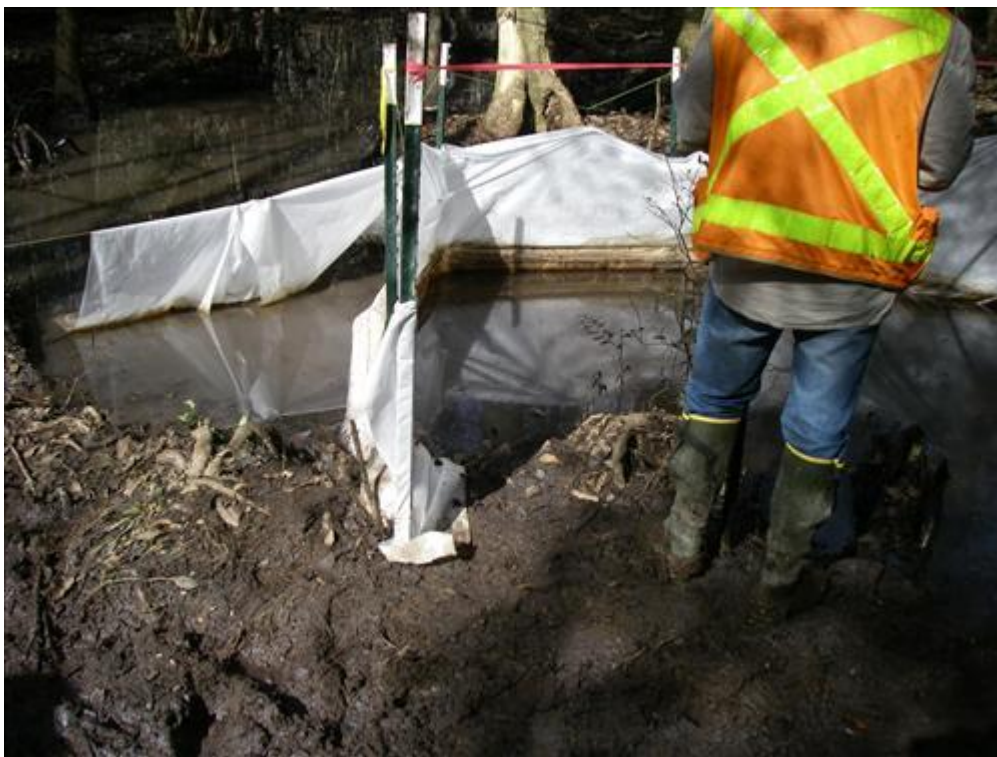
Photo 14: Oil Collection Point

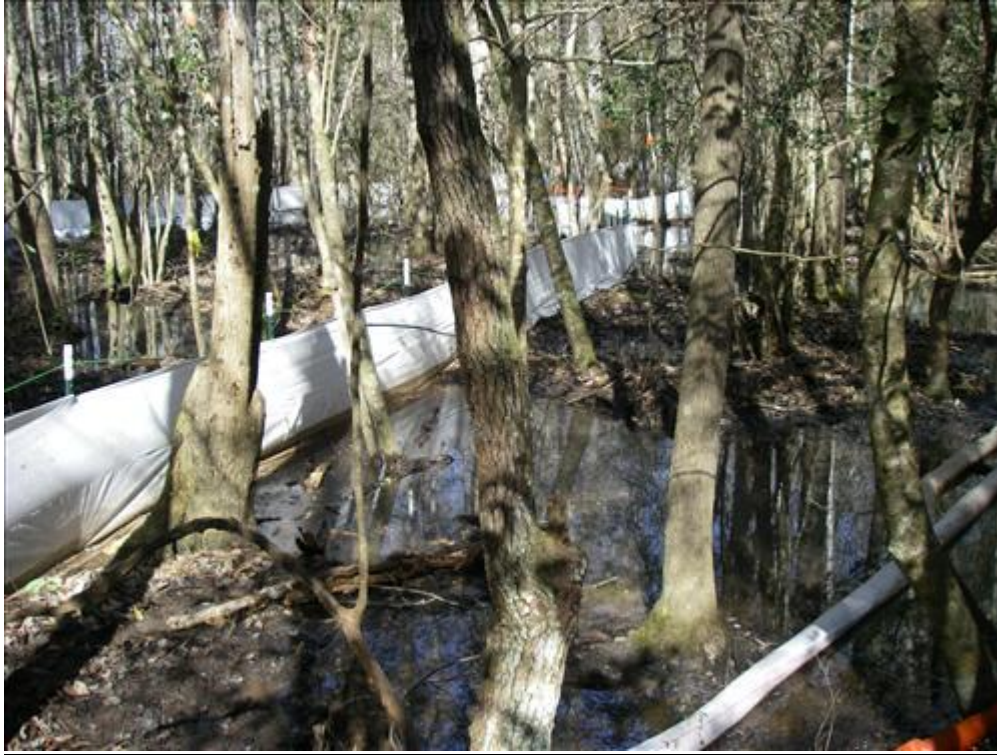
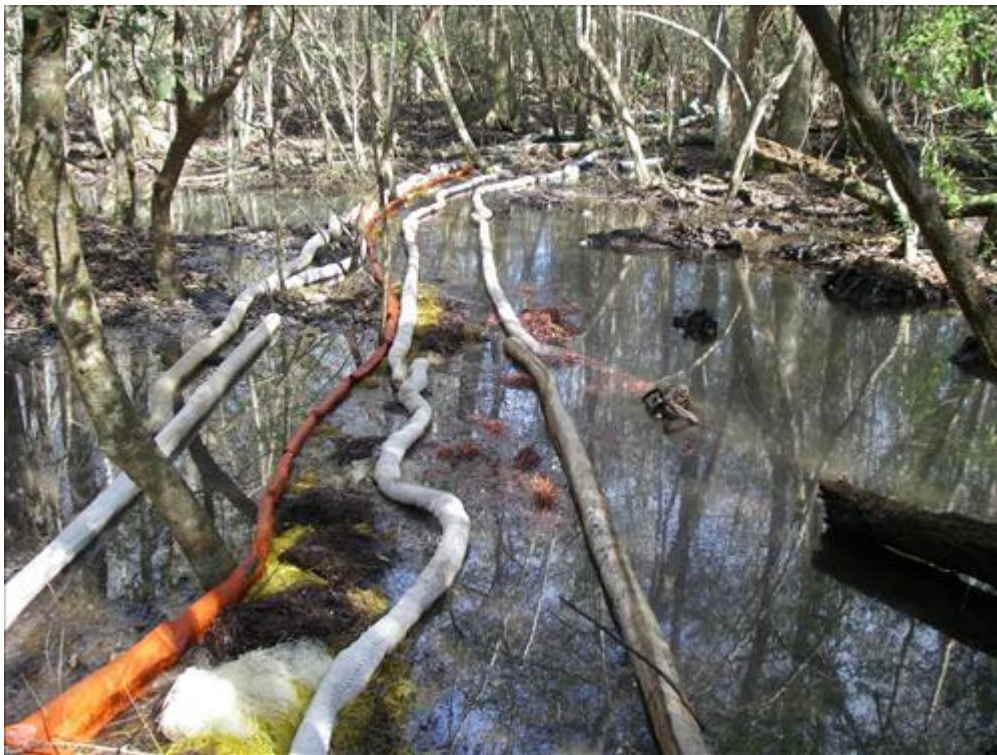
The terrain in Zone E remained relatively flat with well defined flow channels. Oil was observed in areas in a band approximate up to 50 yards wide. The final control was at 31.76087 N 88.85349 W which consisted of hard boom, sock boom and a Nylon 66 curtain boom to contain the oil. No oil was observed past this control point. At 31.76157 N 88.85402 W, there was a beaver dam which had water backed up.

Photo 15: Final Spill Controls (N31°45.670', W088°51.209')

Photo 16: Final Spill Controls (N31°45.670', W088°51.209')
