**Subject: Final Comprehensive Environmental Response, Compensation, and Liability Act
(CERCLA) Removal Action Report
ESB (Exide) Fund Lead
Atlanta, Fulton County, Georgia
EPA Contract No. EP-W-05-054
TDD No. TTEMI-05-001-0002**

**CERCLA REMOVAL ACTION REPORT
ESB (EXIDE) FUND LEAD
ATLANTA, FULTON COUNTY, GEORGIA
EPA CONTRACT NO. EP-W-05-054
TDD NO. TTEMI-05-001-0002**

Final Report

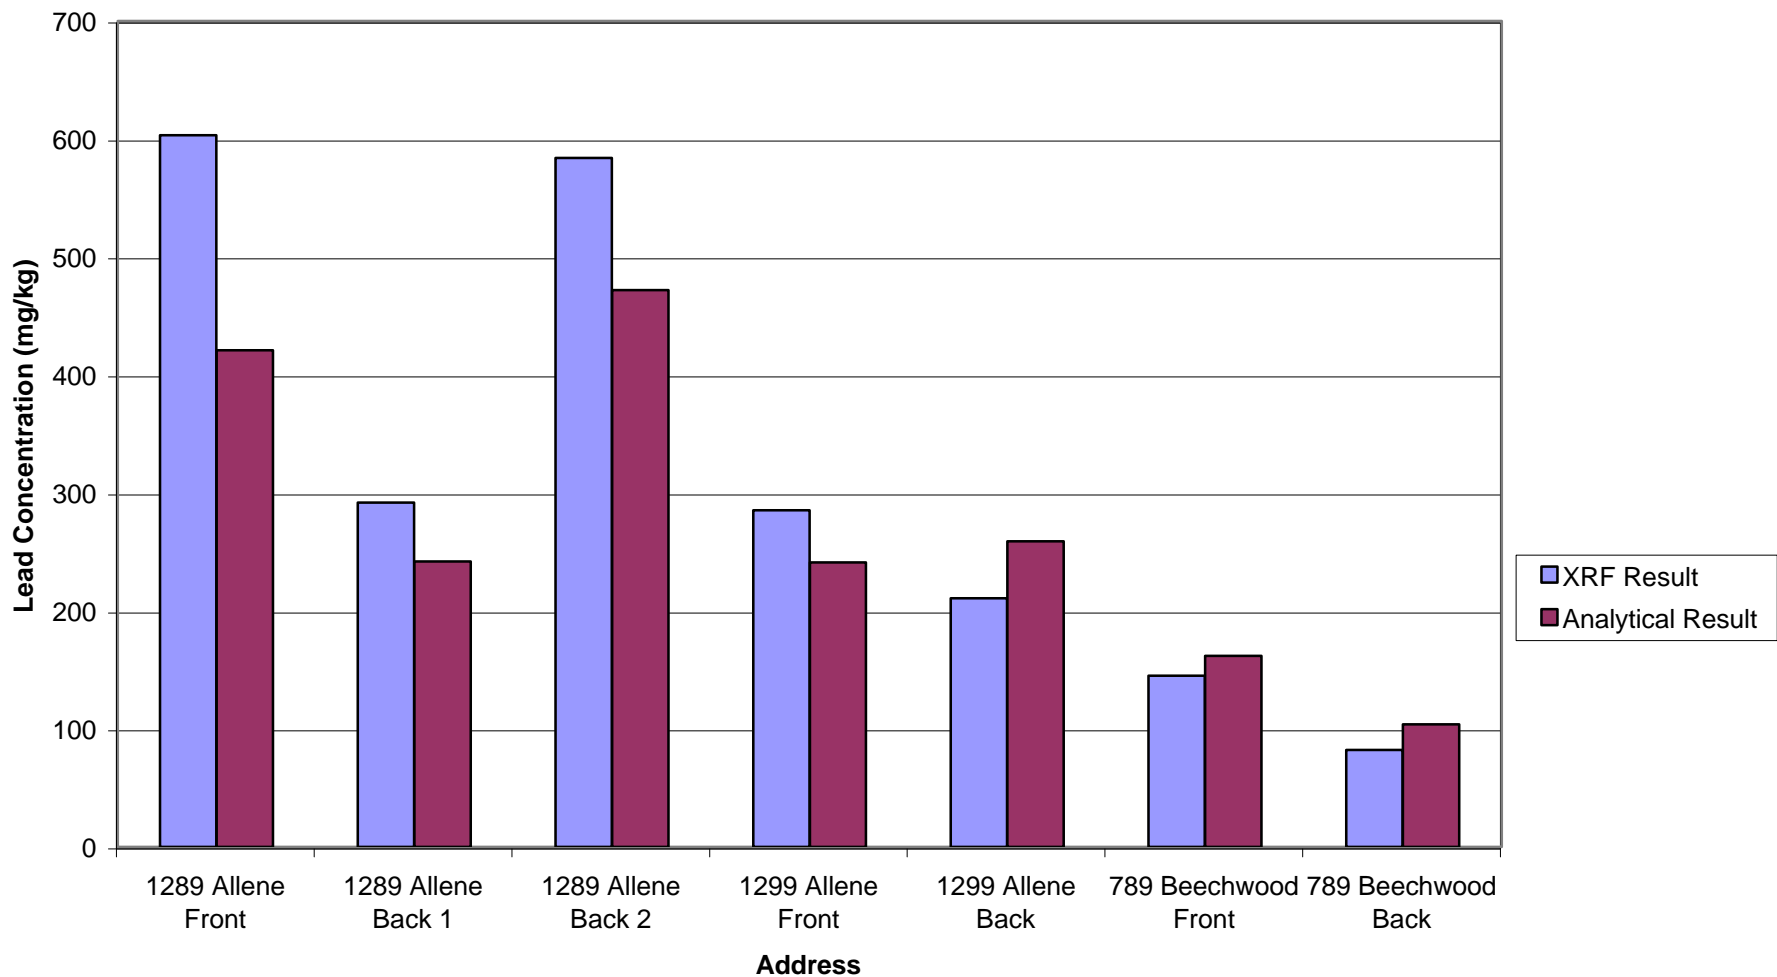
ESB (EXIDE) FUND LEAD
ATLANTA, FULTON COUNTY, GEORGIA
FIGURE 3. PRE-EXCAVATION XRF VS. ANALYTICAL RESULTS FOR LEAD

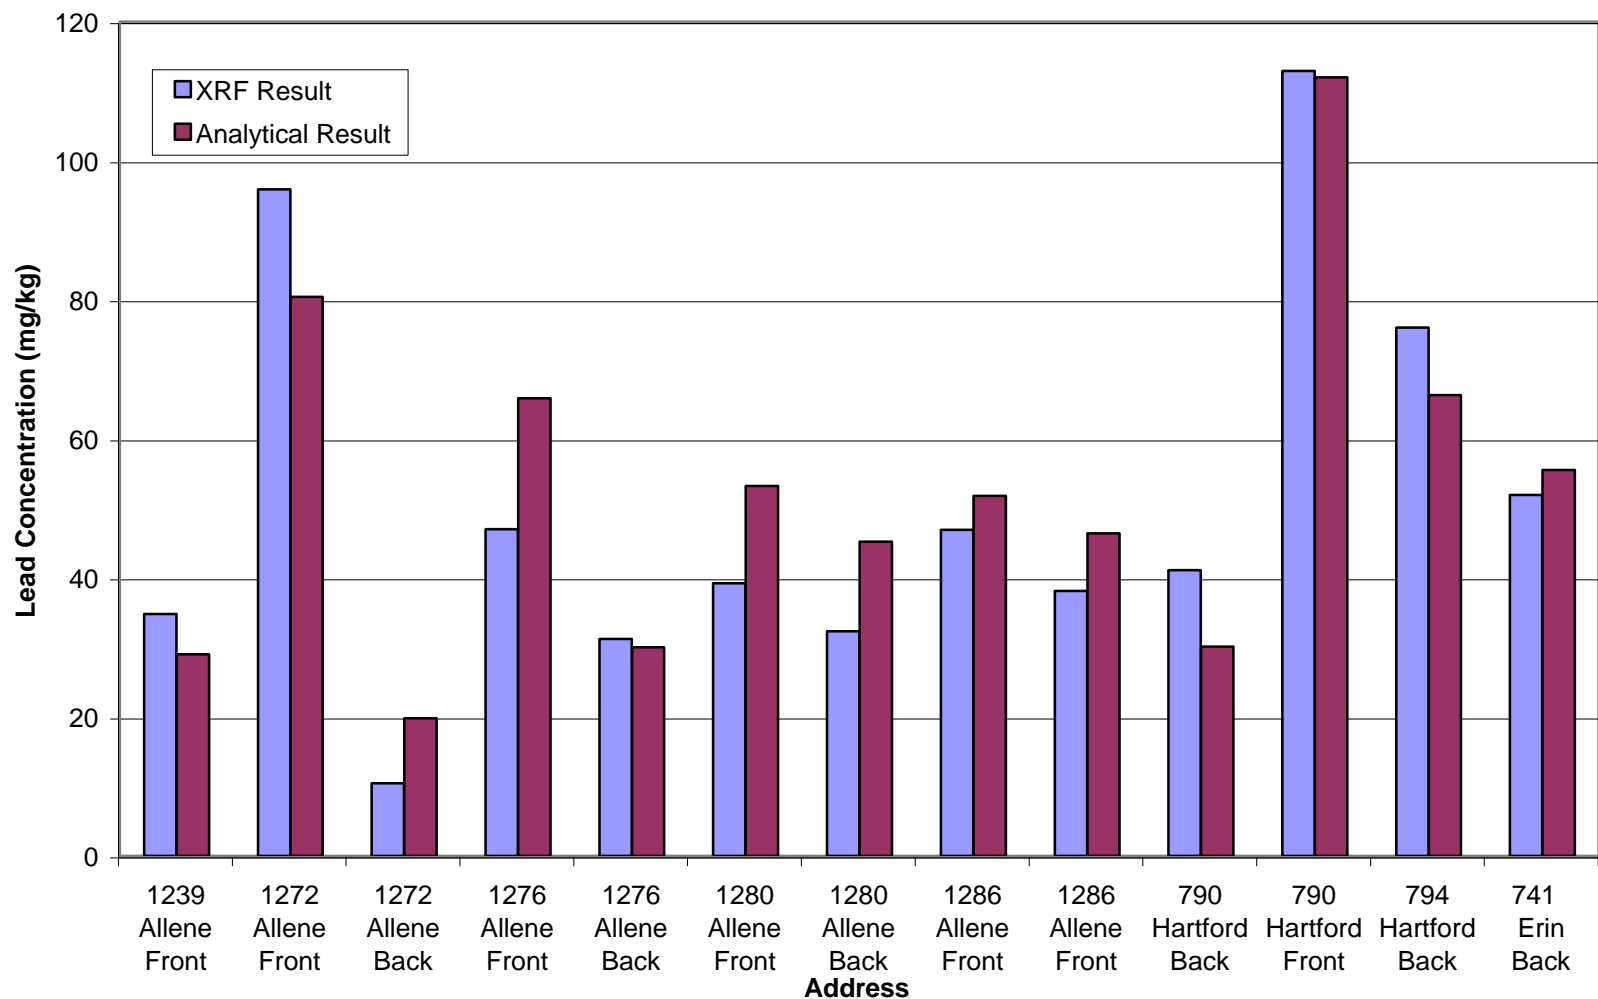
ESB (EXIDE) FUND LEAD
ATLANTA, FULTON COUNTY, GEORGIA
FIGURE 4. POST EXCAVATION XRF VS. ANALYTICAL RESULTS FOR LEAD

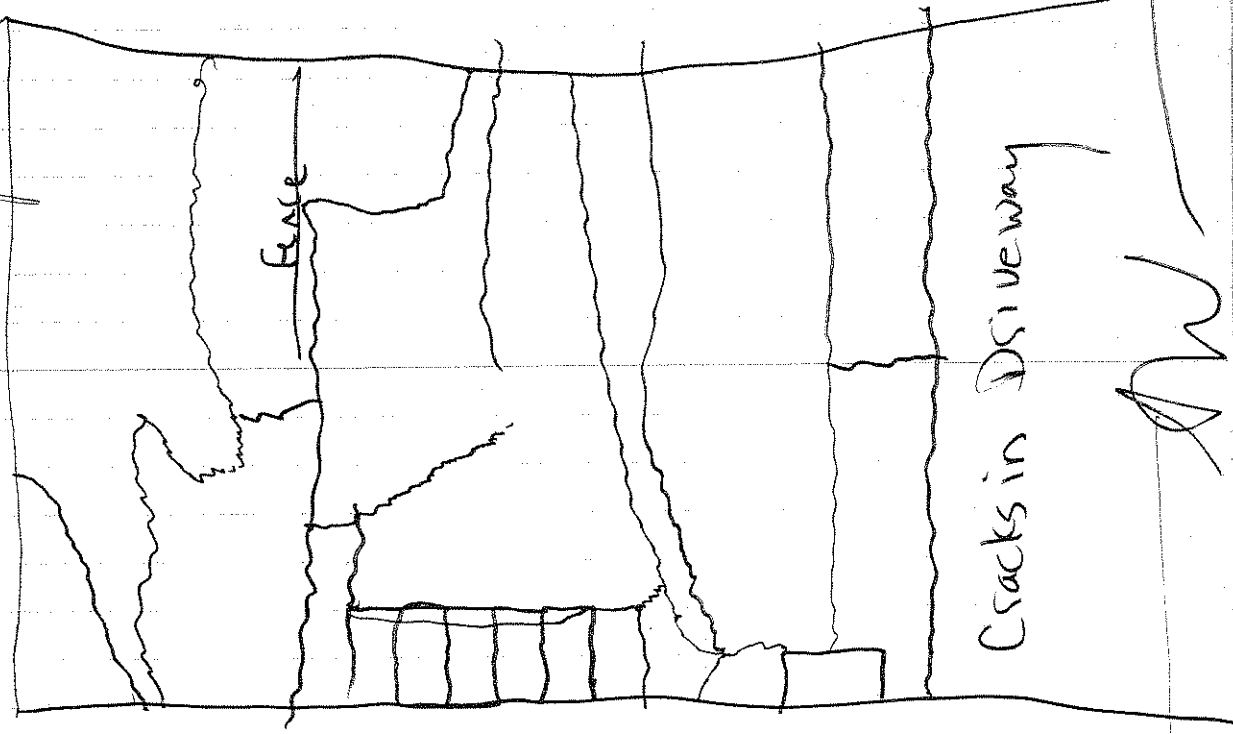
Hawth 790 Driveway Diagram

- 0820 START White documents cracks in driveway. EPA Lucas arrives.
- 0845 START White calls Johnny McKenzie to inquire about the doghouse on his property. Mr. McKenzie stated that he did not care about the doghouse. He said it could be removed. He also said that he was at 790 Hartford Pl on yesterday (6/14/06) and that everything we were doing was OK with him. He stated that the fence could come down if we were going to put sod in the fenced area. Mr. McKenzie will be coming by around 1030 or 1100 today.
- 0850 EPA Lucas arrives departs. He stated that he is going to return after picking up an intern.
- 0858 START White calibrates the XRF.
