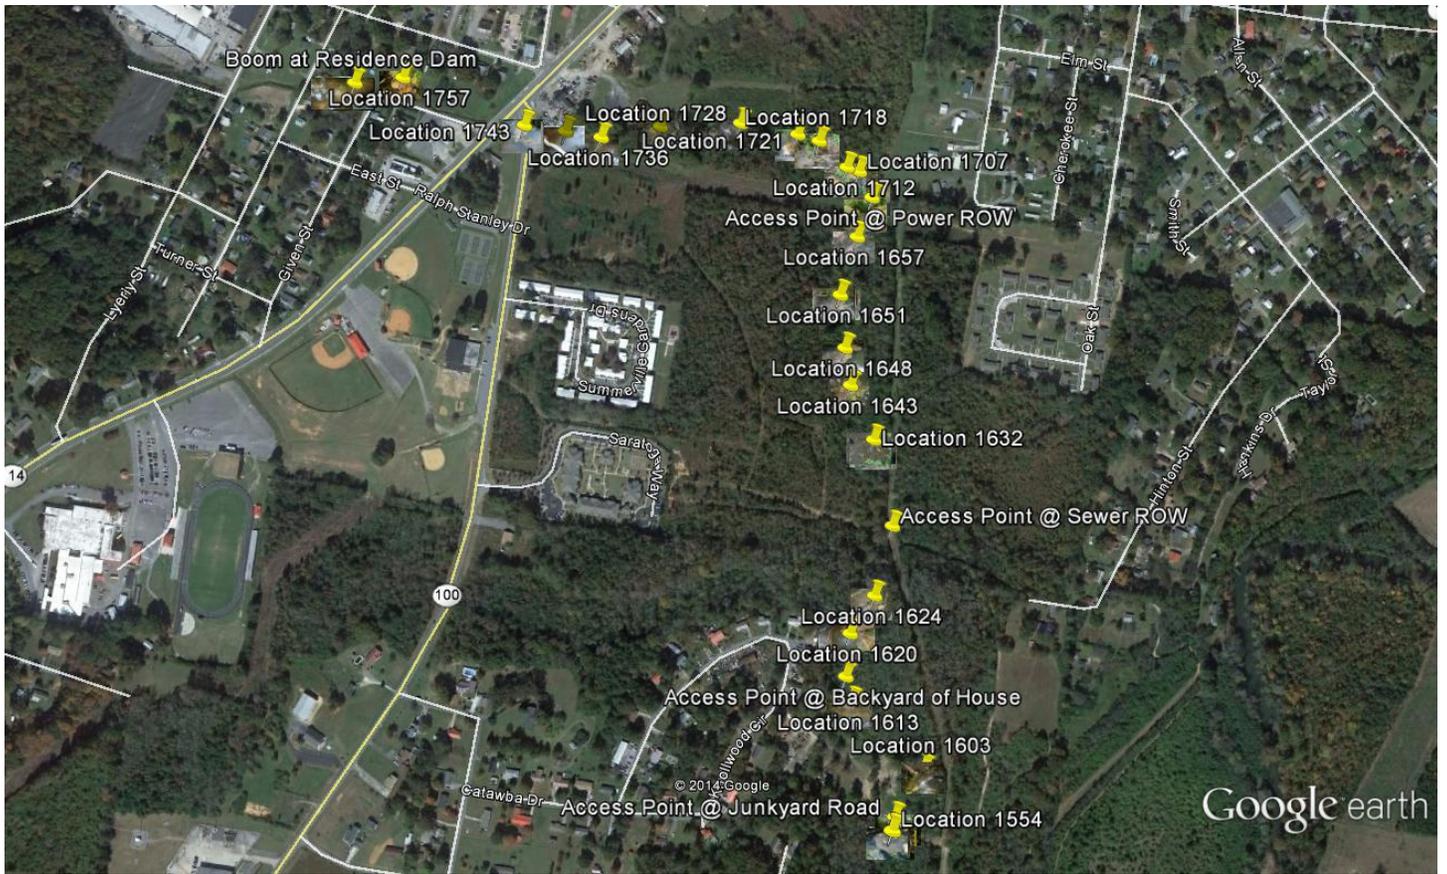
Location: 1554

Priority: **Moderate**

Notes: Dam of sticks and logs across 80% of surface collecting mousse covering surface area approximately 3ft x 10ft (watch out for large 24" snapping turtle seen in water). Access through junkyard road off Catawba Drive.

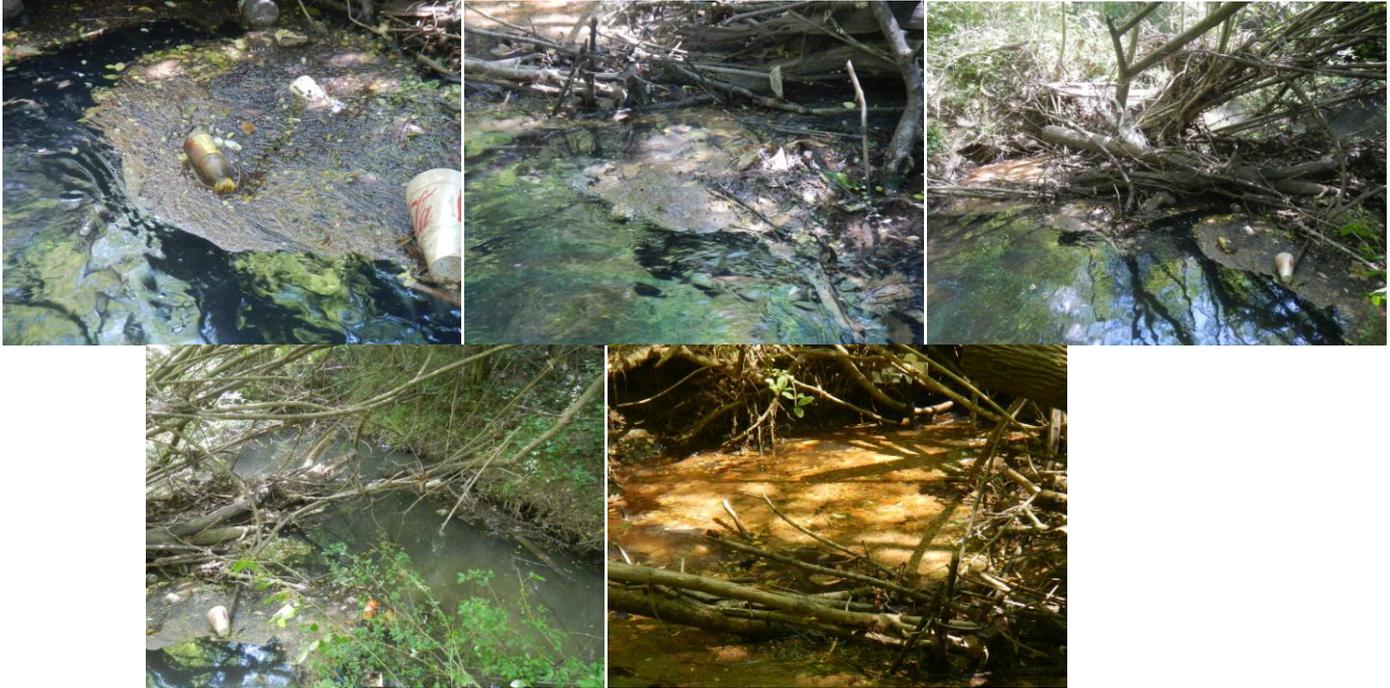
Location: 1603

Priority: **Low**

Notes: Small area of mousse and debris caught. Access 100ft upstream from location 1554.

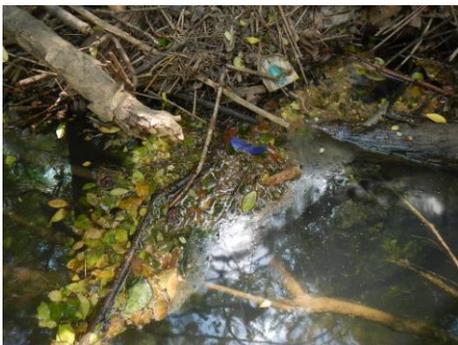
Location: 1613

Priority: **Moderate**

Notes: Mousse and debris trapped in brush over three spots. Covers area approximately 3ft x 5ft, 1ft x 5ft, and 3ft x 5ft. Near backyard of home. The sheen in this area is thicker. Access from backyard of home off Catawba Drive.

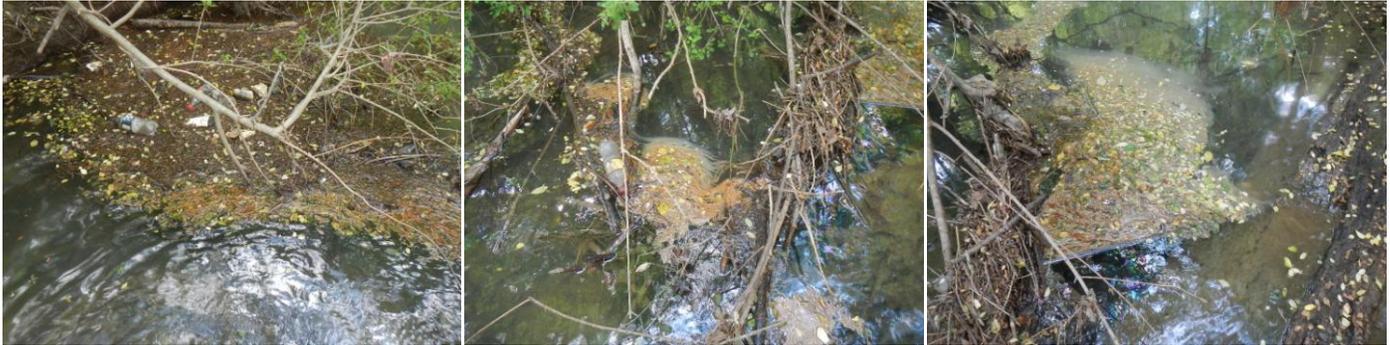
Location: 1620

Priority: **Moderate**

Notes: Spots of mousse with debris trapped in brush and vegetation. Covers approximately 1ft x 3ft. Located approximately 200ft upstream of location 1613 (photos 2674-2675). Red material is bacteria NOT OIL in photos 2676-2677. Also heavy oiling approximately 50ft upstream of location 1620 (photos 2678-2680). Covers approximately 2ft x 8ft. Access is a walk 200-250ft upstream from backyard of home off Catawba Drive.

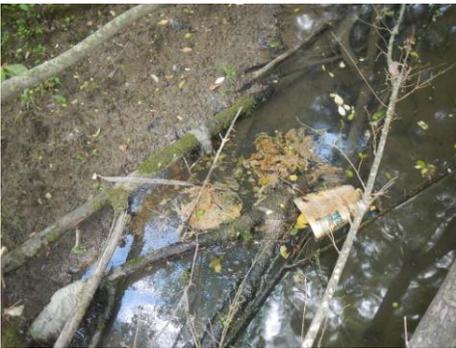
Location: 1624

Priority: **Low**

Notes: Small spot of mousse and debris within brush. Access could be from backyard of house on Catawba drive or from sewer ROW

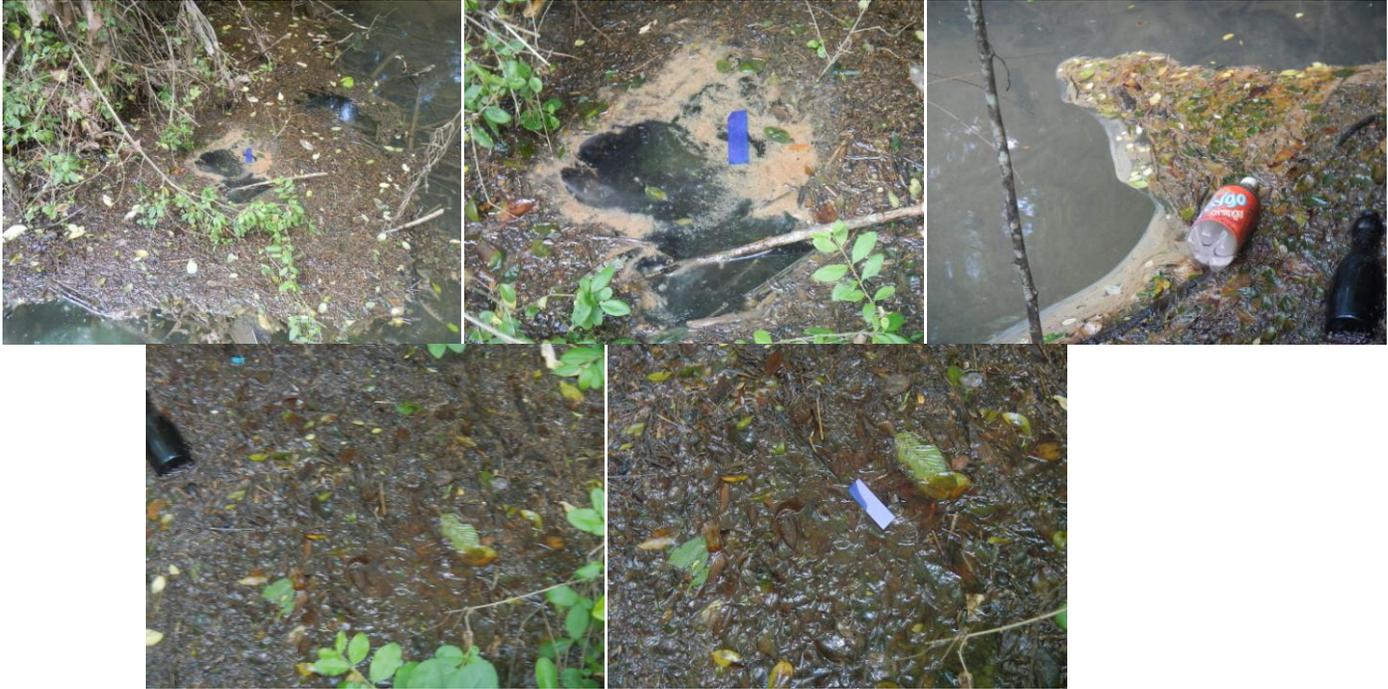
Location: 1632

Priority: **High**

Notes: Heavy oiling with some oil, mixed with debris and vegetation. Covers area approximately 6ft x 10ft. Access would be approximately 250-300ft upstream from sewer ROW.

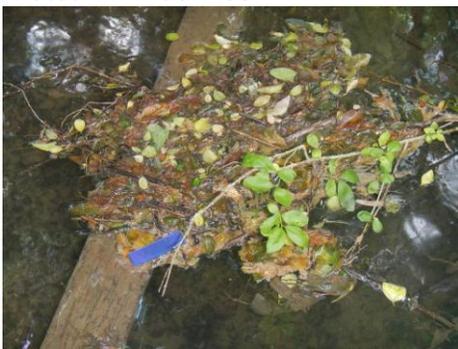
Location: 1643

Priority: **Low**

Notes: Sporadic oiled debris caught in brush. Covers area approximately 1ft x 2ft. Access would be approximately >600ft upstream from sewer ROW.

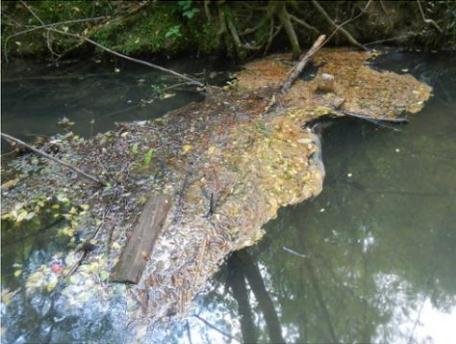
Location: 1648

Priority: **Moderate**

Notes: Large mat of mousse covers area approximately 3ft x 6ft with debris. Material will not easily float downstream. Access would be >700ft from either the sewer ROW or the power ROW.

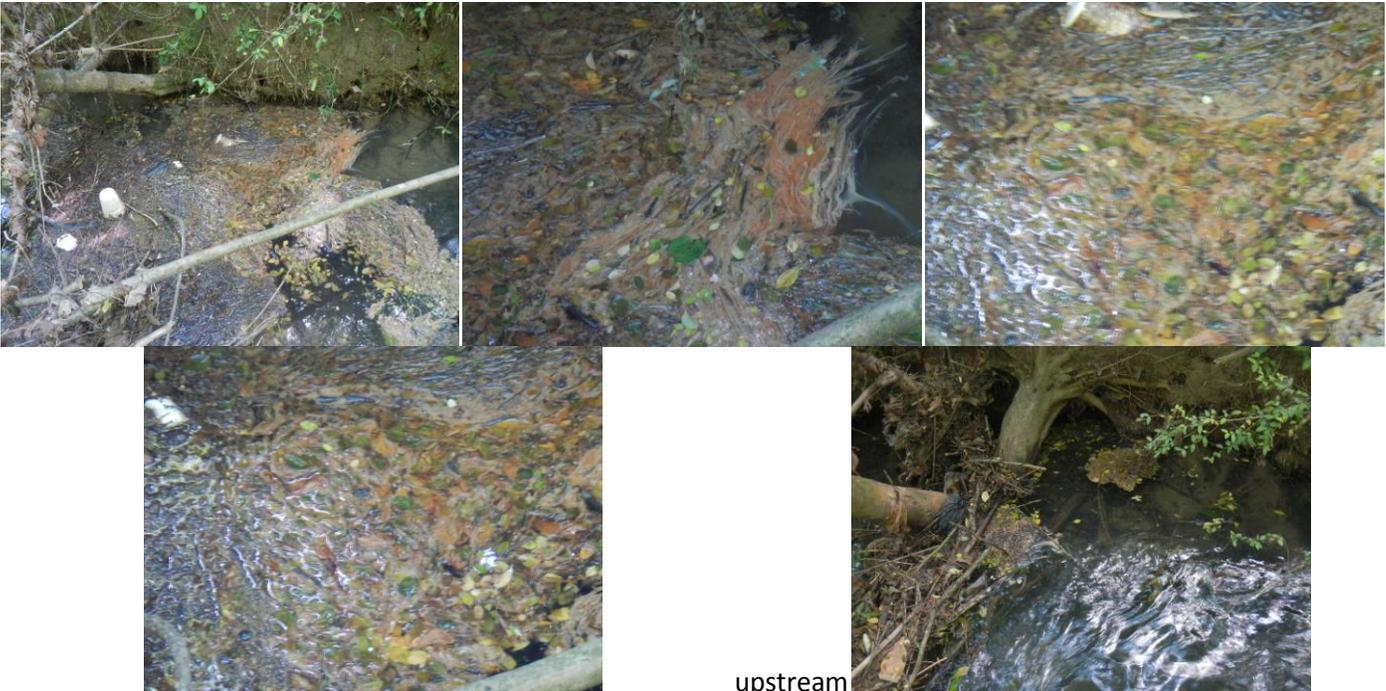
Location: 1651

Priority: **Moderate**

Notes: Large mat of mousse covers area approximately 4ft x 4ft with debris. Mousse appears to be fresher than material seen in downstream locations. Material will not easily float downstream. Access would be >400ft downstream from the power ROW.

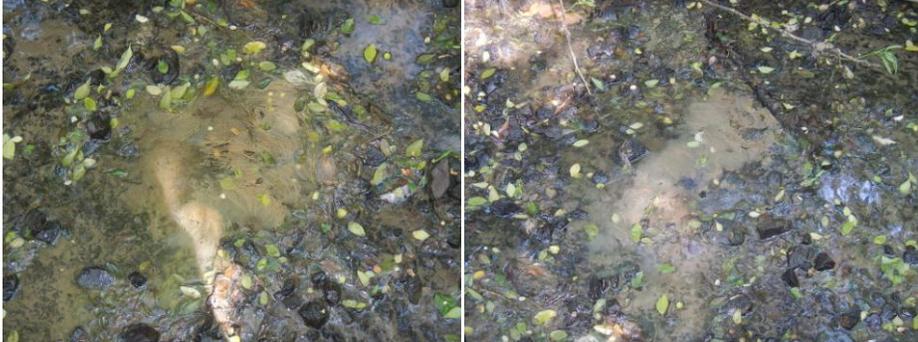
Location: 1657

Priority: **Low**

Notes: Light mousse collecting in area 1ft x 4ft on rocks in shallow water. Access would be 100ft downstream from the power ROW.

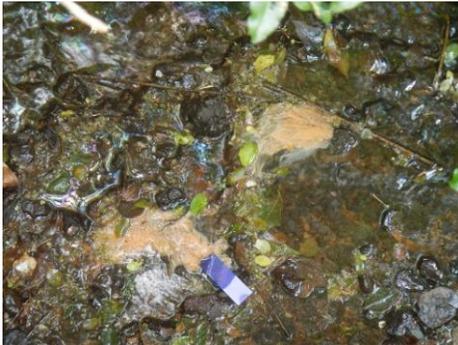
Location: 1707

Priority: **Low**

Notes: Light mousse collecting on rocks in shallow water covering area <1sqft. Access <100ft upstream from the power ROW.

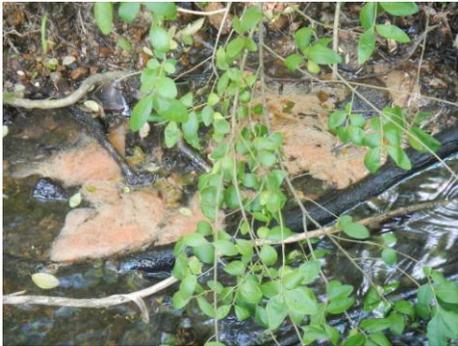
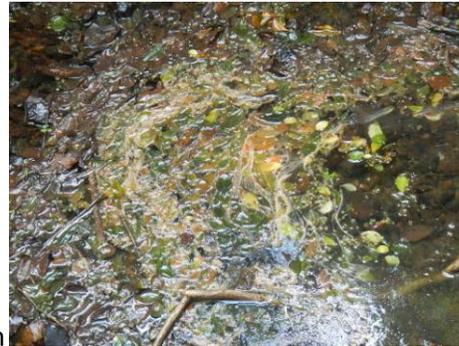
Location: 1712

Priority: **Low**

Notes: Pocket of fresh mousse without debris collecting in area 1ft x 3ft (photo 2703). Also 20ft upstream is area of light mousse with debris and oil on rocks in shallow water. Access 150 feet upstream from the power ROW.

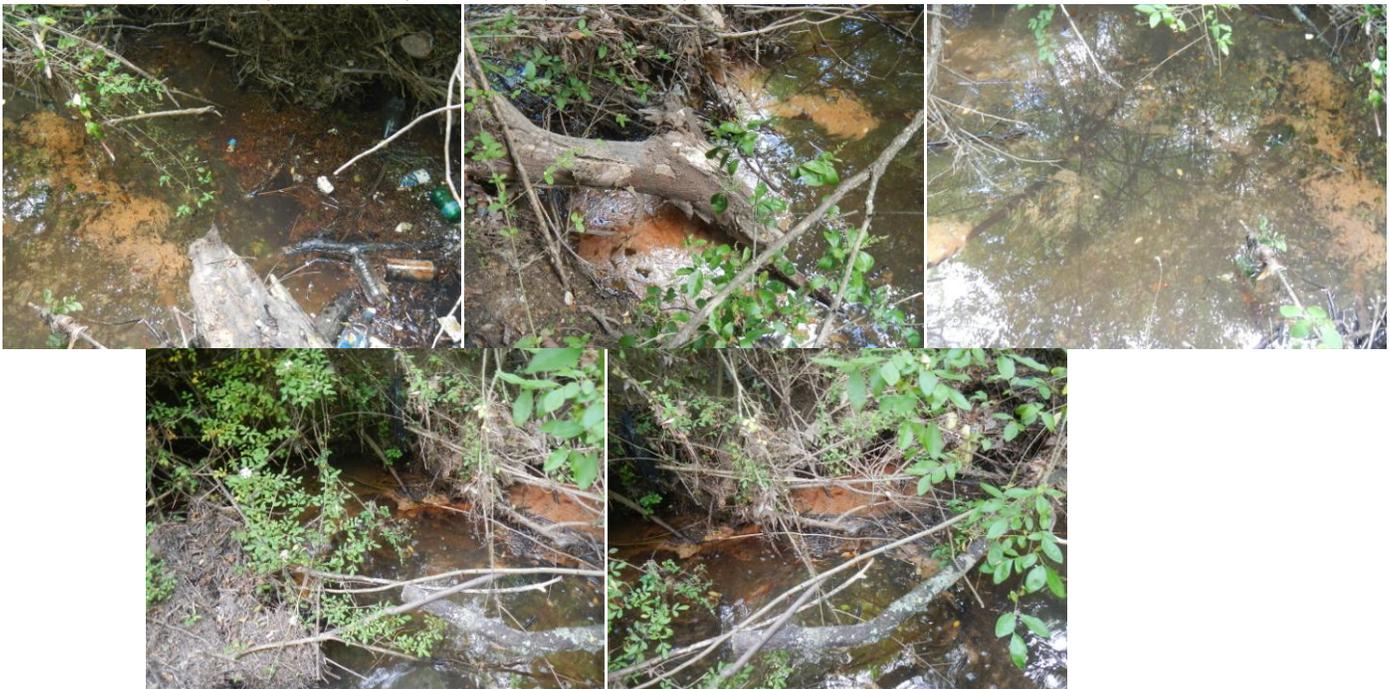
Location: 1718

Priority: **Highest**

Notes: Dammed water surface with logs and brush collected oil and mousse in area in excess of 10ft x 20ft. Access in excess of 300ft upstream from power ROW.

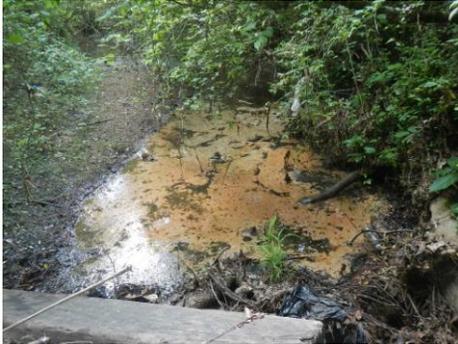
Location: 1721

Priority: **Highest**

Notes: Dammed water surface with logs and brush collected oil and mousse in area in excess of 8ft x 12ft. Located 50ft upstream from location 1718. Access in excess of 300ft upstream from power ROW.

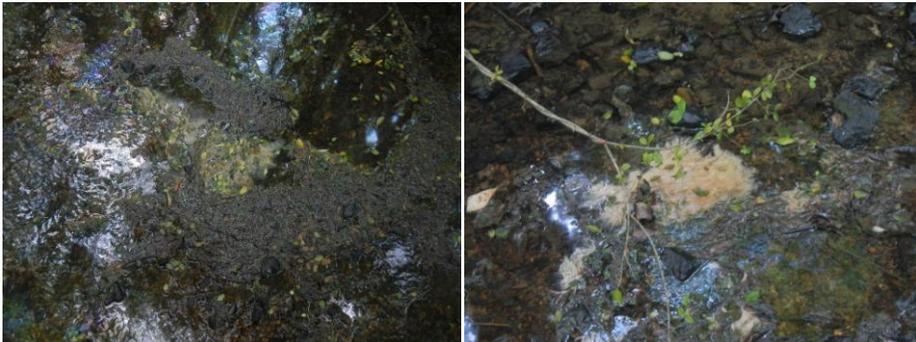
Location: 1728

Priority: **Low**

Notes: Pockets of mousse on rocks in shallow water. Four spots total each approximately 1sqft. Access difficult from either power ROW or highway.

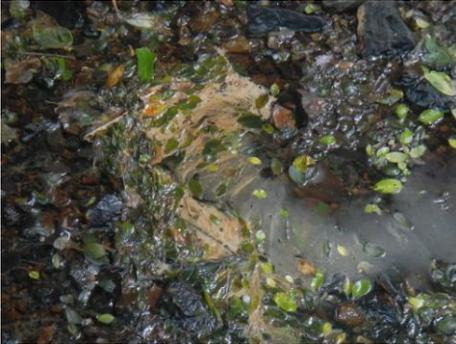
Location: 1732

Priority: **Low**

Notes: Small pocket of light mousse in area approximately 1sqft on rocks. Access difficult from either power ROW or highway.

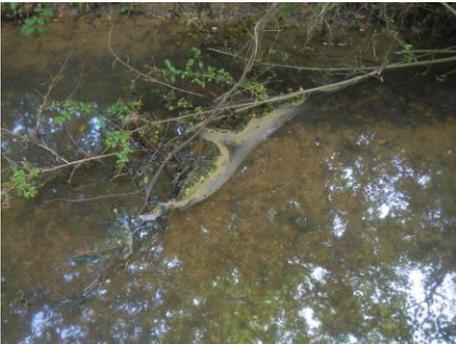
Location: 1736

Priority: **Low**

Notes: Light mousse in brush covers area approximately 1ft x 3ft. May float away before recovery. Access <200ft downstream from boom and vac truck location at highway.

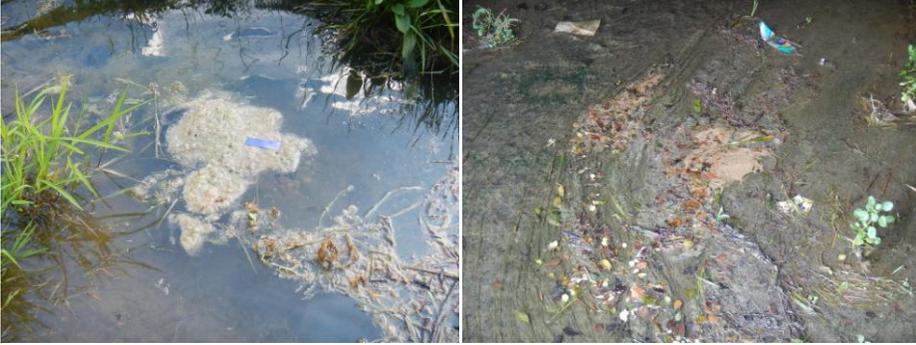
Location: 1743

Priority: **Low**

Notes: Oiled material and mousse on water surface and in culvert. Access from highway.

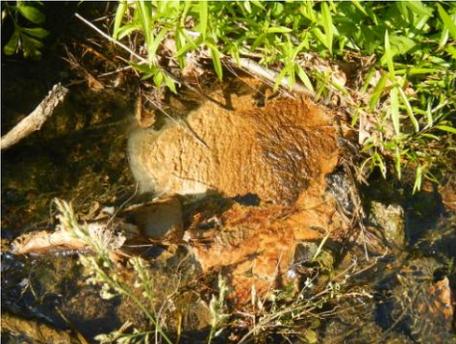
Location: 1757

Priority: **Low**

Notes: Weathered mousse in sun covers approximately 1sqft. Easy access from Given Street.

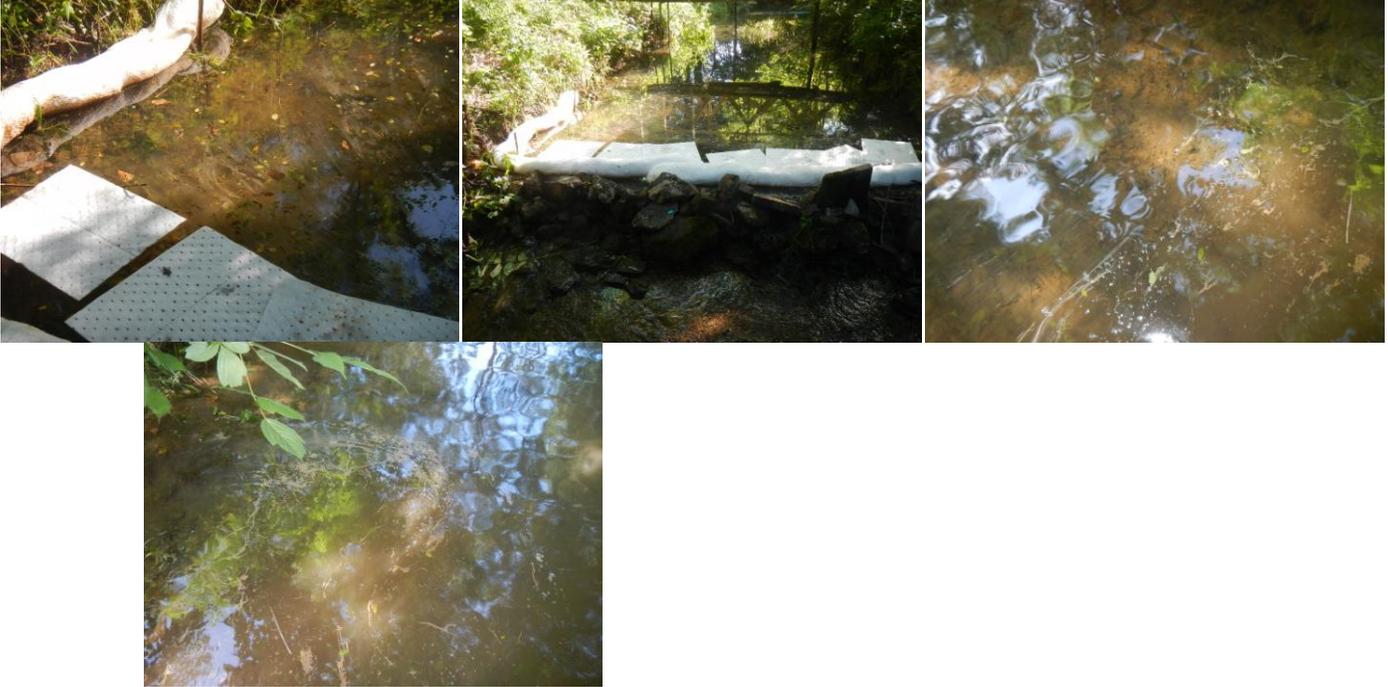
Location: 1800

Priority: **Low**

Notes: Light mousse and stringing mousse along water surface at dam along residence with boom. Easy access from residence Given Street.
