## Appendix C

### Photo Documentation

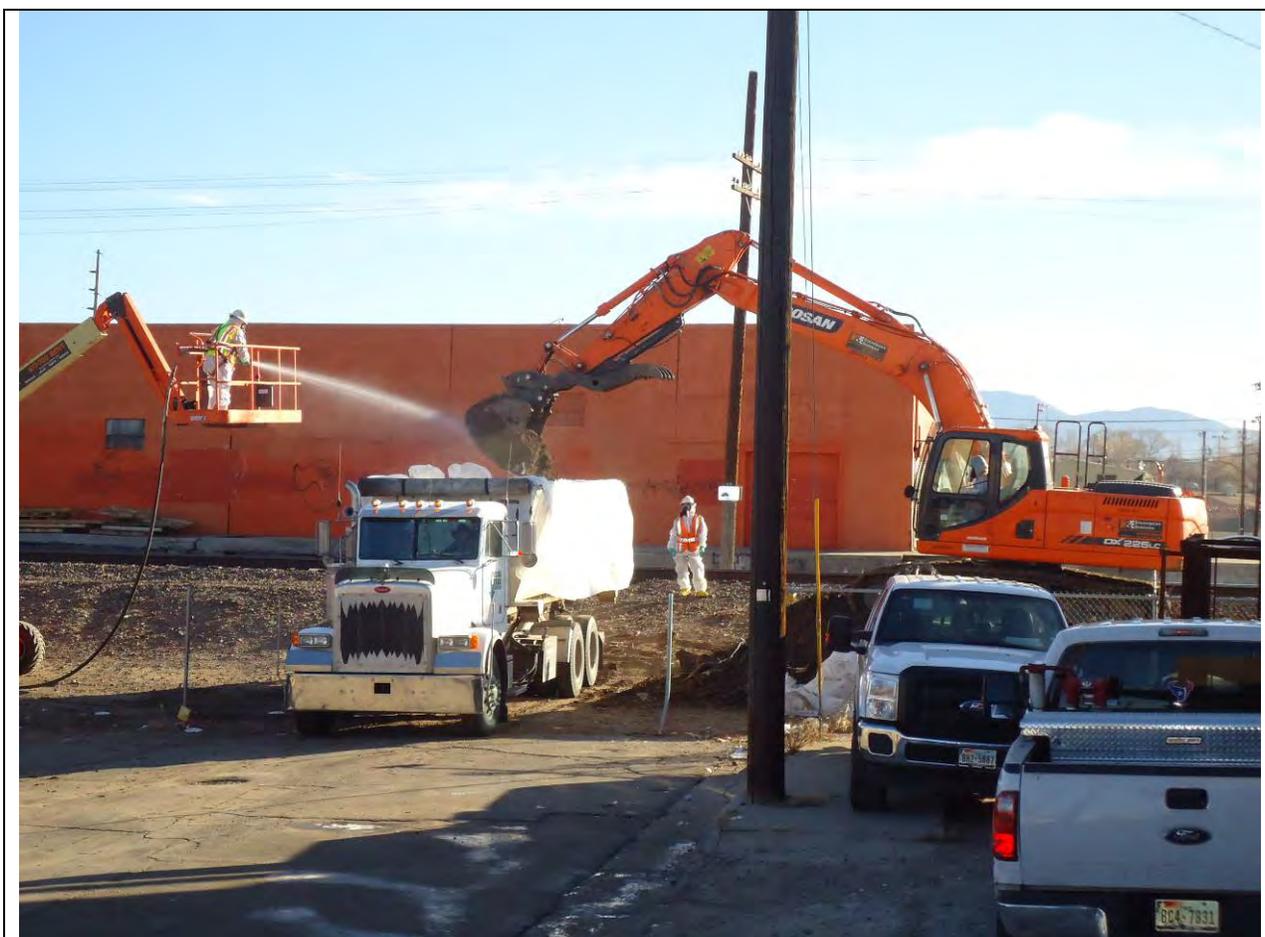
<b>Logbook Photo #</b>	DSC00827
<b>US EPA ID / Task Order Number</b>	CERCLIS: NMN000607041 / TDD No: 1/DYNAMAC-077-13-001
<b>Site</b>	Southwest Vermiculite (Removal 2)
<b>Location Address</b>	1800 1 <sup>st</sup> Street, NW
<b>City, State</b>	Albuquerque, New Mexico 87102
<b>County</b>	Bernalillo
<b>Direction/Orientation</b>	E
<b>Date</b>	1/8/14
<b>Time</b>	0911
<b>Photographer</b>	N. Biscocho (START)
<b>Witness</b>	J. Koehnen (START)
<b>Description:</b>	<p>Loading of contaminated soil from Area B into disposal trucks. Dust suppression in progress.</p>

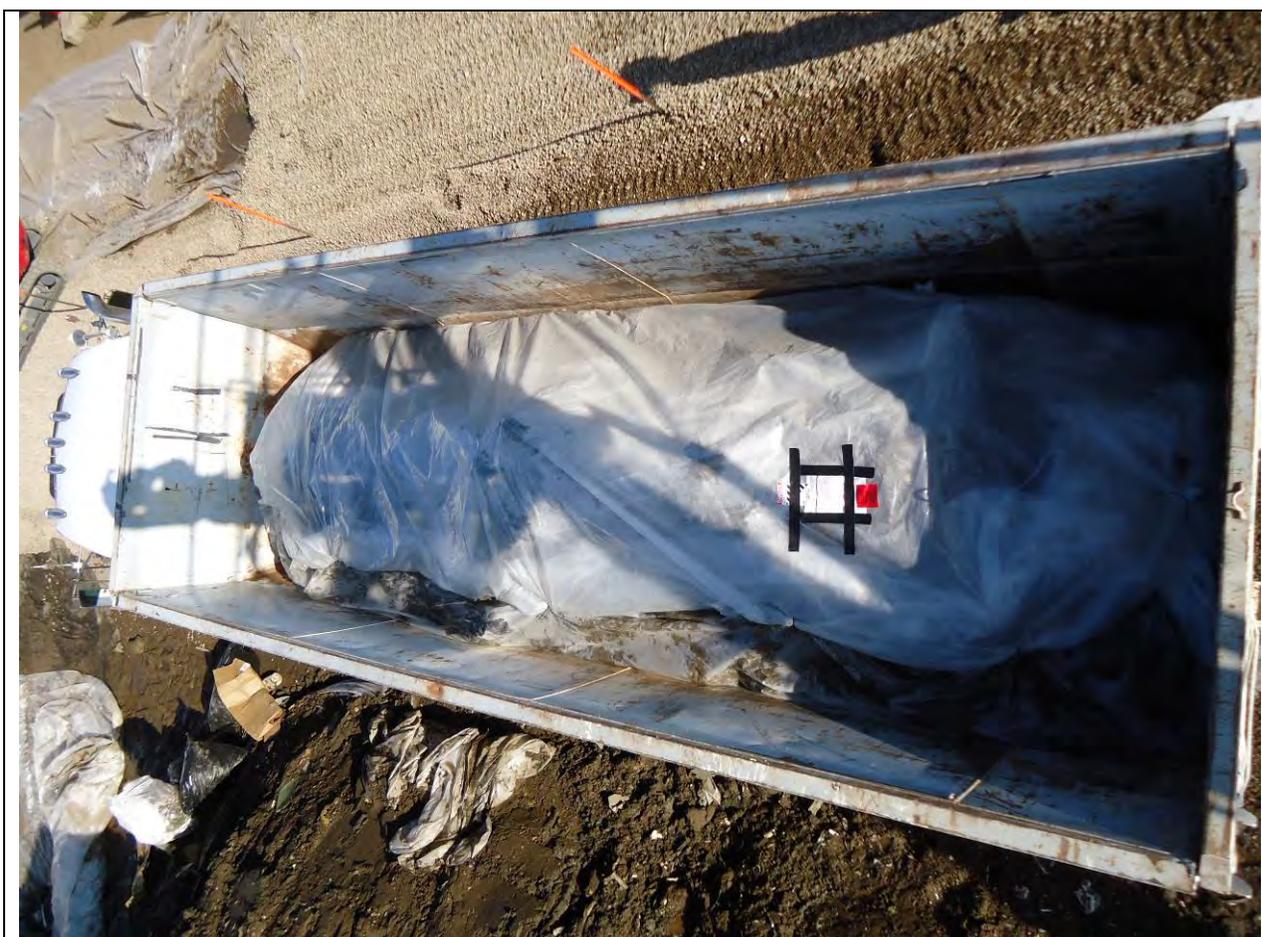
<b>Logbook Photo #</b>	DSC00598
<b>US EPA ID / Task Order Number</b>	CERCLIS: NMN000607041 / TDD No: 1/DYNAMAC-077-13-001
<b>Site</b>	Southwest Vermiculite (Removal 2)
<b>Location Address</b>	1800 1 <sup>st</sup> Street, NW
<b>City, State</b>	Albuquerque, New Mexico 87102
<b>County</b>	Bernalillo
<b>Direction/Orientation</b>	Down
<b>Date</b>	11/13/13
<b>Time</b>	0908
<b>Photographer</b>	N. Biscocho (START)
<b>Witness</b>	J. Koehnen (START)
<b>Description:</b>	Contaminated soil loaded on disposal truck, "burrito-wrapped," proper labels attached, prior to leaving the site for disposal at a disposal facility.

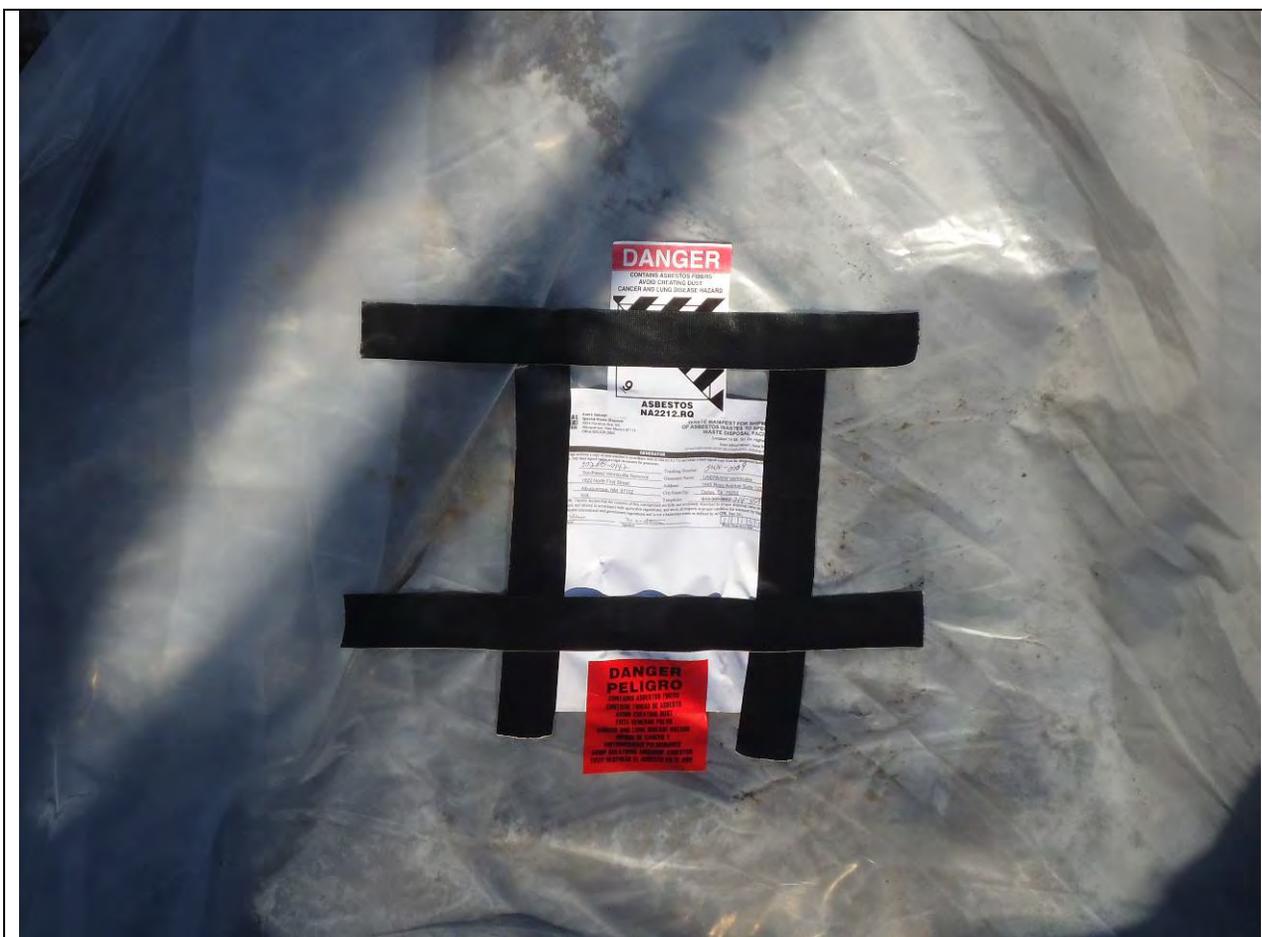
<b>Logbook Photo #</b>	DSC00596
<b>US EPA ID / Task Order Number</b>	CERCLIS: NMN000607041 / TDD No: 1/DYNAMAC-077-13-001
<b>Site</b>	Southwest Vermiculite (Removal 2)
<b>Location Address</b>	1800 1 <sup>st</sup> Street, NW
<b>City, State</b>	Albuquerque, New Mexico 87102
<b>County</b>	Bernalillo
<b>Direction/Orientation</b>	Down
<b>Date</b>	11/13/13
<b>Time</b>	0907
<b>Photographer</b>	N. Biscocho (START)
<b>Witness</b>	J. Koehnen (START)
<b>Description:</b>	Contaminated soil loaded on disposal truck, "burrito-wrapped," proper labels attached (see photo above), prior to leaving the site for disposal at a disposal facility.

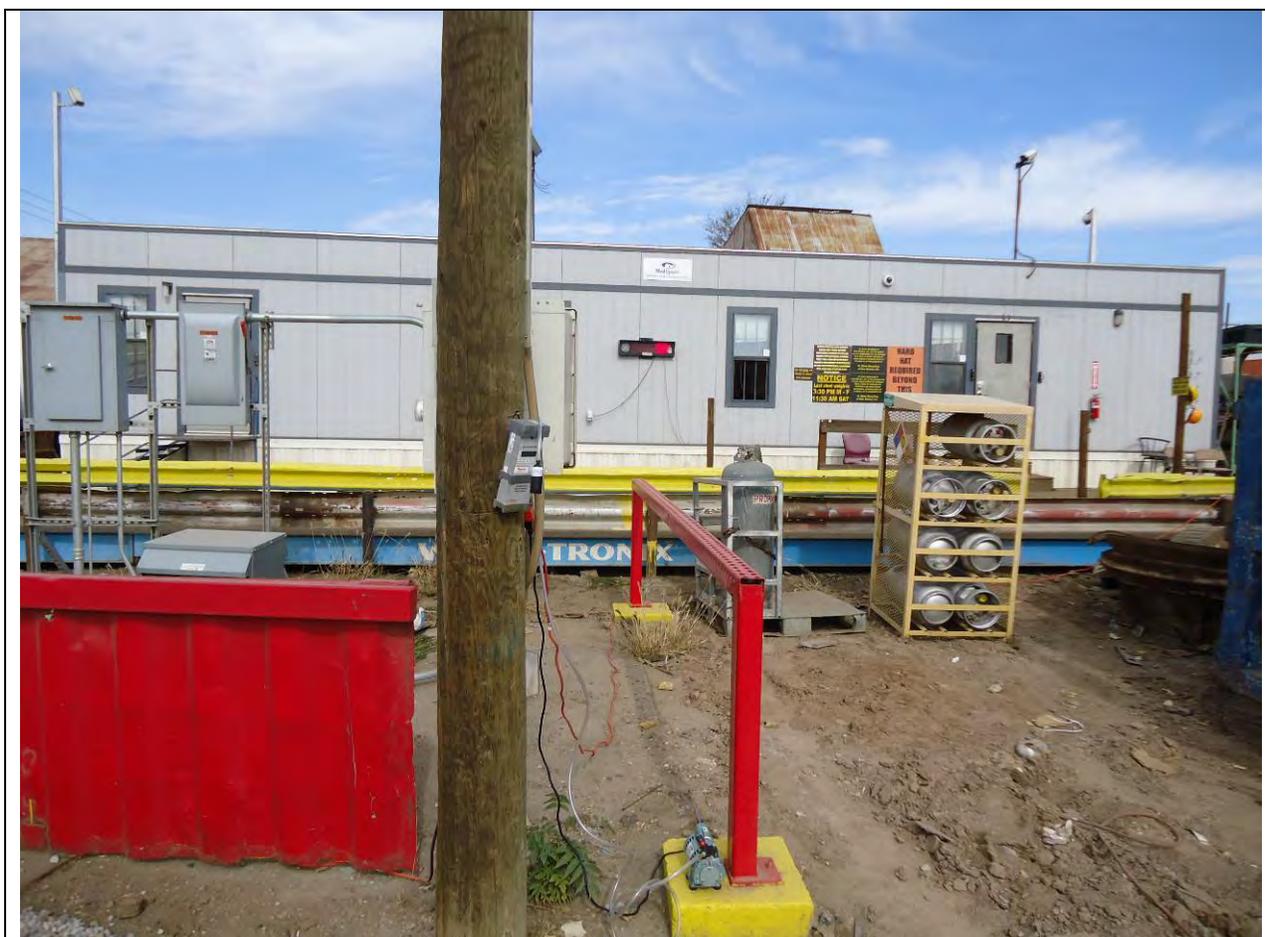
<b>Logbook Photo #</b>	DSC00607
<b>US EPA ID / Task Order Number</b>	CERCLIS: NMN000607041 / TDD No: 1/DYNAMAC-077-13-001
<b>Site</b>	Southwest Vermiculite (Removal 2)
<b>Location Address</b>	1800 1 <sup>st</sup> Street, NW
<b>City, State</b>	Albuquerque, New Mexico 87102
<b>County</b>	Bernalillo
<b>Direction/Orientation</b>	N
<b>Date</b>	11/14/13
<b>Time</b>	1203
<b>Photographer</b>	N. Biscocho (START)
<b>Witness</b>	J. Koehnen (START)
<b>Description:</b>	View of Station 1: air sample and air monitor (see figures for location of Station 1).

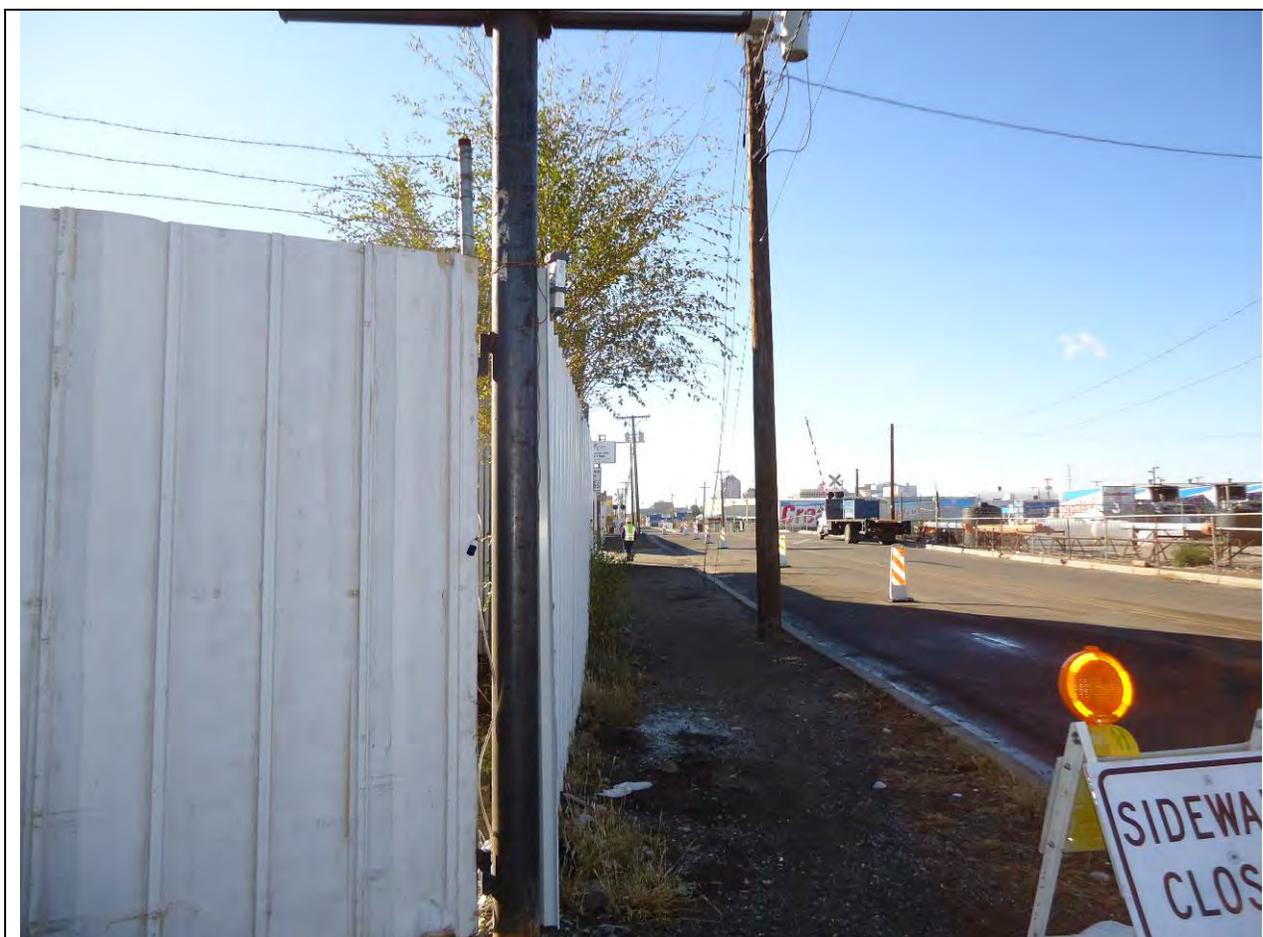
View of Station 7: air sample (cassette hanging from the pole in the middle of the picture). (see figures for location of Station 7).

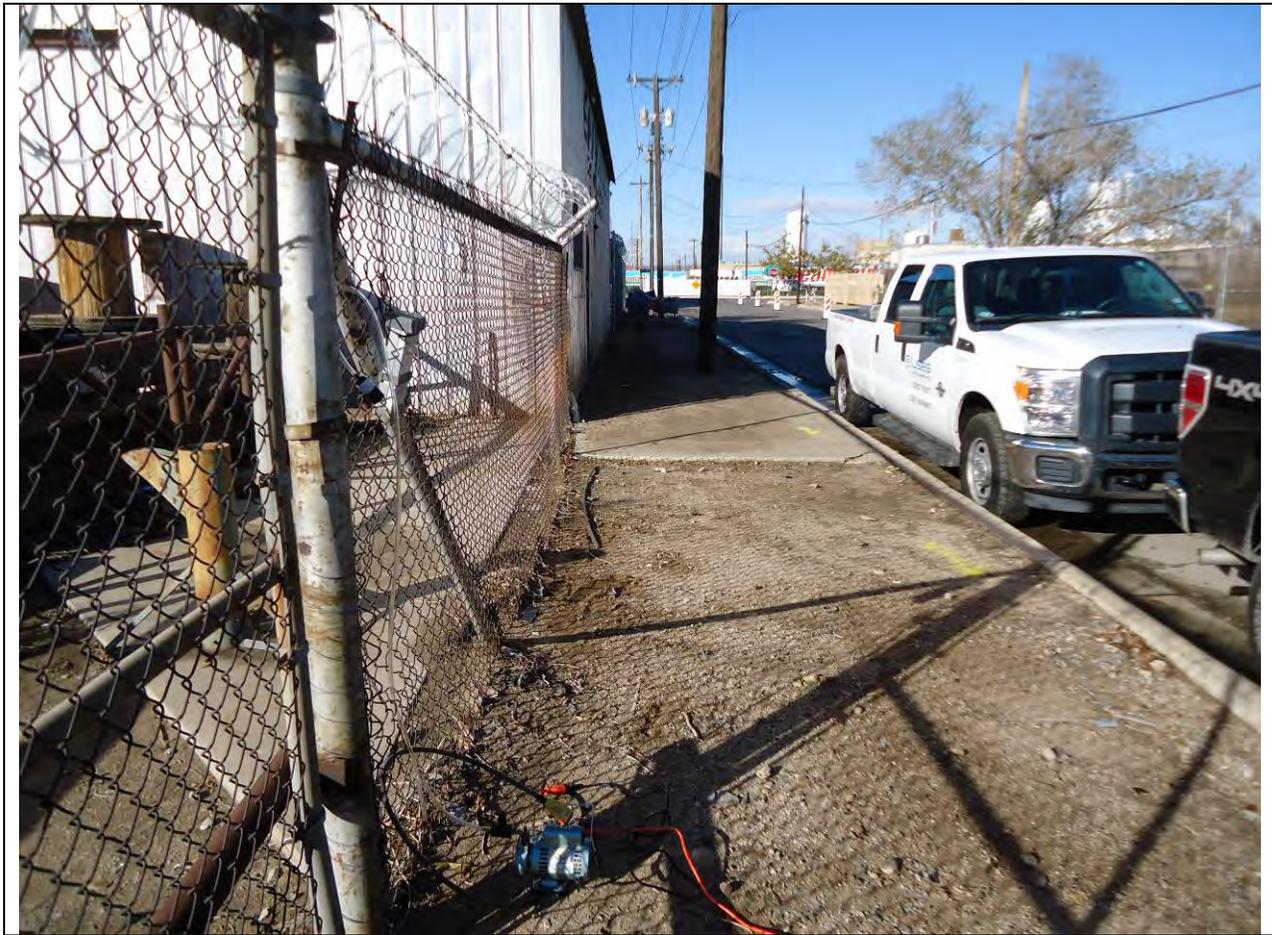
<b>Logbook Photo #</b>	DSC00623
<b>US EPA ID / Task Order Number</b>	CERCLIS: NMN000607041 / TDD No: 1/DYNAMAC-077-13-001
<b>Site</b>	Southwest Vermiculite (Removal 2)
<b>Location Address</b>	1800 1 <sup>st</sup> Street, NW
<b>City, State</b>	Albuquerque, New Mexico 87102
<b>County</b>	Bernalillo
<b>Direction/Orientation</b>	W
<b>Date</b>	11/16/13
<b>Time</b>	0905
<b>Photographer</b>	N. Biscocho (START)
<b>Witness</b>	J. Koehnen (START)
<b>Description:</b>	View of Station 8: air sample and air monitor (see figures for location of Station 8).

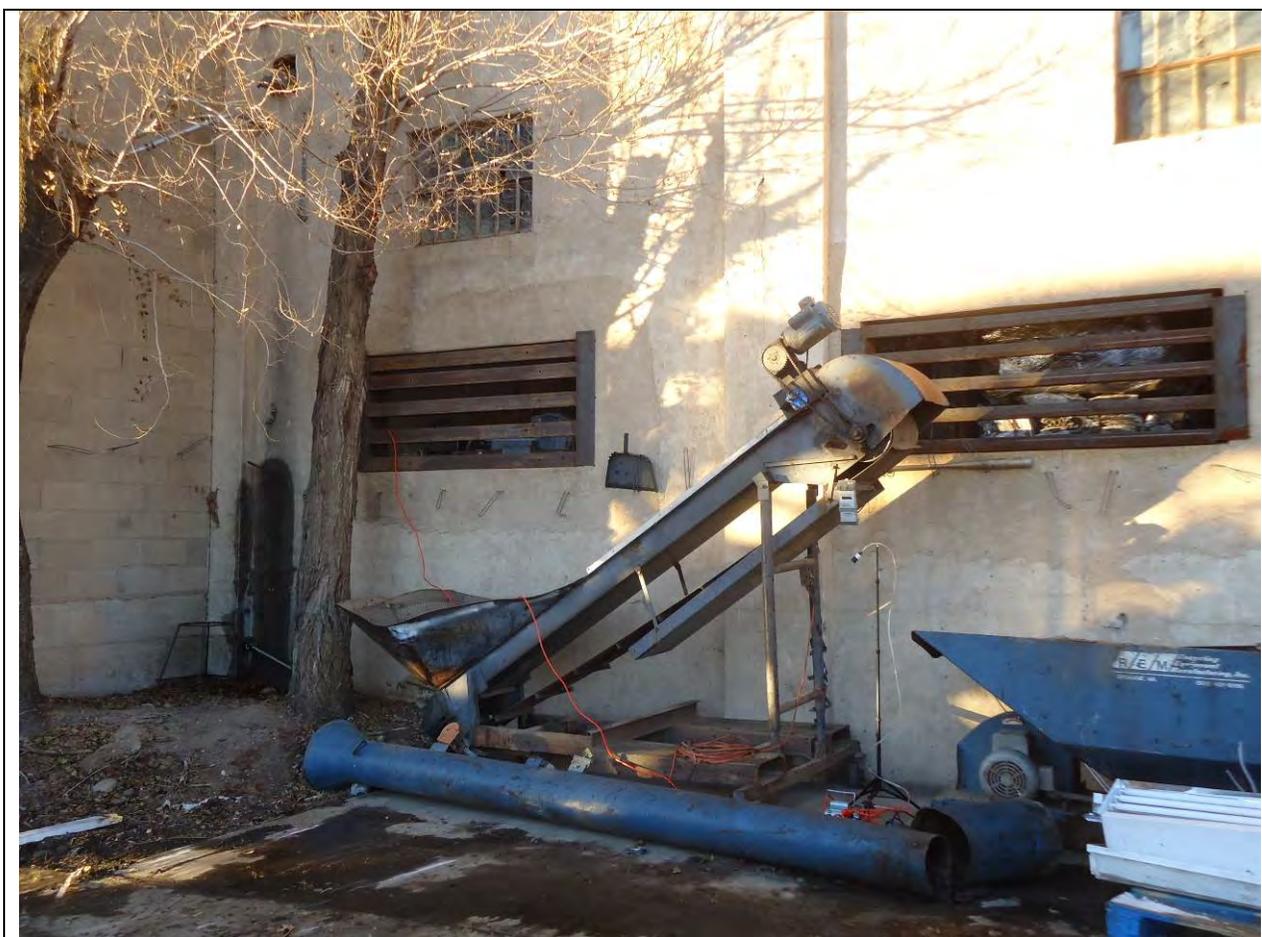
<b>Logbook Photo #</b>	DSC00693
<b>US EPA ID / Task Order Number</b>	CERCLIS: NMN000607041 / TDD No: 1/DYNAMAC-077-13-001
<b>Site</b>	Southwest Vermiculite (Removal 2)
<b>Location Address</b>	1800 1 <sup>st</sup> Street, NW
<b>City, State</b>	Albuquerque, New Mexico 87102
<b>County</b>	Bernalillo
<b>Direction/Orientation</b>	NW
<b>Date</b>	12/6/13
<b>Time</b>	1609
<b>Photographer</b>	N. Biscocho (START)
<b>Witness</b>	J. Koehnen (START)
<b>Description:</b>	
View of Station 9: air sample and air monitor (see figures for location of Station 9).

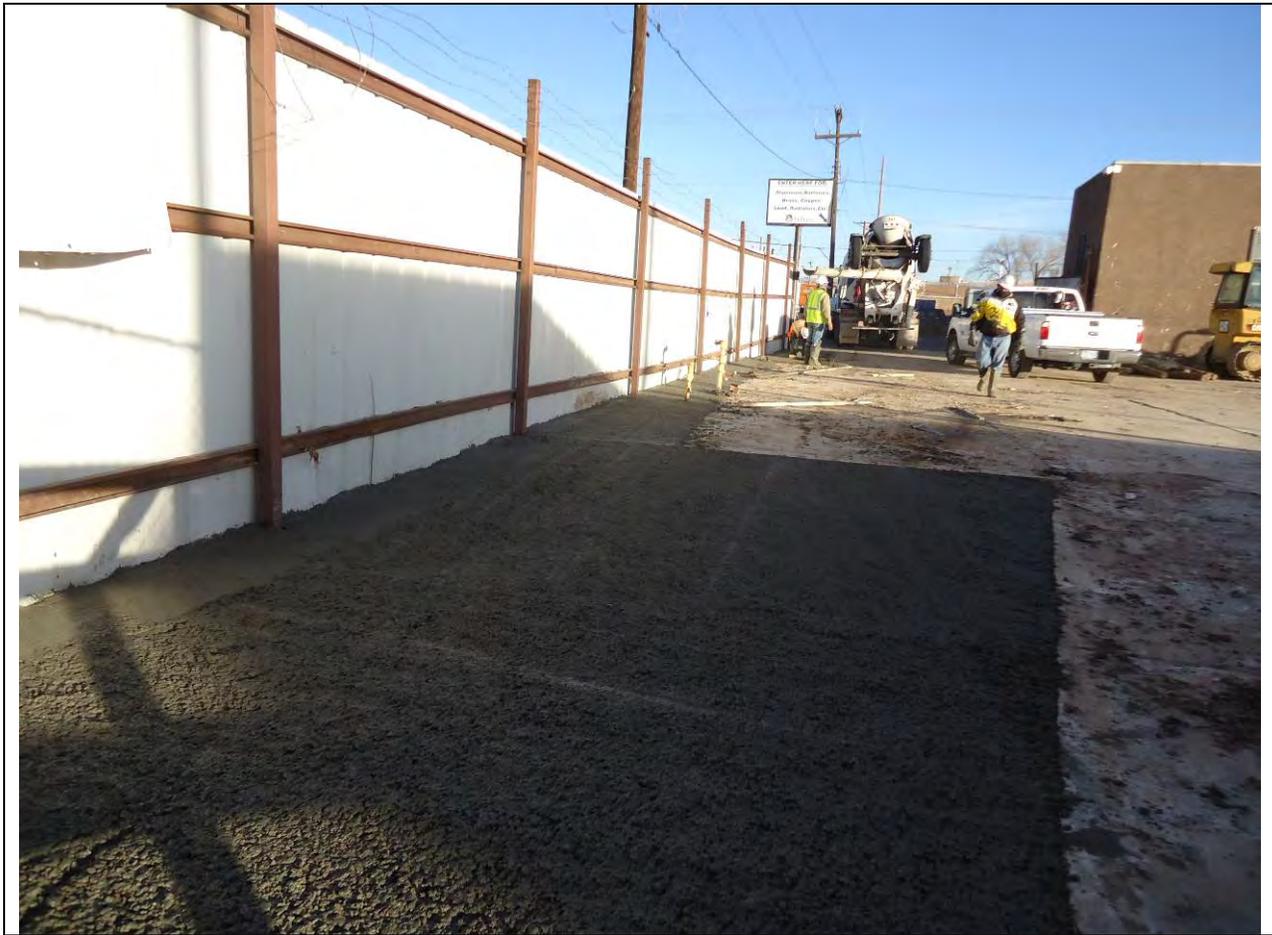
**Description:**  
 Concrete placed around the perimeter of the former exfoliation building, after the excavation and soil confirmation samples were collected. This is in preparation for the new warehouse to be built over the former exfoliation building. Picture shown is Area A, Grid-003.

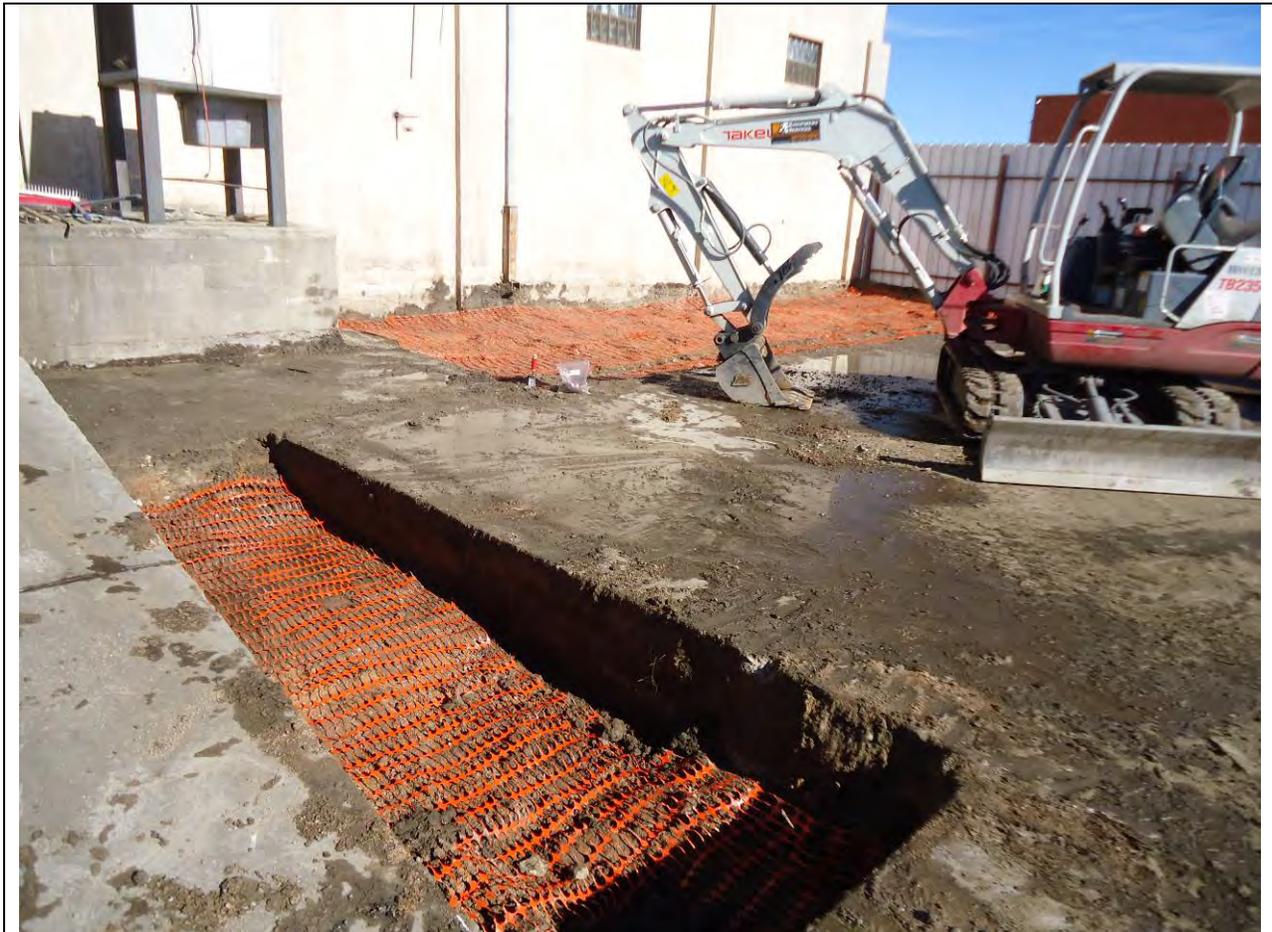
**Description:**  
View of excavated and confirmation sample on Area A, Grid-019 (partial sample). See previous photo for the remaining section of Area A, Grid-019.

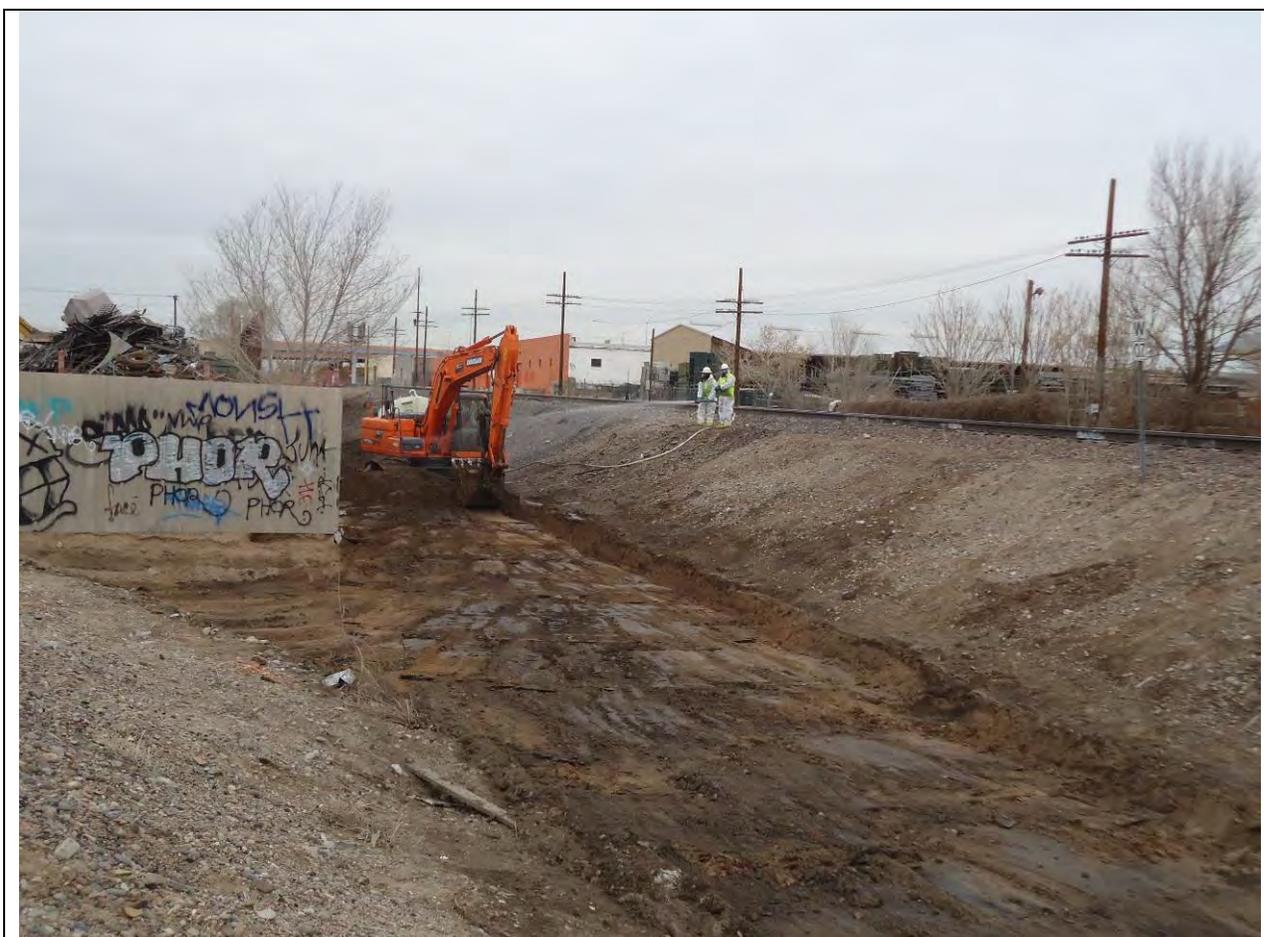
**Description:**  
 Excavation and dust suppression activities in Area B – NM DOT Rail Road Right-of-Way.
