UNITED STATES ENVIRONMENTAL PROTECTION AGENCY

OFFICE OF
ENVIRONMENTAL CLEANUP

SUBJECT: Action Memorandum for the Oregon City Mercury Emergency Response Action,
Oregon City, Clackamas County, Oregon

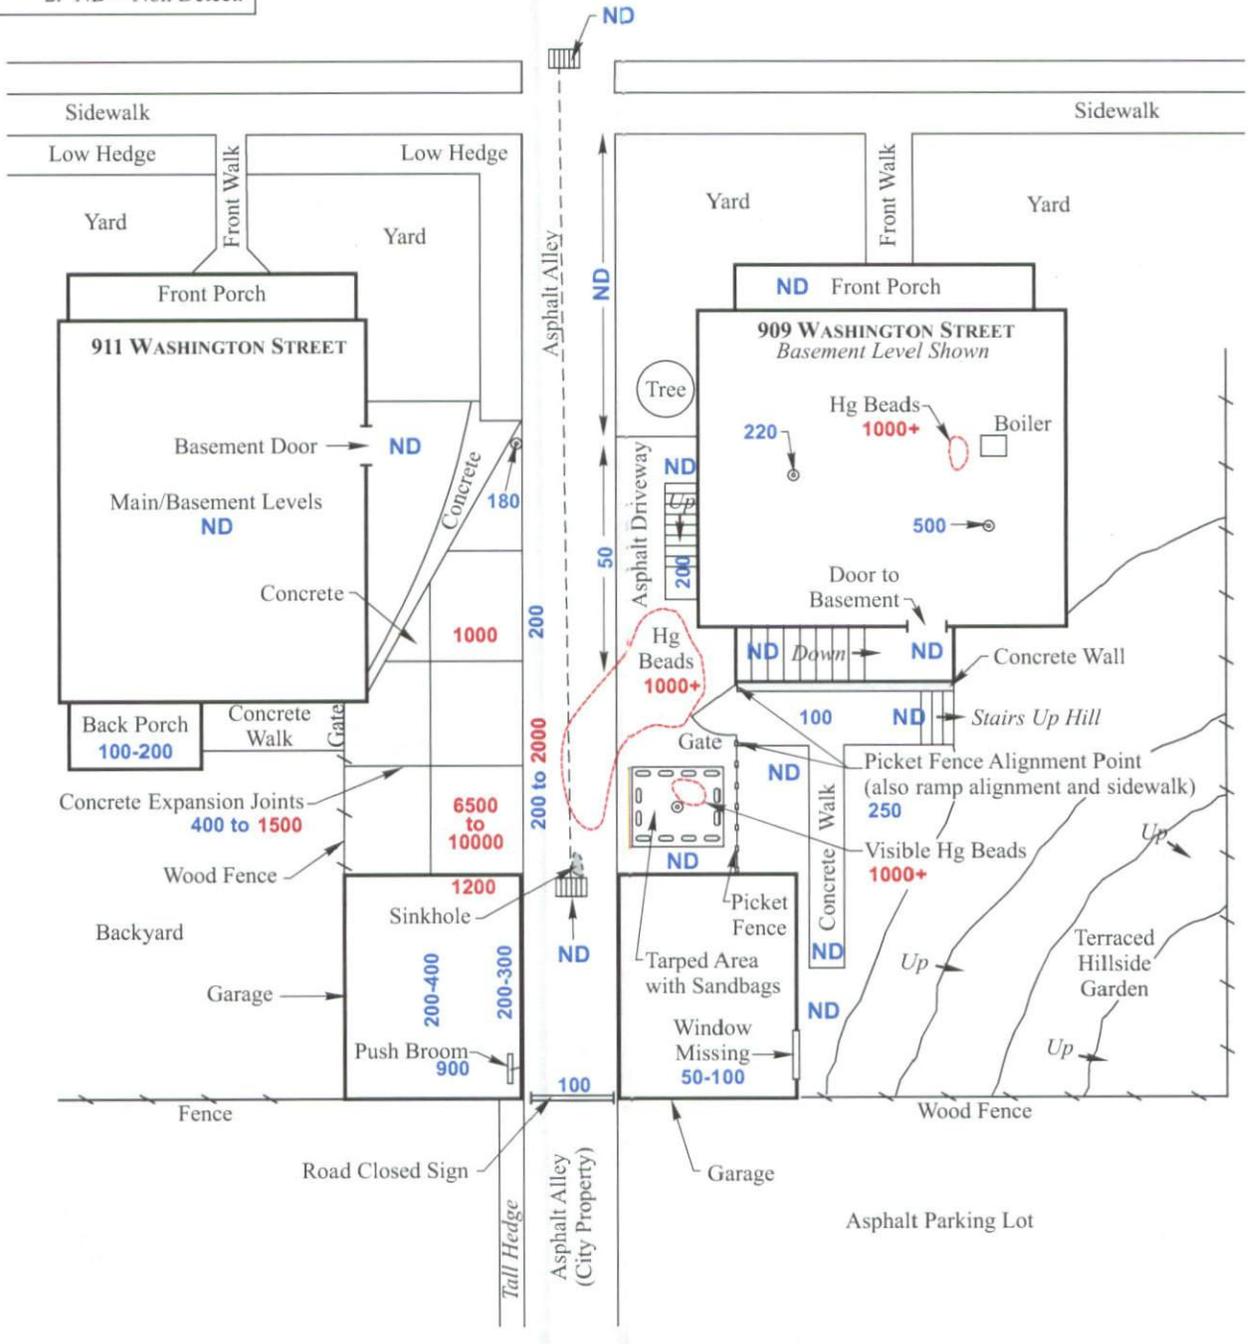
Figure 1-2
DRAFT MERCURY VAPOR
ASSESSMENT RESULTS 3-30-11

EPA conducted air monitoring at the Site and adjacent property using two Lumex Mercury Vapor Analyzers (MVA) (Figures 1-2 and 1-3). Free beads of elemental mercury were observed over a wide area directly in front of the house's detached garage, but were concentrated in a distinct area measuring approximately 4 x 4 feet. Mercury vapors were detected along the ground south/southeast of the garage and near the northwest corner of the house at 1000 nanograms per cubic meter (ng/m^3). Mercury beads and vapors up to $1000 \text{ ng}/\text{m}^3$ were also observed in the house's basement directly adjacent to a new boiler, and mercury vapors were detected in a nearby basement floor drain and one further away. Mercury was detected nowhere else in the basement or first floor of the house. Mercury vapors were also detected in only one location at low levels ($100 \text{ ng}/\text{m}^3$) on a walkway leading along the outside of the house from the basement door. No mercury vapors were detected along the other 3 sides of the house, or the backyard.

Along the alleyway and drive dividing the two homes, mercury vapor levels were observed to be from 100 to $200 \text{ ng}/\text{m}^3$. No mercury vapors were detected in the front portion of the alleyway drive near Washington Street, or the sewer drain on Washington Street. Similarly, no mercury vapors were detected in a storm drain in the middle of the drive near the garage. None of the area of the drive or adjacent church parking lot beyond the rear of the property was evaluated, although mercury vapors were detected at low levels ($100 \text{ ng}/\text{m}^3$) on the drive at the property's rear edge.

EPA detected mercury vapors on the concrete pad and driveway in front of the adjacent home's detached garage owned by the Schweiger family, 911 Washington Street. Concentrations detected on the surface of the concrete and the expansion joints ranged from 400 to $6500 \text{ ng}/\text{m}^3$. Mercury vapors inside the Schweiger's garage were detected along tire tracks at levels from $200 \text{ ng}/\text{m}^3$ to $1200 \text{ ng}/\text{m}^3$. These concentrations exceed the Agency for the Toxic Substances Disease

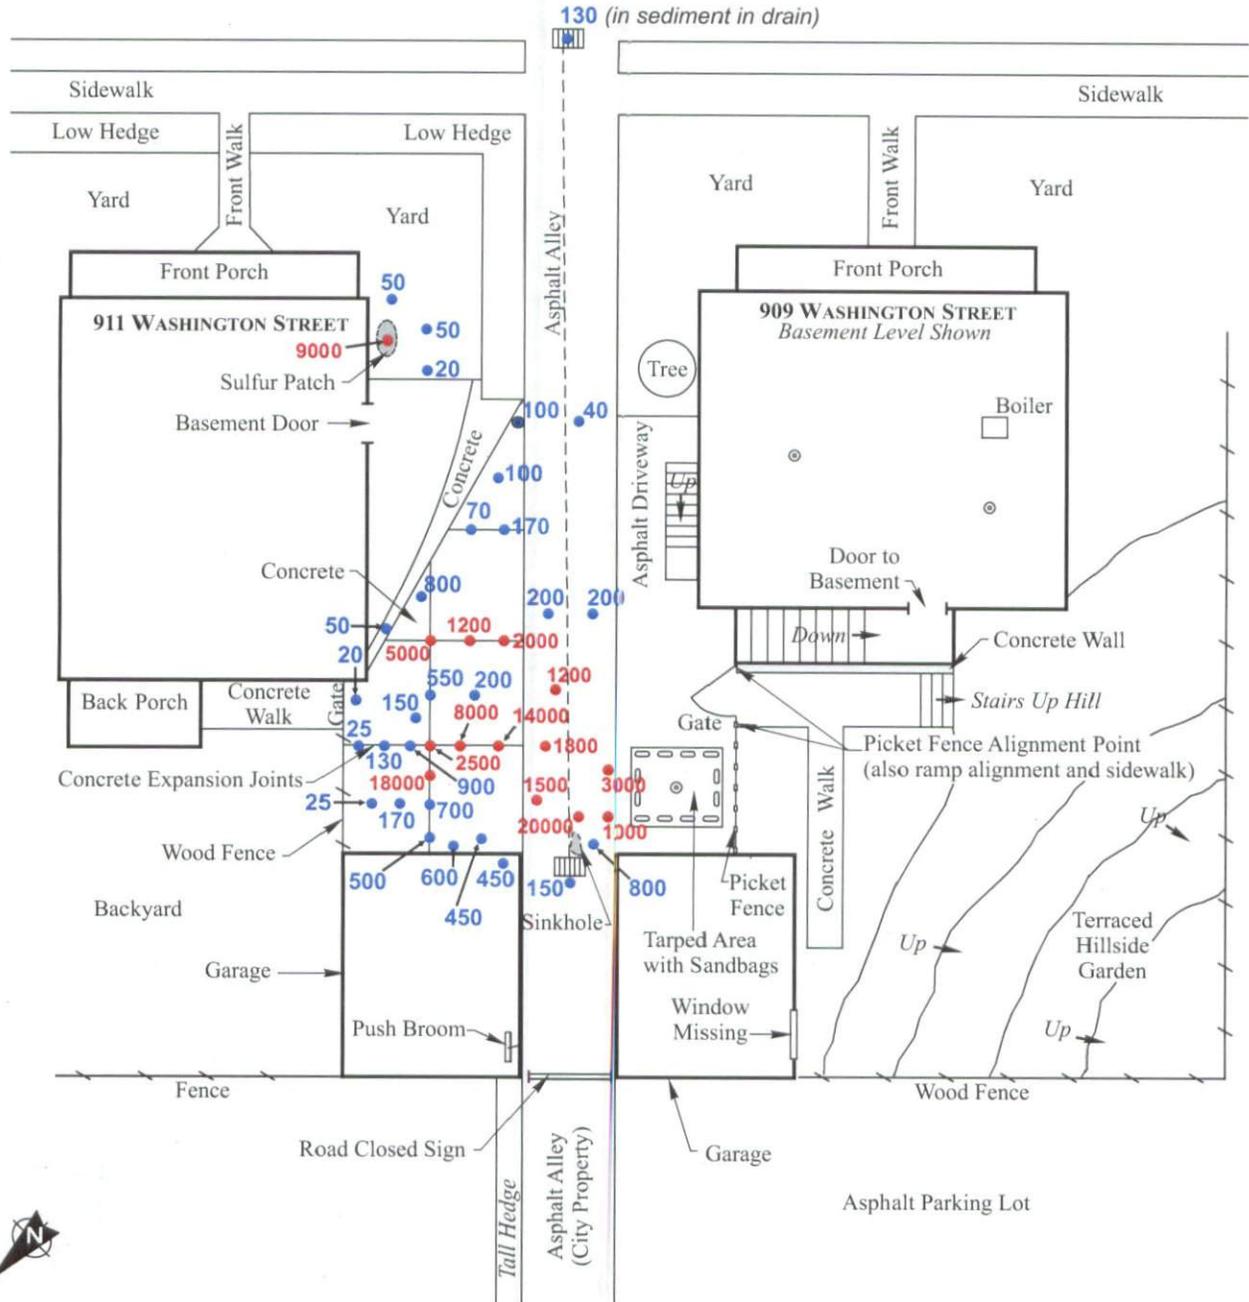
EPA learned that Mrs. Roberts had arrived in Oregon City and had begun conducting cleanup activities at the Site. START and EPA mobilized to the Site to confirm the effectiveness of the cleanup work conducted by Mrs. Roberts. Because Mrs. Roberts had not yet given EPA consent for access to her property, the START began by surveying the Schweiger driveway and the city right-of-way (ROW) (Figures 1-4 and 1-5). In the city ROW, responders found concentrations of mercury in seven of eleven sample locations in excess of the suggested 1,000 ng/m³ ATSDR action level, with a maximum concentration of 20,000 ng/m³. In the Schweiger driveway, seven of 34 sample locations had mercury concentrations in excess of the ATSDR action level, with a maximum concentration of 14,000 ng/m³ (see attached figures).

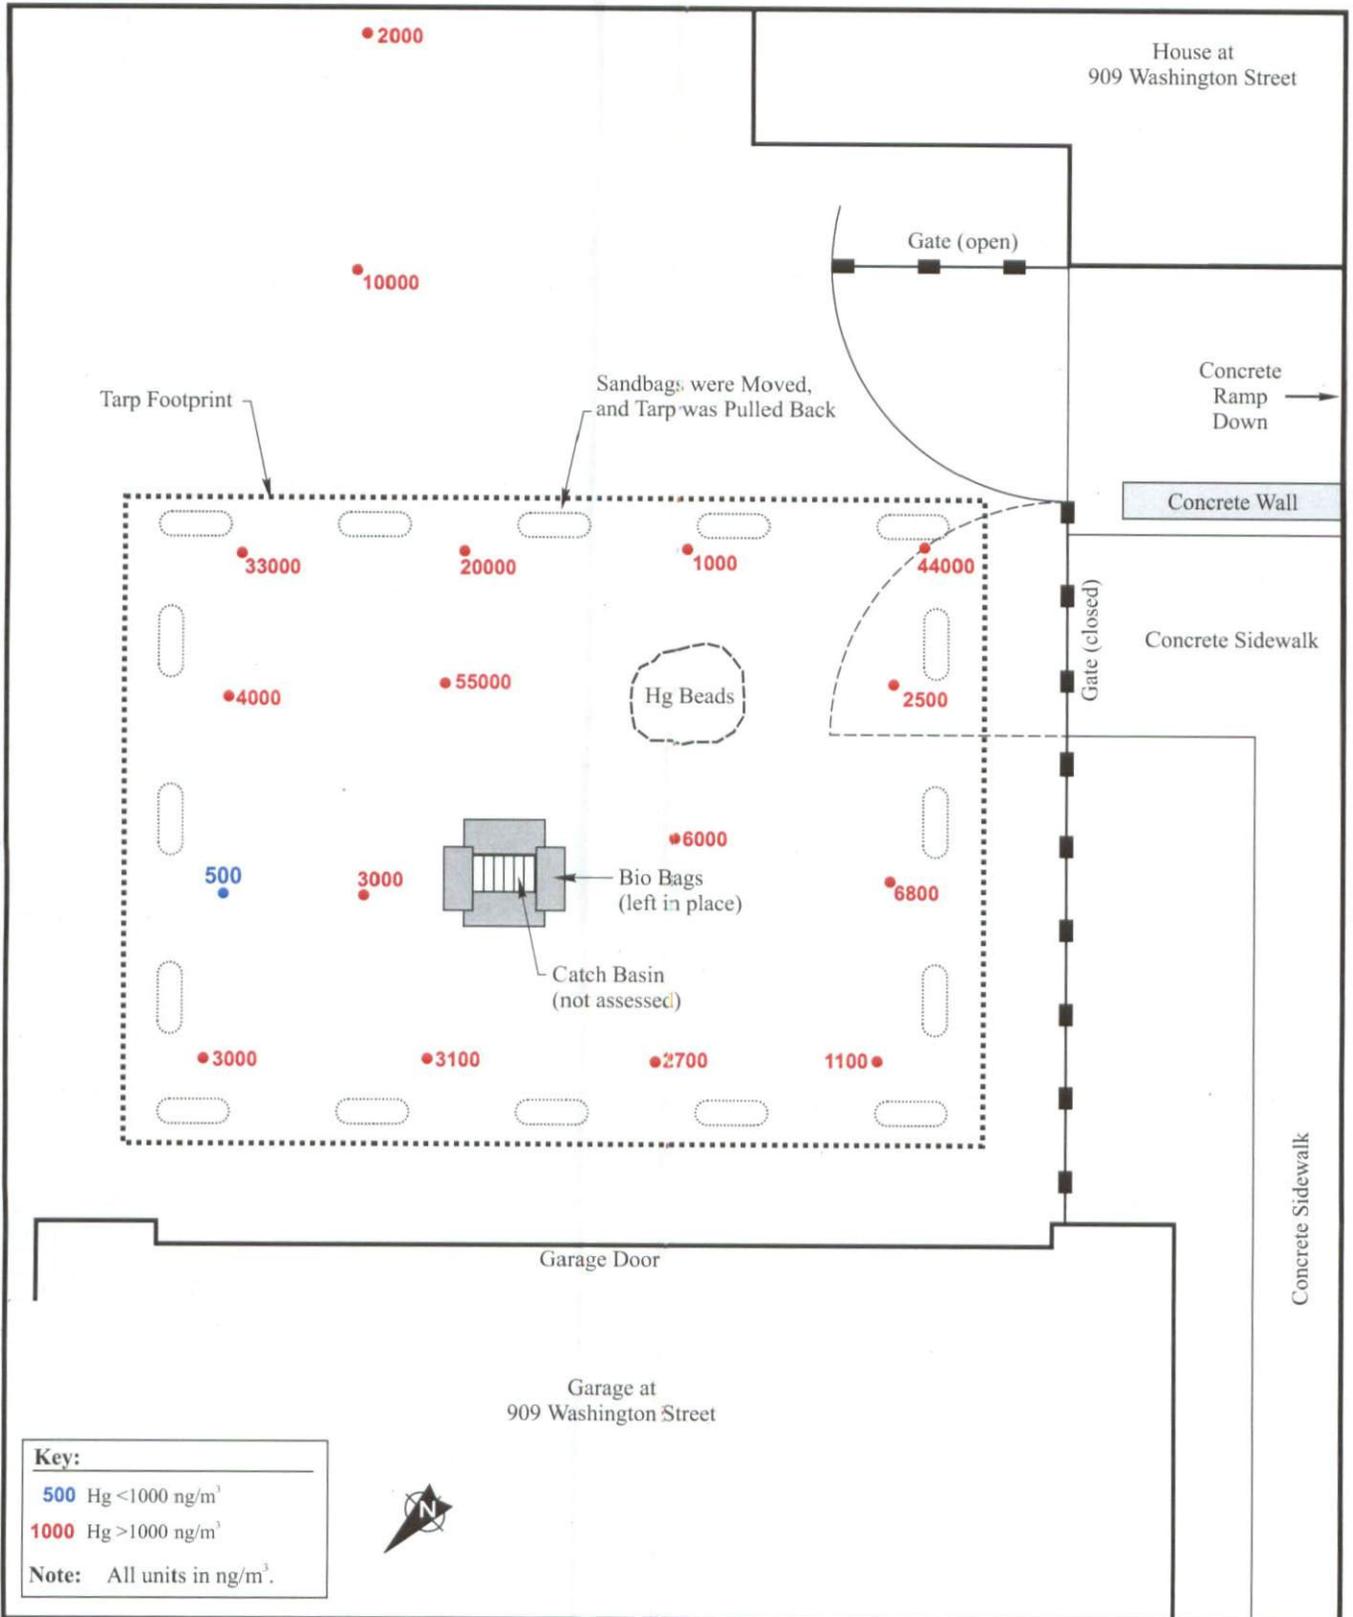
<p>ecology and environment, inc. Global Specialists in the Environment Portland, Oregon</p>	<p>OREGON CITY Hg ER Oregon City, Oregon</p>		<p>Figure 1-5 DRAFT MERCURY VAPOR ASSESSMENT RESULTS, TARPED AREA 4-9-11</p>	
	<p>Not to Scale</p>		<p>Date: 4-11-11</p>	<p>Drawn by: AES</p>

OSC Fowlow requested Mrs. Roberts' consent for access to her property to peel back the tarp which had been placed back over the contaminated area for the purpose of screening the area with the Lumex MVA to determine the residual concentrations of mercury remaining on the driveway. Mrs. Roberts agreed to allow EPA access to perform the survey with the Lumex. Upon removal of the tarp, the asphalt driveway was revealed to be heavily stained by the sulfur powder. In the center of the tarped area there is a storm water drain covered with sandbags to prevent water and contaminants from entering the storm water discharge system. The EPA and START did not investigate the drain system because of concern about allowing any additional contaminants from entering the storm water system. The START used an MVA to collect mercury vapor concentrations at 18 locations on the Roberts' driveway. Of the 18 locations, one location was less than the recommended ATSDR action level of $1,000 \text{ ng/m}^3$, twelve locations had concentrations between $1,000$ and $10,000 \text{ ng/m}^3$, and five locations had concentrations between $10,000 \text{ ng/m}^3$ and $55,000 \text{ ng/m}^3$. There was one area with a sufficient number of mercury beads remaining as to be visible through the sulfur powder. After conducting the survey, the tarp was replaced and was weighted down with sand bags.
