MEMORANDUM FOR FILE

SUBJECT: ARGONAUT TAILINGS STORAGE DAM - INITIAL INSPECTION

SUBJECT: Argonaut Multiple Arch Dam, Jackson, California

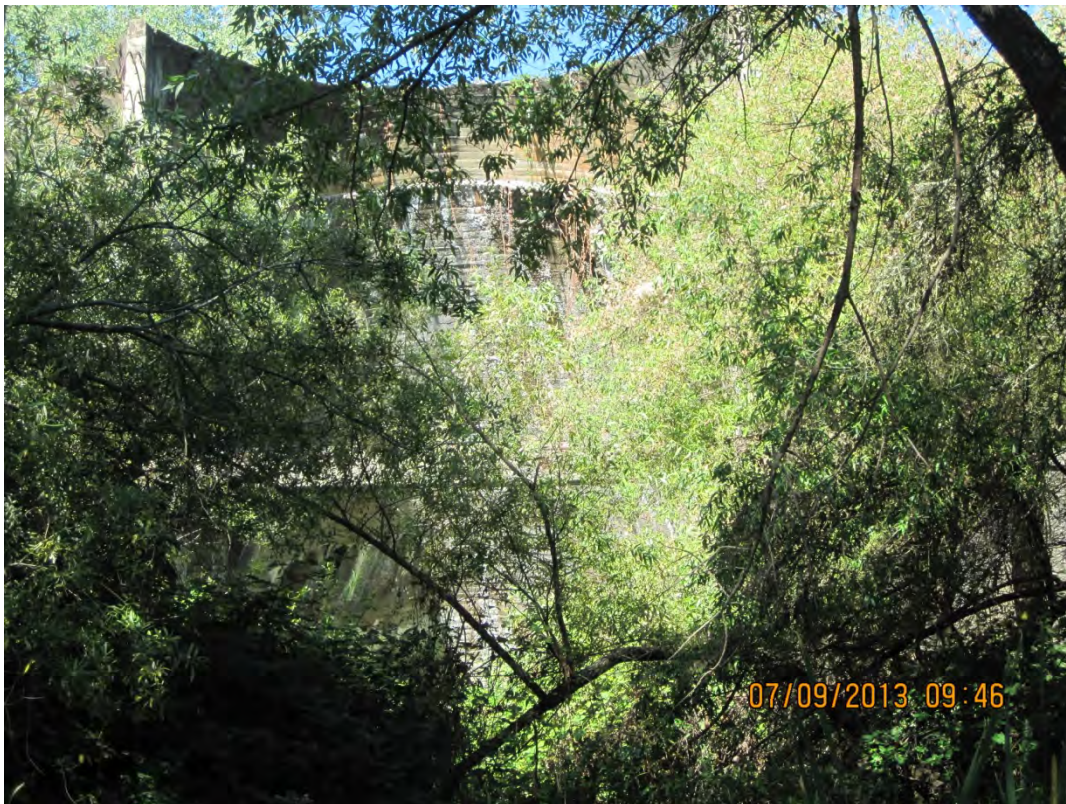
4. Conclusions and Recommendations. A stability assessment of the concrete multi-arch tailings storage dam could not be adequately made during this inspection. The amount of vegetation made it difficult to inspect (**Photo 4**), and just a few of the arches were visually examined. The dam has some apparent structural deficiencies that may indicate some concern. The left abutment arch and buttress (# 1) has been severely compromised and has several pieces of concrete broken off and hanging by the cable reinforcement. Also, the buttress cross braces showed significant signs of spalling and loss of section. An inspection memorandum has been prepared by Christopher Abela, P.E., of the USACE Sacramento District Structural Section, entitled: *Argonaut Multiple Arch Dam, Jackson, California*, 23 July 2013.

Photo 4. View at Downstream Base of Dam Showing Excessive Vegetation Growth.

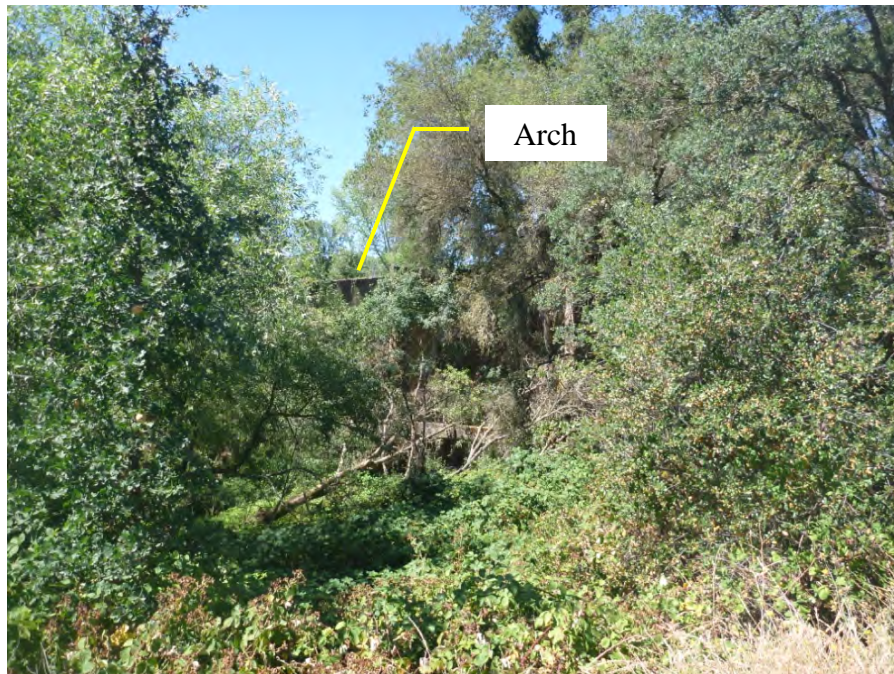
Dense vegetation obstructed the team's ability to visually inspect the dam. Only 3 arches, presumed to be arches 9, 10, and 11, were accessible for inspection from the top of the dam, and 3 arches presumed to be arches 1, 9, and 10 were accessible for inspection from the base of the dam, see Figures 1 & 2.

Figure 1 Dense Vegetation Obstructing View of Arches

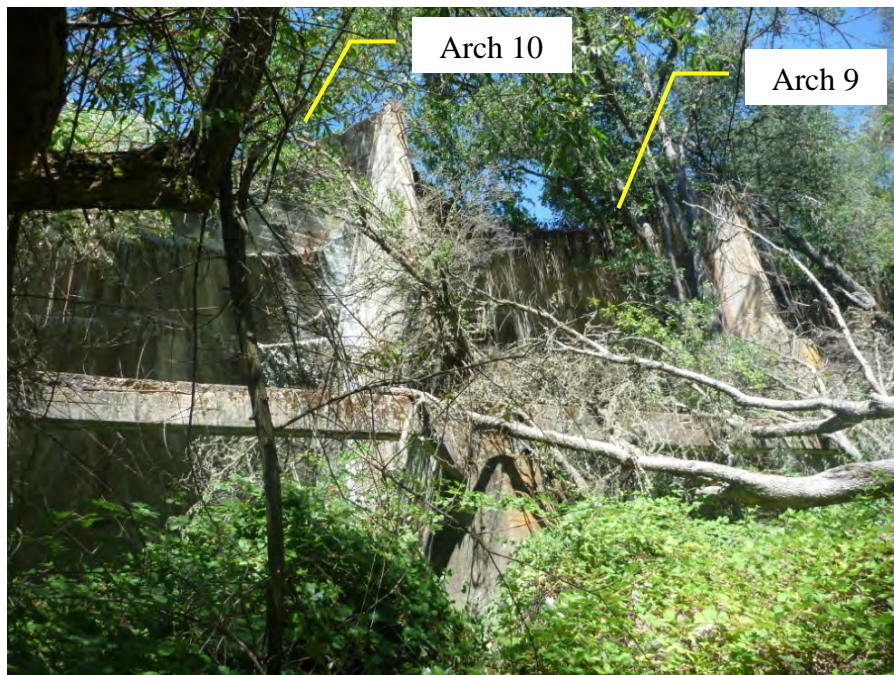
Figure 2 Arches 9 and 10

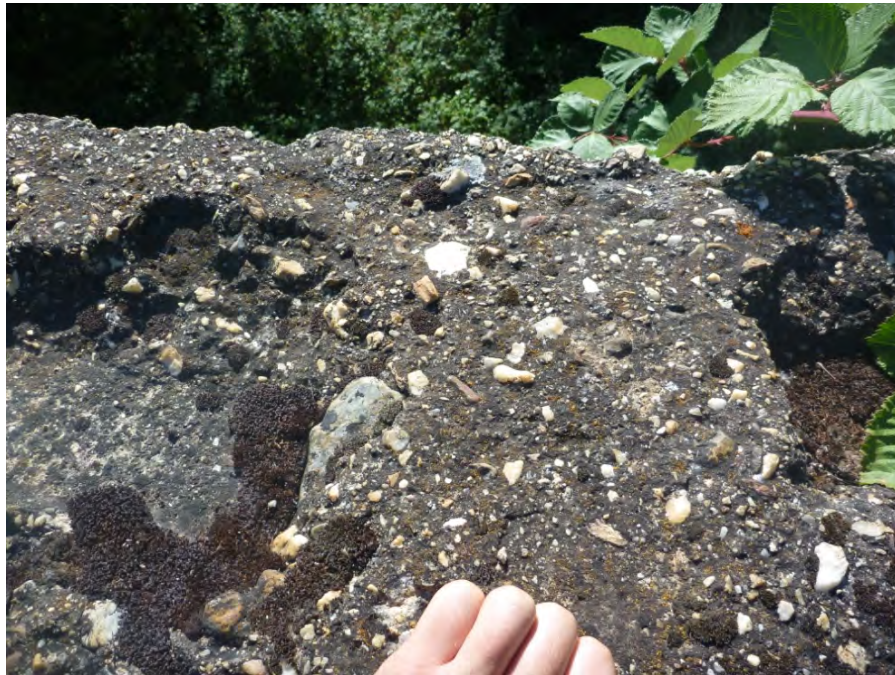
The top surfaces of the concrete arches showed signs of wear possibly due to water running over the dam and or possibly due to freeze thaw cycles, see Figure 3. The downstream end of arches 9, 10, and 11 had signs of efflorescence staining and algae build up, indicating that the dam has been consistently leaking over time, see Figure 4. A crack was noticed at the upper left corner of arches 9 and 10 (facing downstream), which may be consistent with observations made from the inspection in February 1933, where G.F. Engle, a previous inspector, noted a crack at the right end (facing upstream) of arch 9, see Figure 5. In addition, at the base of the dam rust staining was visible on the downstream face of arch 9 where the cable had little or no concrete cover, see Figure 6.

Figure 3 Worn Surface of Concrete (Typical)

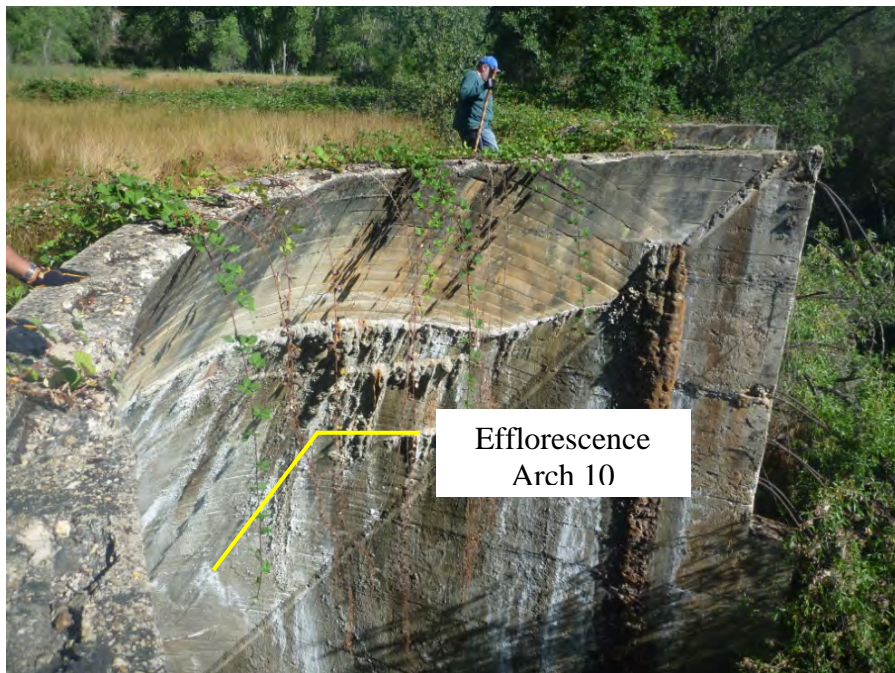
Figure 4 Typical Efflorescence on Arches and Buttress Walls

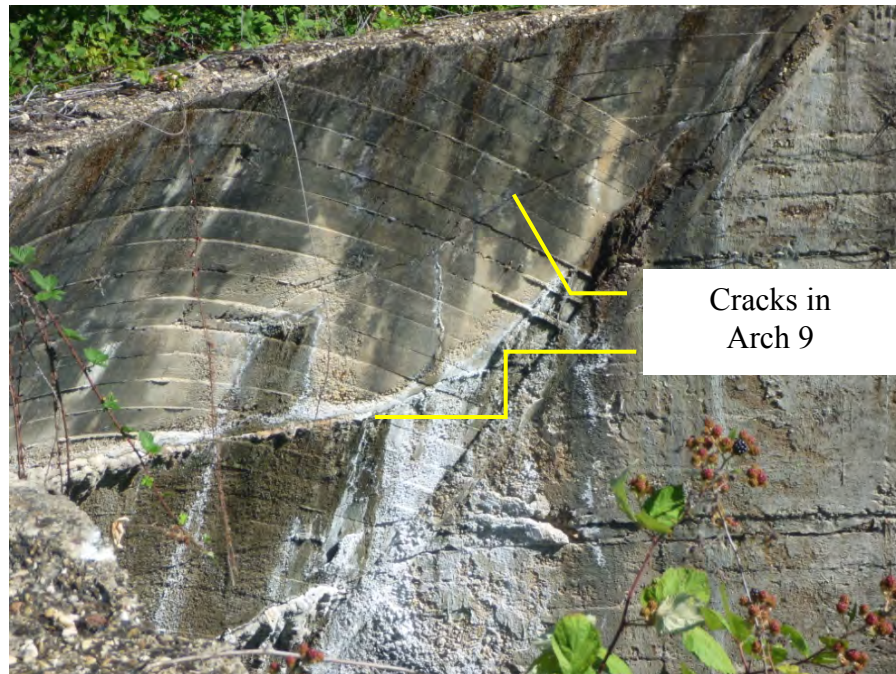
Figure 5 Crack in Arch 9 (Typical)

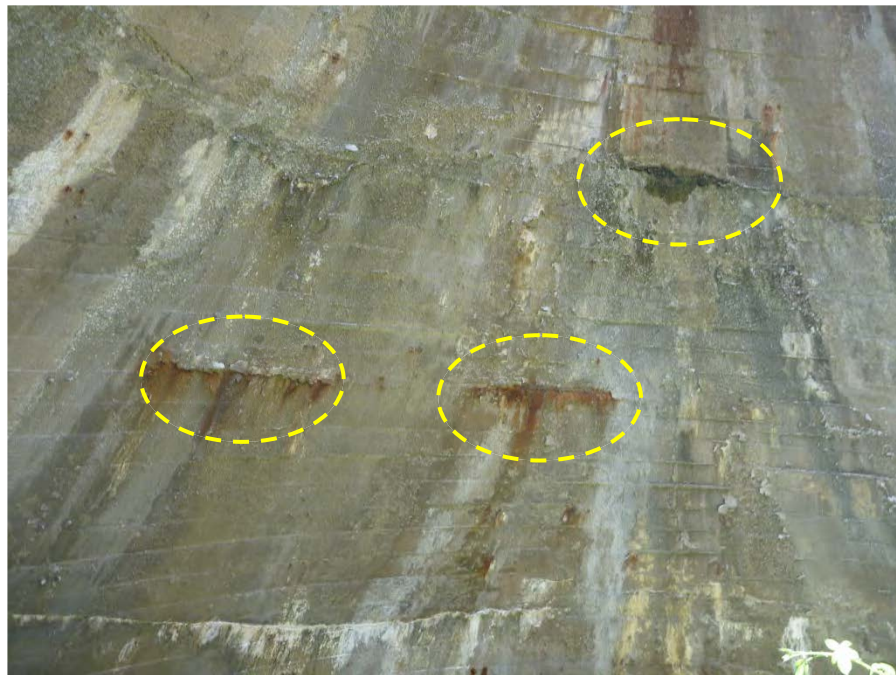
Figure 6 Rust Staining from Embedded Cable

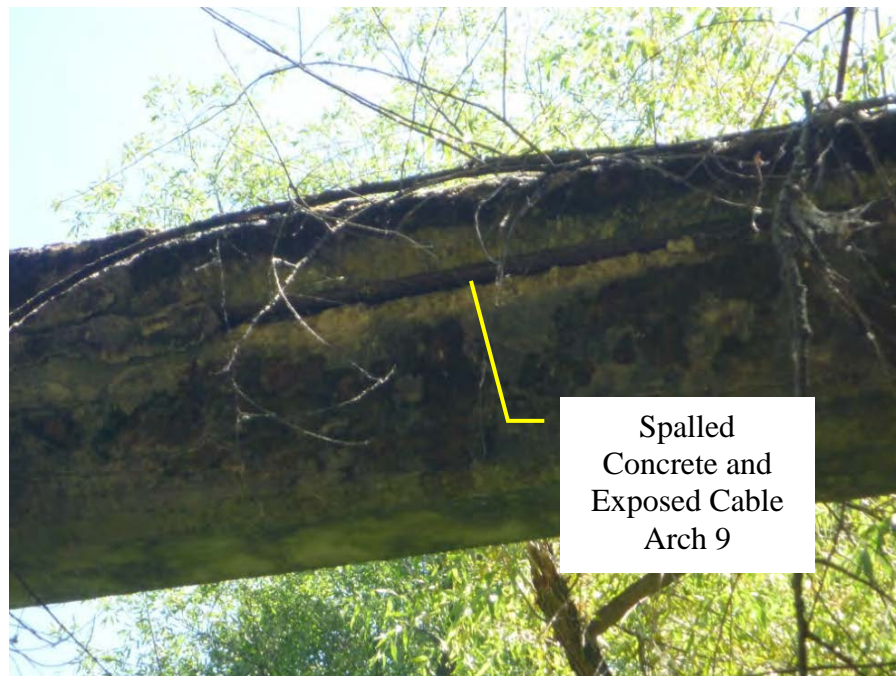
The concrete braces extending between buttresses showed signs of significant spalling. The spalling was most likely due to the corrosion of the embedded cable, which over time caused the concrete to crack and eventually spall, see Figure 7. Although significant spalling was only

observed on the braces associated with arches 9 and 10, it is speculated that all buttress braces are in a similar condition. The brace for arch 11 was not visible due to vegetation overgrowth. The buttress brace dimension was determined to be 12"x 22".

Spalled
Concrete and
Exposed Cable
Arch 9

Figure 7 Buttress Brace with Spalled Concrete and Exposed Cable

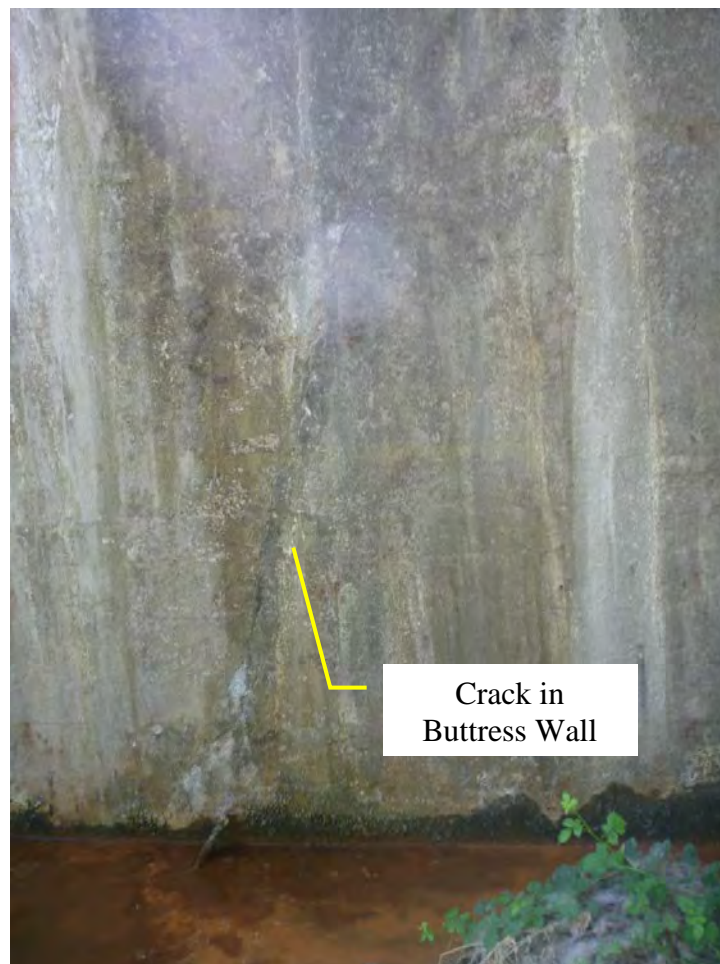
The buttresses were sounded with a geologic hammer and no hollow spots were audible. The concrete surface although stained with efflorescence and algae growth appeared to be in satisfactory condition given the age of the dam. A crack was noted in the buttress wall that extended from the base towards the top of the buttress, see Figure 8. Exposed aggregate on the buttress surface was also noted in various areas, see Figure 9. The upper portion of Buttress 1 was found to have completely cracked off and hanging from its cables, see Figure 10.

Crack in
Buttress Wall

Figure 8 Crack in Buttress Wall of Arches 9 & 10

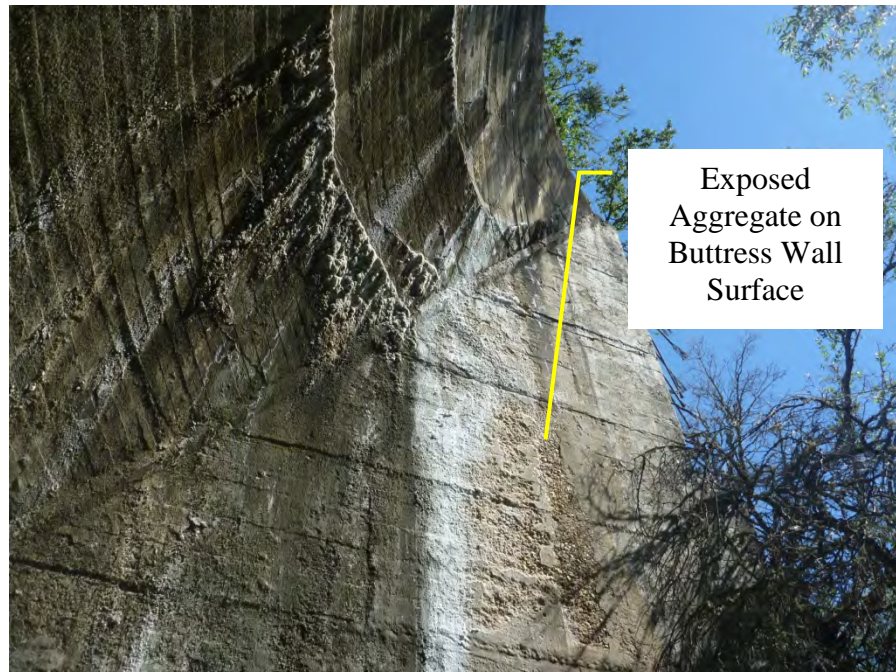
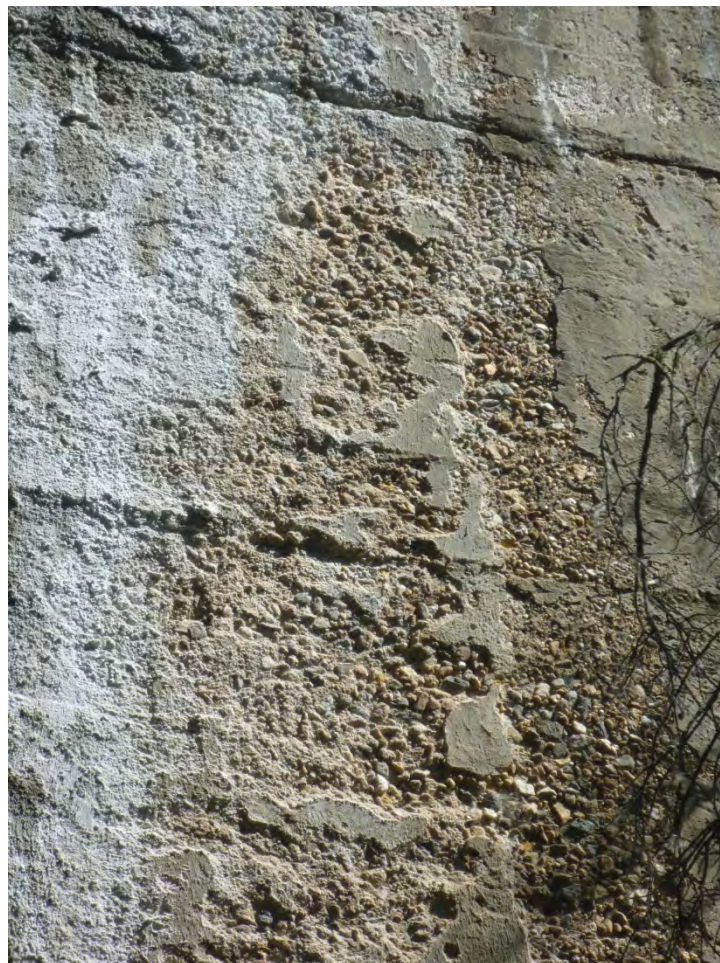
Figure 9 Exposed Aggregate of Buttress Wall

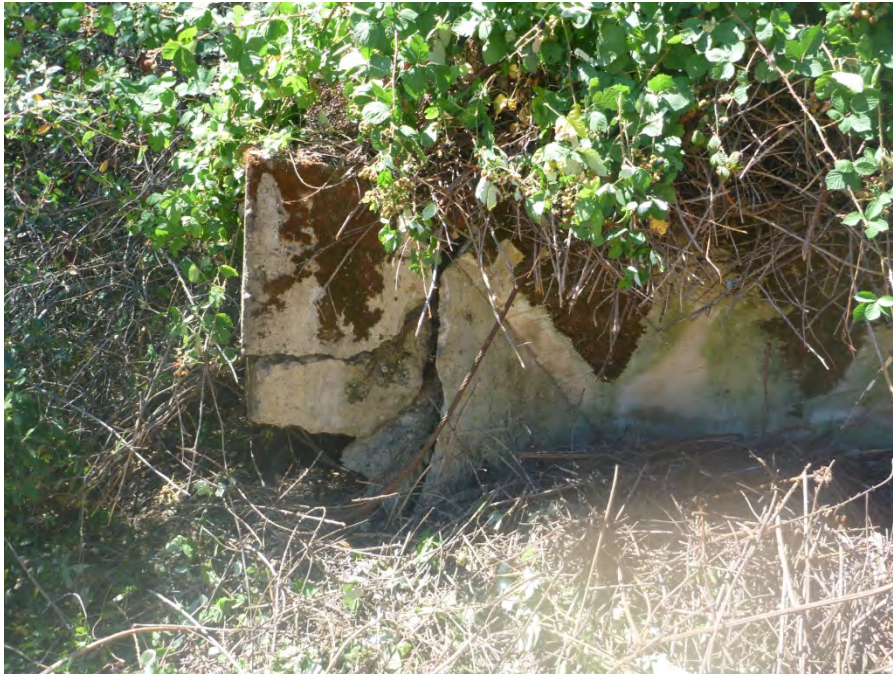
Figure 10 Upper Portion or Remains of Buttrass 1

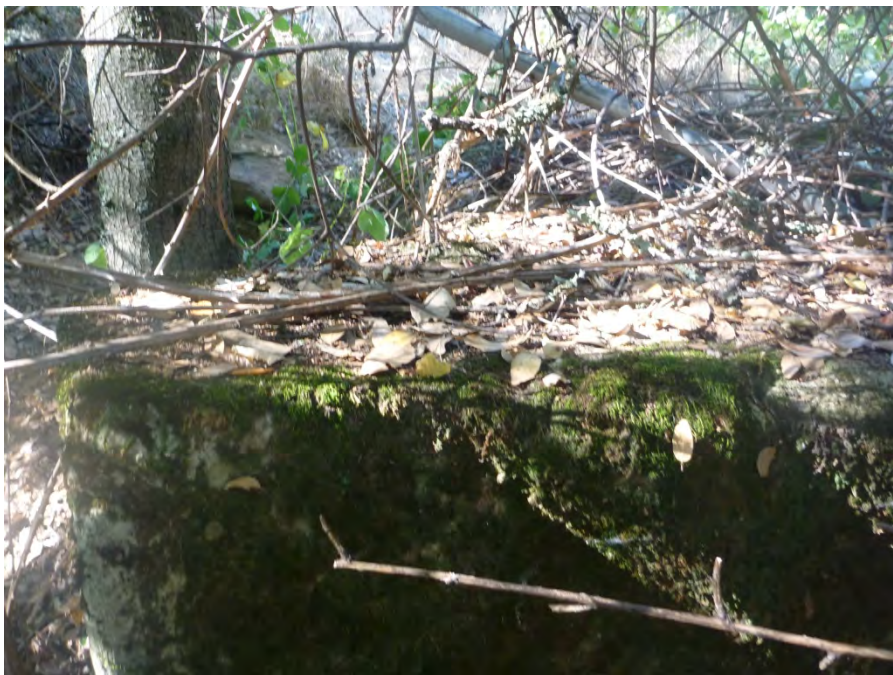
The right abutment was covered in moss and algae, but what was visible appeared intact and in satisfactory condition, see Figure 11. In contrast the left abutment was missing and presumed to have been destroyed during the construction of a road. Cables protruding from the ground provided some evidence of where the right abutment could have rested, see Figure 12. In addition, it was observed that a portion of an arch that connected Buttress 1 and the left abutment was also destroyed during the road construction, see Figure 13.

Figure 11 Right Abutment

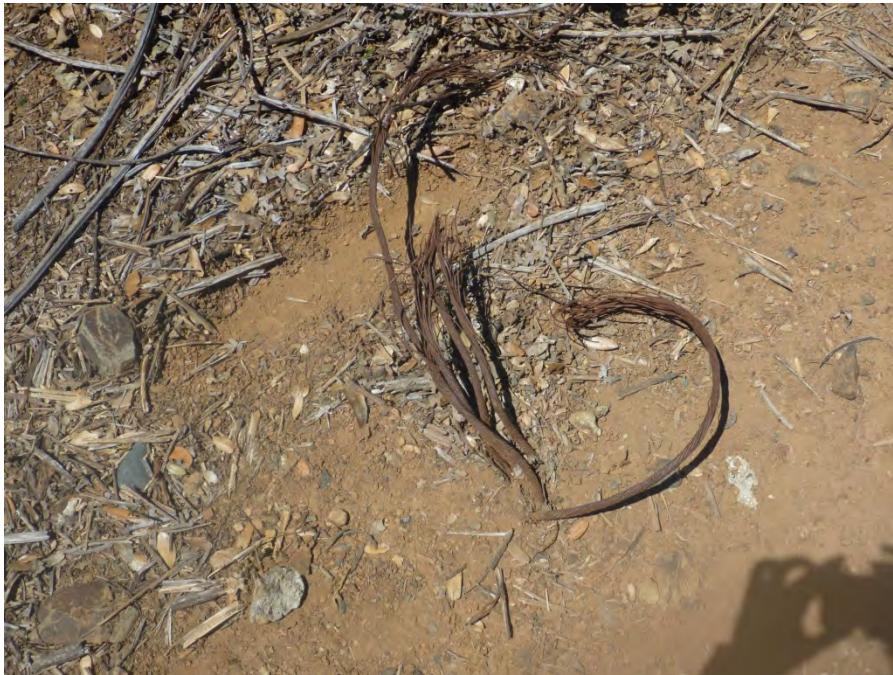
Figure 12 Possible Remains of Left Abutment

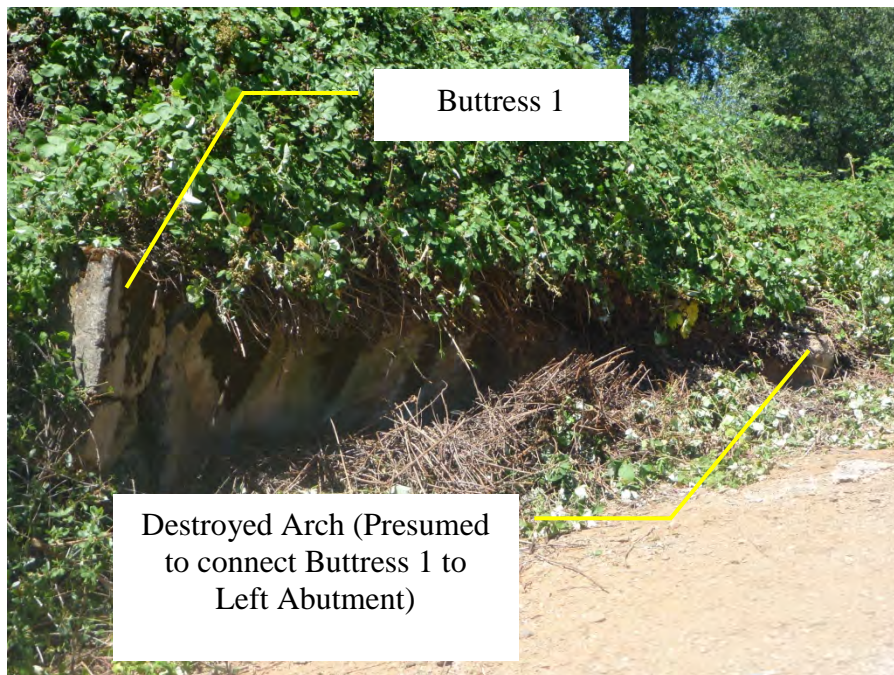
Figure 13 Arch Connecting Buttress 1 to Left Abutment
