MEMORANDUM FOR: Dam Safety Section (ATTN: K. Pattermann)

SUBJECT: Argonaut Multiple Arch Dam, Jackson, California

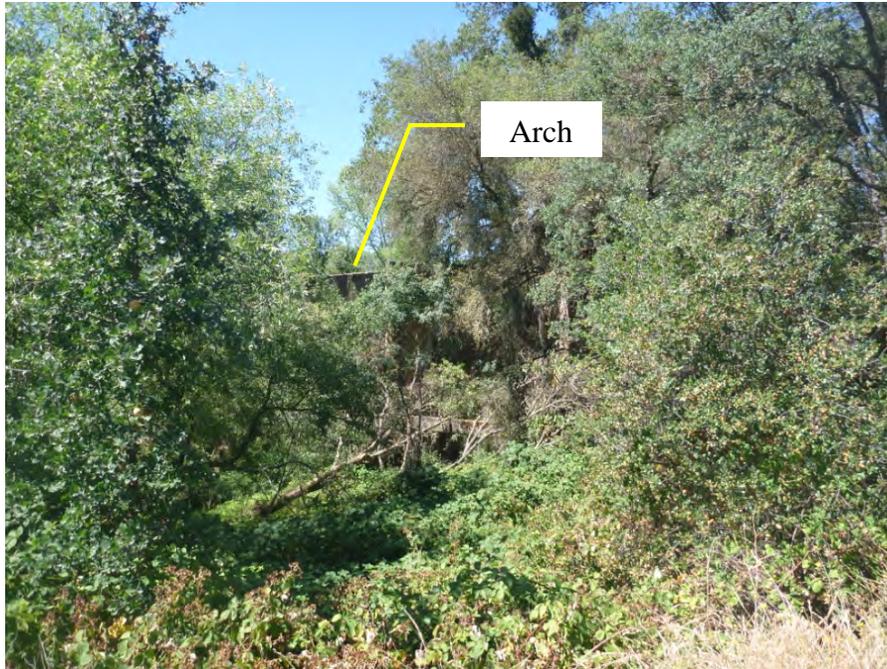
Dense vegetation obstructed the team's ability to visually inspect the dam. Only 3 arches, presumed to be arches 9, 10, and 11, were accessible for inspection from the top of the dam, and 3 arches presumed to be arches 1, 9, and 10 were accessible for inspection from the base of the dam, see Figures 1 & 2.

**Figure 1 Dense Vegetation Obstructing View of Arches**

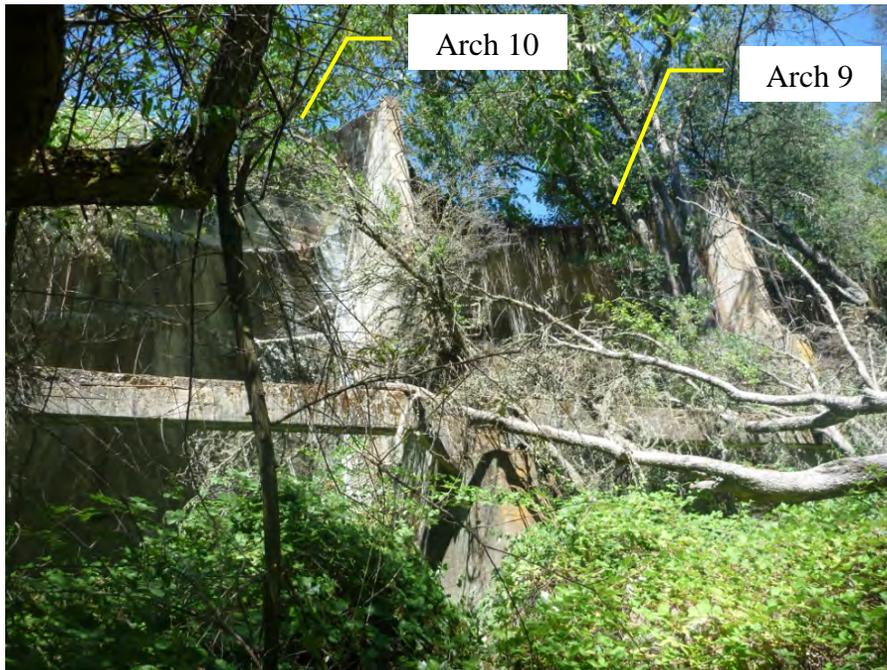
**Figure 2 Arches 9 and 10**

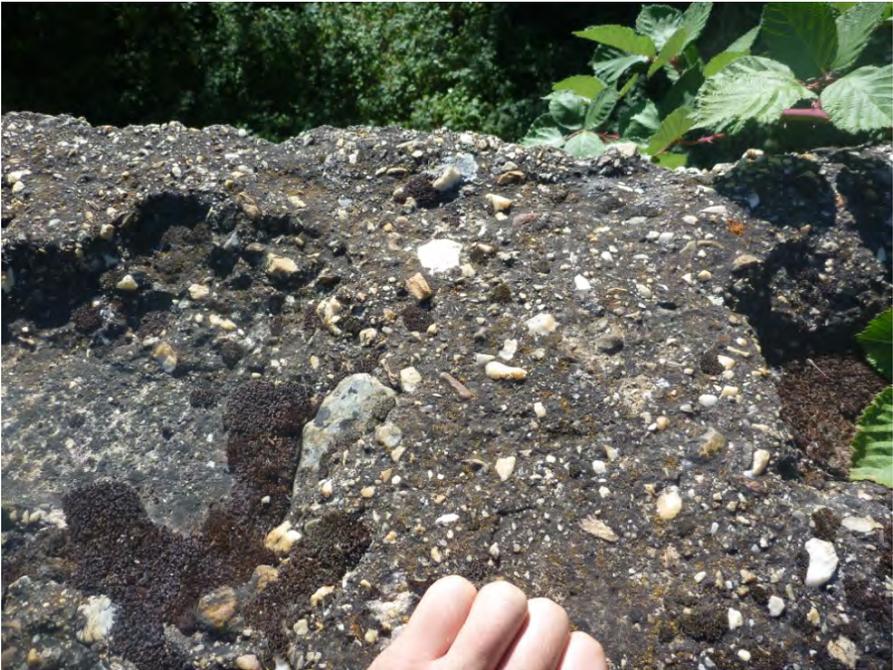
The top surfaces of the concrete arches showed signs of wear possibly due to water running over the dam and or possibly due to freeze thaw cycles, see Figure 3. The downstream end of arches 9, 10, and 11 had signs of efflorescence staining and algae build up, indicating that the dam has been consistently leaking over time, see Figure 4. A crack was noticed at the upper left corner of arches 9 and 10 (facing downstream), which may be consistent with observations made from the inspection in February 1933, where G.F. Engle, a previous inspector, noted a crack at the right end (facing upstream) of arch 9, see Figure 5. In addition, at the base of the dam rust staining was visible on the downstream face of arch 9 where the cable had little or no concrete cover, see Figure 6.

Figure 3 Worn Surface of Concrete (Typical)

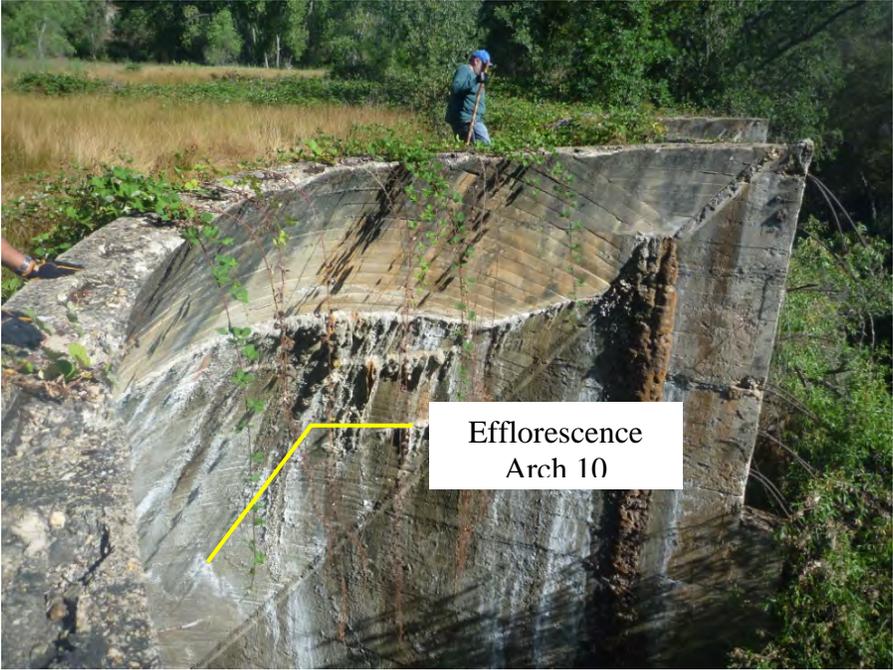
Figure 4 Typical Efflorescence on Arches and Buttress Walls

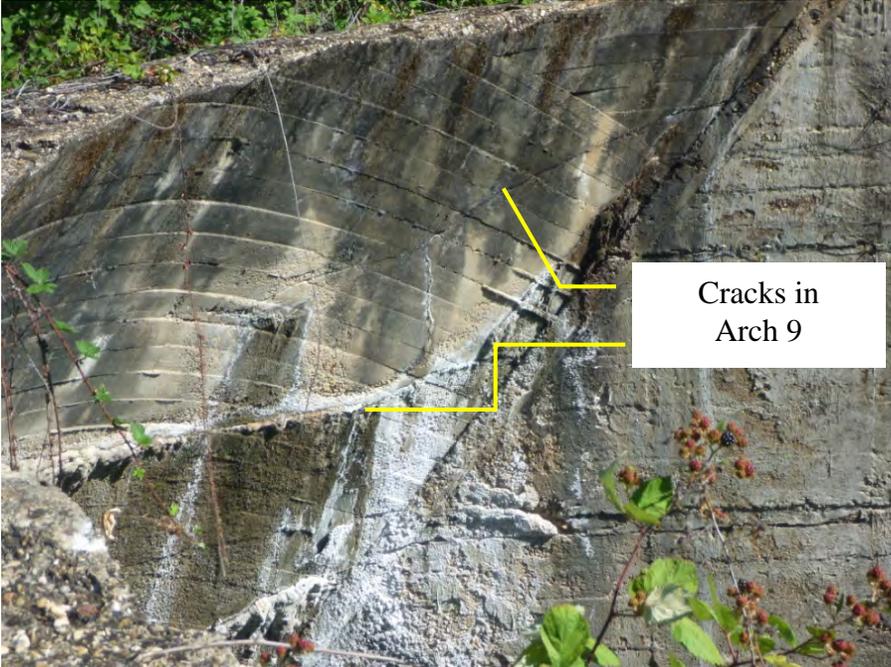
**Figure 5 Crack in Arch 9 (Typical)**

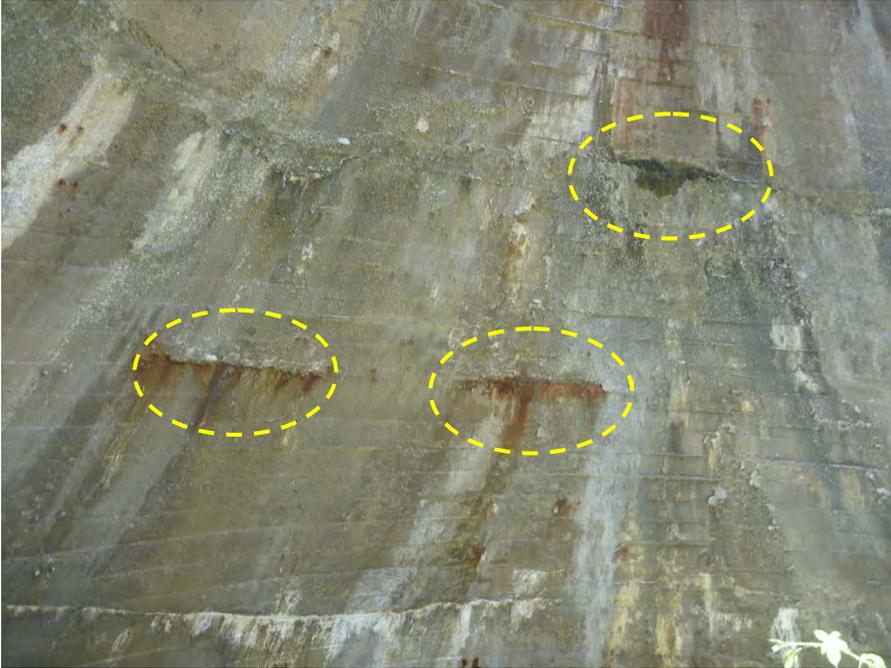
**Figure 6 Rust Staining from Embedded Cable**

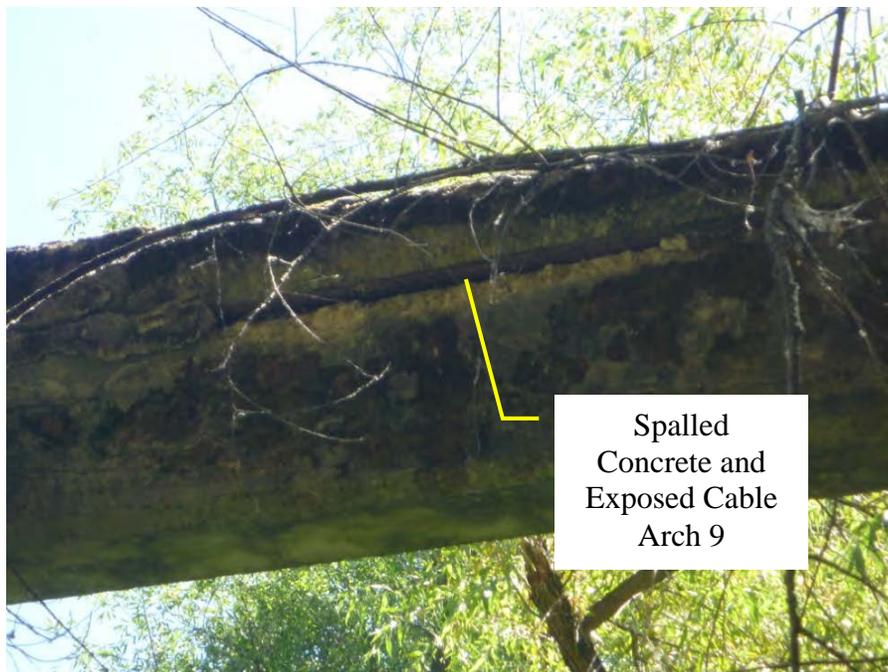
The concrete braces extending between buttresses showed signs of significant spalling. The spalling was most likely due to the corrosion of the embedded cable, which over time caused the concrete to crack and eventually spall, see Figure 7. Although significant spalling was only

observed on the braces associated with arches 9 and 10, it is speculated that all buttress braces are in a similar condition. The brace for arch 11 was not visible due to vegetation overgrowth. The buttress brace dimension was determined to be 12"x 22".

Spalled  
Concrete and  
Exposed Cable  
Arch 9

**Figure 7 Buttress Brace with Spalled Concrete and Exposed Cable**

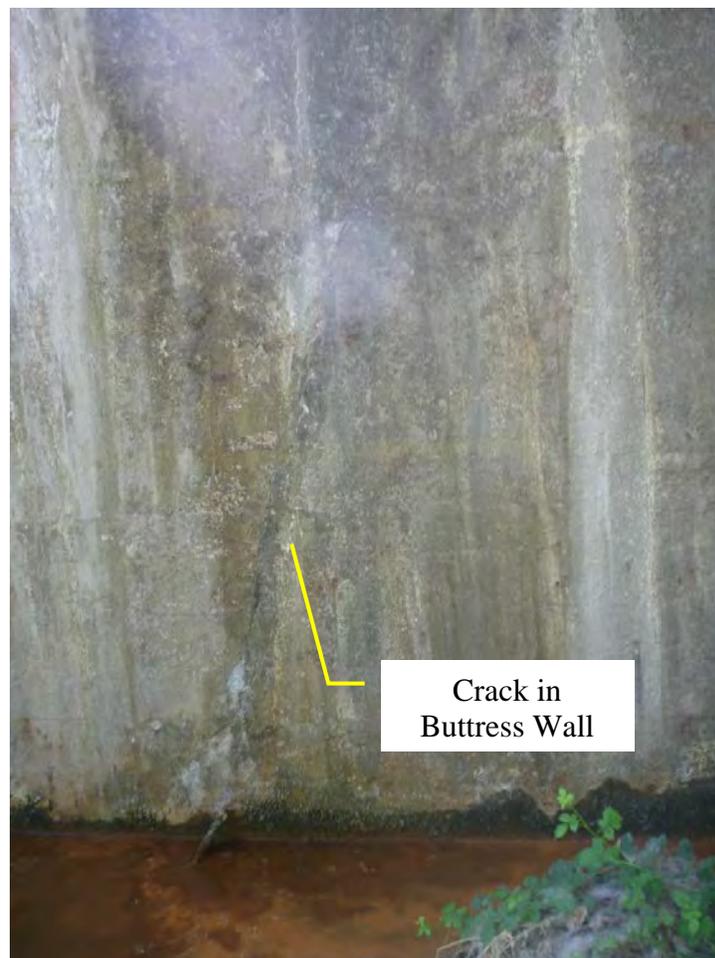
The buttresses were sounded with a geologic hammer and no hollow spots were audible. The concrete surface although stained with efflorescence and algae growth appeared to be in satisfactory condition given the age of the dam. A crack was noted in the buttress wall that extended from the base towards the top of the buttress, see Figure 8. Exposed aggregate on the buttress surface was also noted in various areas, see Figure 9. The upper portion of Buttress 1 was found to have completely cracked off and hanging from its cables, see Figure 10.

Crack in  
Buttress Wall

**Figure 8 Crack in Buttress Wall of Arches 9 & 10**

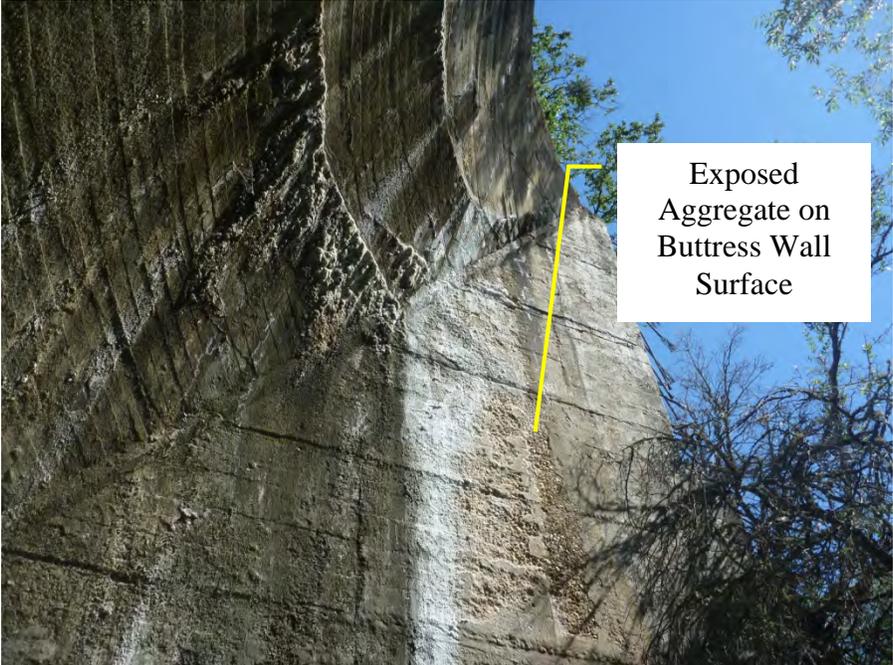
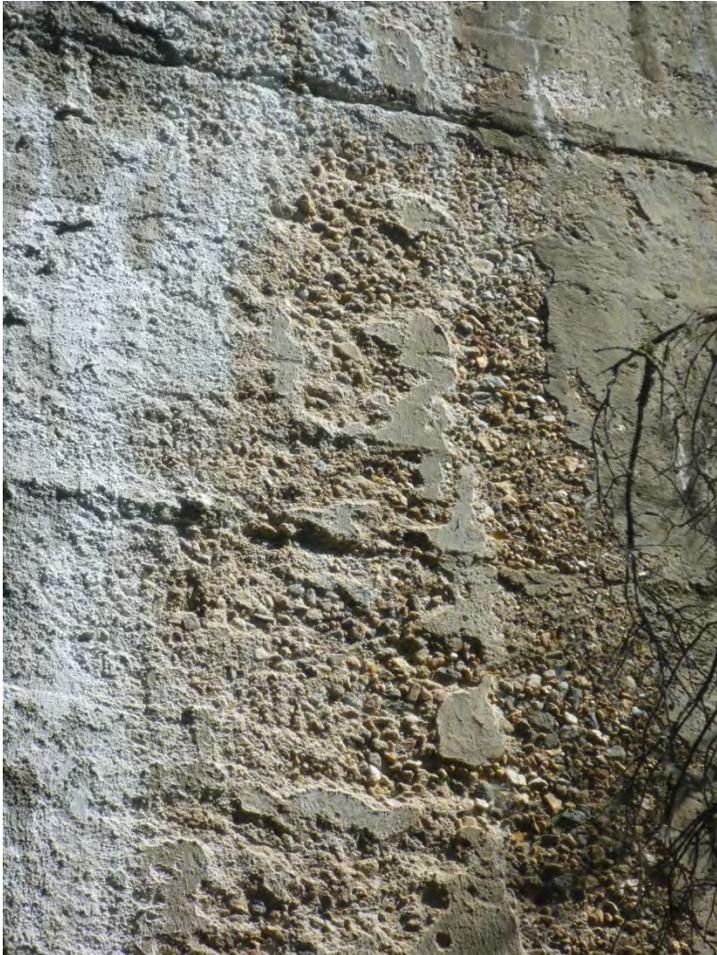
**Figure 9 Exposed Aggregate of Buttress Wall**

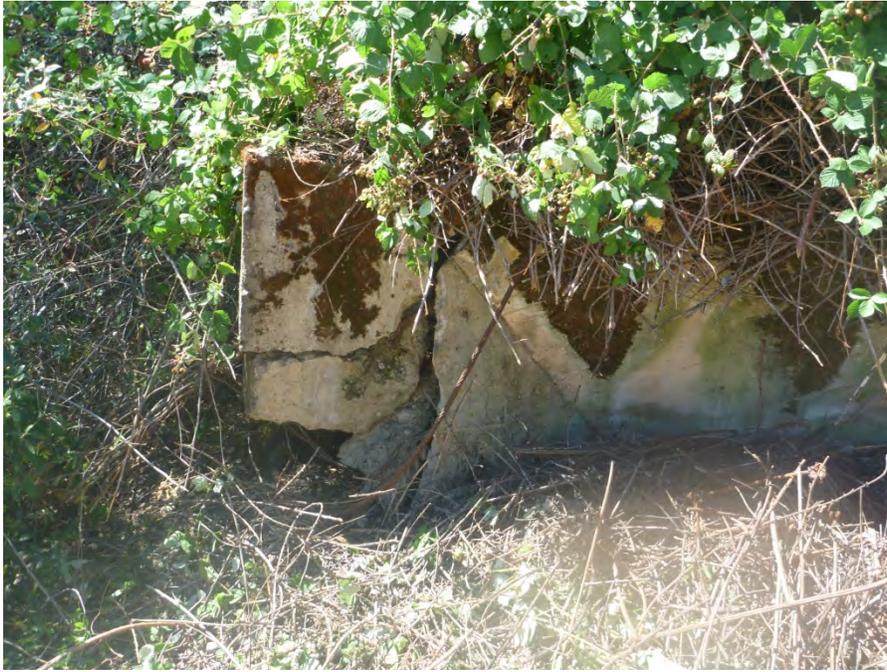
**Figure 10 Upper Portion or Remains of Buttress 1**

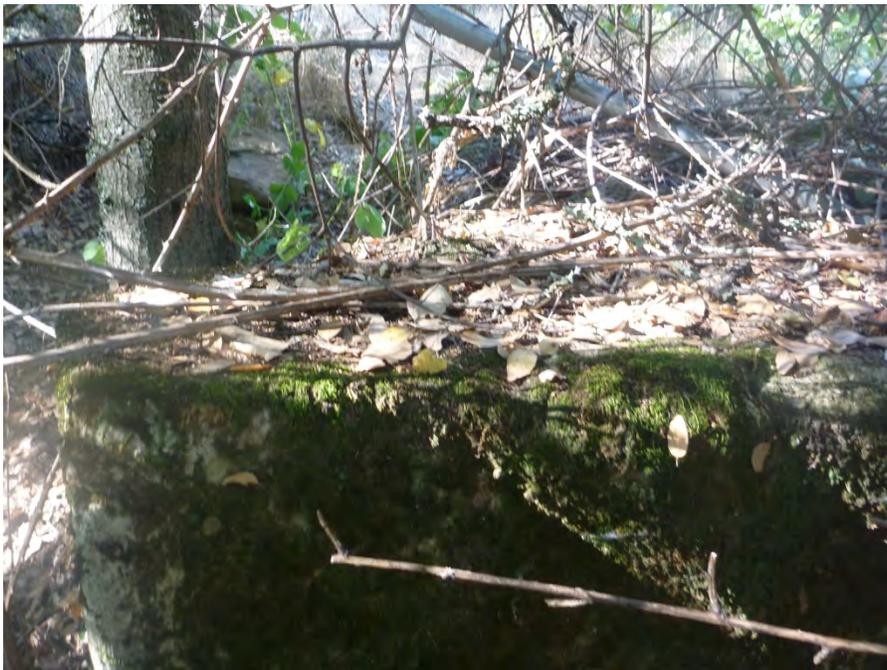
The right abutment was covered in moss and algae, but what was visible appeared intact and in satisfactory condition, see Figure 11. In contrast the left abutment was missing and presumed to have been destroyed during the construction of a road. Cables protruding from the ground provided some evidence of where the right abutment could have rested, see Figure 12. In addition, it was observed that a portion of an arch that connected Buttress 1 and the left abutment was also destroyed during the road construction, see Figure 13.

**Figure 11 Right Abutment**

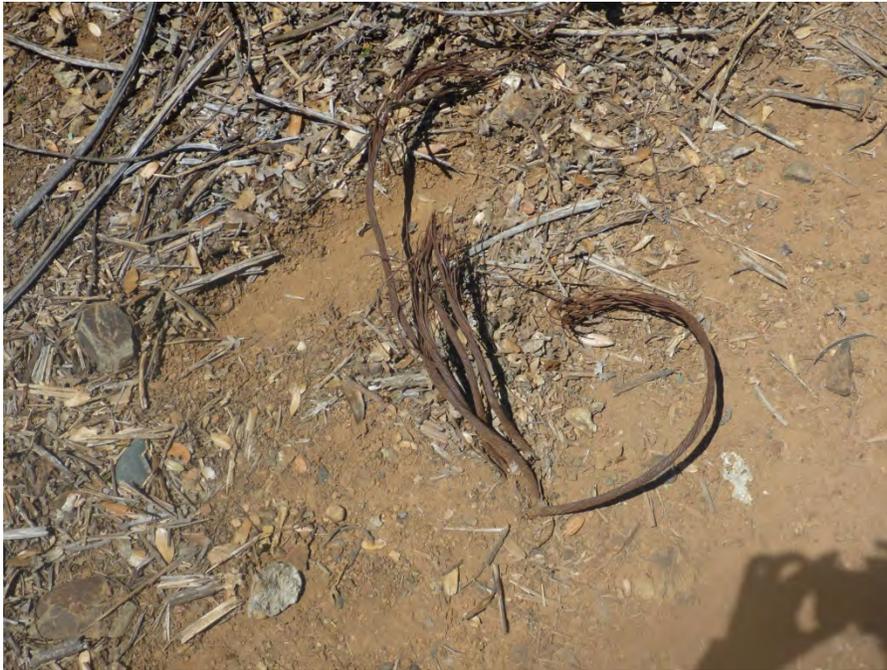
**Figure 12 Possible Remains of Left Abutment**

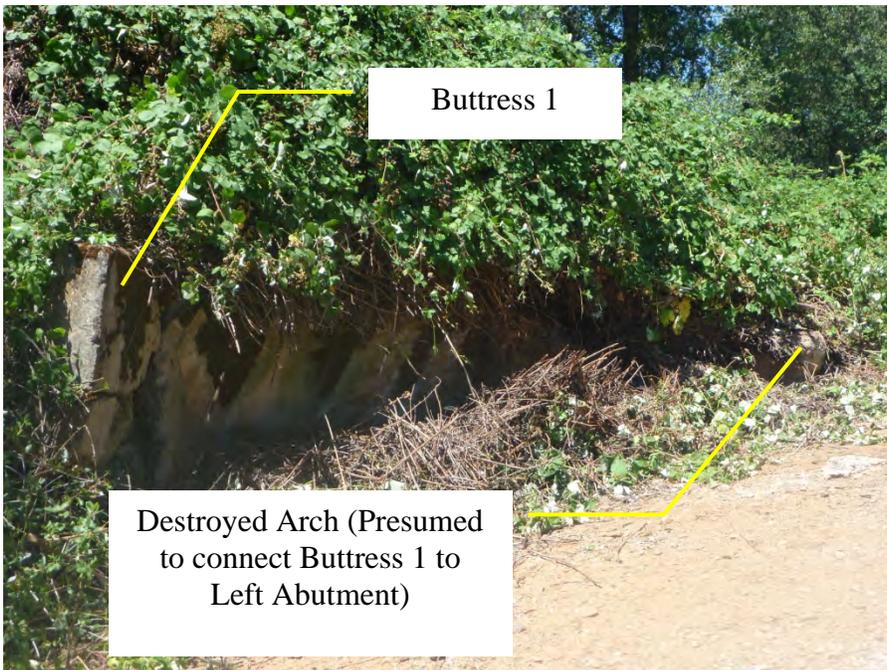
**Figure 13 Arch Connecting Buttress 1 to Left Abutment**
