MEMORANDUM FOR: Dam Safety Section (ATTN: K. Pattermann)

SUBJECT: ARGONAUT TAILINGS STORAGE DAM - SECOND INSPECTION

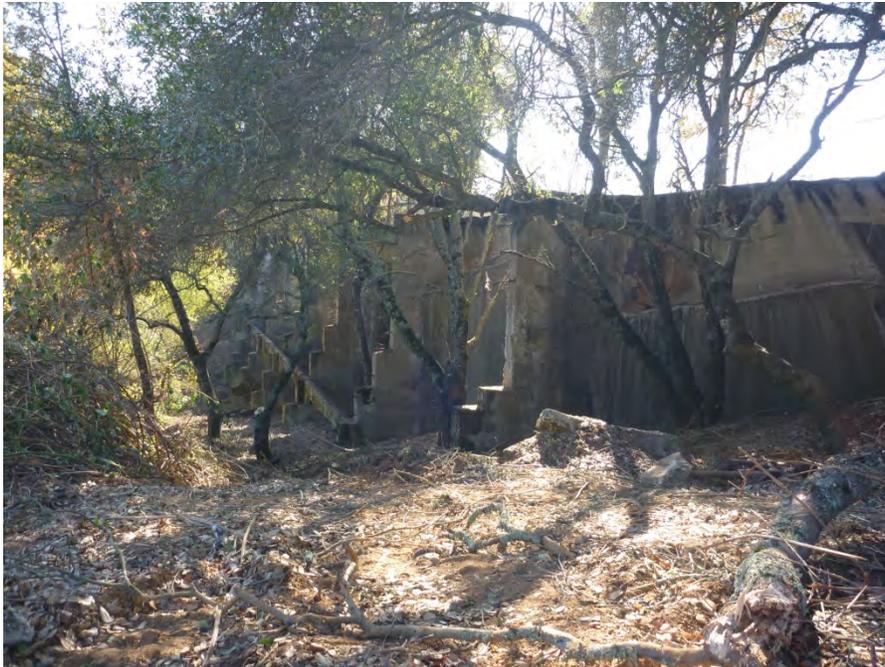
Following recommendations from the initial inspection, much of the dense vegetation was removed allowing for better access to the concrete arches. Inspectors were able to inspect all 13 arches from both the downstream and upstream sides. (Figure 1)

Figure 1 View of Concrete Arches (Looking at Downstream Side from the Furthest Left Arch)

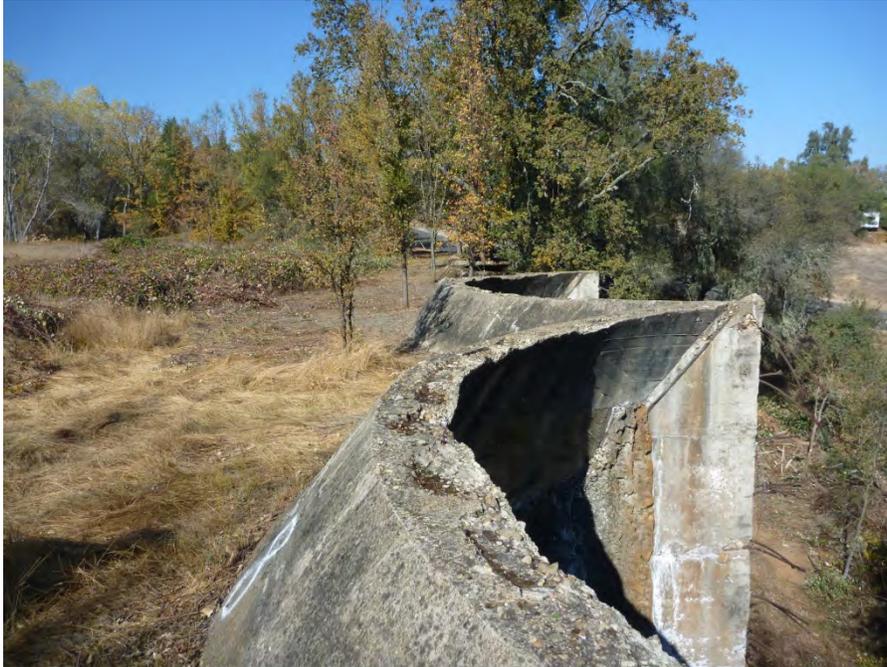
The top surfaces of all the concrete arches showed signs of erosion possibly due to water running over the dam and / or possibly due to freeze thaw cycles, see Figure 2. All downstream faces of the arches have signs of efflorescence, rust staining from the embedded wire rope, and algae build up indicating that the dam has consistently seen water during its service life, see Figures 3 and 4. It is postulated that the areas of the efflorescence, rust staining, and algae build up

Figure 2 View to the Left of Arch 8, Typical Worn Concrete Surface

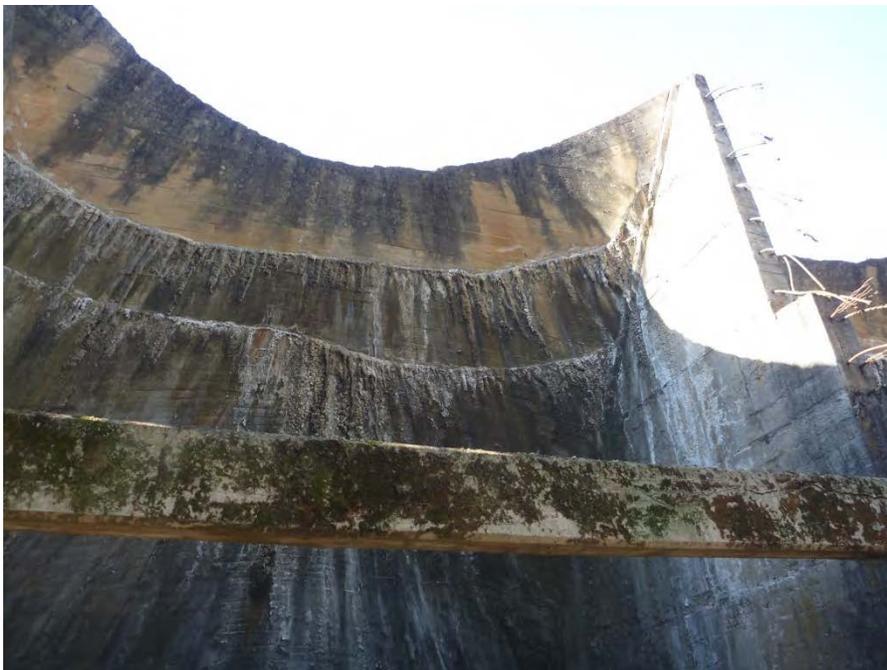
coincide with locations of the wire rope. The wire ropes, due to improper concrete cover, may have corroded causing cracks in the concrete, which lead to efflorescence, rust stains, and water to leach out. Many of the arches also were observed to have large piles of soil between the buttresses. It is unclear if the soil piles were put there intentionally during the construction of the dam (due to left over formwork, Figure 5), or if it was deposited over time during overflow events.

Figure 3 Typical Efflorescence, Rust Staining, and Algae Build up on Arches and Buttress Walls

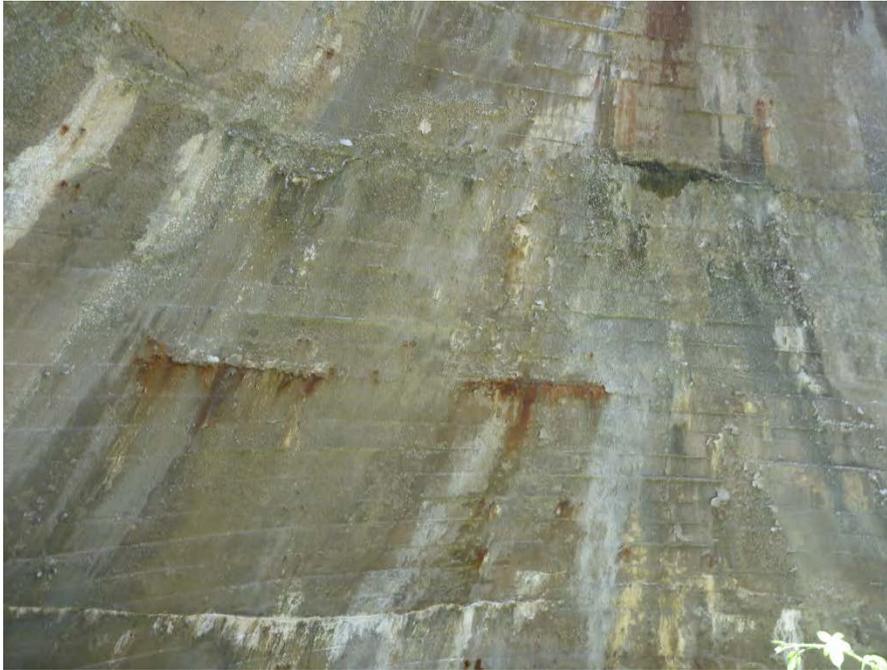
Figure 4 Rust Staining on Downstream Arch Face (insufficient cover around wire ropes)

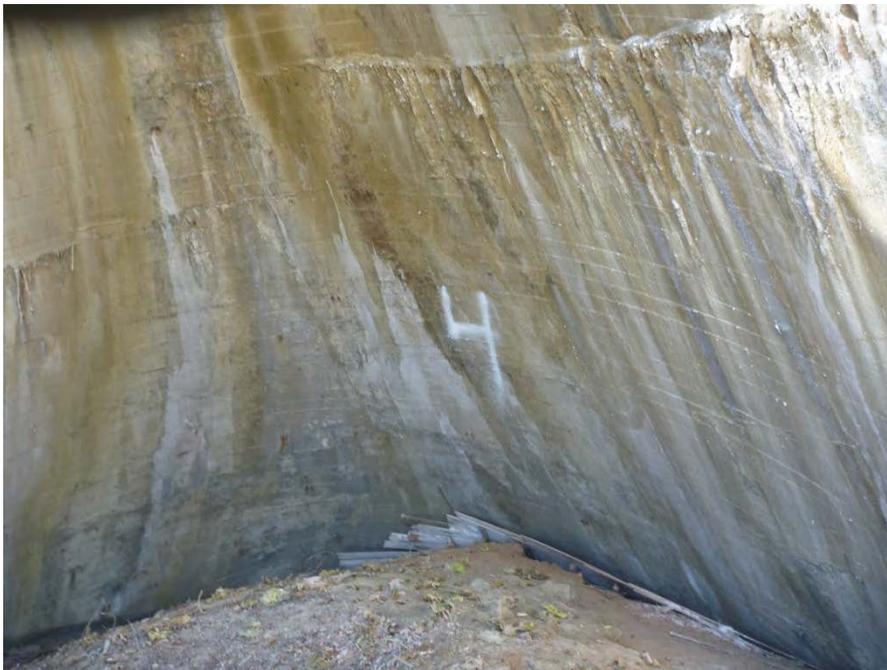
Figure 5 Leftover Formwork from Construction of the Dam

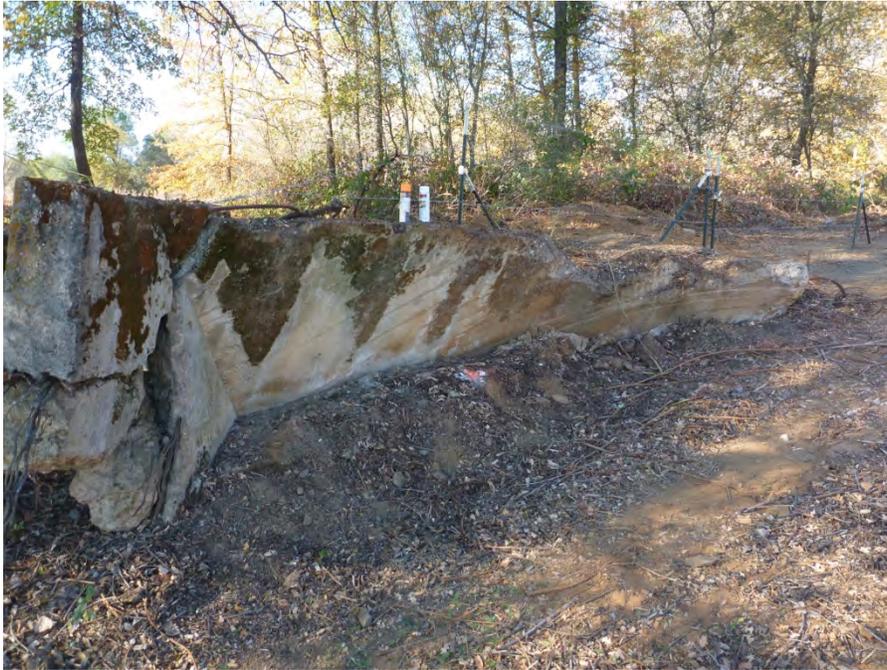
Arch #1 on the far left side was found to be severely deteriorated and buried; perhaps due to the construction of the road for the subdivision above the dam. (Figure 6) Cracks were noticed at the upper left and right corners of Arches #7, #8, #9, & #10, which is consistent with observations made from the inspection in February 1933, where G.F. Engle, a previous inspector, who noted a crack at the right end (facing upstream) of Arch #9, see Figure 7. It is also important to note that water was observed to be pooling behind Arch #7. However, at this time it is unclear where the water is coming from. Arch #11 was discovered to have a hole through its right side, which does not appear to be a recent development due to the buildup of material beneath it. The hole diameter was approximately seven inches. Arch #13 was found to be mostly buried with very little exposed to perform a thorough inspection. (Figure 8) Overall the arches seemed to be performing adequately to resist the soil and water forces pressing up against the dam. However, some arches like Arch #11 do pose structural concerns.

Figure 6 Visible Remains of Arch 1

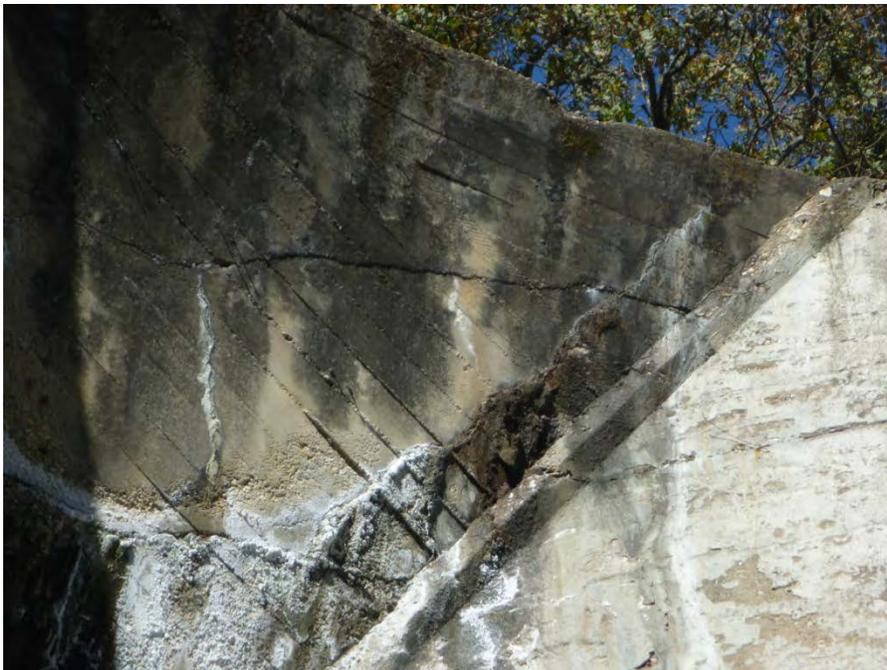
Figure 7 Crack in Arches 7, 8, 9, & 10 Typical Both Sides

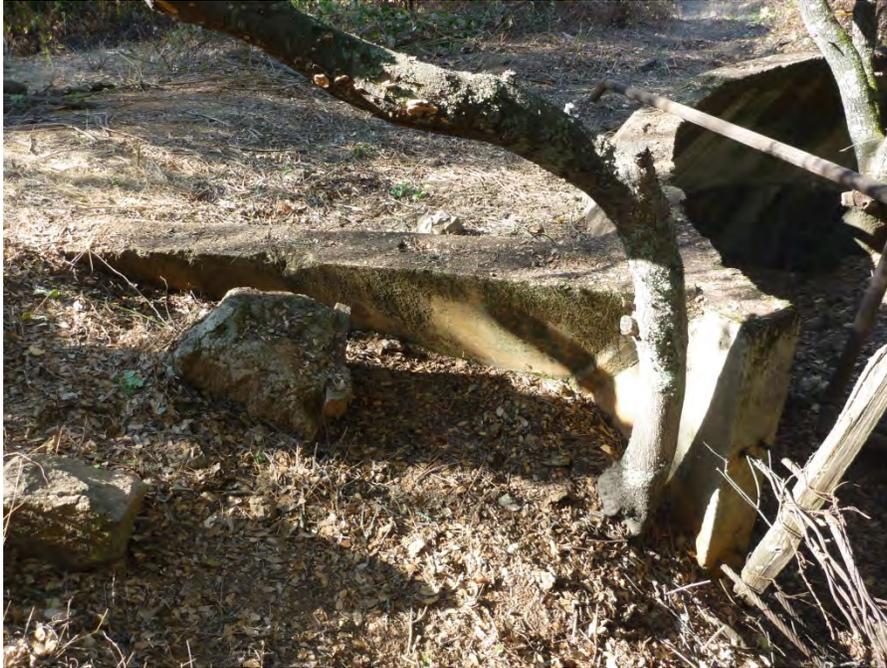
Figure 8 Exposed Portion of Arch 13 on the Far Right

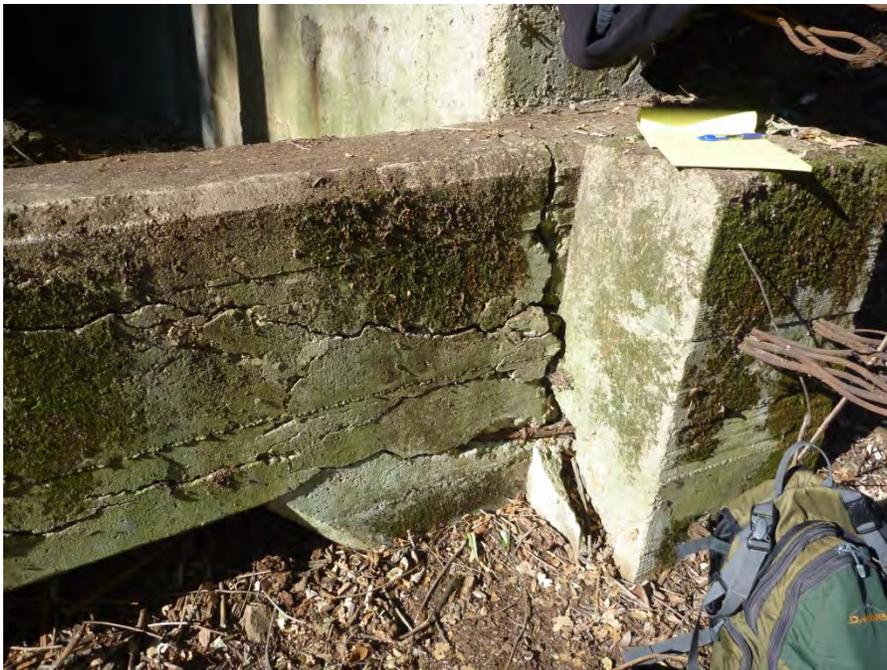
All concrete braces extending between buttress walls showed signs of significant concrete cracking, delamination, and / or spalling. The brace in the worst condition was Arch #5, which had two large horizontal delamination cracks; one at the top 6" and one at bottom 4.5" of the member. In addition, a large vertical crack at the far left support was also observed that extended through the entire member's cross section, see Figure 9. The large horizontal cracks, typical to all braces, is most likely due to the corrosion of the embed wire rope, which over time expanded causing the concrete to either crack, delaminate, and /or spall off the member completely. (Figure 10) In the case of Arch #5 the bracing member has completely failed and is only being held in place by the bottom wire rope and supporting concrete seats. Because the braces play an important role in bracing the buttress walls along their weak axis, their poor condition raises serious concerns of the dam's ability to withstand seismic events in the cross canyon direction (parallel to the dam).

Figure 9 Concrete Brace at Arch 5

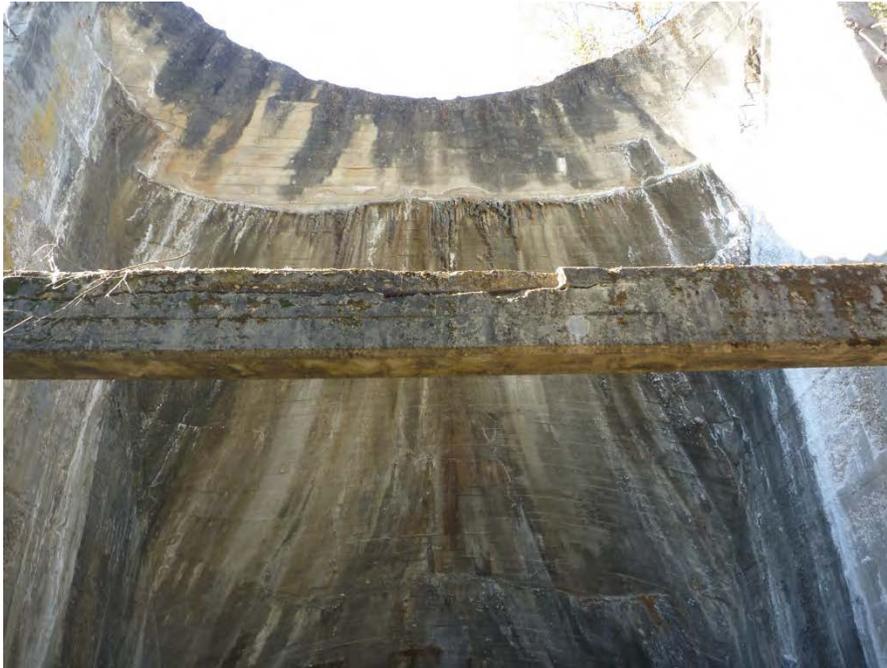
Figure 10 Bracing at Arch 7 Showing Signs of Cracking, Delamination, and Spalling (Typical)

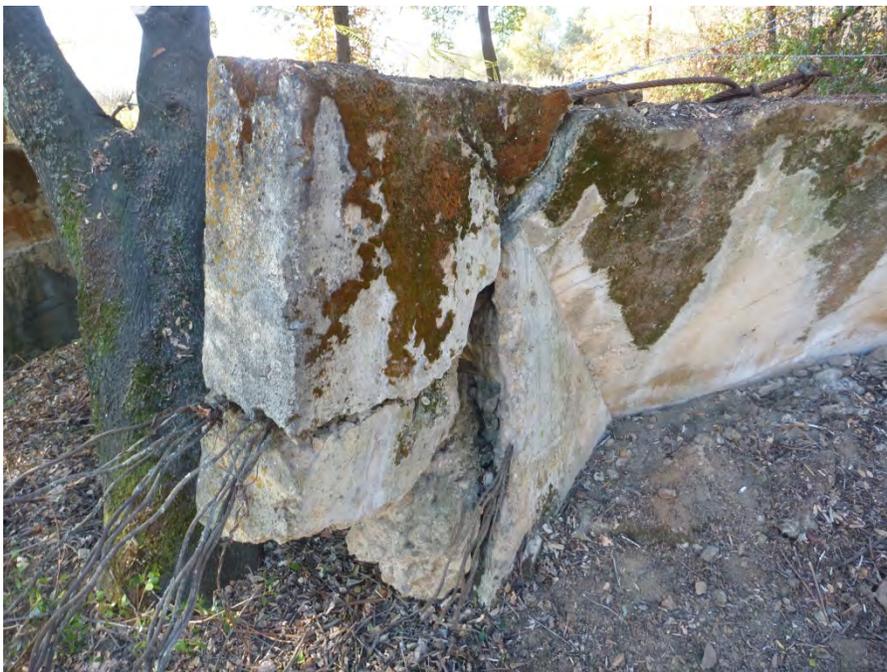
Given the condition of the first arch, the first buttress wall was presumed to have been demolished during the construction of the road and subdivision. The exposed portion of the #2 buttress wall was found to be in severe deterioration with only the wire ropes holding the concrete together. (Figure 11) The #4 and #5 buttress walls showed signs of concrete cracking and spalling around the locations of the embedded wire ropes. The symptoms and cause of distress of the #4 and #5 buttress walls seemed to match those of the concrete brace, (corrosion of the embed wire rope). (Figure 12)

Figure 11 Buttress Wall 2 in Severe Deterioration

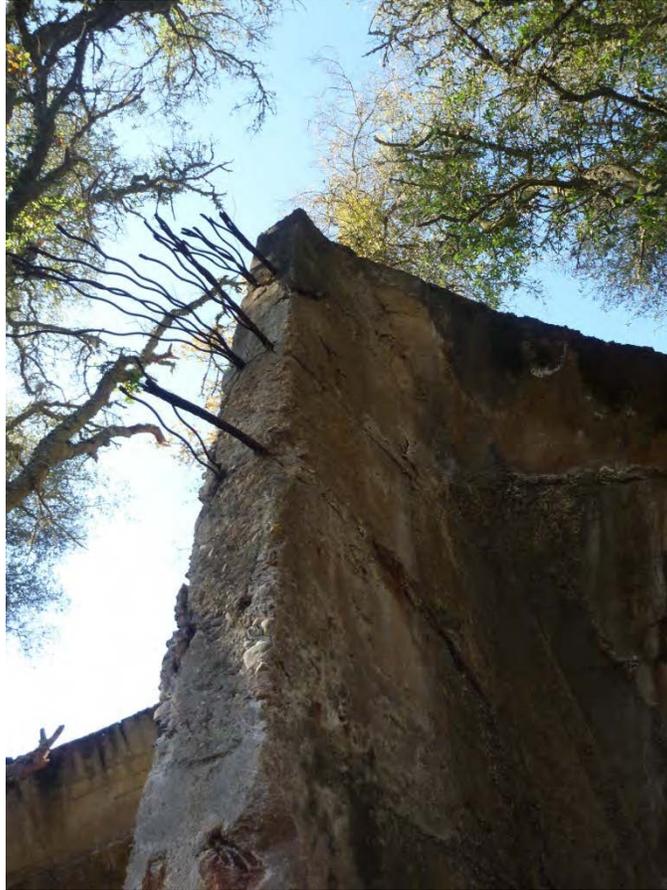
Figure 12 Butress Wall #4 Showing Signs of Cracking and Spalling Around Embed Wire rope

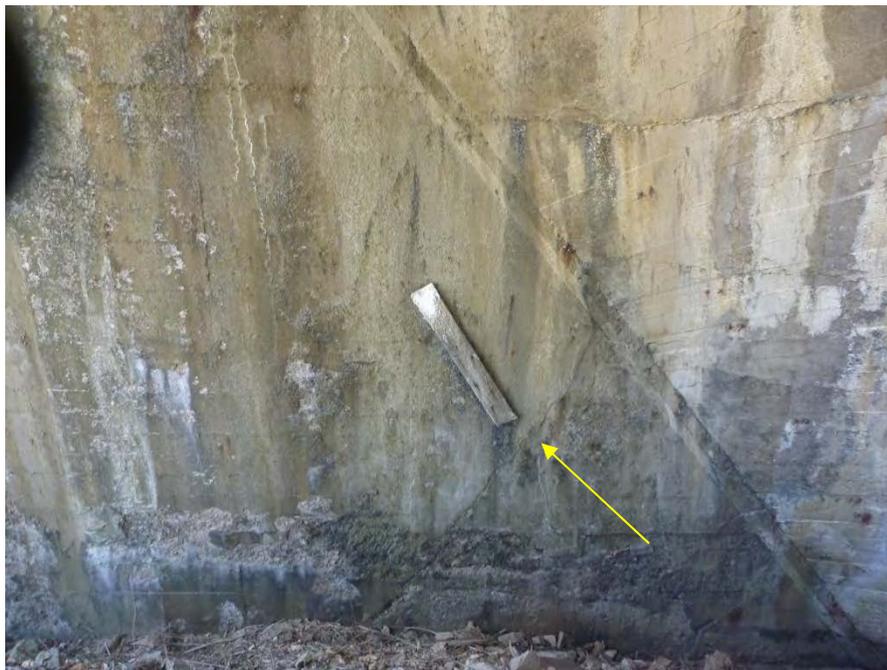
Buttress #6 was found to have a diagonal crack that appeared to pass through the entire walls cross section, see Figures 13 and 14. At this time it is uncertain whether the crack was caused by arch forces pushing on the buttress wall or if the soil/rock underneath the buttress has settled. It

Figure 13 Diagonal Crack on Left Side Buttress #6

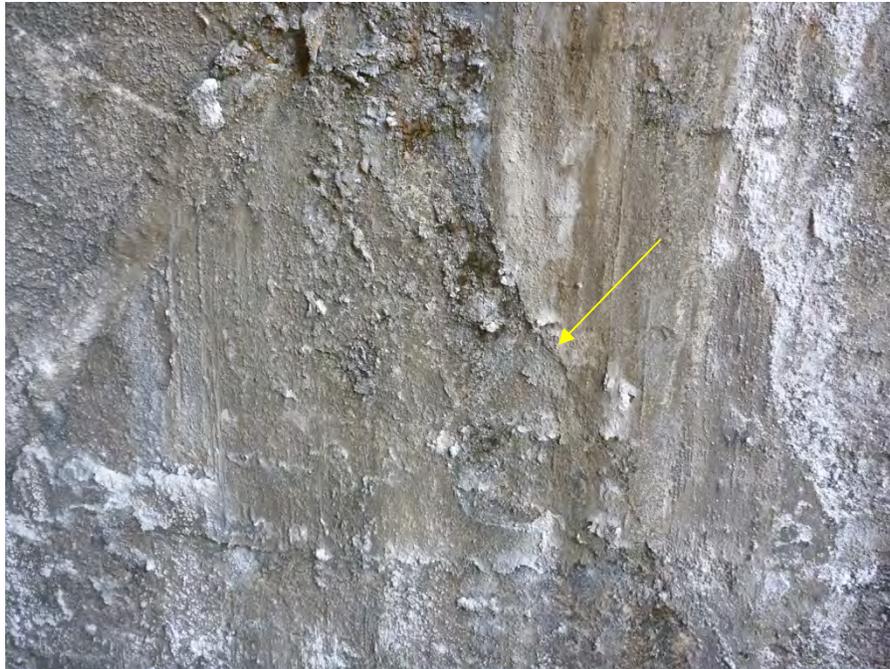
Figure 14 Diagonal Crack on Right Side of Buttress #6

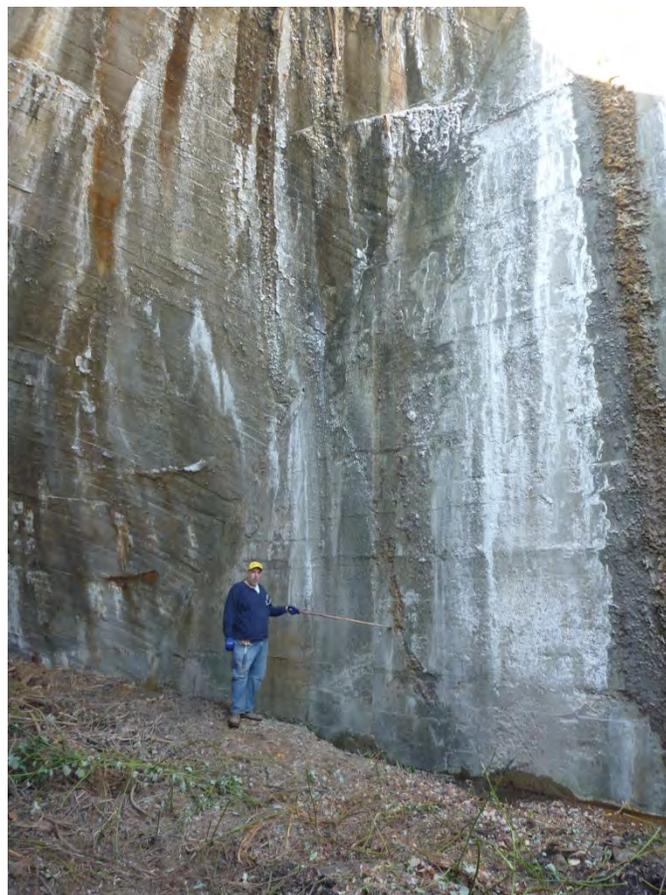
was also observed that Buttress #8 had a nearly identical crack in terms of size and location. (Figure 15)

Figure 15 Diagonal Crack in Buttress #8

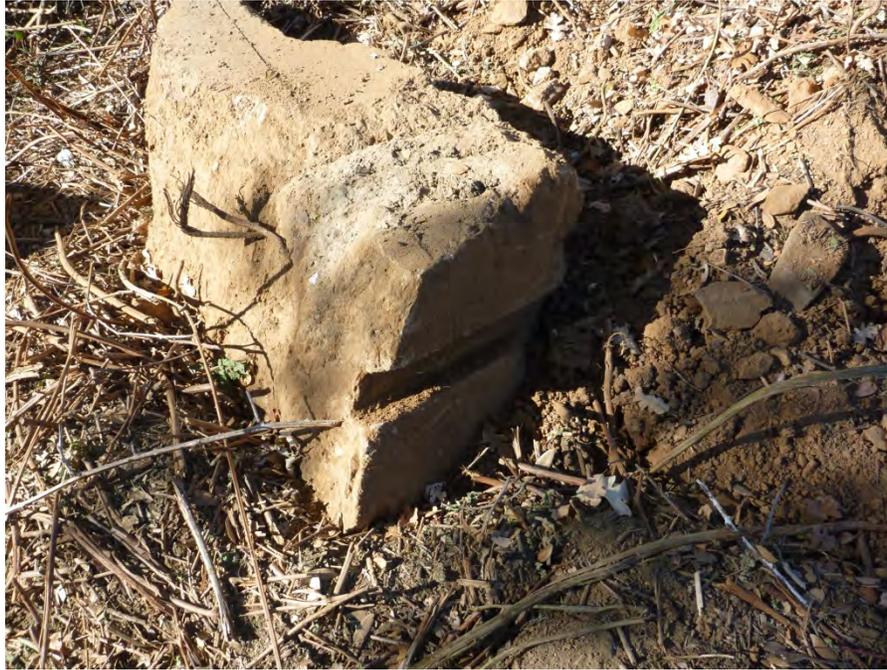
The spillway, which is located on the far left side of the dam, was found to be completely demolished. Remnants of the spillway were found behind Arch #1. (Figure 16) The slot in the concrete shown in Figure 16 matches a sketch of the spillway from historical documents.

Figure 16 Remains of Spillway
