ARGONAUT DAM STABILITY AND RETROFIT ALTERNATIVE INVESTIGATION JACKSON, CA

PHASE I TECHNICAL REPORT

January 6, 2015

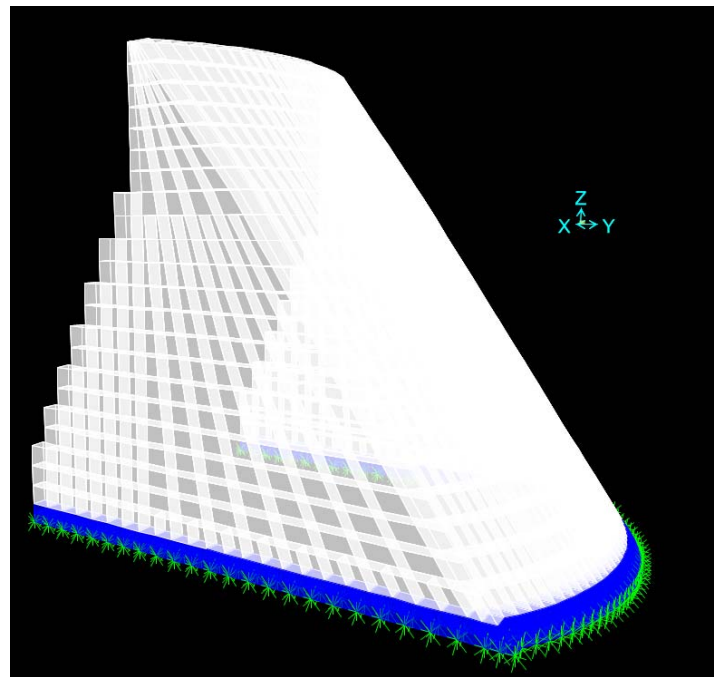
Figure 13. Assumed Shear Plane Failure Location Shown in Blue

From the results it can be seen that only one of the selected friction coefficient values reached the minimum required factor of safety, see LC-4. Of concern, is the extremely low factor of safety values for the friction coefficient value of 0.6 (concrete cast against a hardened surface). Given the amount of efflorescence and algae along some of the cracked planes it is highly unlikely that a friction coefficient of 1.4, which correlates to monolithically placed concrete, is still currently in existence. The figures below illustrate the assumed shear plane failure location and the shear stress within the arch and buttress walls.

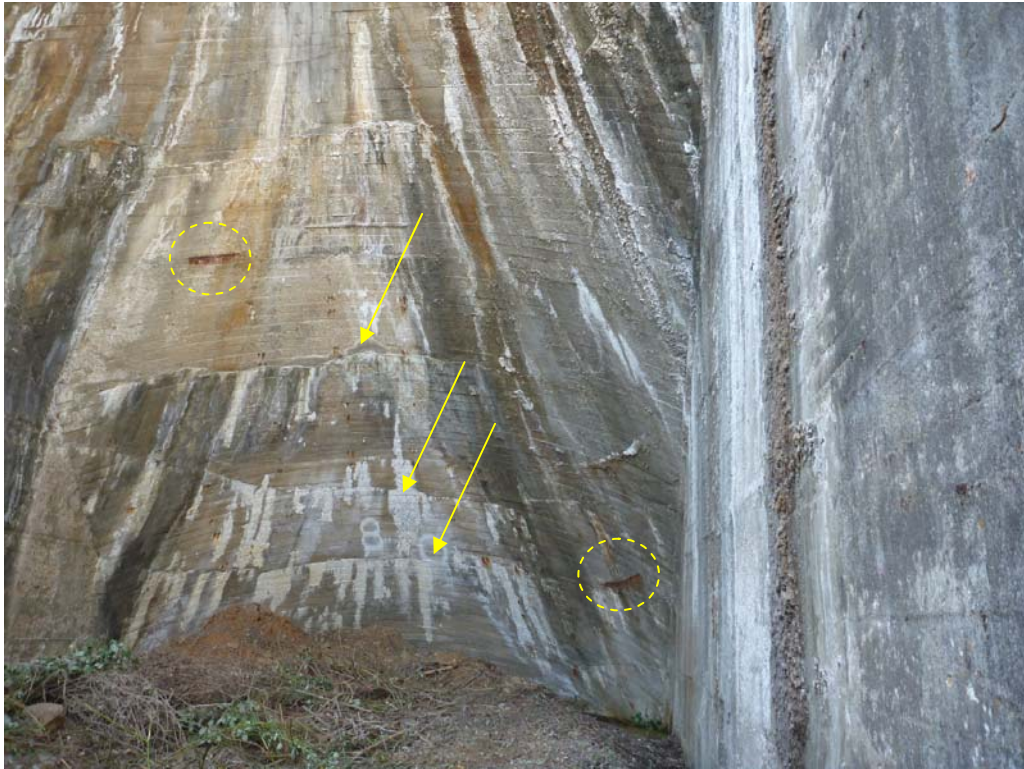
Figure 16. Corrosion of Cables within Arch #8 and Weakened Concrete Planes

From the results of the various stability checks, the most concerning failure mode was sliding shear through the concrete. During inspection of the dam, no visible modern (square or circular) reinforcing bars could be seen, even in the sections that were heavily damaged. In addition, the use of ASTM A15 and ASTM A16 steel was not used as reinforcement until 1911 and 1913 respectively, see CRSI 2001. Based on this information it was assumed that no vertical reinforcement existed in the dam. Unfortunately, due to the lack of vertical reinforcement, the visible signs of corrosion (circled in yellow in Figures below), and the visible horizontal cracked concrete planes (shown with arrows in Figures below), there is a high probability that this failure mode may occur. The concern of this failure mode was justified through the results, which showed failure of every load case despite the range of both high and low frictional coefficients values explored.

From the preliminary results of the Phase I investigation, it is recommended that a larger FEA model composed of a minimum of four of the tallest arches be built to reinvestigate stability values and explore repair / retrofit options to the 35% design stage. The repair / retrofit options will be evaluated from the standpoint of feasibility, constructability, and cost. Following the retrofit comparison, a recommendation on which repair option to pursue up to the 65% design submittal will be provided. It should be noted that seismic loadings, which will be evaluated further in the 35% design submittal, will follow EM 1110-2-2100 and EM 1110-2-6053 regarding progressive analysis methodology, which may increase the complexity of the analysis and FEA model. Also of importance is that the 35% design submittal will not investigate multiple extreme events happening simultaneously (i.e. MDE and Flood) as the chances of this occurring is extremely remote.
