RECORD OF INSPECTION OF DAM

NAME OF DAM Argonaut

ARGONAUT MINE TAILINGS DAM, JACKSON, CALIFORNIA

ARGONAUT DAM #478

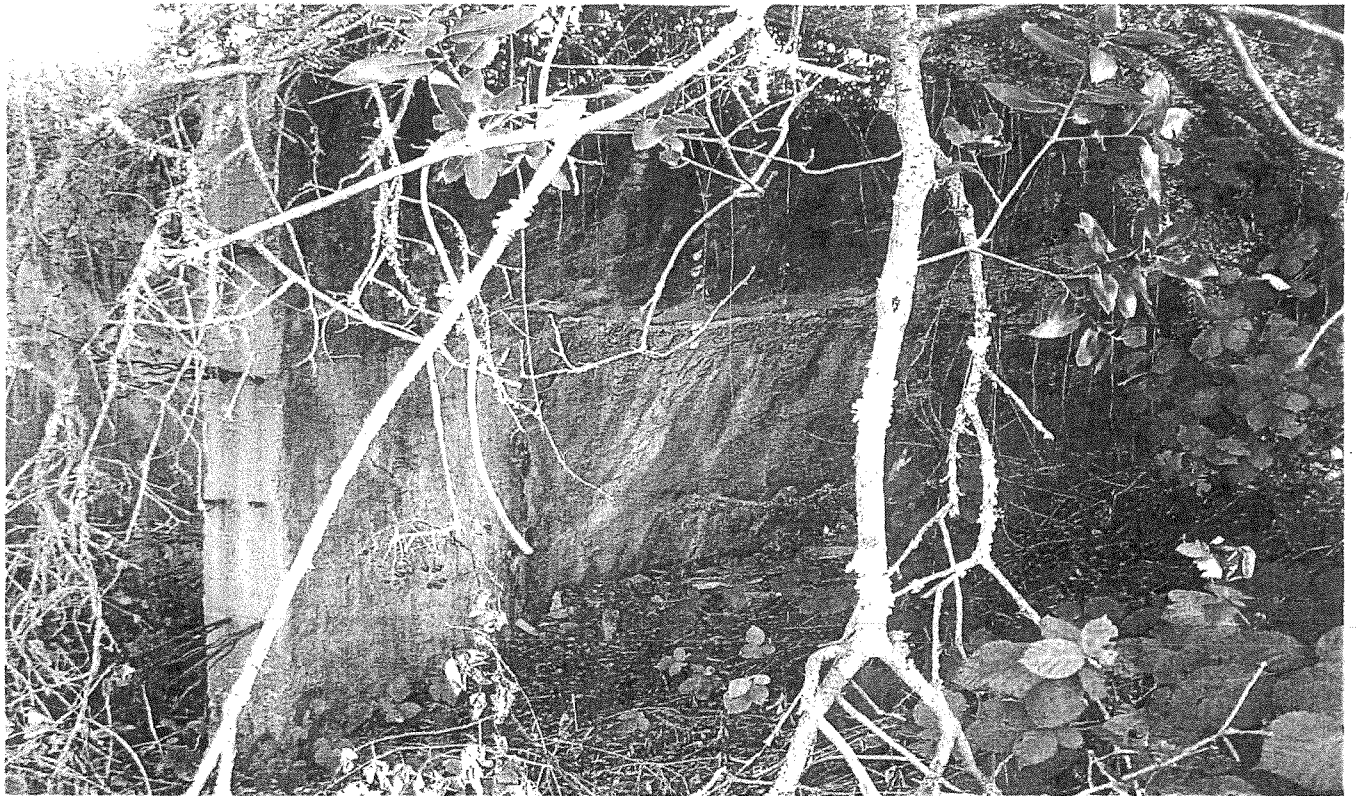
Section of Face of Argonaut Mine Dam

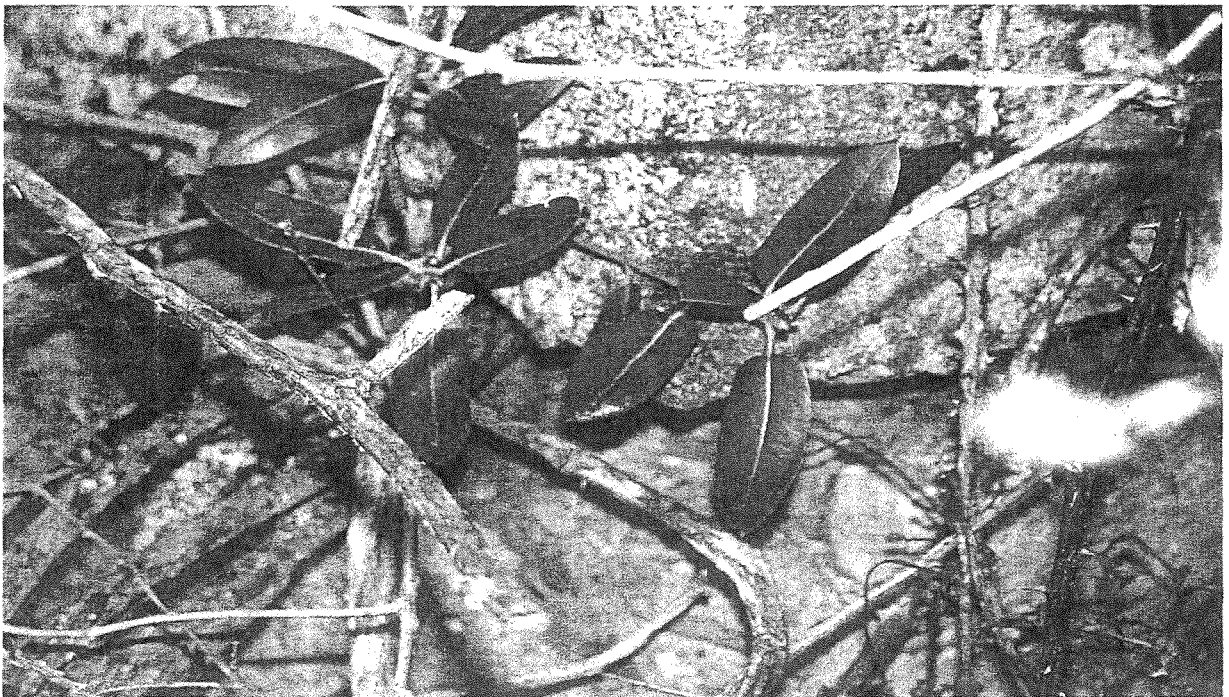
Close-up of blackberry bushes growing in cracks in dam.

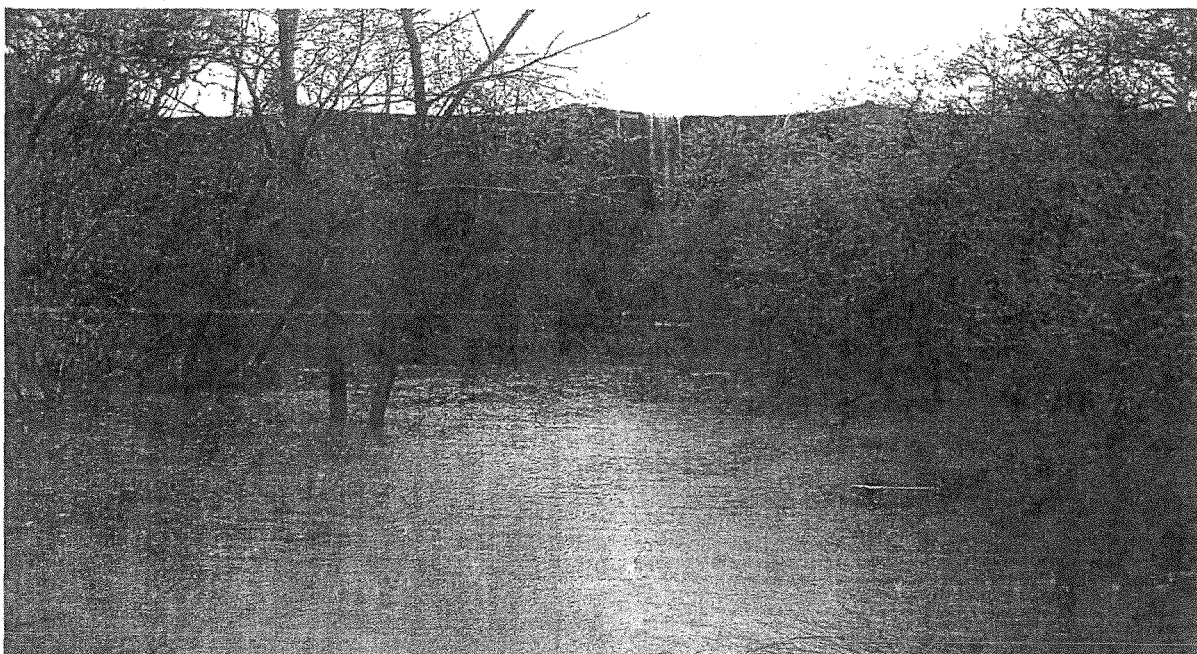
Rain water runoff flowing over the top of Argonaut Mine, April 4, 2006.

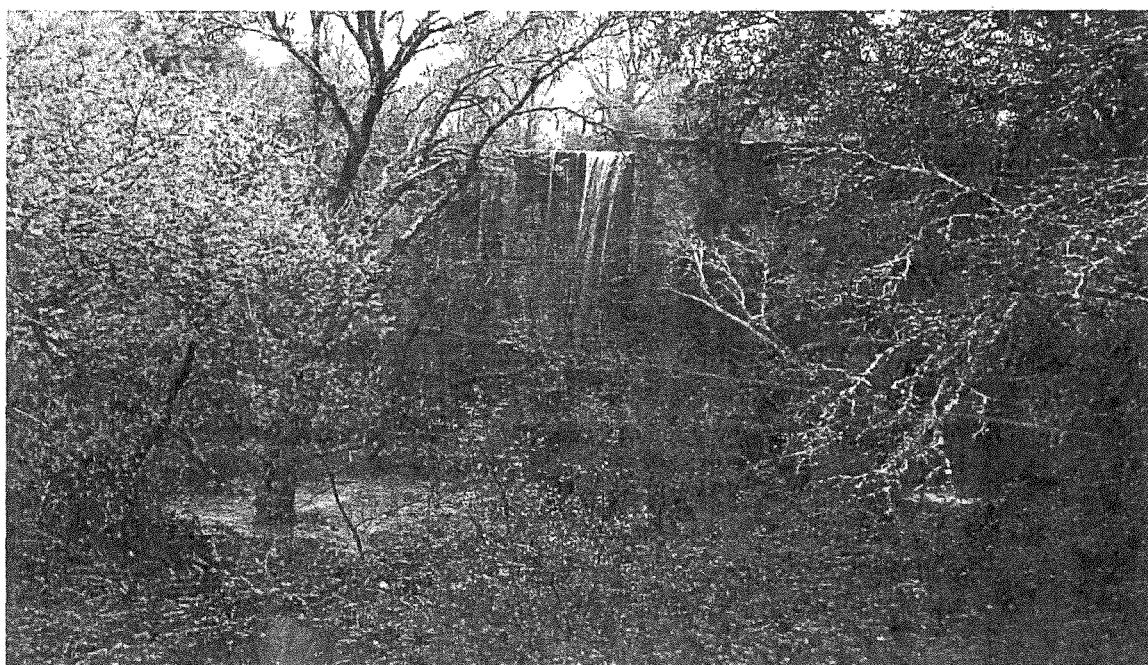
Rain water runoff flowing over the top of Argonaut Mine, April 4, 2006.

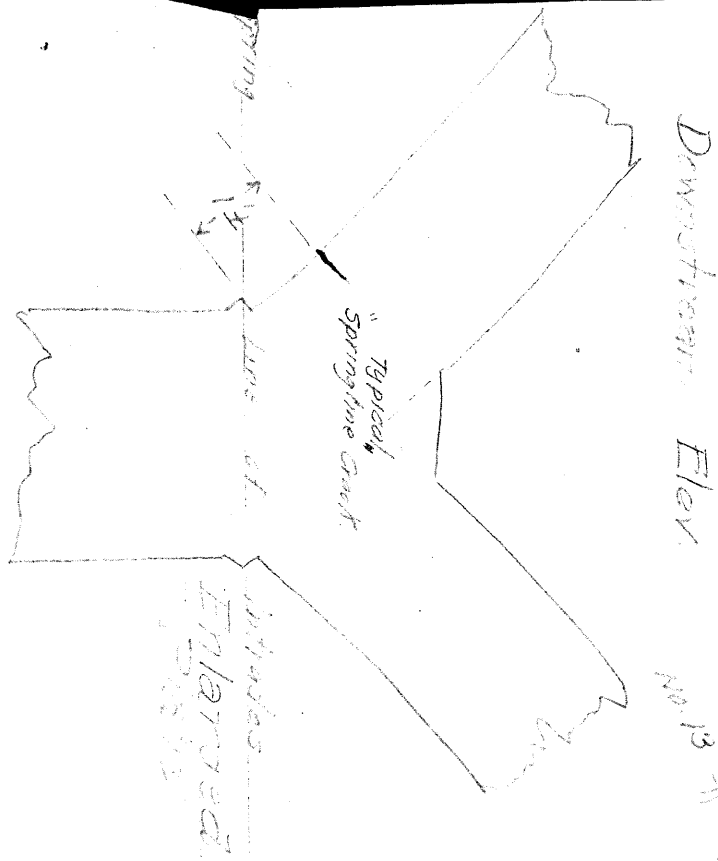
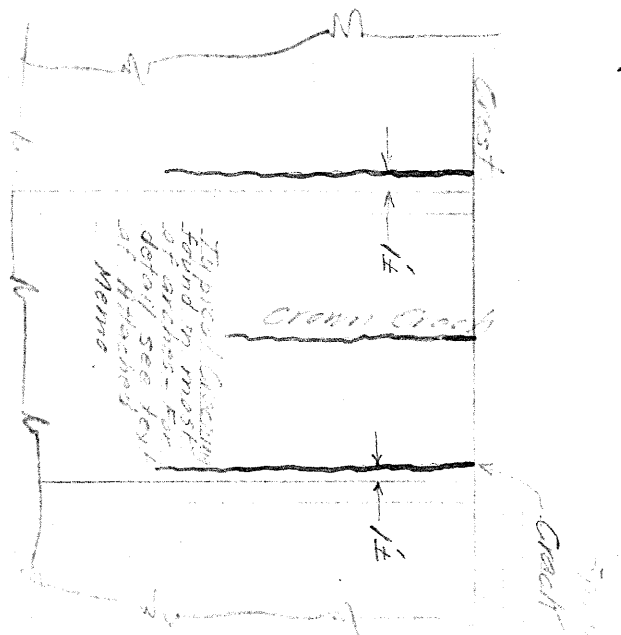
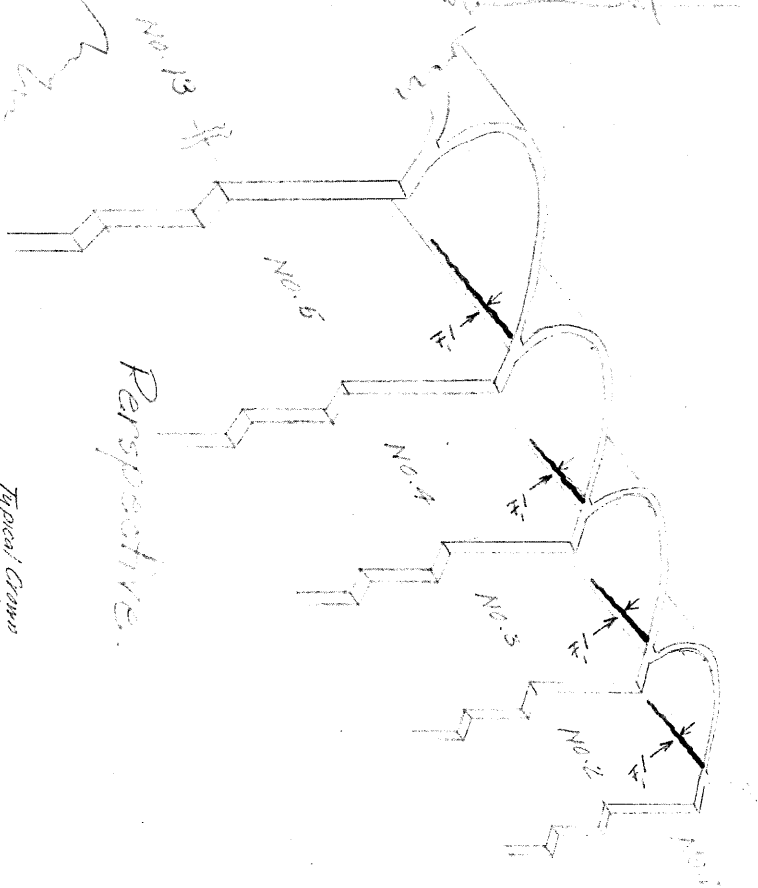
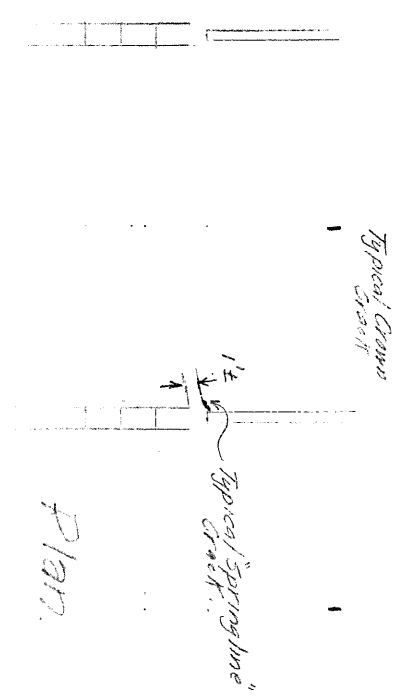
ARGONAUT DAM - No. 478

An examination of the downstream face of the dam disclosed crown cracks in most of the arches and cracks about 1 ft. parallel to the springing line of the extrados. It is significant that these latter occur for the most part near and parallel to the spring line on the right end of the arches (looking upstream). The general condition and location of both crown and "spring line" cracks is shown on the attached sketch in perspective, plan and elevation.

Both crown and "spring line" cracks begin at the crest of dam and extend downward for vertical distances which are more or less indeterminate since the cracks seem to be open a maximum at the crest and gradually play out as hair cracks or terminate at a construction joint or joint between successive concrete pours. They are usually traceable for a distance of 10 feet or more.

- Arch #2 - Crown crack and "spring line" cracks at both ends of arch.
- Arch #3 - " " " " " " " " " "
- Arch #4 - A skewing crown crack.
- Arch #5 - A partial crown crack.
- Arch #6 - A "spring line" crack on the right from crest about 10 feet down, and a crown crack.
- Arch #7 - "Spring line" crack on right.
- Arch #8 - Crown crack.
- Arch #9 - Slight "spring line" crack at right end. This arch leaks more than any of the others, the face being uniformly wet.
- Arch 10 - Crown crack top to bottom. A typical diagonal buttress crack is found in buttress between arches 9 and 10.
- Arch 11 - "spring line" crack on right end from crest to 15-20' down.
- Arch 12 - "Spring line" crack on right and crown crack.

If these cracks did not exist at time of former inspections (roughly a year ago) then something has happened to the structure since then. The recent earthquake disturbance centering in Nevada (approximately 2 months ago) may have influenced the present condition. There is also a possibility of local earth movement due to

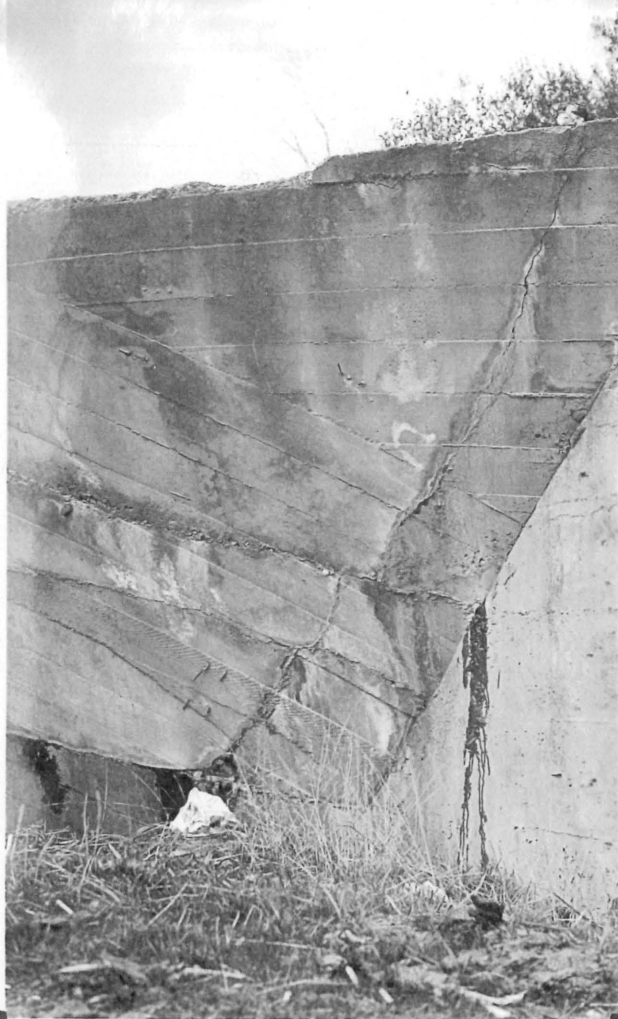
The downstream view of the cracks at the left end of arches 1-2 and 2-3 counting from the left end of the dam is shown in photos #1 and #2. Arch 2-3 is the only one which shows a similar crack at the right end. Photo #3, at the top of buttress #7, shows the typical appearance of the cracks at the top of the arch. These cracks can be traced for a distance of only 12 or 15 feet downward from the top of the dam.

As they do not conform with the usual stress action in an arch, the most logical explanation that occurs to the writer is that they are caused by temperature action. The axis of the dam runs nearly north and south and the left end of the arches near the t is exposed more directly and for a greater length of time to the direct rays of the sun than any other part of the dam. This causes a much greater range of temperature in this region which may be the reason for the cracking.

Photo #1.
Crack at left end of arch 1-2.

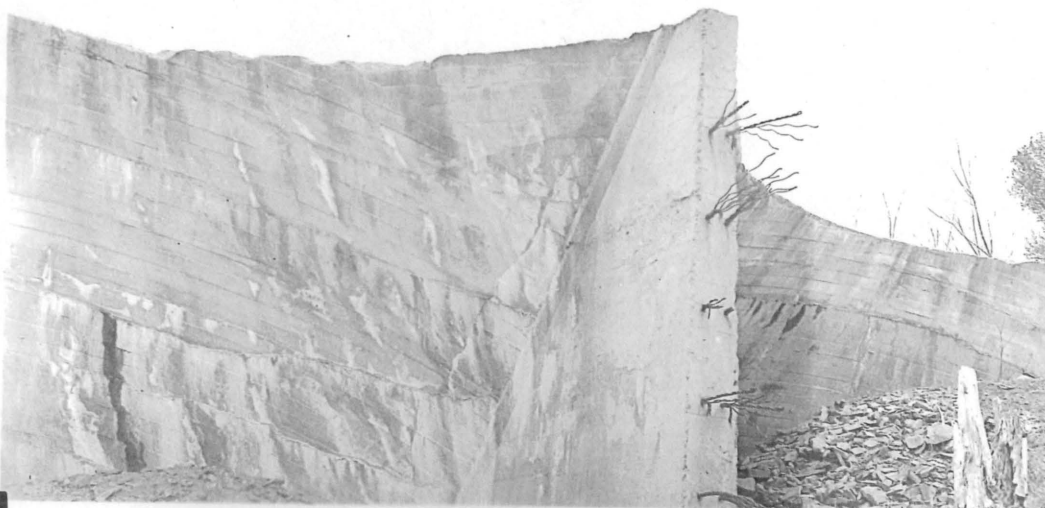
Crack at left end of arch 2-3. (Photo #2).

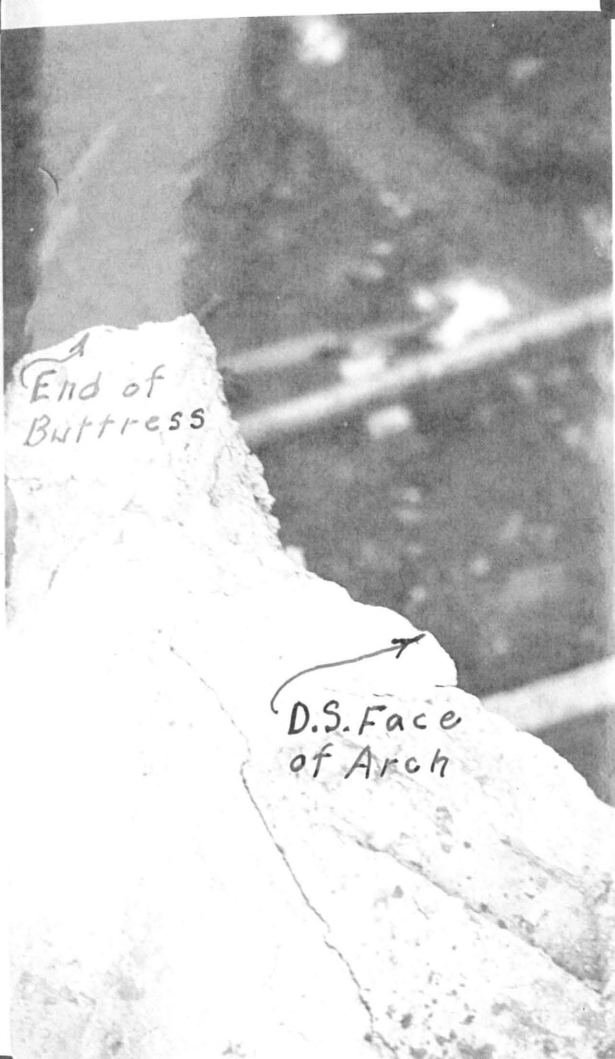
Photo #3. Crack at top of buttress
which is typical of the cracked
condition of the left end of the arches.

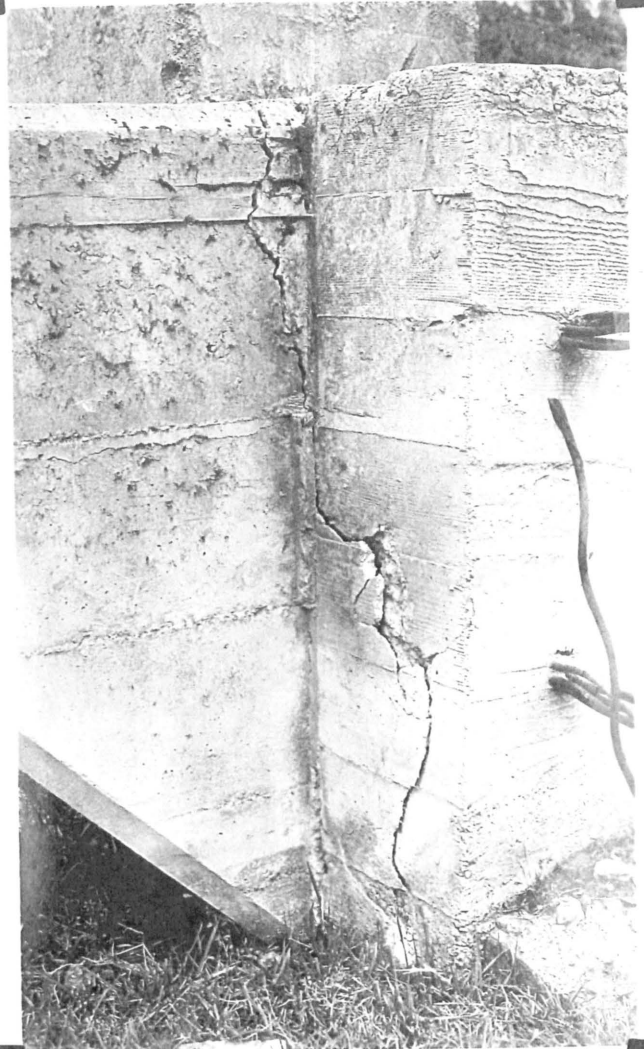
The strut extending through the six higher bays (5 to 10, incl.) shows good continuity without cracking except at the two ends, where it has pulled away from its anchorage at the buttresses, leaving a crack of 1/4" in width.

At the left end there is a slight displacement downward and upstream of the strut with respect to the buttress. Photo #4 shows the condition at the left end of the strut.

Photo #4. Crack at left end of
strut between buttresses.
