# **BNSF Galena Derailment Response:** *How it Played Out & Lessons Learned*

# Incident

At approximately 1:25pm on March 5, 2015, 21 tank cars of a 105-car BNSF Railways train derailed near MP171.6 of the Aurora Sub in Jo Daviess County near Galena.

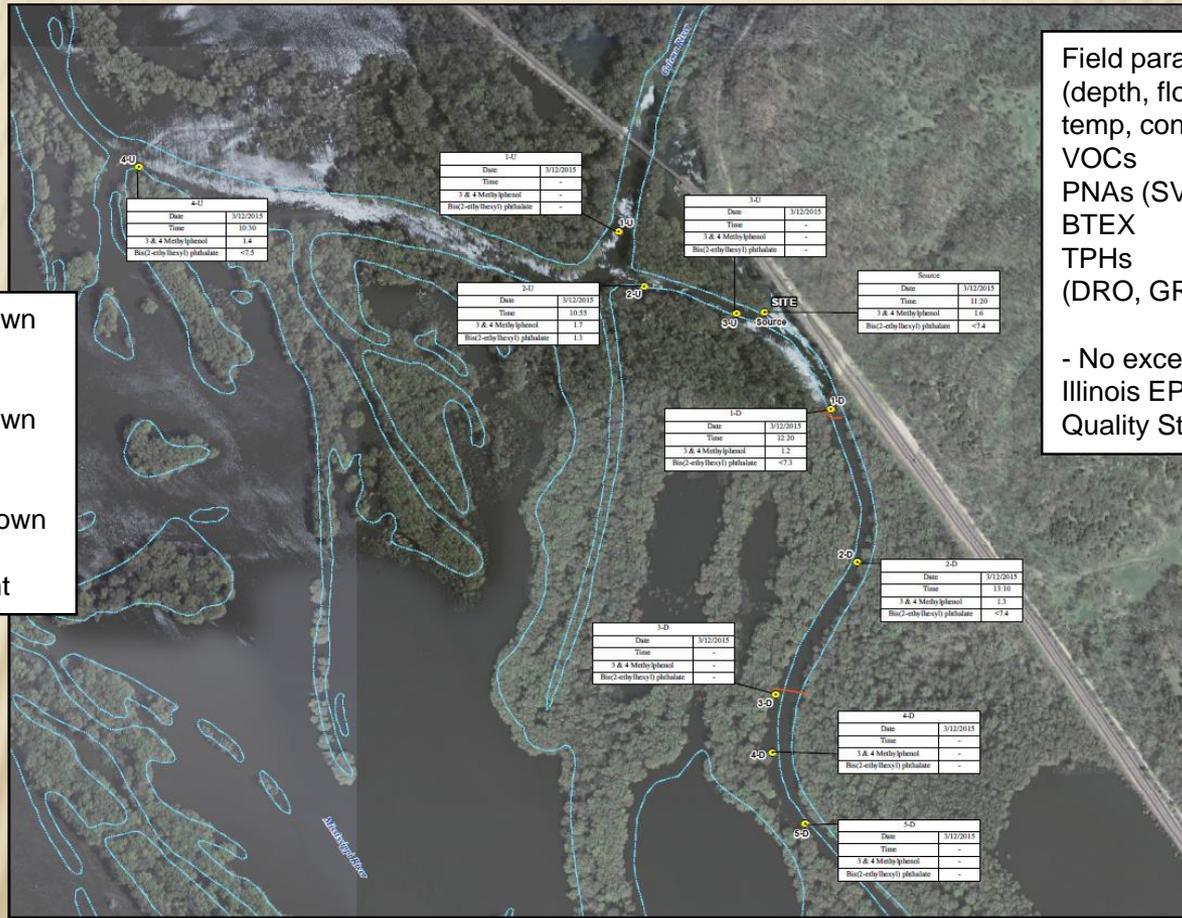
4 up, source, 5 down  
3/7 to 3/11

2 up, source, 2 down  
3/11 to 3/27

2 up, source, 2 down  
If > 1" rain  
3/27 to present

- No exceedances of  
Illinois EPA Surface Water  
Quality Standards

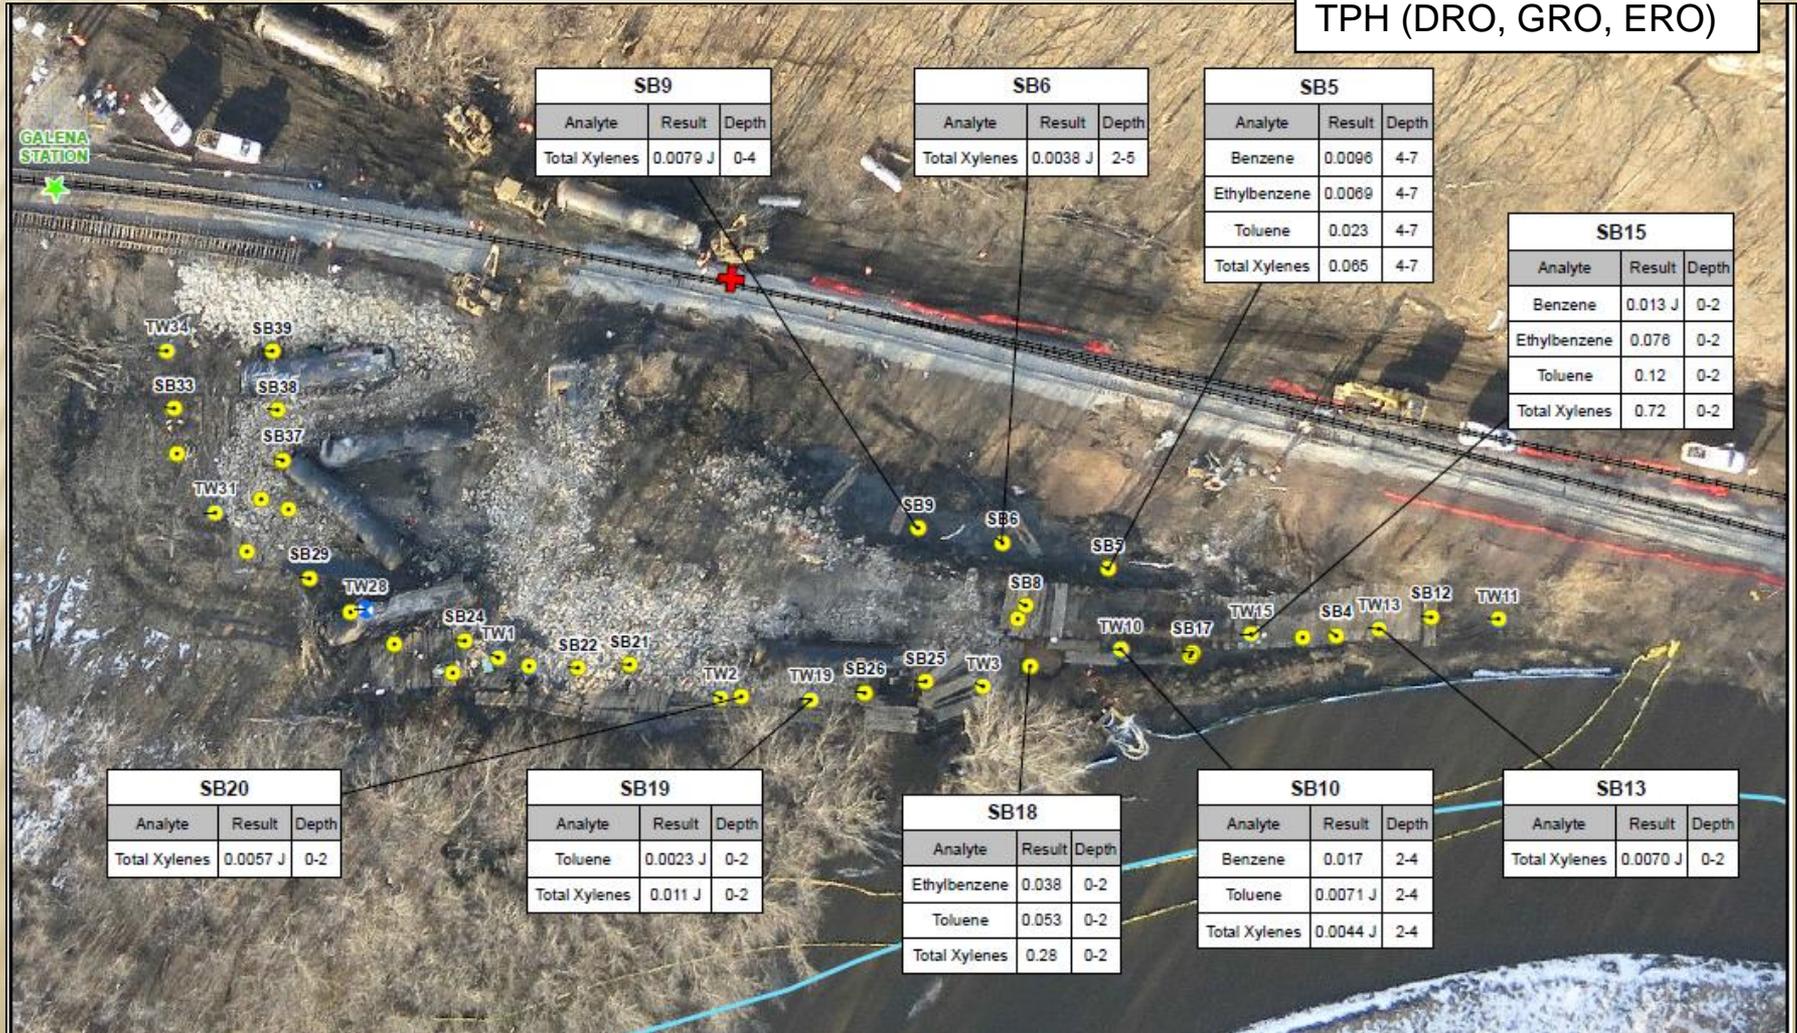
- 143 samples from 35 borings screened  
 39 samples to lab

SB9		
Analyte	Result	Depth
Total Xylenes	0.0079 J	0-4

SB6		
Analyte	Result	Depth
Total Xylenes	0.0038 J	2-5

SB5		
Analyte	Result	Depth
Benzene	0.0096	4-7
Ethylbenzene	0.0069	4-7
Toluene	0.023	4-7
Total Xylenes	0.065	4-7

SB15		
Analyte	Result	Depth
Benzene	0.013 J	0-2
Ethylbenzene	0.076	0-2
Toluene	0.12	0-2
Total Xylenes	0.72	0-2

SB20		
Analyte	Result	Depth
Total Xylenes	0.0057 J	0-2

SB19		
Analyte	Result	Depth
Toluene	0.0023 J	0-2
Total Xylenes	0.011 J	0-2

SB18		
Analyte	Result	Depth
Ethylbenzene	0.038	0-2
Toluene	0.053	0-2
Total Xylenes	0.28	0-2

SB10		
Analyte	Result	Depth
Benzene	0.017	2-4
Toluene	0.0071 J	2-4
Total Xylenes	0.0044 J	2-4

SB13		
Analyte	Result	Depth
Total Xylenes	0.0070 J	0-2
