April 19, 2016

**Re: Old Saratoga Hospital Structural Evaluation
Providence, New York
Ryan Biggs | Clark Davis Project 11373
ER Purchase Order # 11490**

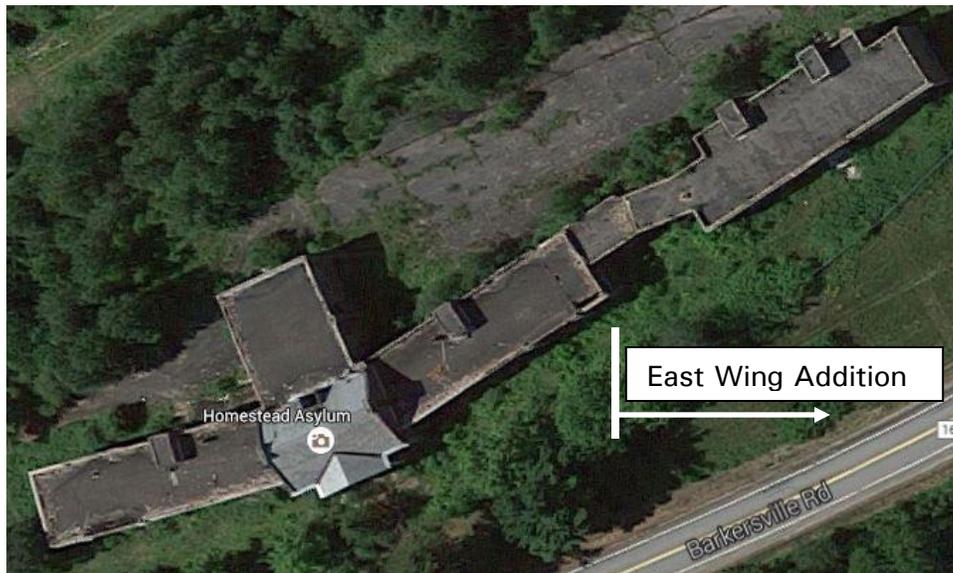
Photograph 1 – Old Saratoga Hospital Aerial View

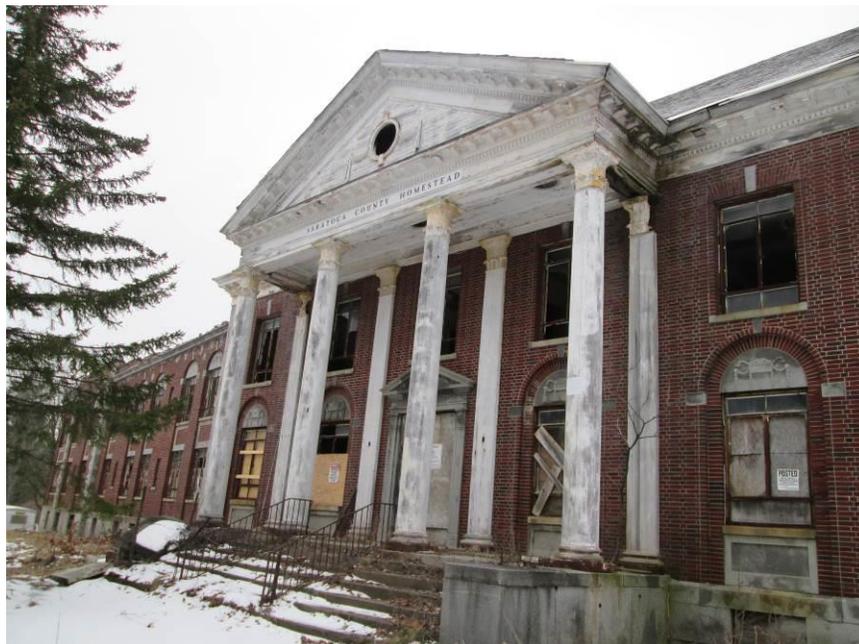
The building has been the object of extensive vandalism. The exterior windows are broken, graffiti is present in many of the rooms, and copper piping and roof-top parapet flashing have been destructively removed. These vandalism activities have opened up the building interior to weather and contributed greatly to the deterioration of the interior finishes and structural system. (Photograph 2)

Photograph 2 – Main (Central) Hospital Entrance

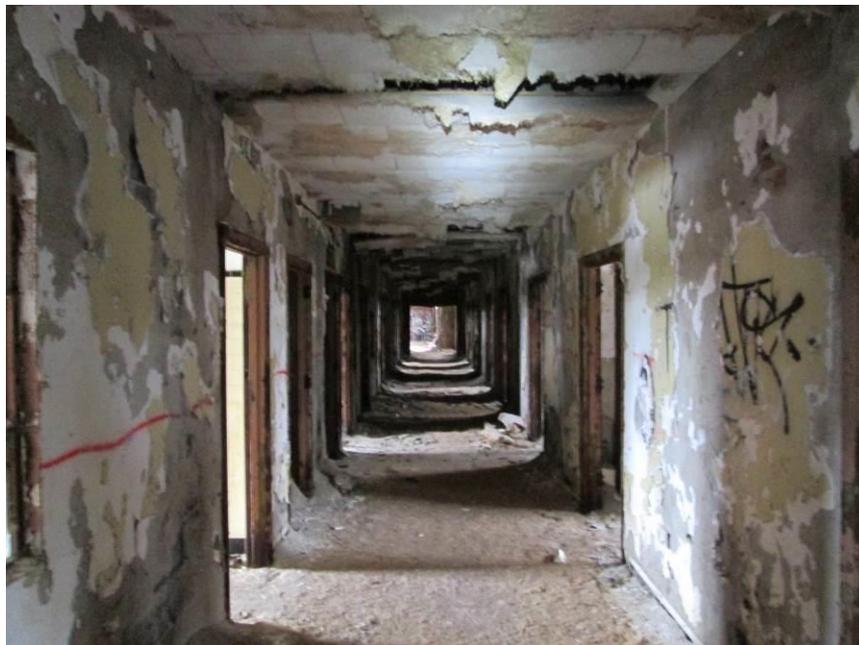
1. Water penetration into the structure has caused irreparable damage to the plaster ceilings in all areas of the structure observed. Where the ceiling has not completely collapsed, danger from deteriorated and compromised plaster and masonry ceiling finishes constitute a falling debris hazard. (Photographs 3, 4, and 5)

Photograph 3 – Deteriorated Ceiling Construction along Main Hospital Corridor

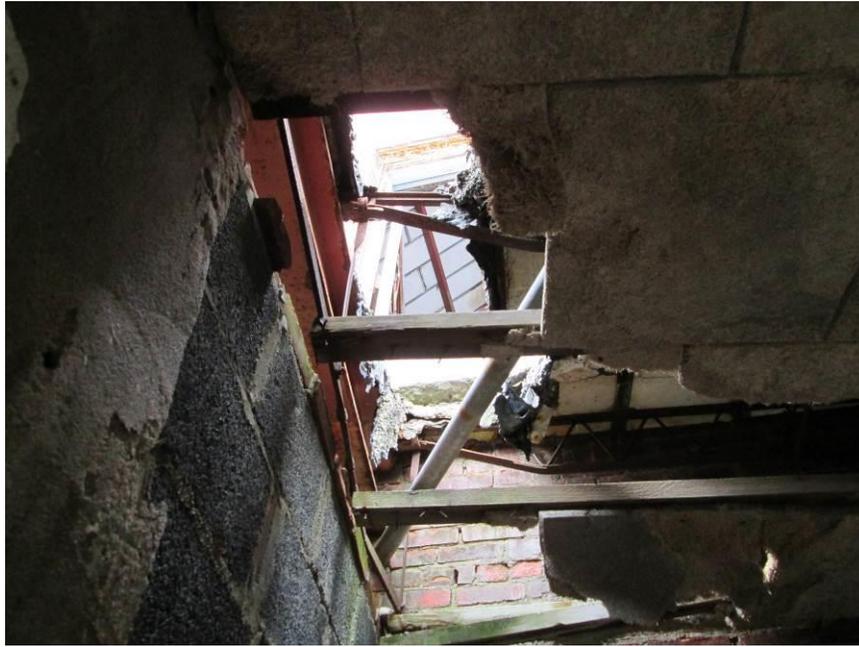
Photograph 4 – Hanging Ceiling Tiles Surrounding Collapsed Roof Decking
(Main Hospital Adjacent to Center Core)

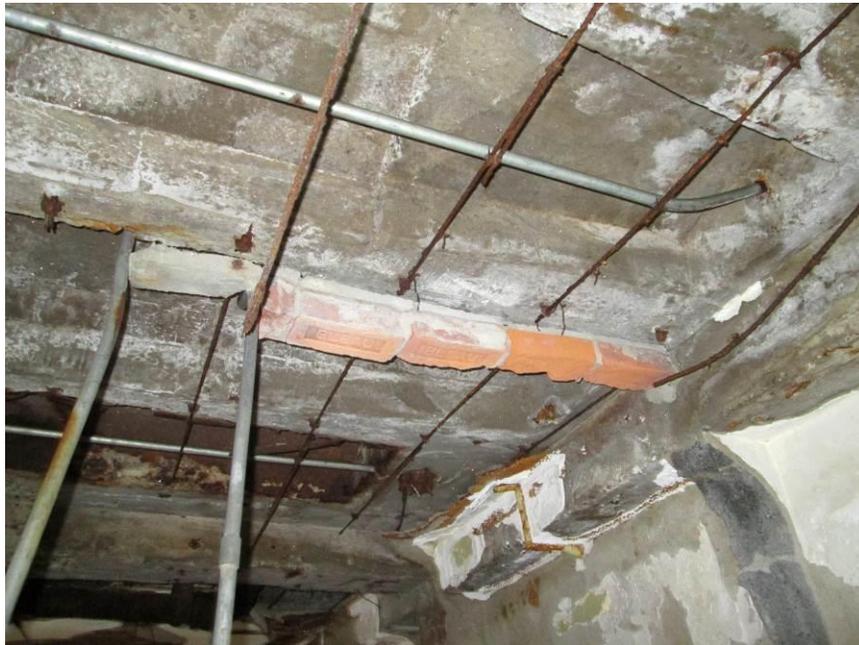
Photograph 5 – Loose Ceiling Material in West Wing, Typical Most Locations

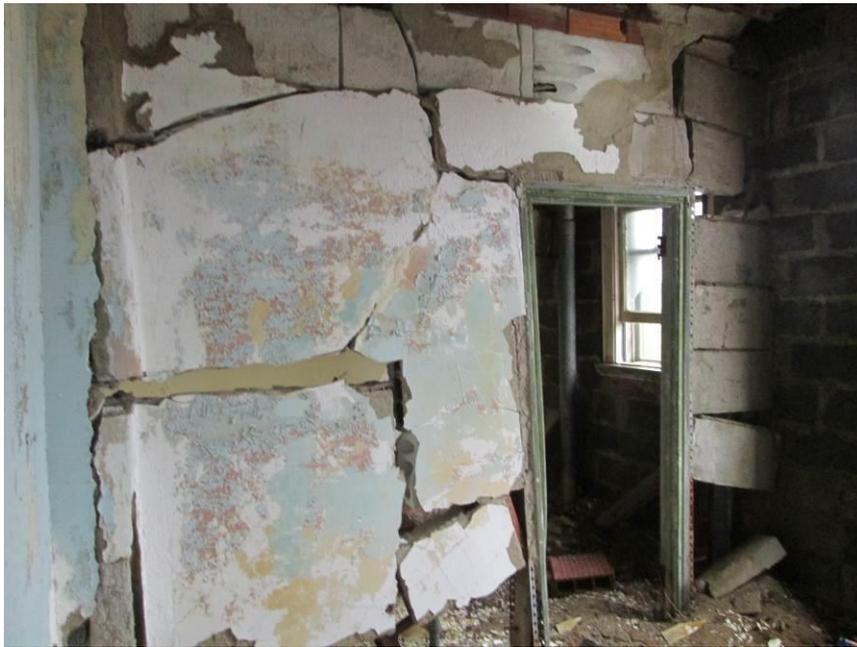
2. Partial demolition of interior masonry partitions, primarily in the eastern children's hospital wing, has left many areas of unstable masonry partition construction. These partially standing partitions present a collapse and falling debris hazard. (Photograph 6)

Photograph 6 – Partially Demolished Interior Masonry Partition

Significant demolition debris is present in the Eastern Children's Wing area as shown in Photograph 6. If asbestos abatement activities are required within the vicinity of present debris, (approximately 10 foot radius outside of debris area), the debris should be removed prior to conducting abatement work to avoid overload of the floor framing.

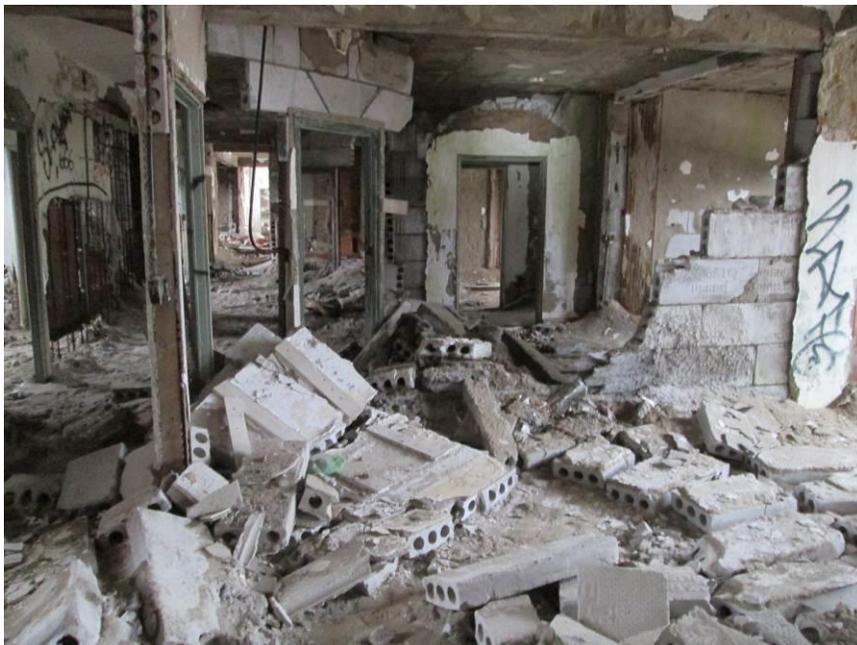
3. Previous redevelopment/renovation activities, which were terminated, have left piles of masonry partition debris in many areas. If abatement activities are required where debris piles are present, the debris should be removed prior to occupancy to reduce the possibility of local overloading of the floor structure from the additional occupancy loading. (Photographs 7 and 8)

Photograph 7 – Demolition Debris on 1st Floor in Children's Wing

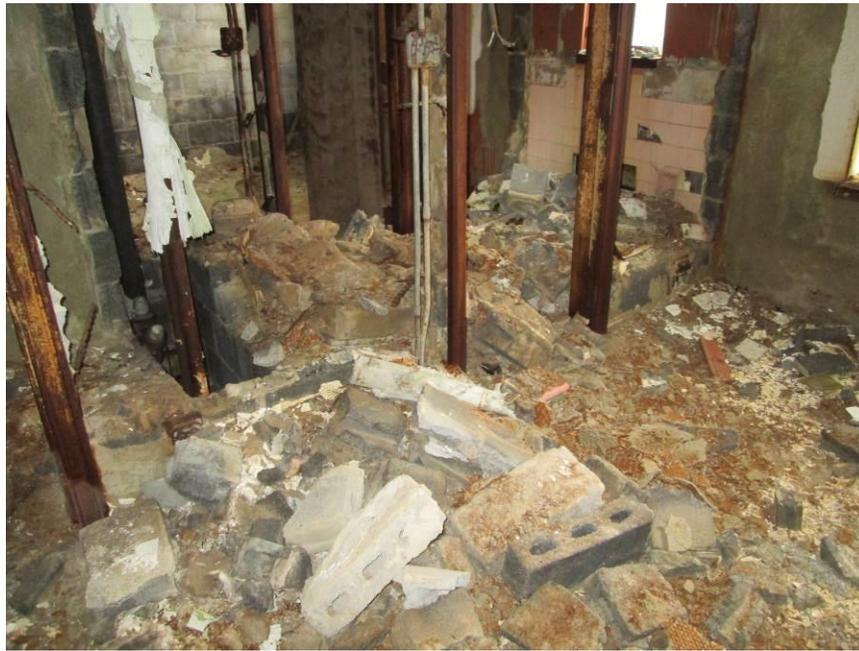
Photograph 8 – Demolition Debris on 1st Floor in Main Hospital Patient Room

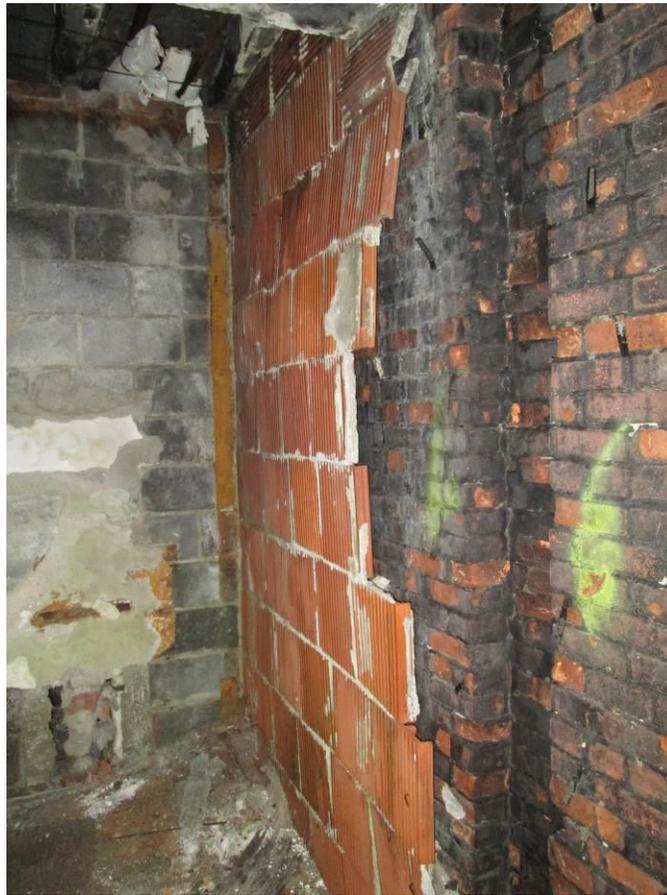
4. Partial collapse of clay masonry wall finishes has occurred in many areas. The remaining clay masonry elements are unstable and constitute a falling debris hazard if disturbed. (Photograph 9.)

Photograph 9 – Unstable Interior Clay Masonry Finish in Main Hospital Patient Rooms

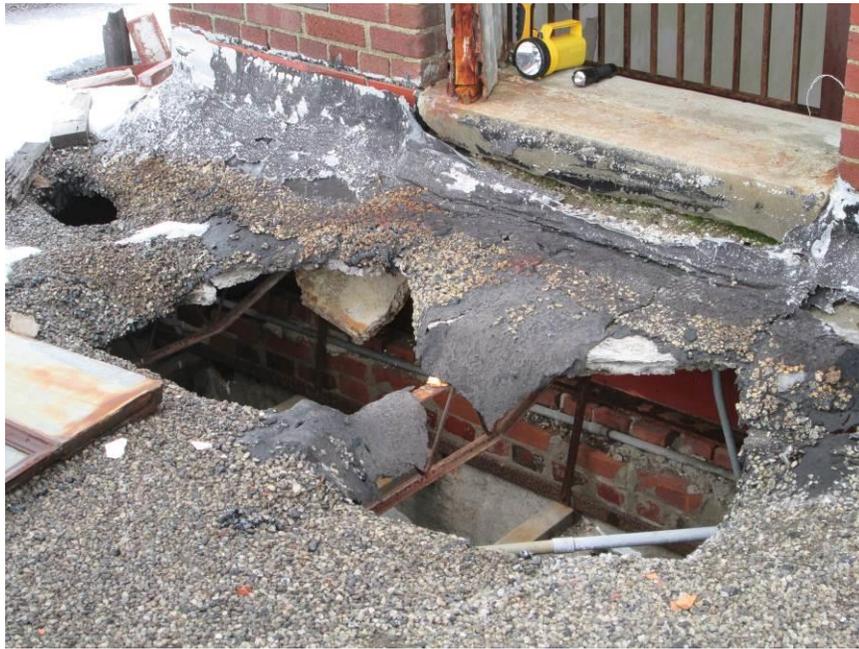
Photographs 10 and 11 indicate areas of local roof decking collapse. No occupancy should be allowed on the roof of the West Wing Main Hospital. See discussion of Figure 6 for further information. Where occupancy is required on the second floor in the area of an existing roof hole, precautions against falling debris (roof decking, ceiling framing, etc.) must be taken. Loose material should be removed and overhead protection in the form of shielding or shoring should be installed.

Photograph 10 – Hole in Roof Framing by West Wing Stair

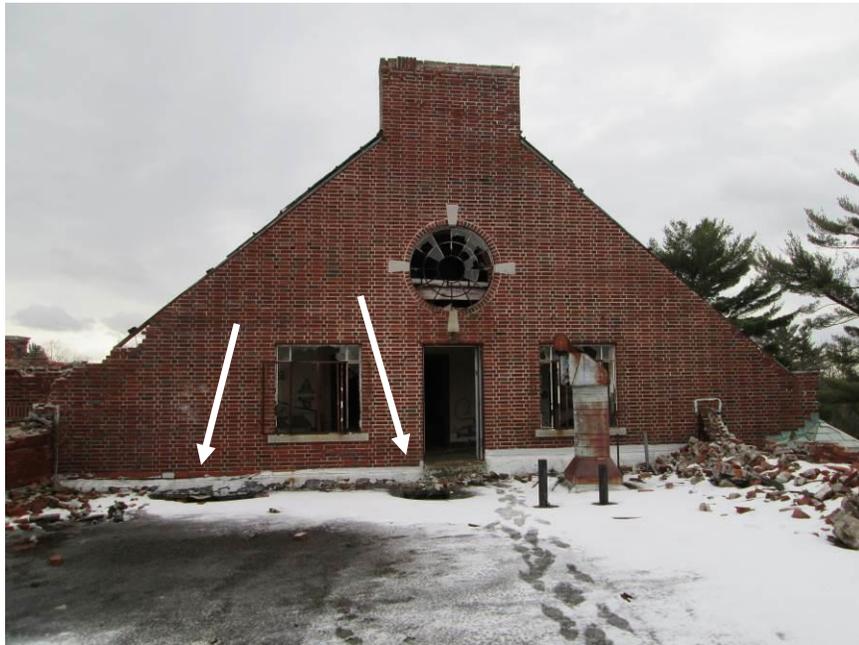
Photograph 11 – Holes in Roof of West Wing Framing Adjacent to Central Roof Top Structure

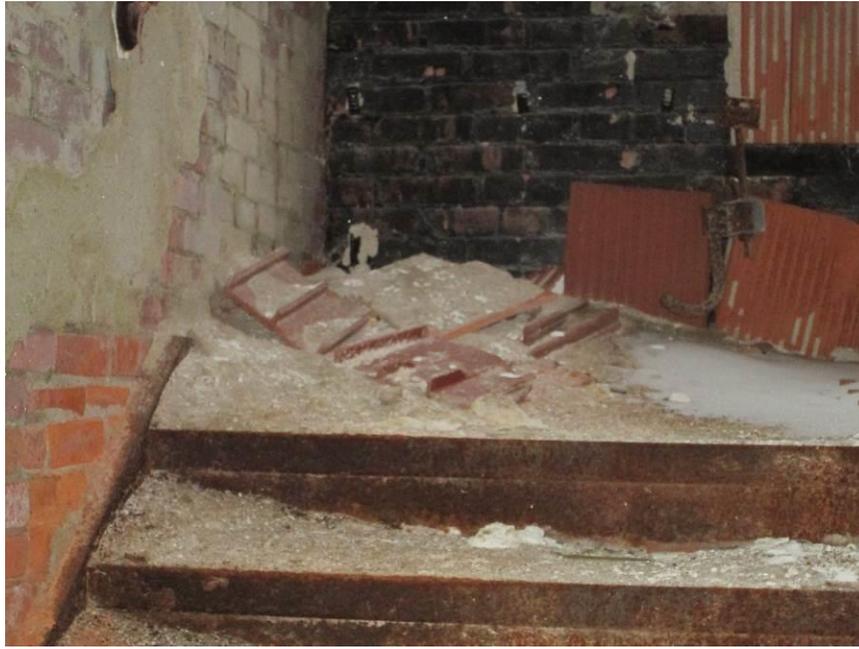
Photograph 12 shows building debris on the risers and landings of the steel stair. All debris should be removed from the stair framing prior to use to avoid overload and hazards due to tripping or falling material.

Photograph 12 – Debris on West Wing Stair

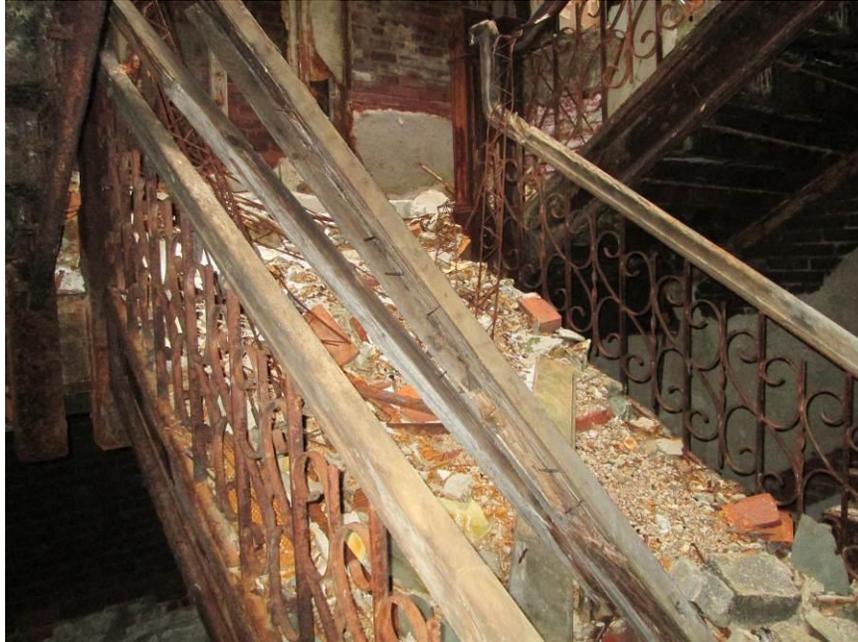
Steel stairs in the central building area are not in a safe or usable condition. Photographs 13 and 14 show heavy debris collapse at the main grand staircase, which prohibited visual observation of the condition of the steel and does not allow for safe pedestrian access. Clearing of building debris to allow structural evaluation of the integrity of this stair by a registered professional engineer is required prior to use.

Photograph 13 – Debris on First Floor of Central Grand Staircase

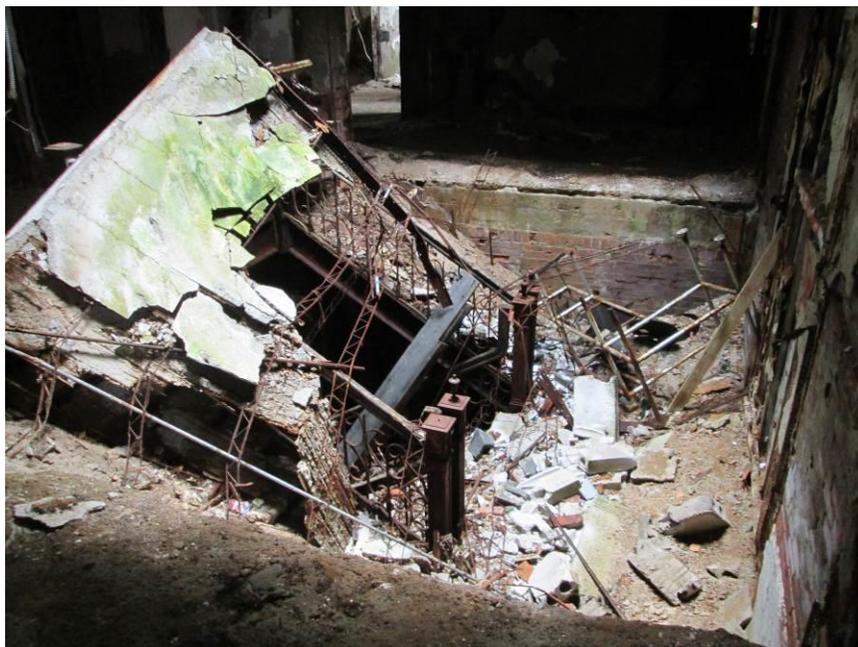
Photograph 14 – Debris on Second Floor of Central Grand Staircase

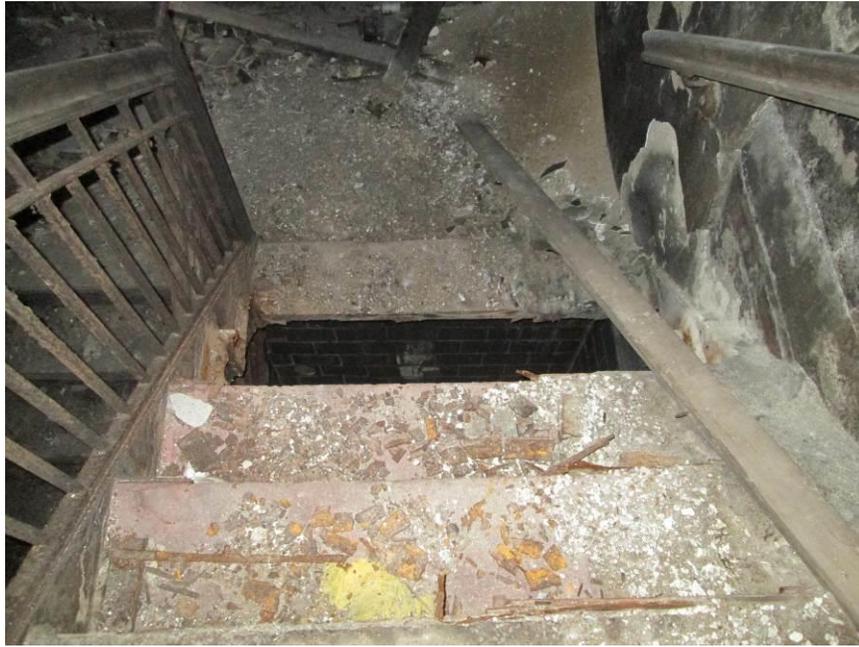
Photograph 15 shows collapse of the stair framing in the northmost back-stage area caused by extensive rust and deterioration of the steel treads and connection clips. Replacement of the deteriorated and failed steel framing and evaluation of the other existing treads of this stair is the minimum required remedial measure to allow use. Design of remedial framing for this stair should be provided by a registered professional engineer.

Photograph 15 – Failed Stair Treads and Risers at Back-Stage Stair

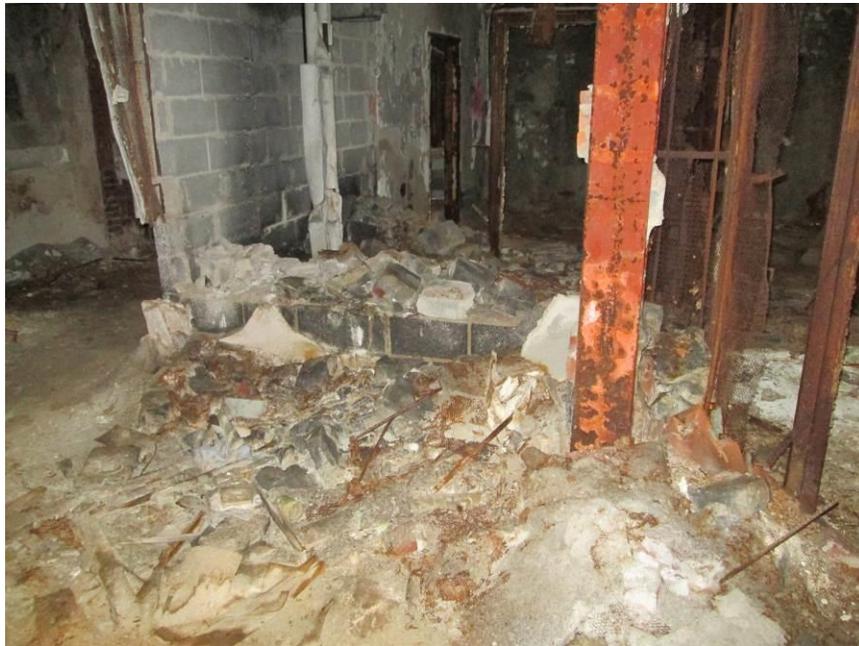
Significant demolition debris is present in the central core area as shown in Photograph 16. If asbestos abatement activities are required within the vicinity of present debris, (approximately 10 foot radius outside of debris area), the debris should be removed prior to conducting abatement work to avoid overload of the floor framing.

Photograph 16 – Demolition Debris in Central Core Floor Area

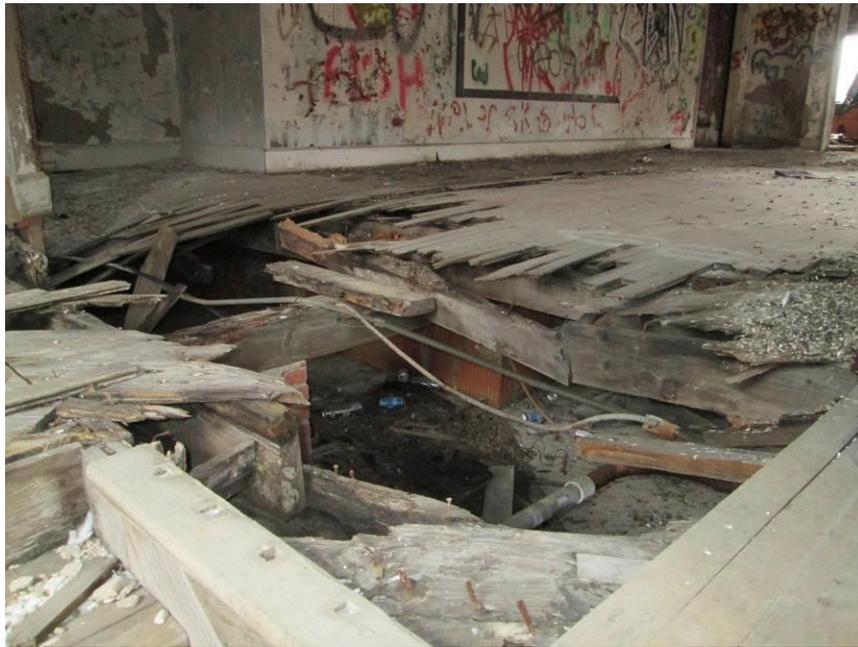
The wood stage framing on the second floor of the Central Core is not safe to support loading. (Photograph 17) Temporary shoring and support of this wood platform framing should be installed to the concrete floor below if access is required.

Photograph 17 – Failed Wood Stage Platform Framing

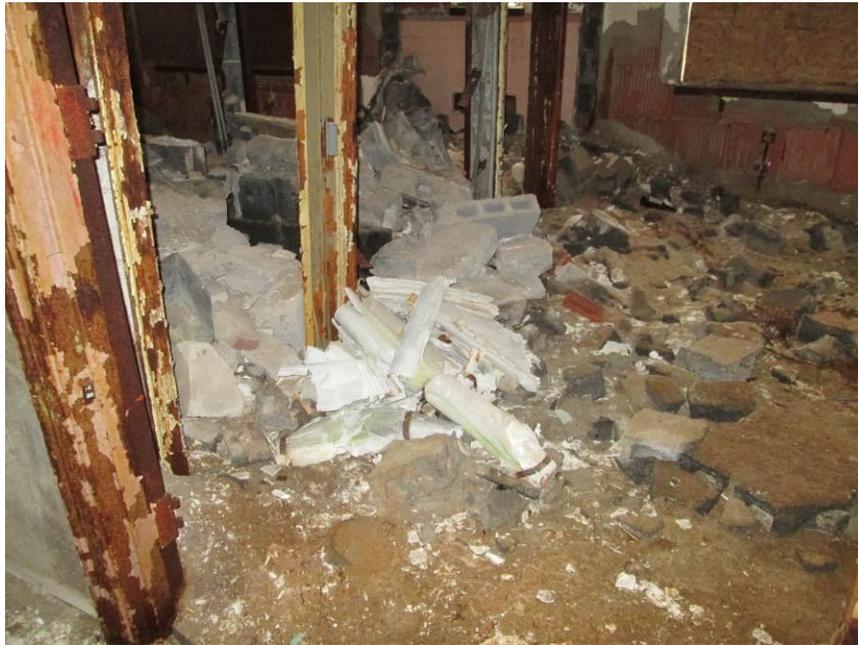
Significant demolition debris is present in the East Wing area as shown in Photographs 18 and 19. If asbestos abatement activities are required within the vicinity of present debris, (approximately 10 foot radius outside of debris area), the debris should be removed prior to conducting abatement work to avoid overload of the floor framing.

Photograph 18 – Demolition Debris in East Wing – First Floor

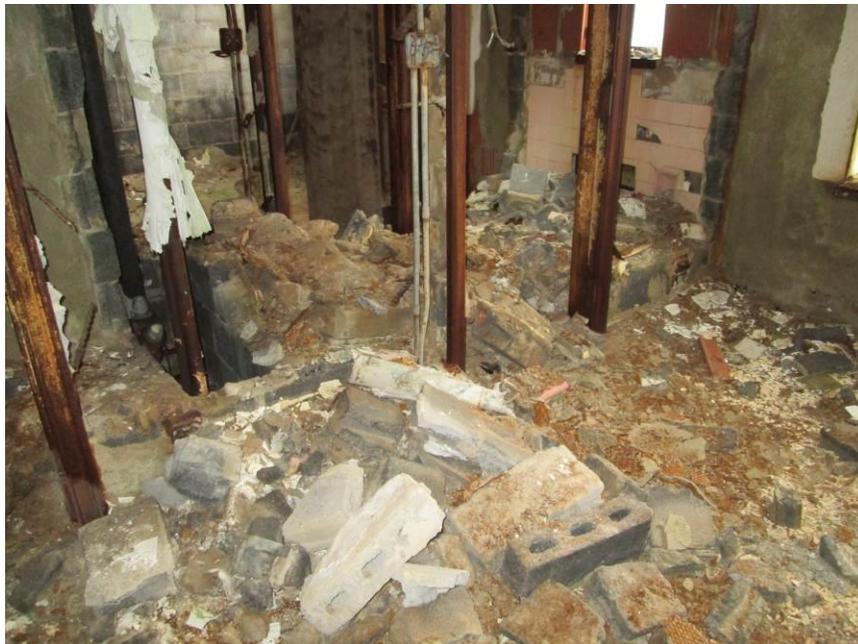
Photograph 19 – Demolition Debris in East Wing – First Floor

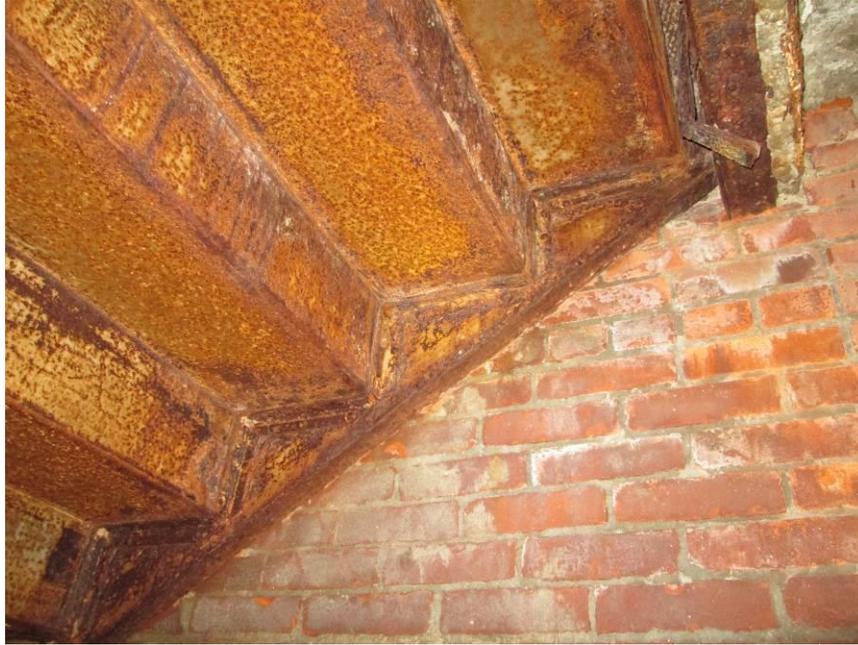
The staircase located at mid-length of the East Wing Main Hospital is not safe for use. Photograph 20 shows the deterioration of the steel clips supporting the treads and risers, which has compromised the load-carrying capacity of the framing. Repair or replacement of deteriorated steel components is required prior to use and occupancy of this stair. Remedial structural framing should be provided by a registered professional engineer.

Photograph 20 – Deteriorated Stair Framing – East Wing – First Floor

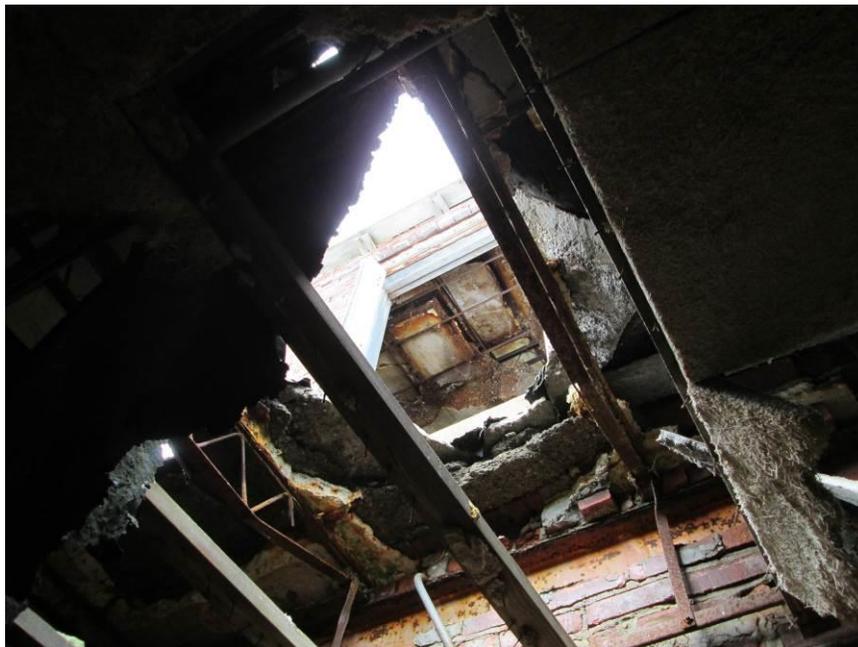
Photograph 21 – Hole in Roof Framing by East Wing Stair

Photographs 21 and 22 indicate areas of local roof decking collapse. No occupancy should be allowed on the roof in the East Wing Main Hospital. Where occupancy is required on the second floor in the area of an existing roof hole, precautions against falling debris (roof decking, ceiling framing, etc.) must be taken. Loose material should be removed and overhead protection in the form of shielding or shoring should be installed.

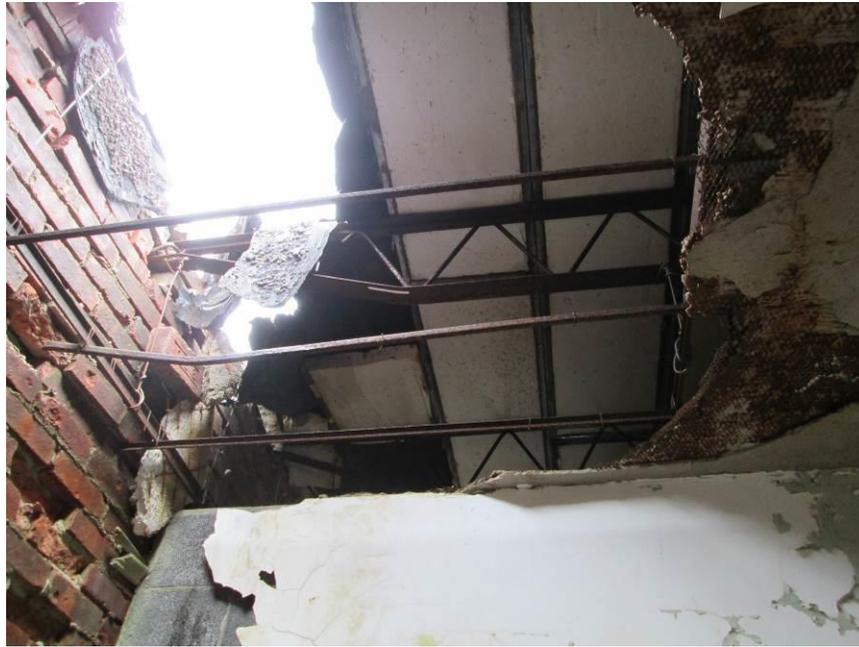
Photograph 22 – Hole in Roof – East Wing Main Hospital

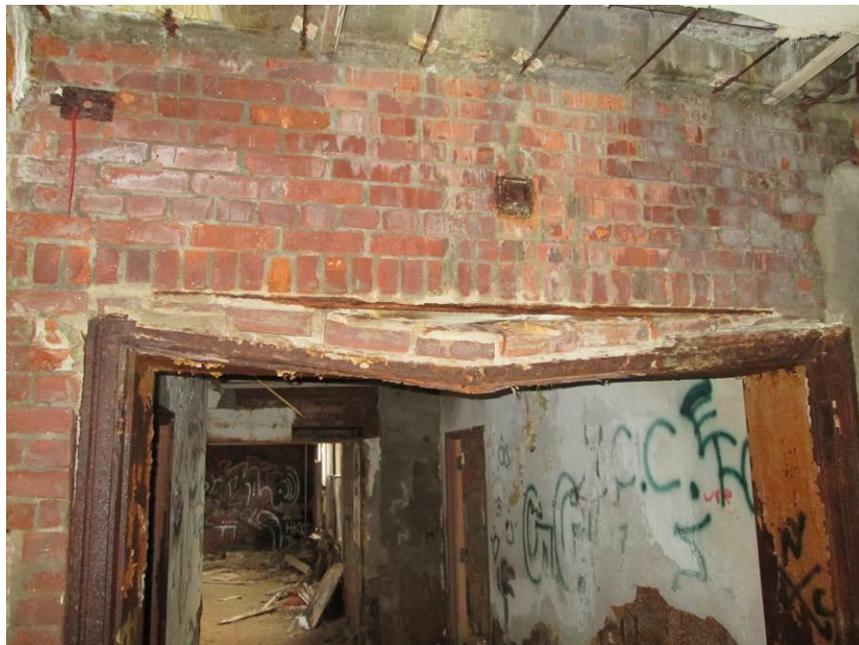
Photograph 23 – Brick Supported on Failing Steel Door Frame – East Wing – First Floor

Photograph 23 indicates brick supported by a failing door frame. The falling debris hazard is limited to the row of brick immediately above the steel door frame as the remaining brick above is supported by a steel angle lintel, which appears to still be in serviceable condition.

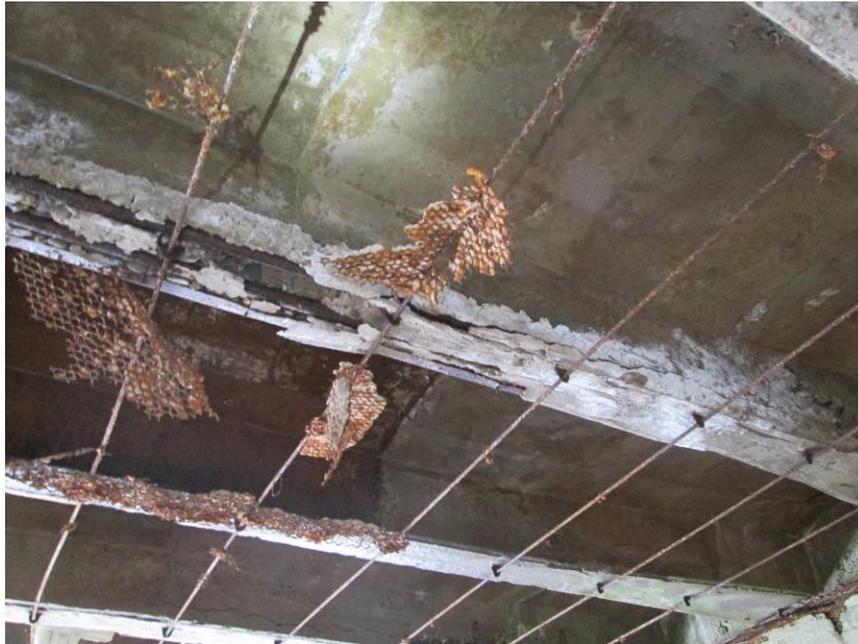
Photograph 24 – Unsafe Concrete Joist Framing – Second Floor

Local collapse of the roof structure and subsequent deterioration of the second-floor concrete joist framing have created an unsafe condition in the room area indicated by Photographs 24, 25, and 26. Occupancy on either the first or second floor in these areas is not safe. Shoring of the floor framing to grade at the basement level should be conducted if abatement activities are required in this area. Design of safety shoring should be conducted by a registered professional engineer.

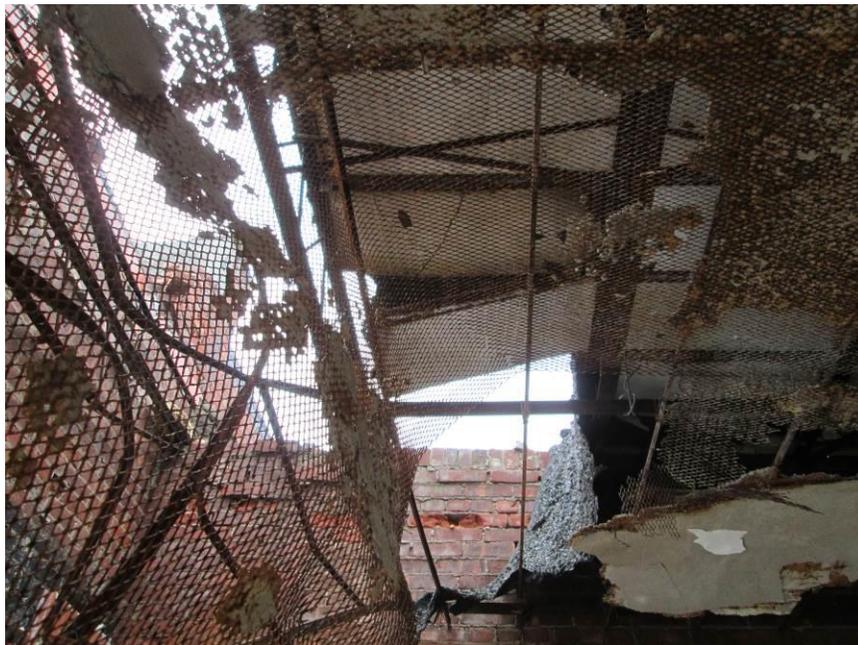
Photograph 25 – Hole in Roof Framing

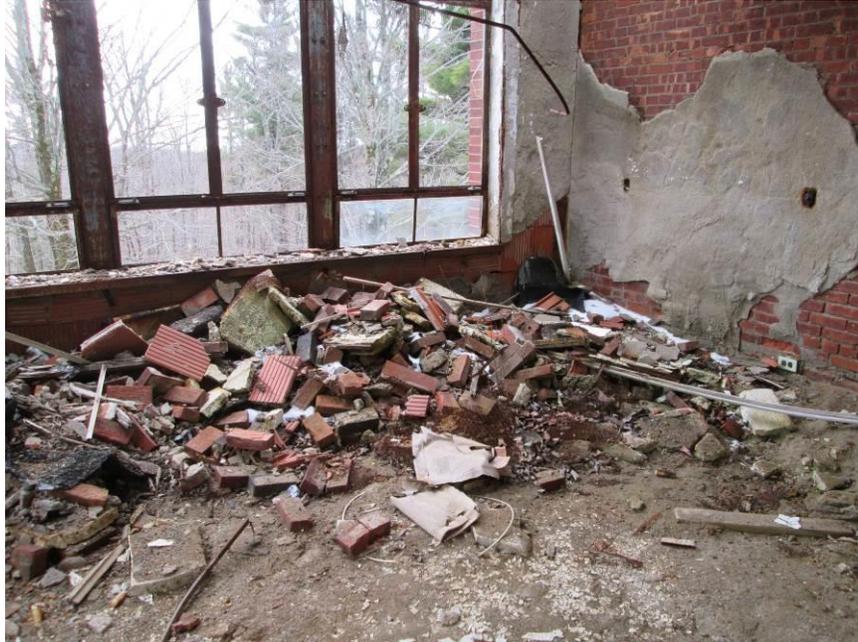
Photograph 26 – Debris Below Roof Framing Collapse and Above Deteriorated Joist Framing

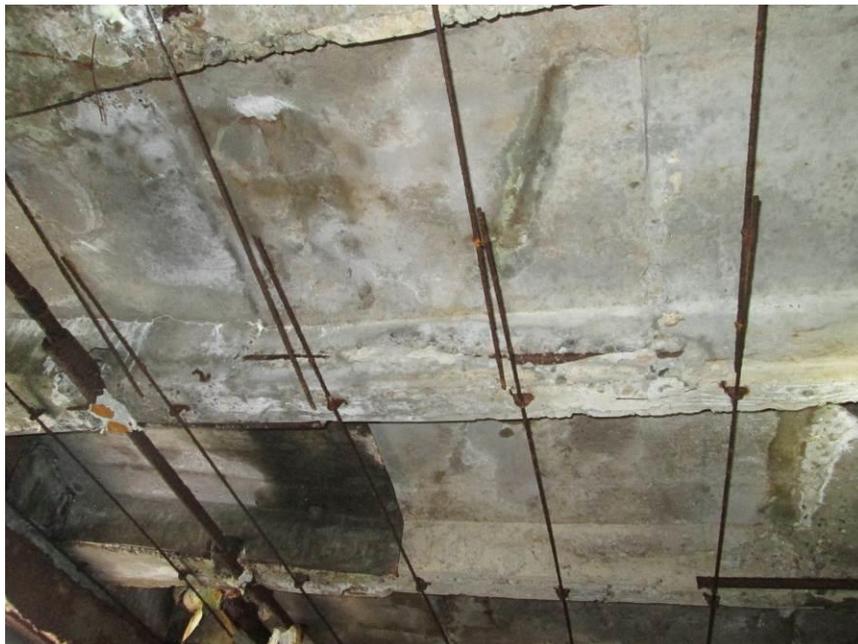
Photograph 27 – Damaged Concrete Joist Framing – East Wing – Second Floor

Second-floor framing indicated in the area of Photograph 27 has been compromised due to rusting and corrosion of the steel reinforcing which has caused cracking and deterioration of the concrete joists. The framing is not safe for occupancy during asbestos abatement operations. If occupancy of this area on the second floor is required, reshoring of the floor to the first-floor framing and to grade is required. Design of safety shoring should be conducted by a registered professional engineer.

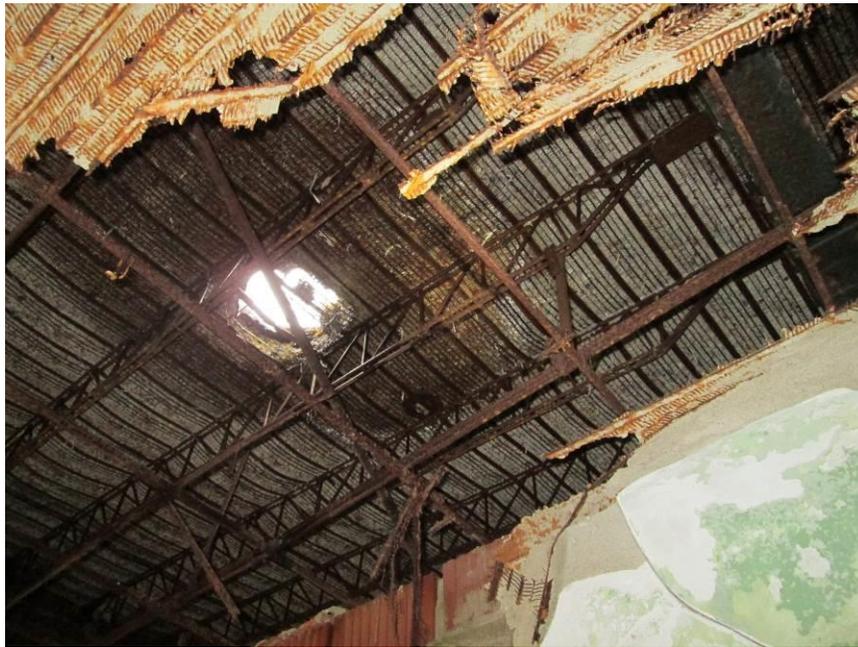
Photograph 28 indicates an area of local roof decking deterioration. No occupancy should be allowed on the roof of the Eastern Children's Wing.

Photograph 28 – Hole in Roof – Children's Wing

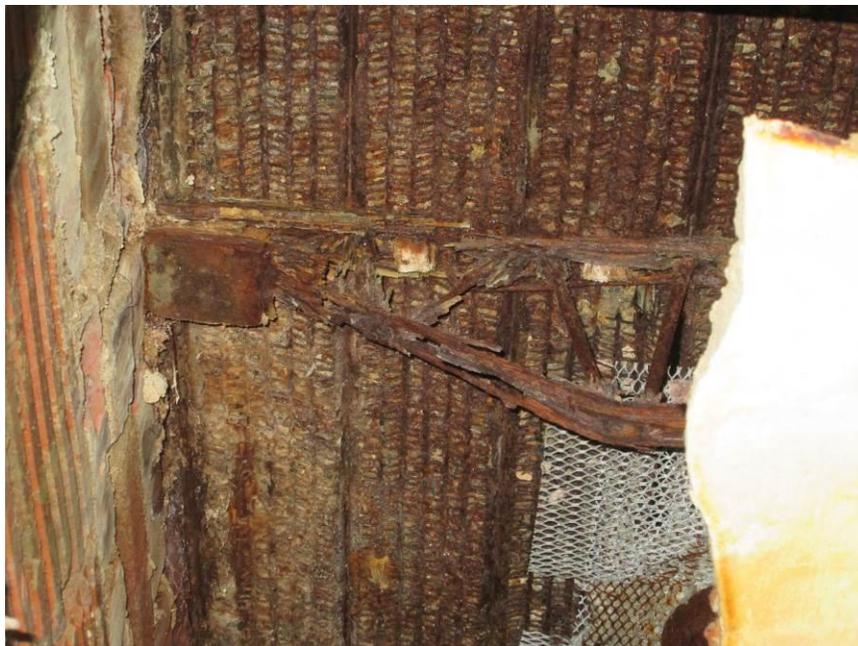
Photograph 29 – Failed Roof Joists in Eastern Children's Wing

Water infiltration through the roof deck has caused rusting and deterioration of the roof joists at their bearing against the exterior load bearing wall. Photograph 29 shows a typical condition of approximately 5 adjacent joists at this location. Occupancy of the roof in this area is not safe and occupancy of the second floor beneath this area should be prohibited. If occupancy in this area is required for asbestos abatement activities, shoring of the roof joists to the second floor slab should be conducted. Structural shoring should be designed by a registered professional engineer.

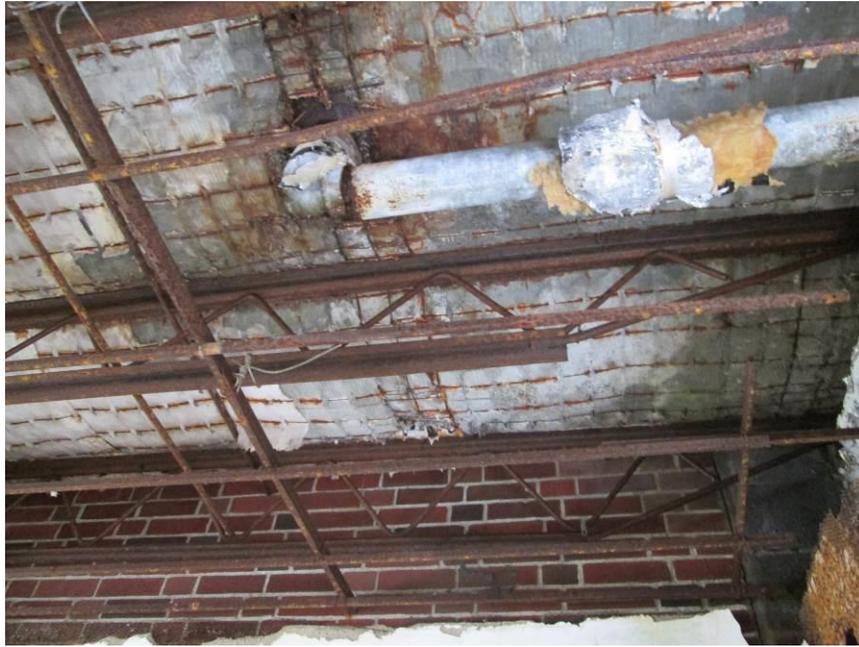
Photograph 30 – Rusting Roof Framing at Roof Drain and Ponding Location

Ponding of water above the framing indicated in Photograph 30 may cause a temporary overload condition. Leakage through the roof deck has caused rusting of the roof framing and roof deck reinforcement. Do not occupy the interior space below this area if ponded water is present.

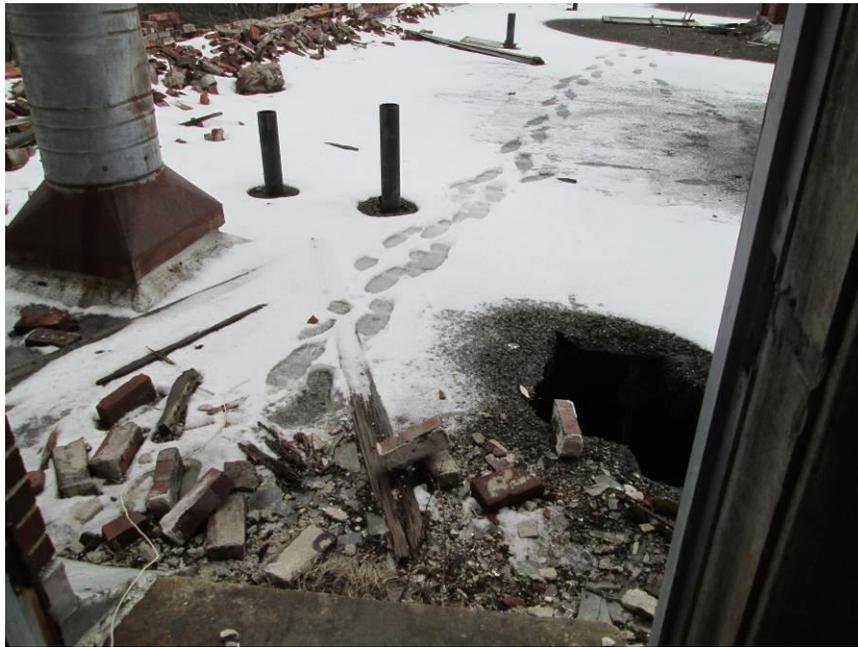
Photograph 31 shows an access path, indicated by footprints in the snow above a main roof beam, from the West Wing stair to the Central Roof Top Structure. Two local roof deck collapses have occurred in this area. However, the steel joist framing has not been significantly compromised and is still capable of supporting load. If asbestos remediation activities require access to the roof top structure, temporary structural decking must be provided over collapsed roof deck areas to provide safe access. This temporary decking may bear directly on the steel joist and beam framing below, which does not exhibit a significant degree of deterioration and is safe for pedestrian traffic. Design of a temporary structural decking system should be provided by a registered professional engineer.

Photograph 31 – Path from West Wing Stair to Doorway of Central Roof Top Structure

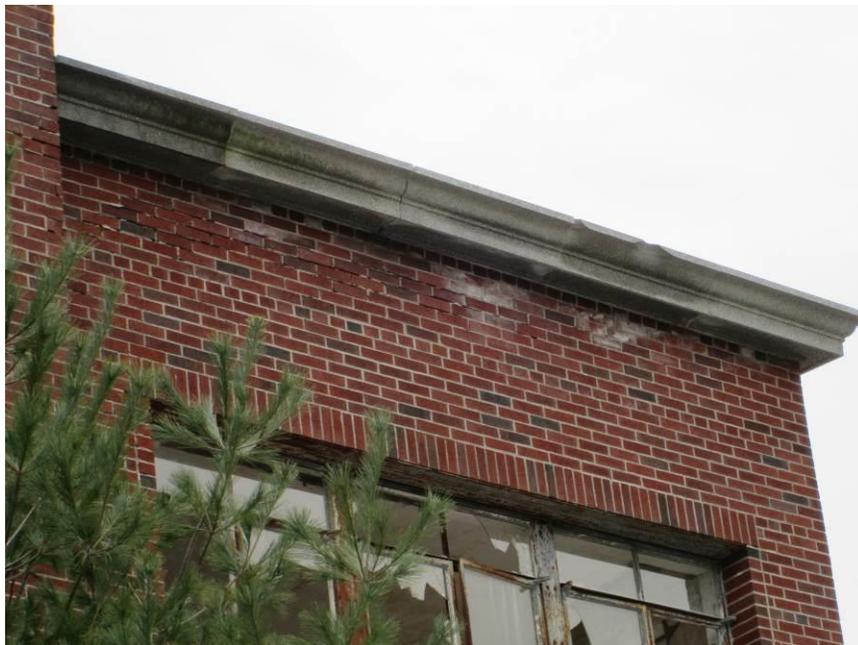
Photograph 32 – Displaced Cornice at West Wing Main Hospital

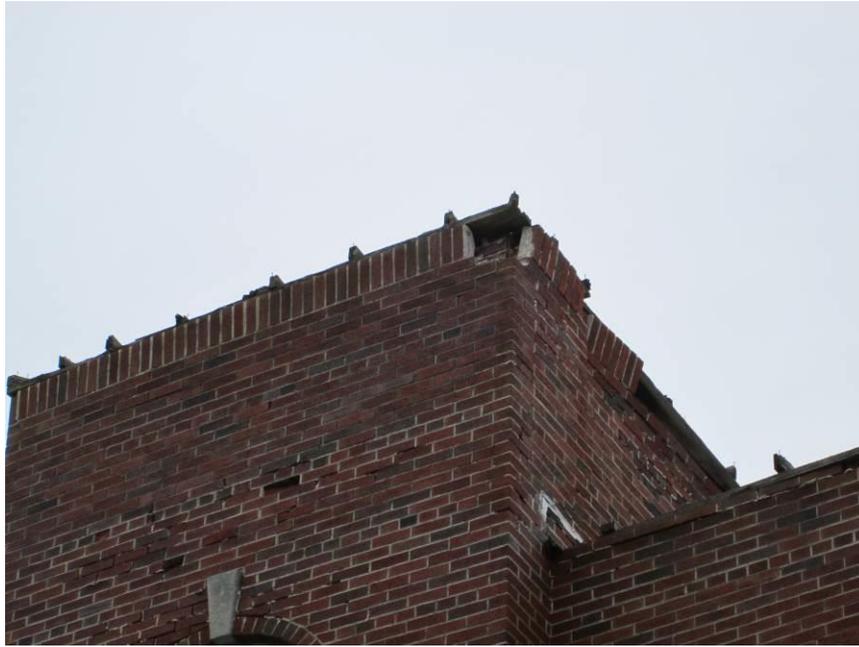
Photograph 33 – Crumbling Brick at Parapet of West Wing Main Hospital

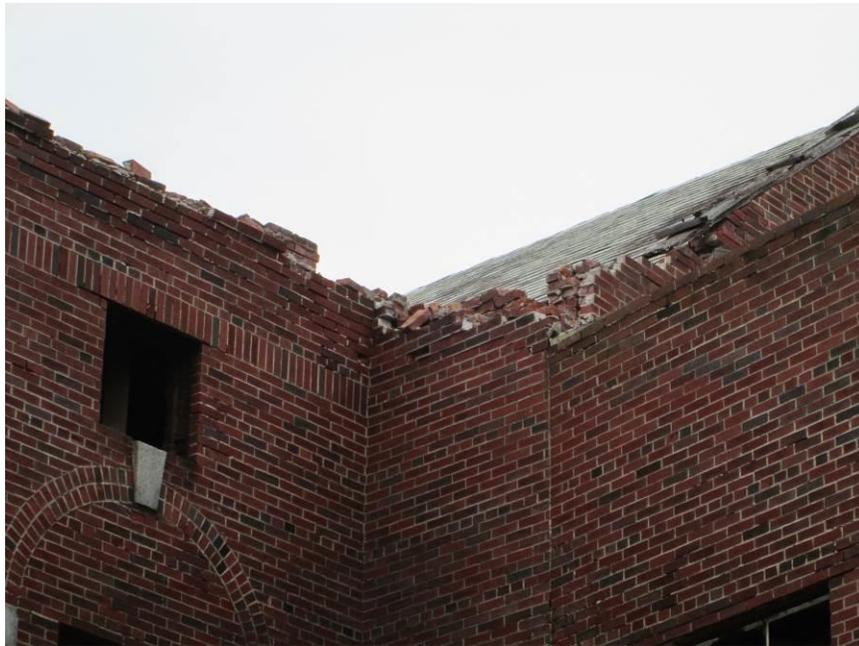
Photograph 34 – Crumbling Brick at Parapet of West Wing Main Hospital

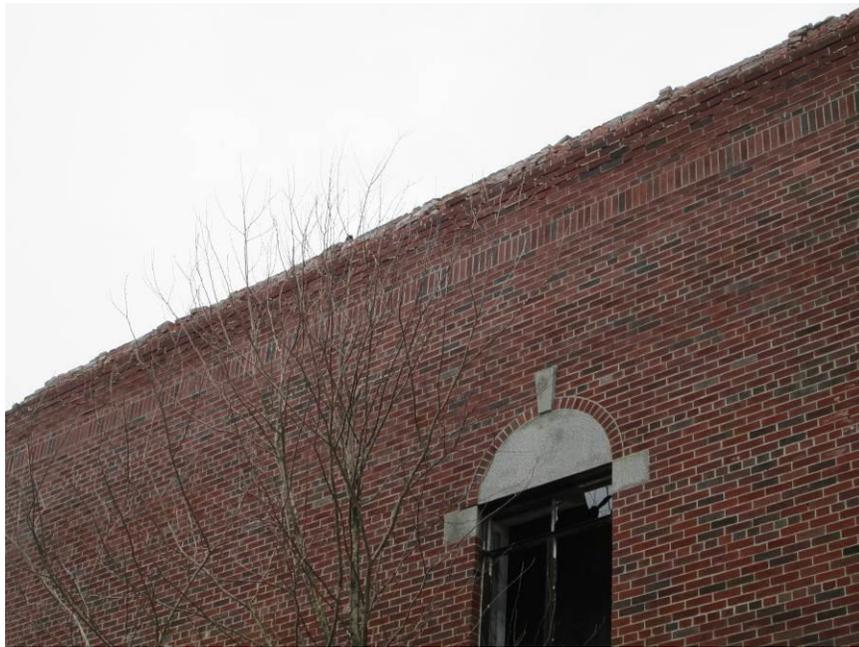
Photograph 35 – Crumbling Brick at Leaning Parapet of West Wing Main Hospital

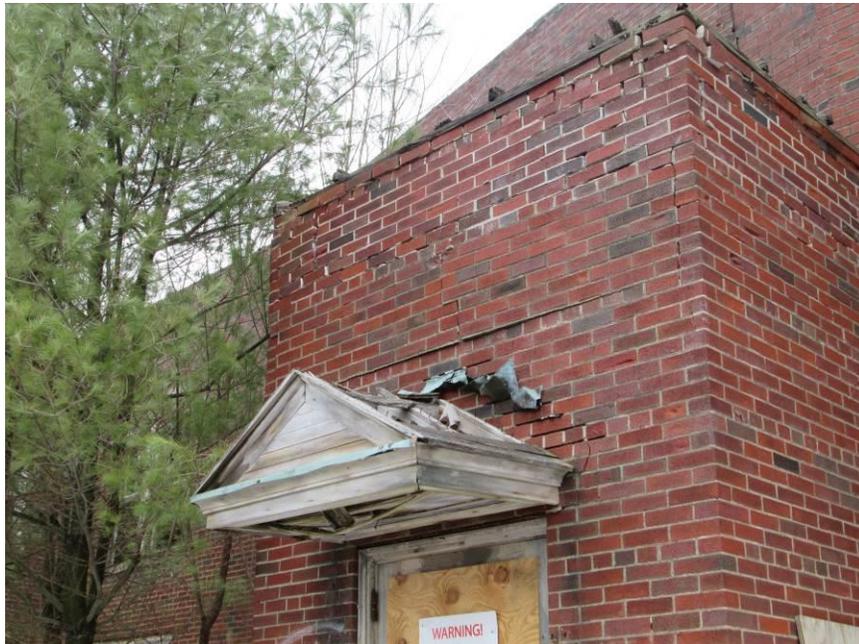
Photograph 36 – Deteriorated Brick and Compromised Awning near Children’s Wing Rear Entry
