April 19, 2016

**Re: Old Saratoga Hospital Structural Evaluation
Providence, New York
Ryan Biggs | Clark Davis Project 11373
ER Purchase Order # 11490**

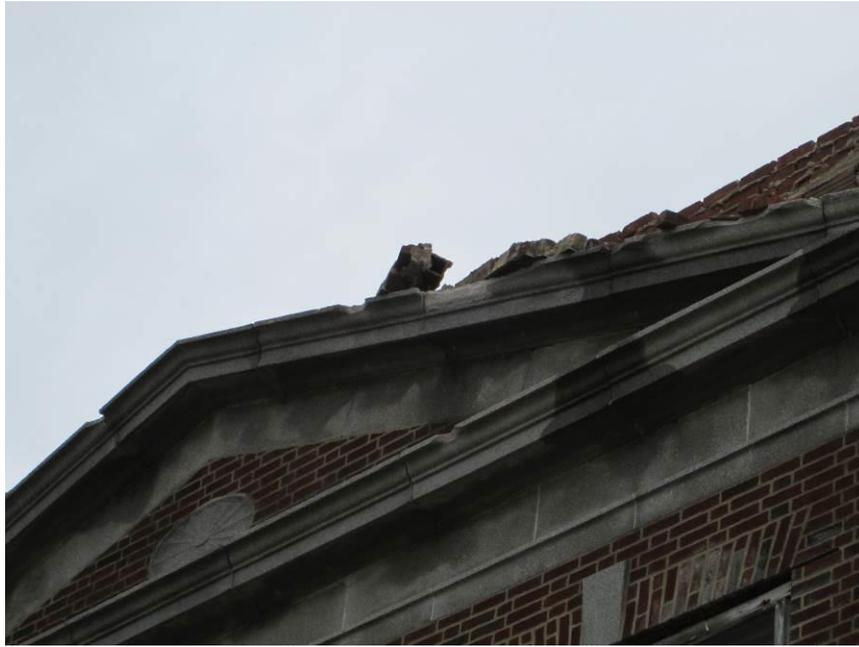
Photograph 37 – Brick Fall Hazard at Children’s Wing Entry

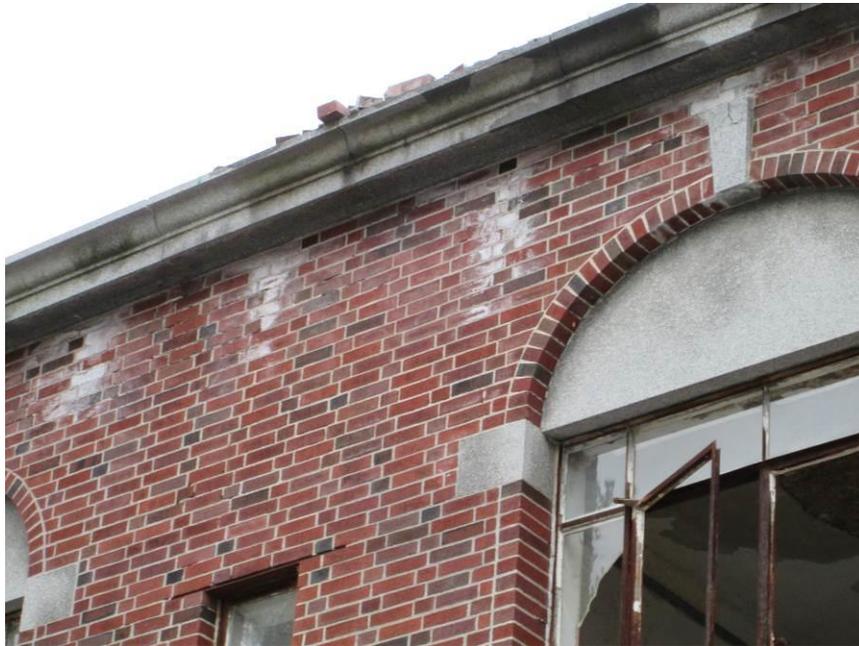
Photograph 38 – Brick Fall Hazard at Main Hospital South Face

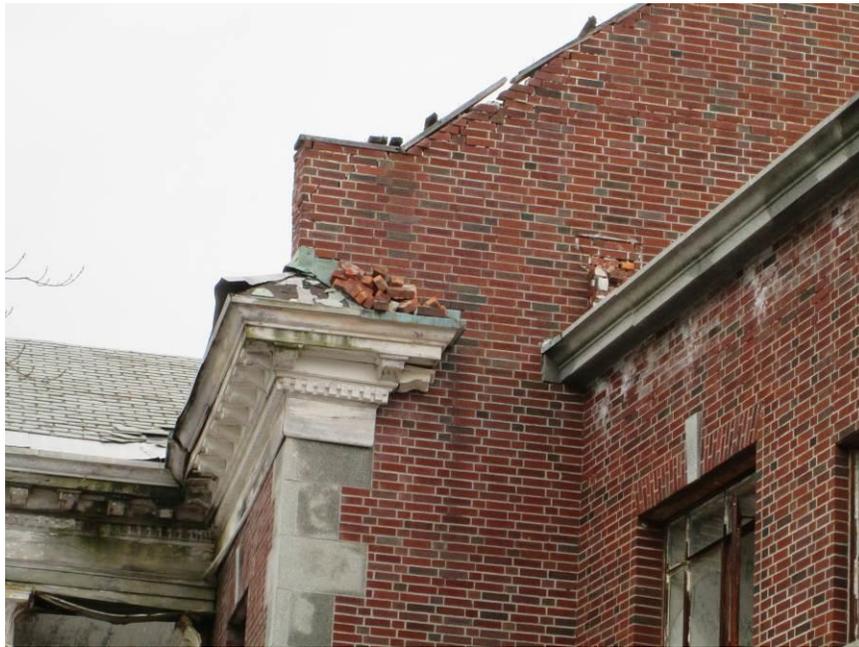
Photograph 39 - Brick Fall Hazard at Main Hospital South Face

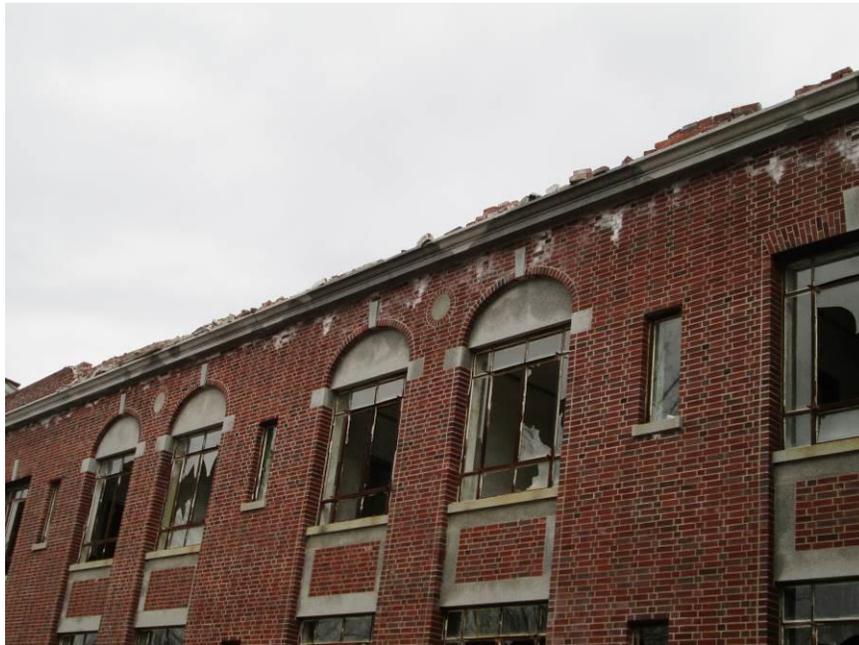
Photograph 40 - Brick Fall Hazard at Main Hospital South Face
