MEMORANDUM

SUBJECT: Request for Approval and Funding for a Time-Critical Removal Action at the Kewaunee Marquette School Site, 317 Dorelle Street, Kewaunee, Kewaunee County, Wisconsin (Site ID #C57X)

**PHOTO LOG
KEWAUNEE MARQUETTE SCHOOL SITE
KEWAUNEE, KEWAUNEE COUNTY, WISCONSIN
JUNE 2016**

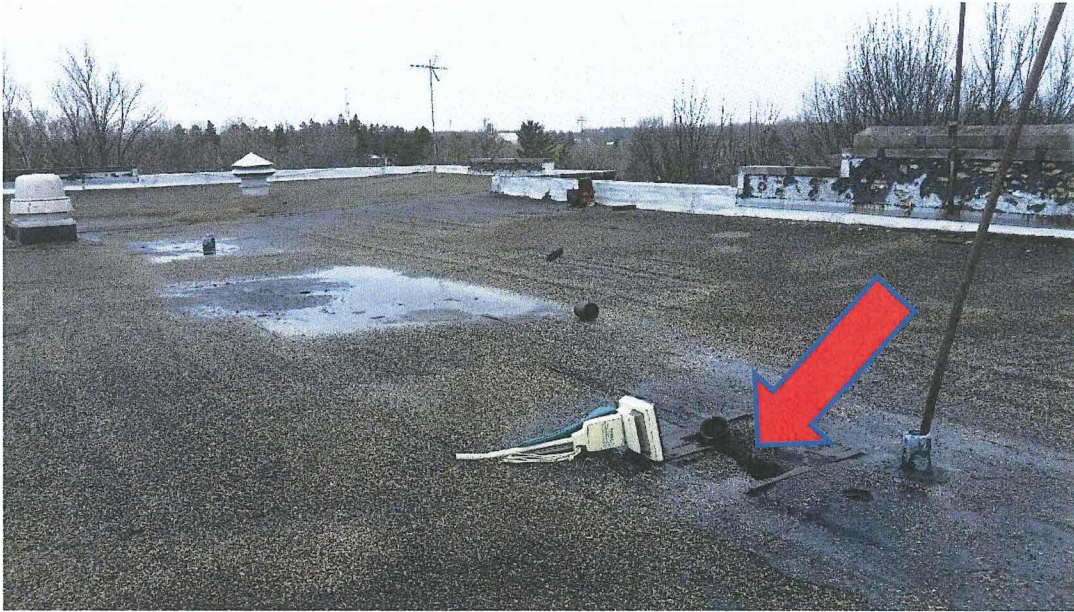
Portions of the roof have collapsed (Attachment 3, photo 1) resulting in rain and snow regularly entering the building (Attachment 3, photo 3). Many walls are now covered with mold and moss is growing throughout the building (Attachment 3, photos 2 & 4). Lead and PCB paint is peeling from the walls and has accumulated with friable asbestos on the floors (Attachment 3, photo 6).

Photo 1: Hole in roof

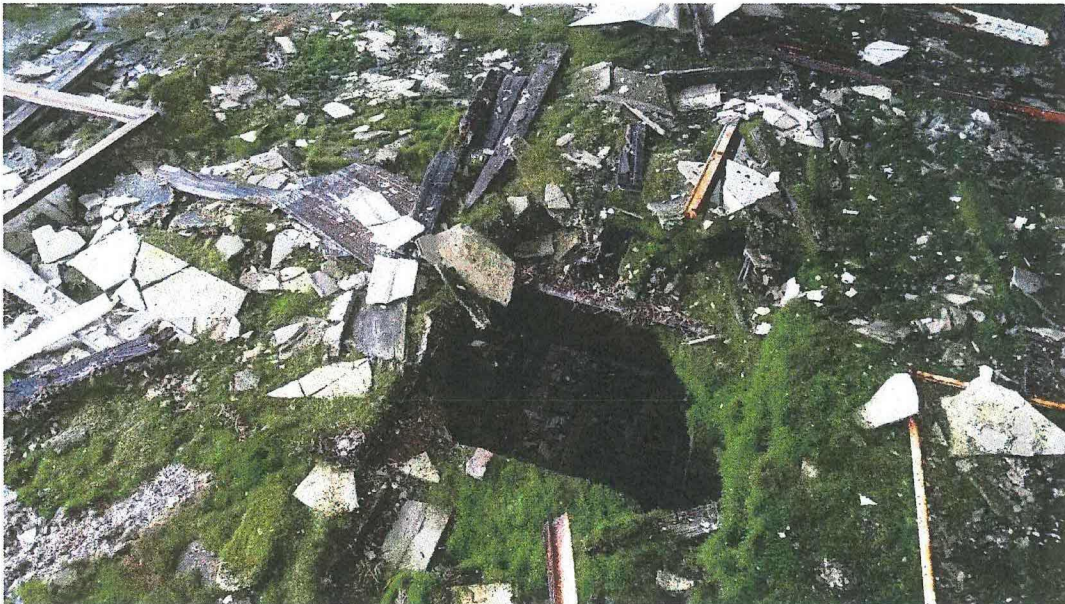
building (Attachment 3, photos 2 & 4). Based on the reconnaissance visit, WDNR asked EPA to conduct a removal site assessment (AR, Document #11).

Photo 2: Water damage, including hole in floor and moss

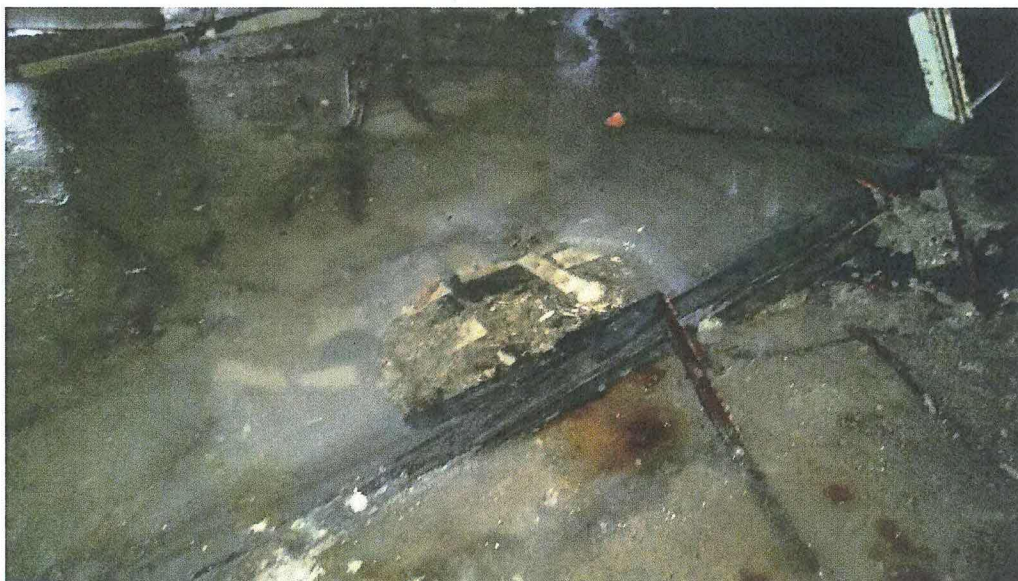
Photo 3: frozen pooled water on buckled floor

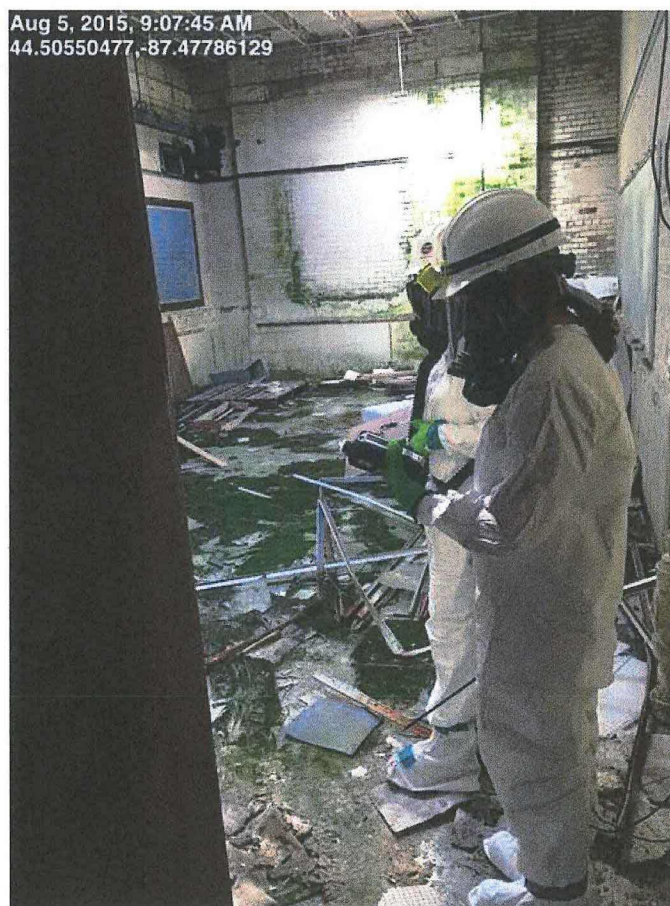
Photo 4: EPA air monitoring during assessment recon; conditions on first floor

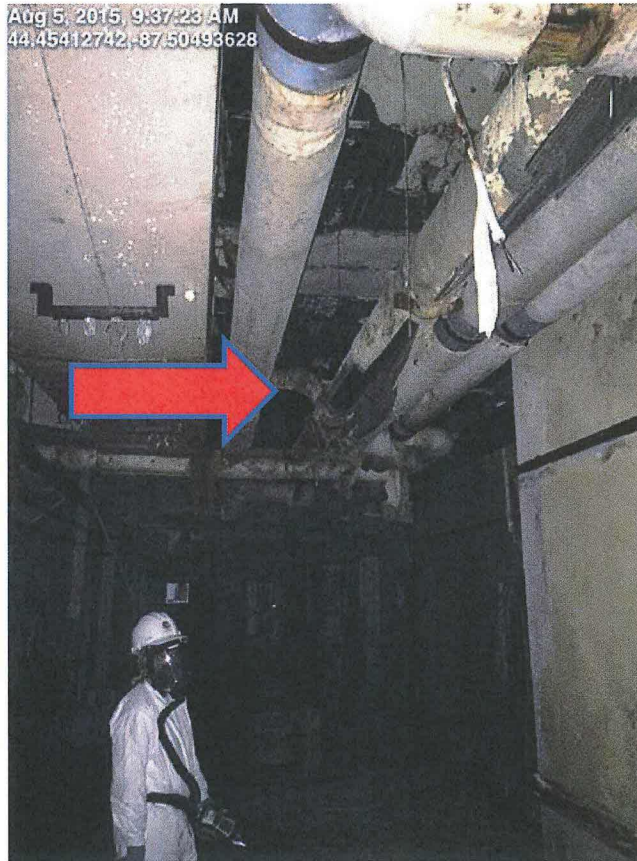
Asbestos surveys conducted in 1990 for AHERA and in 2011 for demolition (AR, Documents #1 and #6) identified approximately 3,200 linear feet and 70,000 square feet of asbestos containing material (ACM), much of which is now damaged and friable (Attachment 3, photo 5).

Photo 5: Damaged pipe wrap/friable asbestos

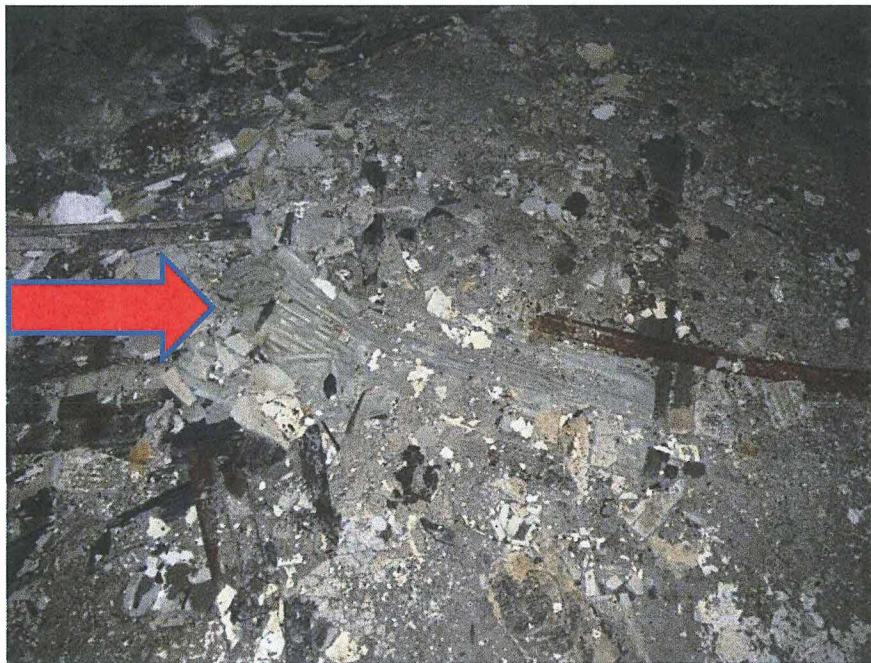
Photo 6: Comingled friable asbestos (pipe wrap) and lead/PCB paint pulverized on floor

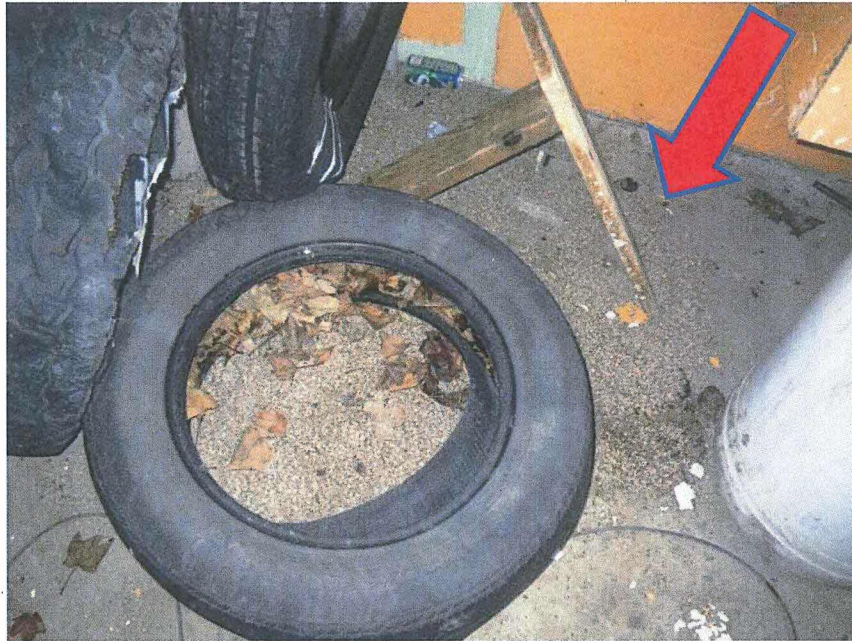
Additional containers were found in a number of rooms on the first floor. Suspected asbestos containing material, including a bag of Zonolite insulation that had apparently been used as floor dry (Attachment 3, photo 7), was observed. Water was dripping from the ceilings in several rooms. Water damage, including peeling paint, mold, and moss, are prevalent throughout the

Photo 7: Zonolite insulation (ACM) used as floor dry for spill

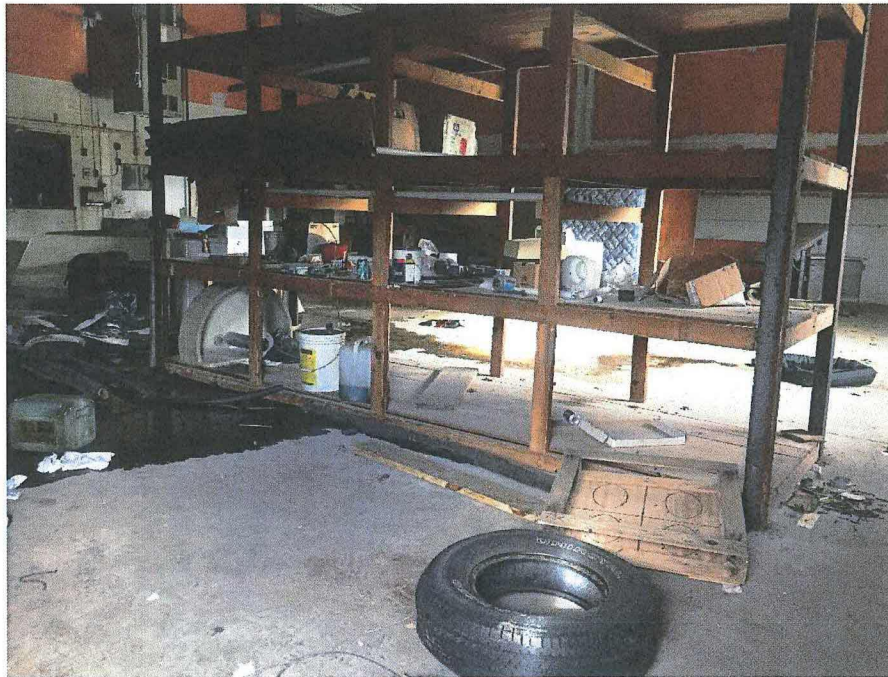
Numerous small (1-5 gallon) containers are being stored in the building (Attachment 3, photo 9). Some contain flammable materials (flashpoint of 79.3). Vandals have spilled contents of some containers onto the floors near drains which lead to the City's sewers (Attachment 3, photo 8).

Photo 8: Abandoned containers of PCB oil spilled and flowing into floor drain

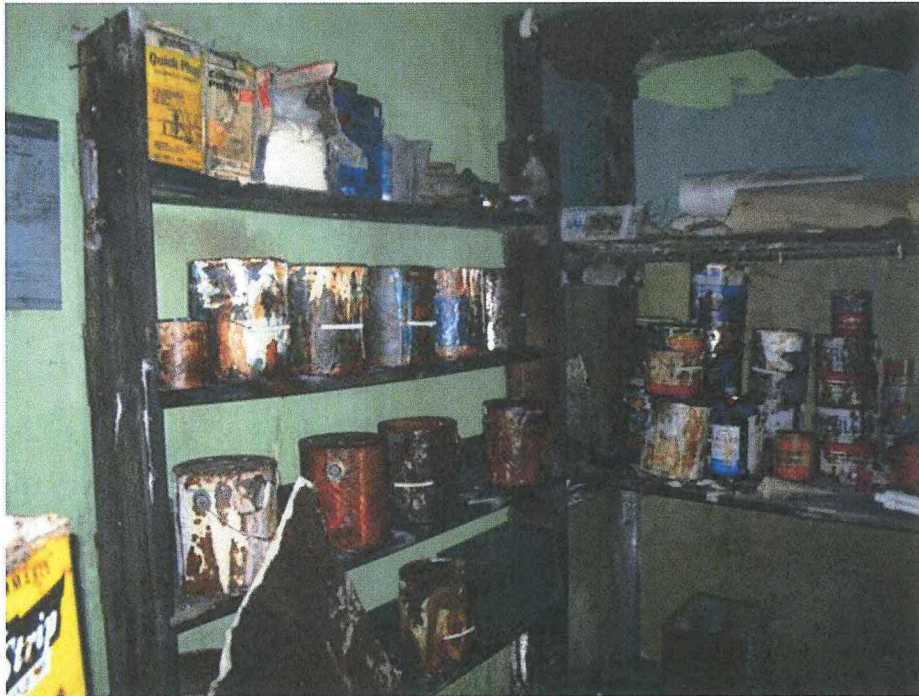
Photo 9: various abandoned containers

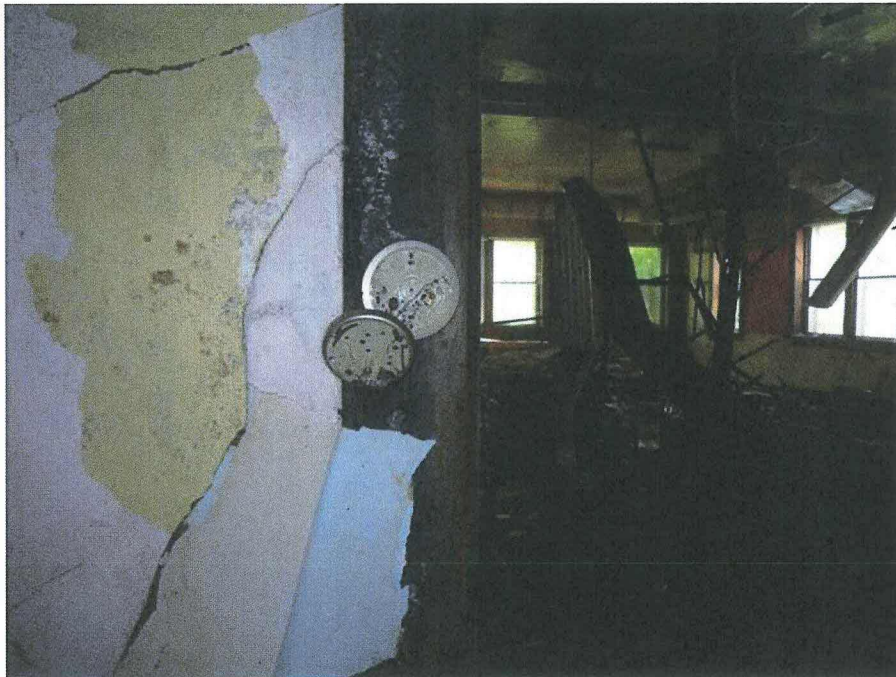
Thermostats have been ripped from the walls (Attachment 3, photos 10-11). Fluorescent bulbs and light ballasts are strewn throughout the building. Pockets of elevated mercury were detected in the building. Piles of ash with elevated arsenic (105 ppm) and PCB levels remain on the floor of the furnace room. An 8,000 gallon underground storage tank was closed in 1995, but numerous above ground tanks remain in the boiler room.

Photo 10: Broken thermostat

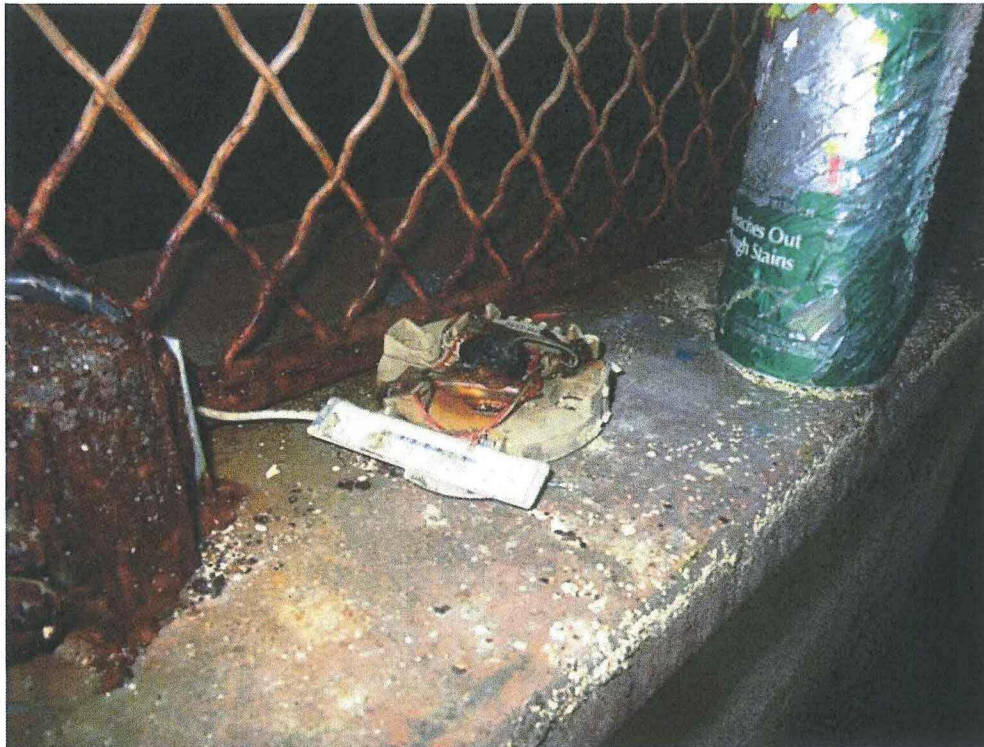
Photo11: Damaged thermostat containing mercury

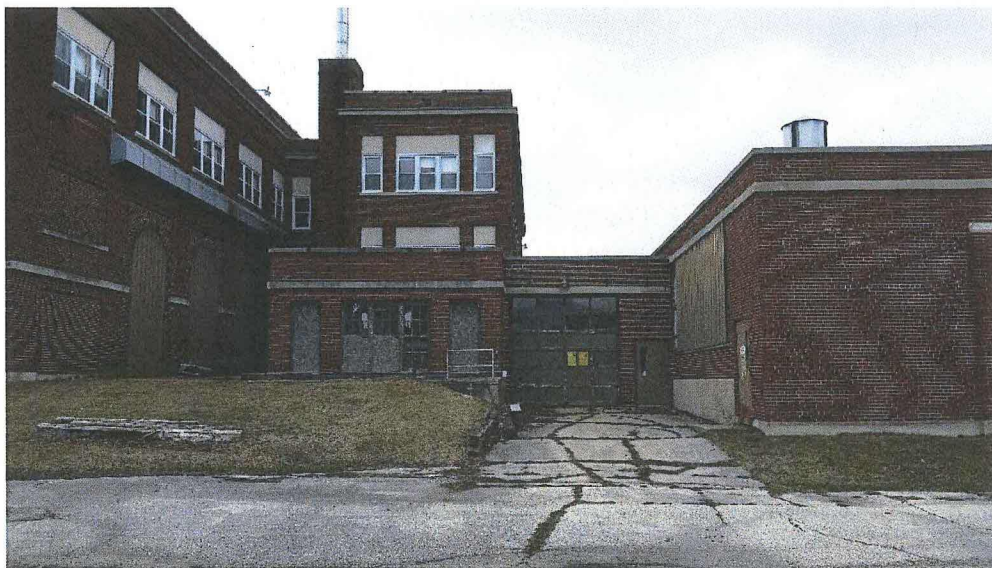
The City of Kewaunee Public Works and Police Departments have made numerous efforts to secure the building (Attachment 3, photos 12-13). The Fire Department has restricted operations to exterior firefighting only for the Site due to the numerous hazards in the building. The Kewaunee City Administrator requested EPA assistance with the Site on June 23, 2015 (AR, Document #9).

Photo 12: Measures to secure the building (warning signs and boarded up windows)

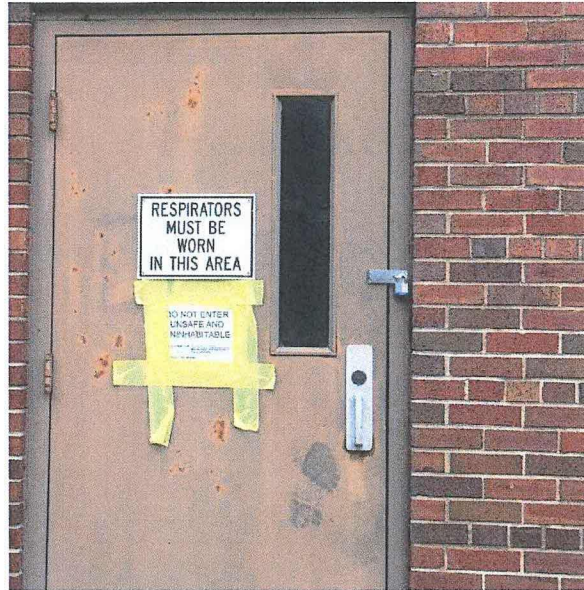
Photo 13: Measures to secure the building (warning signs and door lock)

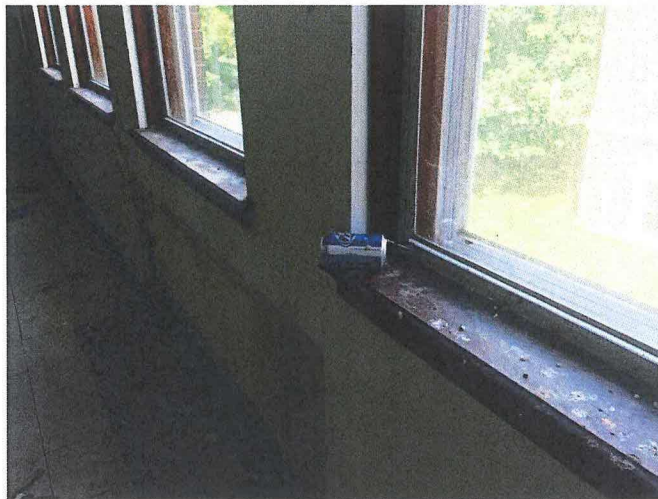
There is evidence of vandalism in the building (Attachment 3, photo 14). Despite numerous attempts to secure the building, trespassing persists. The Site cannot be adequately secured because of the building's dilapidated condition. Flammable materials (flashpoint = 79.3°F) are abandoned at the Site. Vandals reasonably can be expected to cause fires at the Site that would potentially release hazardous substances, including arsenic, asbestos, lead, and PCBs, into the surrounding residential community. The current structure has no operating fire alarm or sprinkler system.

Photo 14: Evidence of trespassing
