# Appendix A

## Current Site Photographs, Iron King Mine – Humboldt Smelter Superfund Site

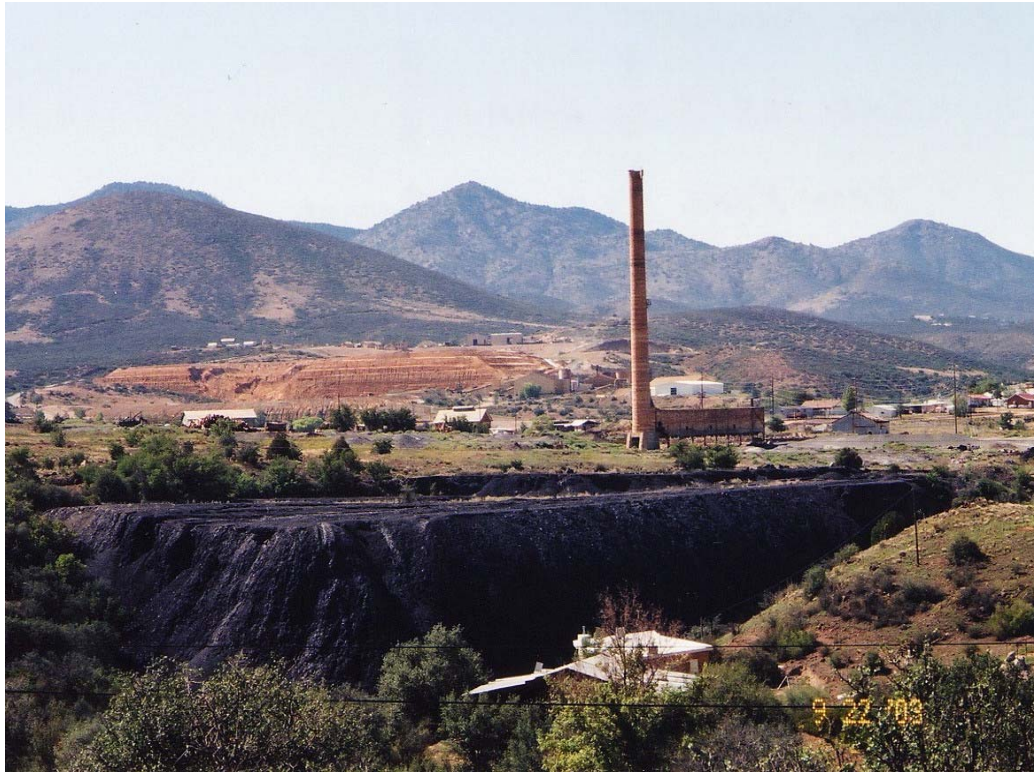
*Photograph 1: Site Overview. Former Humboldt Smelter property in the foreground and former Iron King Mine property in the background at Viewpoint (VP) 1 (see Figure A-1)*

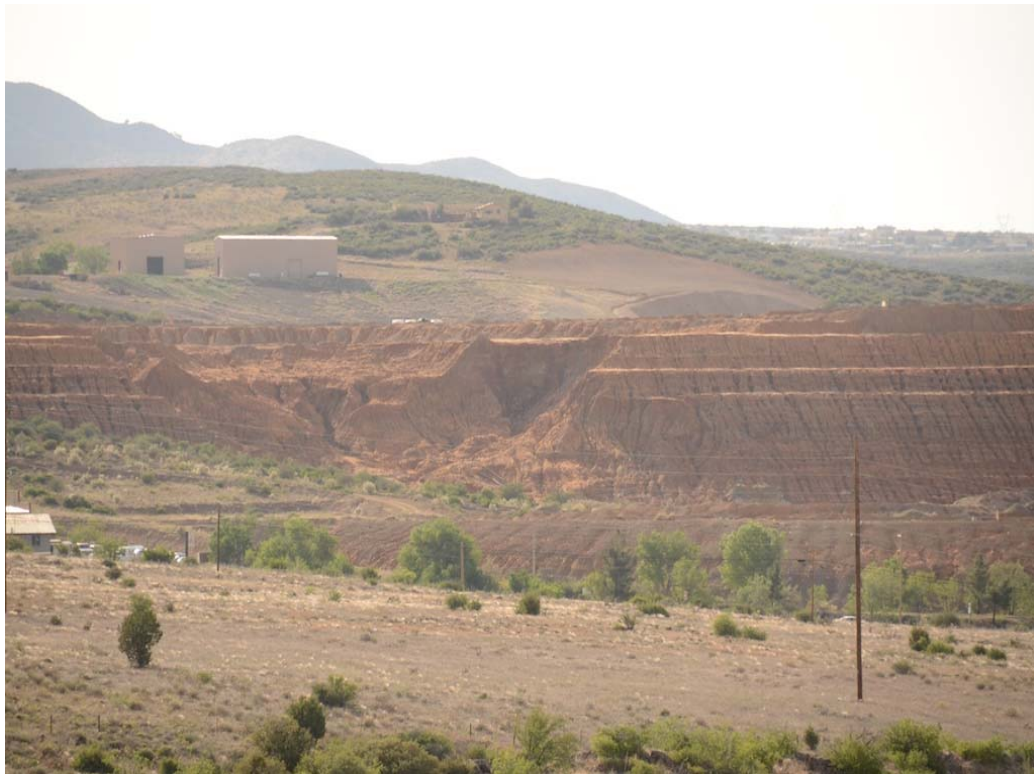
*Photograph 2: Iron King Mine Main Tailings Pile at VP2*

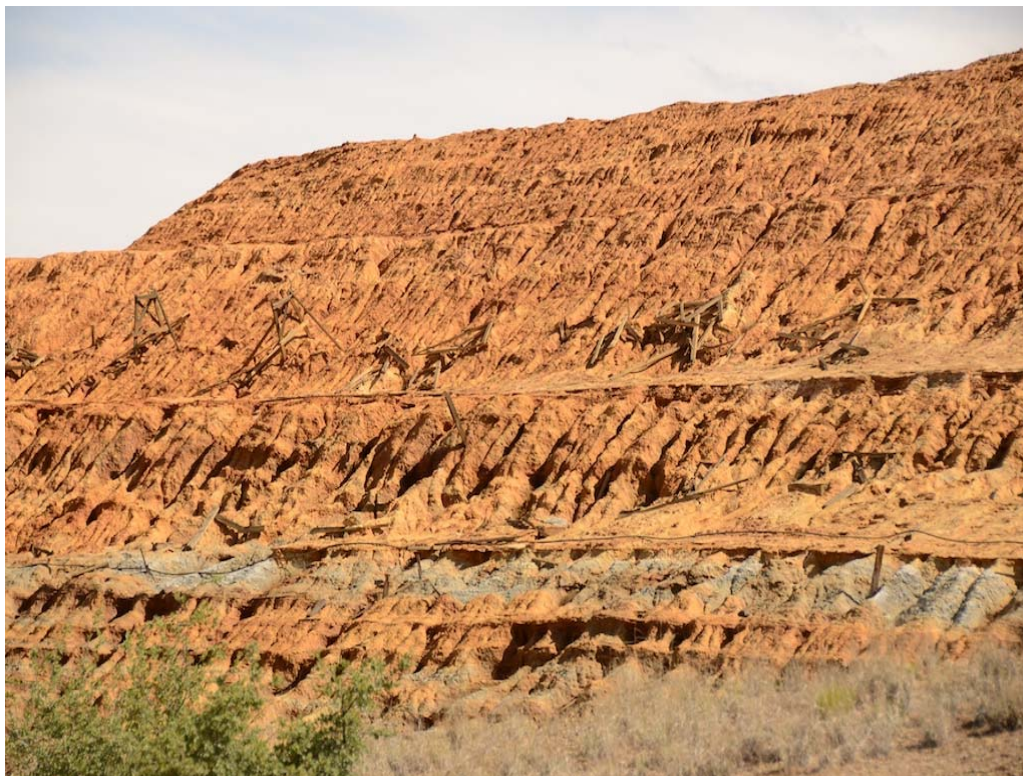
*Photograph 3: Iron King Mine Main Tailings Pile at VP3*

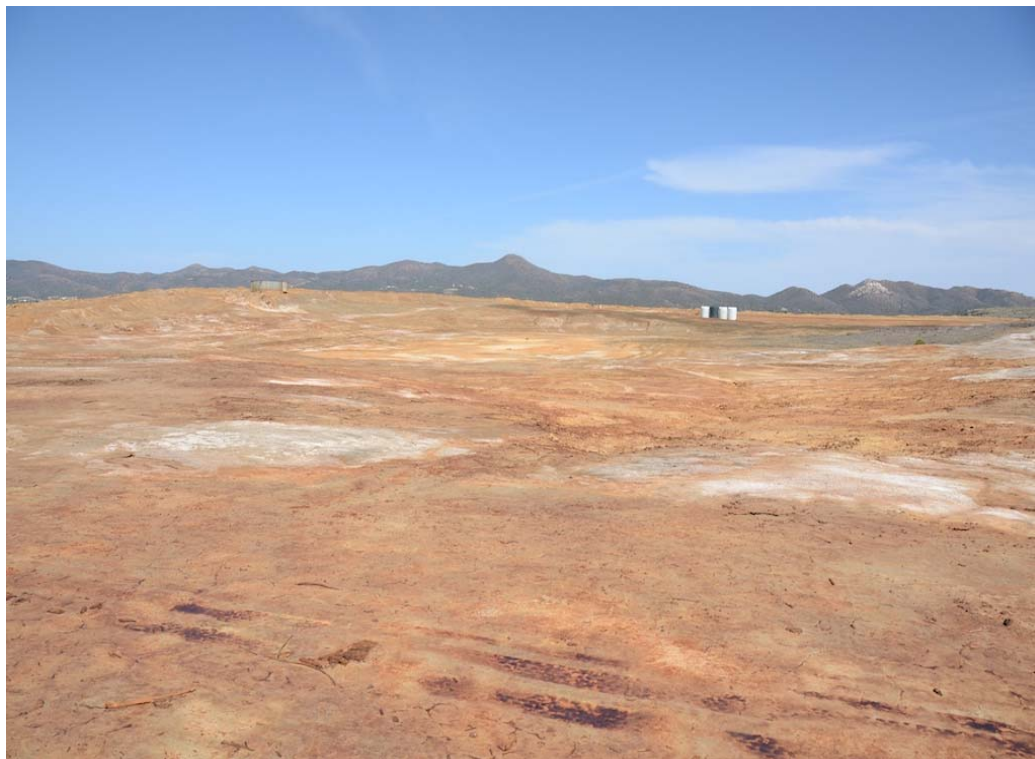
*Photograph 4: Iron King Mine Main Tailings Pile at VP4*

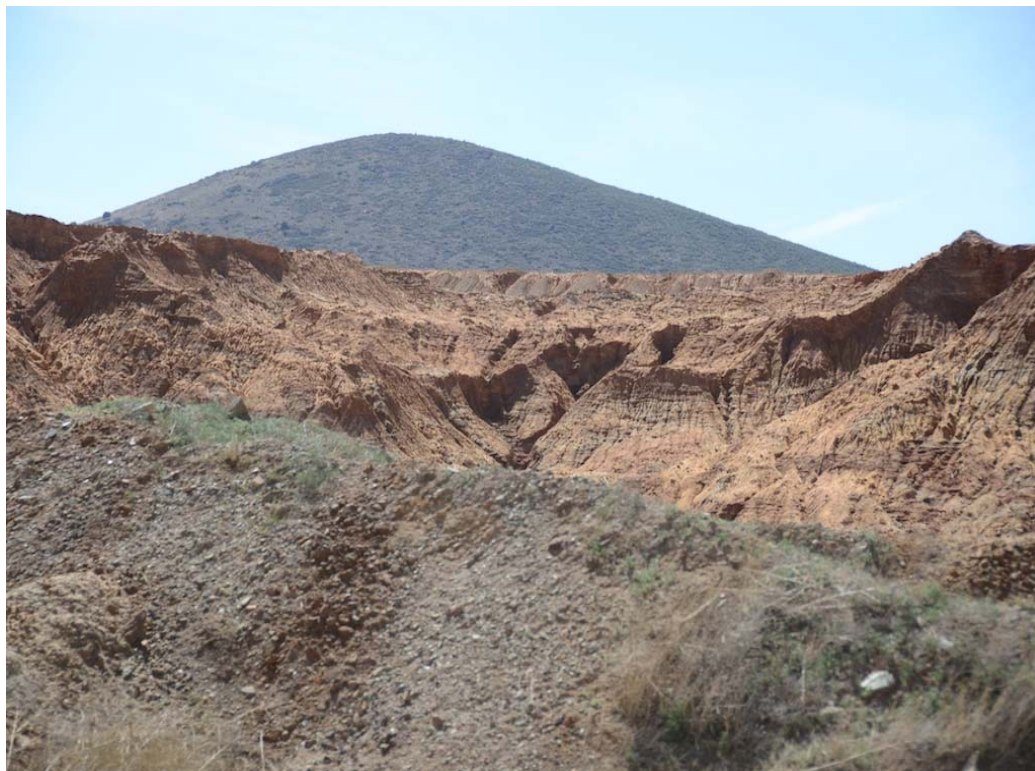
*Photograph 5: Iron King Mine Main Tailings Pile, Blowout at VP5*

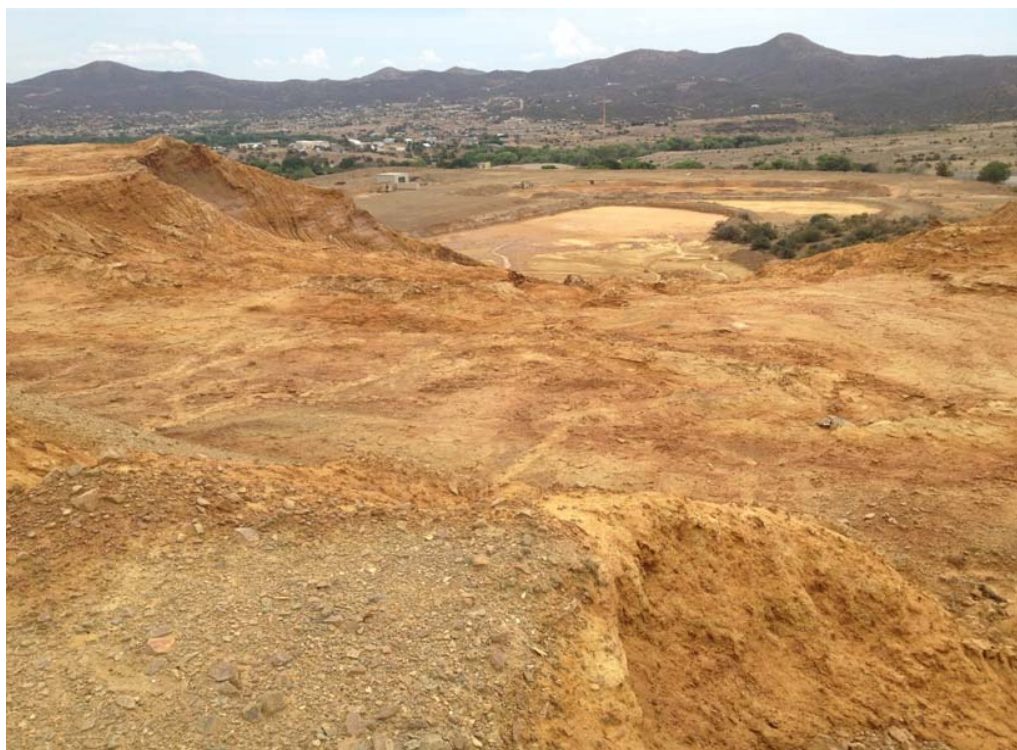
*Photograph 6: Iron King Mine Main Tailings Pile, looking east toward former Humboldt Smelter at VP6*

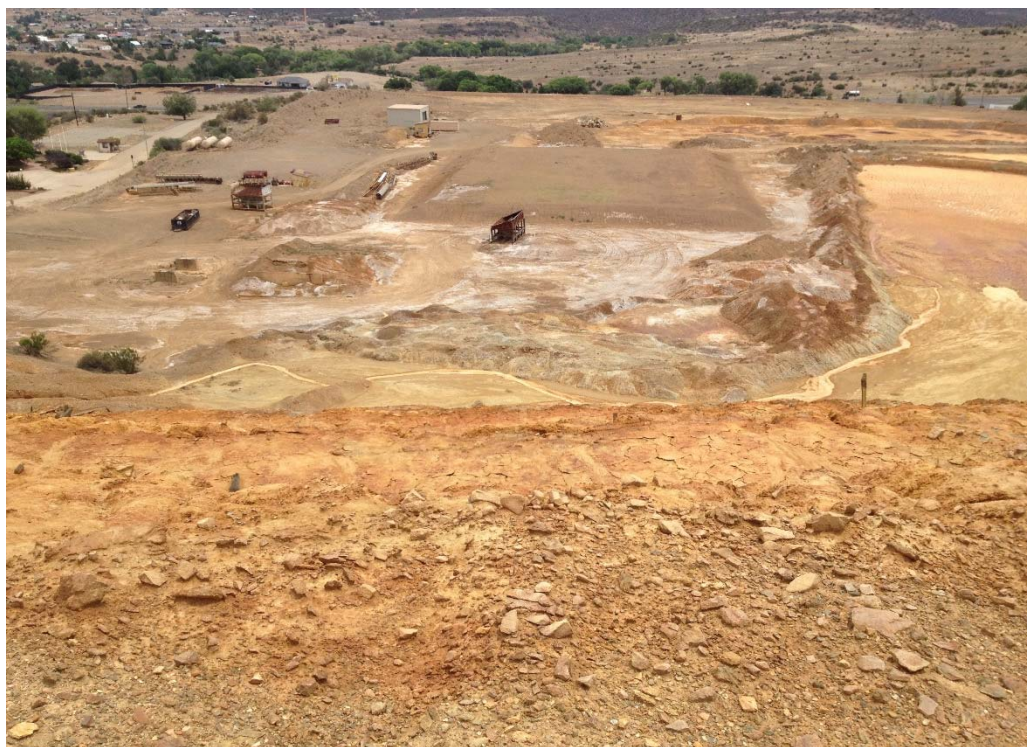
*Photograph 7: Iron King Mine Main Tailings Pile, Retention Pond and NAI Operations area at VP6*

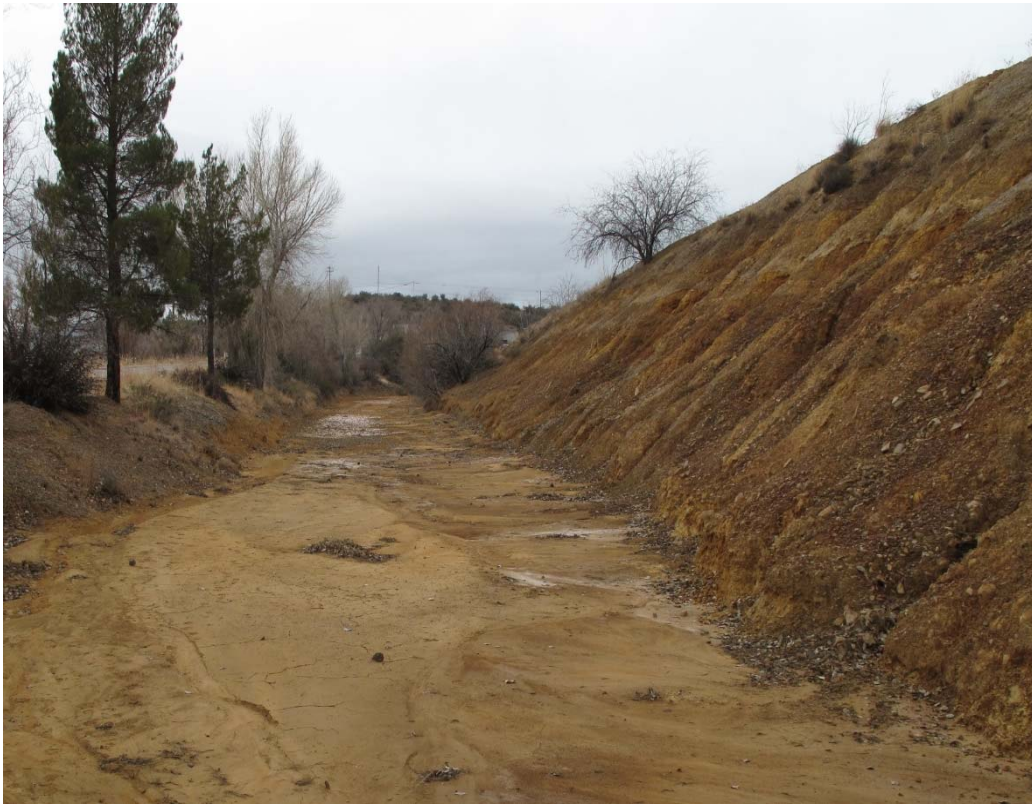
*Photograph 8: Iron King Mine Main Tailings Pile, drainage channel west of Highway 69 at VP7*

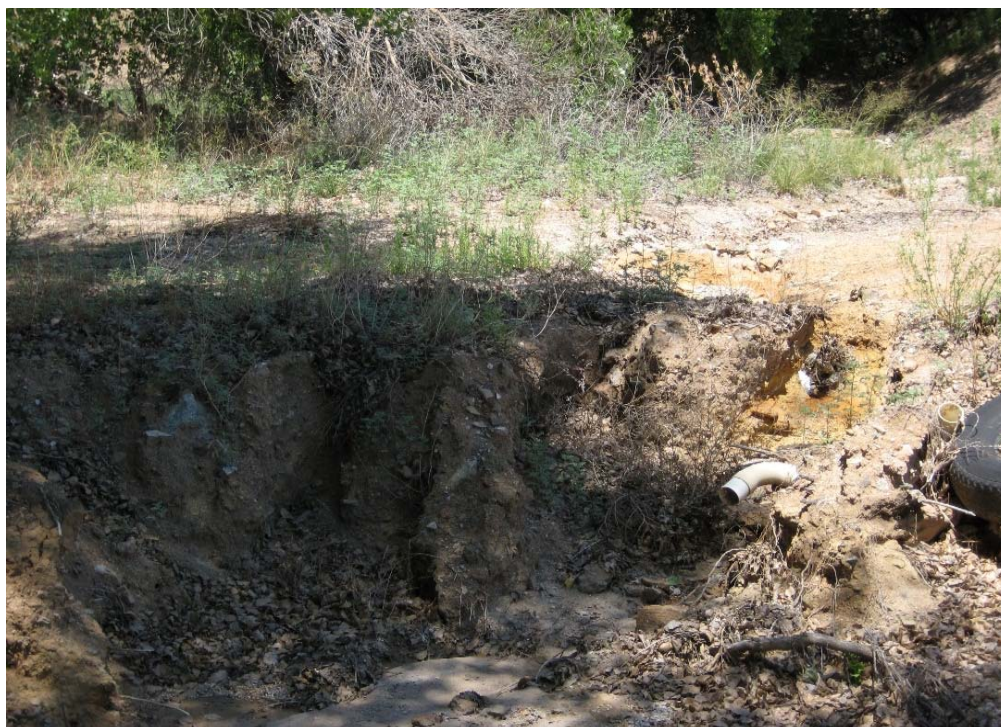
*Photograph 9: Unnamed drainage near Blowout Path at VP8*

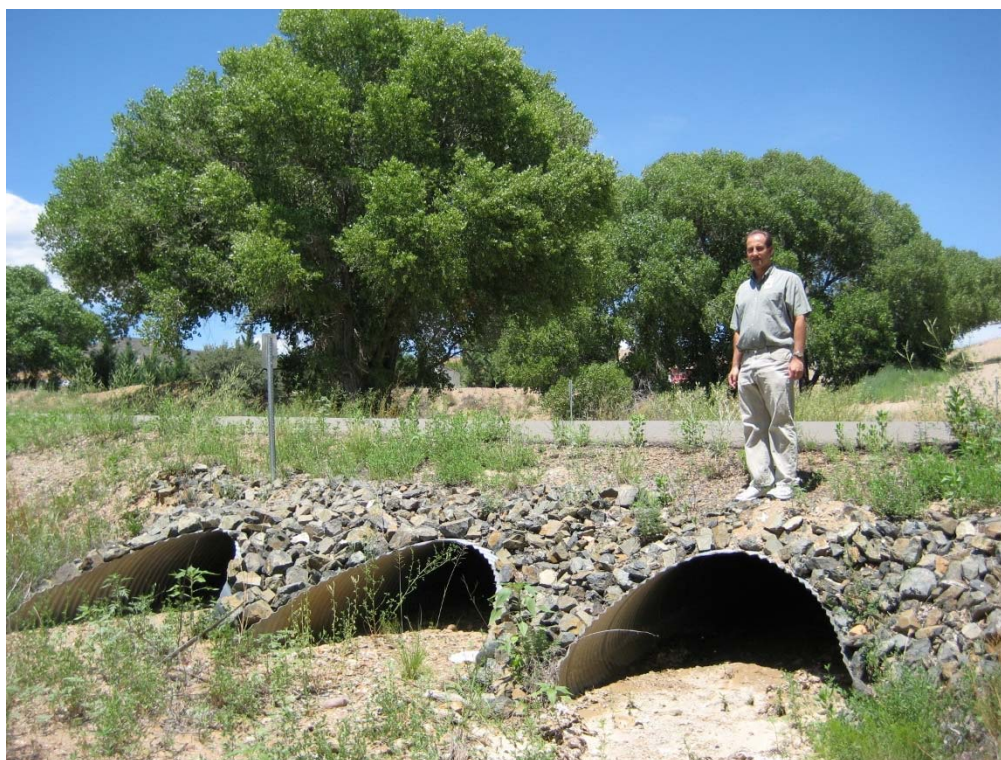
*Photograph 10: Chaparral Gulch at 3rd Street, downstream of Highway 69 at VP9. Photograph taken in 2008; additional alluvium (from other sources in the drainage basin) has been deposited at this VP in recent years.*

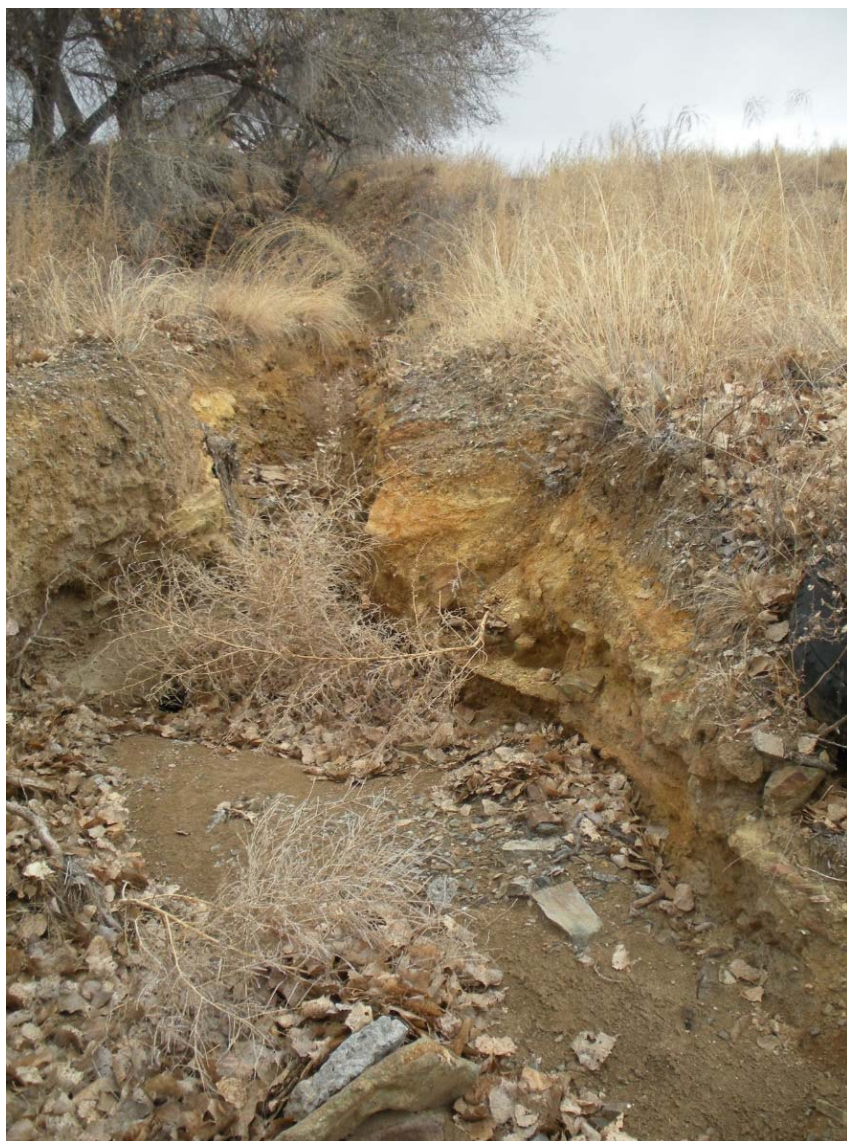
*Photograph 11: Middle Chaparral Gulch at VP10; tailings evident along banks of southern channel*

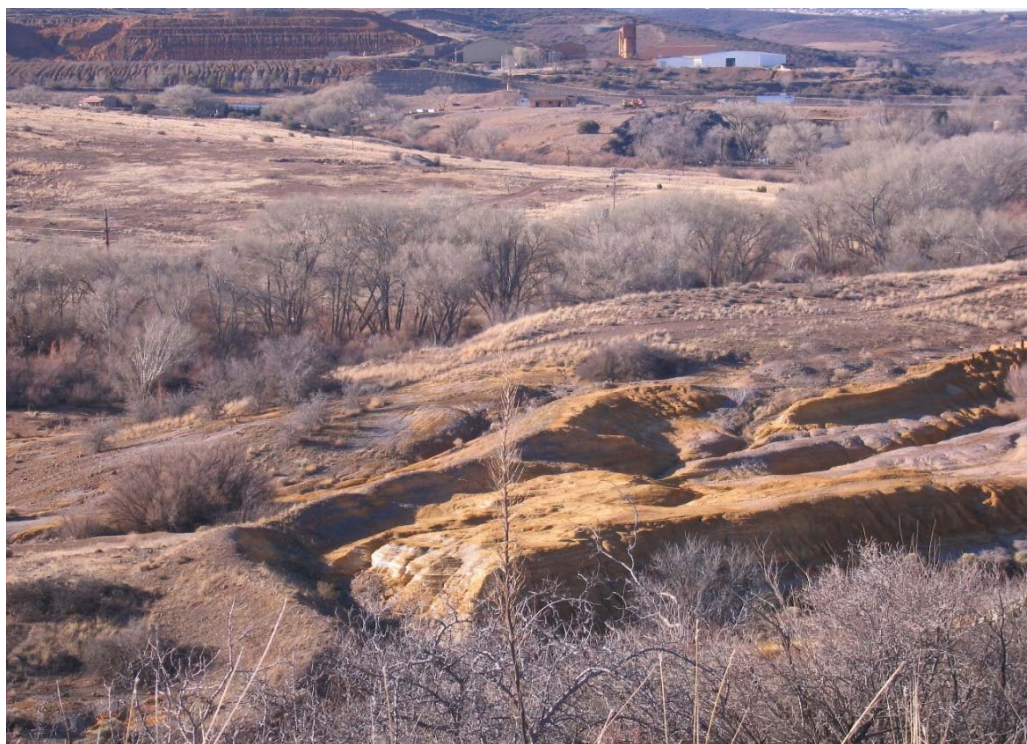
*Photograph 12: Smelter Tailings Swale with former Iron King Mine in background at VP11*

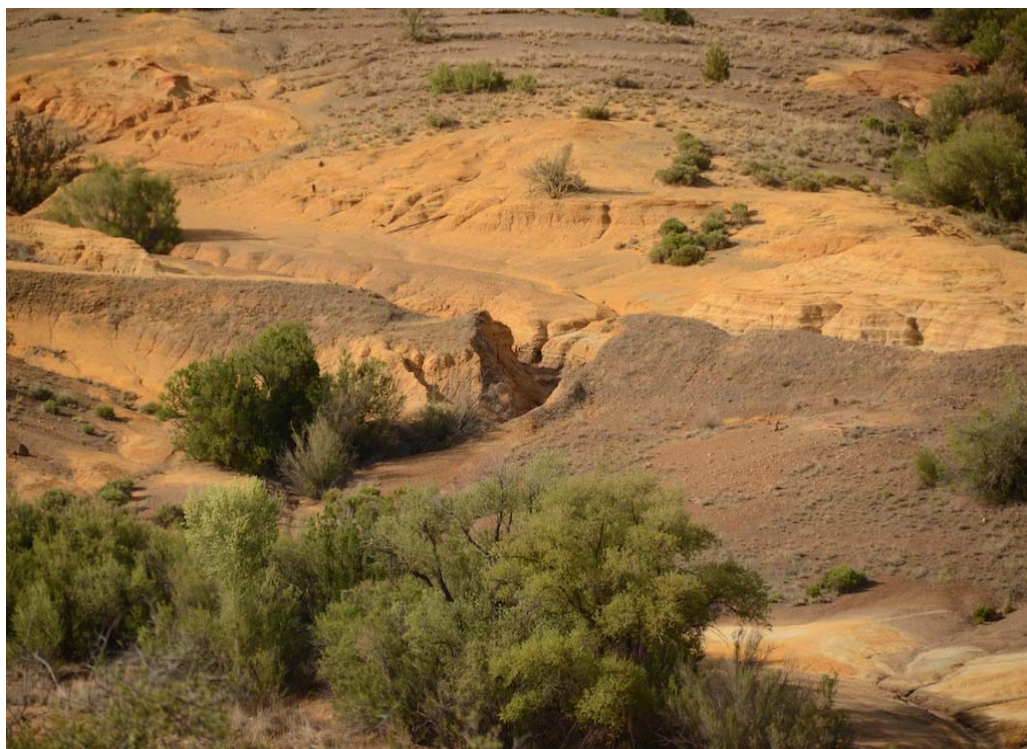
*Photograph 13: Smelter Tailings Swale, tailings pond berm, and blowout at VP12*

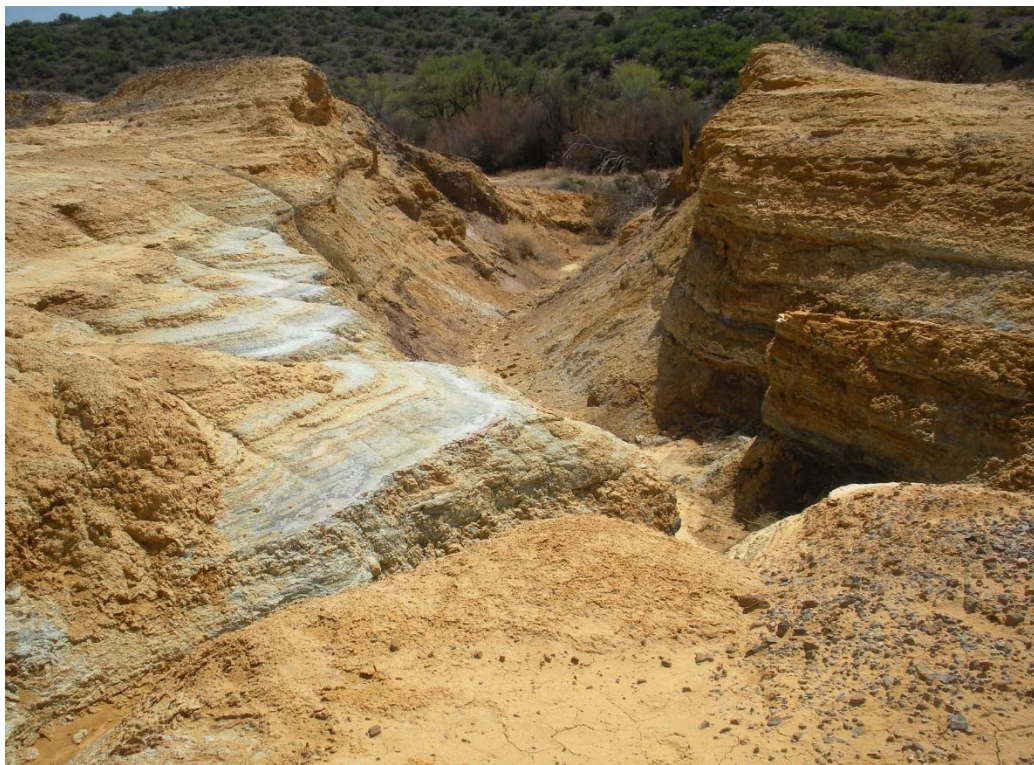
*Photograph 14: Smelter Tailings Swale at VP13*

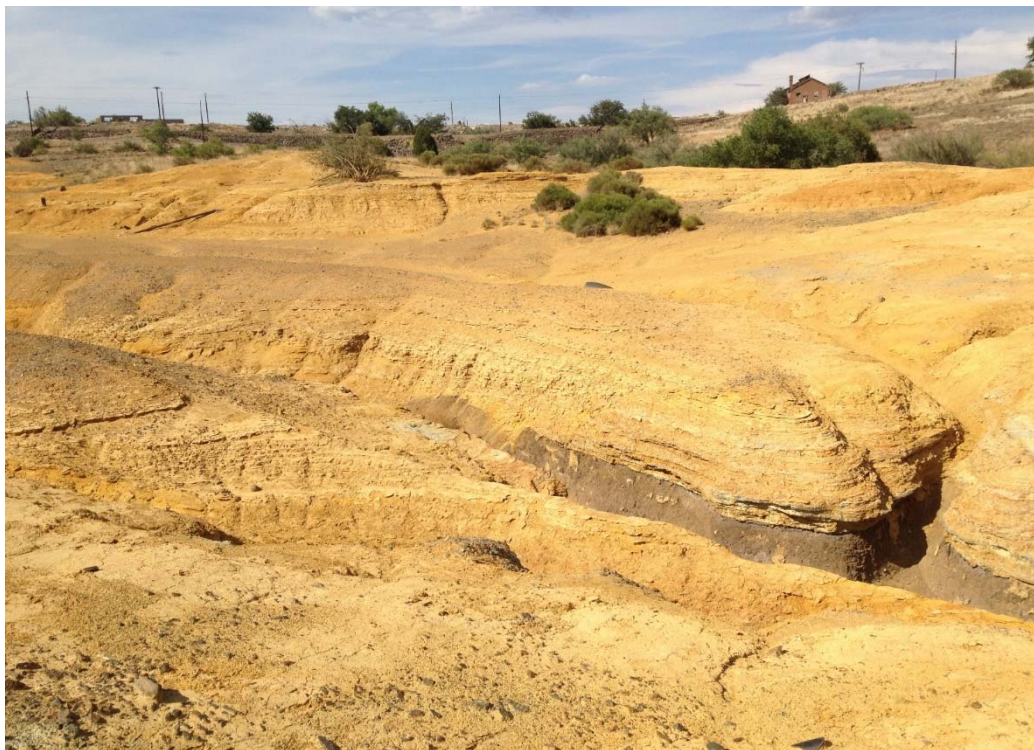
*Photograph 15: Smelter Tailings Swale at VP14*

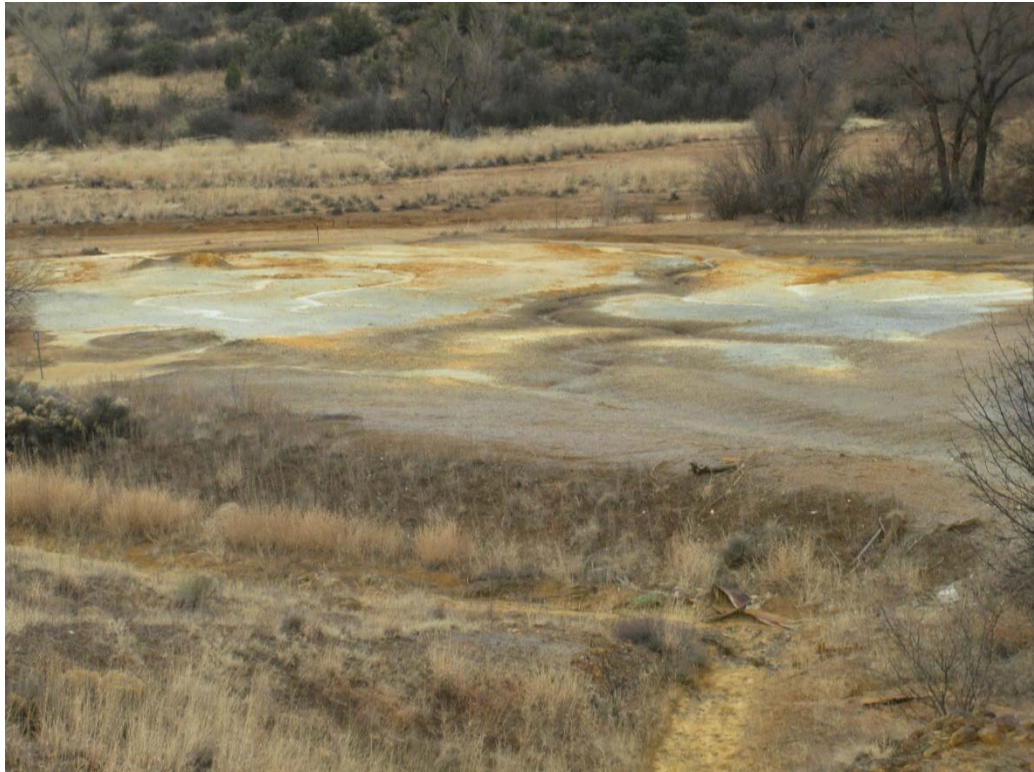
*Photograph 16: Tailings Floodplain, efflorescent salts from repeated evapoconcentration at VP15*

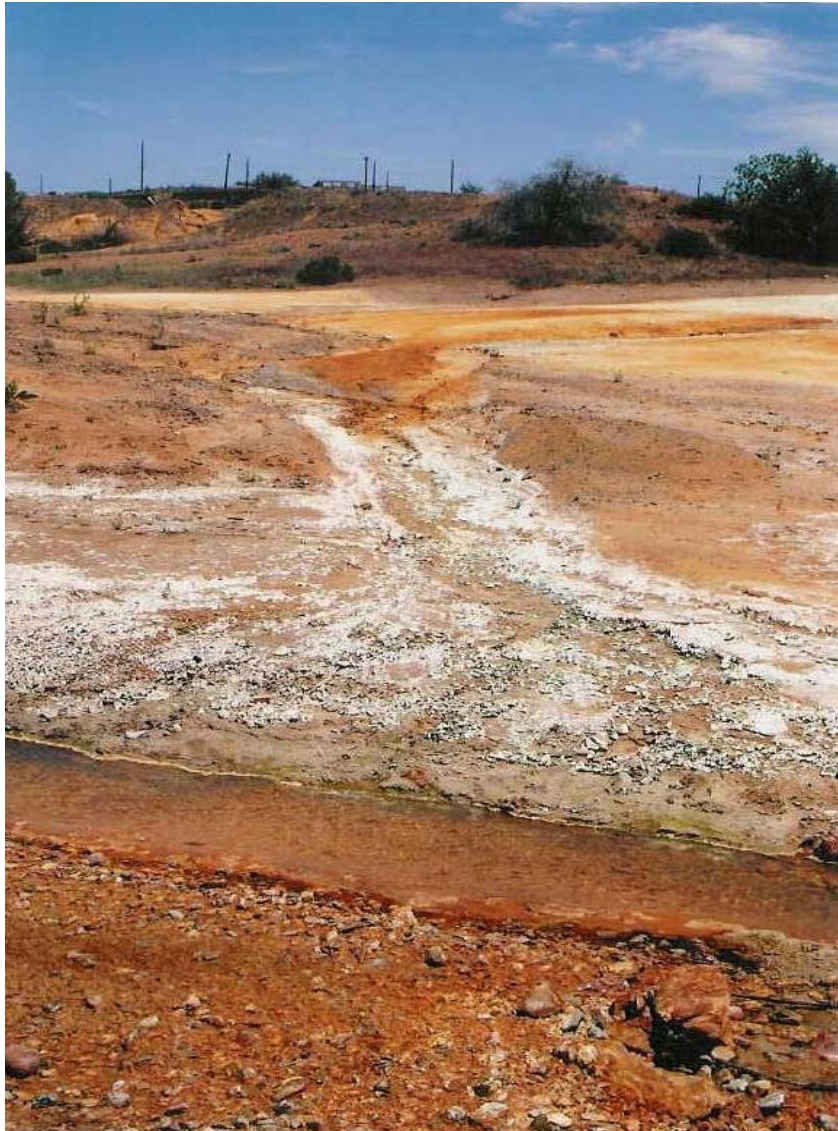
*Photograph 17: Tailings Floodplain, efflorescent salts from repeated evapoconcentration at VP16*

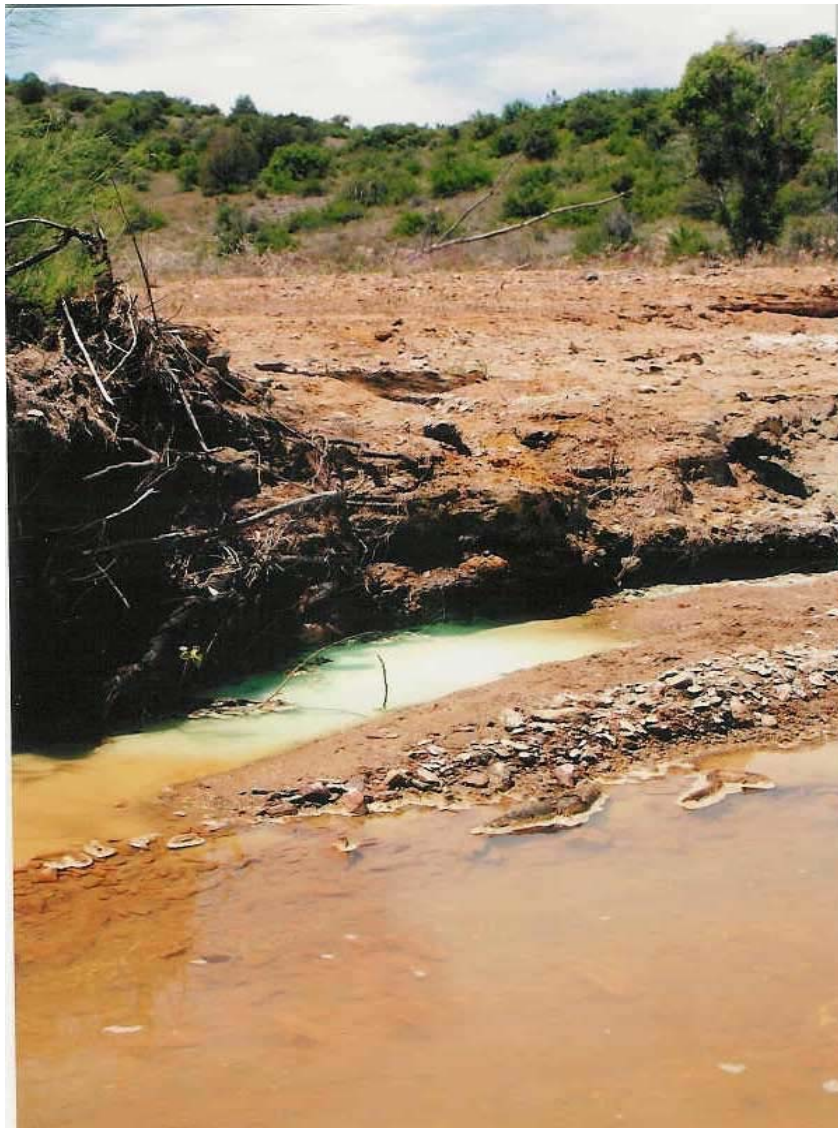
*Photograph 18: Tailings Floodplain, Chaparral Gulch at VP17*

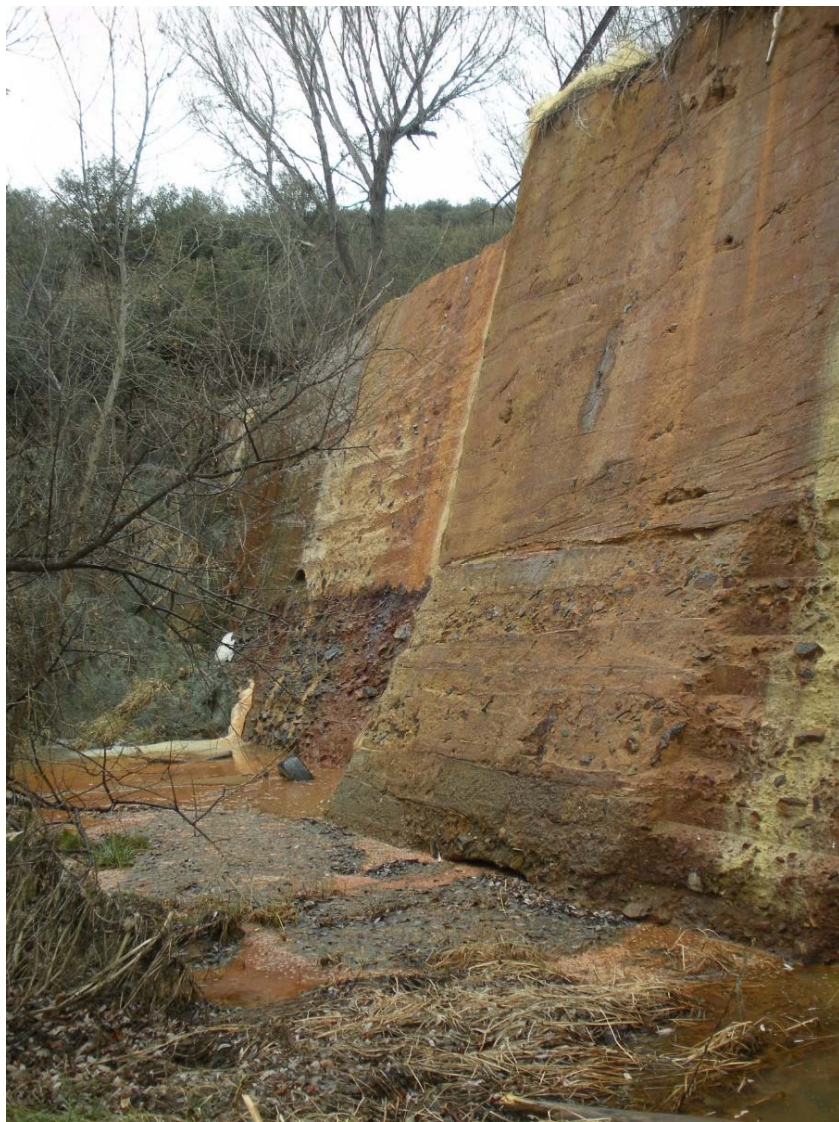
*Photograph 21: Chaparral Gulch Dam at VP19*

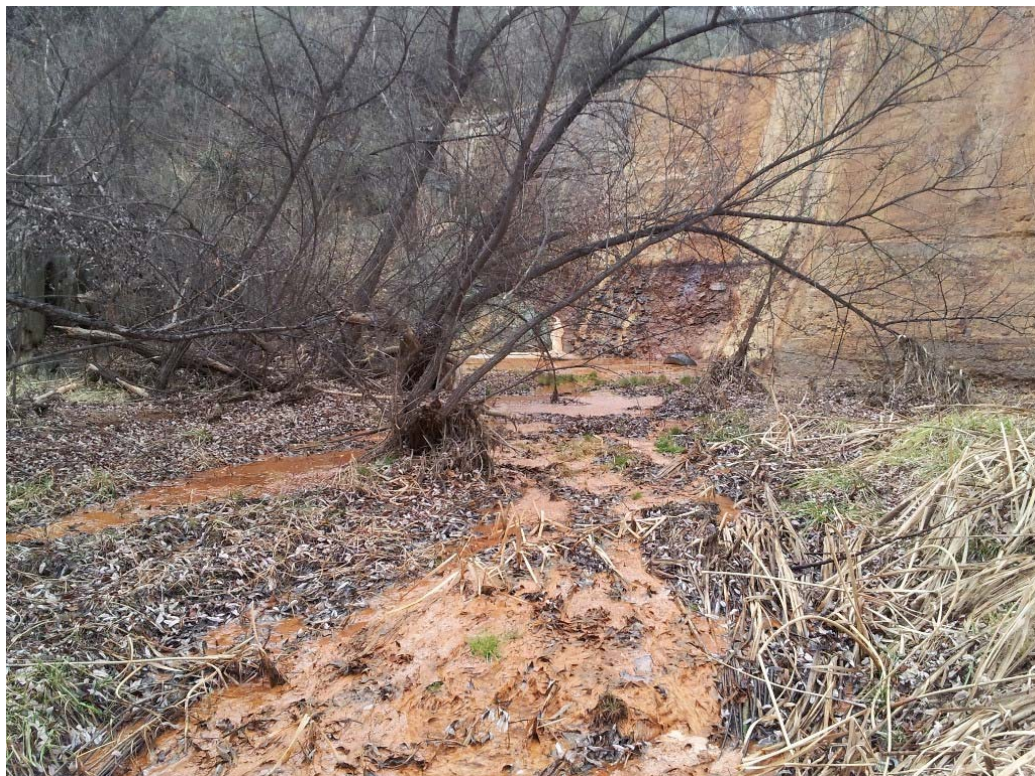
*Photograph 22: Chaparral Gulch Dam at VP20*

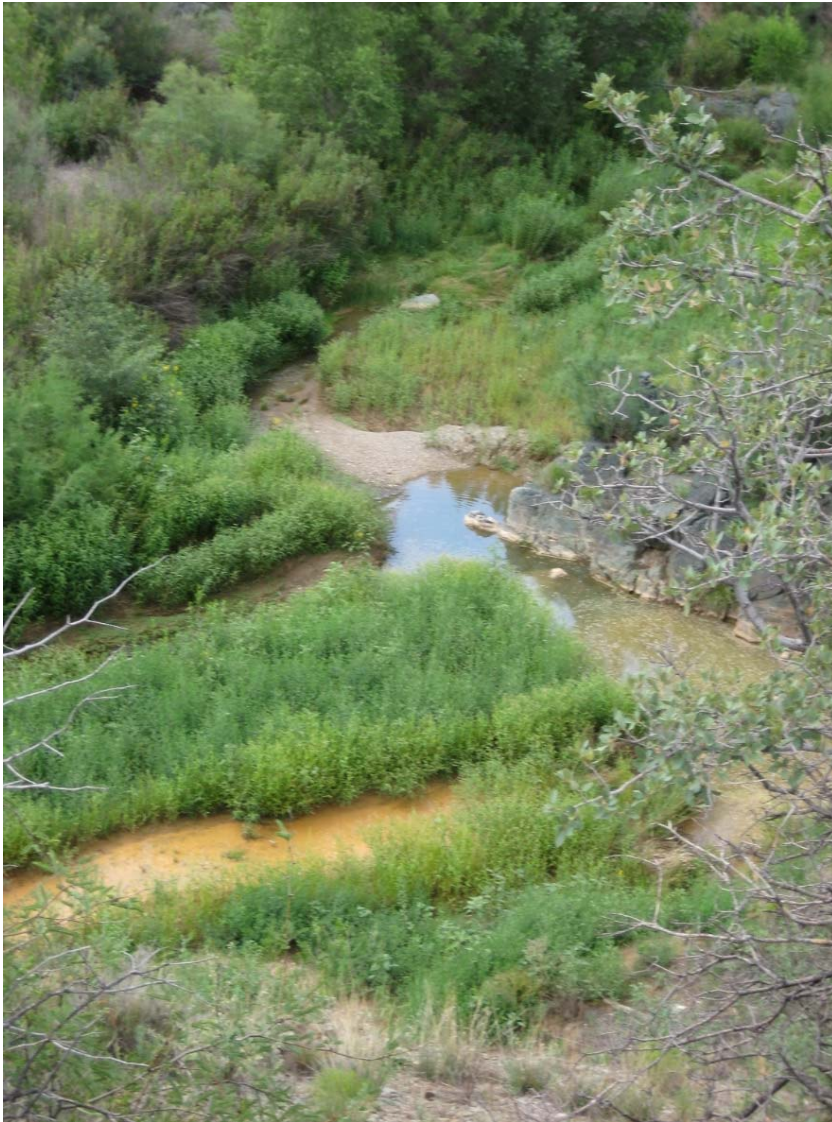
*Photograph 23: Lower Chaparral Gulch at VP21*

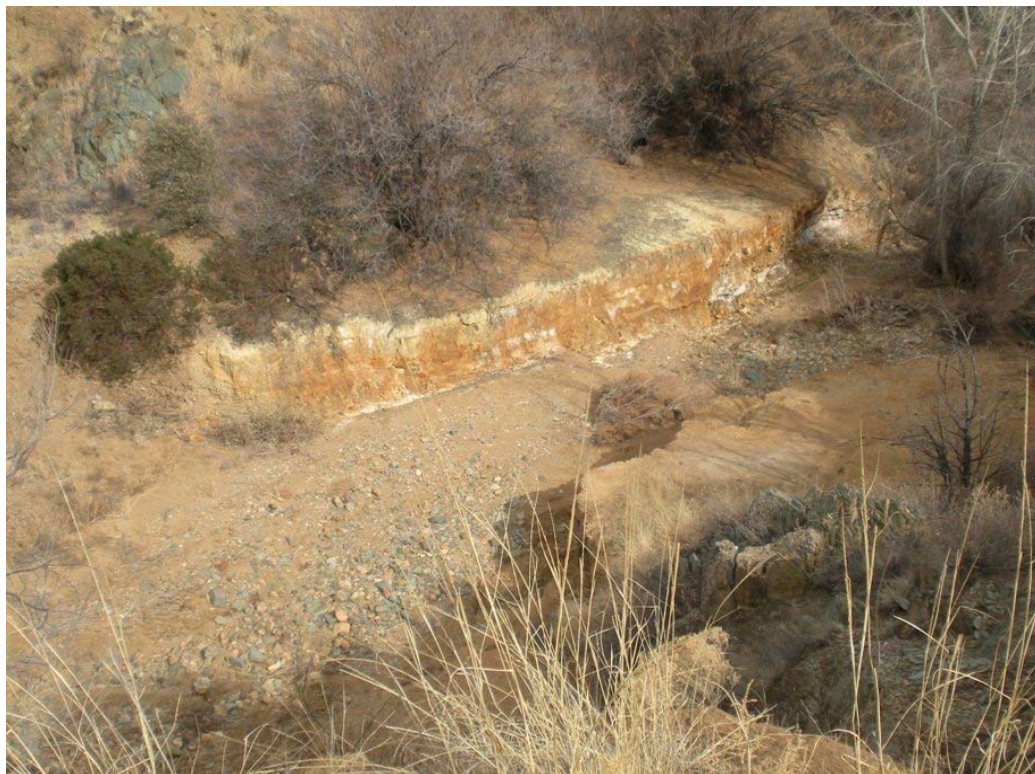
*Photograph 25: Lower Chaparral Gulch at VP23*

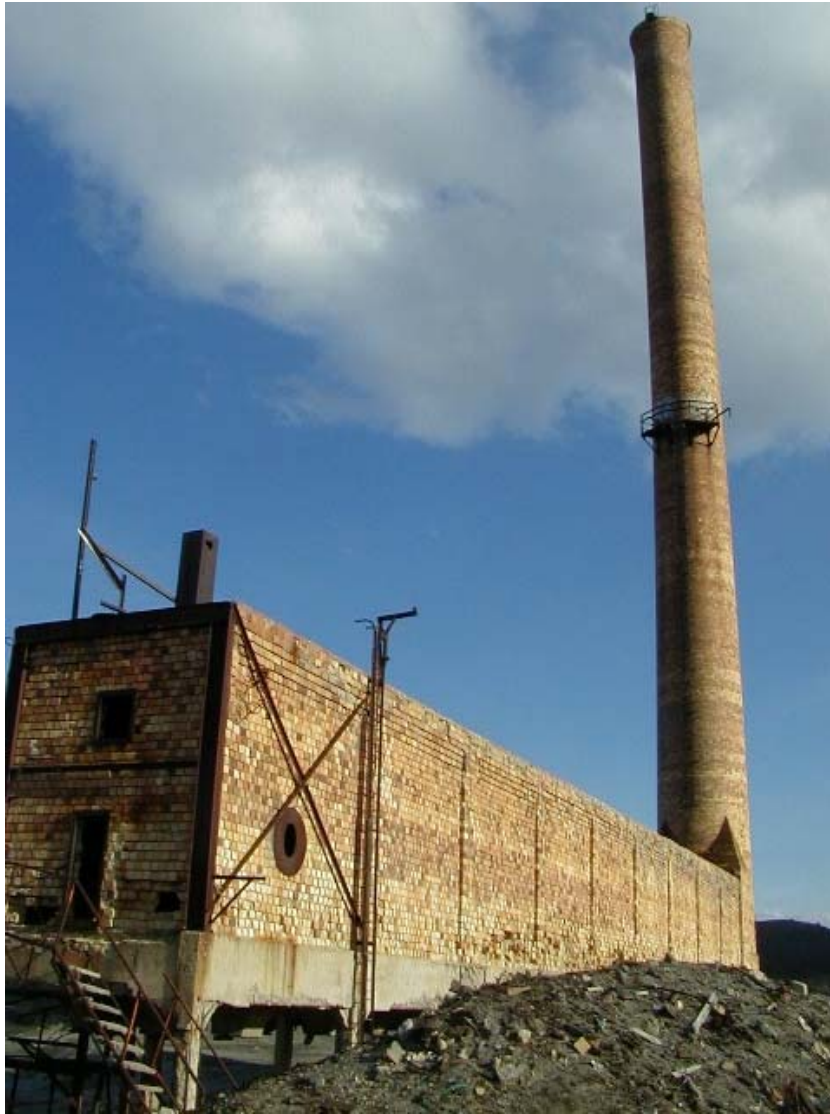
*Photograph 26: Former Humboldt Smelter Pyrometallurgical Operations area, Smelter Stack and brick flue at VP24*

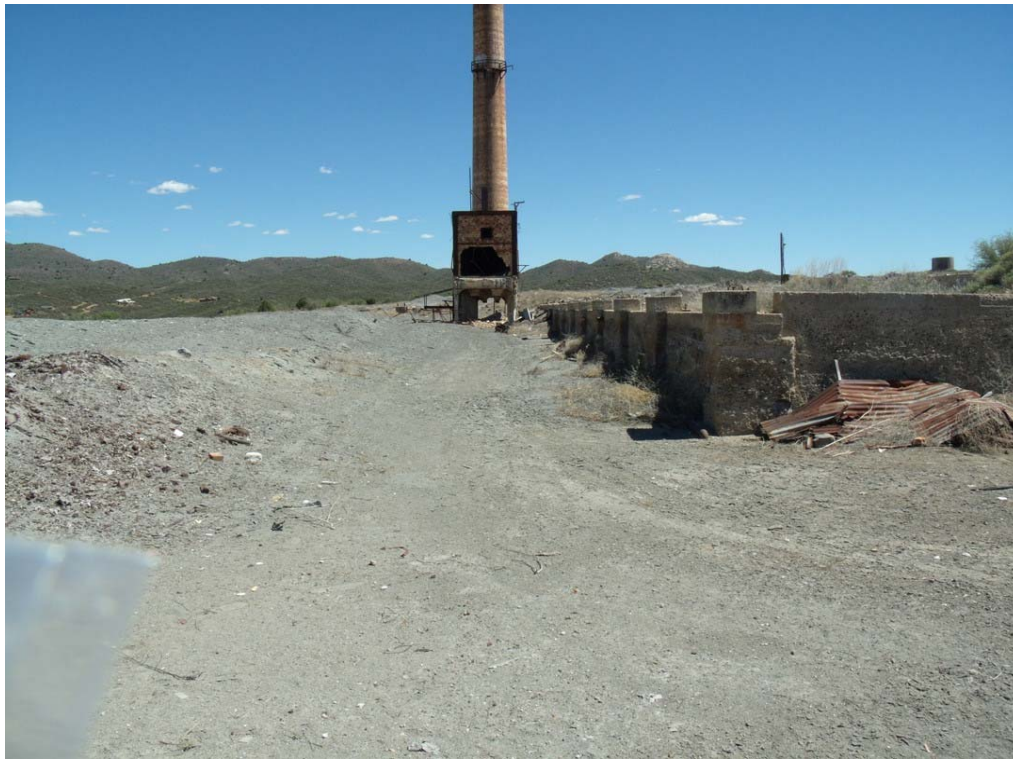
*Photograph 27: Former Humboldt Smelter buildings, Smelter Stack, and dross at VP25*

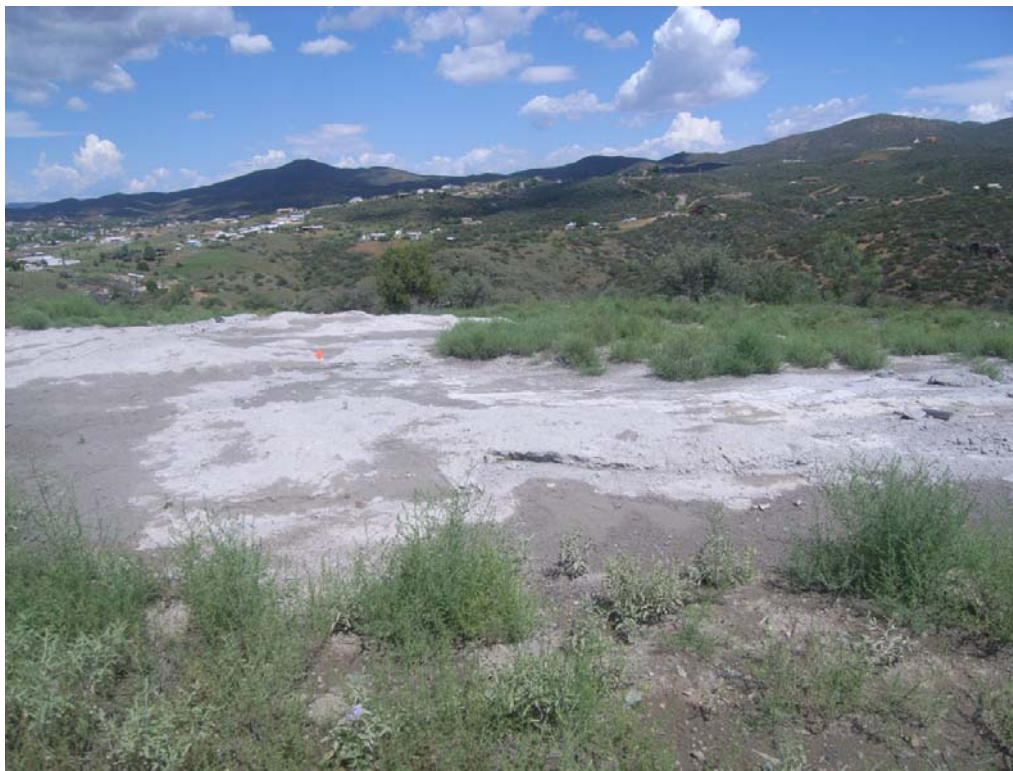
*Photograph 28: Dross at VP26*

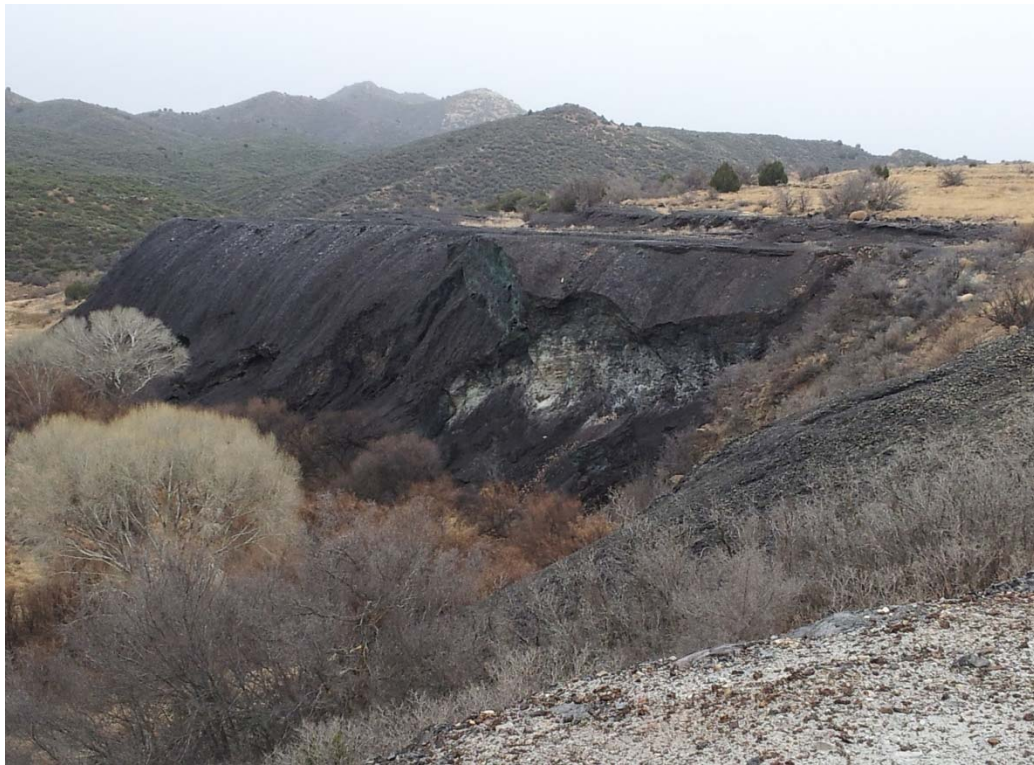
*Photograph 29: Former Humboldt Smelter slag pile and Agua Fria River, looking southwest at VP27*

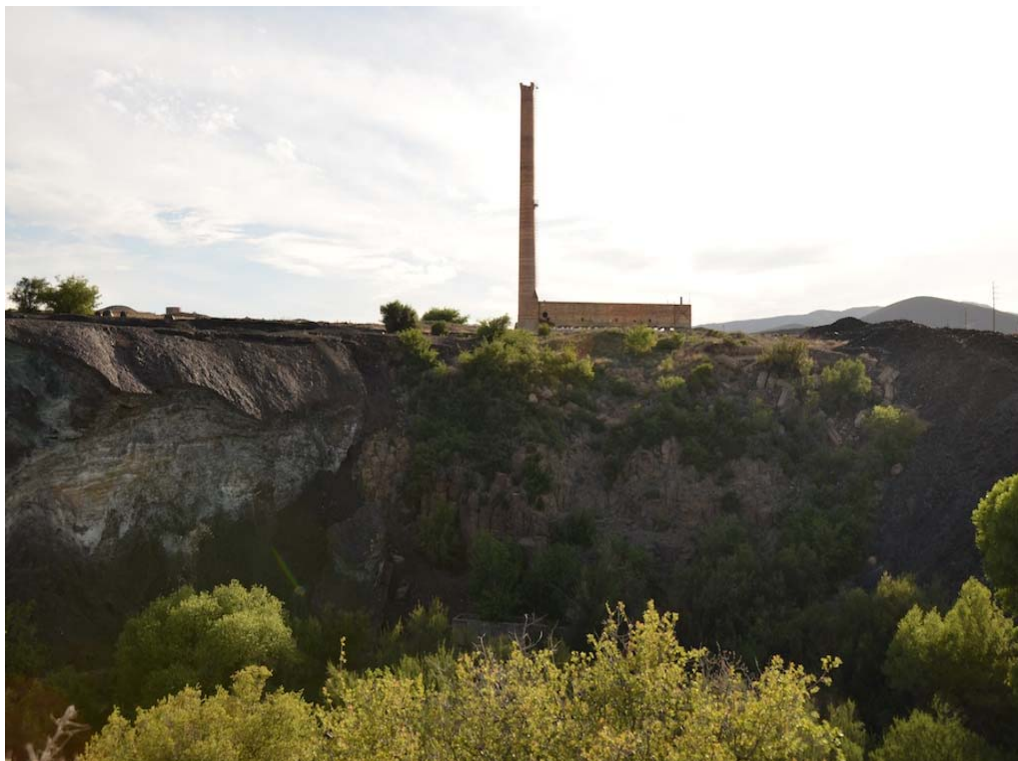
*Photograph 30: Former Humboldt Smelter slag pile and Agua Fria River, looking west at VP27*
