# Appendix A

## Current Site Photographs, Iron King Mine – Humboldt Smelter Superfund Site

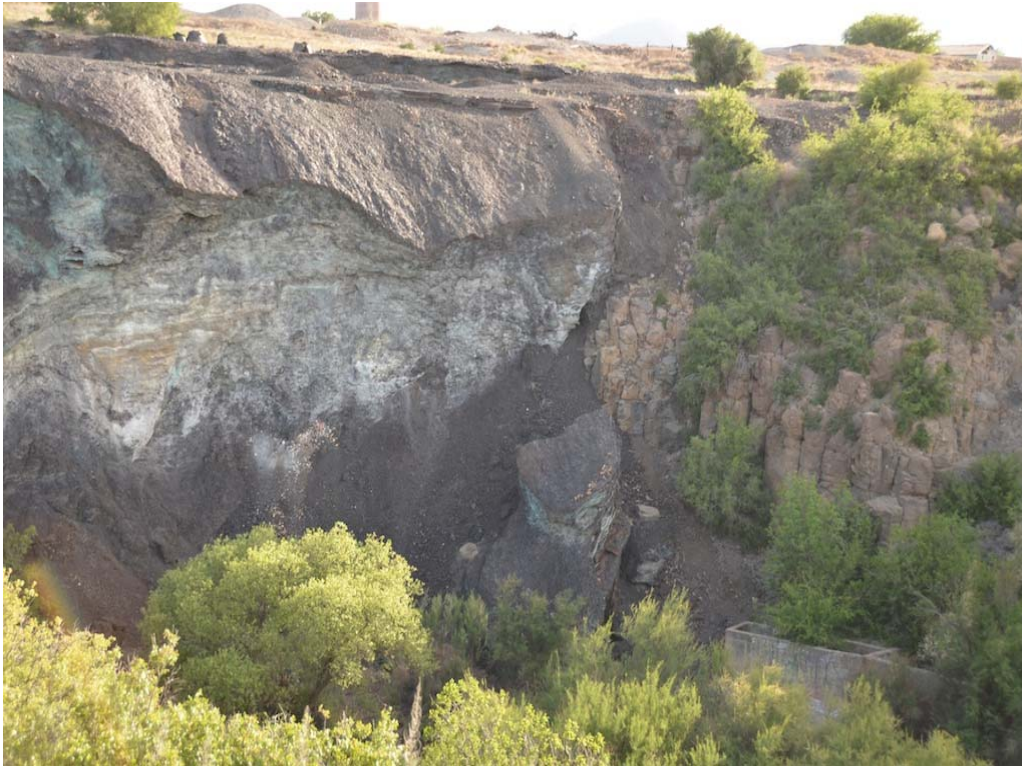
*Photograph 31: Slag pile and Agua Fria River, looking west at VP27*

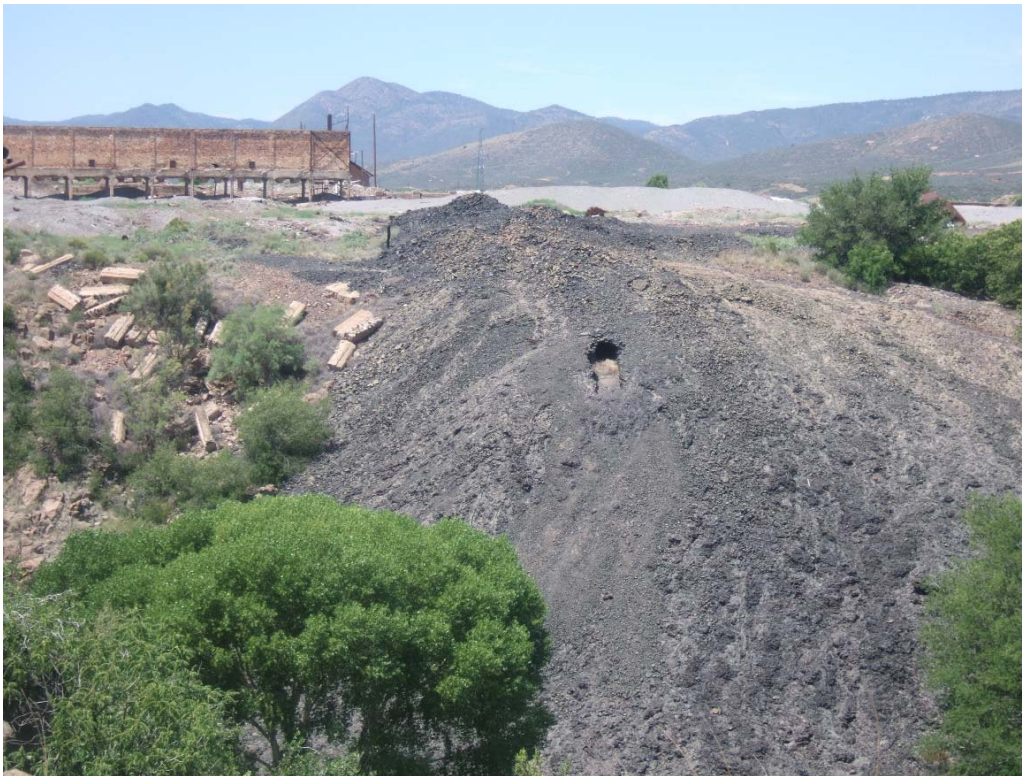
*Photograph 32: Northeastern corner of the primary slag pile, looking northwest at VP27*

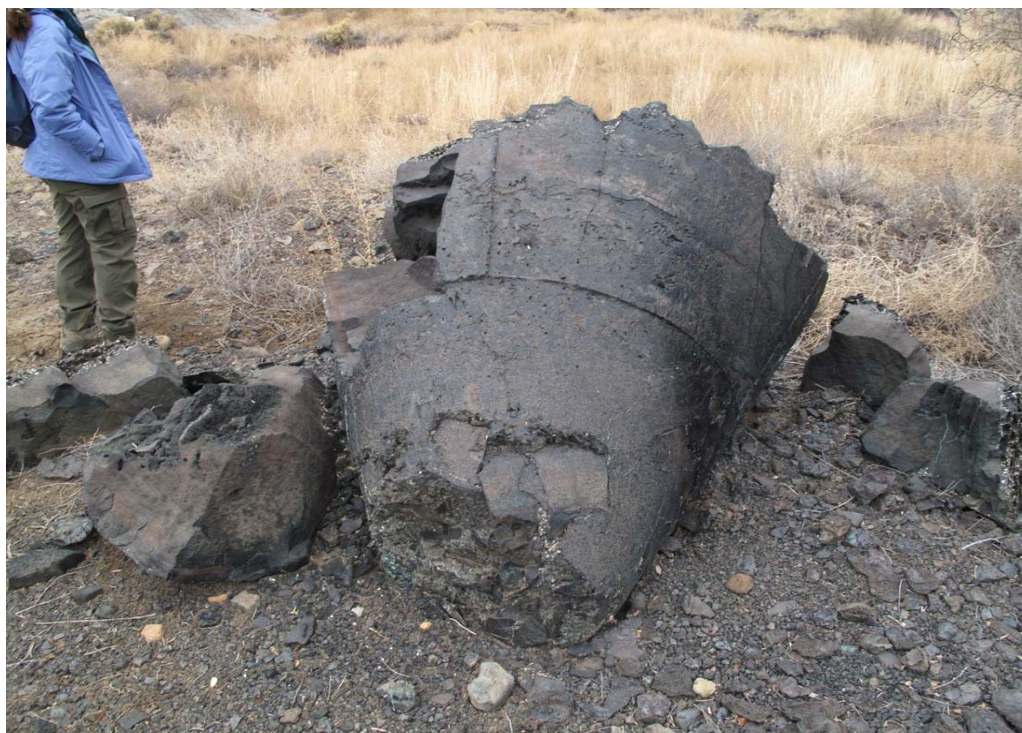
*Photograph 33: Slag material dumped in a solid form from the retort or kiln, resulting in a funnel-shaped 3-foot-diameter fragment at VP28*

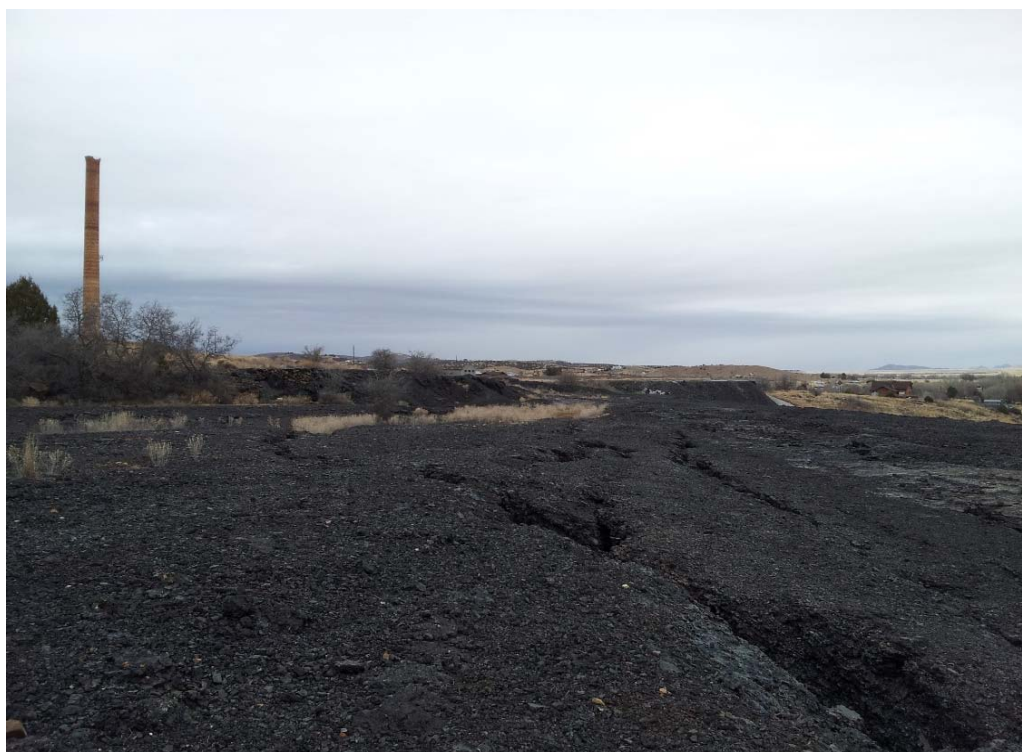
*Photograph 34: Slag Pile at VP29*

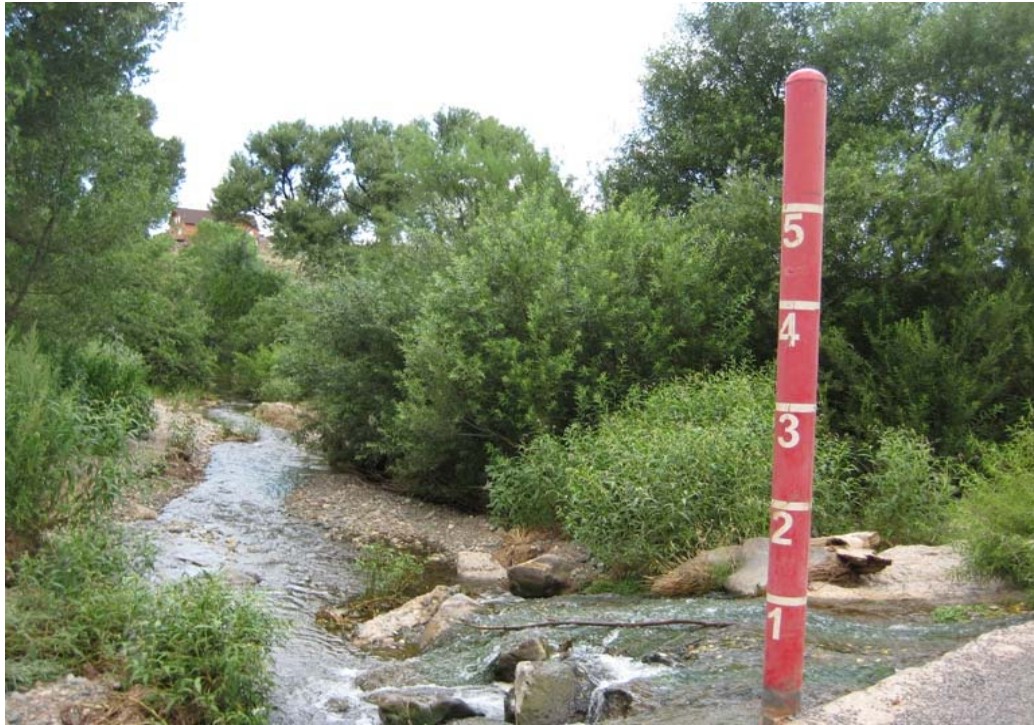
*Photograph 35: Agua Fria River at Prescott Street, looking south at VP30*

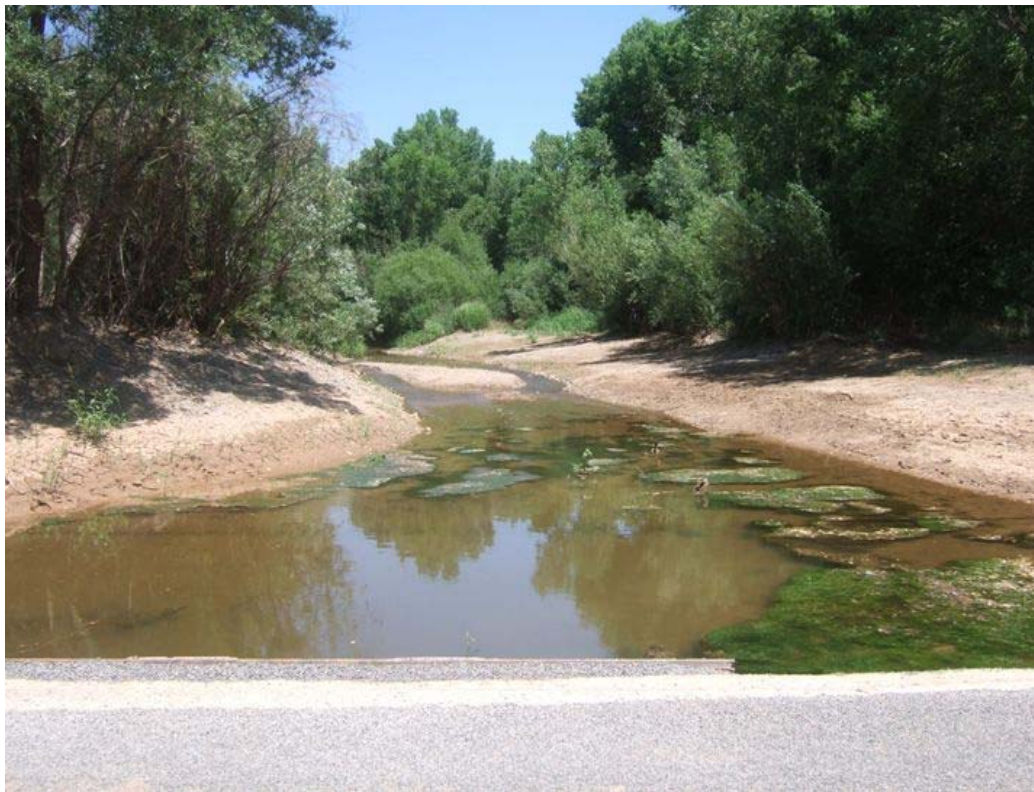
*Photograph 36: Agua Fria River at Prescott Street, looking north at VP31*

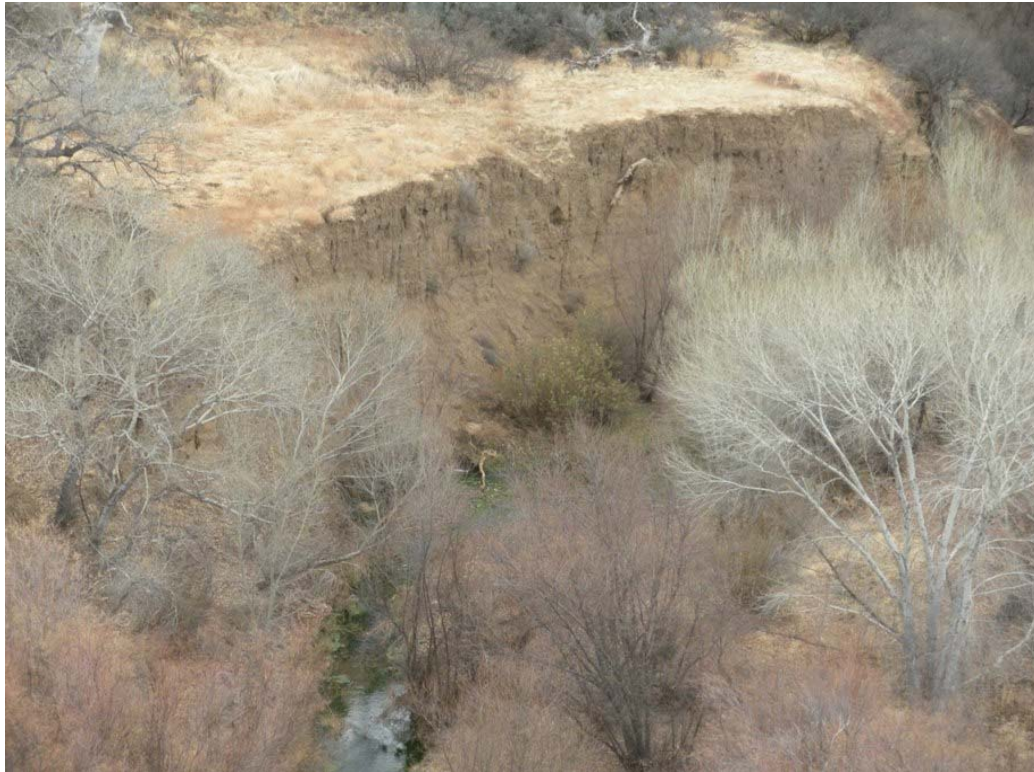
*Photograph 37: Agua Fria Tailings Pile (NR10), just upstream of confluence with Chaparral Gulch at VP32*

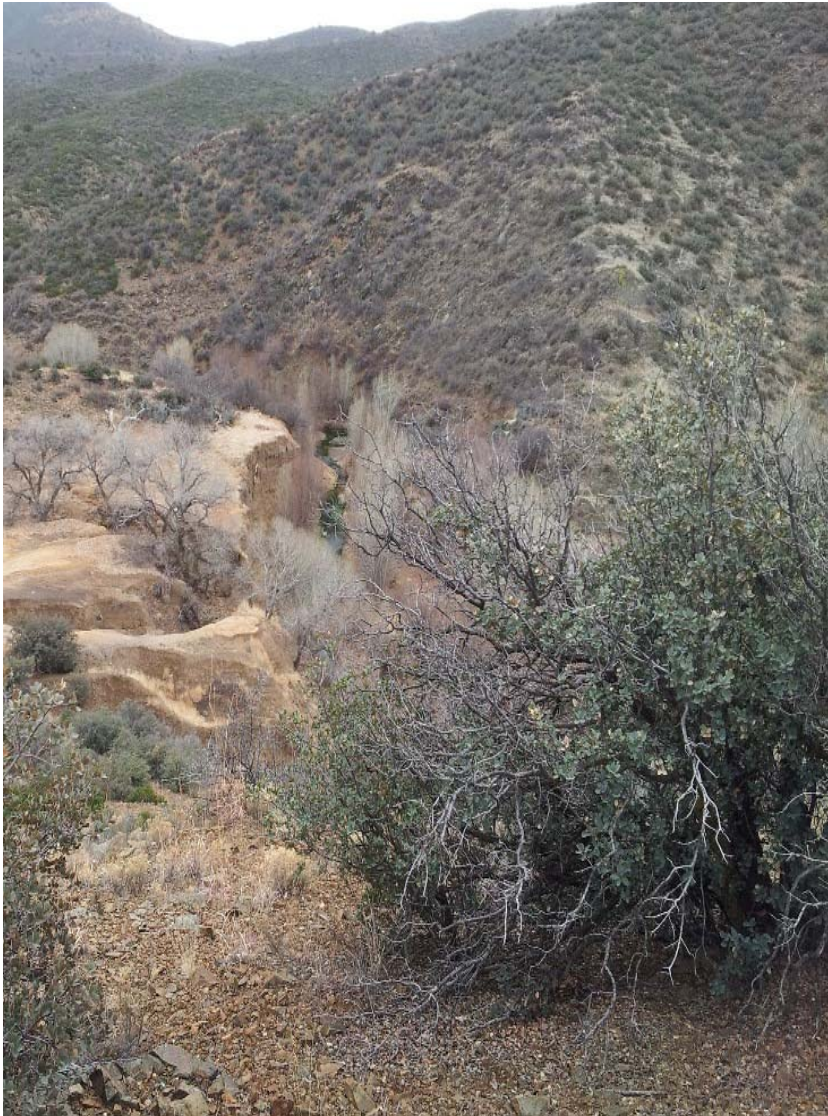
*Photograph 38: Agua Fria River near confluence with Chaparral Gulch at VP33*

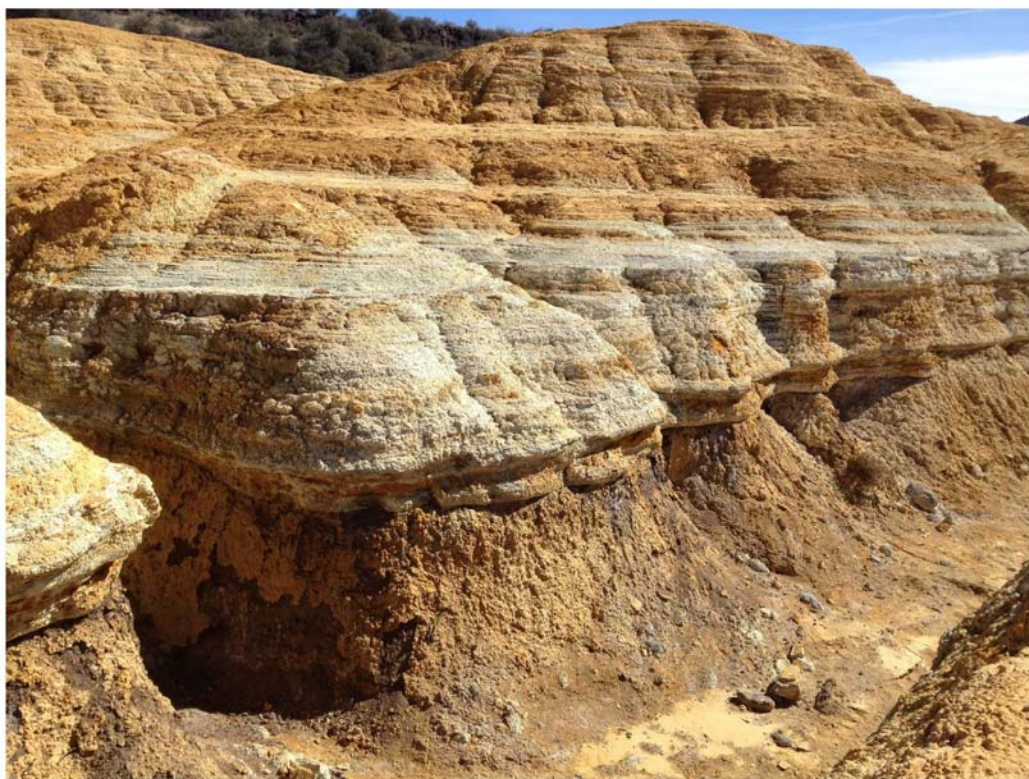
*Photo D004 IMG\_0830: Example of deep erosional gulley cut through existing tailings in the Smelter Tailings Swale; shows underlying natural brown clay layer*

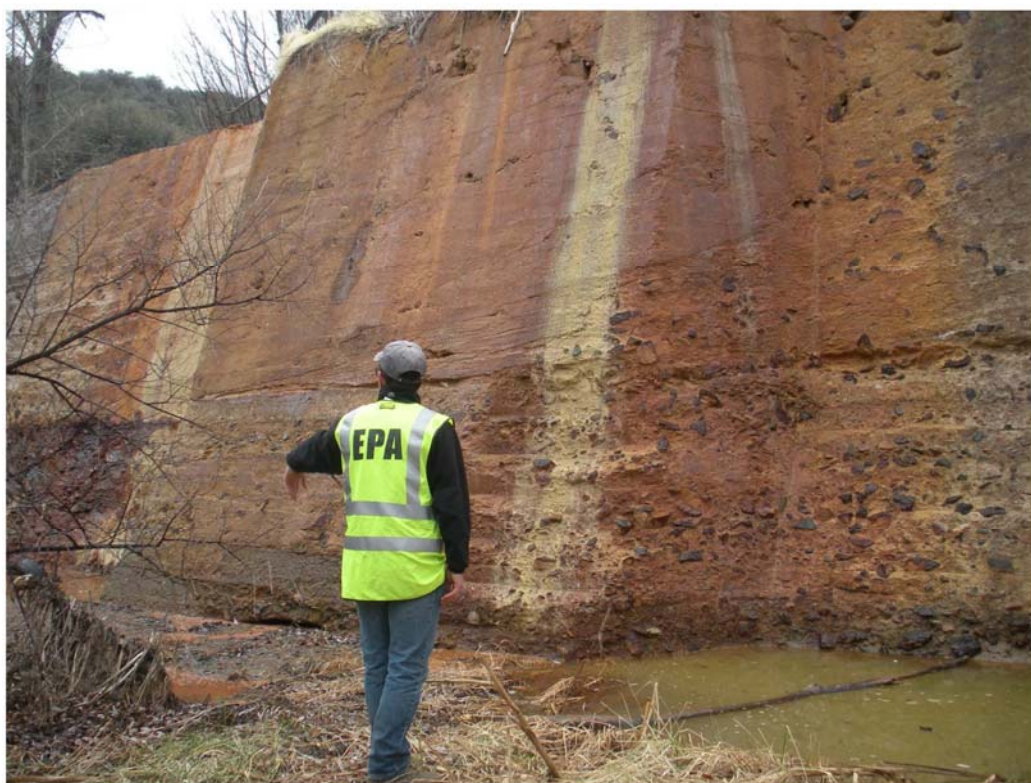
*Photo F002 DSCN0939: Chaparral Gulch Dam*

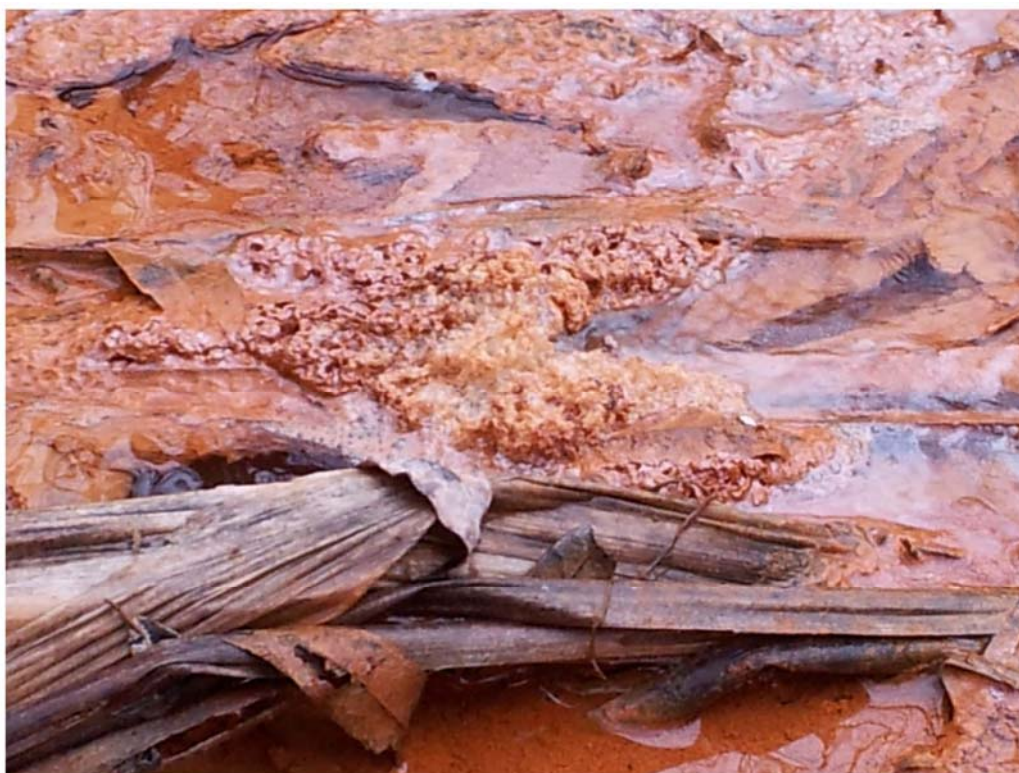
*Photo F009: Red precipitate immediately downstream of Chaparral Gulch Dam*

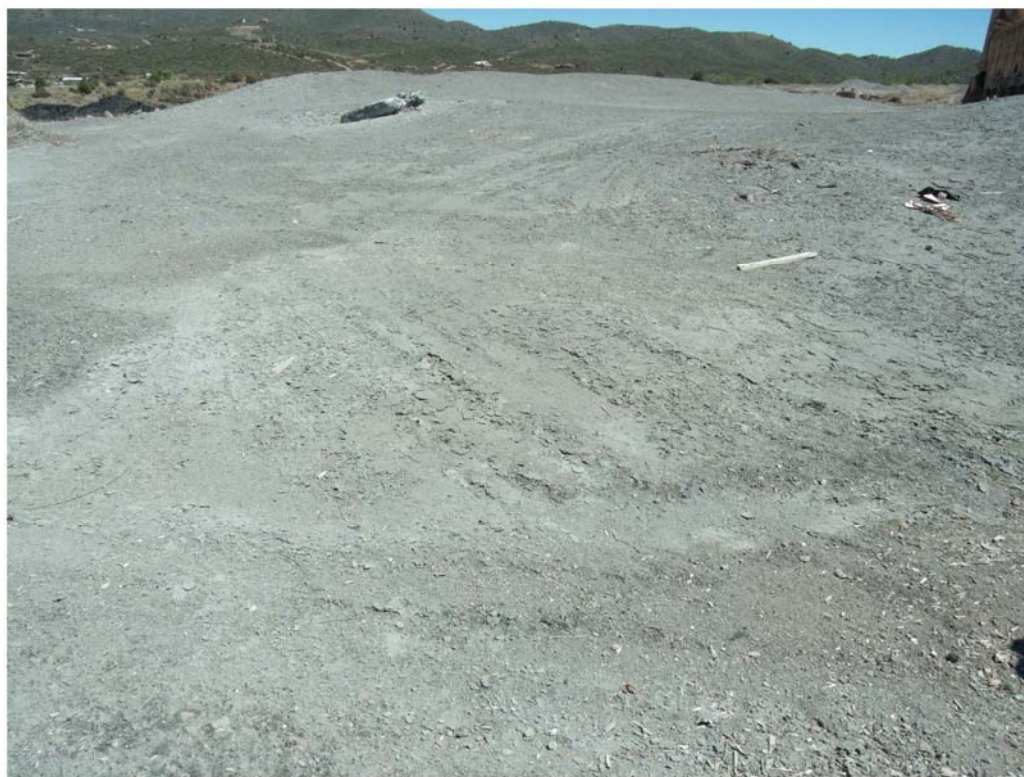
*Photo GEDC1485: Dross material covering Pyrometallurgical Operations area*

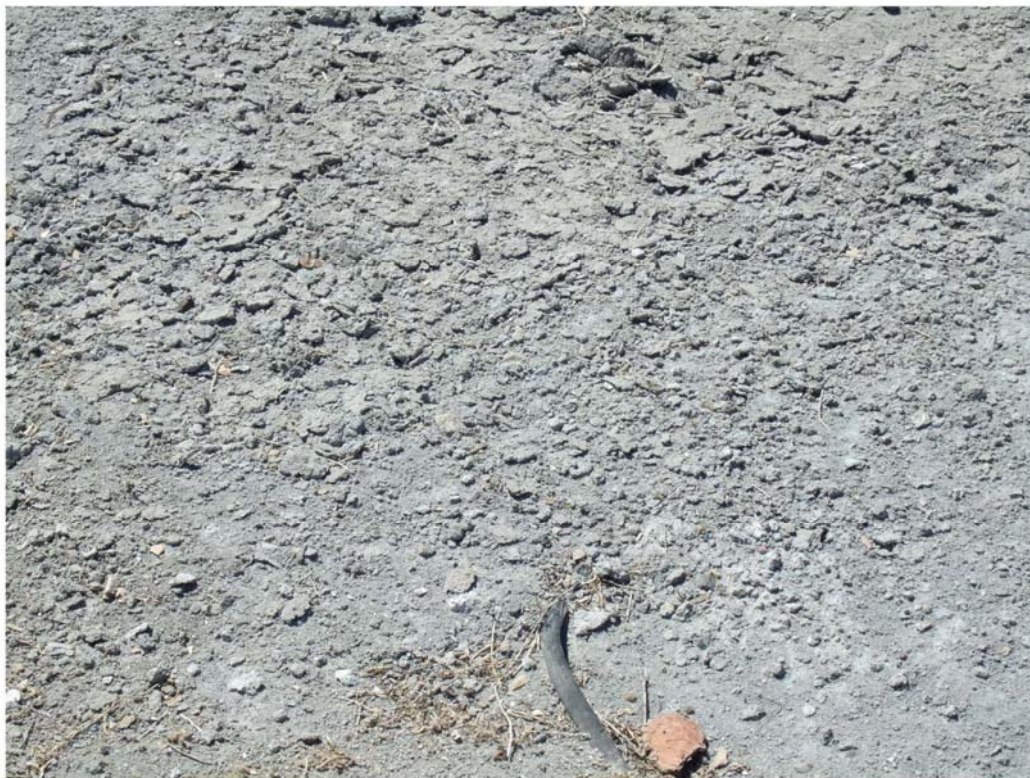
*Photo GEDC1488: Dross material covering Pyrometallurgical Operations area*

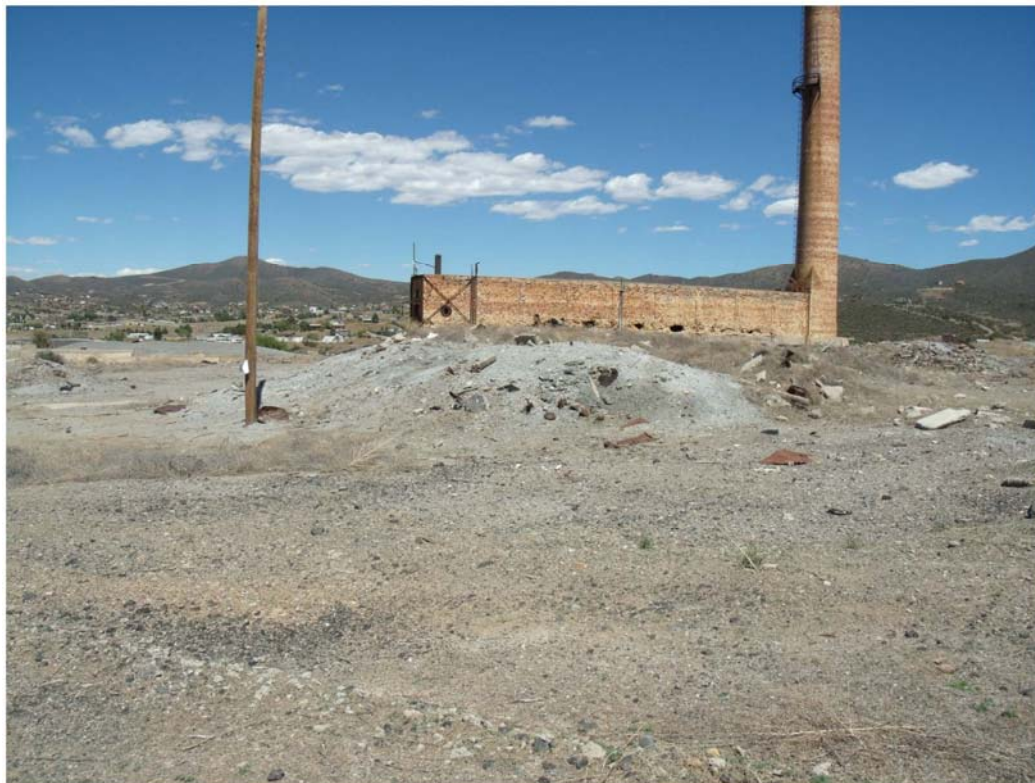
*Photo GEDC1490: Dross material covering Pyrometallurgical Operations area at Humboldt Smelter*

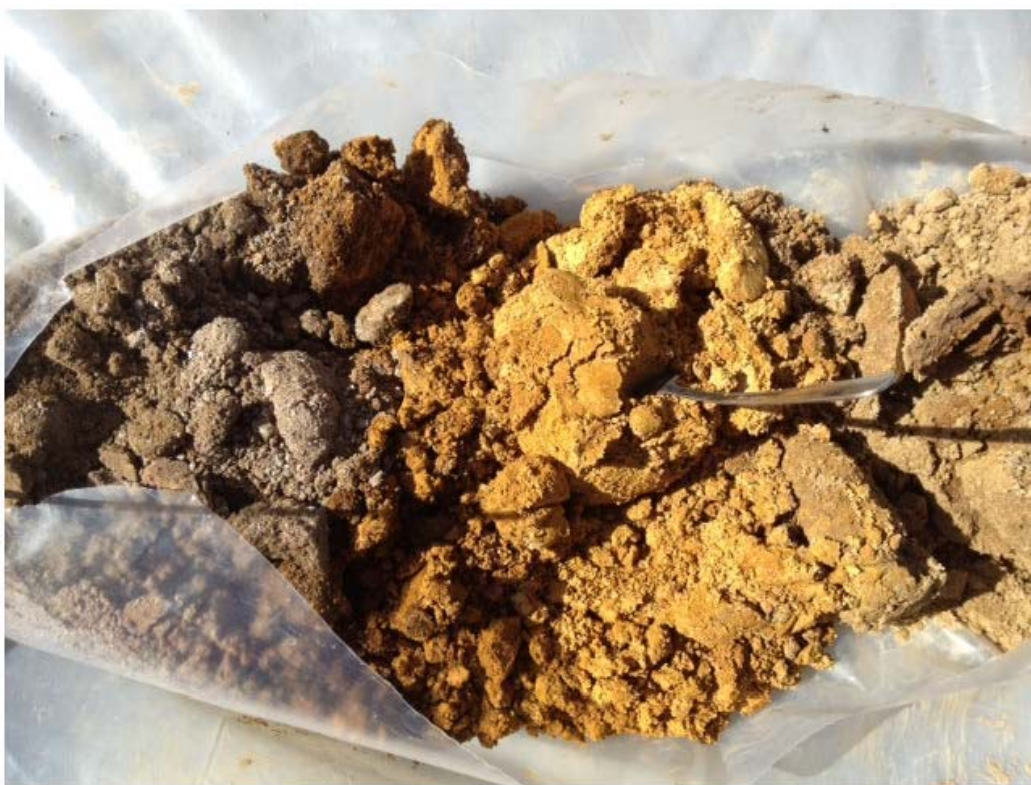
*Photo 1: Part of a core into the Tailings Floodplain showing yellow-orange oxidized tailings layer on top of other deposit material*

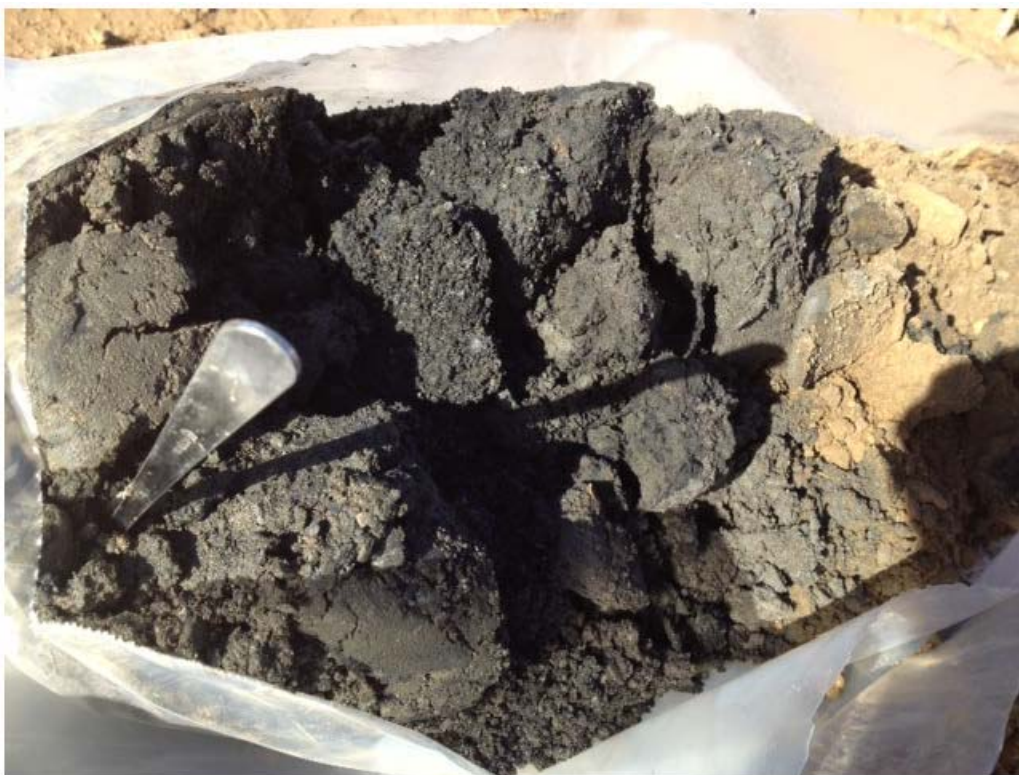
*Photo 2: Part of a core into the Tailings Floodplain, showing black reduced (anoxic) tailings*
