Appendix E: Photographs, Zizzo Properties, Kenosha, WI

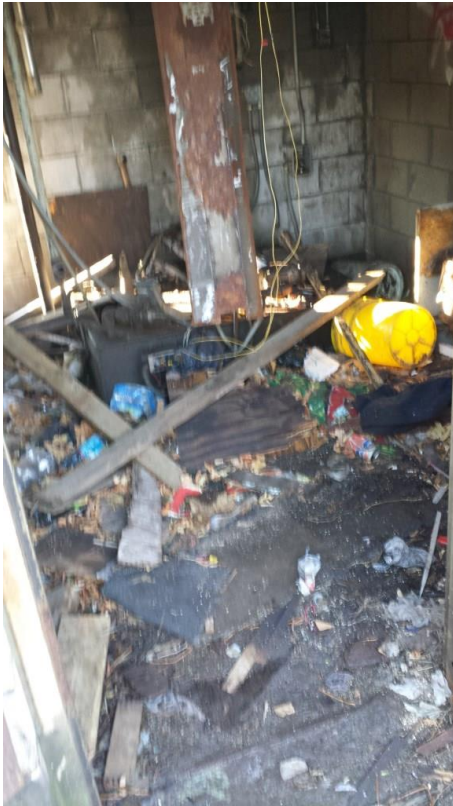
Photo 1: View inside conveyor tower

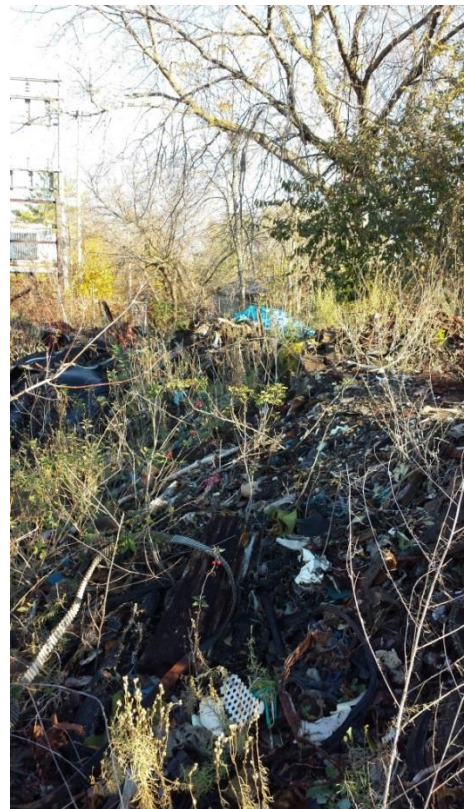
Photo 4: View NE toward debris pile on east side of property

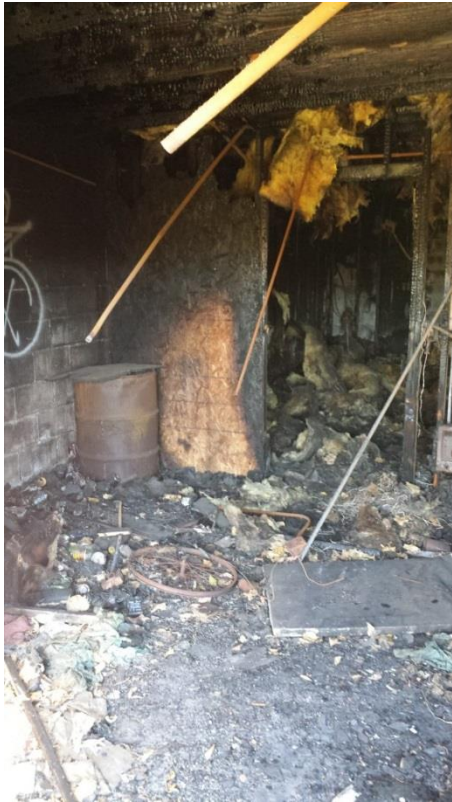
Photo 5: View inside red building on NW corner of property

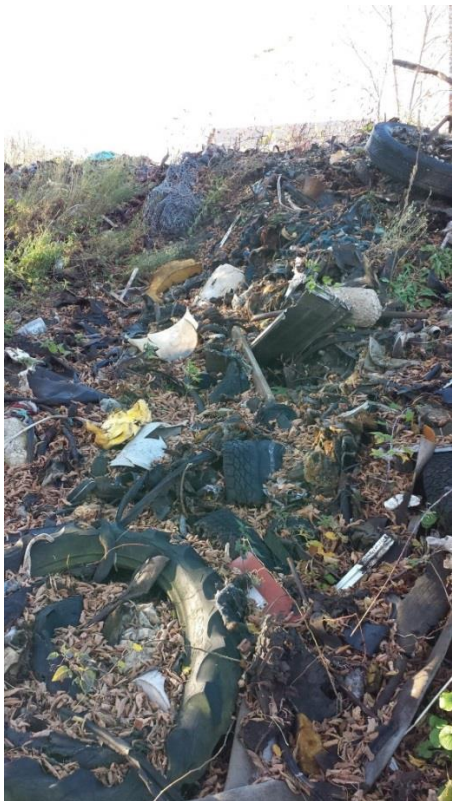
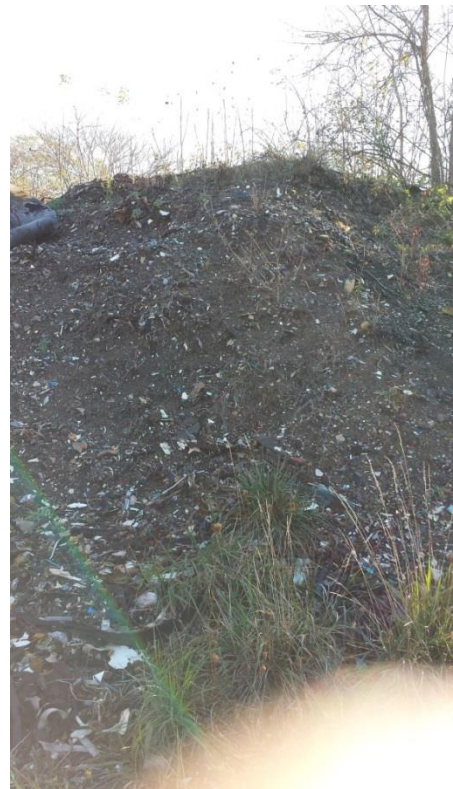
Photos 7 & 8: Views east toward auto shredder fluff on east side of property

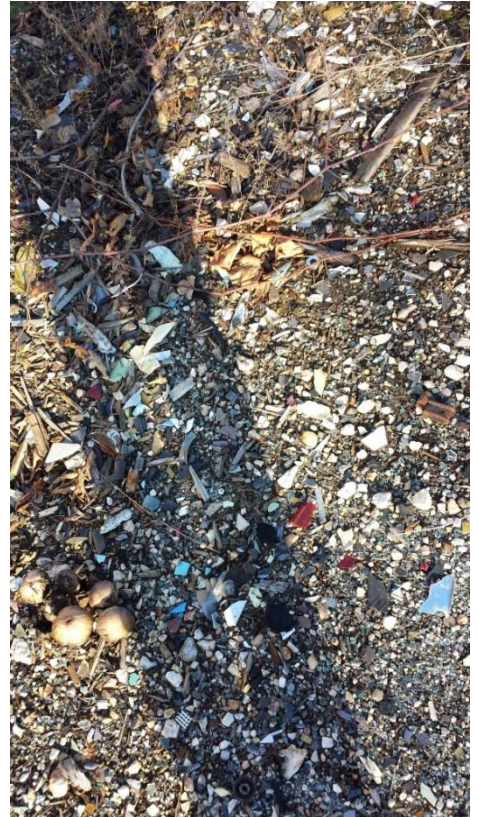
Photo 12: Common ground surface appearance

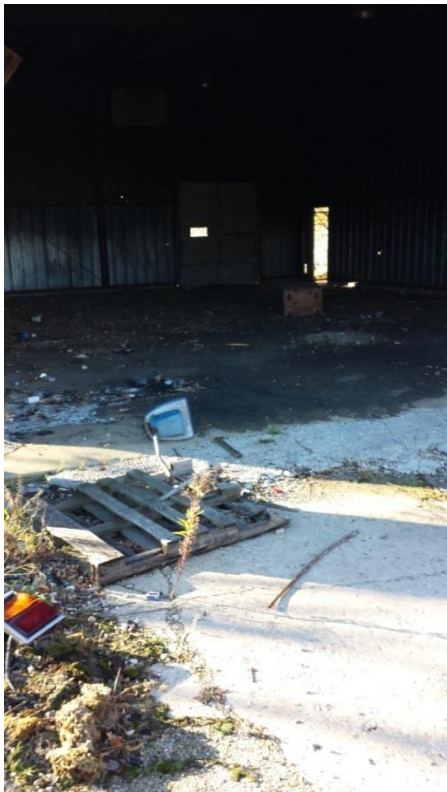
Photo 15: View inside building in south portion of site

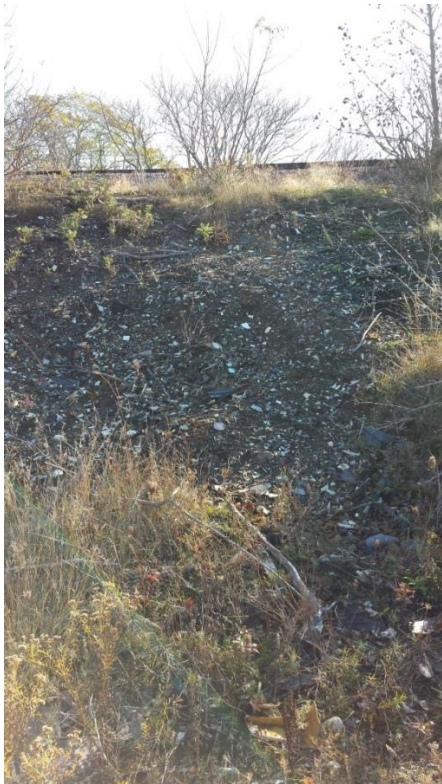
Photos 19: Auto fluff along east side of site

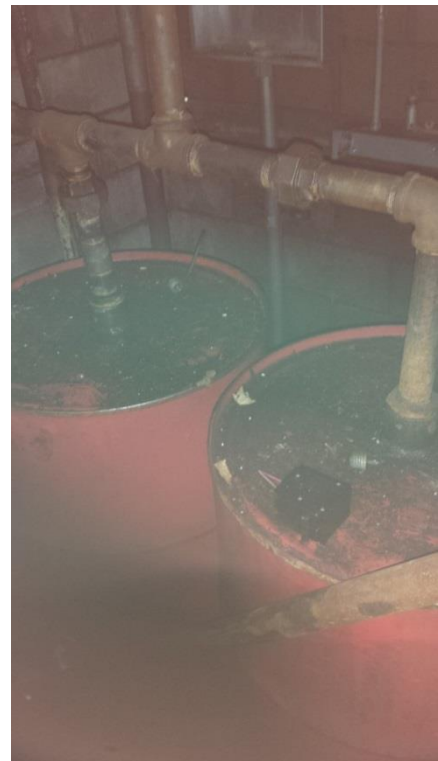
Photo 20: Drums on 2<sup>nd</sup> floor of tower

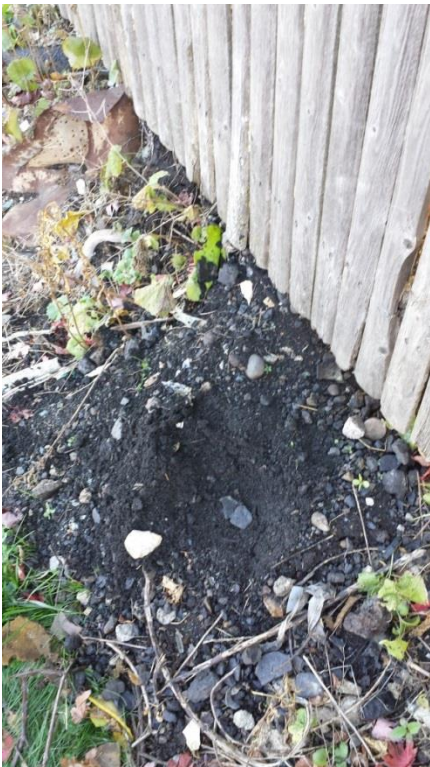
Photo 23: Debris and black soil beneath fence on west side of site

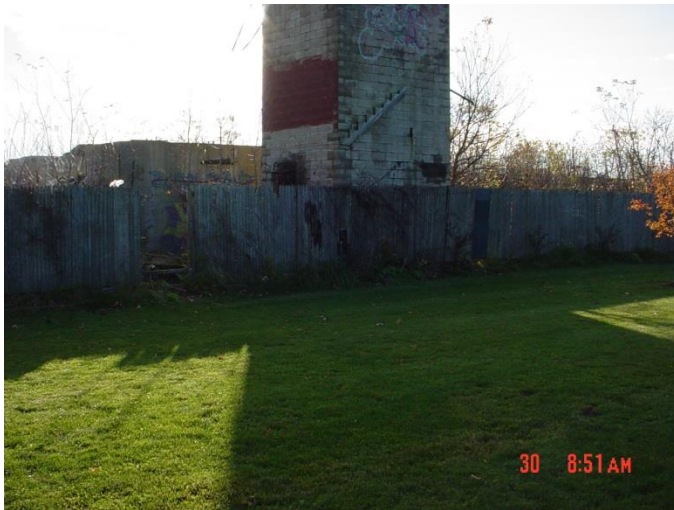
Photo 29: View southeast toward west side of property (note hole in fence)

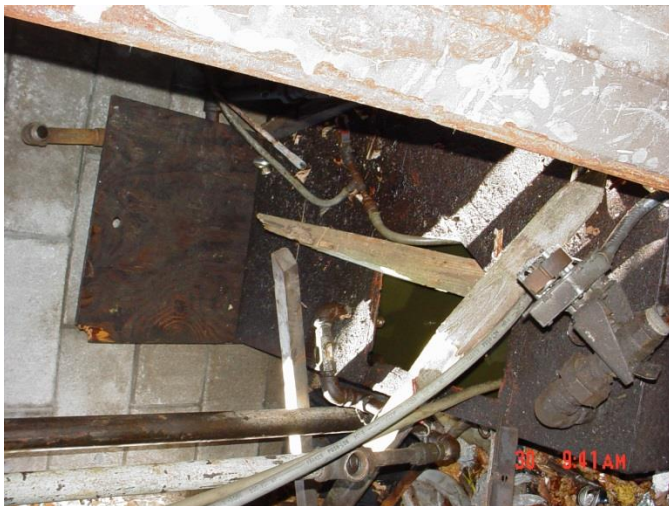
Photo 30: Container of hydraulic oil in conveyor tower

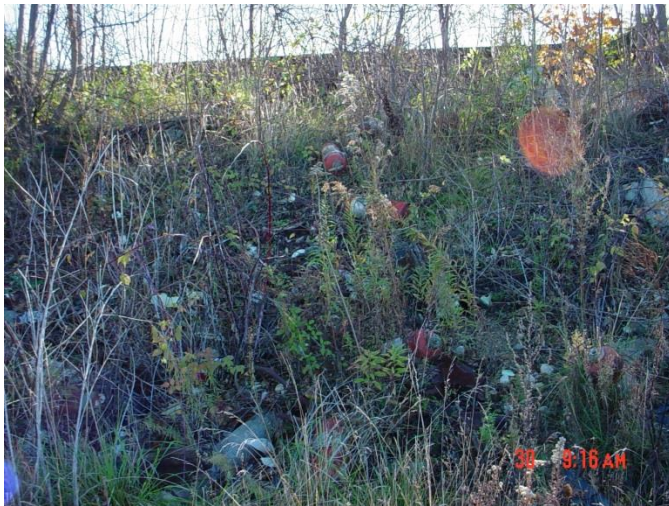
Photo 32: View east toward several fire extinguishers incorporated within auto shredder fluff

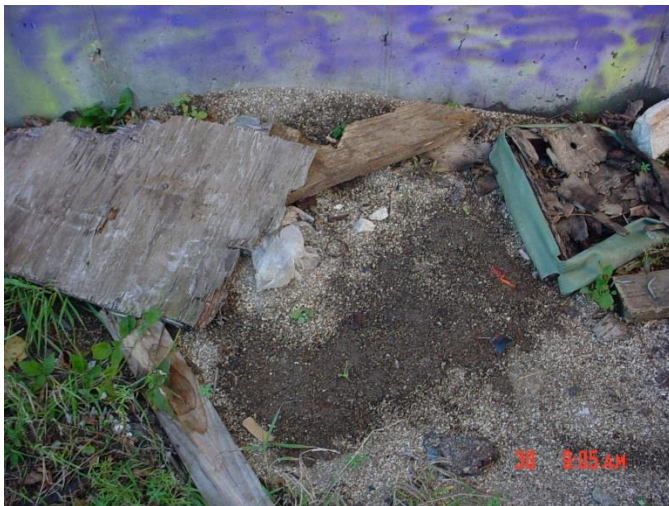
Photo 33: Stained soil near conveyor tower
