US Army Corps of Engineers

Heavy Rainfall Inspection Monitoring Report 2015

Argonaut Mine Dam Inspection and Site Support
Amador County, California

Report Date: 1-20-2016

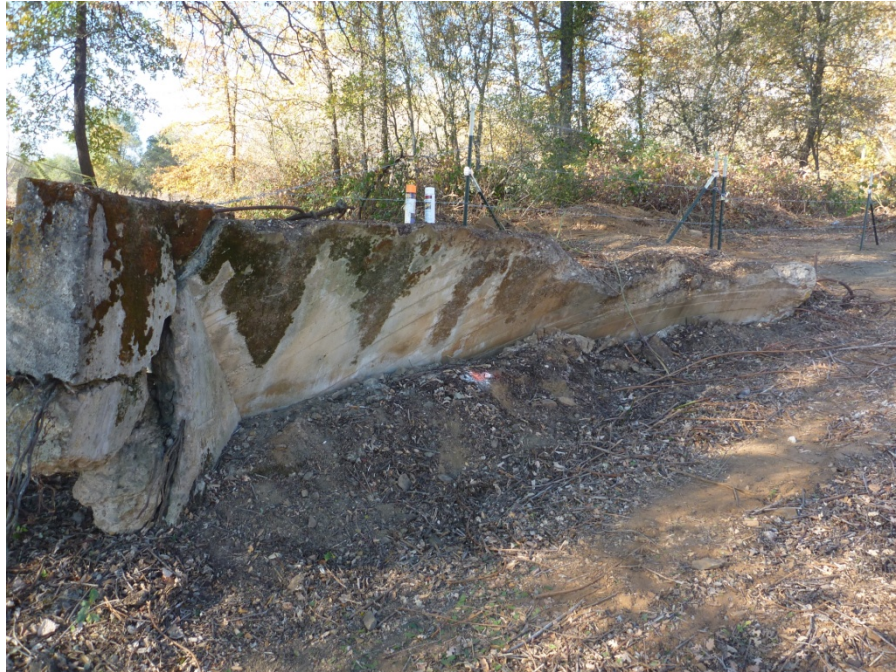
- *Arch #1*: Found to be partially demolished from road construction and remnants possibly buried. The right buttress wall is severely damaged with several large pieces of concrete hanging away from the buttress and held in place by only the embed cable.

Figure 1 Condition of Arch #1

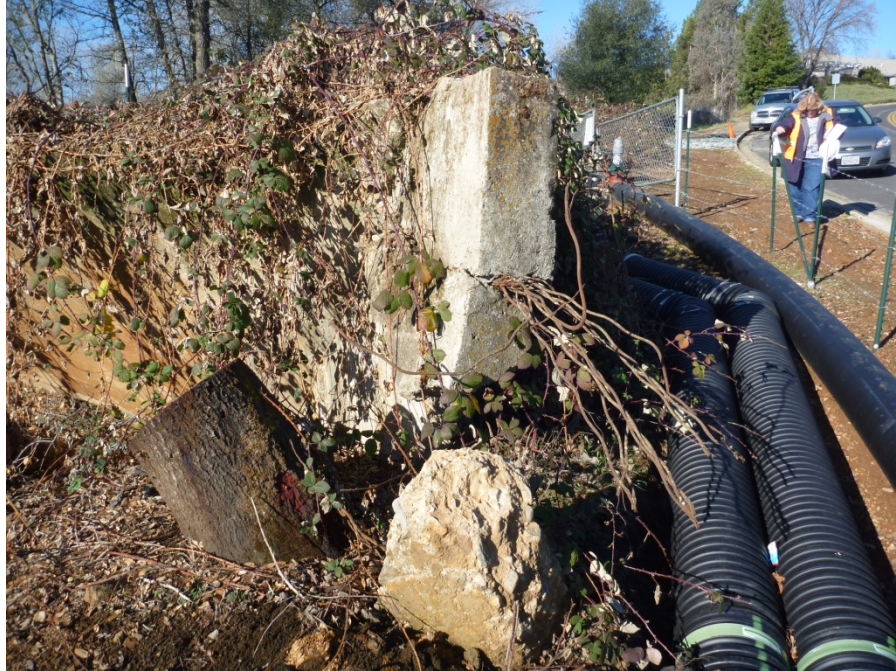
Figure 2 Condition of Right Buttress Wall of Arch #1

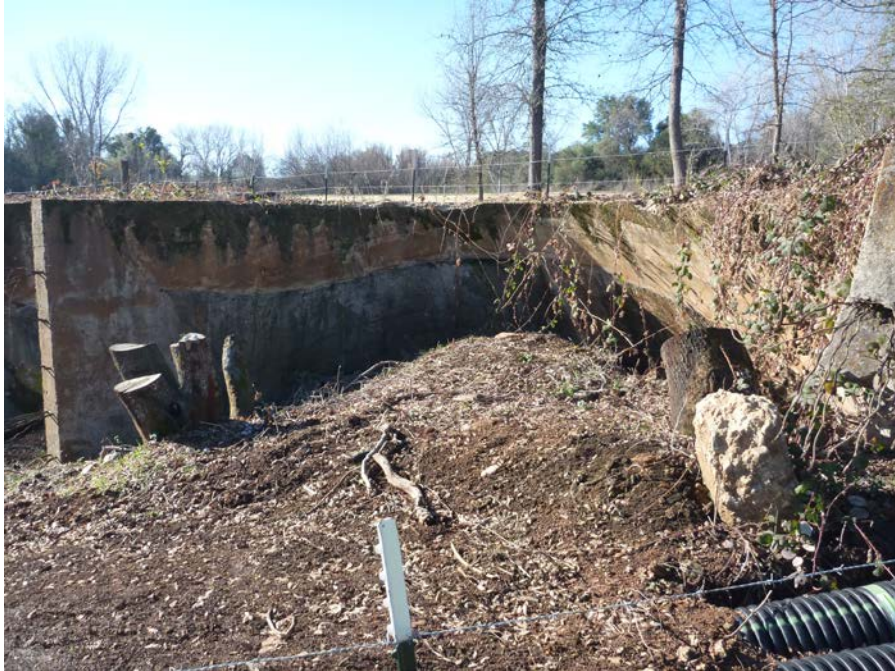
- *Arch #2*: Found to have several large cracks through the arch with active seepage. The right buttress wall has delaminated sections of concrete. Appendix A illustrates the locations of some of the large cracks within the arch. These cracks do not appear to be new due to the large accumulation of algae and sediment build up suggesting that water leakage thru the cracks has occurred consistently over the years. See Figure below.

Figure 3 Condition of Arch #2

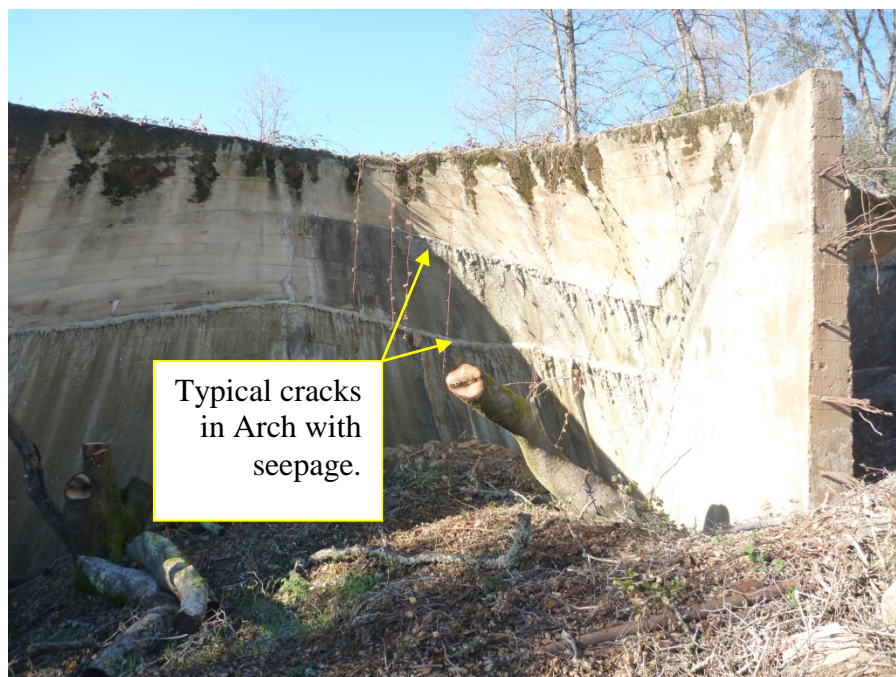
- *Arch #3*: Observed to have similar cracks in the arch as Arch #2. The top edge of the arch in multiple locations was also noted to have small concrete spalls. Other locations on the right buttress were also observed to have concrete spalls that have exposed the embed cables. See Figure below.

Figure 4 Condition of Arch #3

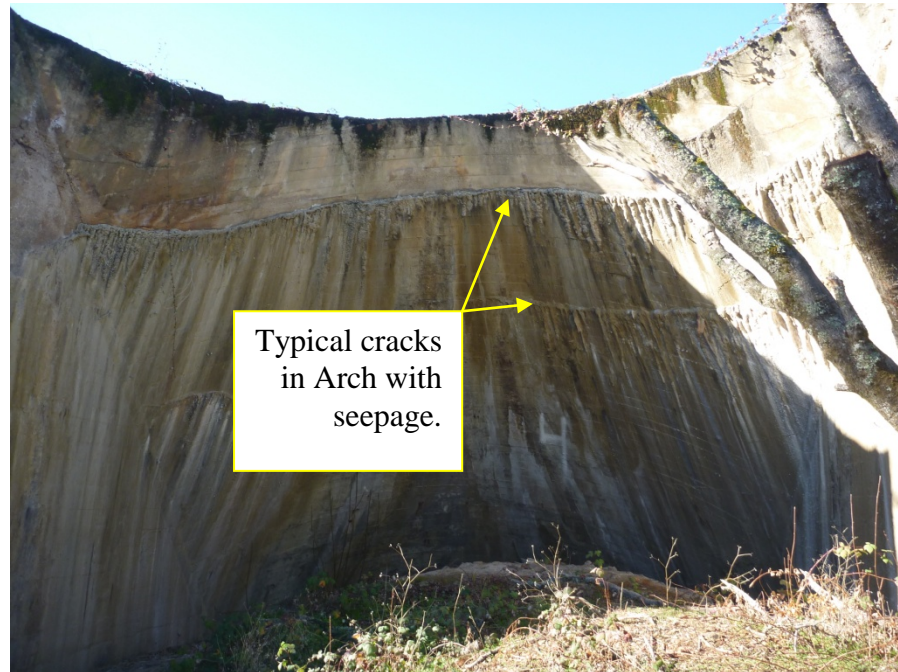
- *Arch #4*: Observed to have similar cracks in the arch as discussed previously for Arches #2 and #3. Large cracks were observed along the upper portion of the buttress walls and minor spalling also was found along the arch edge. These conditions do not appear to be new. See Figure below.

Figure 5 Condition of Arch #4

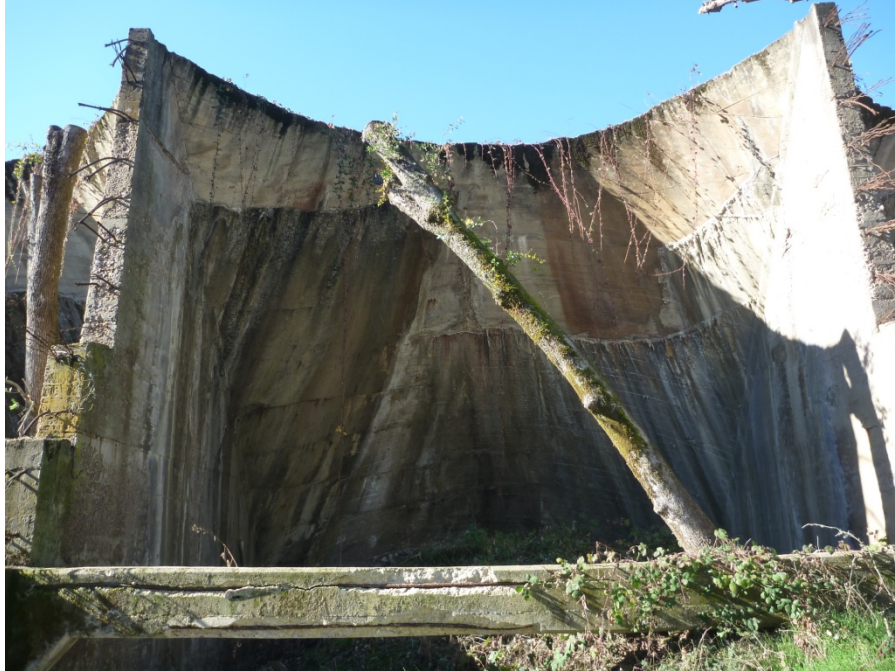
- *Arch #5*: Typical cracking and active seepage of the arch was again observed. However, a large diagonal crack in the right buttress wall was found, which was not found to be typical among the previously inspected arches. This crack should be monitored closely with the use of crack gauges. The type of crack gauges to be used and the location to position the gauge is discussed in the recommendation section. The figure below illustrates the crack, which was found to disappear possibly into the foundation 13'-6" from the visible arch, see Appendix A. The surface of the right buttress was found to be flaky possibly due to years of freeze thaw damage. The tie beam connecting the two buttress walls was found to be in poor condition. As noted in the previous inspection reports and the Phase I and Phase II inspection reports, the left support of the tie beam has cracked completely through and only the embed cables appear to be holding the tie beam in place. Severe cracking with extensive spalling, which exposes much of the embed cables to the elements was observed along the length of the tie beam. Freeze thaw damage was also observed on the buttress steps. The figures below illustrate some of the observations made for this arch.

Figure 6 Condition of Arch #5

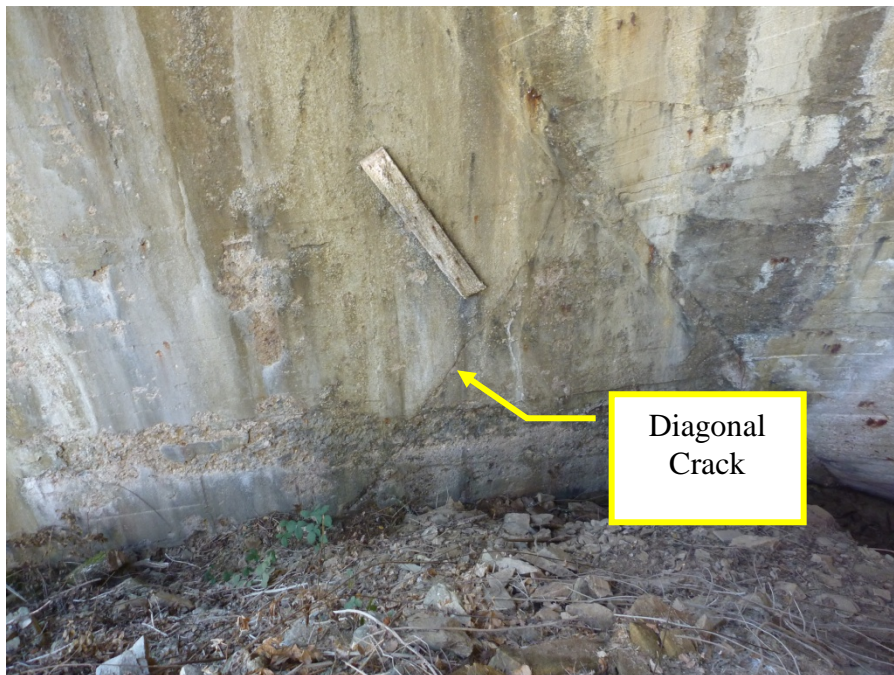
Figure 7 Right Buttress Wall of Arch #5 with Diagonal Crack

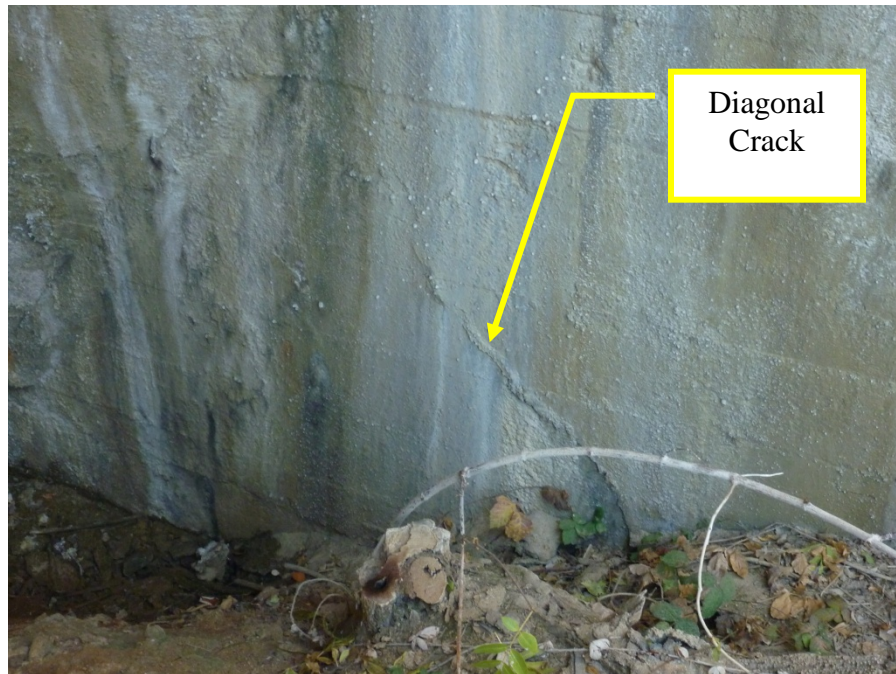
Figure 8 Left Buttress Wall of Arch #5 with Diagonal Crack

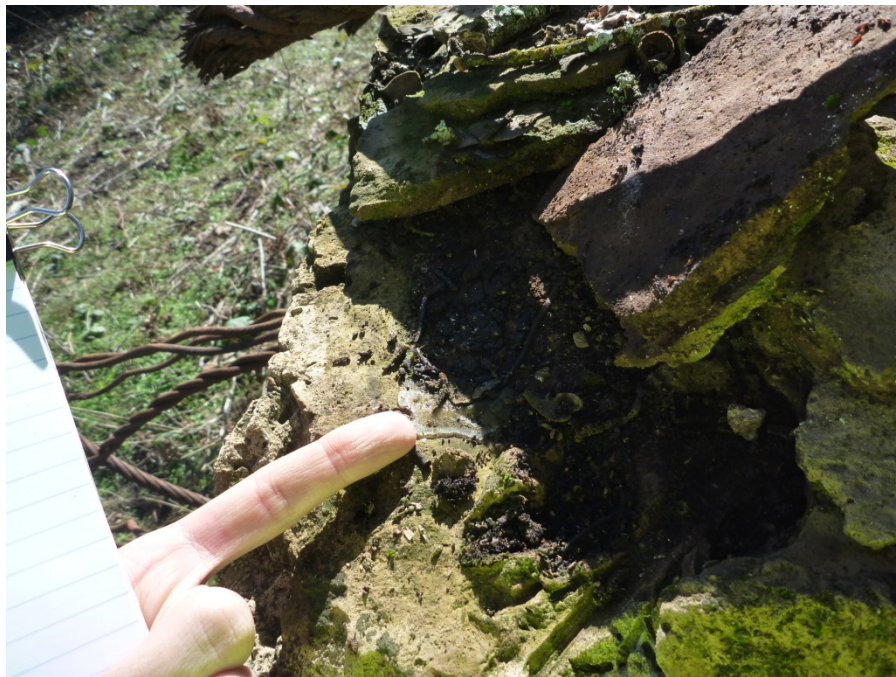
Figure 9 Right Buttress Wall of Arch #5 showing signs of Freeze Thaw Damage

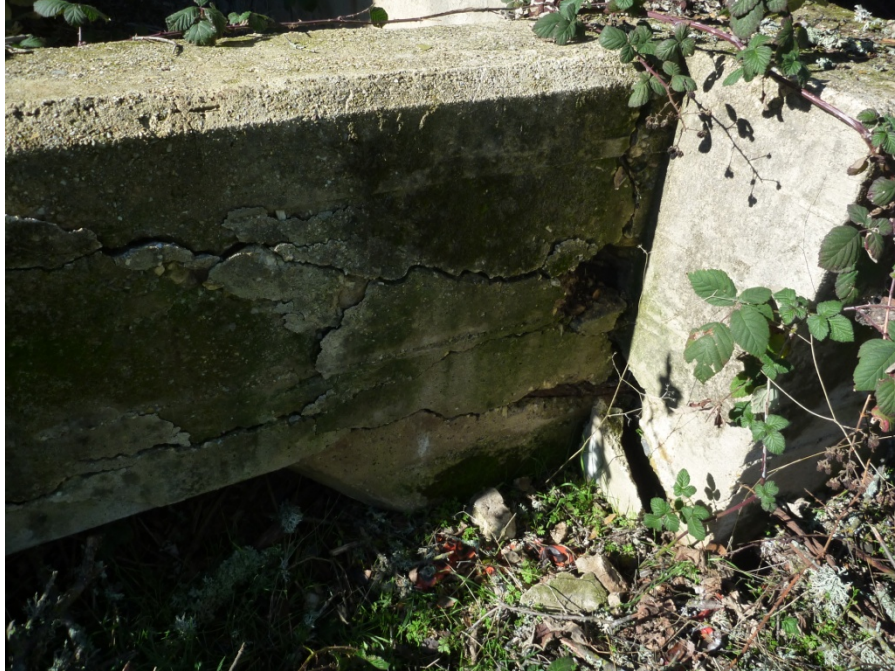
Figure 10 Failed Tie Beam extending between Buttresses of Arch #5

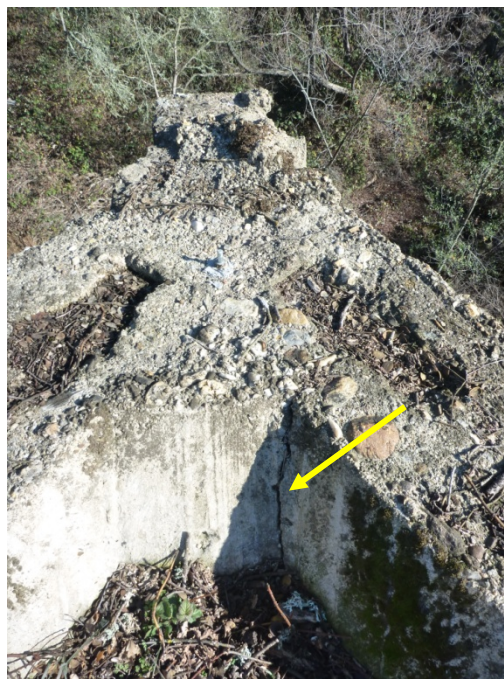
Figure 11 Crack between Arch and Buttress Shared by Arches 5 and 6

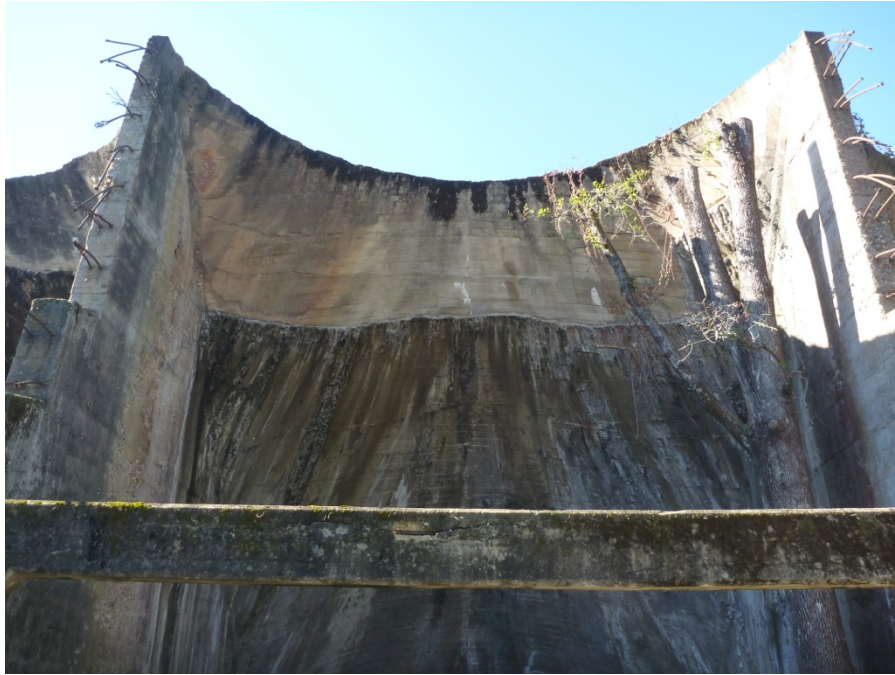
- *Arch #6:* The diagonal crack observed in the right buttress of Arch #5 was found to extend through the entire thickness of the buttress wall shared between Arch #5 and Arch #6. This is concerning as there is little to no modern reinforcement within the buttress to maintain structural integrity across this crack. It is likely that the embed cables do cross the crack and provide some level of stability, but nonetheless this crack should be closely monitored for changes and movement. Further recommendations regarding this crack will be discussed

later. The buttress shared by arches 5 and 6 appeared to have a very slight bow to it based on a visual observation of the tie beam line extending across the dam. However, this bow may also be a result of construction and not necessarily dam movement. The tie beam showed extensive cracking and was found to be in poor condition. The figures below illustrate the various conditions found at Arch #6.

Figure 12 Condition of Arch #6

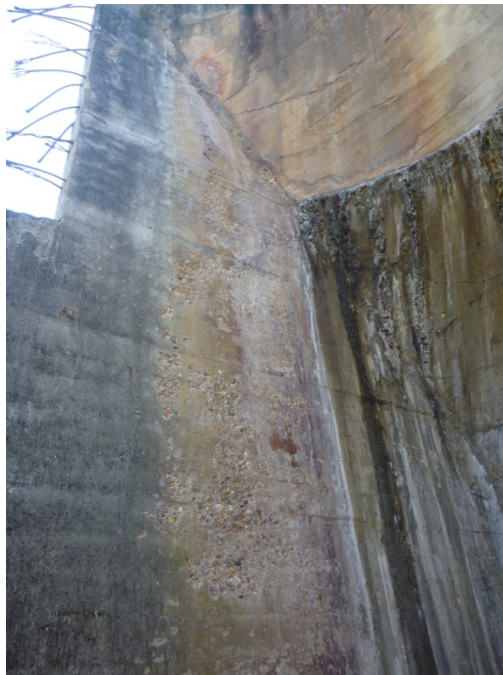
Figure 13 Possible Freeze Thaw Damage on Buttress Wall

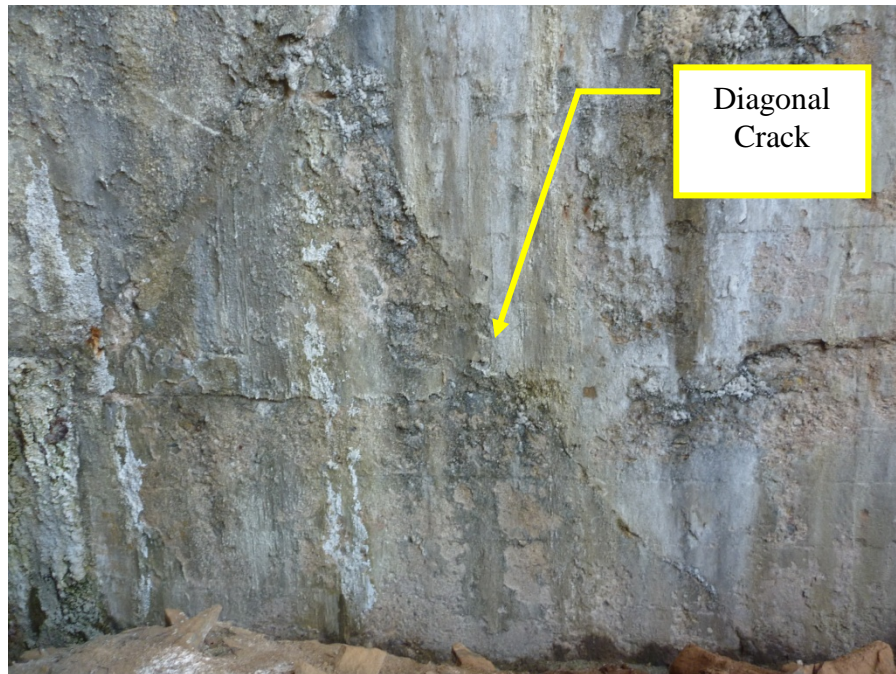
Figure 14 Diagonal Crack Identified on Right Buttress Wall of Arch #5 Extended through the entire Buttress Wall and into Left Buttress of Arch #6

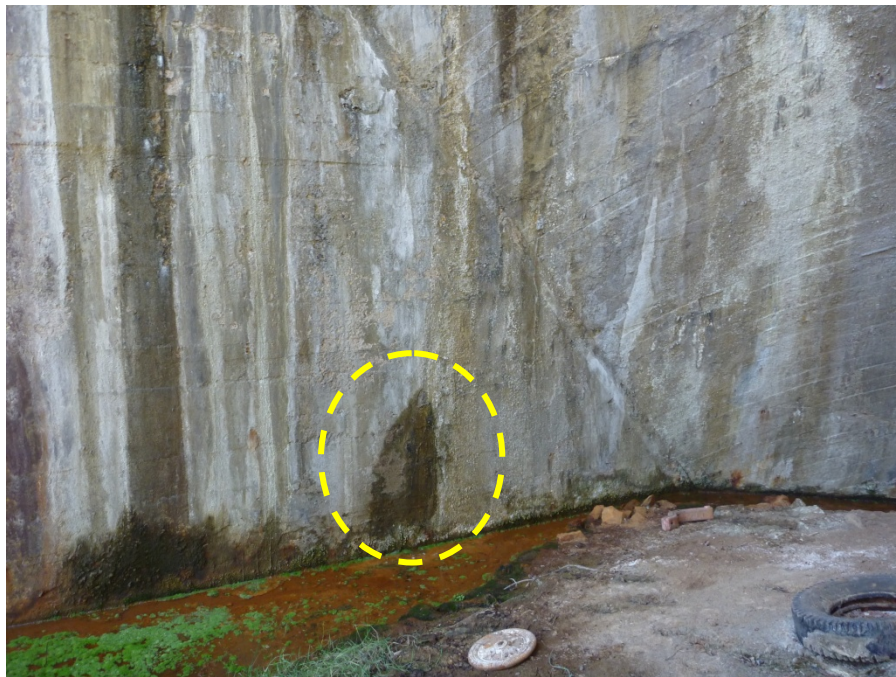
Figure 15 Seepage Coming through possible Diagonal Crack on Right Buttress Wall of Arch #6

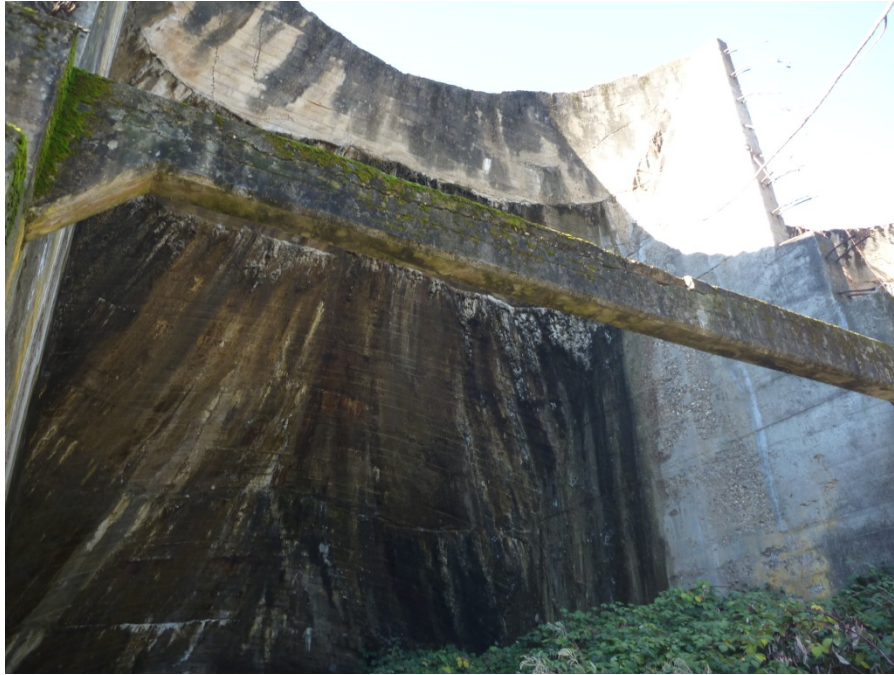
- *Arch #7*: Due to extensive blackberry overgrowth this arch could not be inspected as well as the other arches. The arch was found to have the typical cracking with active seepage dripping through the arch cracks. The tie beam was found to have extensive spalls

delamination and cracks with the cables in some locations exposed. The figures below illustrate the condition of Arch #7.

Figure 16 Condition of Arch #7

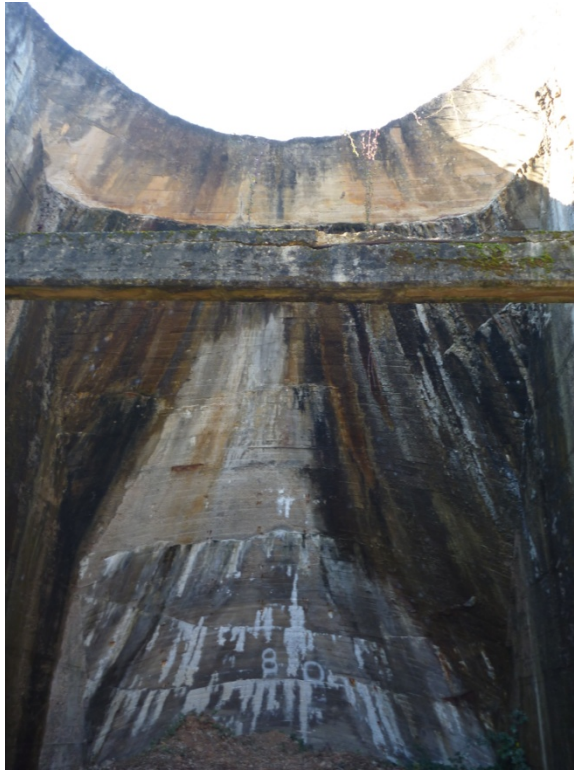
- *Arch #8*: The tallest of all the arches was found to have a very similar diagonal crack through its left buttress wall as what was observed in the buttress wall shared by Arches #5 and #6. The crack width was found to vary between 1/8" to 3/16". This crack is again very concerning given that this arch is the tallest of the all of the arches and is required to hold back the largest amount of soil and water pressure. The crack requires very close monitoring and further actions are discussed in the recommendations section. The right buttress wall was also noted to have a very similar diagonal crack. Other observations made of Arch #8 included typical cracking within the arch downstream face and freeze thaw damage along the exposed faces of the buttress walls. Large spalls, exposed cables, and extensive cracking were also seen along the tie beam. The figure below illustrates some of the observed conditions.

Figure 17 Condition of Arch #8

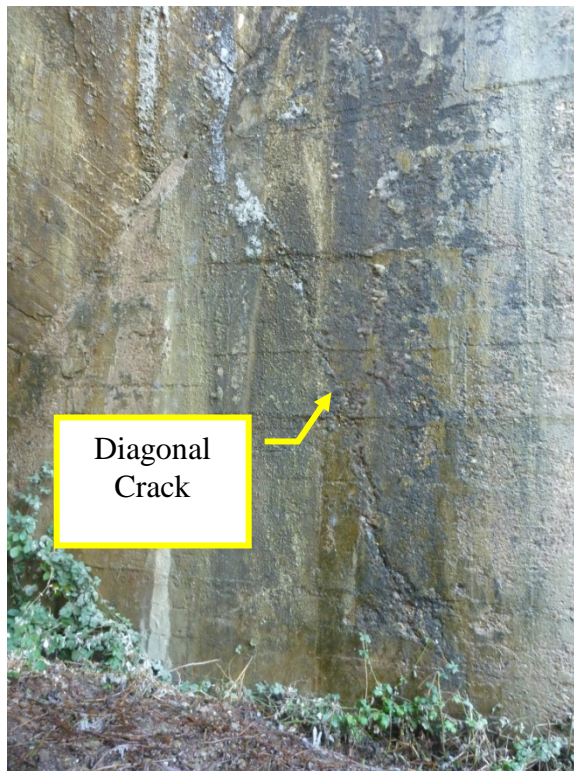
Figure 18 Large Diagonal Crack along Left Buttress of Arch #8

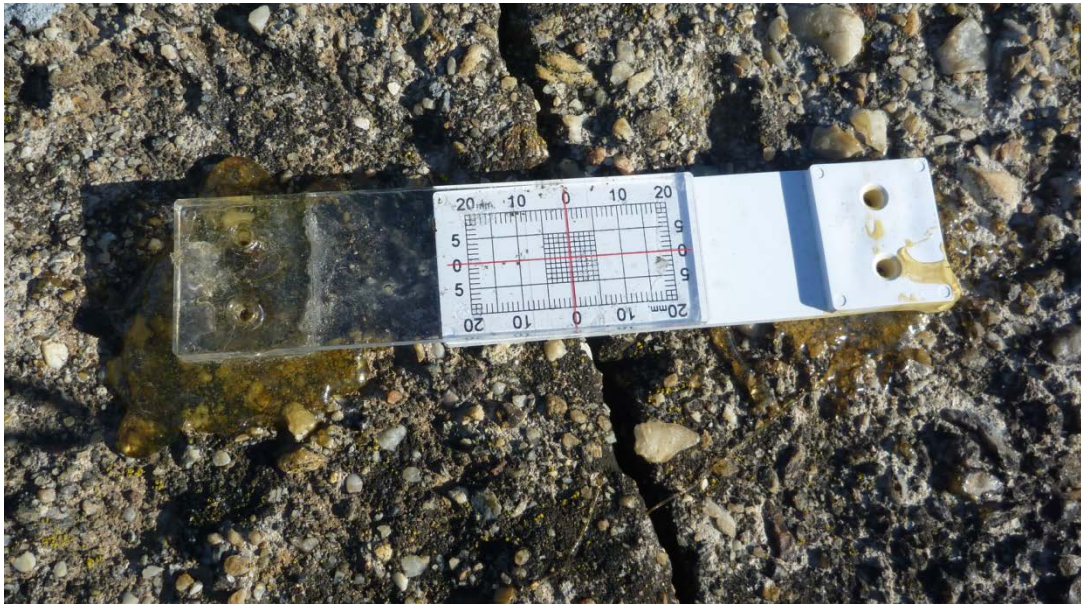
Figure 19 Crack between Arch and Buttress Shared by Arches 8 and 9

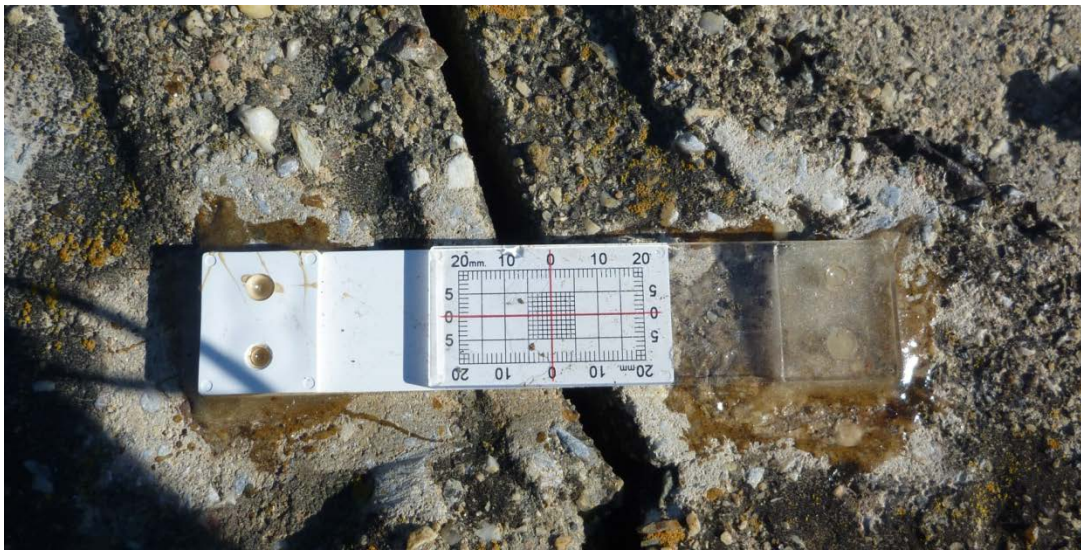
Figure 20 Crack between Arch and Buttress Shared by Arches 7 and 8

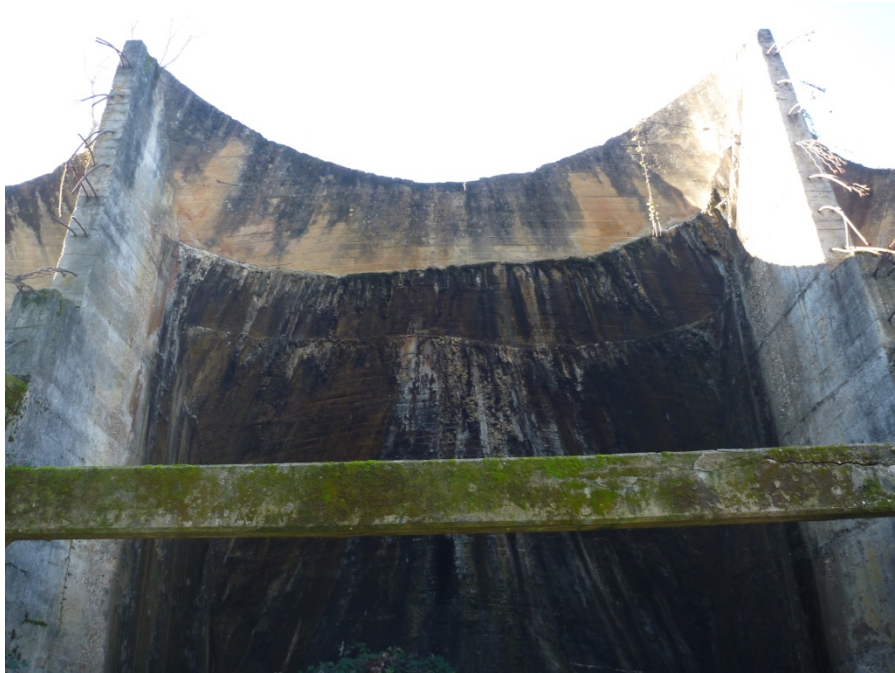
- *Arch #9*: Typical cracks with active seepage were observed within the arch along with typical freeze thaw damage along the faces of the buttresses. See figures below.

Figure 21 Condition of Arch #9

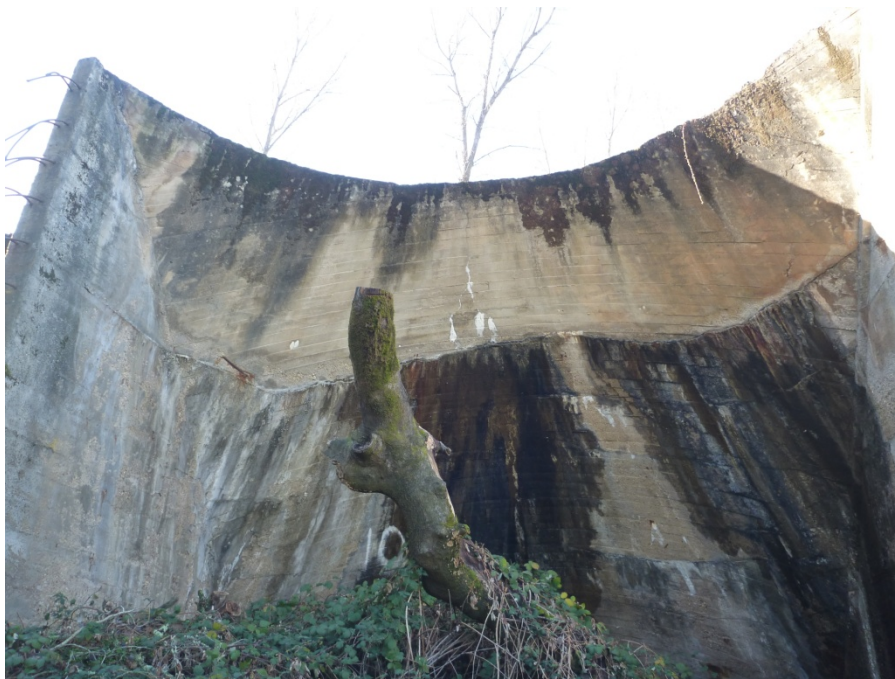
- *Arch #10*: Typical cracks with active seepage were observed within the arch along with typical freeze thaw damage along the faces of the buttresses. See figures below.

Figure 22 Condition of Arch #10

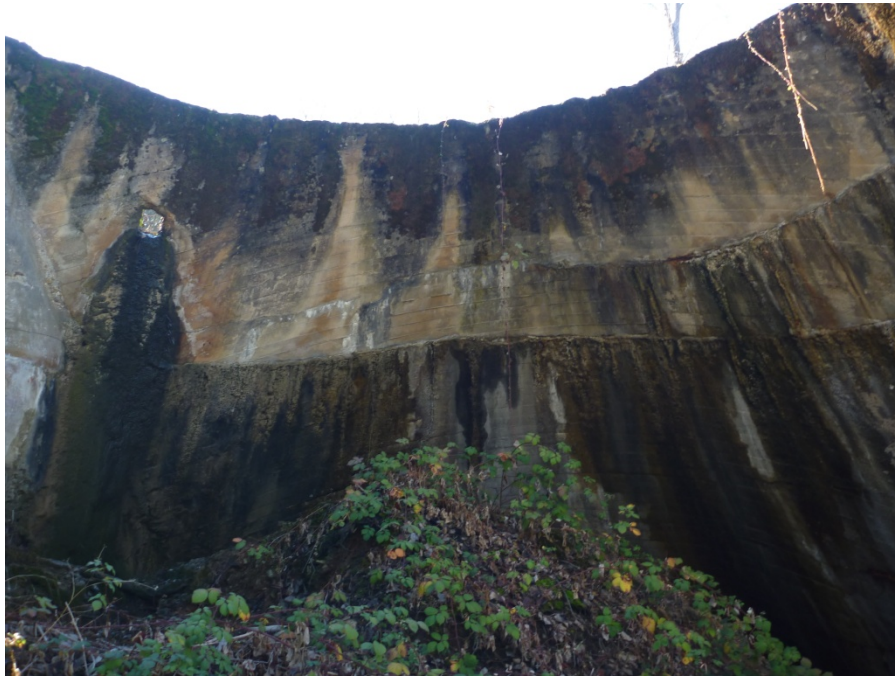
- *Arch #11*: Observed to have a hole through its right side, which does not appear to be a recent development due to the buildup of material beneath it. The hole diameter was approximately seven inches. This was noted in the previous inspection reports. During the

inspection water was found to be actively draining through it. The arch also contained typical cracking seen in the other arches along with active seepage, see Figures below.

Figure 23 Condition of Arch #11

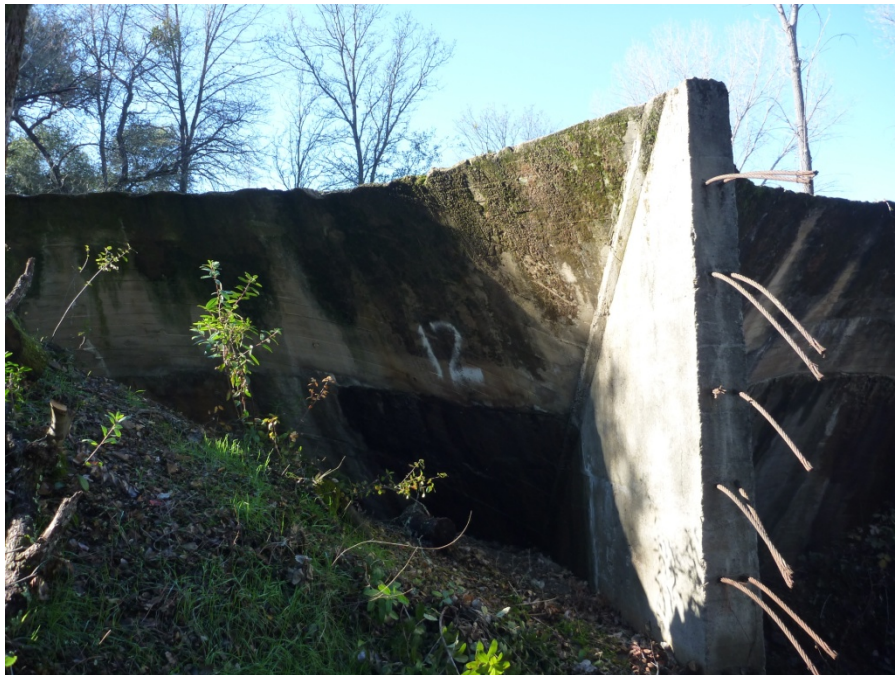
- *Arch #12*: Typical cracks with active seepage were observed within the arch along with typical freeze thaw damage along the faces of the buttresses. See figures below.

Figure 24 Condition of Arch #12

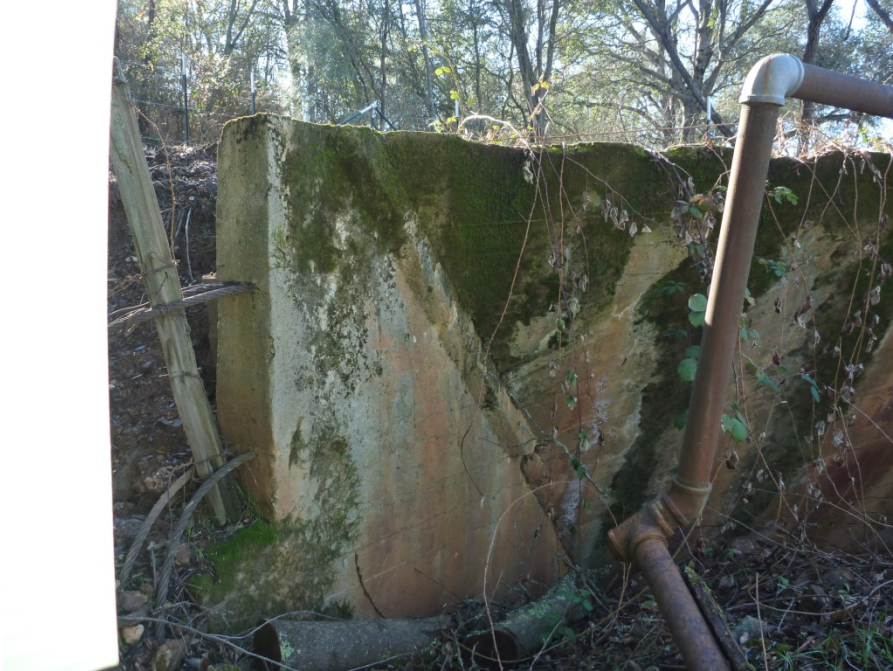
Figure 25 Right Buttress of Arch #12

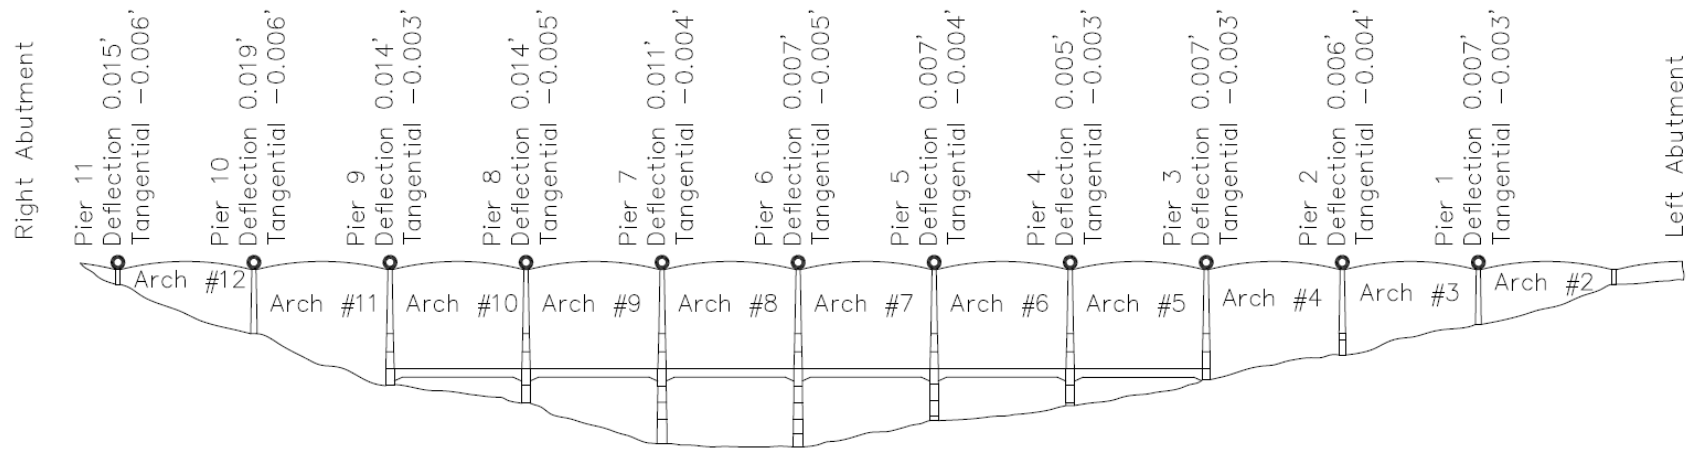
Figure 26 Survey Data for Various Pier

In order to make a more definitive observation on whether or not the dam has moved, more survey data is needed. The dam should continue to be monitored and survey data collected following heavy rain events (typically in the winter) and the summer, which will provide survey data during the cold and hot seasons. This data will help determine what seasonal and or water differential movements the dam experiences.

Comparison between Surveys performed on 10-20-2015 and 1-4-2016

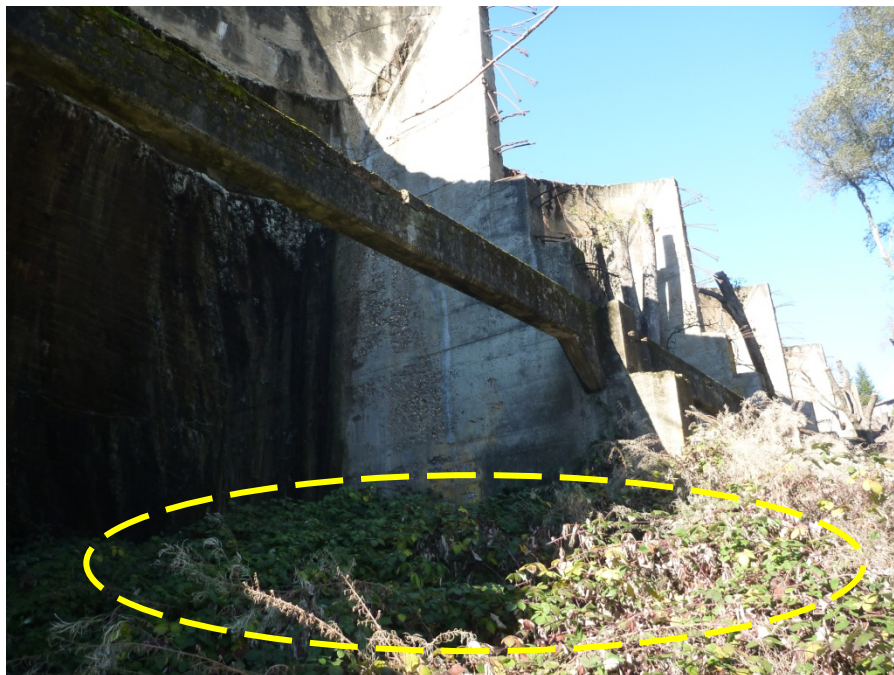
Figure 29 Vegetation overgrowth at Arch #7

- b) Clear vegetation at Arch #7 to allow for inspection of both buttress walls and arch face. See figure below.
