MEMORANDUM

SUBJECT: Approval and Funding for an Emergency Removal Action at the Bear Hollow Mercury Site, Park City, Summit County, Utah, pursuant to the On-Scene Coordinator's delegated authority under CERCLA Section 104.

Re: Bear Hollow Mercury – Draft Letter Report
Park City, Summit County, UT
TDD: 001/1606-15
DCN: W0384.1A.01081
WO#: 20408.012.001.0384.00

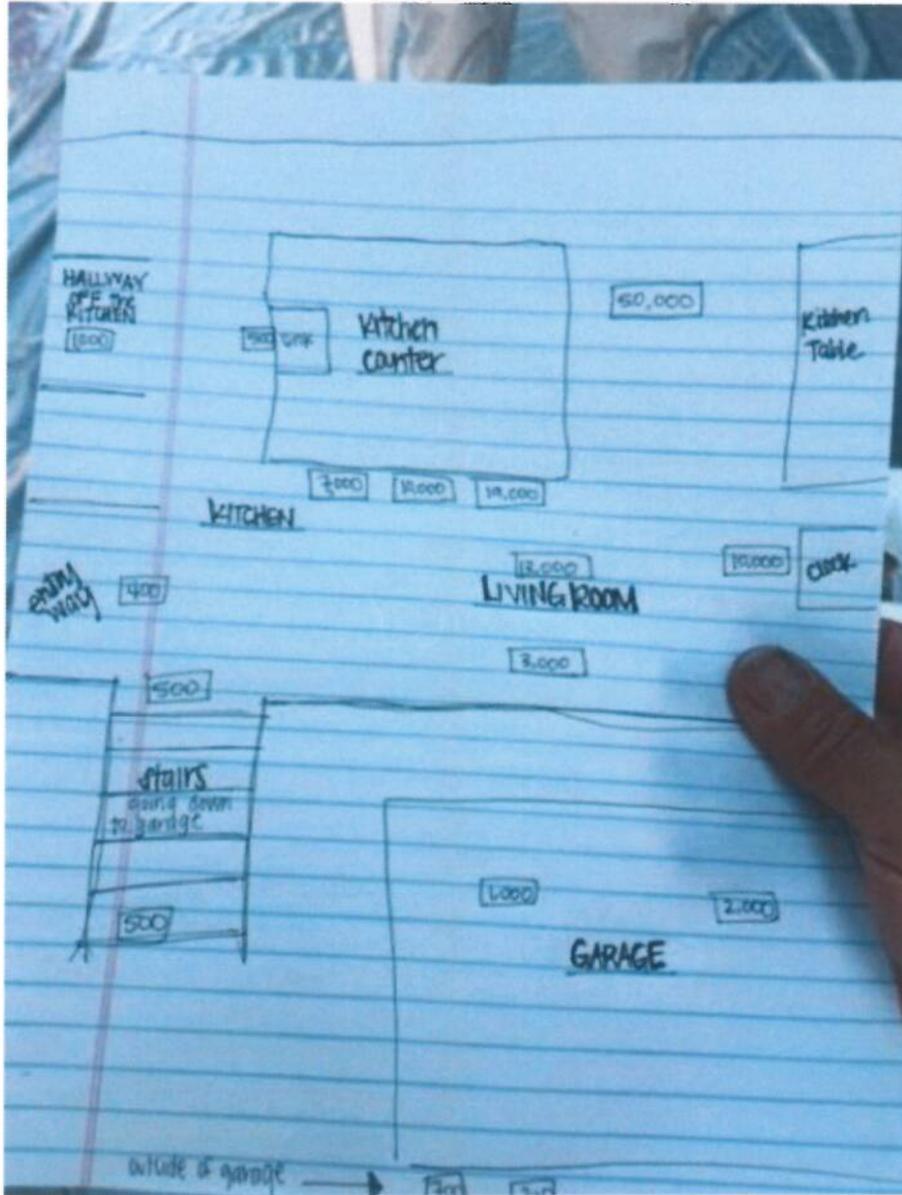
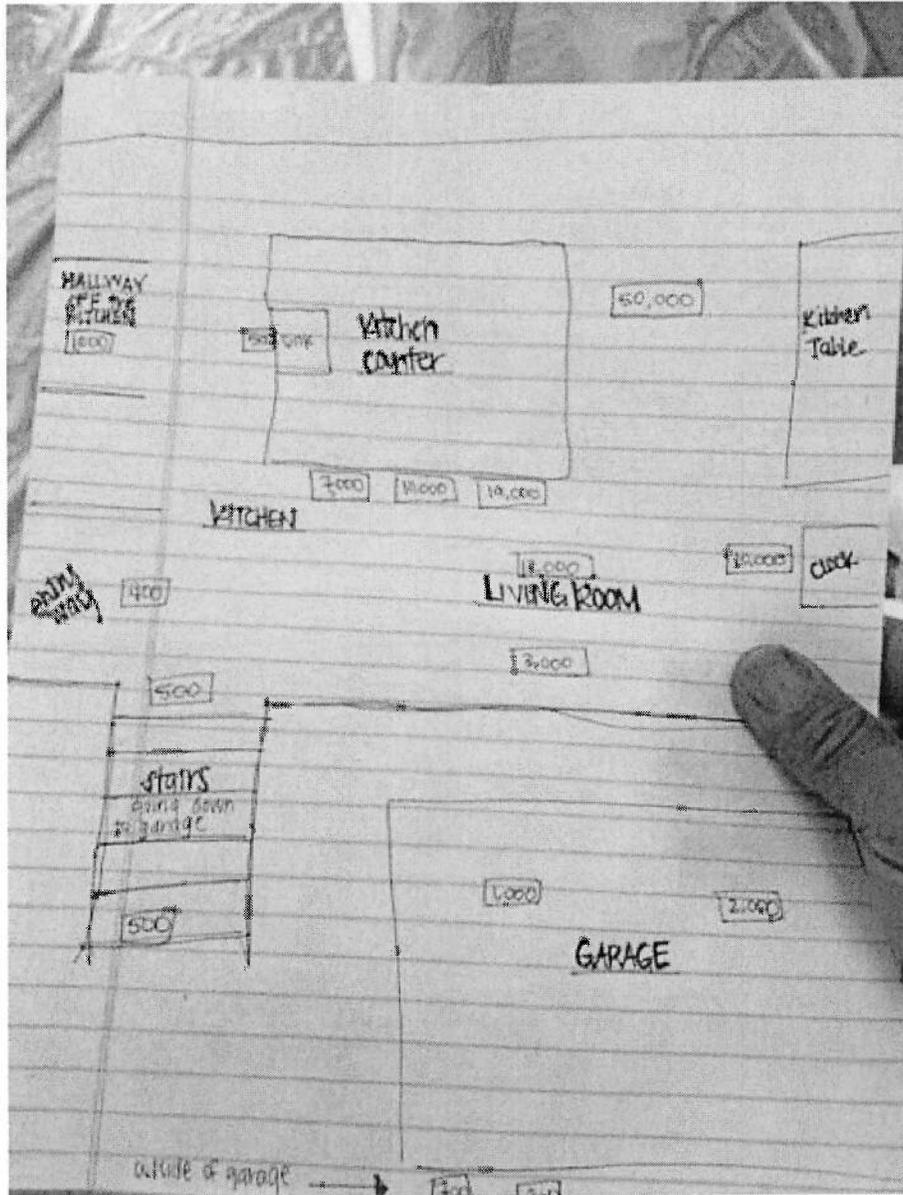
Attachment 1
Schematic of Park City Residence

A diagram of the main living area of the home and sampling locations is provided as Attachment #1.

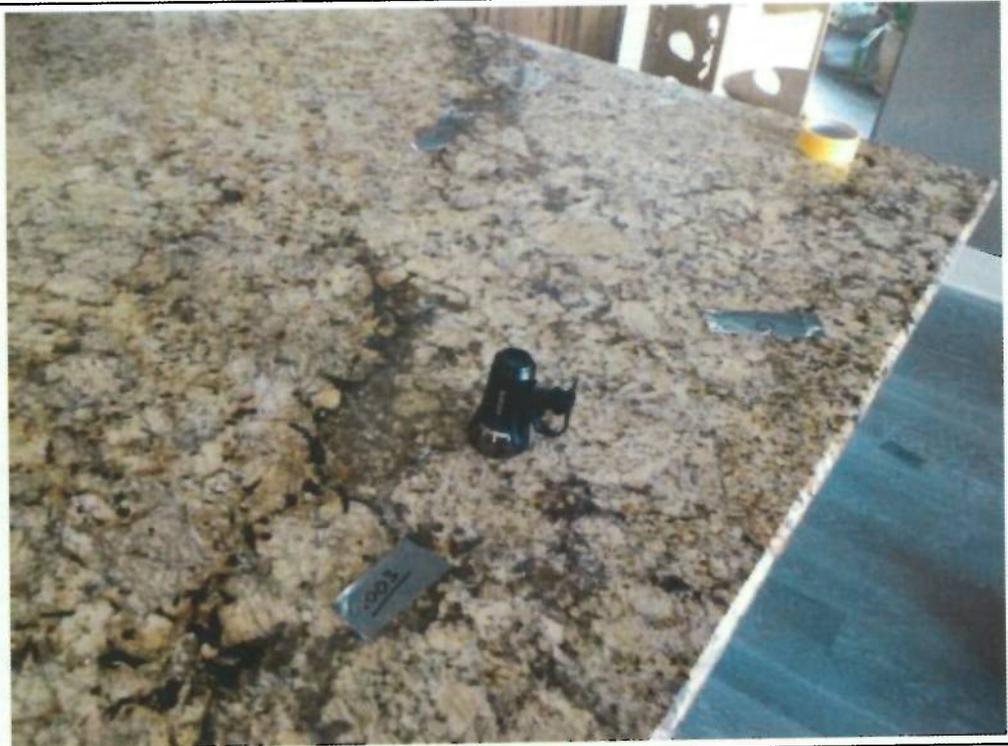
Kitchen counter, location of initial mercury spill. Duct tape labels on items indicate mercury readings (mg/m3).

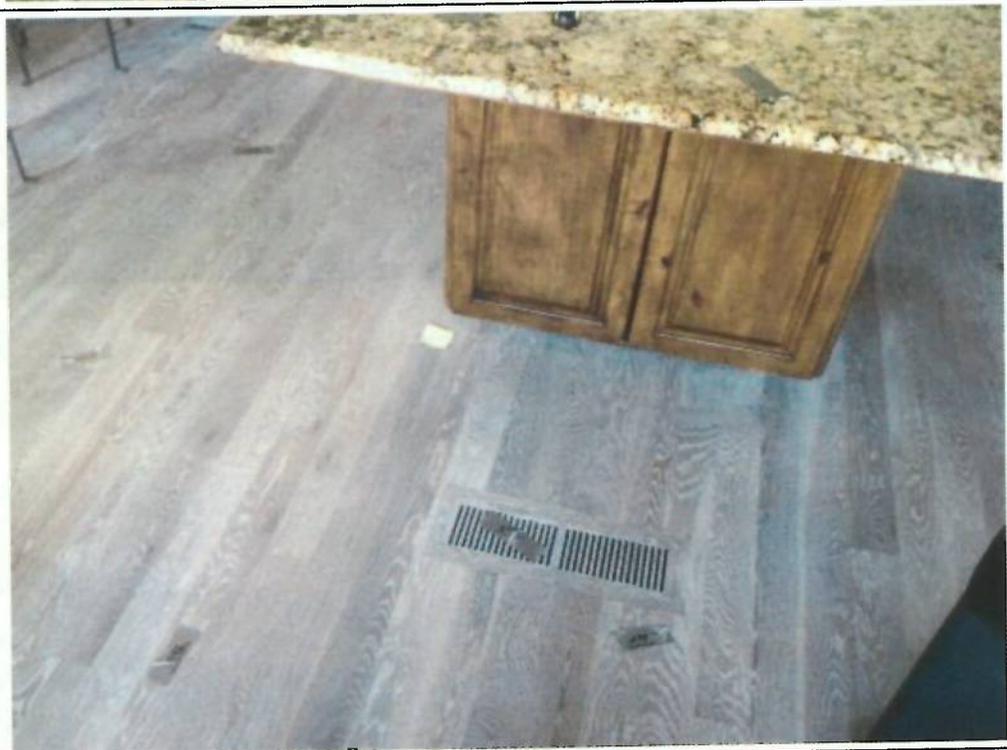
Photo No.
14

Kitchen floor below counter, location of initial mercury spill. Duct tape labels on items indicate mercury readings (mg/m3).

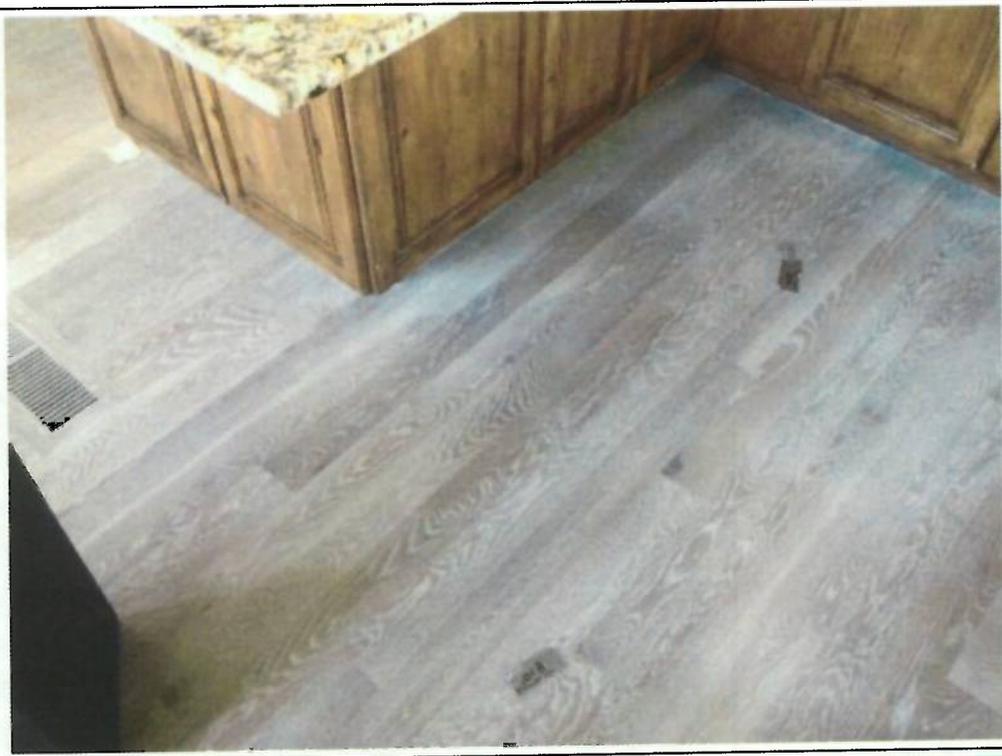
Photo No. 21	Date: 06/08/2016
Photo Coordinates	
Lat	
Long	
Direction Photo Taken:	
Description: Kitchen area floor, initial spill location near floor vent in photo right. Duct tape labels on items indicate mercury readings (mg/m3).

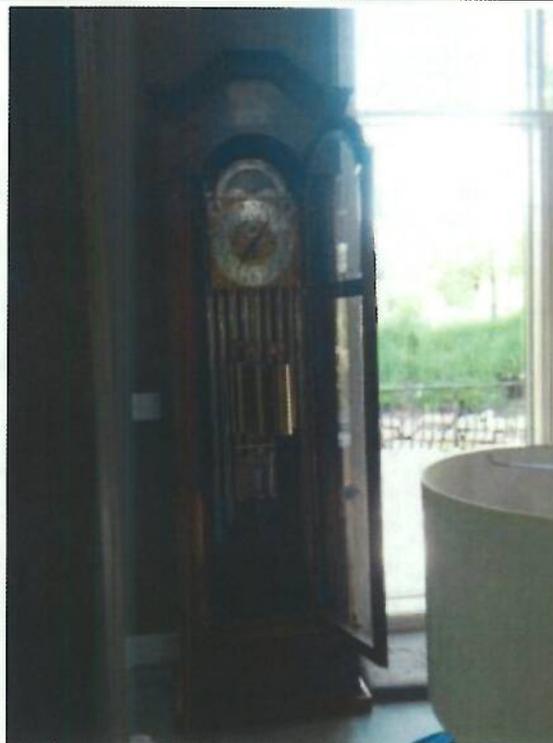
Photo No. 28	Date: 06/08/2016
Photo Coordinates	
Lat	
Long	
Direction Photo Taken:	
Description: Grandfather clock. Pendulum weights visible on clock are the source of mercury related to the spill.

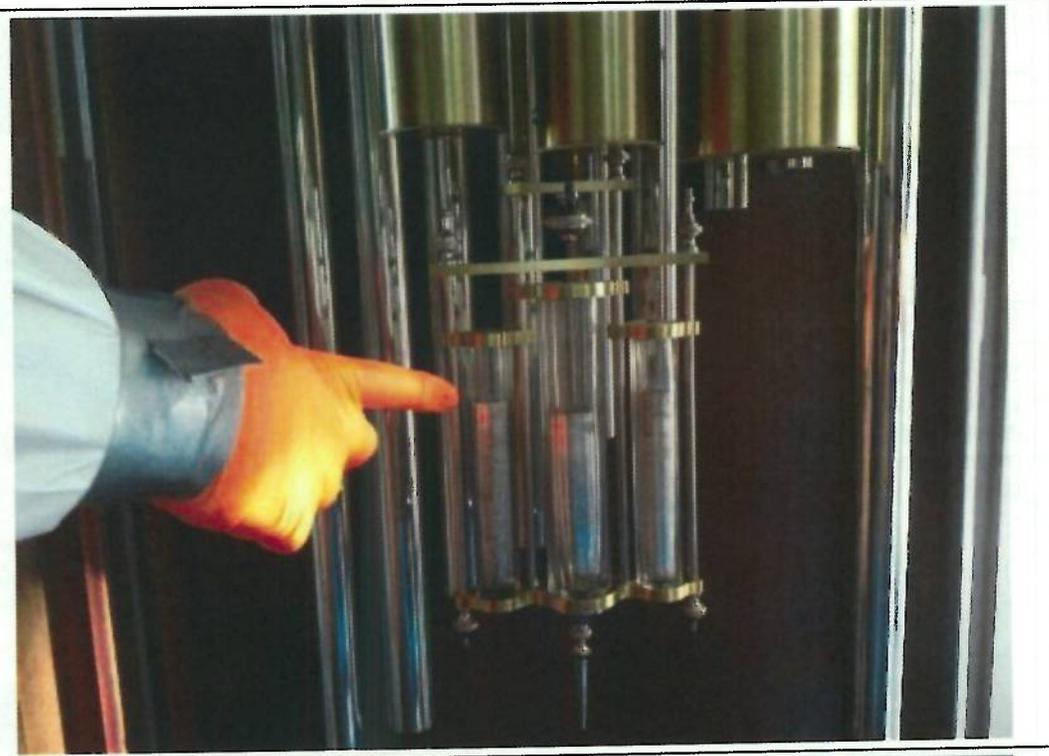
Photo No. 29	Date: 06/08/2016
Photo Coordinates	
Lat	
Long	
Direction Photo Taken:	
Description: Grandfather clock. Pendulum weights on clock are the source of mercury related to the spill. Remaining mercury visible in the (antique) glass vials.

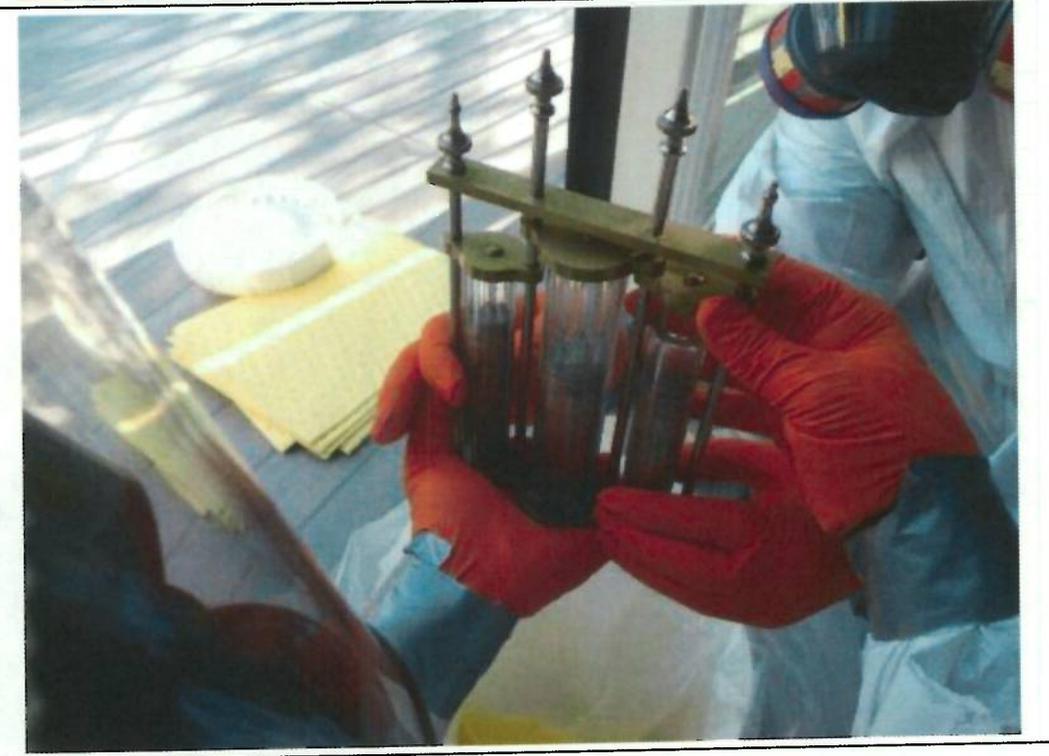
Photo No. 30	Date: 06/08/2016
Photo Coordinates	
Lat	
Long	
Direction Photo Taken:	
Description: Pendulum weights removed from the grandfather clock. Approximately 2-3 cups of mercury removed from the weights for disposal.

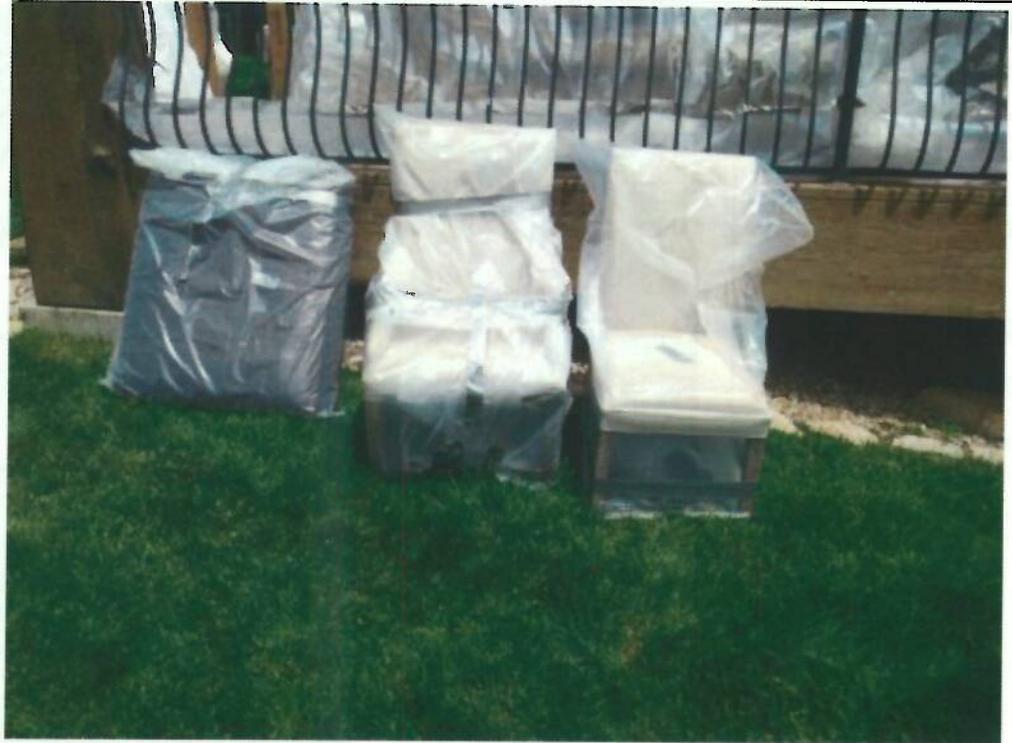
Heating mercury-contaminated house items in the sun.

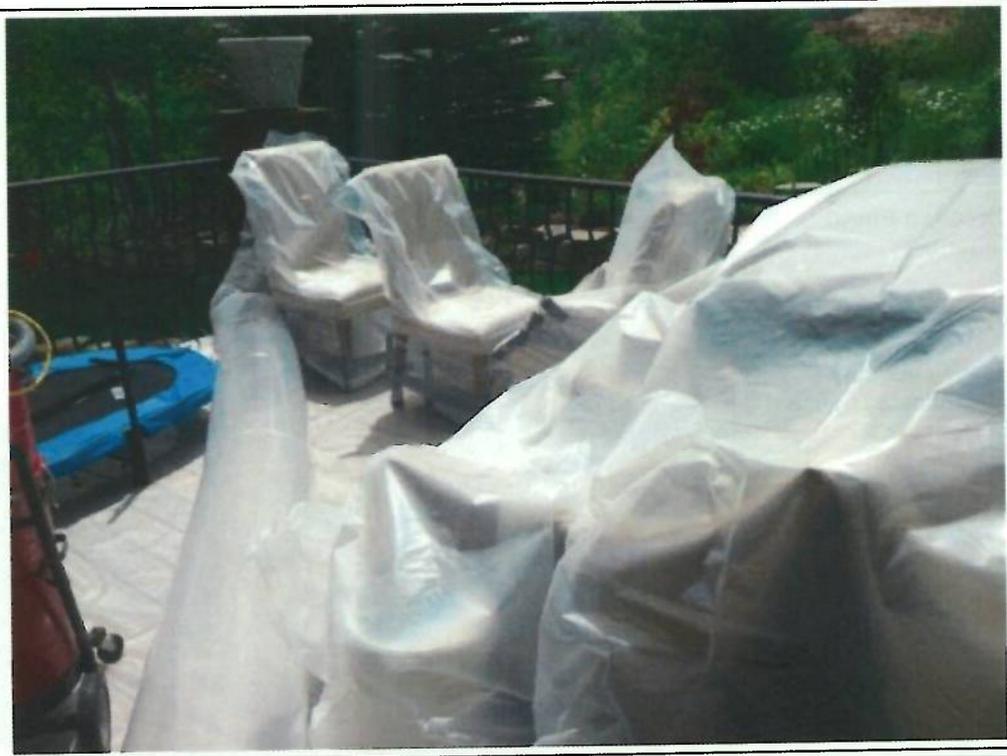
Photo No. 33	Date: 06/09/2016
Photo Coordinates	
Lat	
Long	
Direction Photo Taken:	
Description: Heating mercury-contaminated house items in the sun.

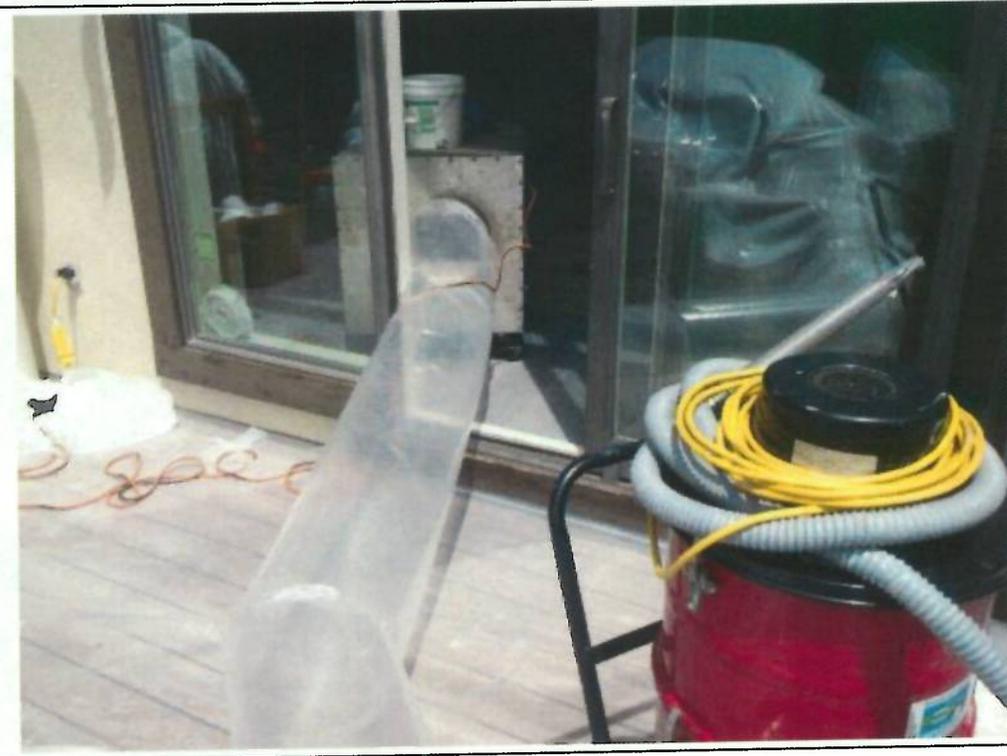
Photo No. 34	Date: 06/09/2016
Photo Coordinates	
Lat	
Long	
Direction Photo Taken:	
Description: Negative air machine exhausting air from House. Mercury vacuum in foreground.

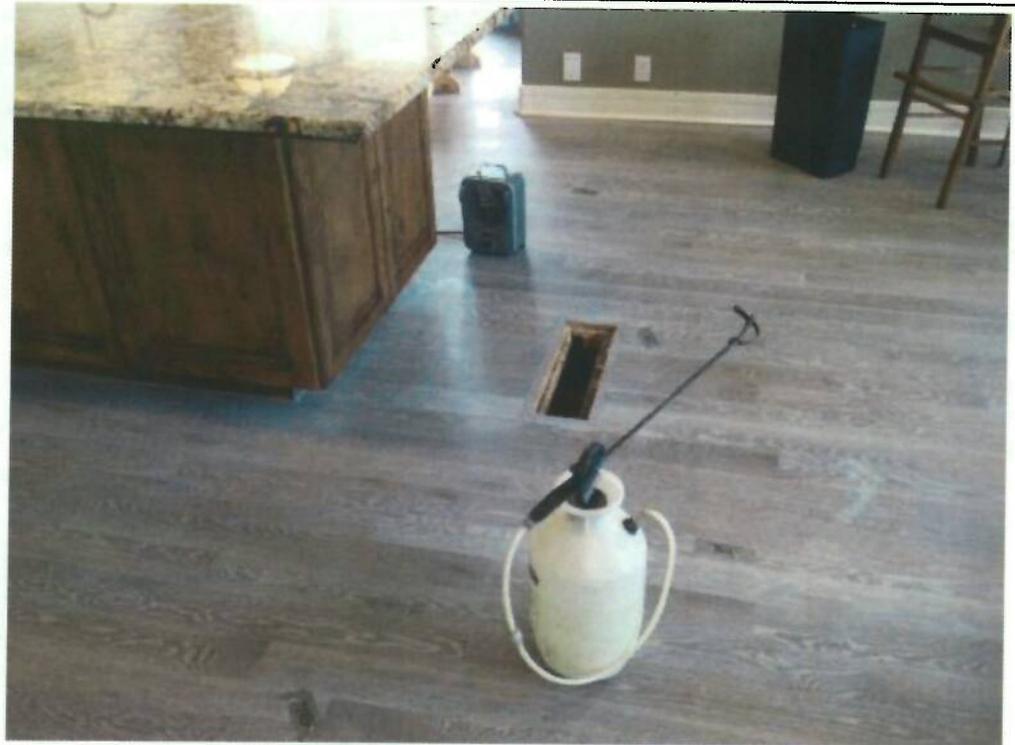
Photo No. 35	Date: 06/09/2016
Photo Coordinates	
Lat	
Long	
Direction Photo Taken:	
Description: Floor and counter areas where initial mercury spill occurred. Sprayer contains merc-x solution that aids in mercury treatment. Note the floor vent is removed, cleaned.

A combination of three heat cycles, vacuuming with an equipped mercury vacuum, scrubbing with merc-X® cleaning solution, routine venting, and removal of highly contaminated items from the house resulted in reducing mercury vapors to below ATSDR recommended levels and allowed for the reoccupation of the house.

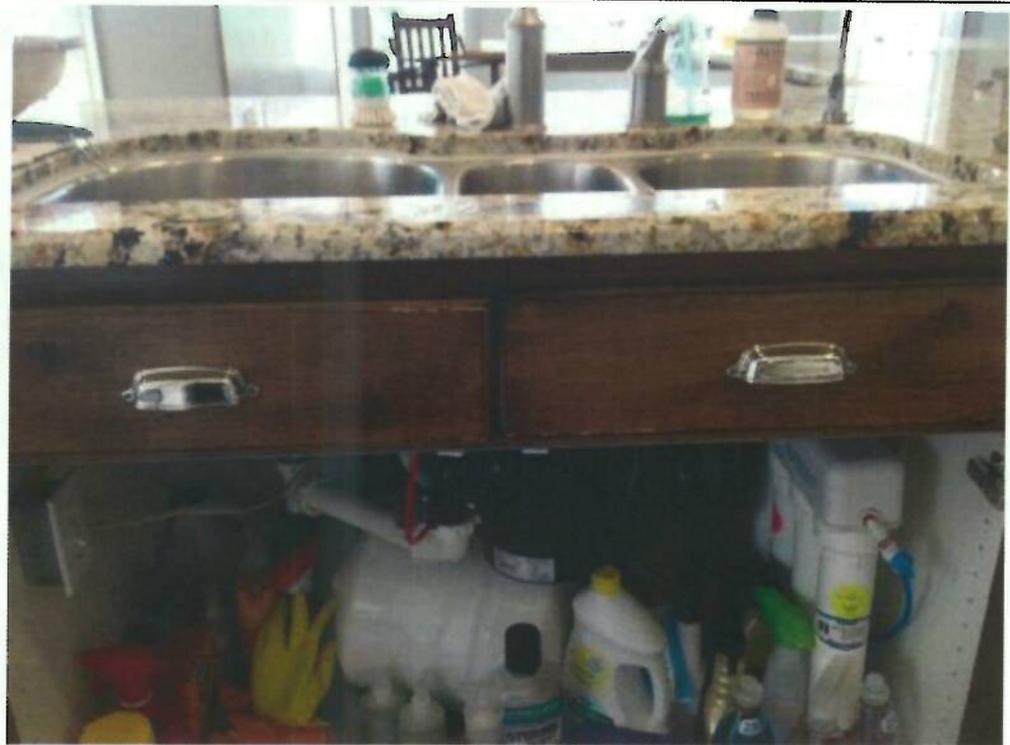
Photo No. 36	Date: 06/09/2016
Photo Coordinates	
Lat	
Long	
Direction Photo Taken:	
Description: Kitchen sink showing drain piping (three sink drains).

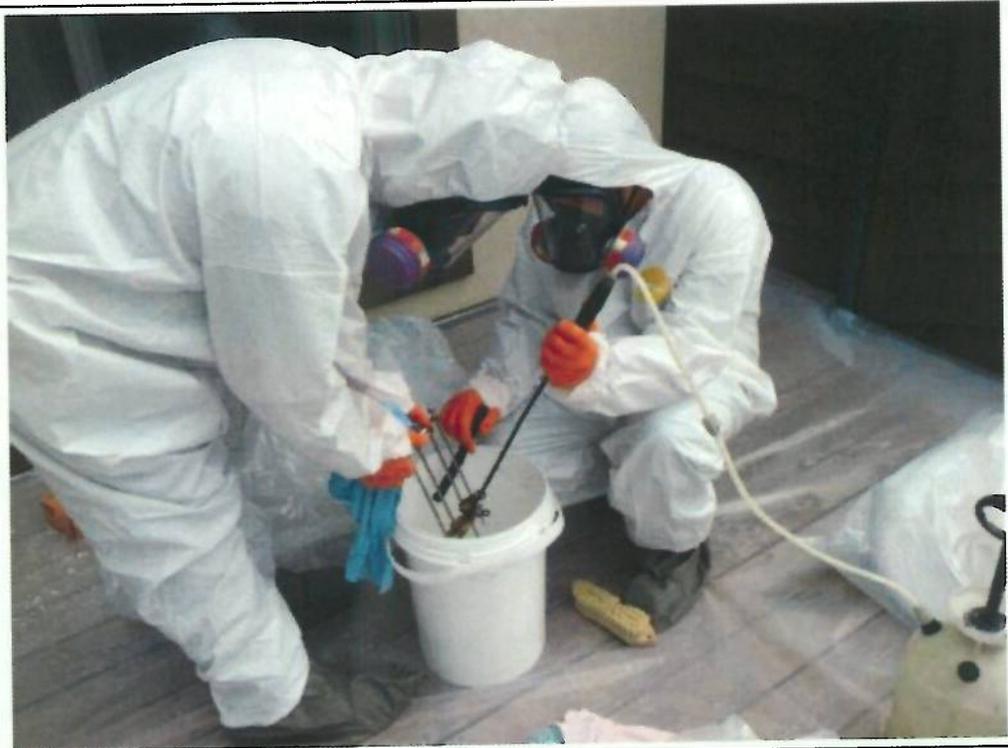
Decontaminating grandfather clock pendulum apparatus.

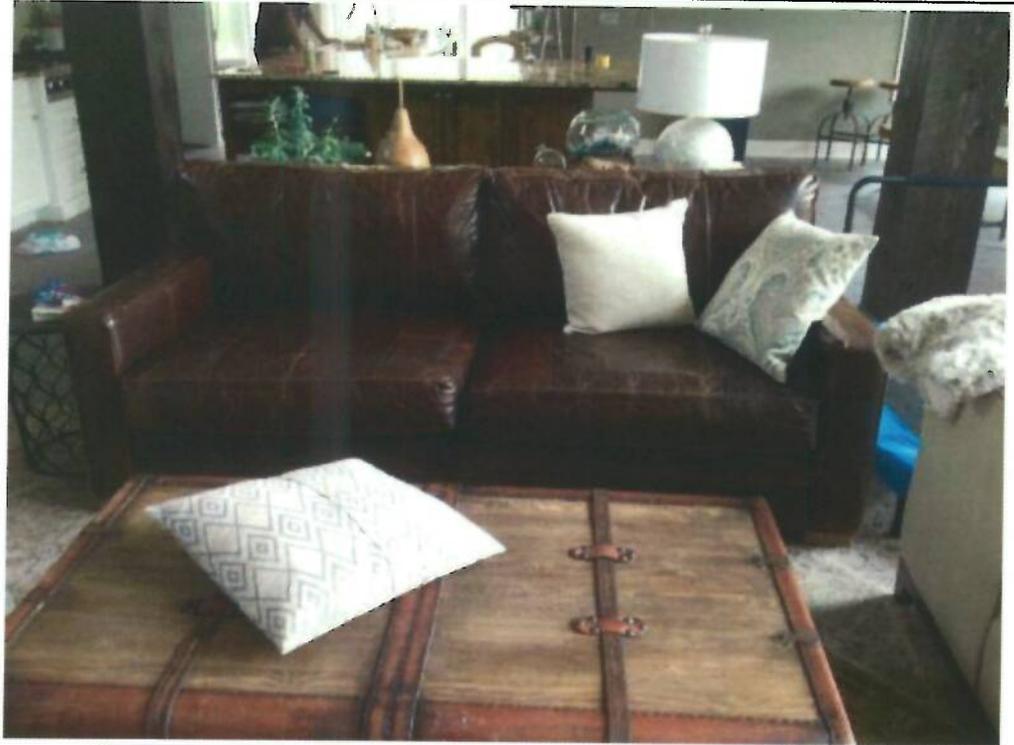
Seating area with kitchen area visible in background post mercury clean-up activities.
