DESIGN MEMORANDUM

Project: River Street Wharf Clean-up

Location: River Street Warehouse Wharf, 1300 N. River Street, Portland, Oregon 97227

INSPECTION REPORT

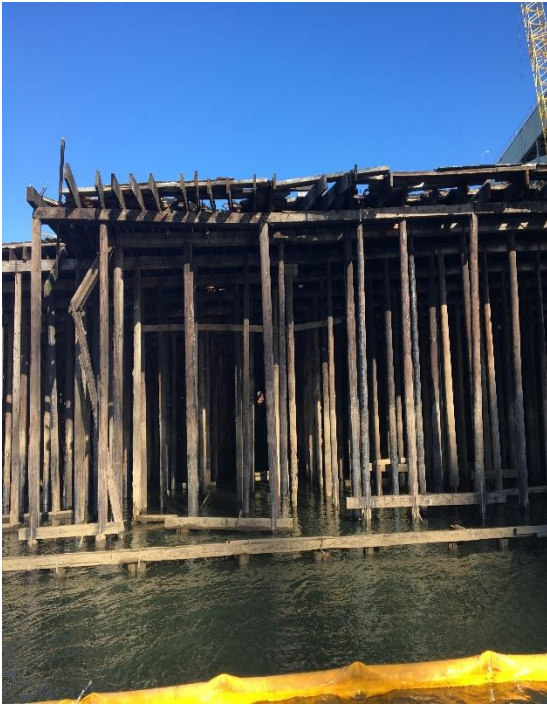
PHOTO NO. 1:

1. The damaged deck above, and fire damaged condition of the piles made it unsafe to position personnel below the deck.
2. The piles spacing of 10-8 feet of the timber piles did not provide sufficient clearance to maneuver below the deck.
3. Cross bracing of the piles at the water level prevented the movement of floats or boats in both directions.
4. Horizontal pile caps used for pile splicing at the water line blocked access for boat or other floating equipment.

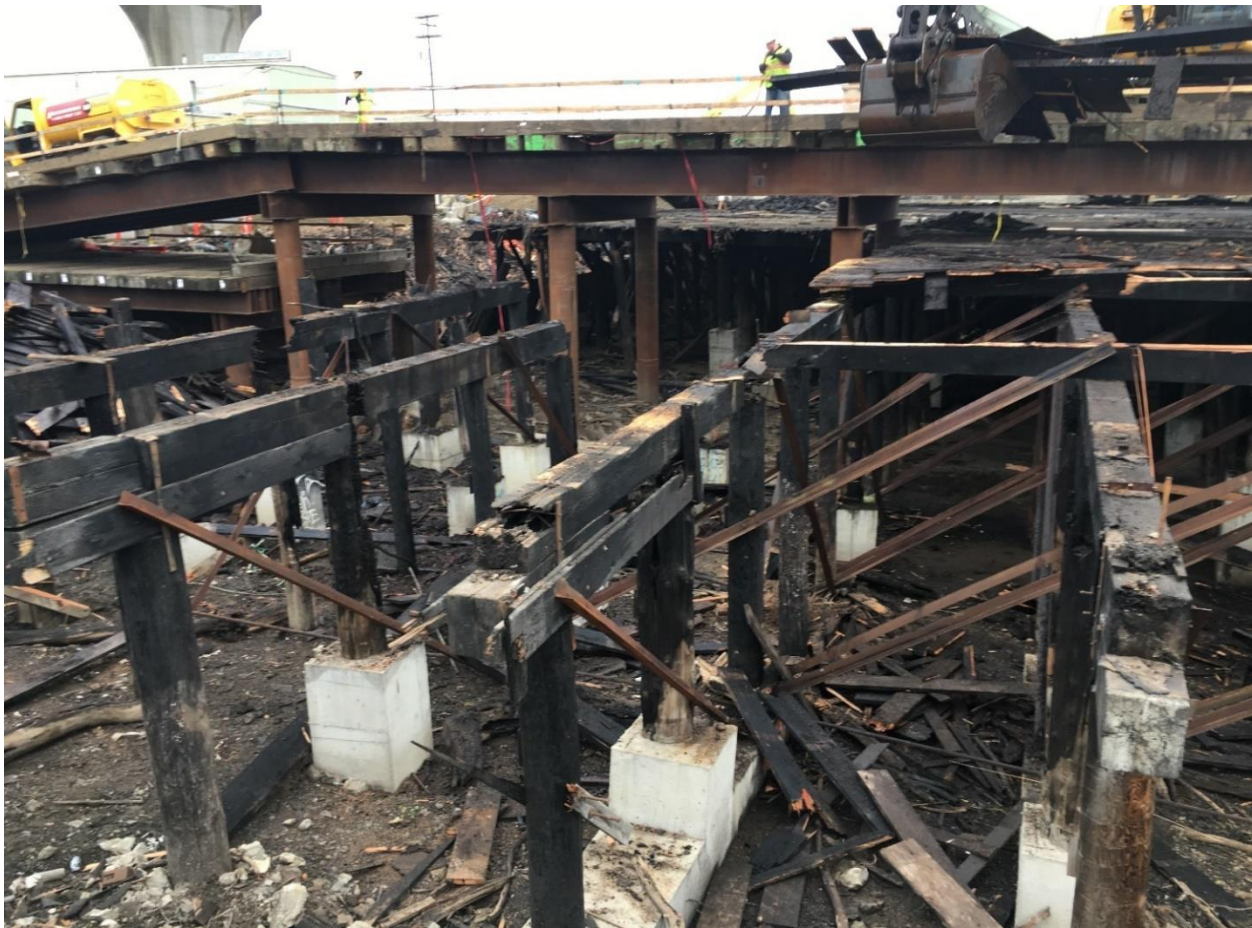
PHOTO No. 5 also shows the long-reach backhoe in the process of removing deck. As can be seen in this photo, the deck is essentially ripped off the timber caps without the aid or assistance of personnel having to work out on the unsafe fire damaged deck area or below the wharf deck. In areas where the timber piles and caps have been undamaged by fire or existing rot, it is possible to remove the deck and fire damaged debris and leave behind the existing timber piles and caps. However, as can be seen from these 7 photos, the in-place condition and value of the remaining timber piles and caps is highly questionable.

PHOTO NO. 5- Wharf area downstream of Access Trestle A with timber deck and stringers removed, exposing fire damaged piles and caps below.

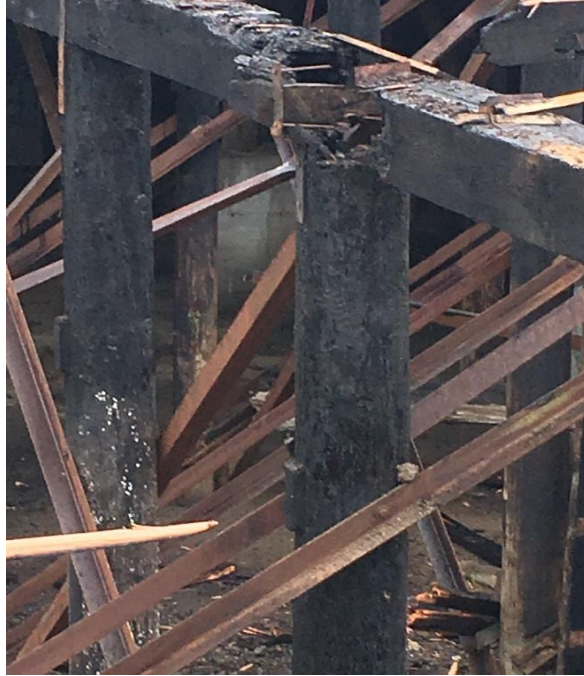
PHOTO NO. 6: Fire damaged pile cap with pile remaining.

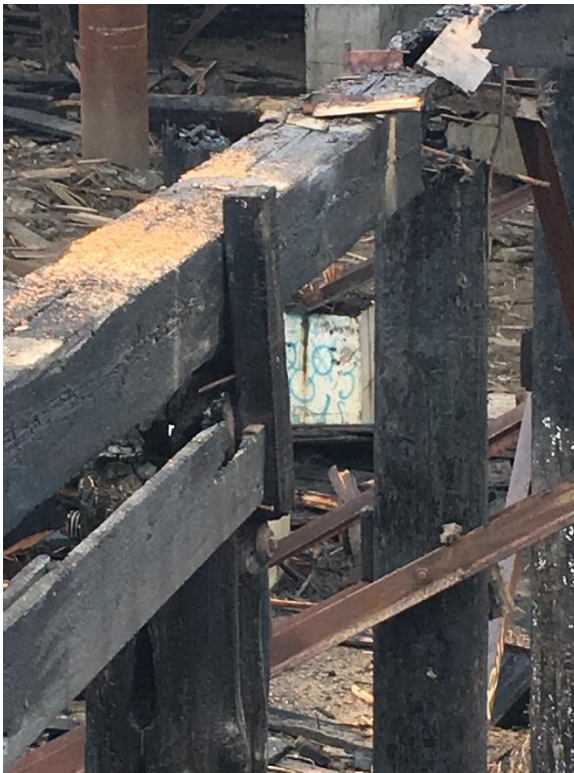
PHOTO NO. 7: Fire damaged piles and cap

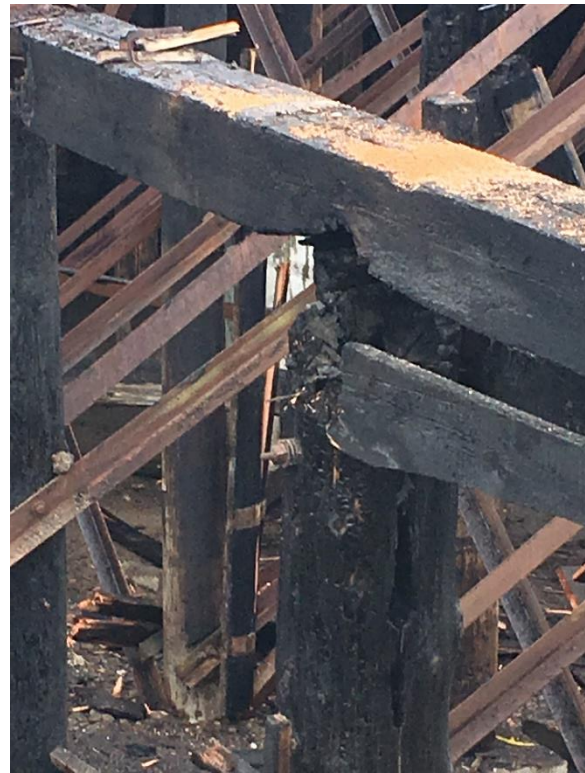
PHOTO NO. 8: Fire damaged pile top below existing pile cap.

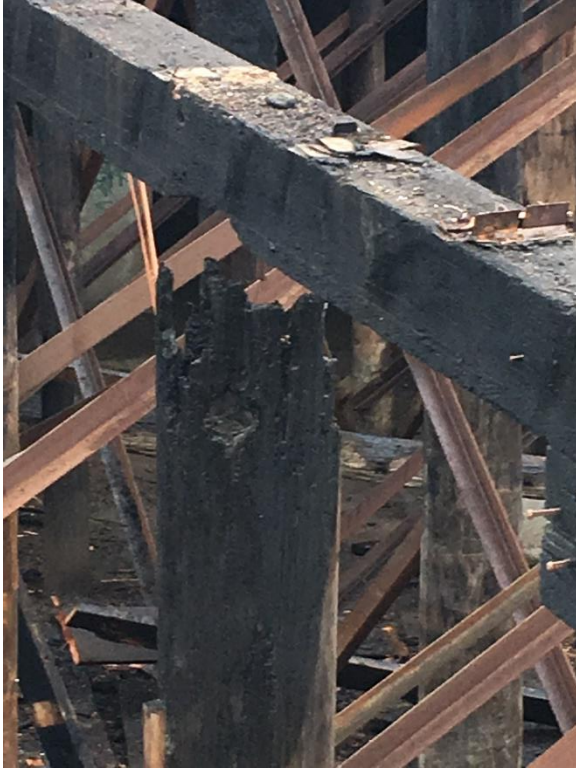
PHOTO NO. 9: Fire damaged pile with cap still in place above.

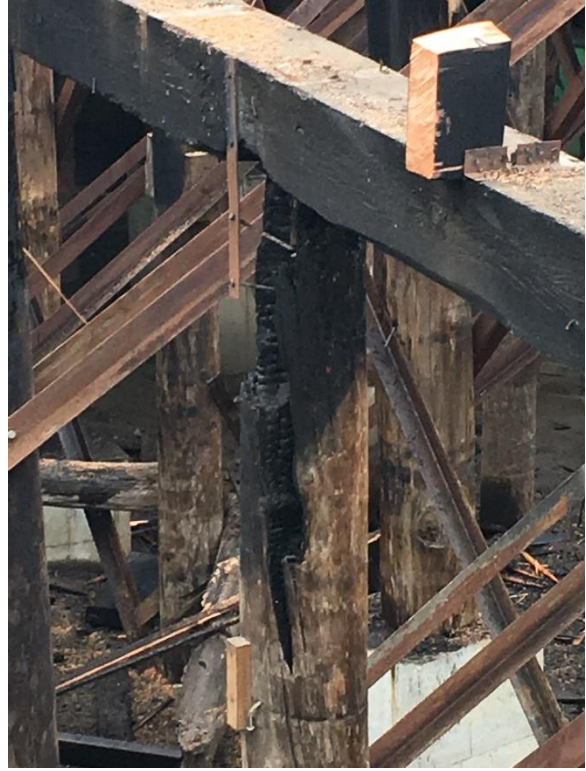
PHOTO NO. 10: Cap and stringers in place, but fired damaged pile below

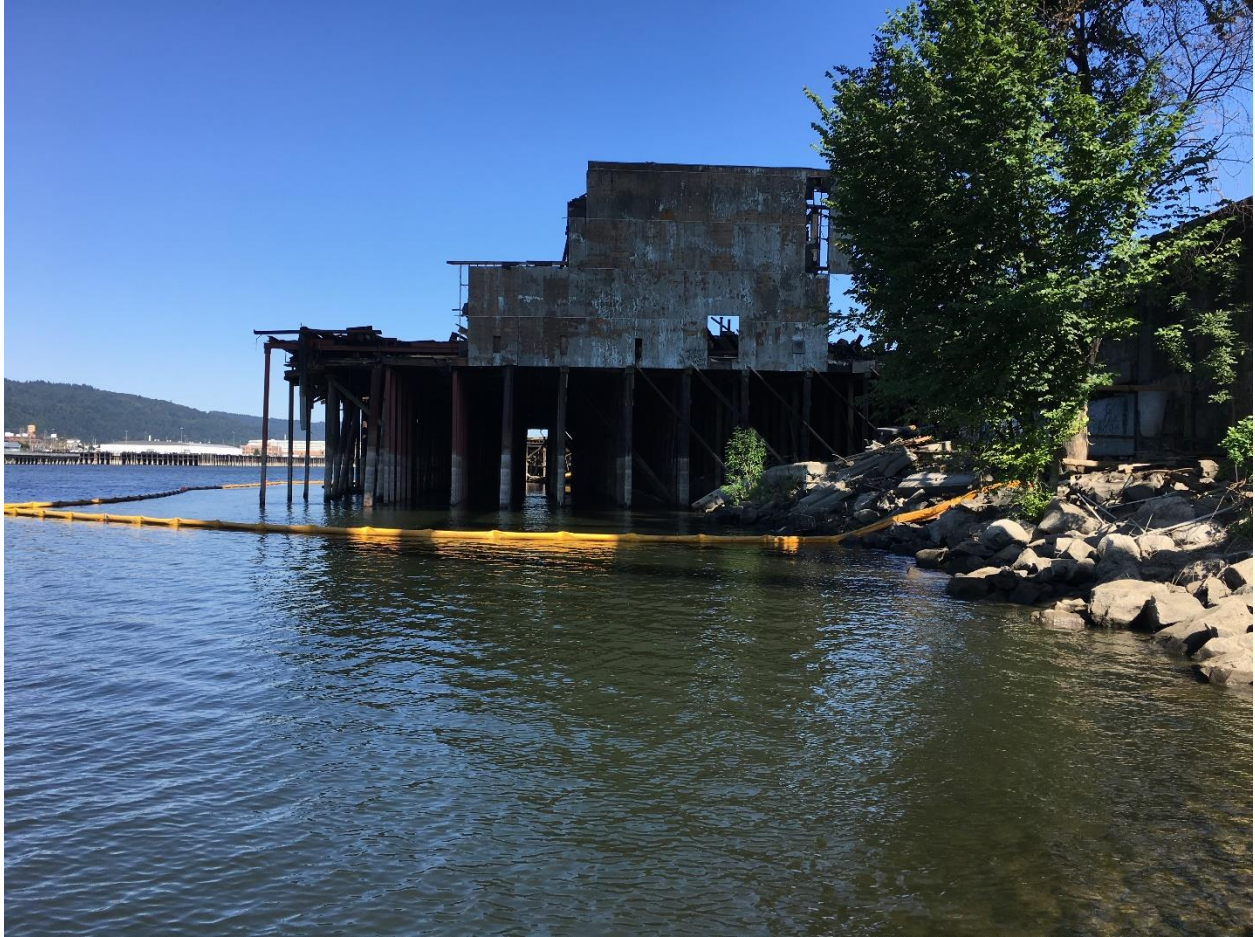
Photo # 1 - Side view of wharf from upstream side

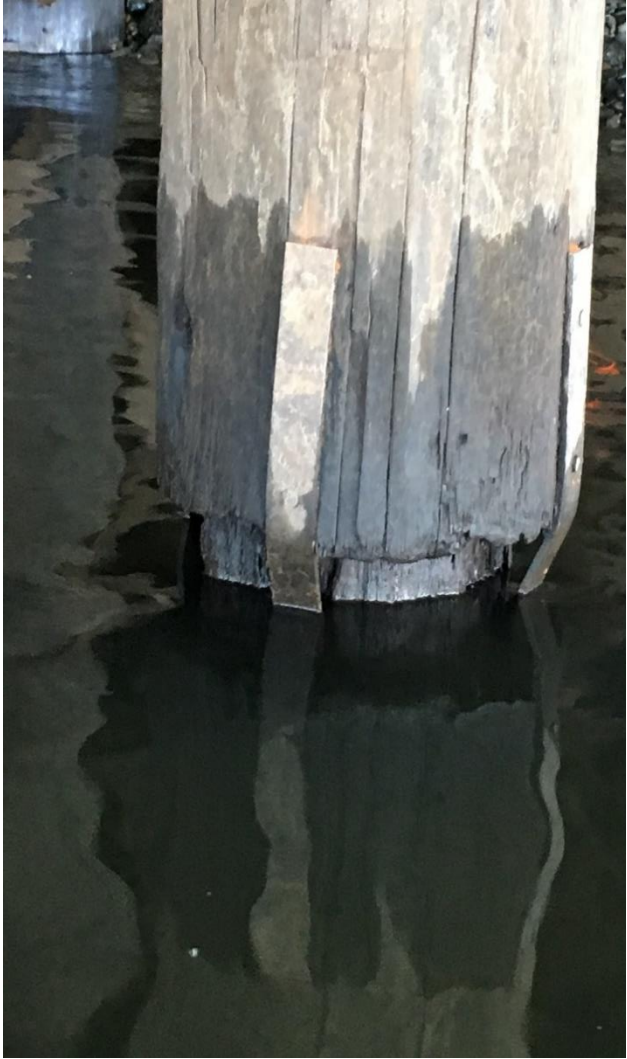
- Approximately 30% of the tops of the existing piles in the first 6 rows closest to shore are completely destroyed by the fire.
- Approximately 90% of the remaining piles have been modified by cutting off the upper 20 to 30-ft at the ground line and splicing on a fresh upper section. Upper piles sections look sound, but bottom sections are either unexposed for inspection or where exposed, they can be seen to be in an advanced stage of decay. (See photos #2, #3, and #5.)
- The upper sections are held in place by two steel straps bolted above and below the splice at the ground line. (See attached photos #2, #3, #6 and #7)

Photo #2 – Typical pile splice at waterline

Based on this information collected from the existing wharf inspection, it is concluded that the existing timber piles cannot be depended on to safely provided added support capacity for the temporary access trestles, and new piles should be installed for the temporary trestle support.

The recommended piles for this temporary support are open ended 24-inch diameter by 0.375-inch wall pipe piles. Using soil boring information from the adjacent Fremont Bridge foundations, these pipe piles will require a penetration of approximately 50 feet.

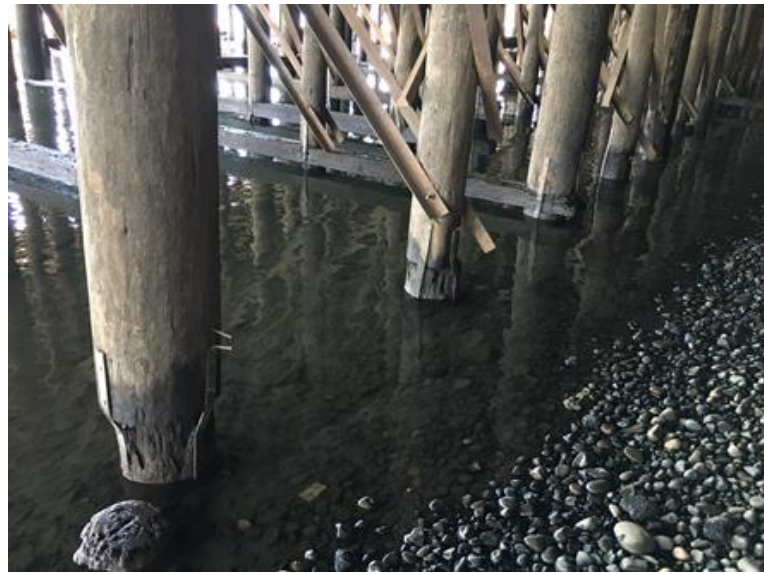
Photo #3 –Typical pile splice at waterline

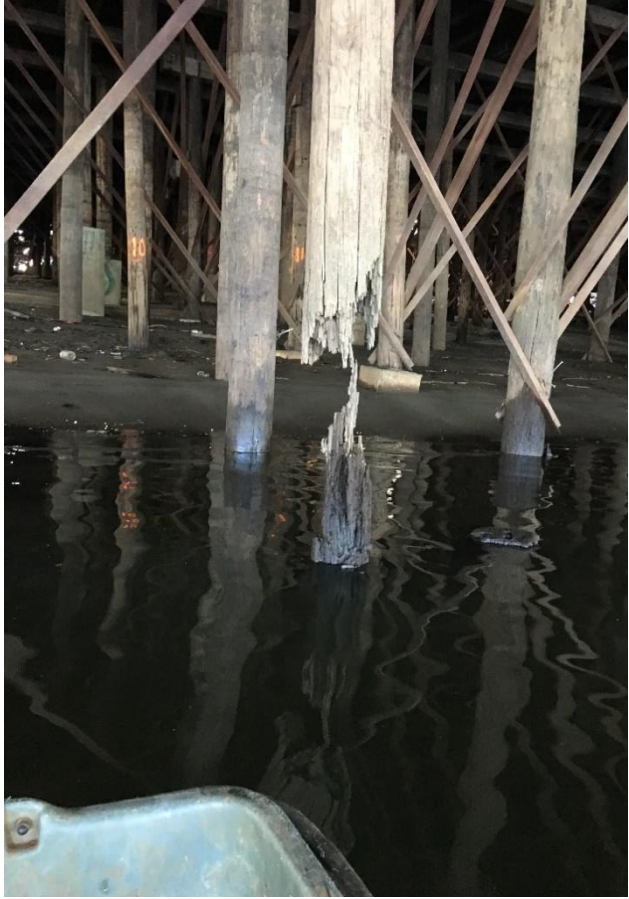
- A significant number of the splice points are out of site below the ground and cannot be inspected because they are buried. However, the straps are visible and indicate a splice below the ground.
- There is significant rot at some of the pile stubs at the mud line (on the lower original piles). (See attached photos #4, #5, and #7.)

Photo #4 – Completely rotted pile

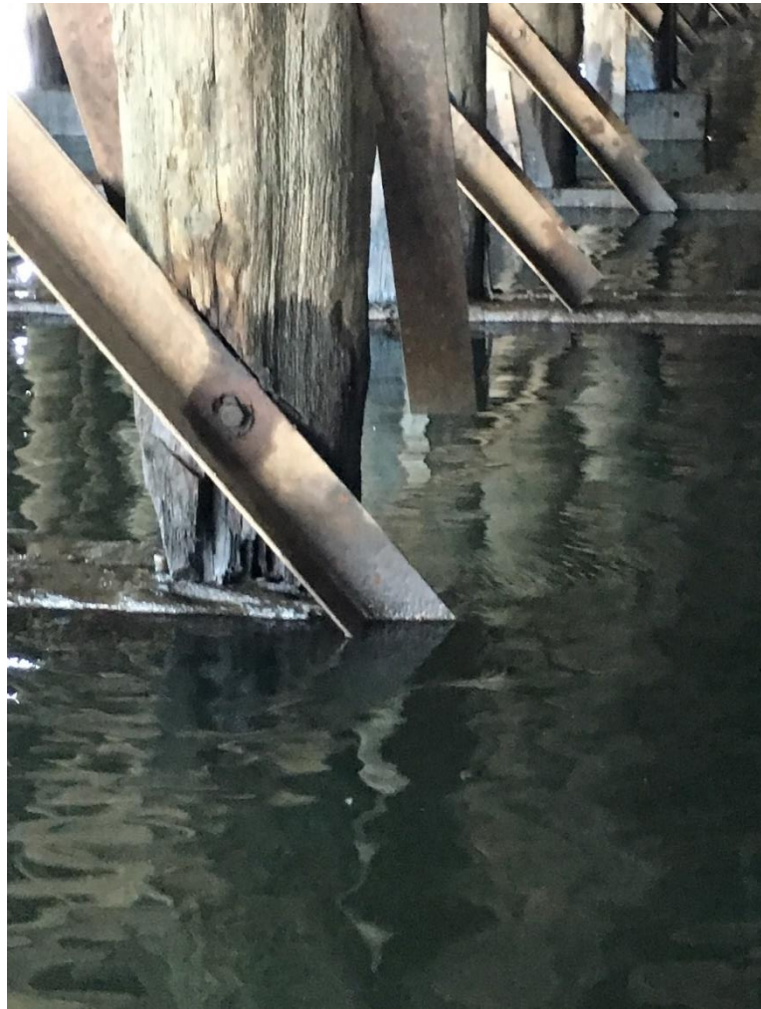
Photo #5 – Typical pile rot at waterline

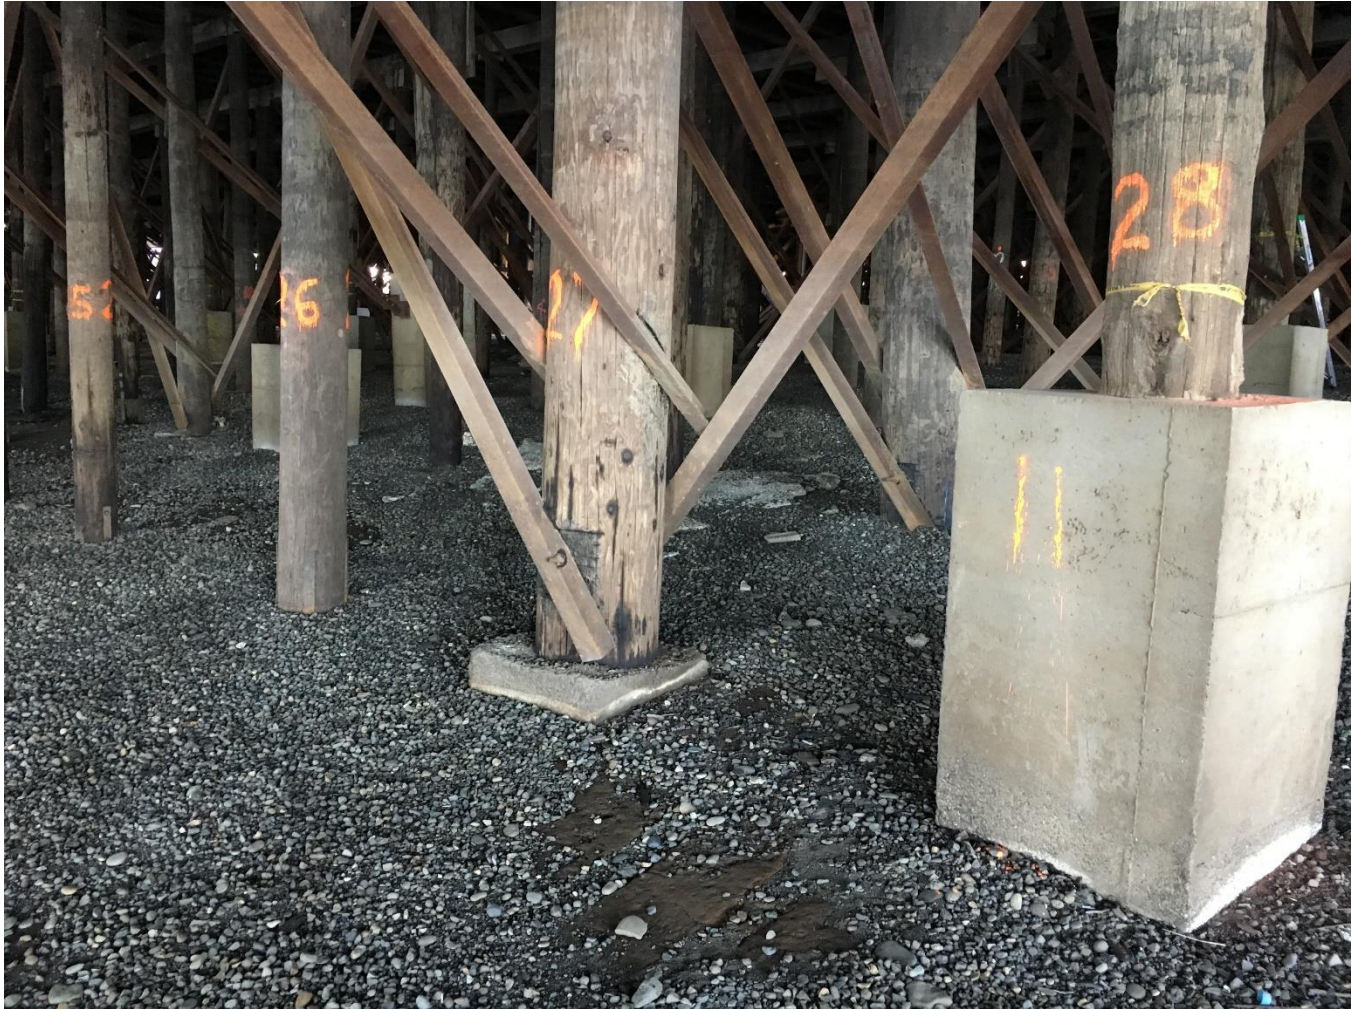
Photo #6 – Typical pile bent on shore with pile splice hidden below ground, but straps indicate that the pile has been spliced. It is assumed that the concrete blocks shown in this photo encase pile splice joints.

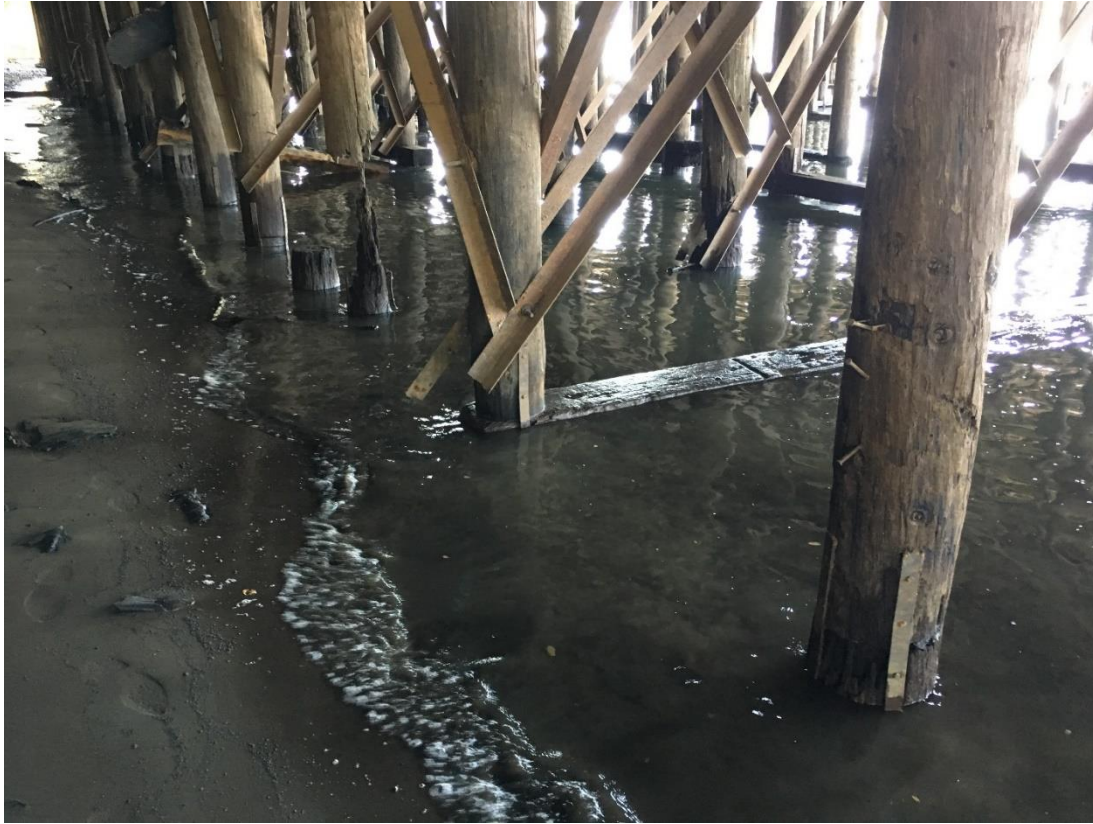
Photo #7 – Pile bent at waterline with straps exposed to indicate piles have been spliced.
Note rotted pile in upper right area of photo.
