Re: Jumbo Mine – Letter Report
Montezuma, Summit County, Colorado
TDD: 1706-12
DCN: W0499.1A.01572
WO#: 20408.012.001.0499.00

The United States Environmental Protection Agency (U.S. EPA) tasked the Weston Solutions, Inc., (WESTON®) Superfund Technical Assessment and Response Team (START) under Technical Direction Document (TDD) 0001/1706-12 to support U.S. EPA's site assessment and removal action at the Jumbo Mine site (the Site) in Montezuma, Summit County, Colorado. The removal action was initiated after it was determined that significant metal loading was being introduced to the Snake River from the draining Jumbo Mine adit and subsequent waste rock pile.

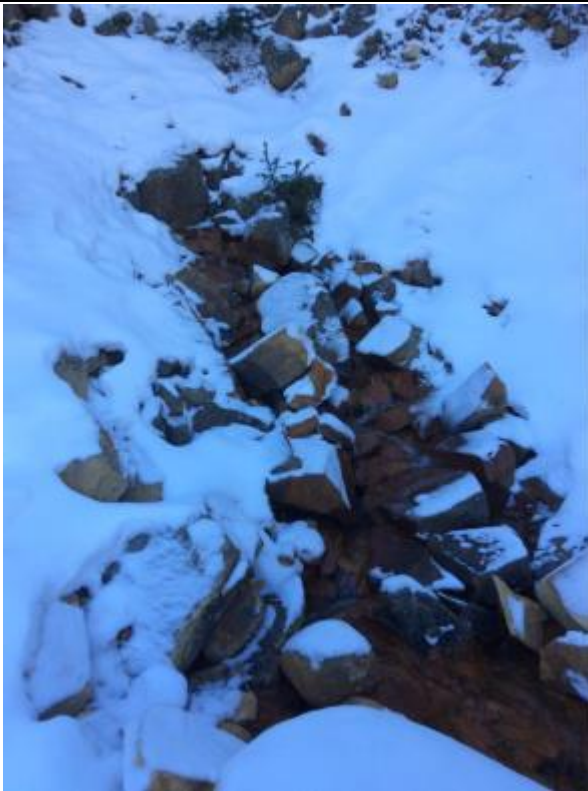
Photo No. 1	Date: 10/10/2017

Direction Photo Taken:				
Description: Jumbo Mine adit before removal action began.				
Photo No. 2	Date: 10/10/2017

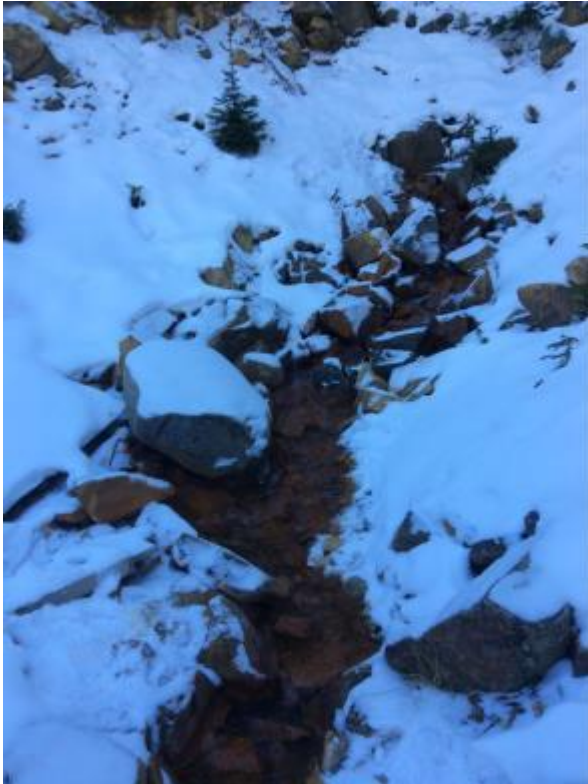
Direction Photo Taken:				
Description: Mouth of the Jumbo Mine discharge channel before removal action began.

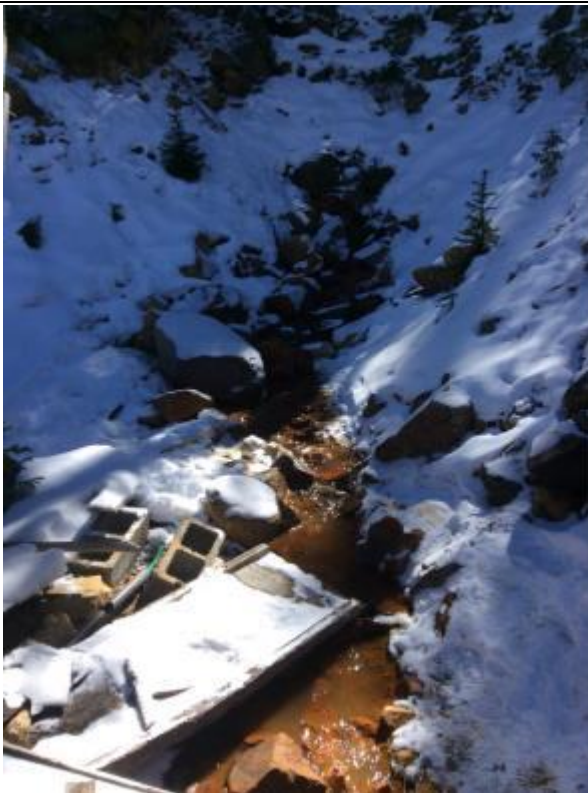
Photo No. 3	Date: 10/10/2017

Direction Photo Taken:		
Description: View of the mouth of the Jumbo Mine discharge channel standing next to the onsite cabin structure before the removal action began.		
Photo No. 4	Date: 10/10/2017

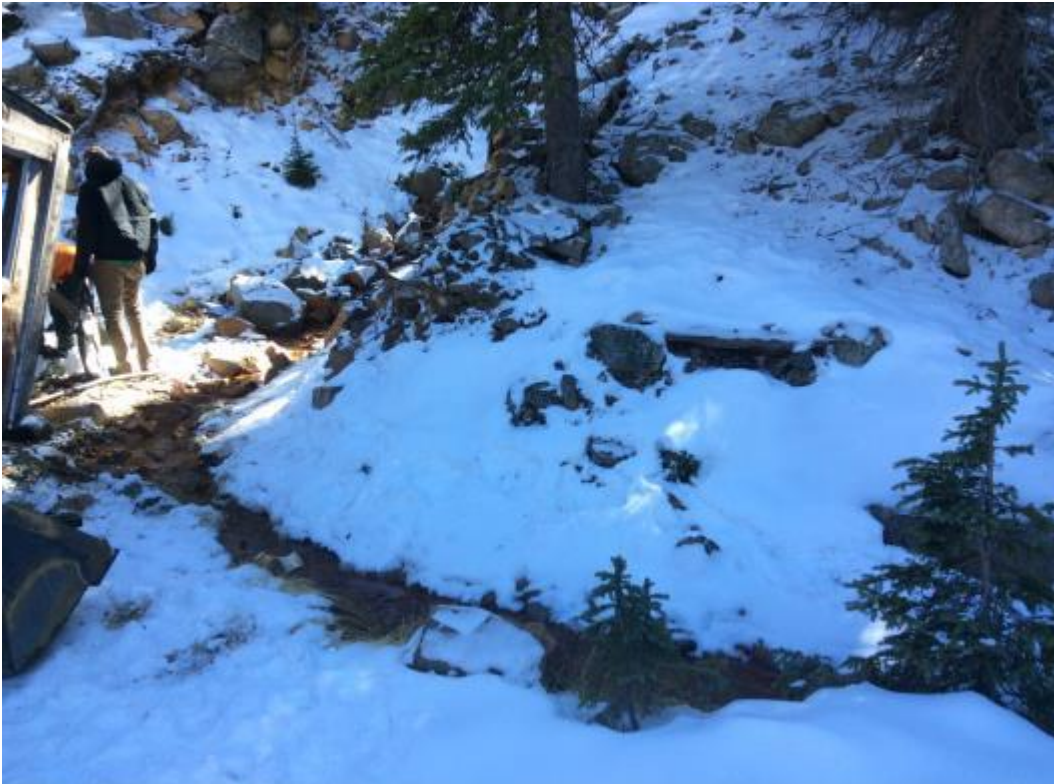
Direction Photo Taken:		
Description: Section 1 of the Jumbo Mine adit discharge channel before the removal action began. ERRS contractors clearing debris from the adjacent cabin structure so construction could begin.

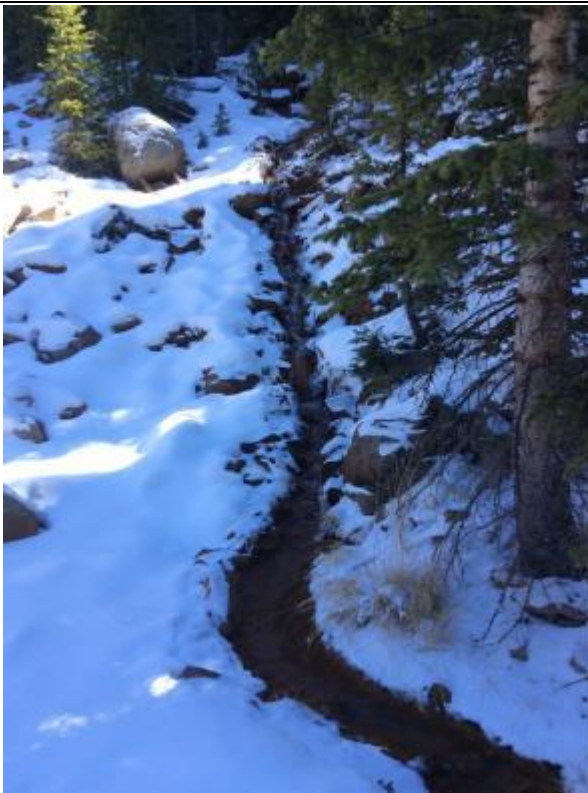
Photo No. 5	Date: 10/10/2017

Direction Photo Taken:		
Description: Section 2 of the Jumbo Mine adit discharge channel before the removal action.		
Photo No. 6	Date: 10/10/2017

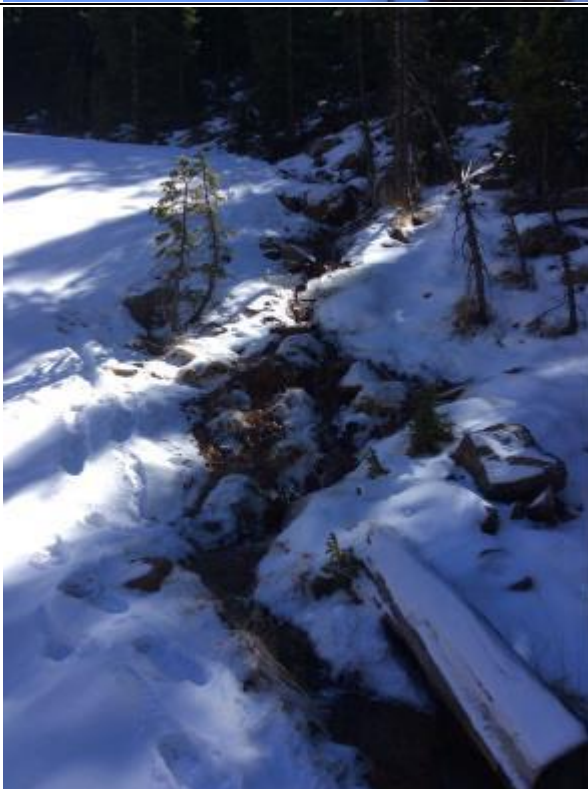
Direction Photo Taken:		
Description: Section 3 of the Jumbo Mine adit discharge channel before the removal action.

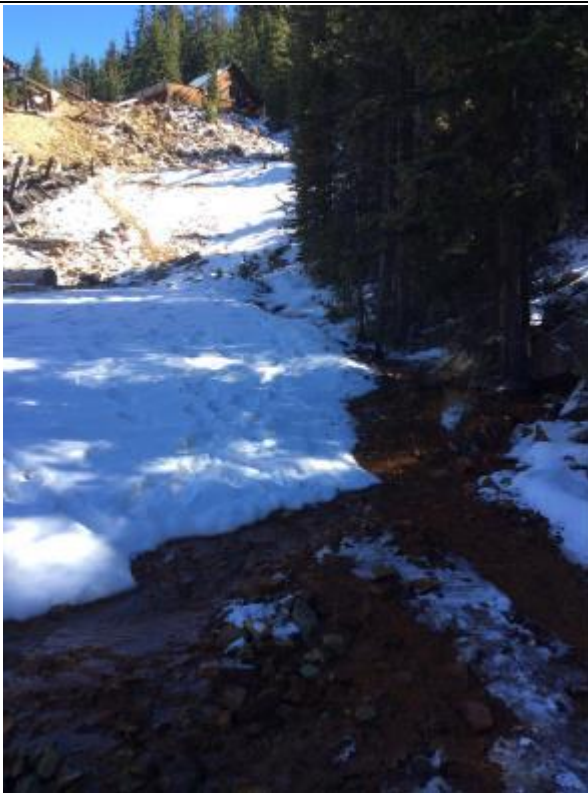
Photo No. 7	Date: 10/10/2017

Direction Photo Taken:		
Description: Section 4 of the adit discharge channel before the removal action, directly upstream of the confluence with the waste rock pile toe drainage.		
Photo No. 8	Date: 10/10/2017

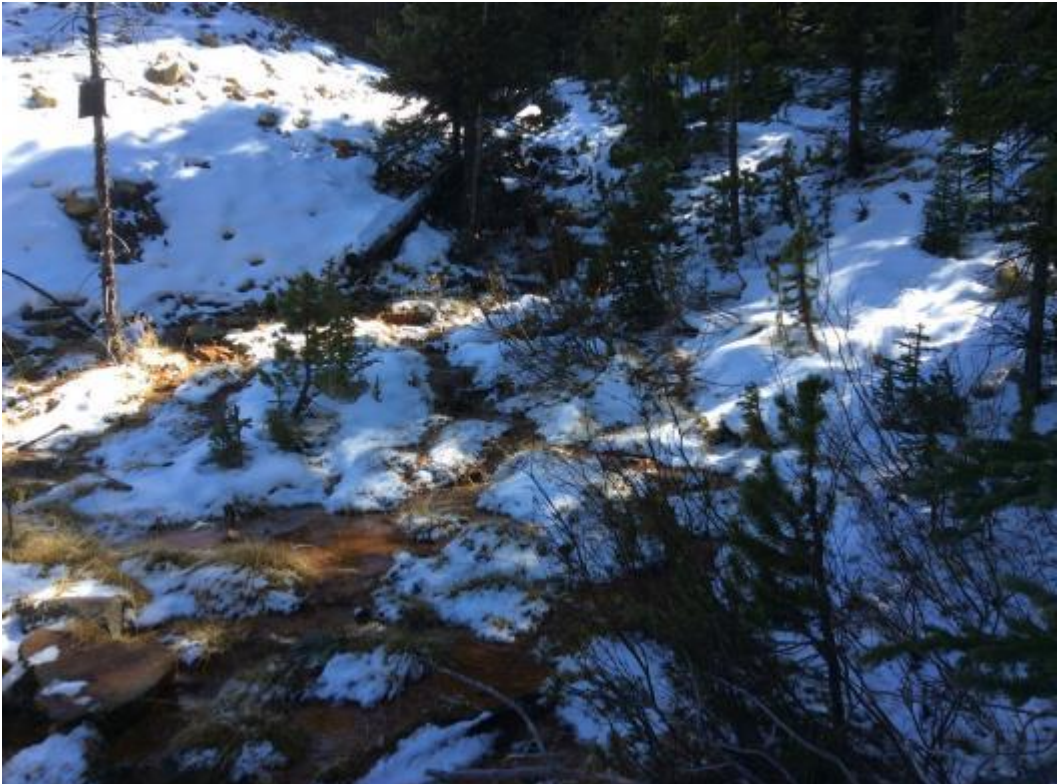
Direction Photo Taken:		
Description: Flat area where the Jumbo Mine adit drainage meets the waste rock toe drainage. Before the removal action.

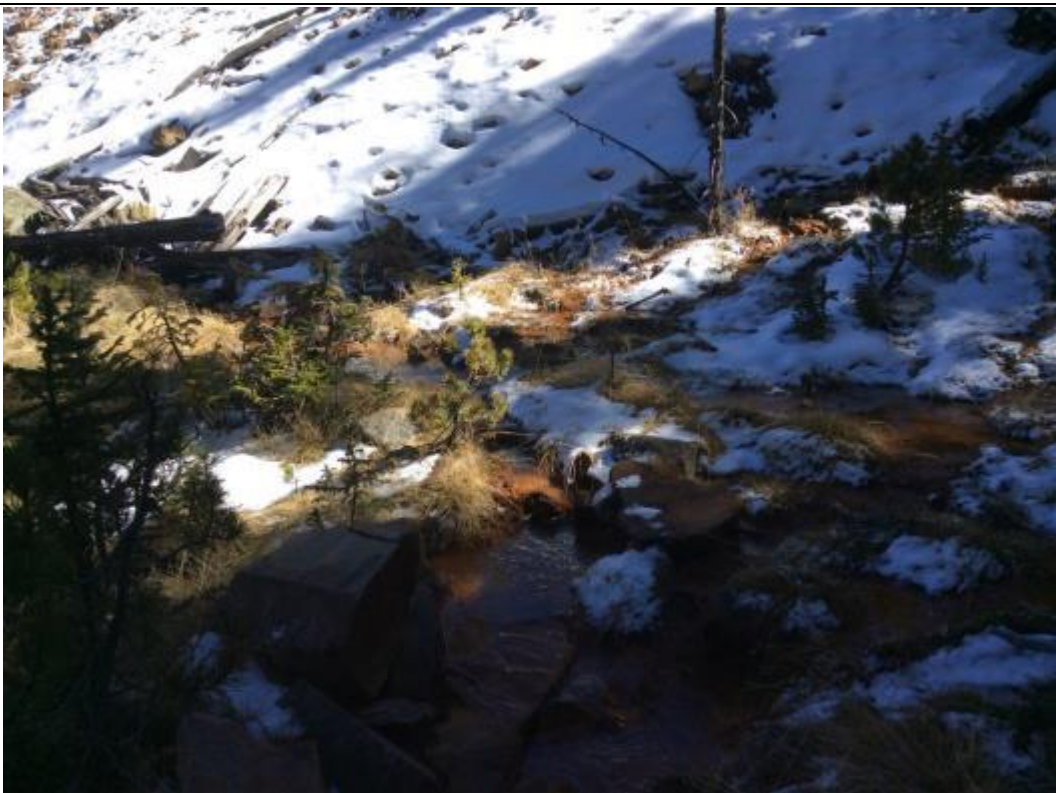
Photo No. 9	Date: 10/10/2017

Direction Photo Taken:		
Description: Channel segment carrying water from the waste rock toe drainage. Before the removal action.		
Photo No. 10	Date: 10/10/2017

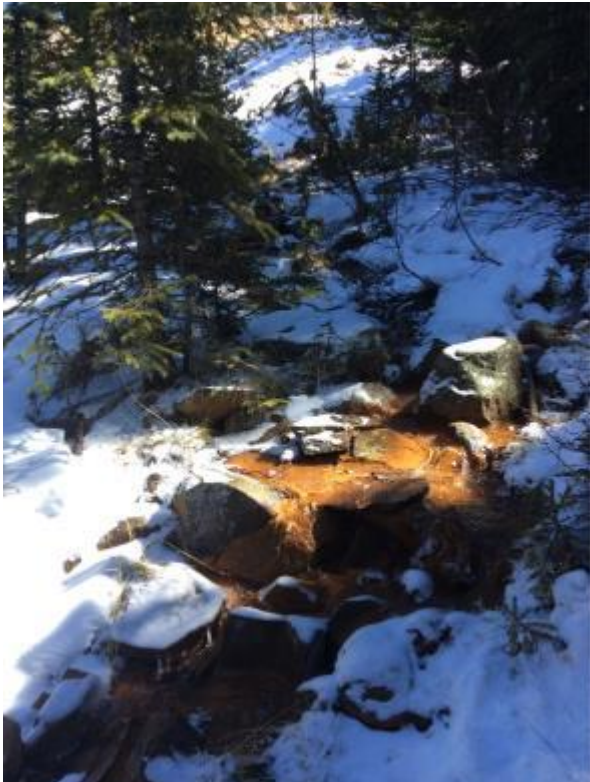
Direction Photo Taken:		
Description: Section 5 of the Jumbo Mine adit drainage channel before the removal action. Photo taken from the dirt road leading up to the adit.

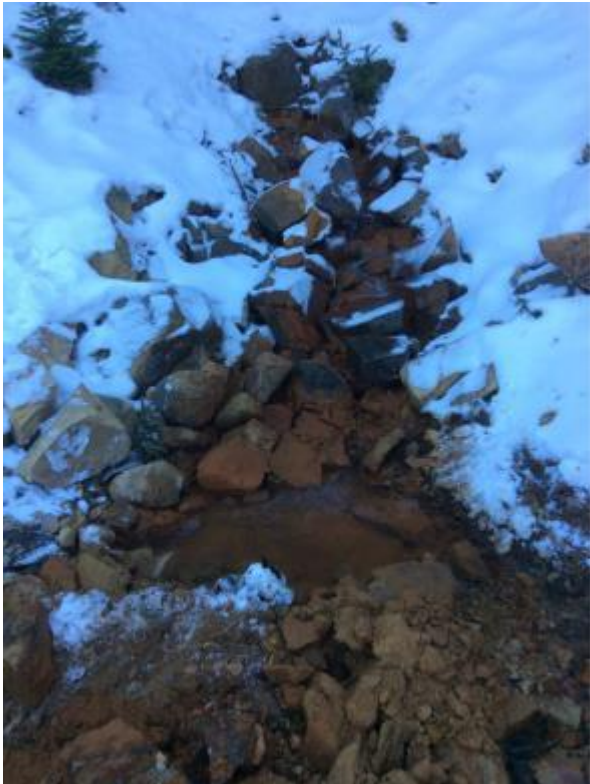
Direction Photo Taken:		
Description: View of the small pond created next to the draining Jumbo Mine adit at the beginning of channel construction. A pump was placed in the pond to redirect the adit drainage around the new channel during construction.

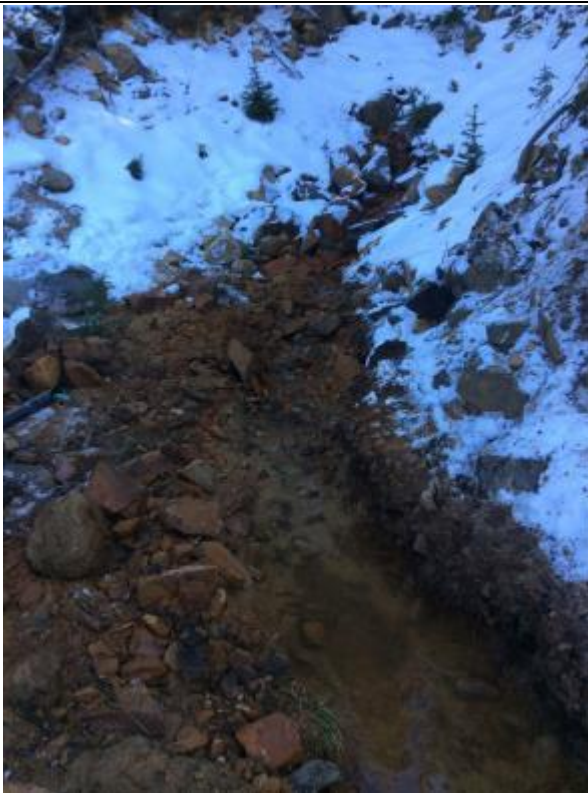
Photo No. 21	Date: 10/10/2017

Direction Photo Taken:				
Description: Beginning of channel excavation for the new constructed adit drainage channel.

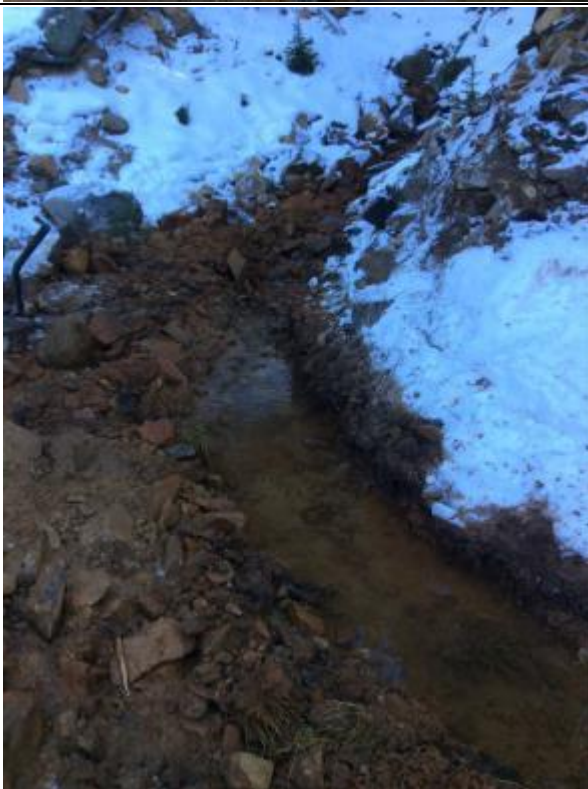
Photo No. 22	Date: 10/10/2017

Direction Photo Taken:				
Description: Beginning of channel excavation for the new constructed adit drainage channel at the beginning of the removal action.

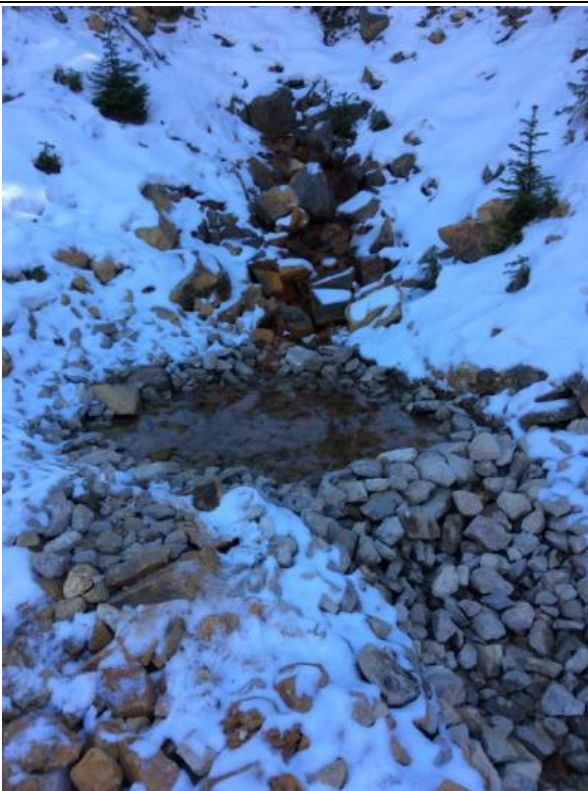
Photo No. 23	Date: 10/25/2017

Direction Photo Taken:		
Description: View of the start of the newly constructed Jumbo Mine drainage channel once the removal action was completed.		
Photo No. 24	Date: 10/25/2017

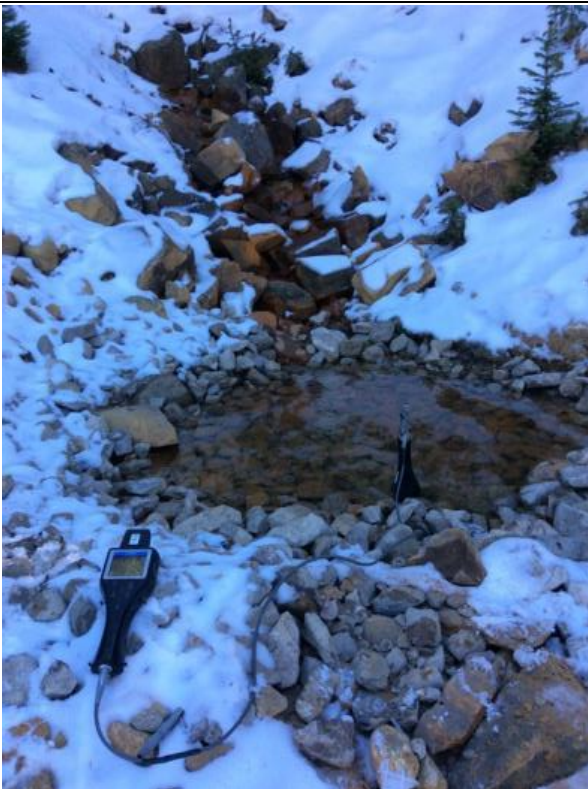
Direction Photo Taken:		
Description: Water quality parameters being taken from the pond at the start of the Jumbo Mine adit discharge channel after the removal action was completed. A water sample was collected from the pond to determine the effect of the removal action on improving water quality.

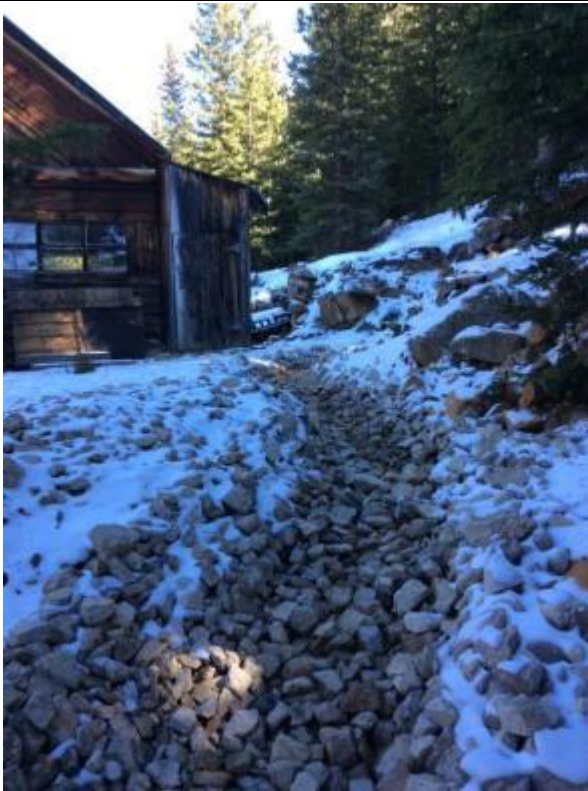
Photo No. 27	Date: 10/25/2017

Direction Photo Taken:		
Description: Section 1 of the Jumbo Mine adit discharge channel facing the onsite cabin structure adjacent to the adit after the removal action was completed.		
Photo No. 28	Date: 10/25/2017

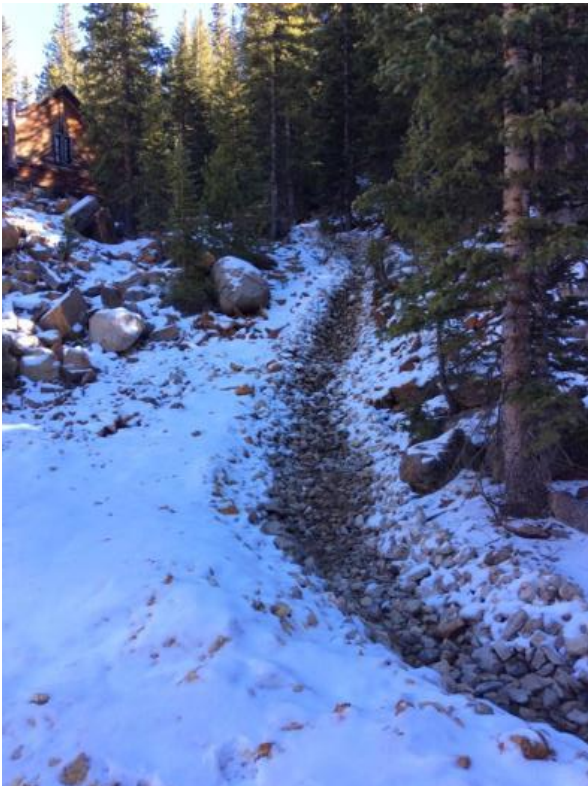
Direction Photo Taken:		
Description: Section 2 of the Jumbo Mine adit discharge channel after the removal action was completed.

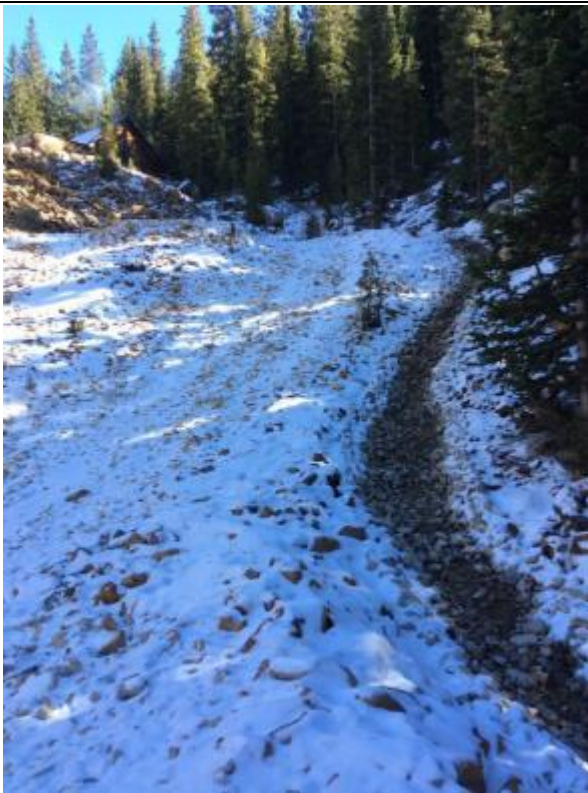
Photo No. 29	Date: 10/25/2017

Direction Photo Taken:		
Description: Section 3 of the Jumbo Mine adit discharge channel after the removal action was completed.		
Photo No. 30	Date: 10/25/2017

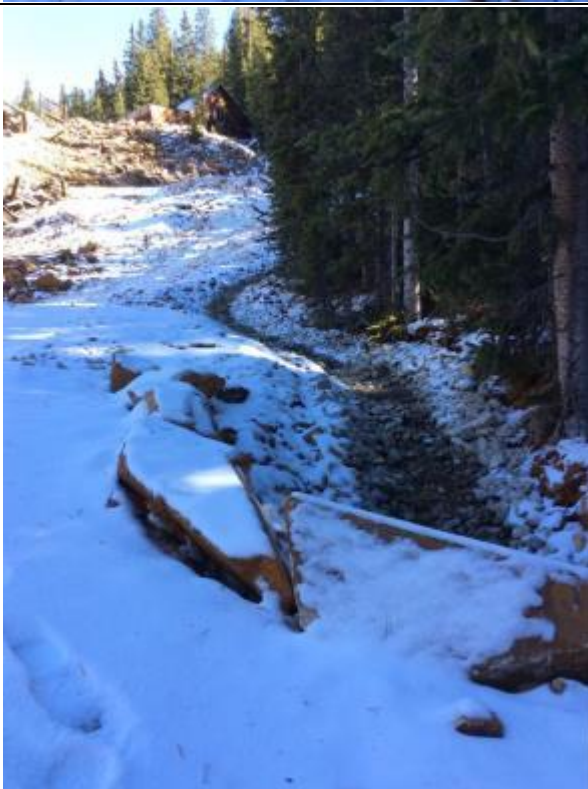
Direction Photo Taken:		
Description: Section 4 of the Jumbo Mine adit discharge channel after the removal action was completed. A culvert was constructed to transport the discharge water to the confluence with the waste rock pile toe drainage.

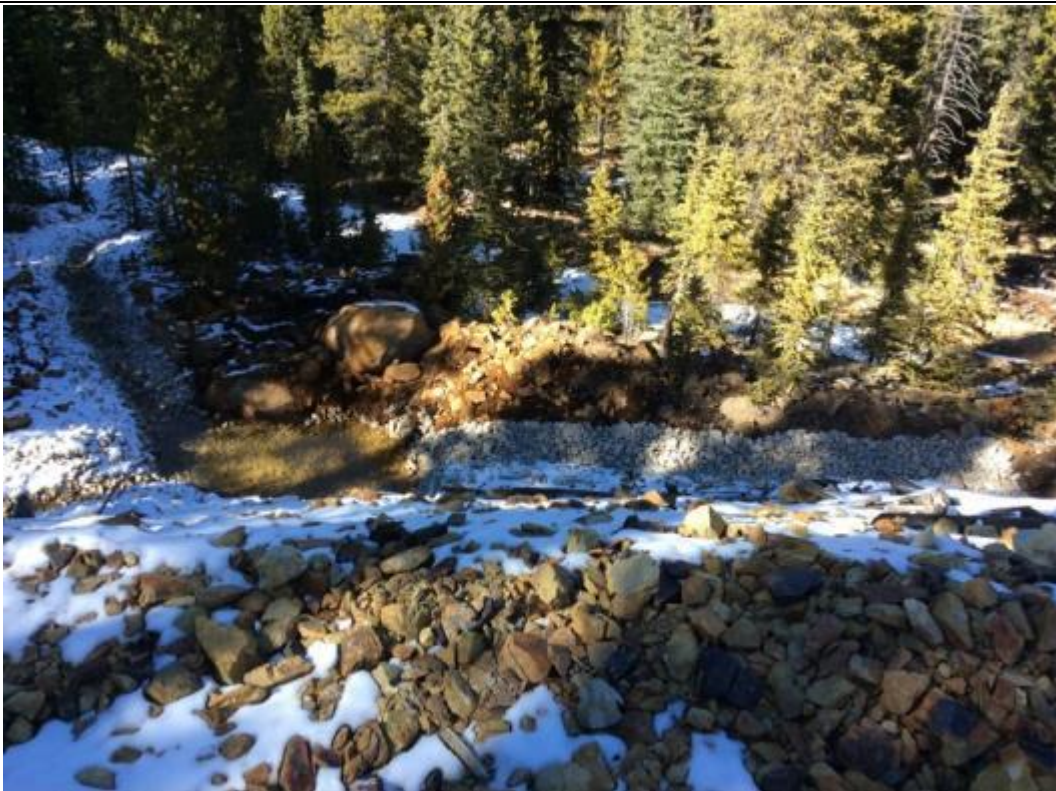
Photo No. 31	Date: 10/25/2017

Direction Photo Taken:		
Description: View of the Jumbo Mine adit discharge channel and the waste rock pile toe drainage channel confluence after the removal action was completed. A ponding area was constructed at the confluence to allow for extra particulate precipitation.		
Photo No. 32	Date: 10/25/2017

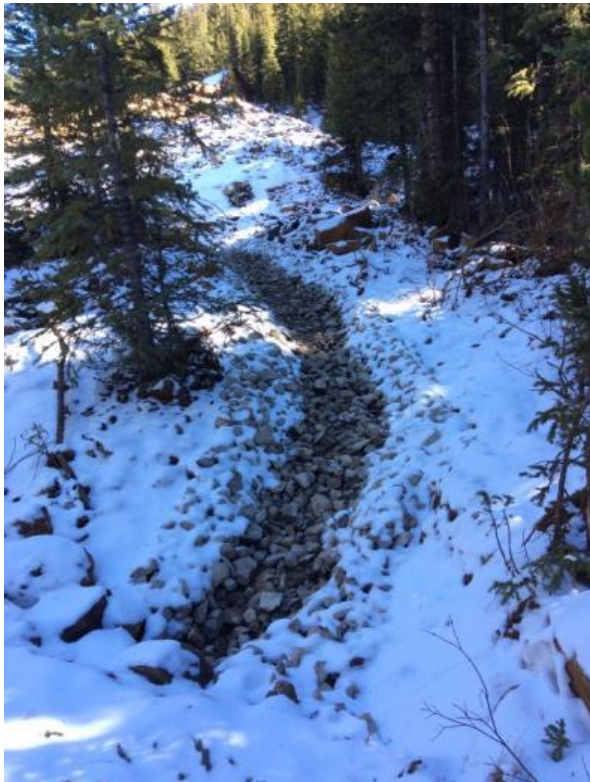
Direction Photo Taken:		
Description: Section 6 of the Jumbo Mine adit discharge channel after the removal action was completed. Photo taken from the dirt road leading up to the Jumbo Mine adit where a culvert was installed to transport the adit drainage under the roadway.

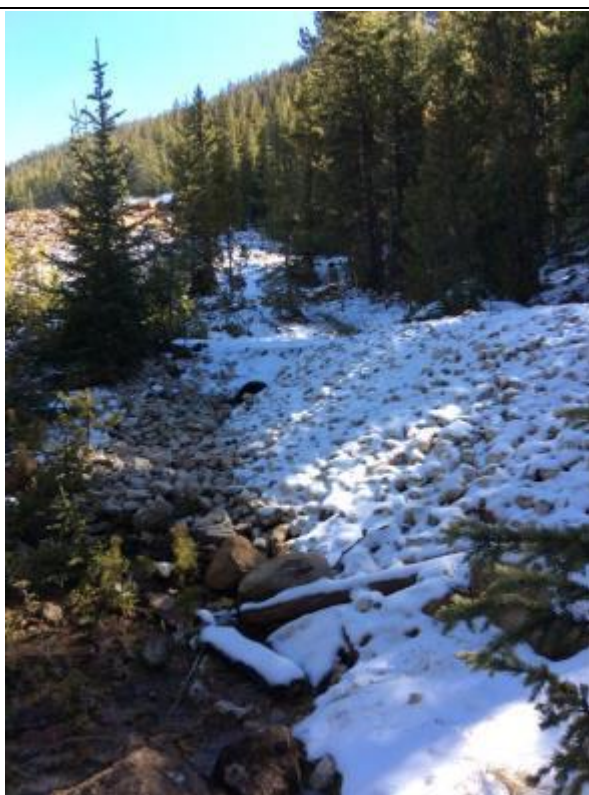
Photo No. 33	Date: 10/25/2017

Direction Photo Taken:		
Description: View from the bottom of the constructed Jumbo Mine drainage channel after the removal action was completed.		
Photo No. 34	Date: 10/25/2017

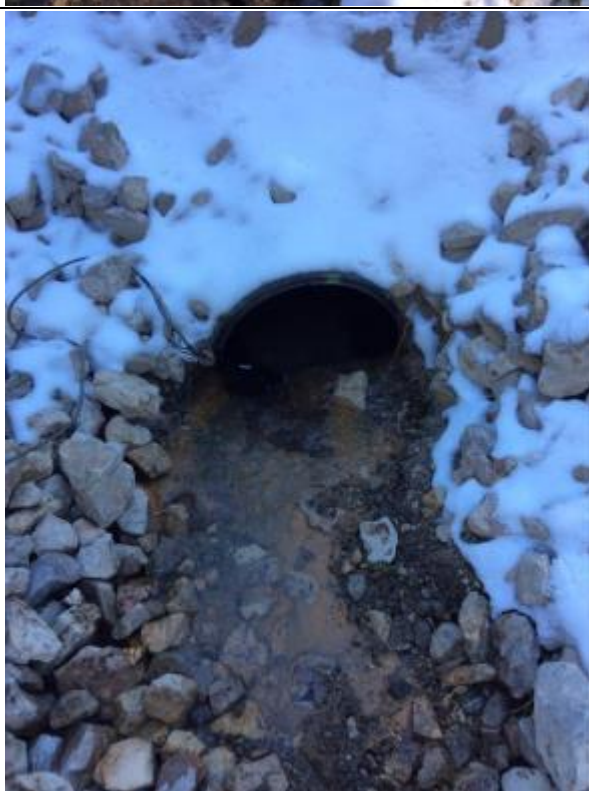
Direction Photo Taken:		
Description: Downstream orifice of the culvert at the end of the constructed channel. A sample to evaluate the removal action on improving water quality was collected at the effluent of the culvert.
