January 5, 2018

**Subject: C&H Mineral Building Roof Overview (Revision 3)**  
**C&H Mineral Building - RS Site**  
**EPA Contract No.: EP-S5-13-01**  
**Technical Direction Document No.:**  
**S05-0001-1711-007 Document Tracking No.: 2224C**

ACBM Letter Report  
January 5, 2018

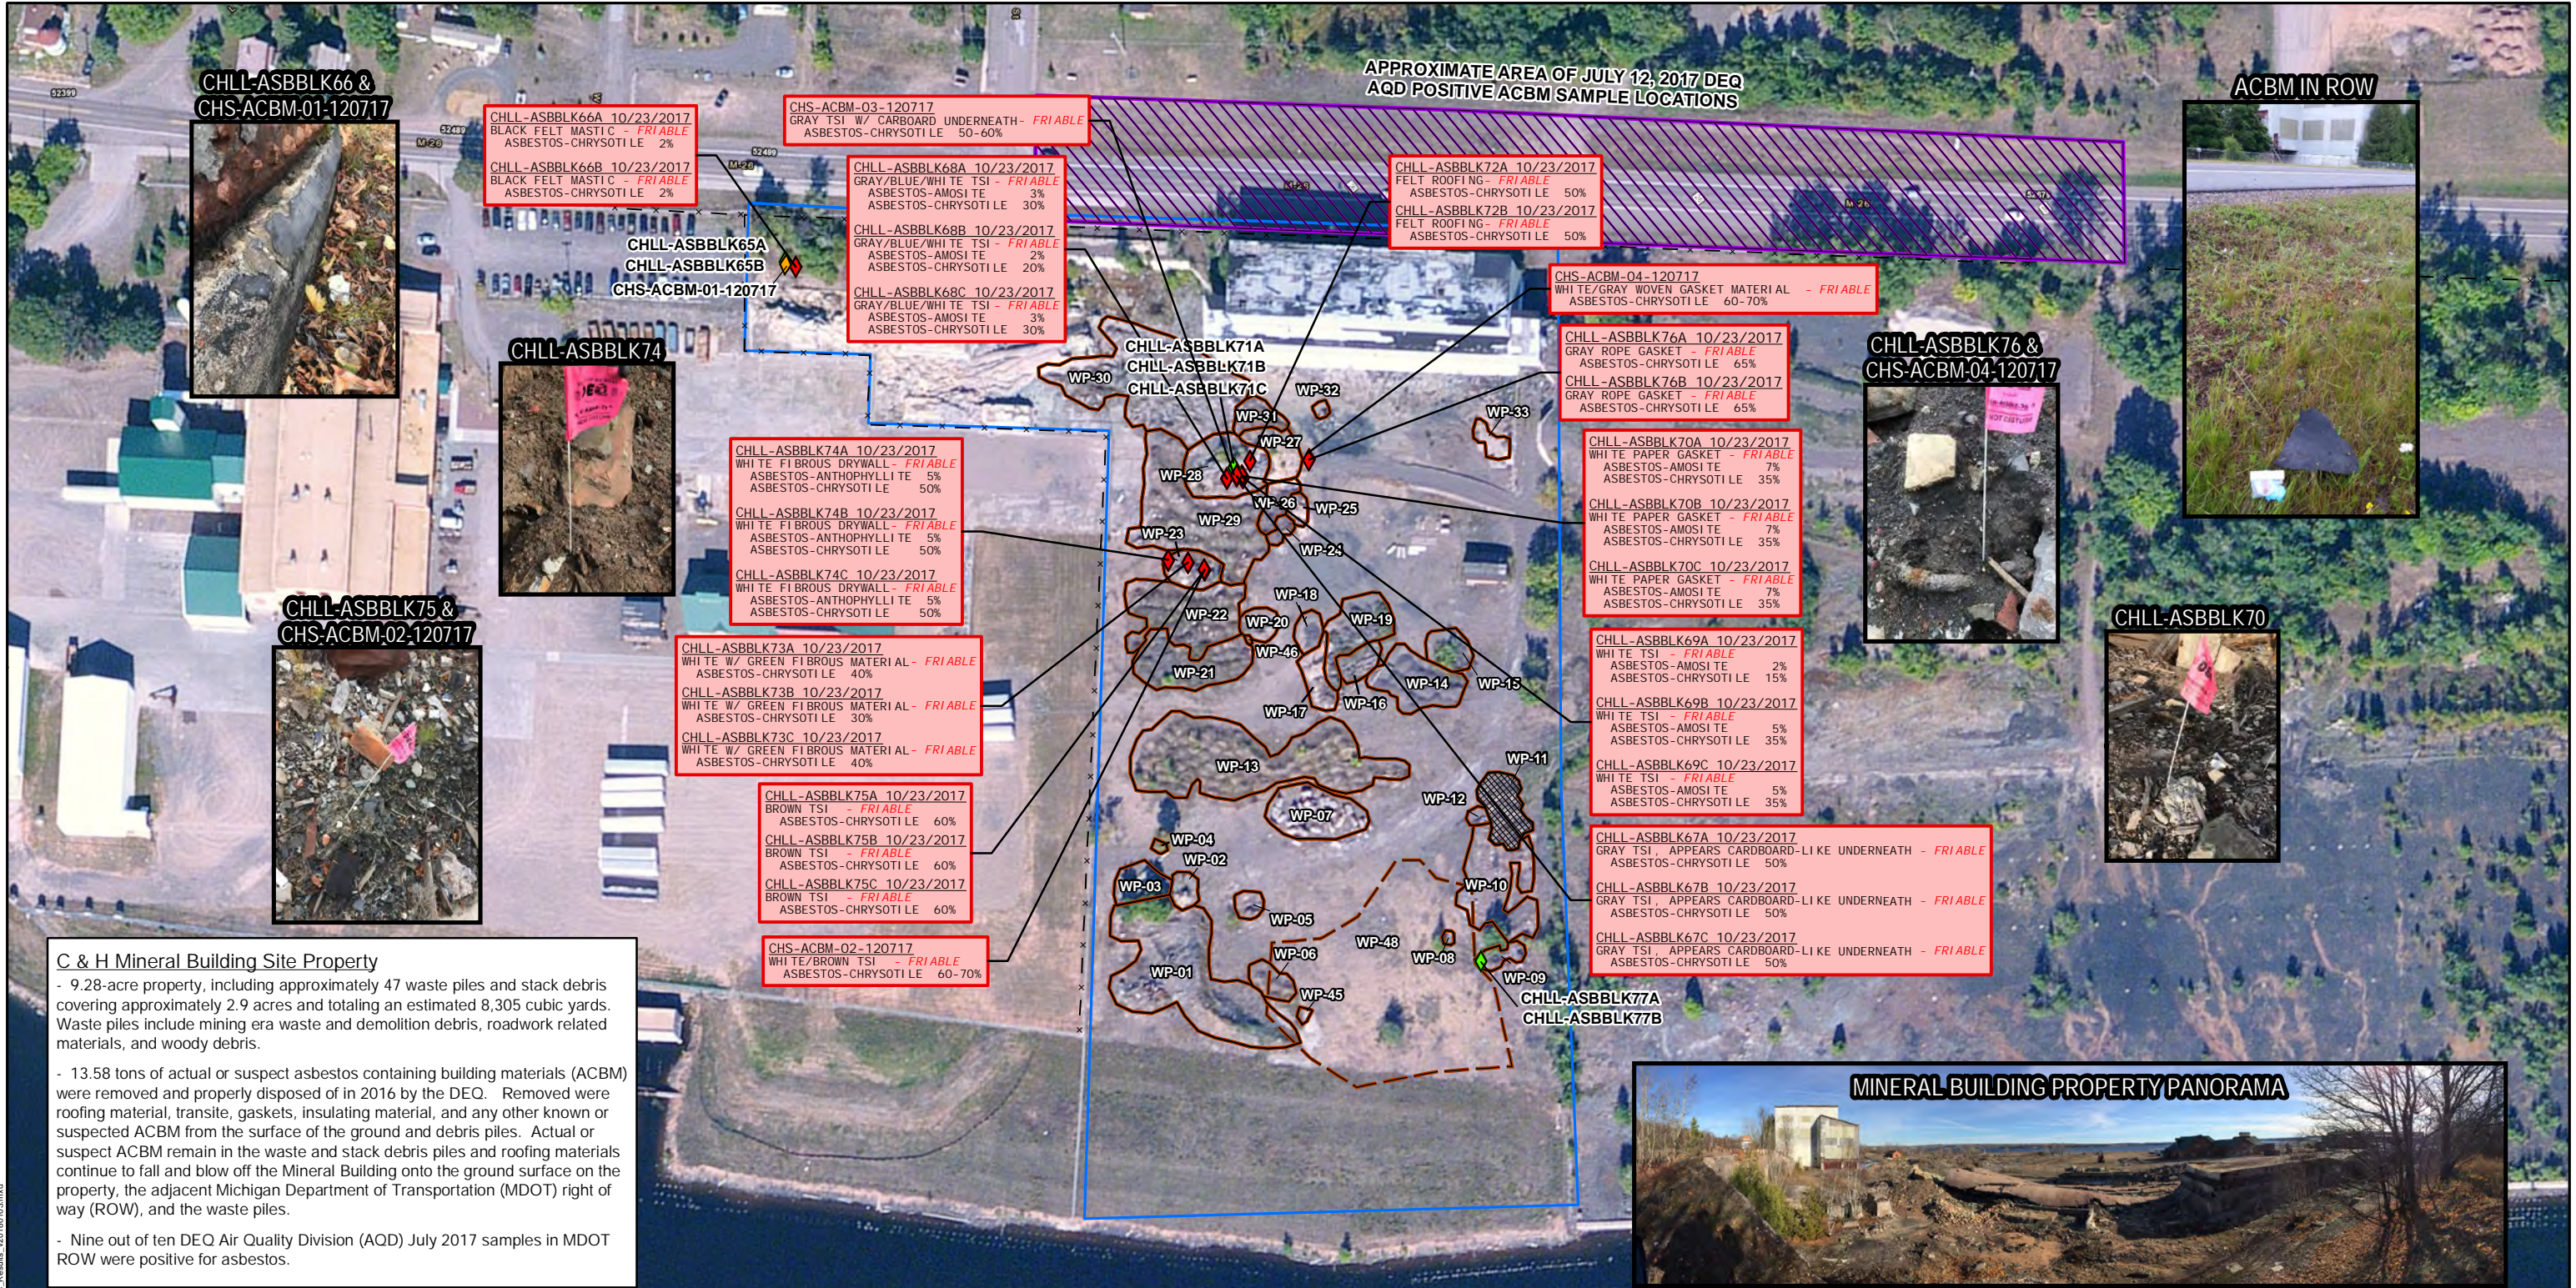
**Figure 3**  
**Asbestos Analytical Results Map**

On December 7, 2017, START conducted sampling that verified prior ACBM analytical results. **Attachment B** includes a table that summarizes the bulk asbestos analytical data collected by DEQ RRD and DEQ AQD prior to and after RRD's ACBM recovery efforts, and recent START verification sampling. The analytical results indicate the majority of samples collected contained asbestos. **Figure 3** depicts the locations and provides a summary of the tabulated analytical data for ACBM not recovered.

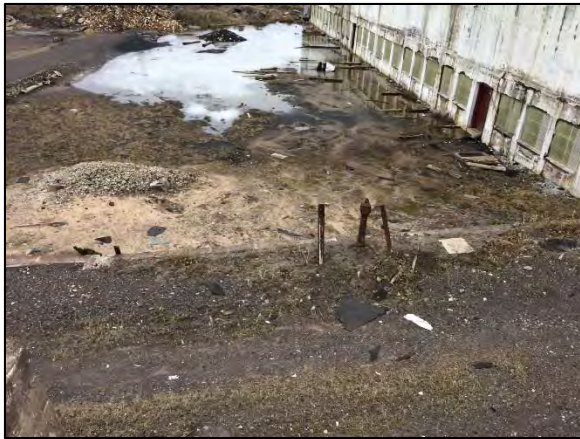
Photo 1: View looking southwest to fallen roofing material on the lake side of the Mineral Building. Photo taken: November 28, 2017.

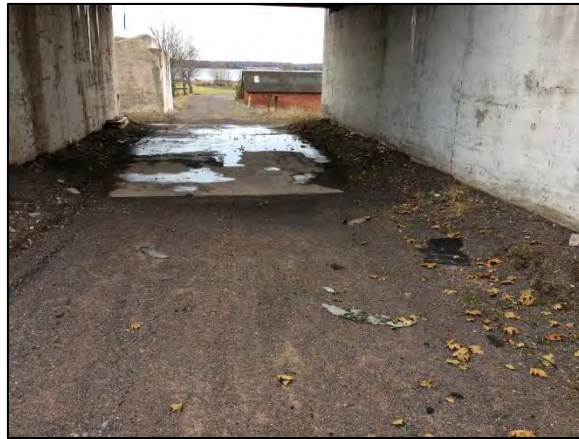
Photo 2: View looking southeast to fallen roofing material near the ramp on northeast end of the Mineral Building. Photo taken: November 28, 2017.

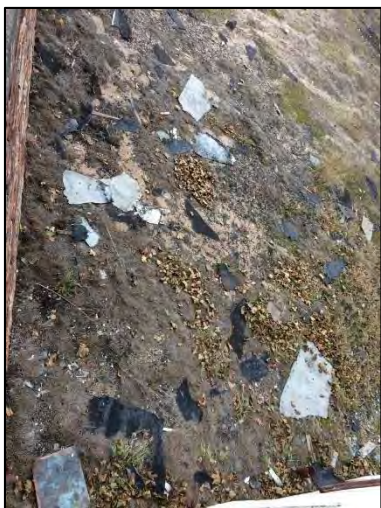
Photo 3: View of fallen roofing material near the northeast corner of the Mineral Building on the lake side. Photo taken: November 28, 2017.

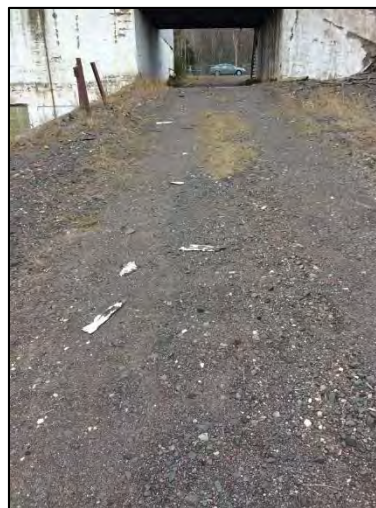
Photo 4: View looking northwest to fallen roofing material near the ramp of the Mineral Building. Photo taken: November 28, 2017.

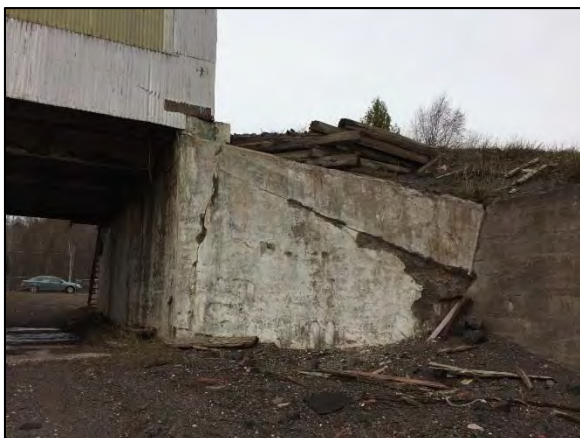
Photo 5: View looking north to fallen roofing material near the ramp of the Mineral Building. Photo taken: November 28, 2017.

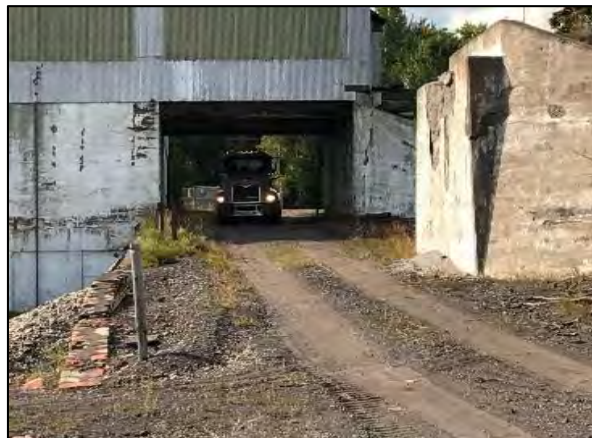
Photo 6: View of same location as Photo 4 showing no roofing in the access roadway three months prior to Photo 4. Photo taken: August 28, 2017.

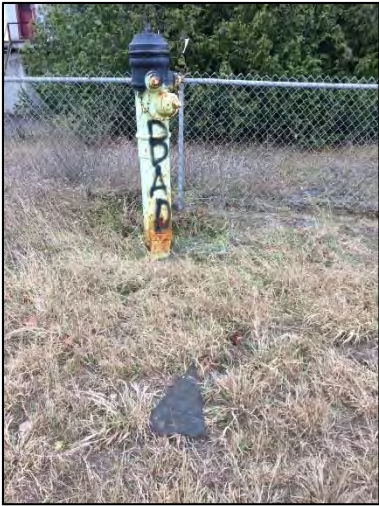
Photo 7: View of fallen roofing material in MDOT ROW outside of fencing on west side of the Mineral Building. Photo taken: November 28, 2017.

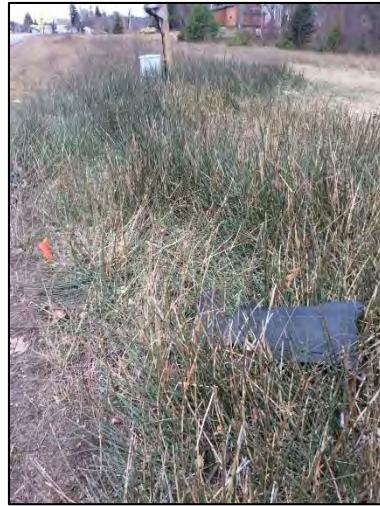
Photo 8: View looking southwest to roofing material in the MDOT ROW on the west side of M-26, across the highway from the Mineral Building. Photo taken: November 28, 2017.

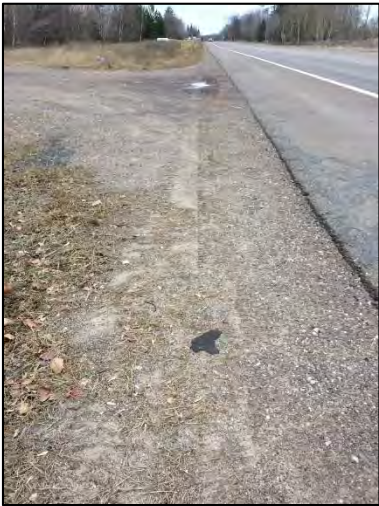
Photo 9: View looking northeast to roofing material in the MDOT ROW on the west side of M-26, across the highway from the Mineral Building. Photo taken: November 28, 2017.
