January 5, 2018

**Subject: C&H Mineral Building Roof Overview (Revision 3)**  
**C&H Mineral Building - RS Site**  
**EPA Contract No.: EP-S5-13-01**  
**Technical Direction Document No.:**  
**S05-0001-1711-007 Document Tracking No.: 2224C**

ACBM Letter Report  
January 5, 2018

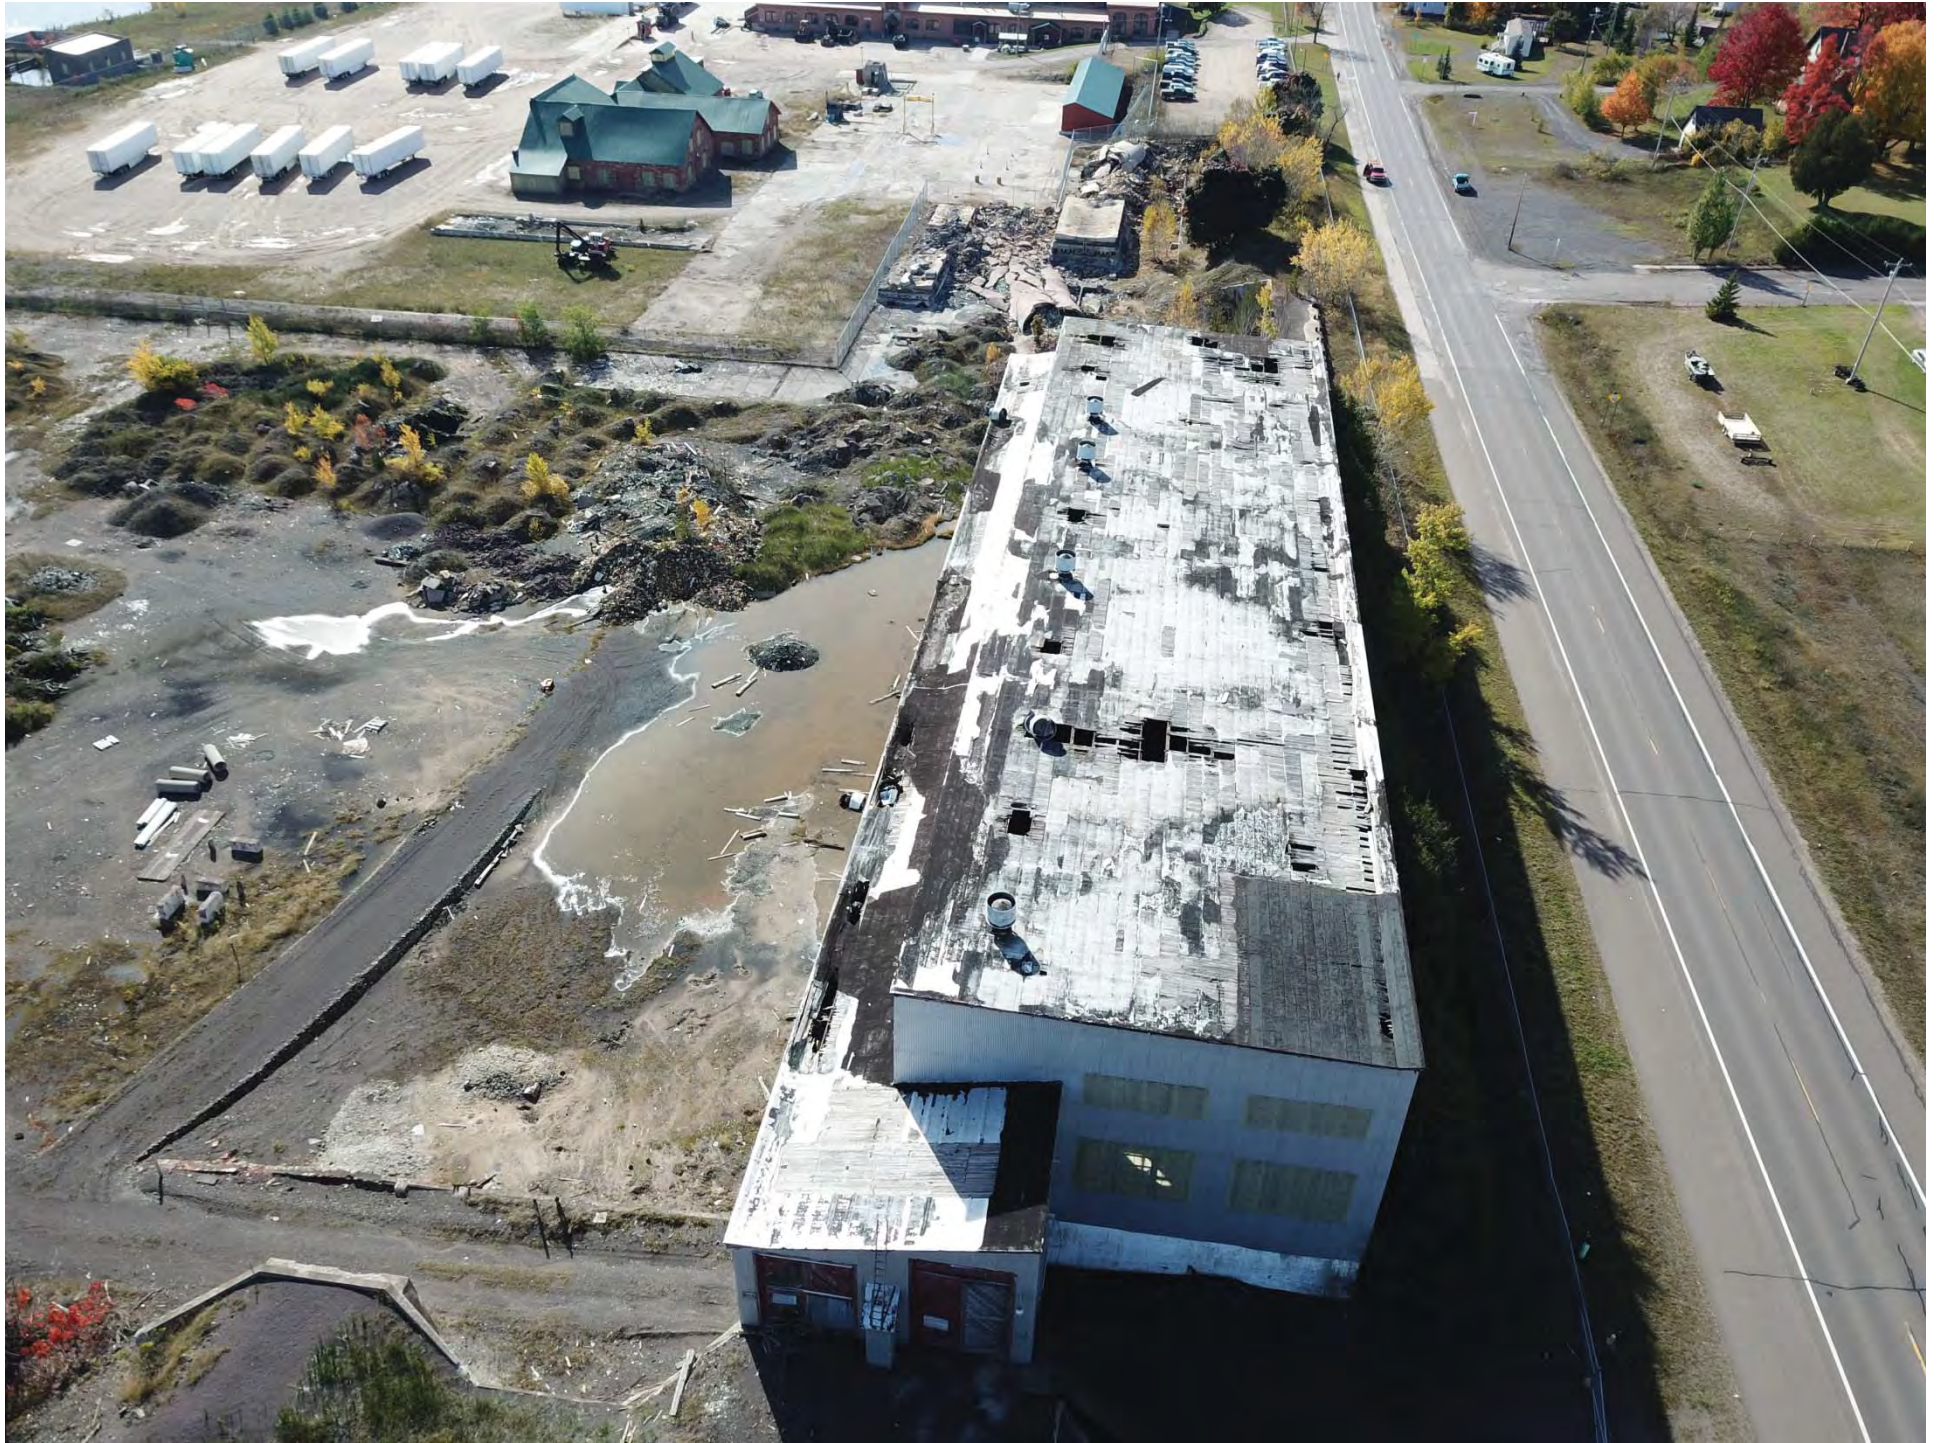
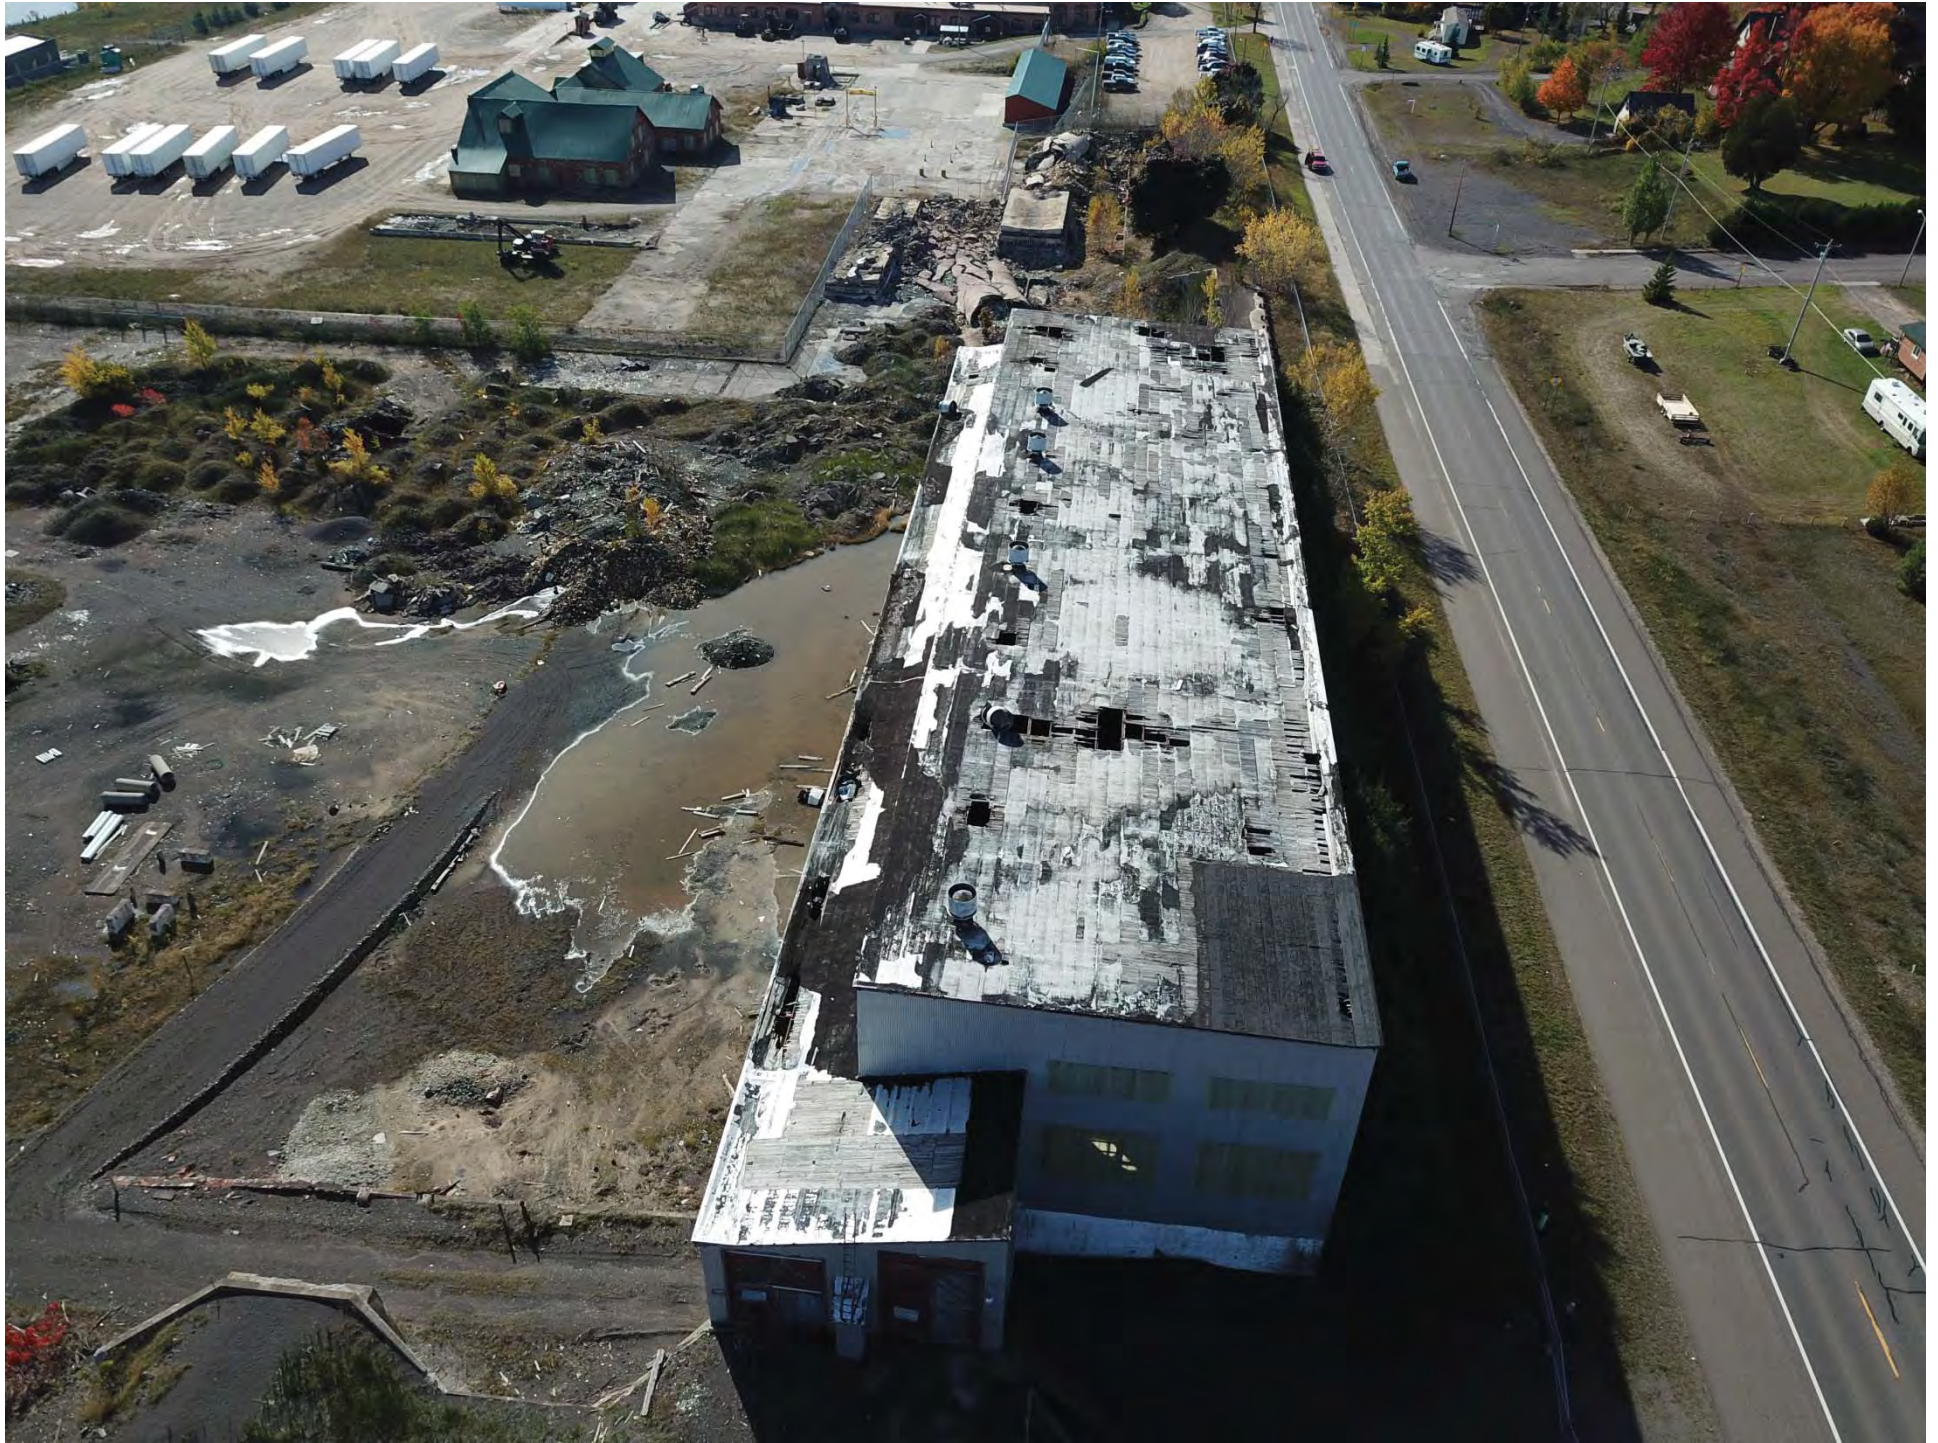
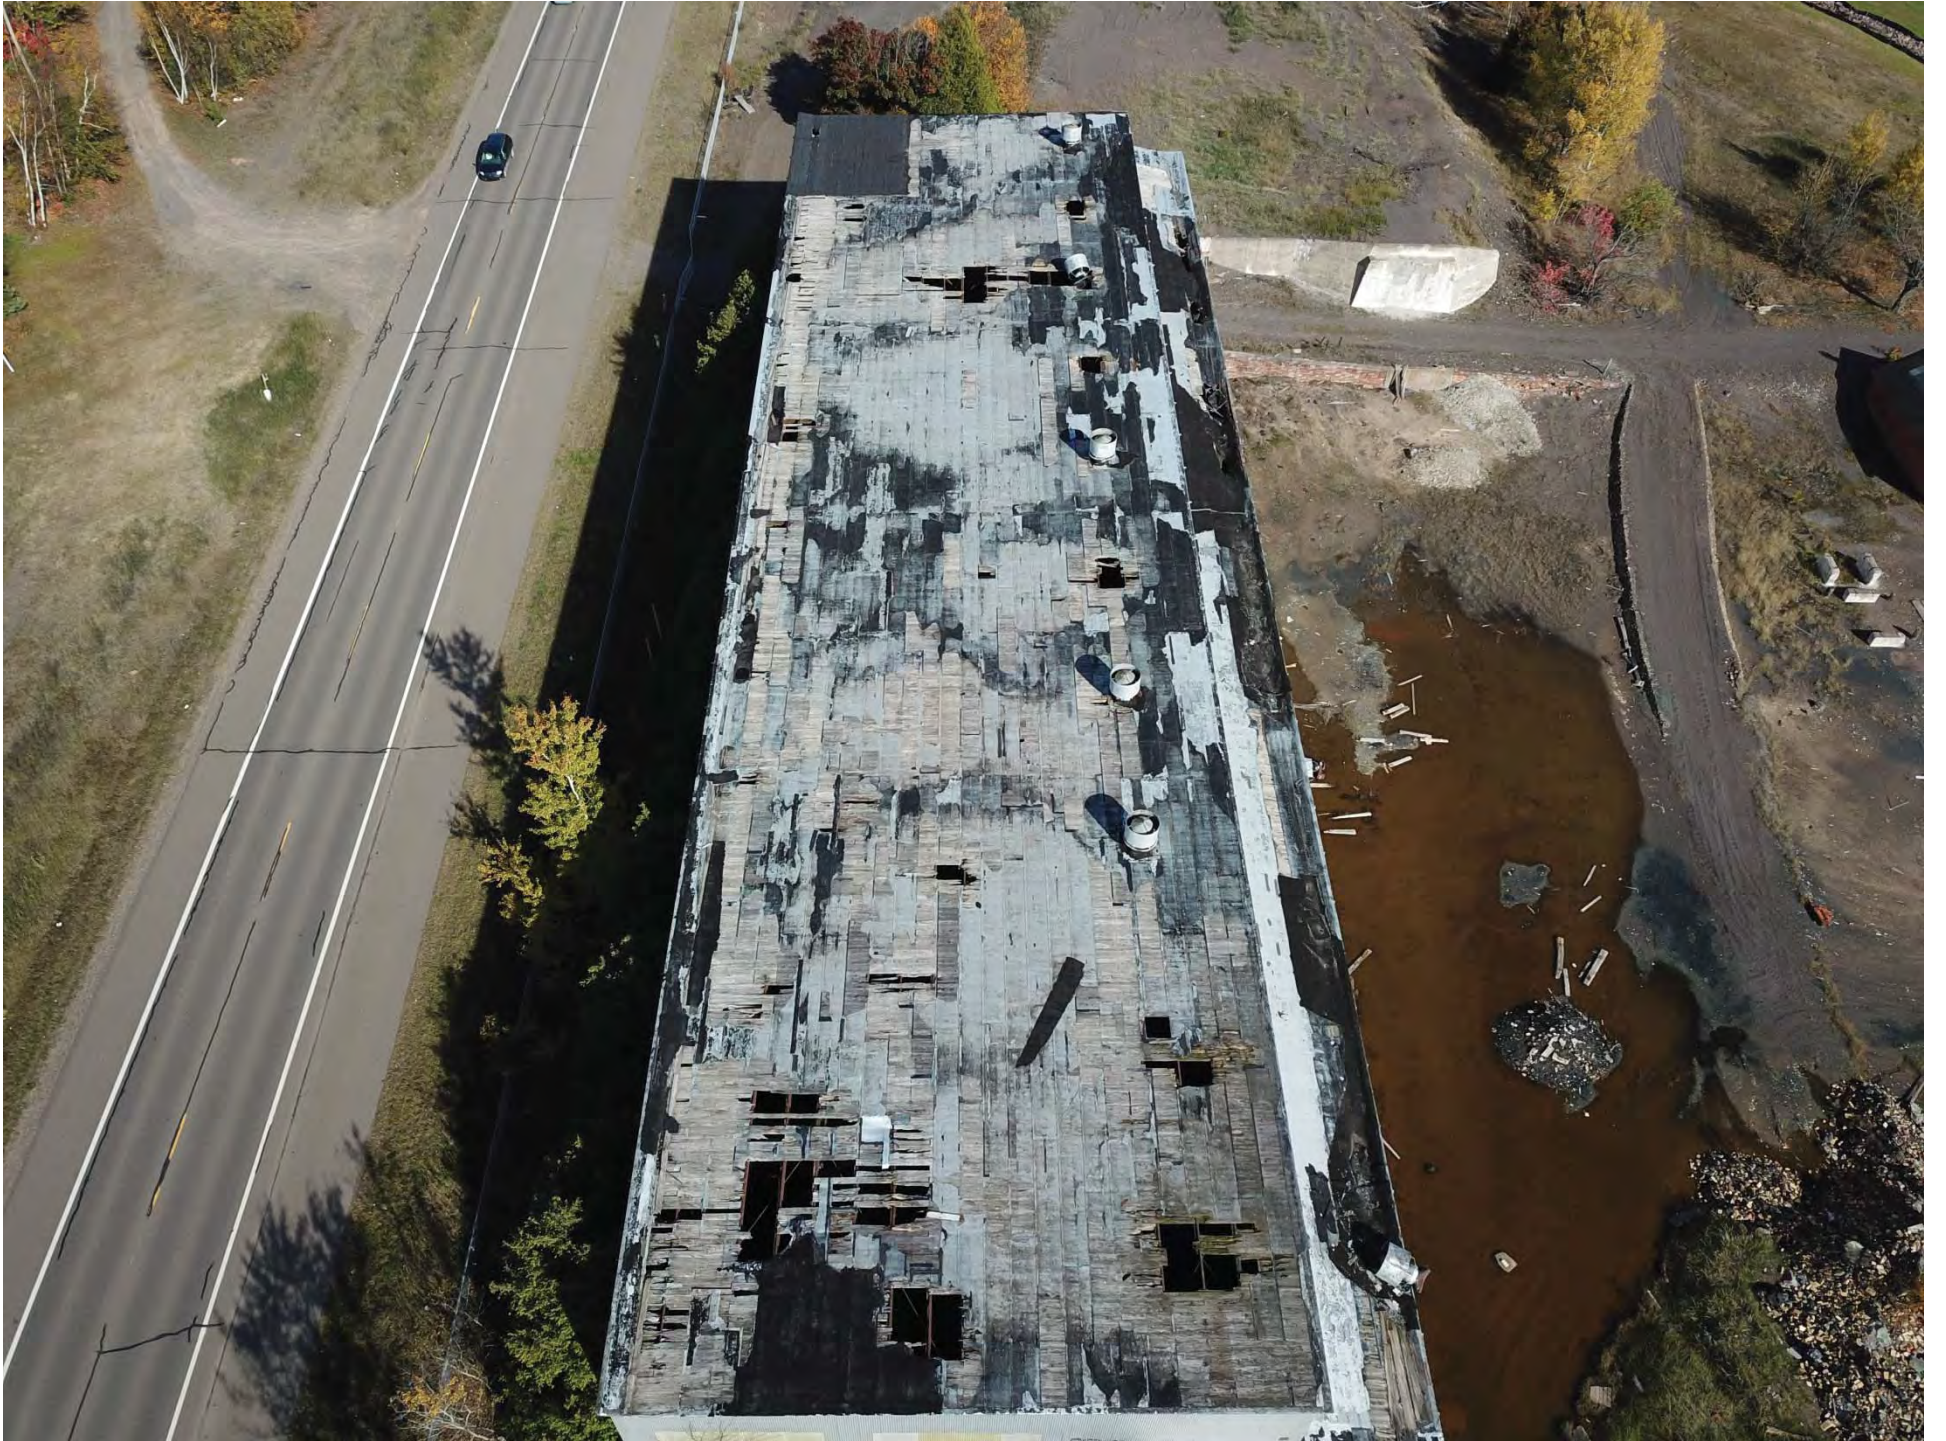
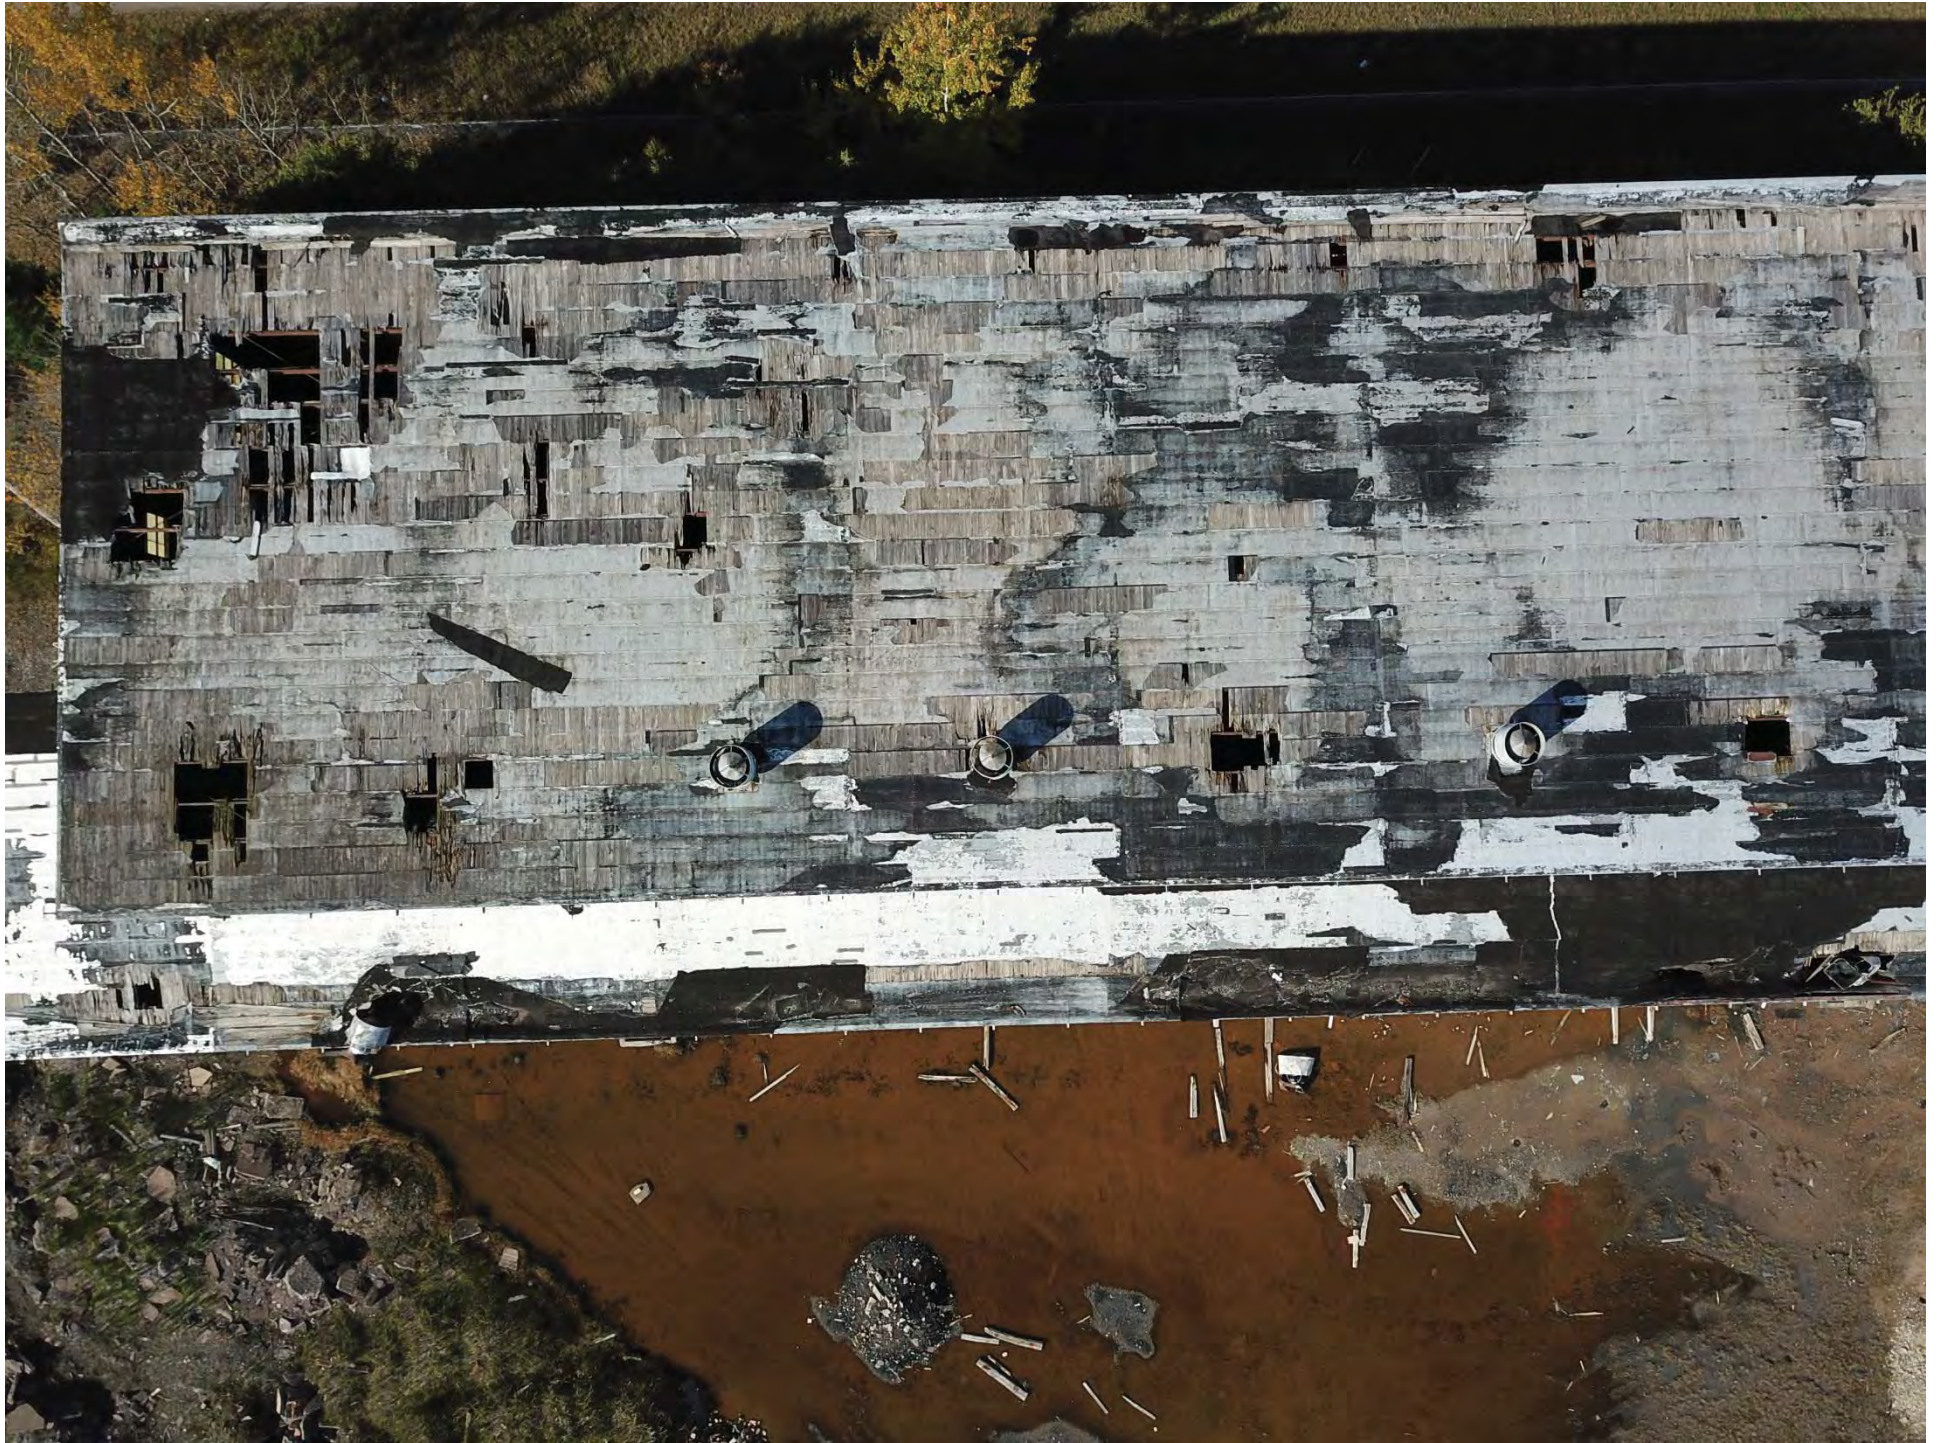
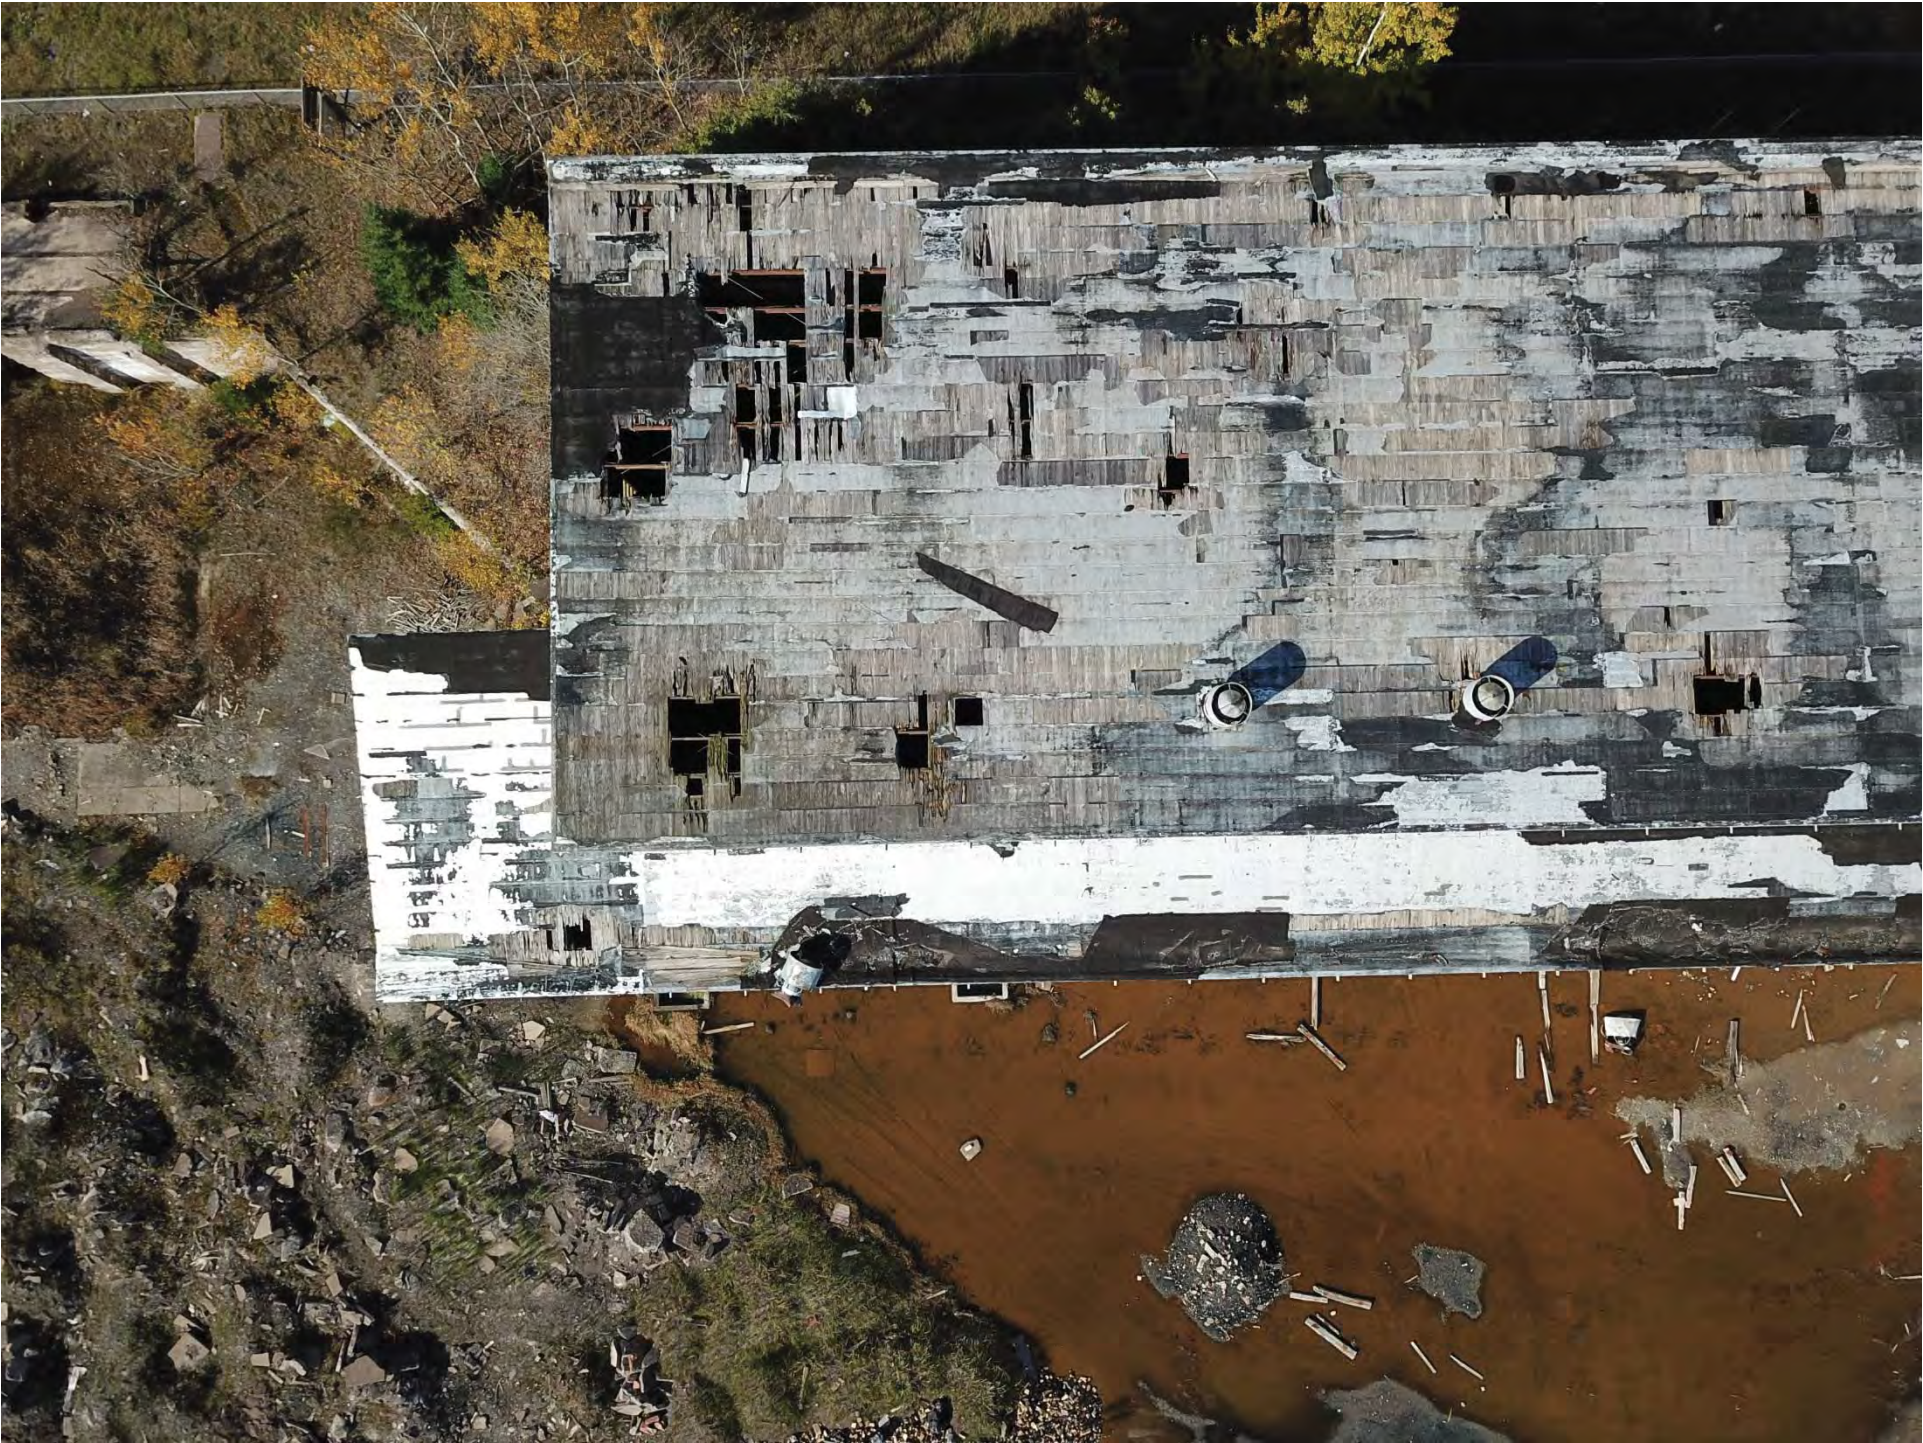
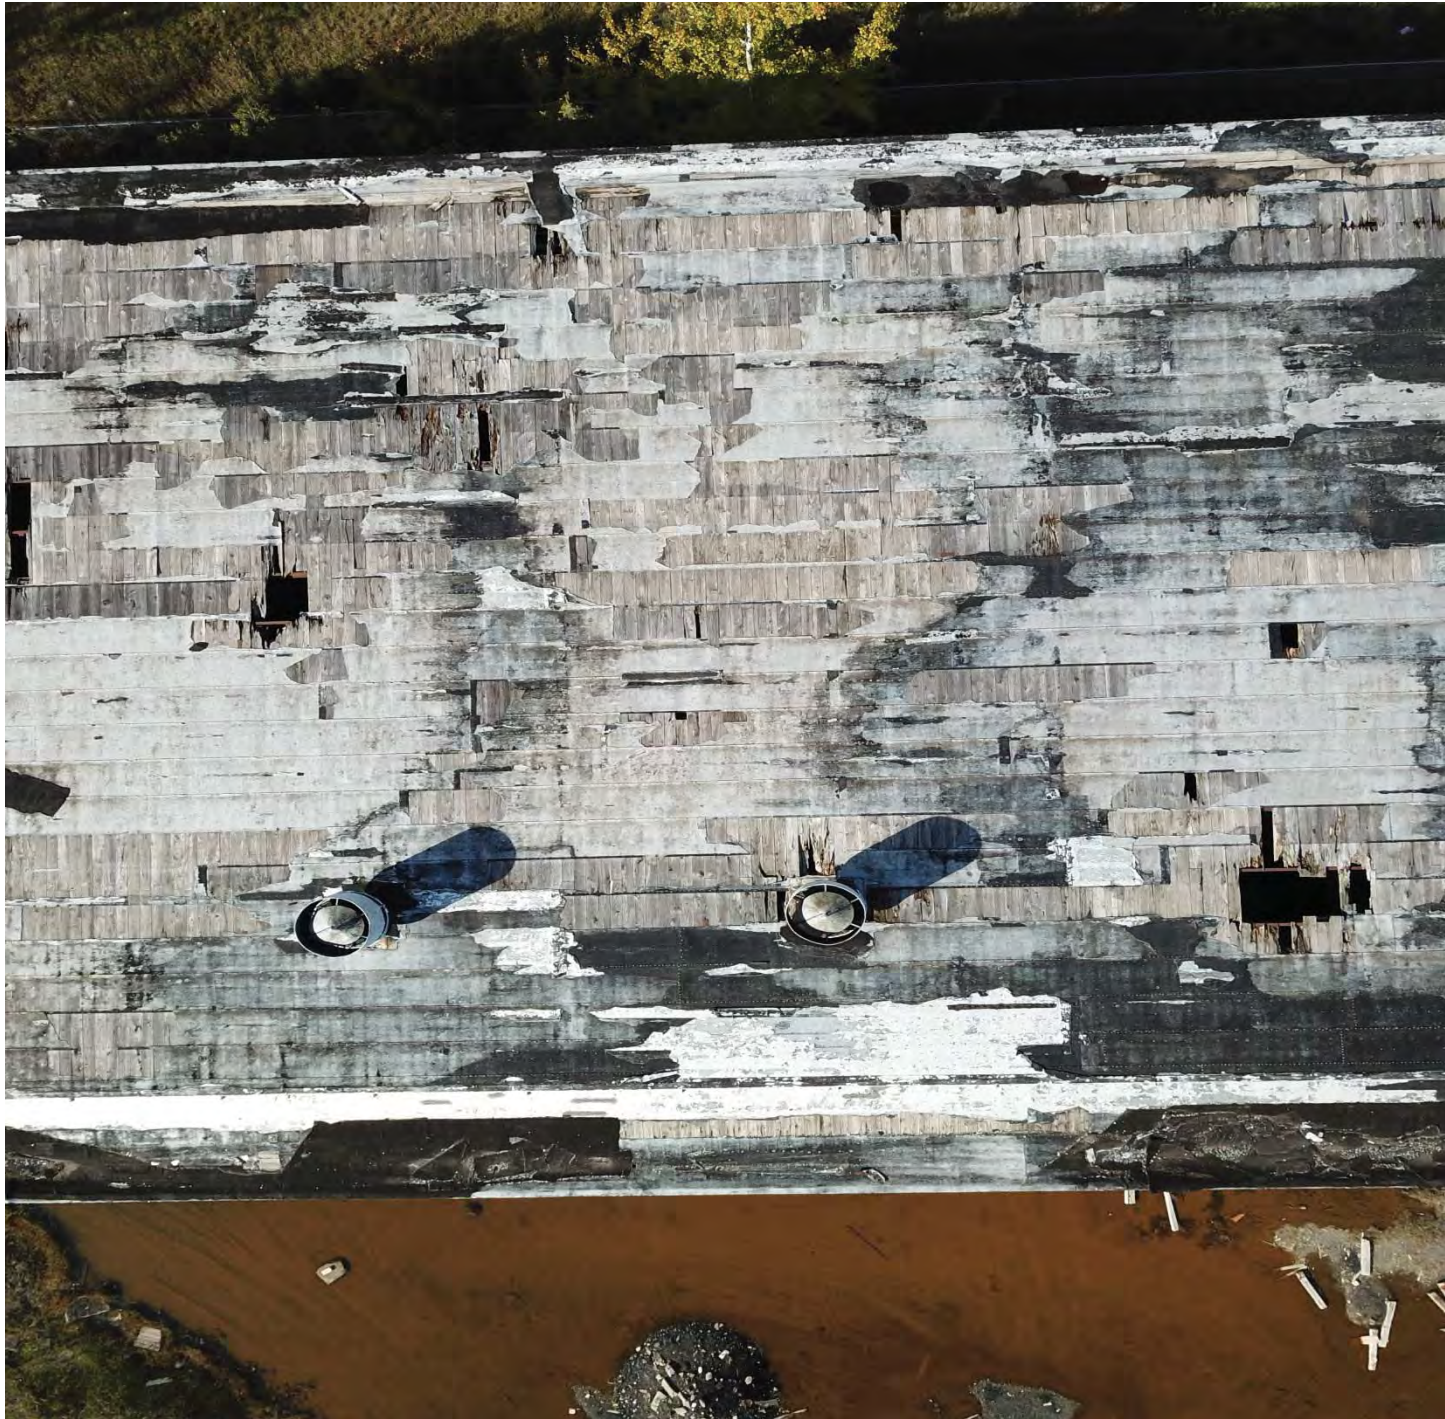
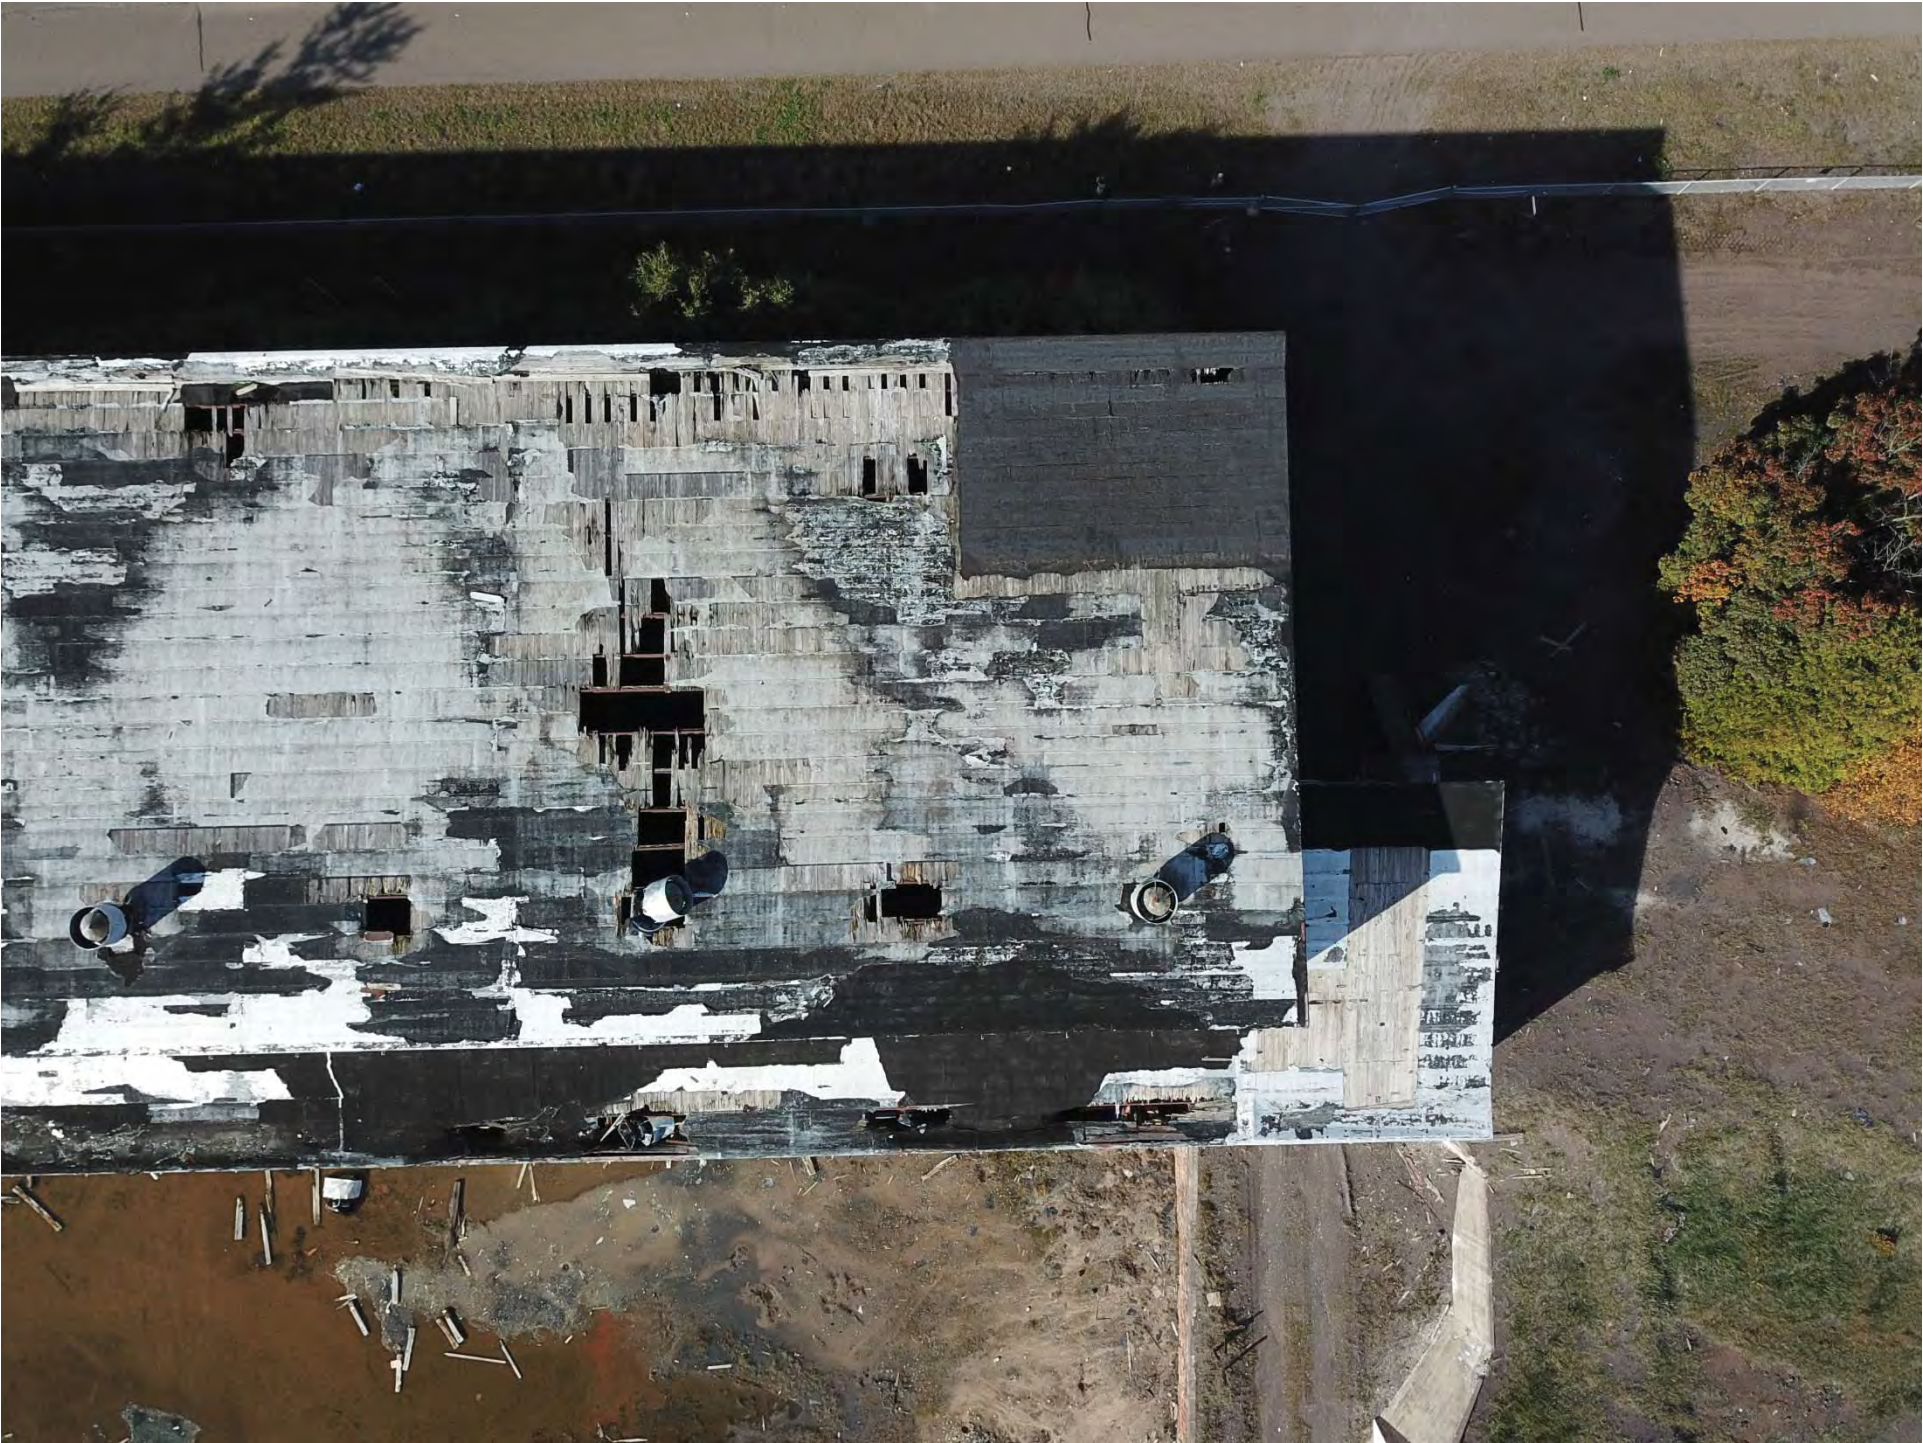
Actual or suspect ACBM roofing materials have been and will continue to fall and blow off of the Mineral Building roof onto the Site property, bordering properties, and the adjacent MDOT Highway M-26 ROW. There are multiple lines of evidence of the continued deterioration of the Mineral Building roof. Of note, between the two DEQ RRD recovery efforts in 2016, an additional 1.77 tons of ACBM, a portion of which was Mineral Building roofing material, re-accumulated on the ground surface in the area previously subjected to recovery efforts. Since 2016, DEQ RRD staff and START personnel have noted additional ACBM on the Site and bordering properties during implementation of SI and IR activities. Evidence of this is provided by two of the photographs in **Attachment C** that show the same segment of access roadway in August 2017 (after roofing was again removed to allow truck traffic) and November 2017 (roofing again present). In addition, the DEQ AQD asbestos inspector observed and sampled Mineral Building roofing materials in July 2017 that had further re-accumulated in the MDOT ROW following the 2016 IRs that had removed all visible roofing materials from the ROW.

October 2017 DEQ RRD aerial photographs of the Mineral Building  
roof indicating its deteriorated condition.
